## MECHANICAL INSPECTION

907 Blue Willow Dr  
Houston TX 77042

DECEMBER 29, 2020

# PROPERTY INSPECTION REPORT

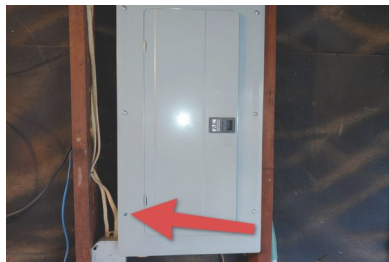
Garage

**1: Cover Plate - Missing screw**

The dead front cover for the breaker panel was missing one or more screws.

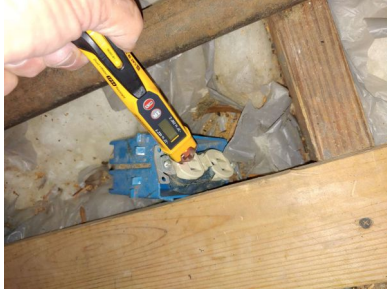
**2: Outlet - Damaged**

Attic near water heater  
An outlet was damaged and should be replaced.

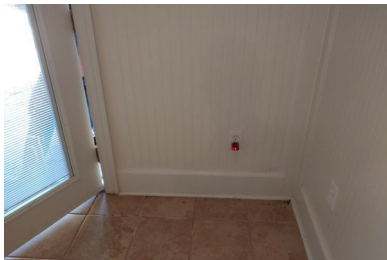
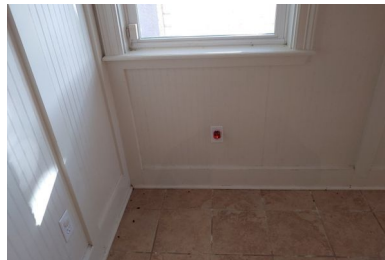
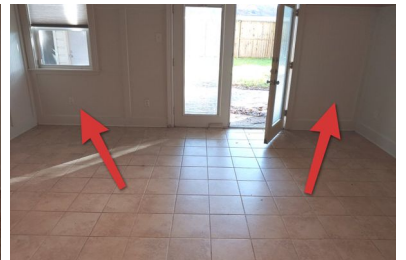
**3: Outlet - Ungrounded**

A three prong outlet that was not grounded properly and needs to be repaired. It is recommended that an electrician be contacted, and the necessary repairs made to the outlet.

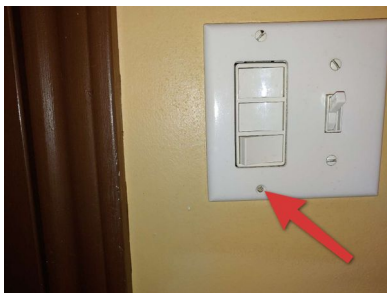
**4: Cover Plate - Missing screw**

A screw was missing on cover plate.

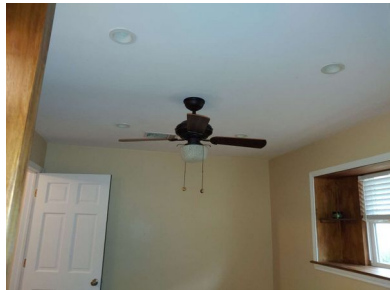
**5: Light Fixture - Nonfunctional**

The ceiling light fixtures were non-functional when the switch was on was observed. The problem may be a burned out bulb, defective light fixture, or defective switch.

**Further investigation is recommended.**

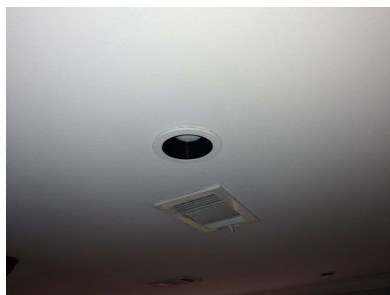
Master Bedroom

**7: Light Fixture - Loose on ceiling**

A light fixture was not properly secured to the ceiling.

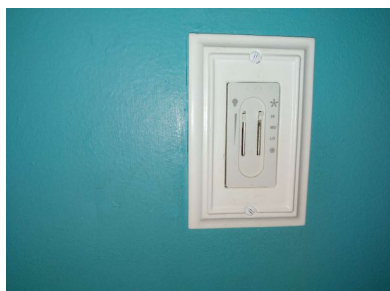
South Bedroom

**8: Switch - Dimmer Knob damaged/missing**

A dimmer switch whose knob was damaged/missing was observed.

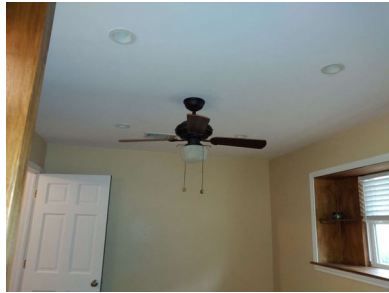
The ceiling fan was nonfunctional.

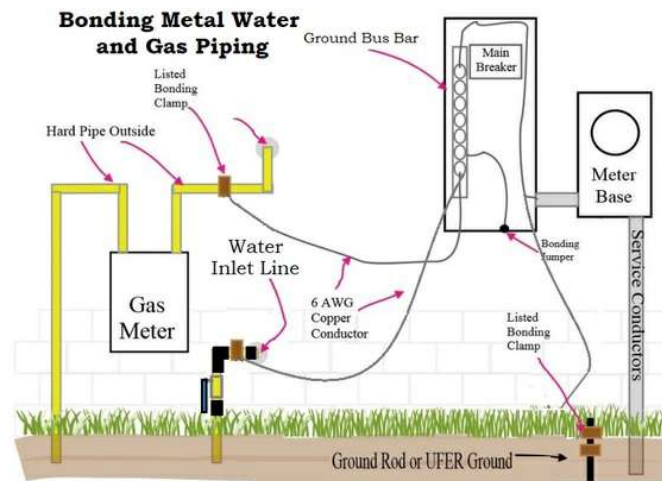
**11: Gas and Water Piping - Bonding Not visible**

The location(s) where the water supply piping and gas supply piping were bonded together and/or back to the electrical ground system were not visible at the time of the inspection. It is recommended that an electrician be contacted to determine if the plumbing in the house is properly bonded and to make any needed repairs.

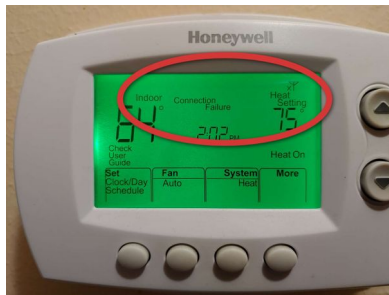
The thermostat was damaged and needs to be repaired or replaced. The unit was flashing 'Connection Failure' during operation and the furnace would cycle off.

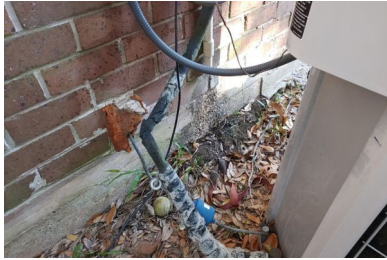
The insulation for the low pressure refrigerant line is partially missing and needs to be replaced to prevent condensation from dripping from the line and to promote proper refrigeration cycling.

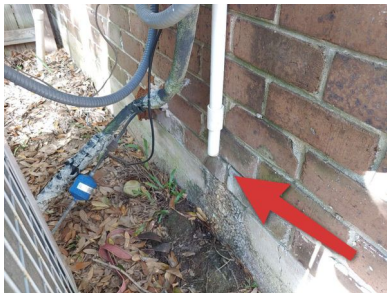
The primary condensate drain line terminates outside at the South side of the foundation. Over time, the constant moisture that is produced by the HVAC system and emptied onto the ground can contribute to foundation settlement. The drain line should be rerouted to an approved location.

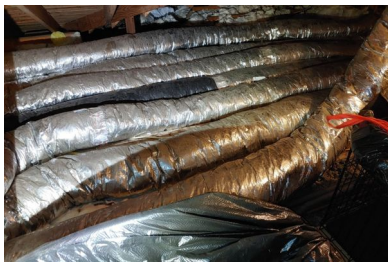
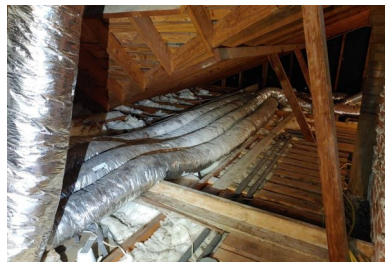
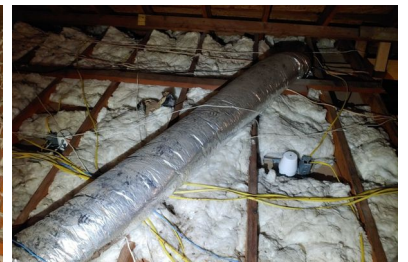
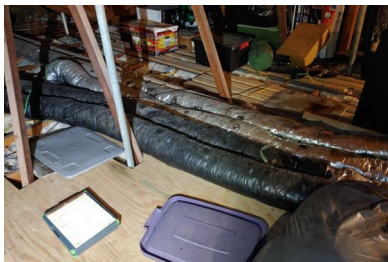
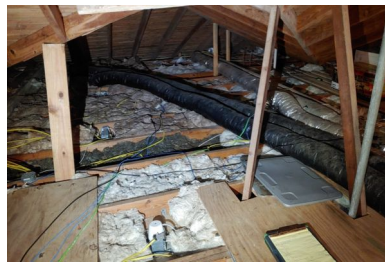
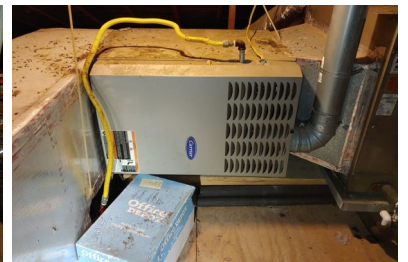
**2: Ducts - Not supported properly**

The ducts were laying on the insulation and ceiling joints and are not supported properly. The ducts should be supported in accordance with the manufacturer's installation instructions, which typically includes hanging the ducts from the rafters supported by 1 1/2 inch straps spaced approximately every four feet. Have a service company make the necessary repairs.

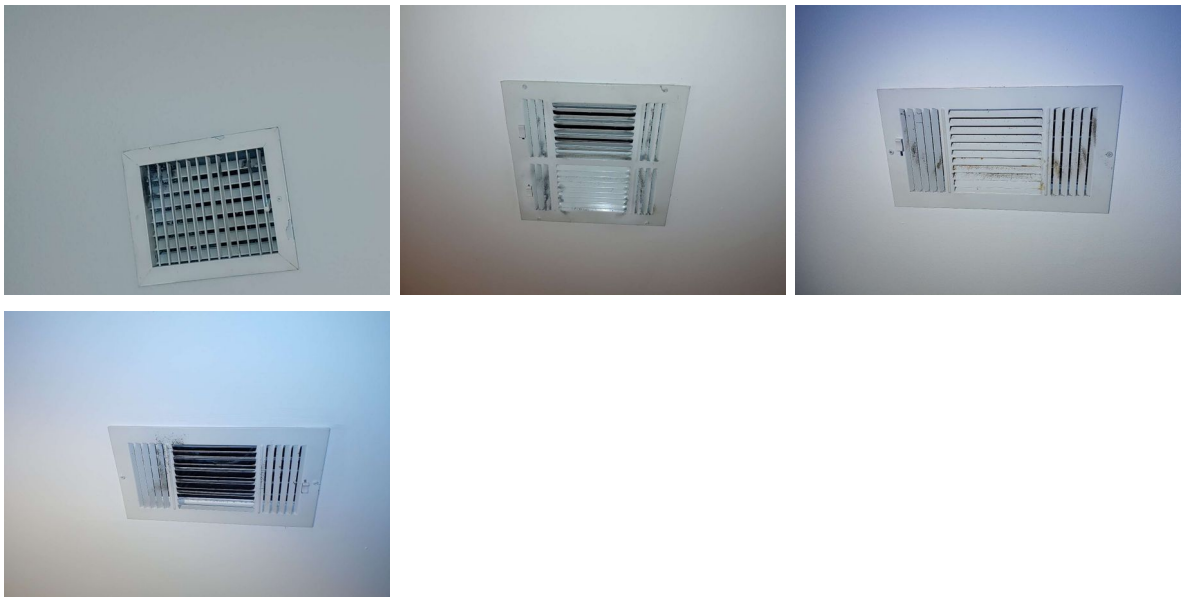
Throughout House

**3: Registers - Dirty**

The registers and adjacent ceiling areas were covered with debris that has passed through the air conditioning duct work. Have a service company check the inside of the duct work to determine if there is a build-up of debris, and to clean the ducts if necessary.

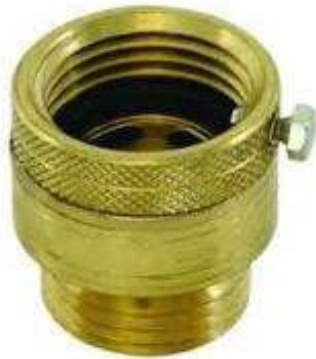
The atmospheric vacuum breaker devices were missing at one or more of the hose bibbs, and it is recommended that they be installed to prevent cross connections, which can allow contaminated water to enter the potable water supply.

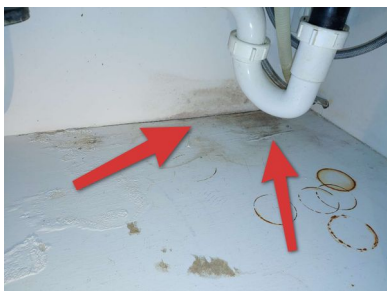
Kitchen Sink Cabinet

**3: Water Stains/Damage/Microbial Growth**

Water damage/stains were observed indicating a current or previous leak. It is pointed out that a microbial growth was observed in the affected area apparently due to an extended period of elevated moisture levels. The source of the condition was not determined, with certainty, at the time of the inspection. Further investigation is recommended with a contractor to determine the source of the condition and to make any necessary repairs to correct the moisture condition and, if present, any secondary damage.

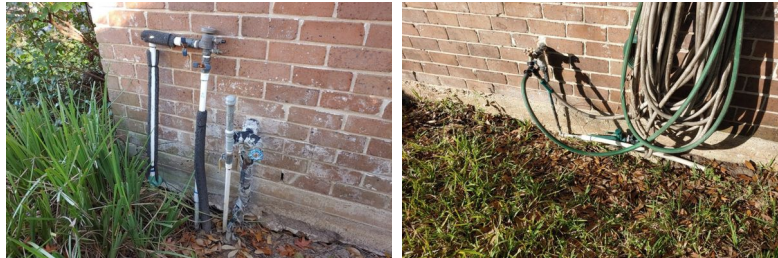
South side

#### **4: Insulate Exterior Water Piping**

Exterior water piping that was not properly insulated was observed. It is recommended that the piping be properly insulated.

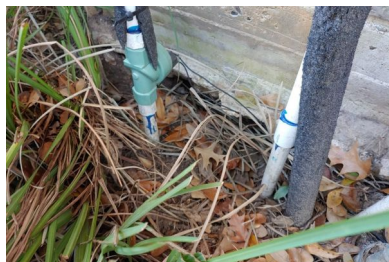
#### **5: Inlet Water Line - Possible Underground Leak**

The ground in the vicinity of the inlet water line was muddy and/or had an unusual depression in the ground possibly indicating a plumbing leak. Further investigation is recommended with a plumber.

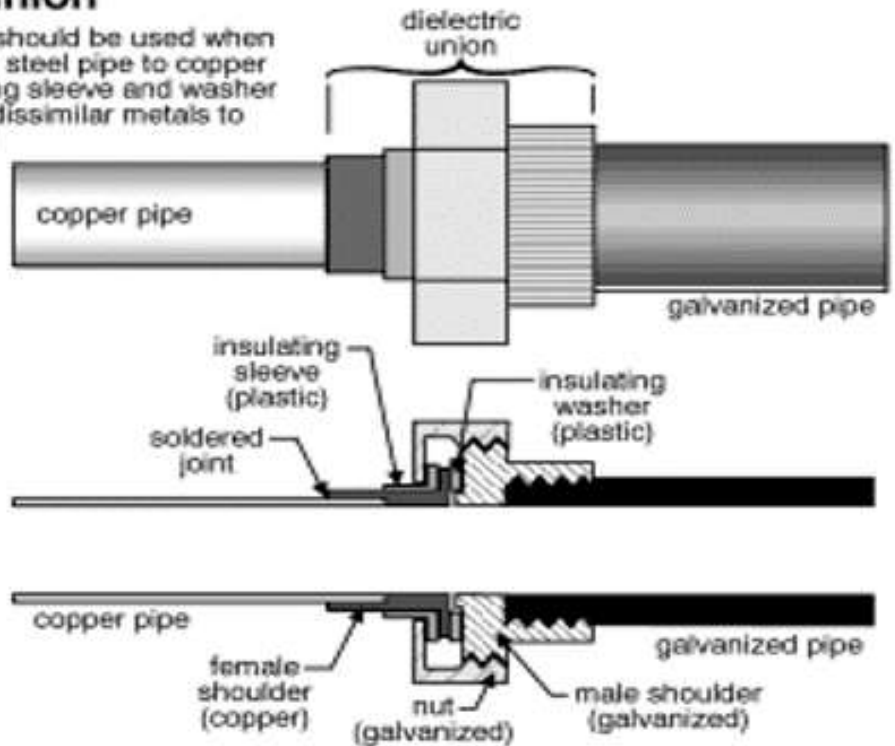
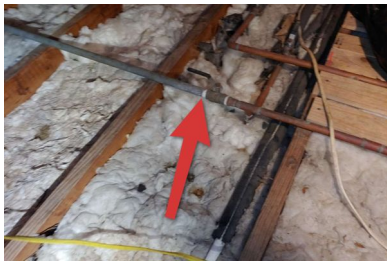
#### **6: Dielectric unions missing**

a dielectric union should be used when joining galvanized steel pipe to copper pipe - the insulating sleeve and washer separate the two dissimilar metals to prevent corrosion

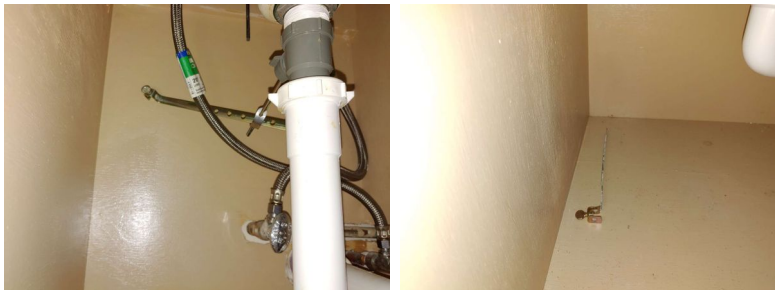
Master bathroom at both sinks

### 7: Sink Drain Stopper - Linkage disconnected

The linkage was disconnected on the drain stopper, and the stopper was nonfunctional.

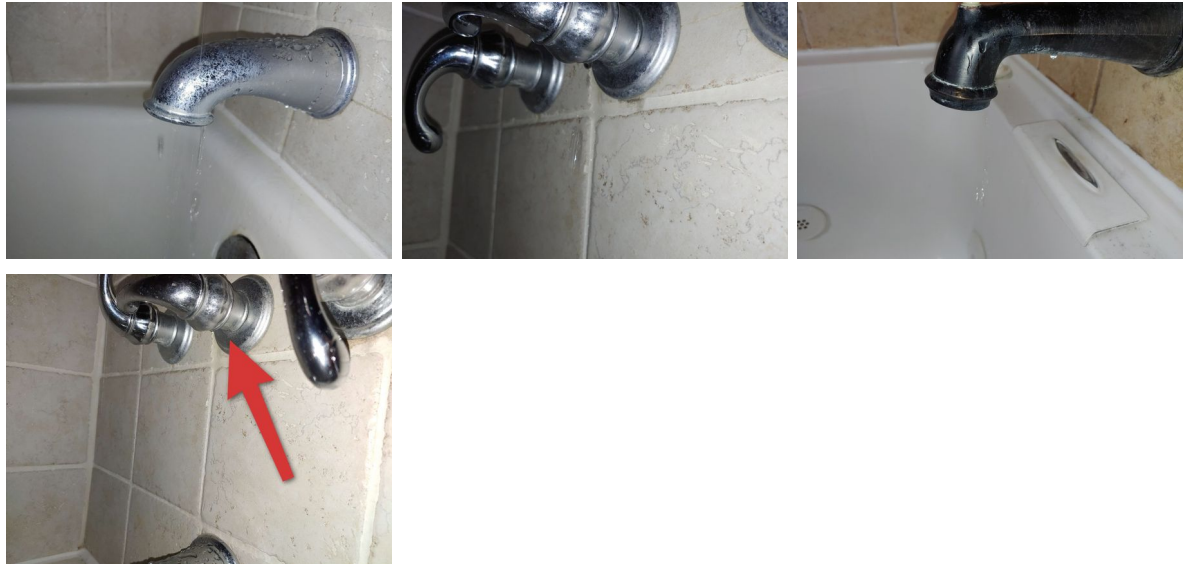
The diverter valve was leaking water past the valve when the valve was turned to the shower.

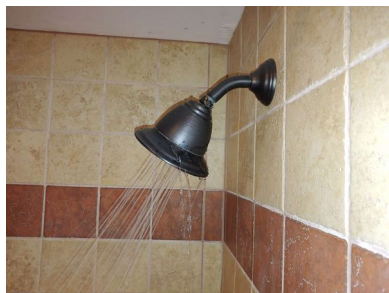
Master bathroom

**10: Shower/Tub - Shower head leak**

The shower head was leaking at the connection and needs to be repaired.

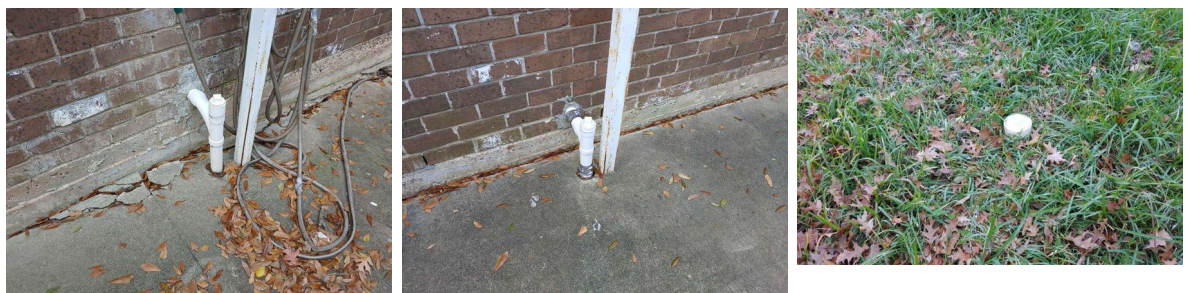
*Sewer Piping - Evidence of repairs observed:* PVC clean out present, PVC drain(s) extended through wall and rerouted -

Evidences of sewer line repairs and/or replacement were observed. It is noted that we could not determine the extent of the repairs to the sewer system or if any of the original cast iron piping is still active. Further investigation is recommended with the owner and/or a service company to determine the extent of the repairs and to determine if any further repairs are needed. A sewer inspection with a plumber to verify the extent of the repairs and the condition of the sewer piping and repairs is recommended.

**Further investigation is recommended**

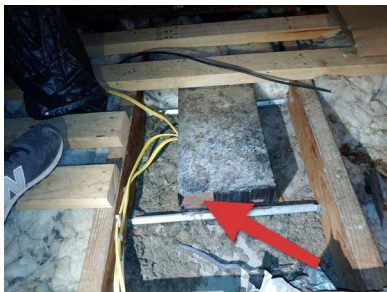
No vent pipe installed

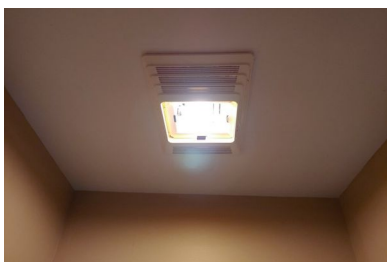
**2: Exhaust Fan- Cover missing**
