**This Professional Inspection Report Has Been Prepared Exclusively For:**

**Christopher Noland  
31525 Timber Grove Ln Lot 3206  
Spring, TX 77386  
May 10, 2018**

## PROPERTY INSPECTION REPORT

By: Alfonso Ulloa, Lic #21313 05/10/2018  
(Name and License Number of Inspector) (Date)

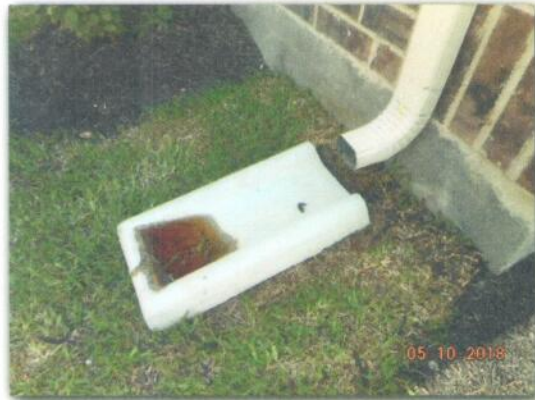
**X:** All gutter down-spouts should terminate into proper, solid splash blocks to catch water from downspout and prevent soil erosion at slab by routing water away from house, prevent expansion of clay soils and ponding near the home. It was noted that all splash blocks throughout the perimeter of the house are placed backwards; the short lip is intended to be at the back (close to slab/house) to prevent water backing up.

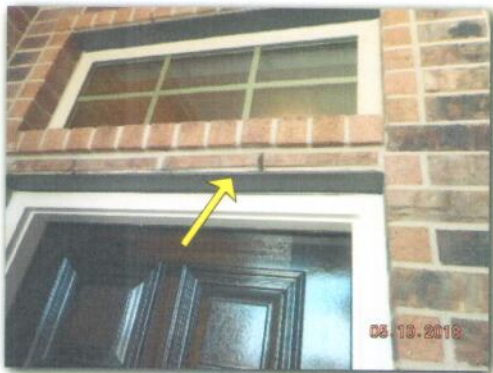
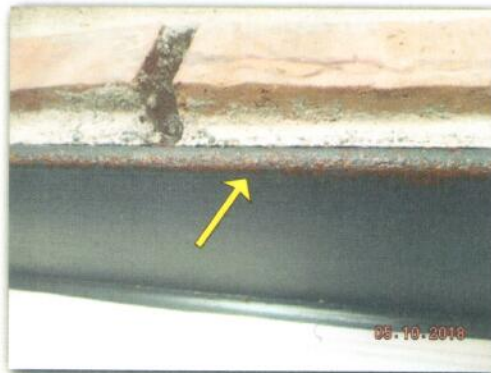
^: Metal lintels deteriorated from rusting. Lintels at exterior walls should be cleaned and painted with "Rust-Oleum" paint to prevent deterioration. Some locations include: above main front door and above vehicle garage door.

**^:** Metal lintels deteriorated from rusting. Lintels at exterior walls should be cleaned and painted with "Rust-Oleum" paint to prevent deterioration. Some locations include: above main front door and above vehicle garage door.

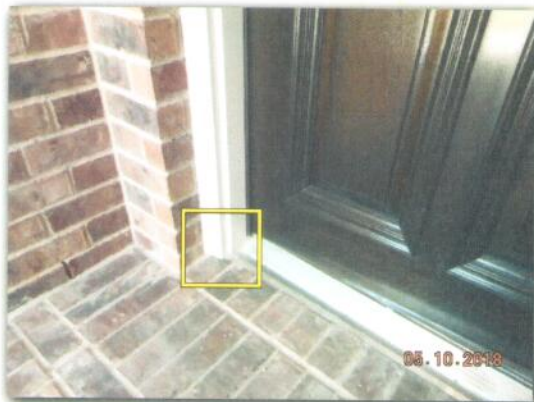
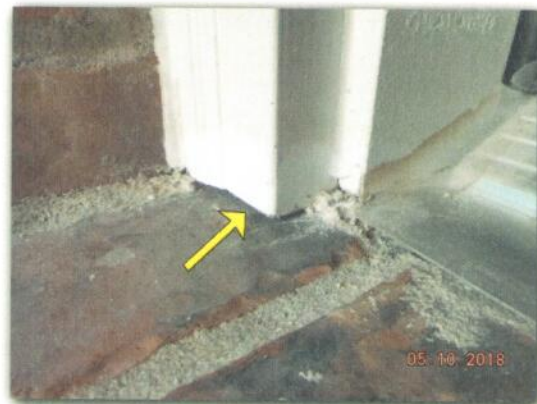
**X:** Recommend caulking all exterior door casings down to the floor to prevent rot. Caulk was noted missing at the front and rear doors.

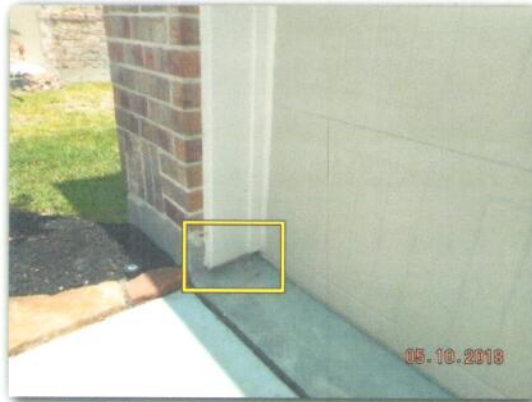
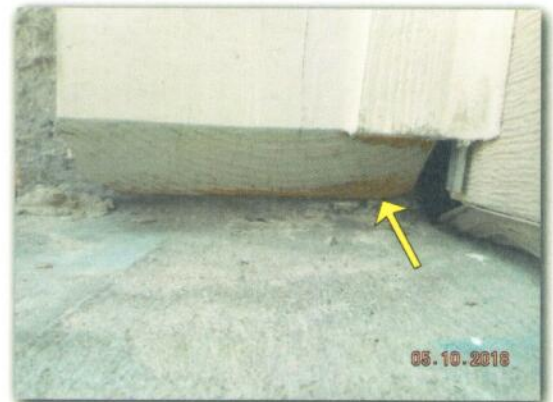
**X:** The garage vehicle door casings are angle cut to allow painting in order to prevent material breakdown. The angle cuts were not fully painted.

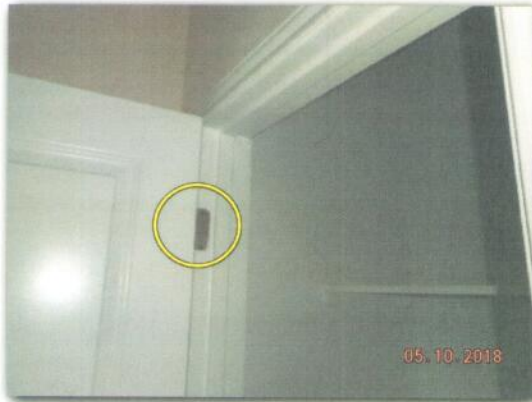
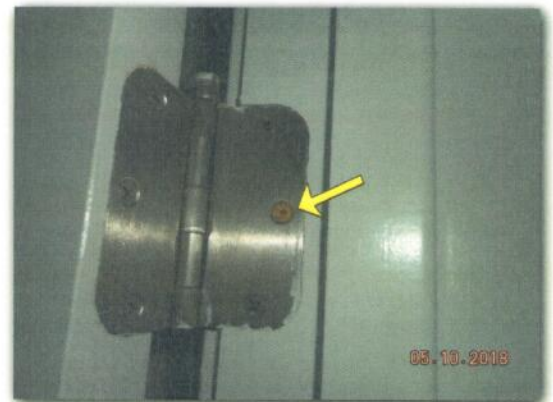
X: Missing one hinge screw on master bathroom's closet door (top hinge).

**X:** Missing one hinge screw on master bathroom's closet door (top hinge).

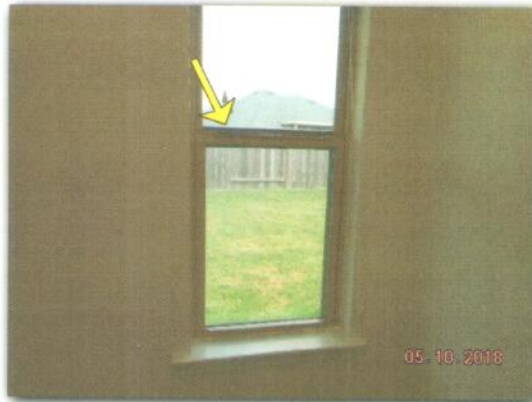
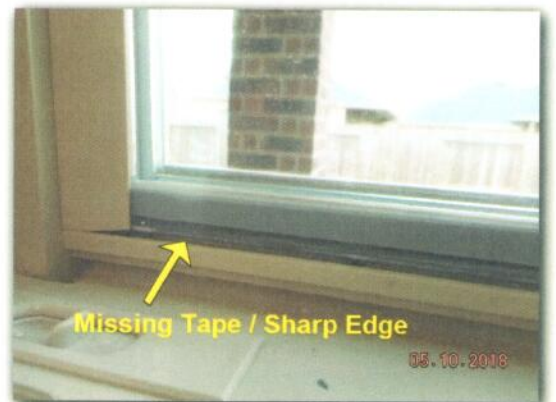
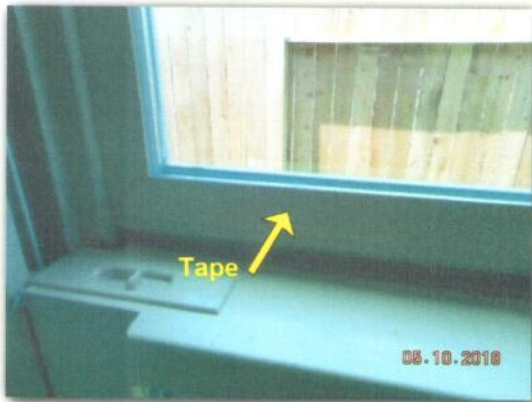
X: The seal tape to cover the glass edge at the interior, was noted missing at the following locations: laundry, master bedroom right window and study right window. Without the tape, the sharp edge of the glass pane is exposed.

**X:** The seal tape to cover the glass edge at the interior, was noted missing at the following locations: laundry, master bedroom right window and study right window. Without the tape, the sharp edge of the glass pane is exposed.

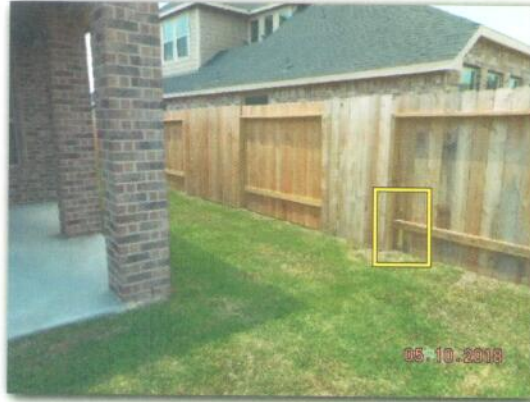
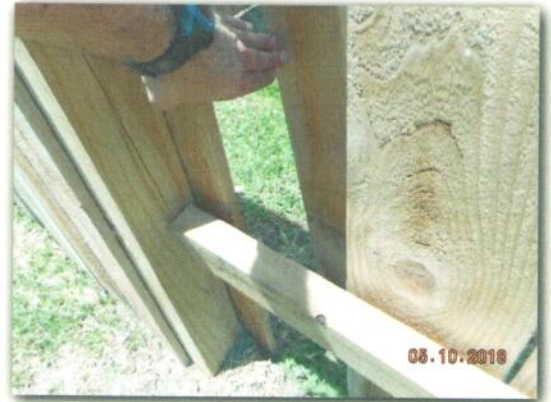
▲: A loose board was noted on the exterior wooden fence, at the right side of the home (close to rear porch). Secure board.

**^:** A loose board was noted on the exterior wooden fence, at the right side of the home (close to rear porch). Secure board.

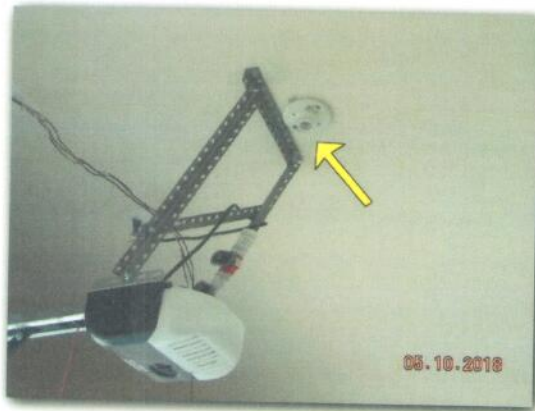
**X:** Light fixture inoperable, due to missing light bulb, inside the garage.

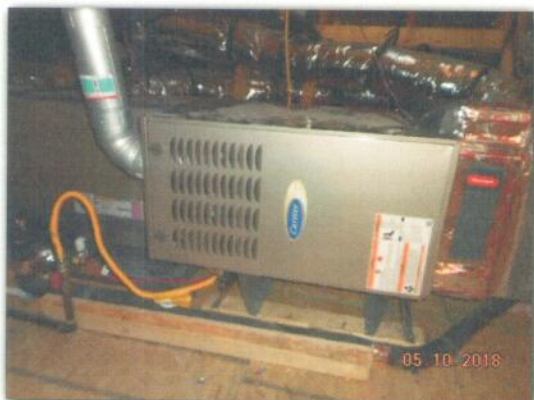
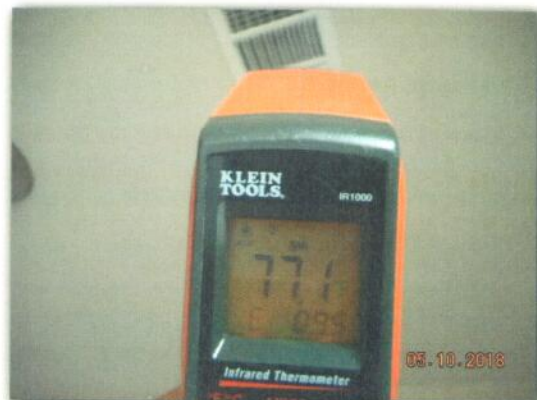
**X:** Heating system did not respond to controls when tested. Heating equipment should be checked/serviced by licensed HVAC technician to determine necessary repairs.

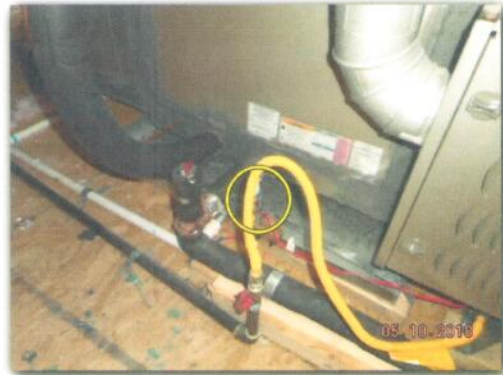
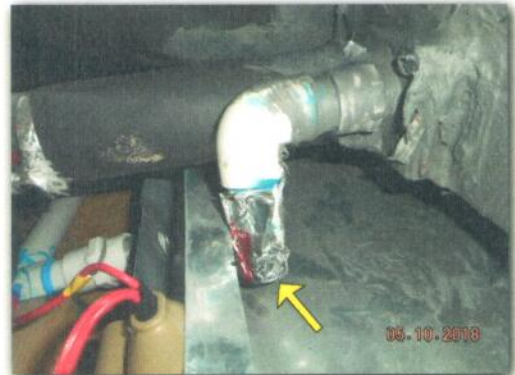
^: The secondary drain line that comes out of the evaporator coil cabinet in the attic, is taped and will not fulfill its purpose of draining condensate into the emergency pan if needed.

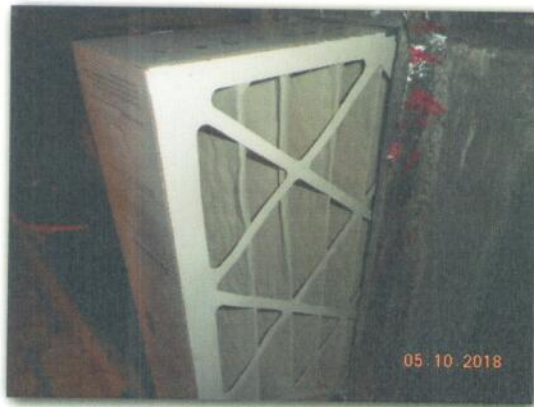
**X:** Dirty media filter was noted in line with the air handler in the attic. It should be changed regularly for an efficient operation of the cooling/heating equipment. Dirty media filters can cause dirty coils at the evaporator which can have a negative effect on the performance of the A/C system.

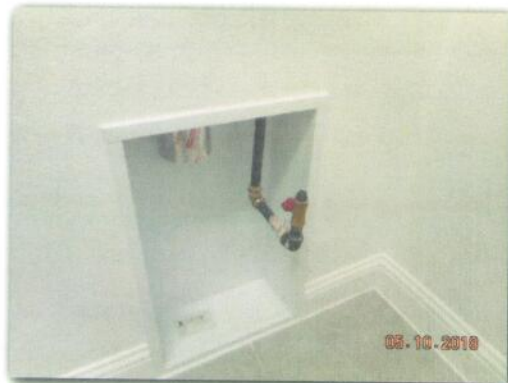
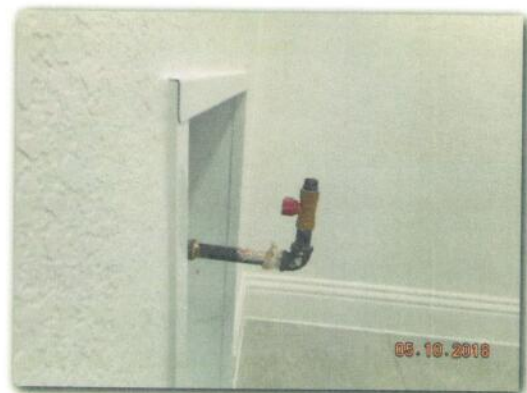
**X:** The gas pipe and valve for the dryer is sticking out to much at the laundry room. It should be closer to the wall.

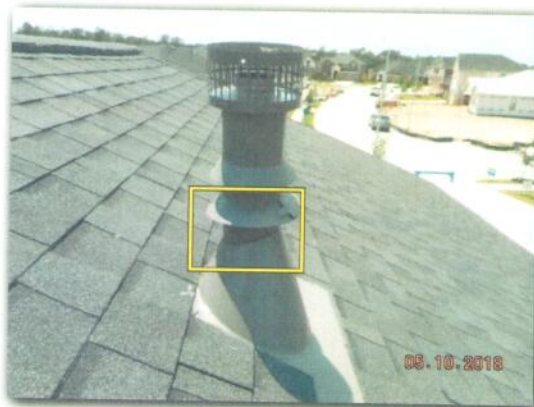
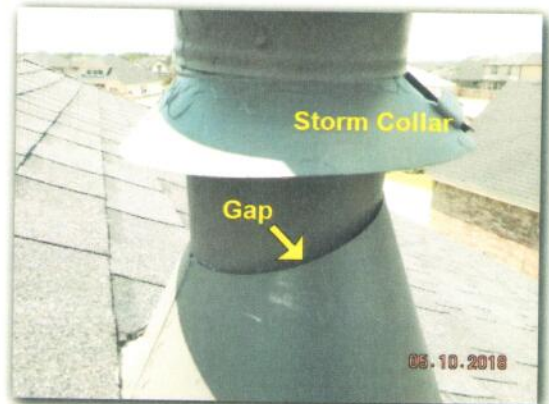
**X:** The storm collar above the roof, is placed too high and it does not cover adequately the gap around the flue pipe, where it meets the flashing. The storm collar should be sealed and placed right above the roof flashing, to prevent water penetration.

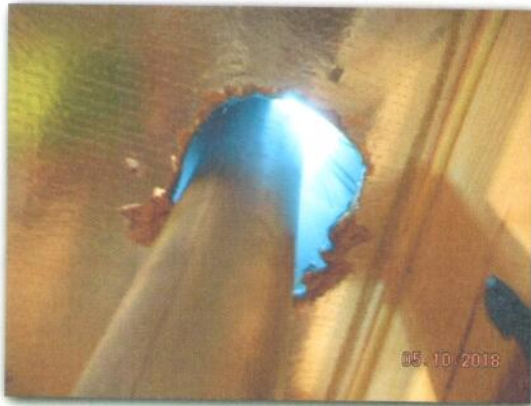
**X:** Daylight around the water heater exhaust flue was noted from inside the attic. This gap might allow water penetration and should be sealed above the roof.

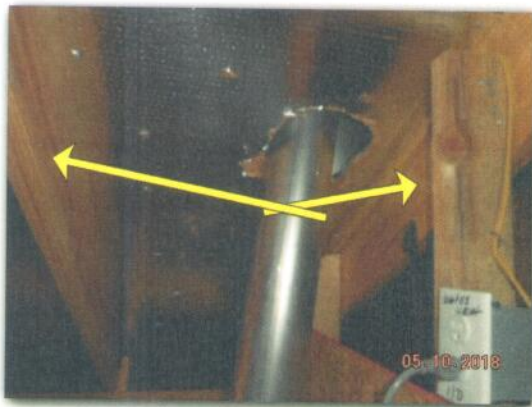
**X:** The water heater flue vent is not properly secured in the attic space. It should be secured to the adjacent wood rafters with a metal strap, to prevent any contact with combustible materials (wood roof sheathing), which may start a fire. This is a safety hazard.

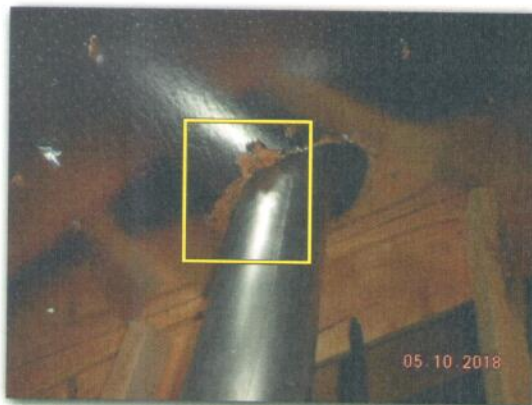
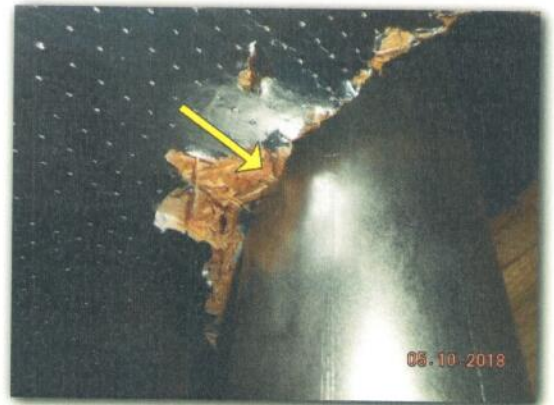
**X:** Water heater flue vent is in contact with the roof wood sheathing (combustible). This is a fire hazard. Recommendation: provide adequate clearance to combustible materials around the water heater exhaust vents (minimum 1 inch clearance, or verify manufacturer guidelines).
