Inspection Report

Property Address:
34518 Lake Side Dr
Brookshire TX 77423

PROPERTY INSPECTION REPORT

By: S. Brad Williams TREC# 23549 / Sunbelt Inspections 1/23/2021

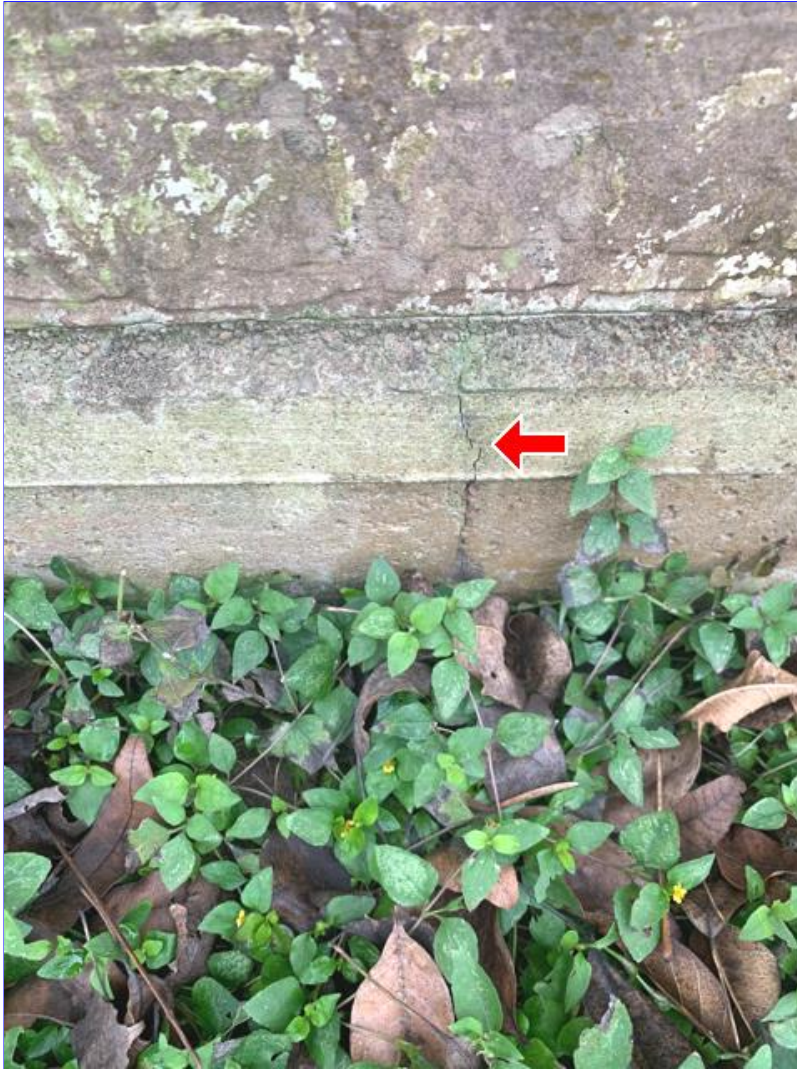
(1) There is some slab edge cracking. There is little to no deflection across the crack. This type of flexural crack is generally the result of seasonal variations in soil moisture causing the soils to shrink and/or swell exerting pressure on the foundation.

A. Photo 1(Picture) There is some slab edge cracking. There is little to no deflection across the crack. This type of flexural crack is generally the result of seasonal variations in soil moisture causing the soils to shrink and/or swell exerting pressure on the foundation.

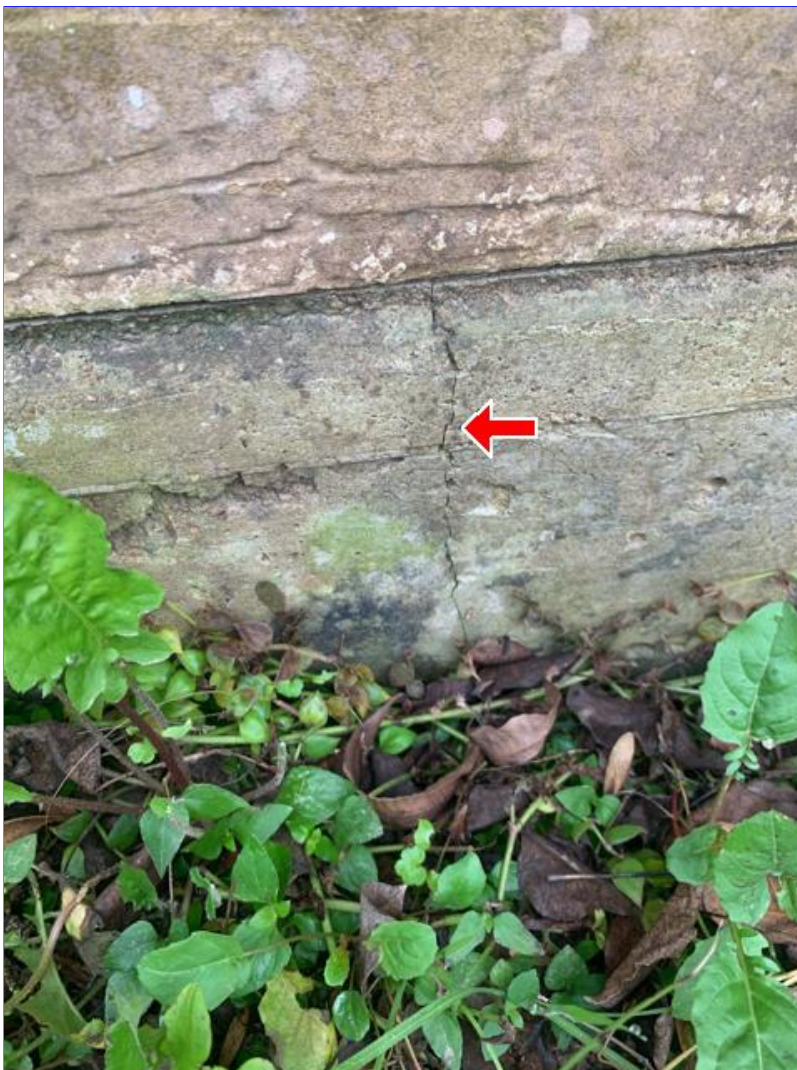
A. Photo 2(Picture) There is some slab edge cracking. There is little to no deflection across the crack. This type of flexural crack is generally the result of seasonal variations in soil moisture causing the soils to shrink and/or swell exerting pressure on the foundation.

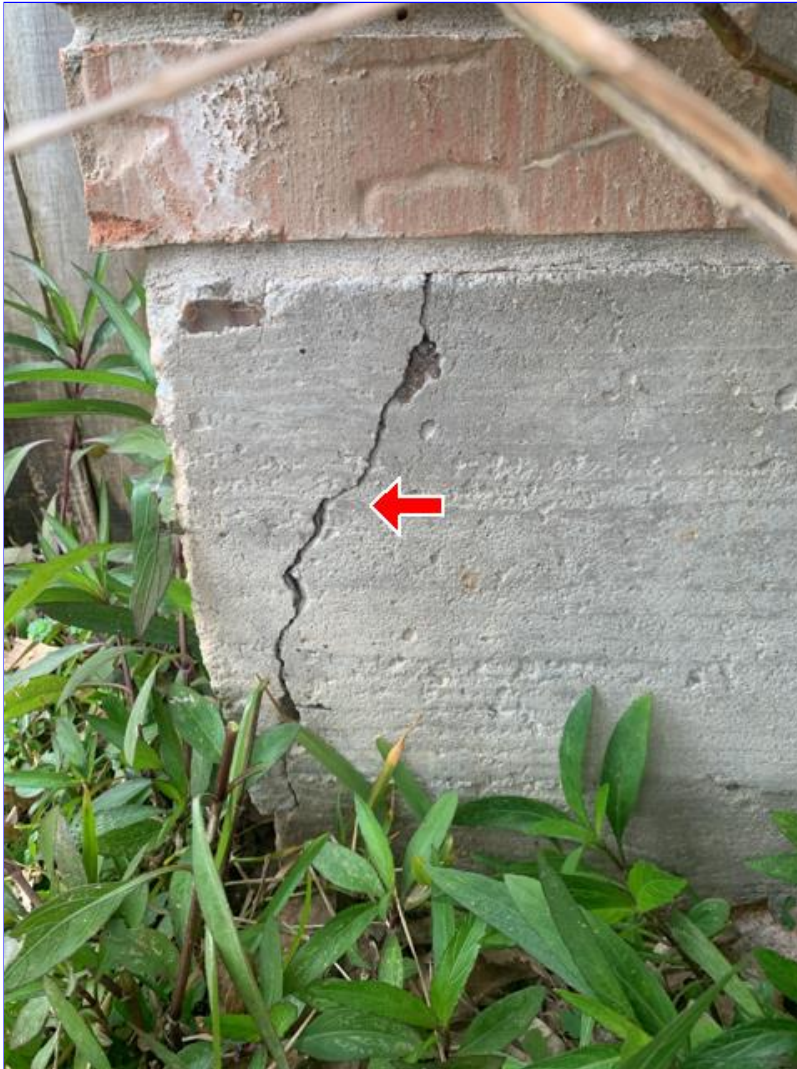
A. Photo 3(Picture) Typical corner "pops" observed at foundation corners. This condition is cosmetic in nature and not structurally significant.

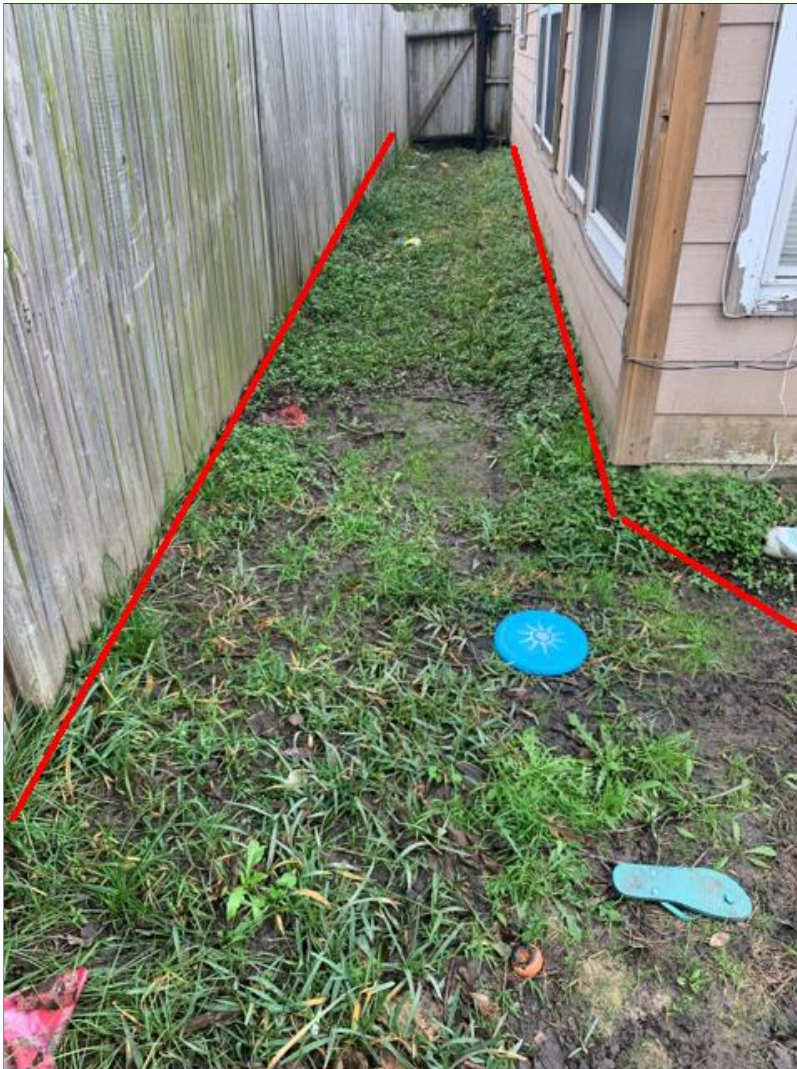
B. Photo 1(Picture) Drainage swales at rear and sides of home appears to have low spots. Water will most likely pool in the drainage swales and not drain normally towards the street. Possible remedies might include the installation of catch basins, or French Drains at low spots connected to underground drain pipe to the street.

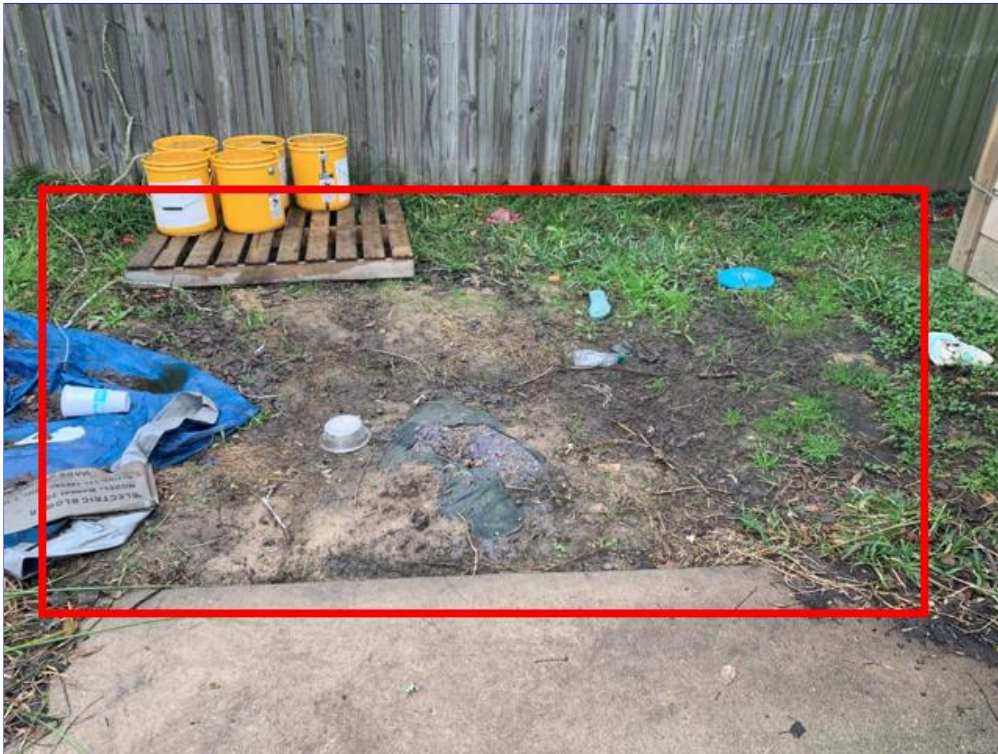
B. Photo 2(Picture) Drainage swales at rear and sides of home appears to have low spots. Water will most likely pool in the drainage swales and not drain normally towards the street. Possible remedies might include the installation of catch basins, or French Drains at low spots connected to underground drain pipe to the street.

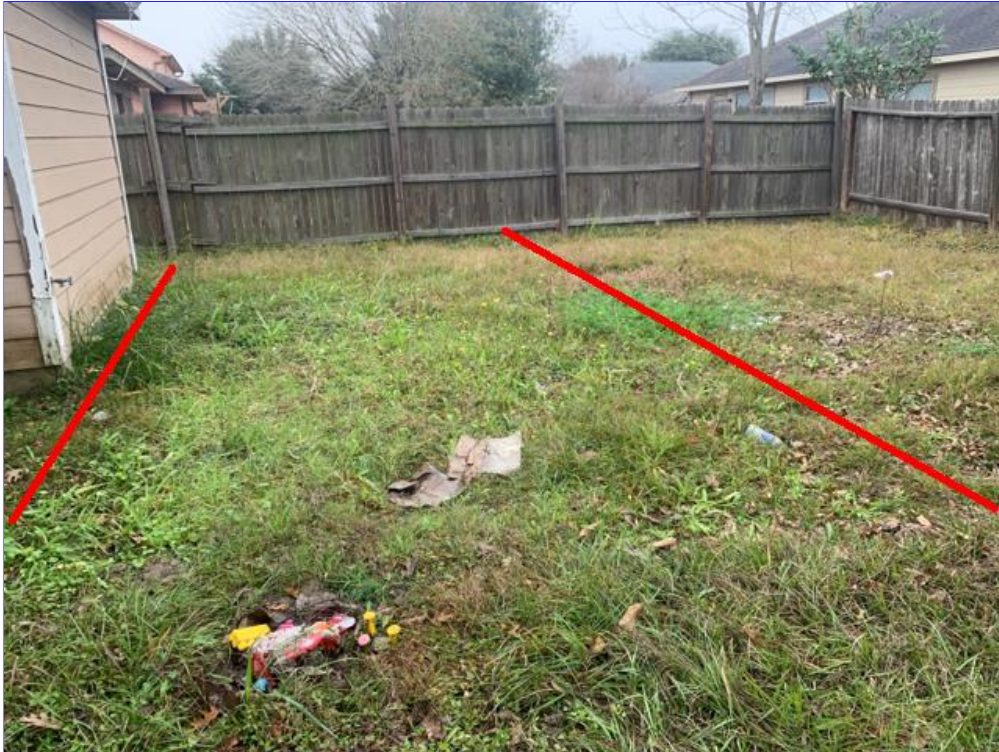
B. Photo 3(Picture) Drainage swales at rear and sides of home appears to have low spots. Water will most likely pool in the drainage swales and not drain normally towards the street. Possible remedies might include the installation of catch basins, or French Drains at low spots connected to underground drain pipe to the street.

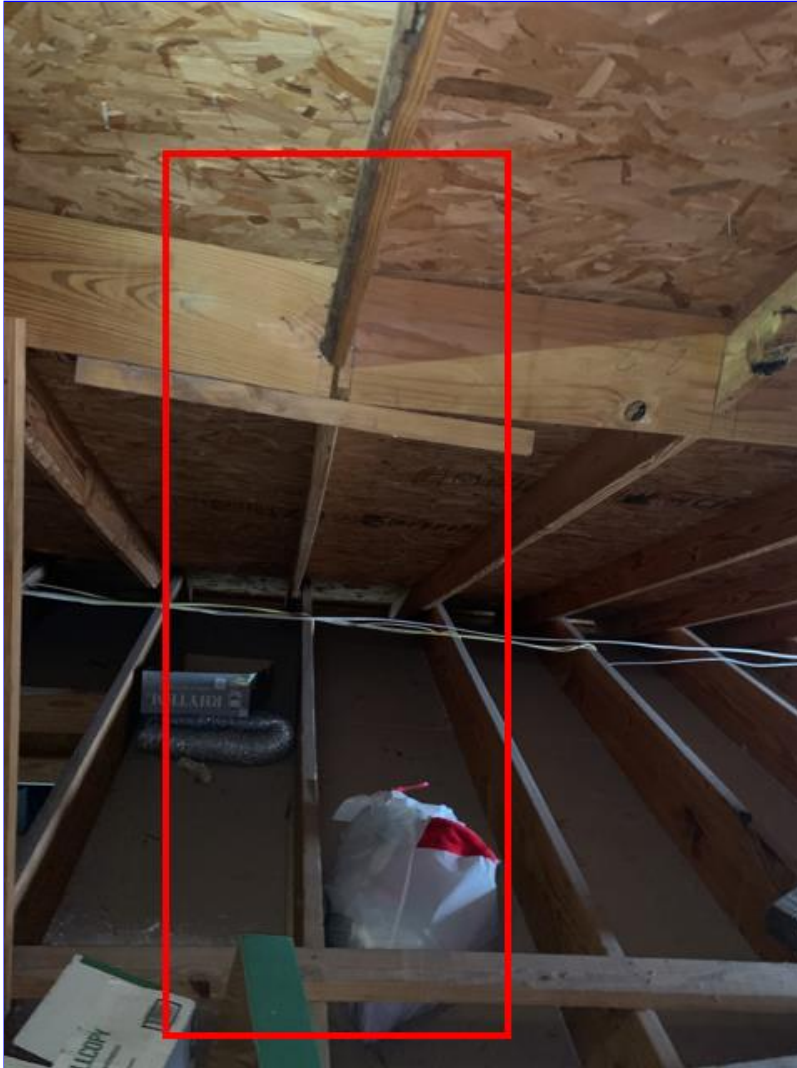
In the attic, above the garage, where the garage ridge beam ties in to the purlin beam, it is not properly spliced nor supported.

D. Photo 1(Picture) In the attic, above the garage, where the garage ridge beam ties in to the purlin beam, it is not properly spliced nor supported.

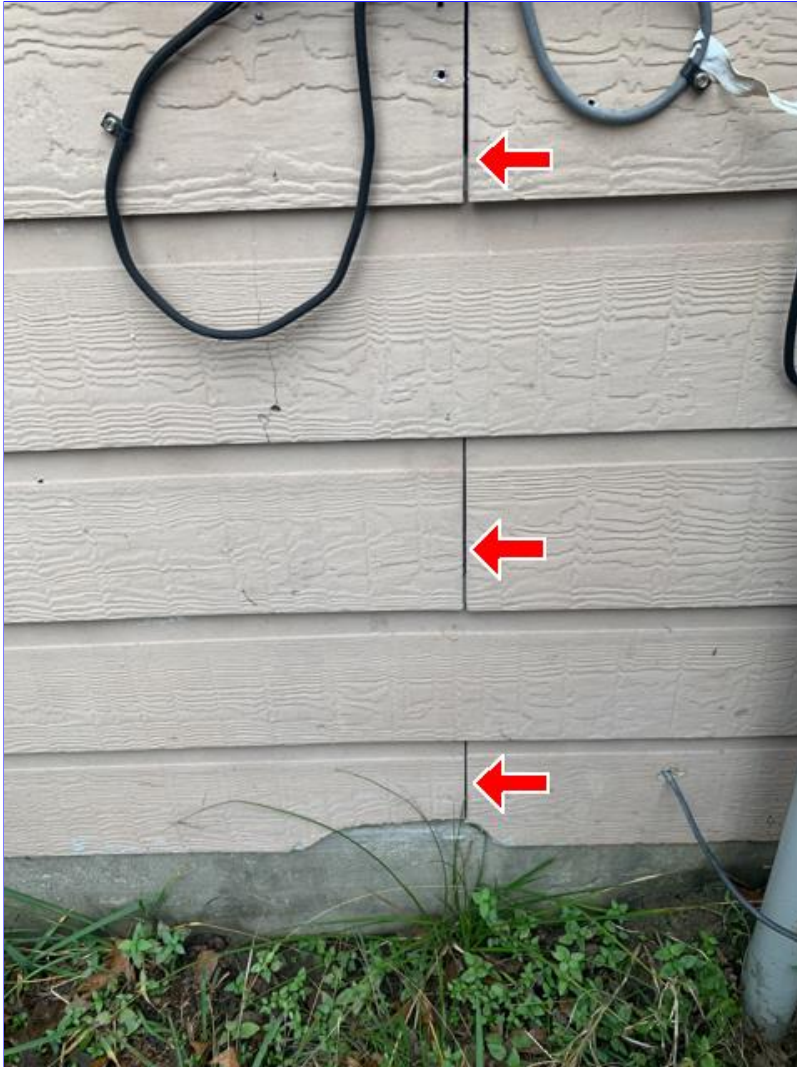
E. Photo 1(Picture) Areas were observed, where the brick, siding and/or trim needs to be resealed.

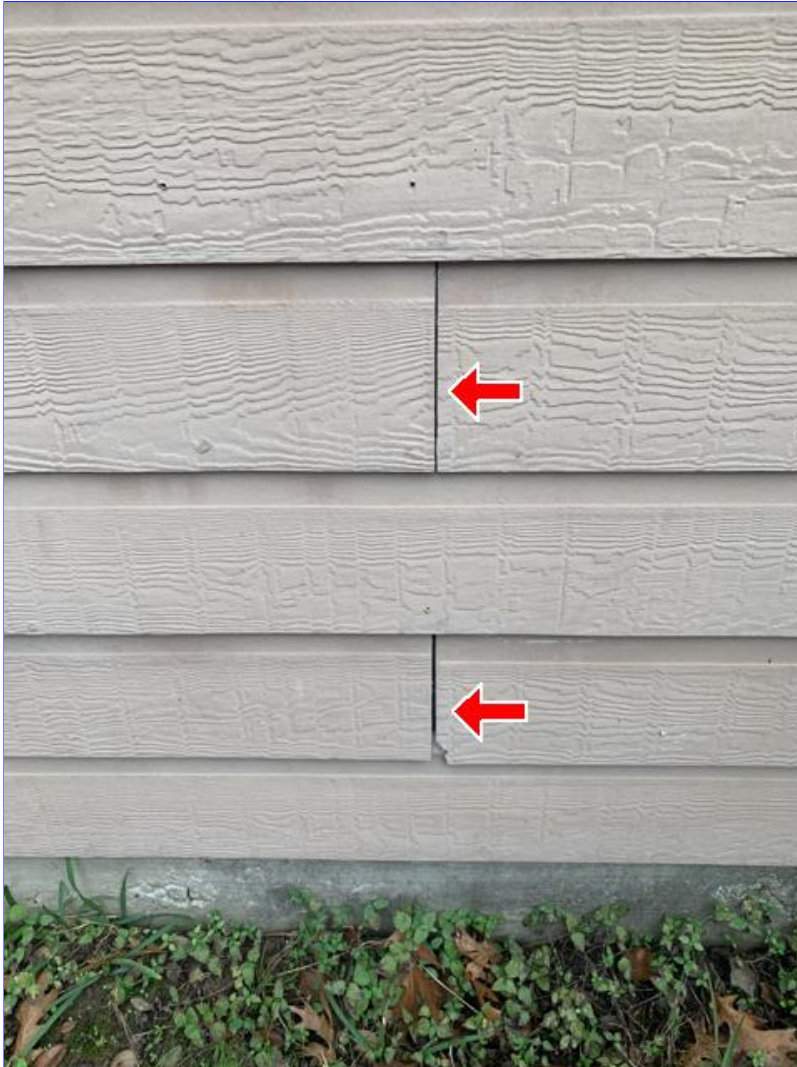
E. Photo 2(Picture) Areas were observed, where the brick, siding and/or trim needs to be resealed.

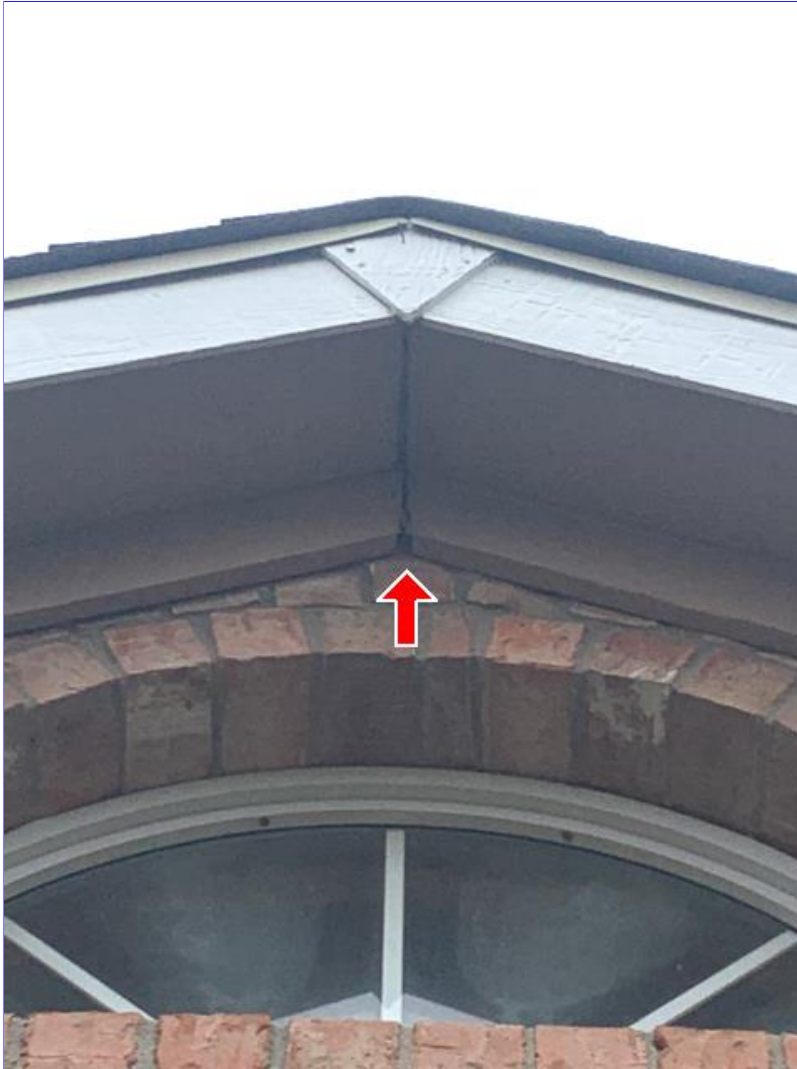
E. Photo 3(Picture) Areas were observed, where the brick, siding and/or trim needs to be resealed.

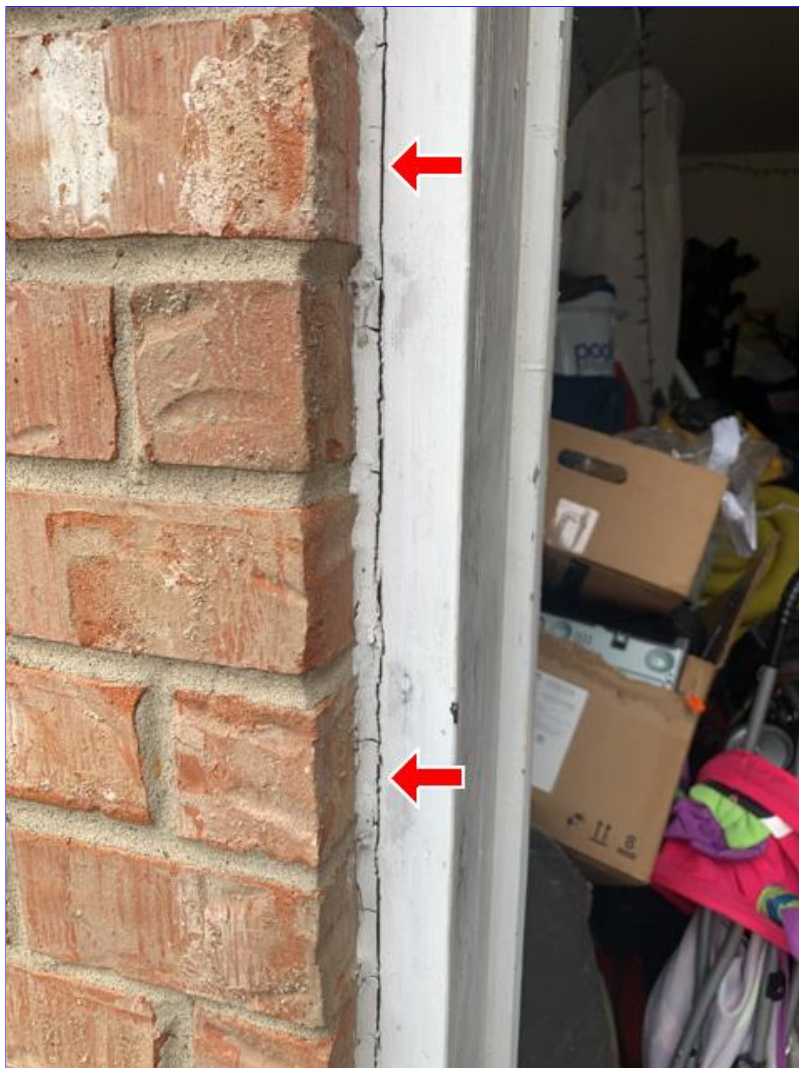
E. Photo 4(Picture) Areas were observed, where the brick, siding and/or trim needs to be resealed.

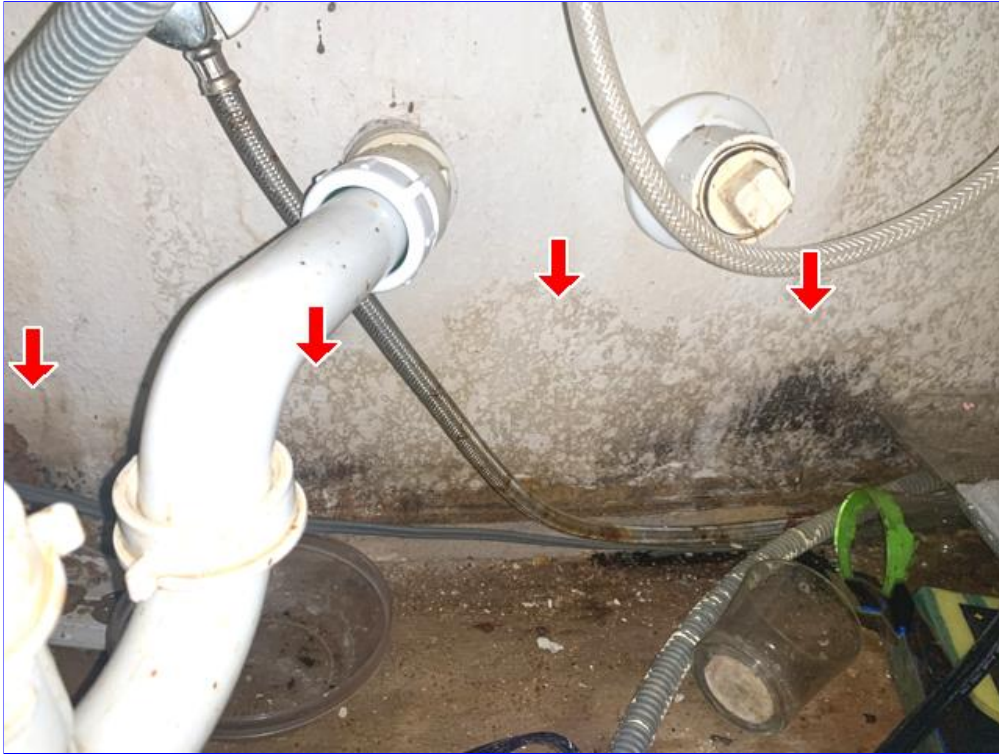
E. Photo 5(Picture) What appears to be Fungi or mildew is present. The identification of the organism(s) is beyond the scope of this home inspection. My recommendation is to remove moisture source and clean up the mold. Consult with a licensed mold remediation expert to determine the best method for remediation, estimate costs, and perform the remediation.

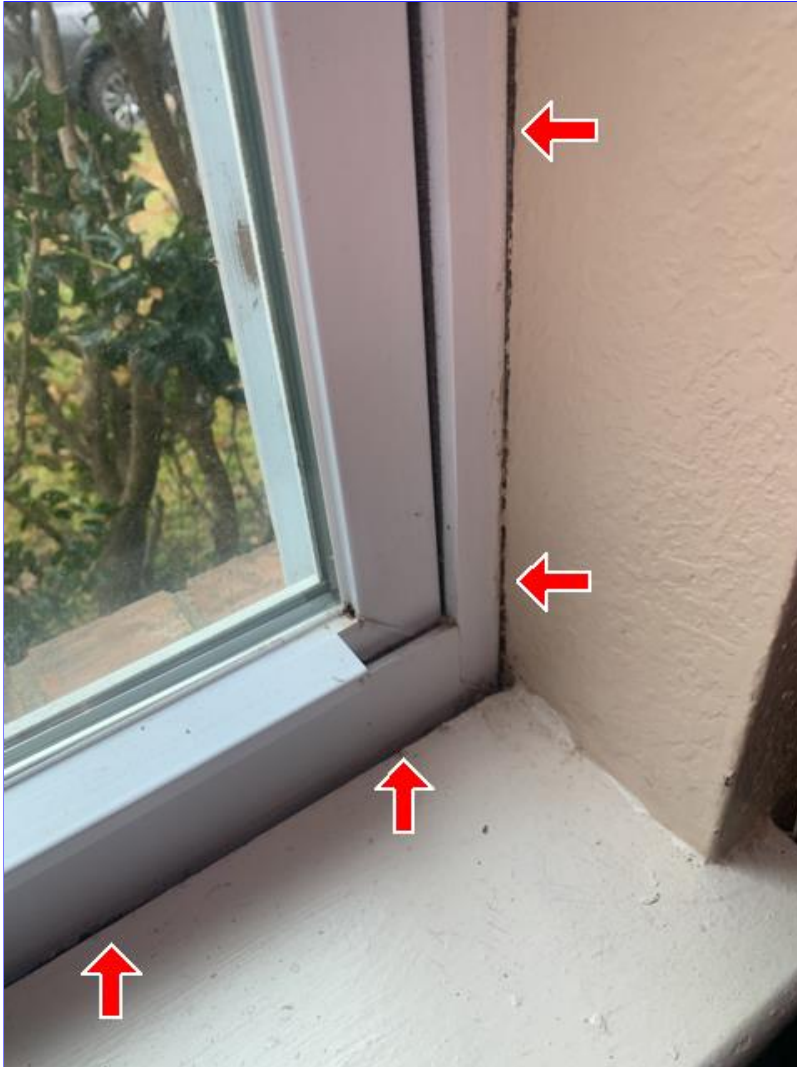
E. Photo 6(Picture) In the front right bedroom, the window needs to be sealed at the perimeter.

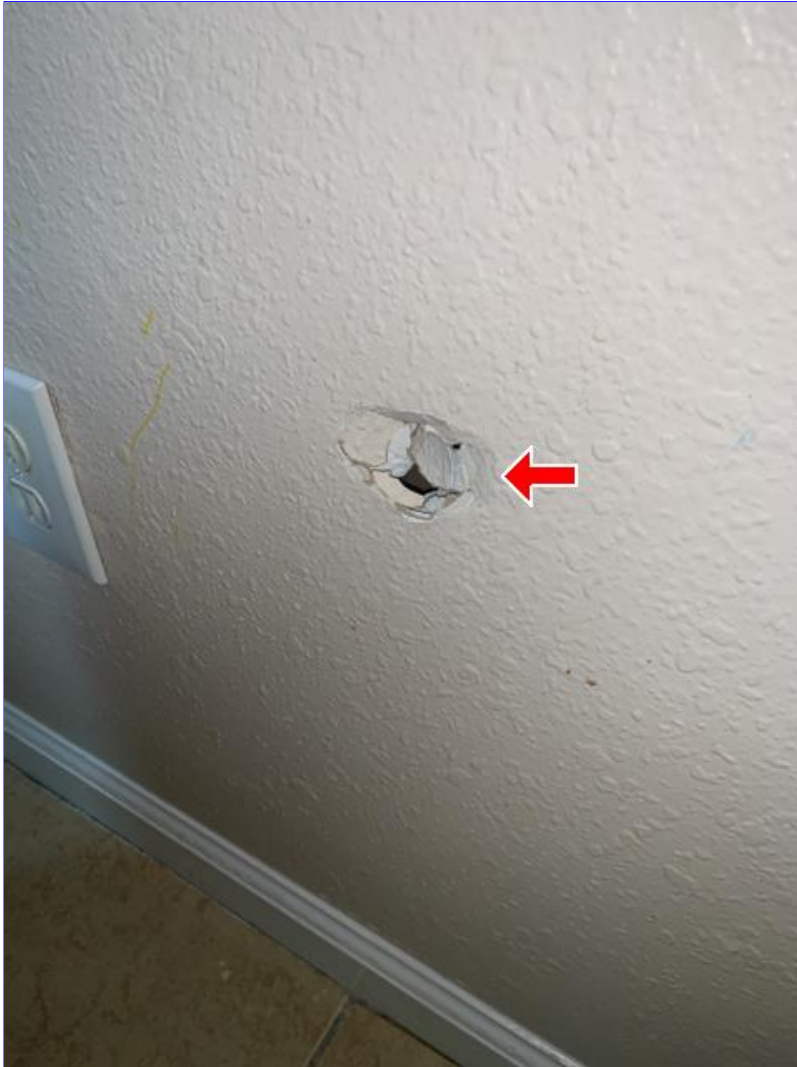
E. Photo 7(Picture) Drywall damage was observed in the second right bedroom

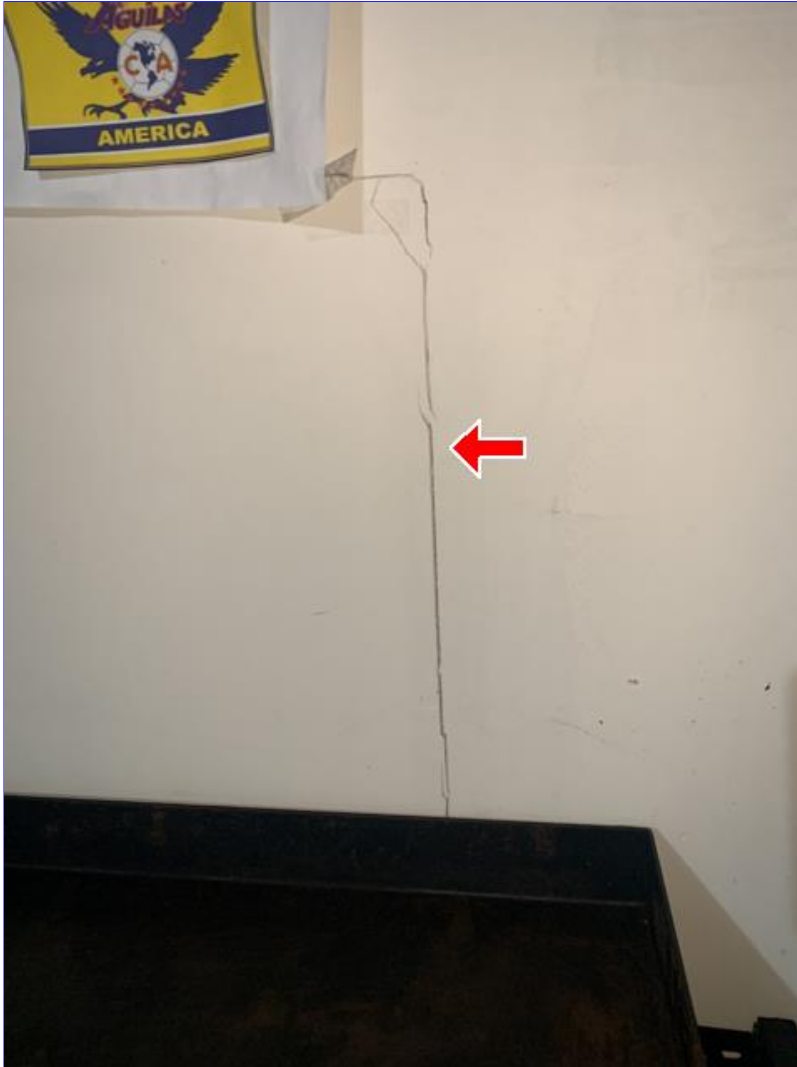
E. Photo 8(Picture) Drywall tape joint cracks and/or nail pops were observed around the home. These are cosmetic in nature, and can be repaired as needed.

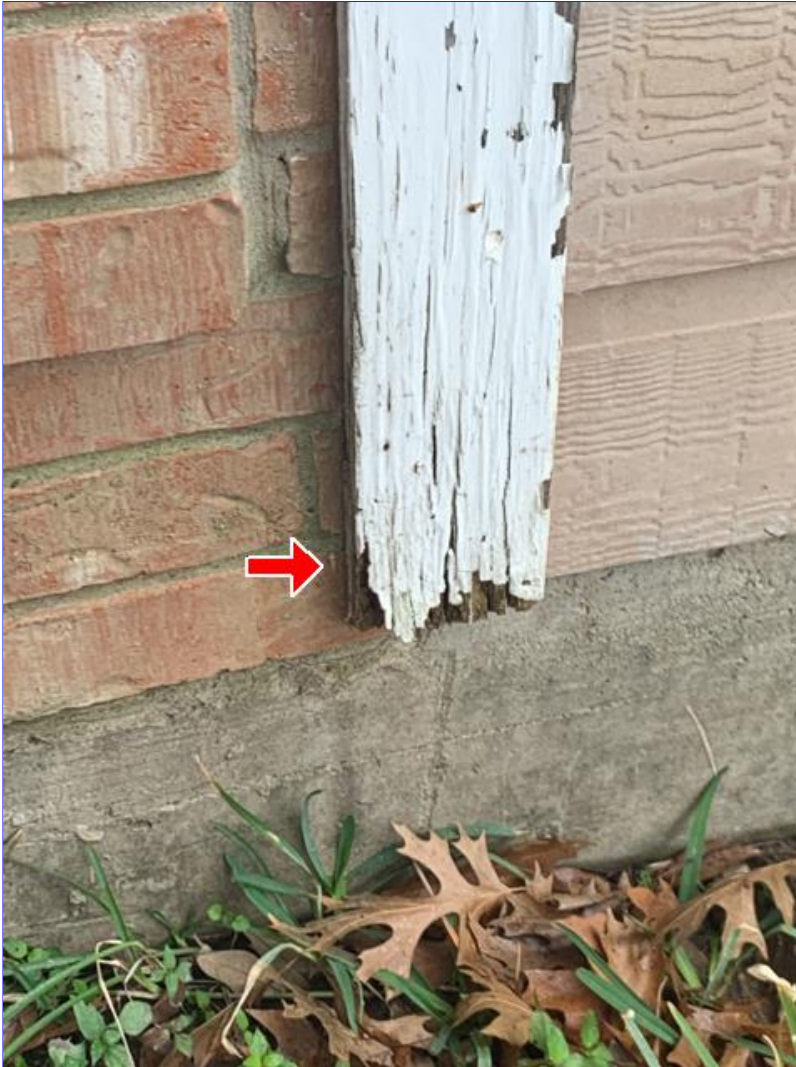
E. Photo 9(Picture) Areas of wood rot were observed on the trim boards.

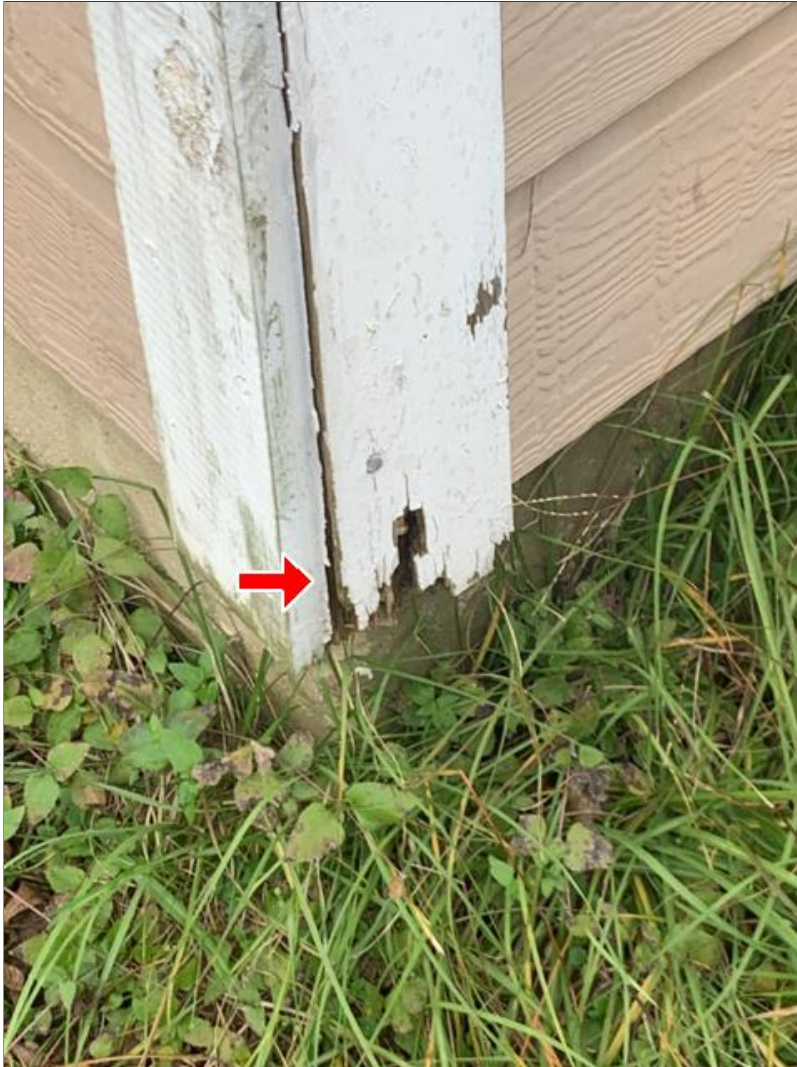
E. Photo 10(Picture) Areas of wood rot were observed on the trim boards.

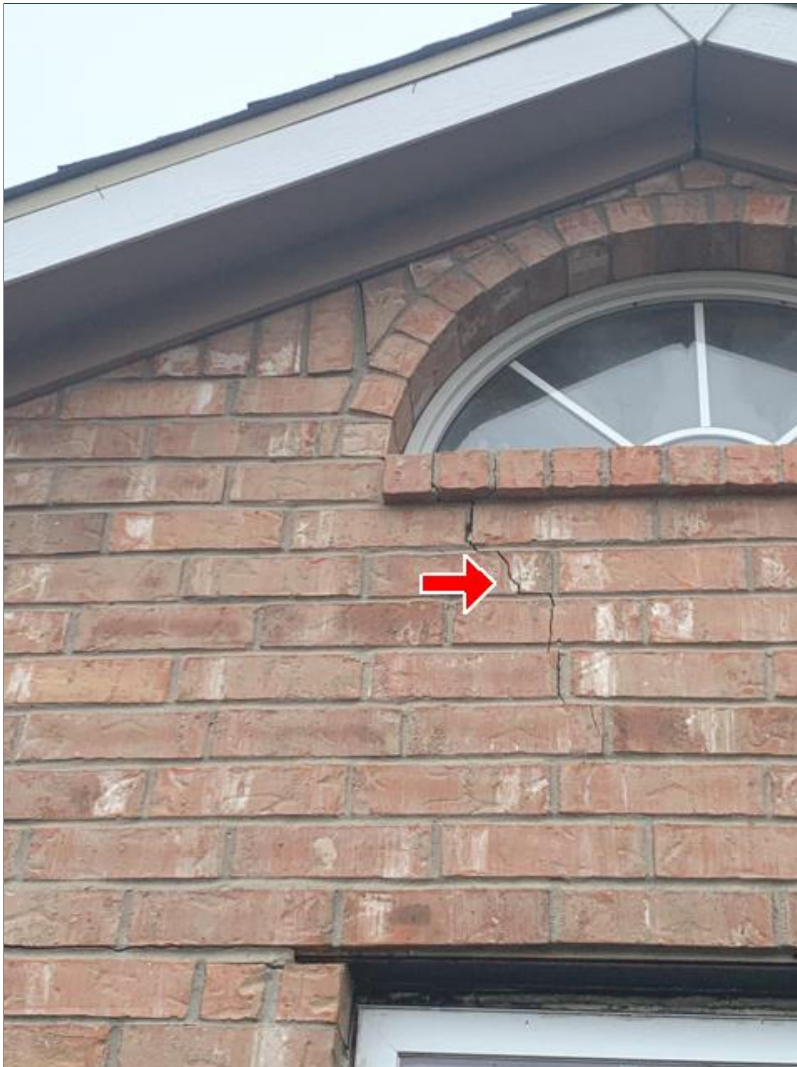
E. Photo 11(Picture) Brick veneer mortar cracks were observed. This condition is cosmetic in nature and not structurally significant. The cracking of the brick veneer is likely due to flexing of the foundation during repeated seasonal changes. The expansive clay soil in the area is prone to excessive swelling during rainy periods and shrinkage during dry periods.

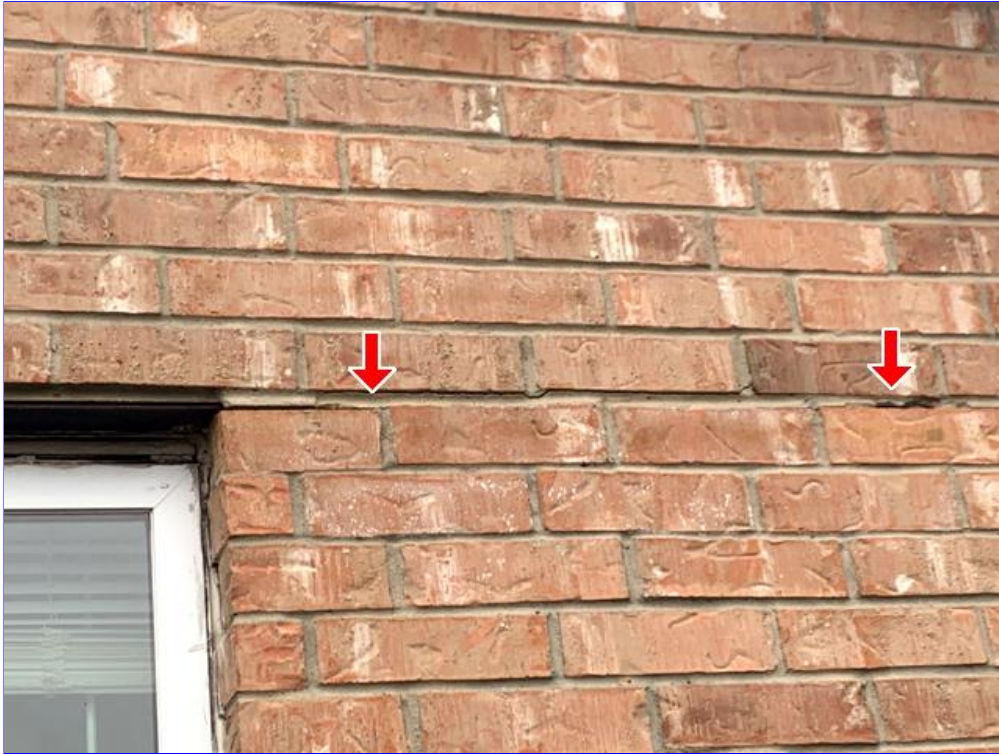
E. Photo 12(Picture) Brick veneer mortar cracks were observed. This condition is cosmetic in nature and not structurally significant. The cracking of the brick veneer is likely due to flexing of the foundation during repeated seasonal changes. The expansive clay soil in the area is prone to excessive swelling during rainy periods and shrinkage during dry periods.

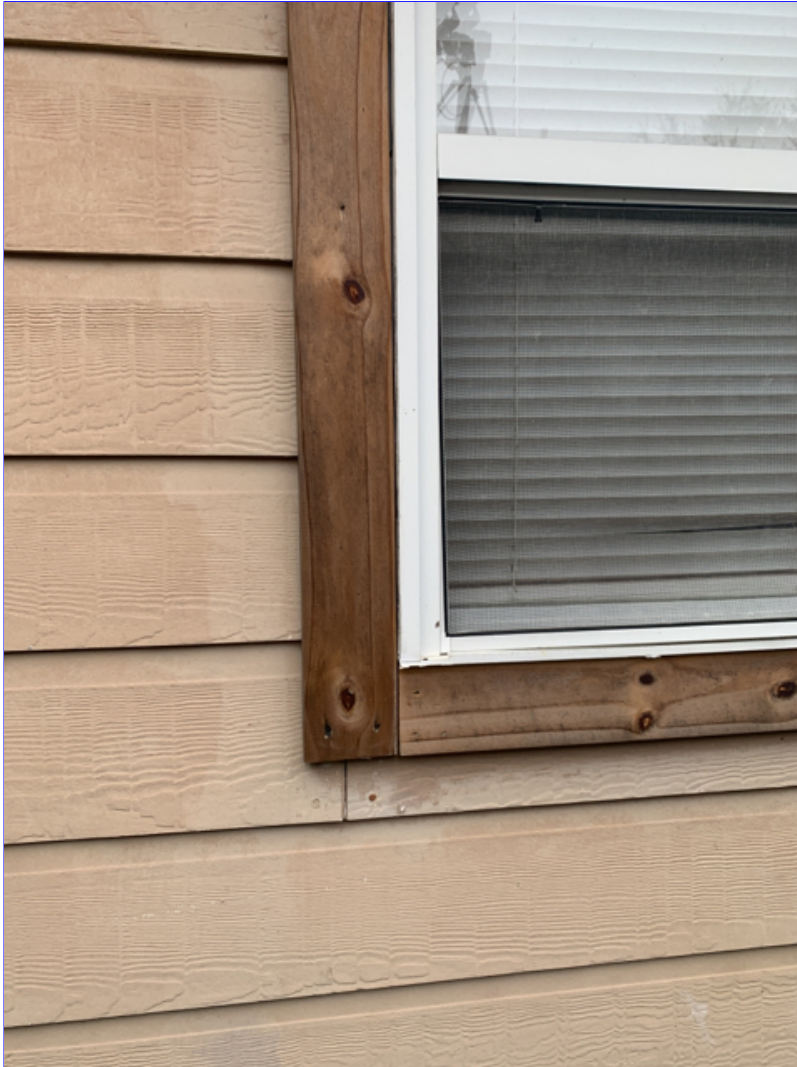
E. Photo 13(Picture) Areas of the home was observed to have bare wood. Recommend priming and painting.

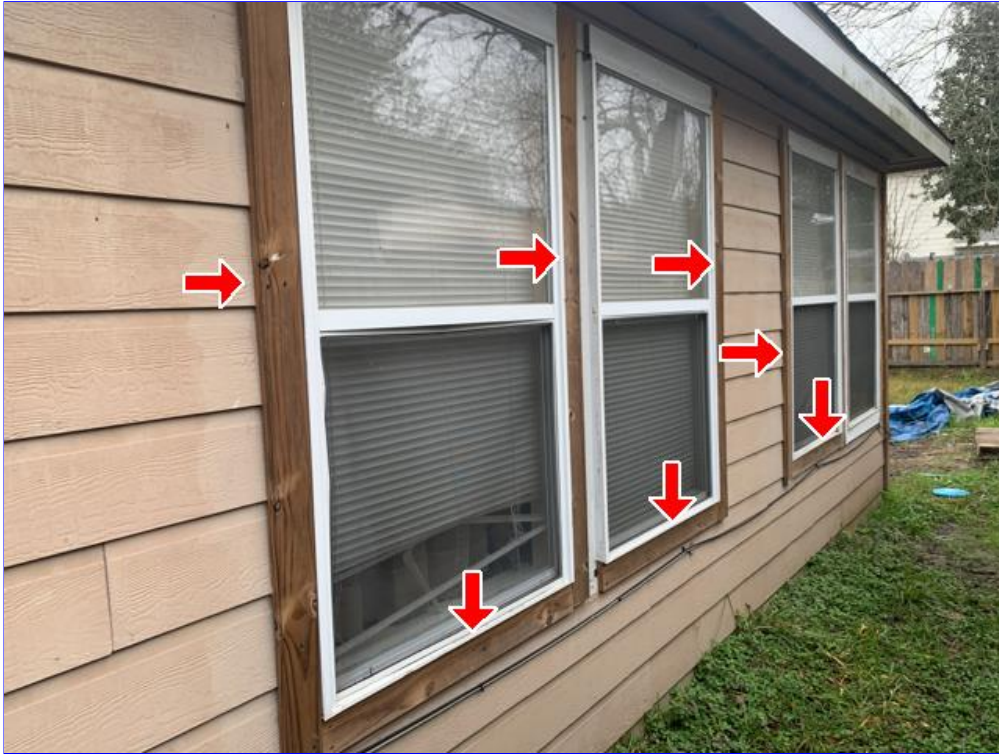
E. Photo 14(Picture) Areas of the home was observed to have bare wood. Recommend priming and painting.

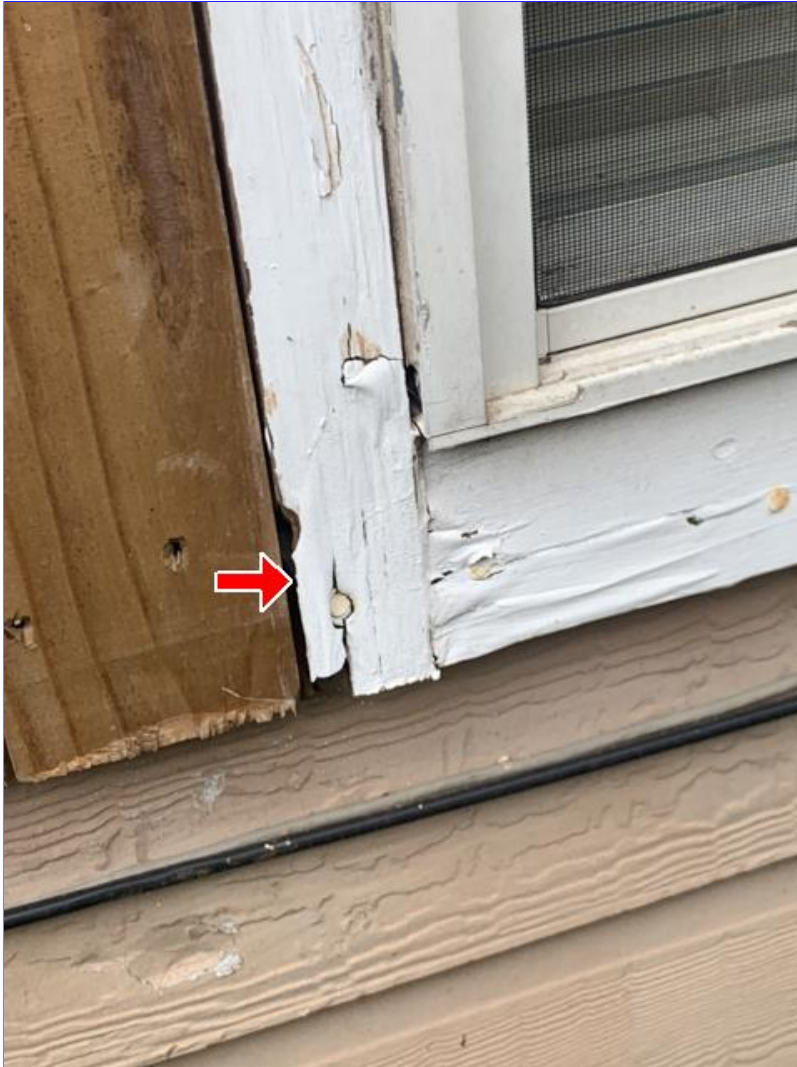
E. Photo 15(Picture) Areas of wood rot were observed on the window trim.

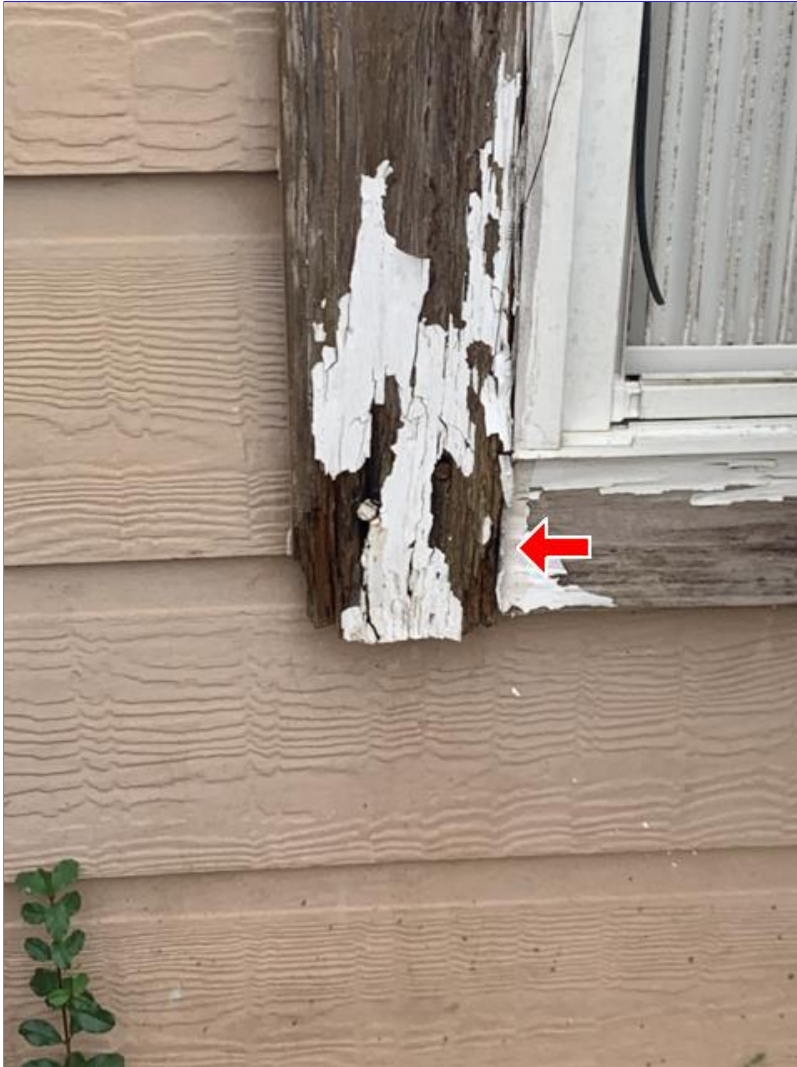
E. Photo 16(Picture) Areas of wood rot were observed on the window trim.

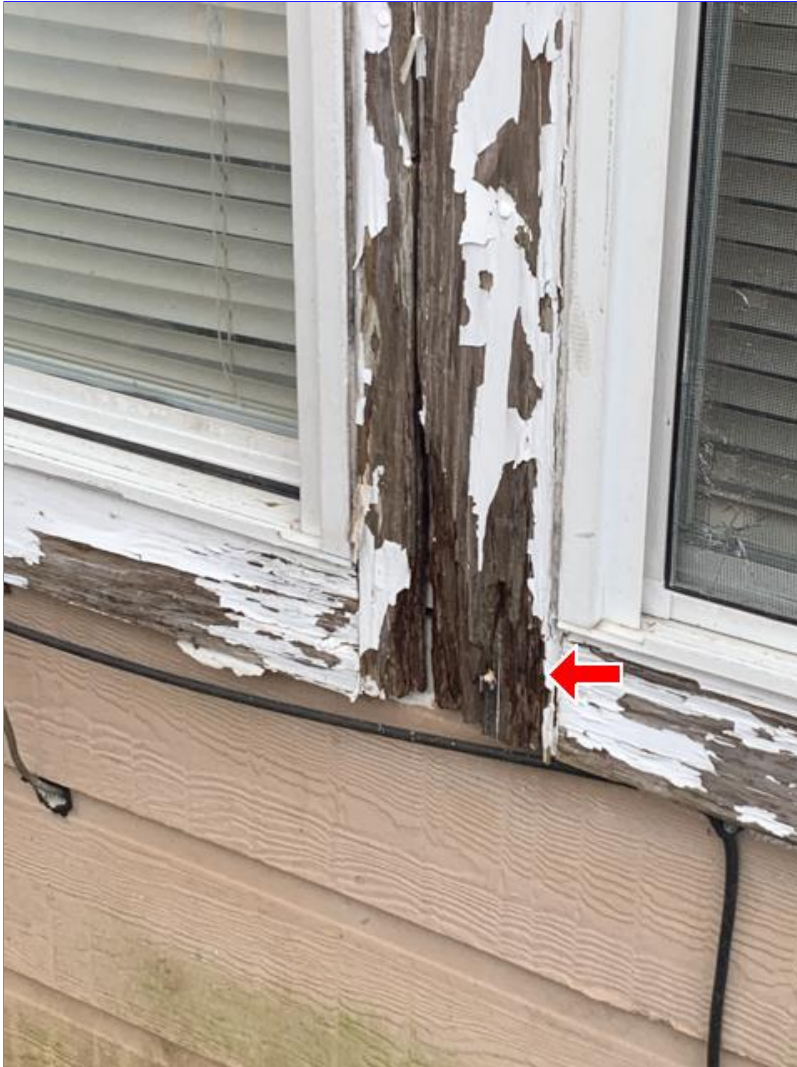
E. Photo 17(Picture) Areas of wood rot were observed on the window trim.

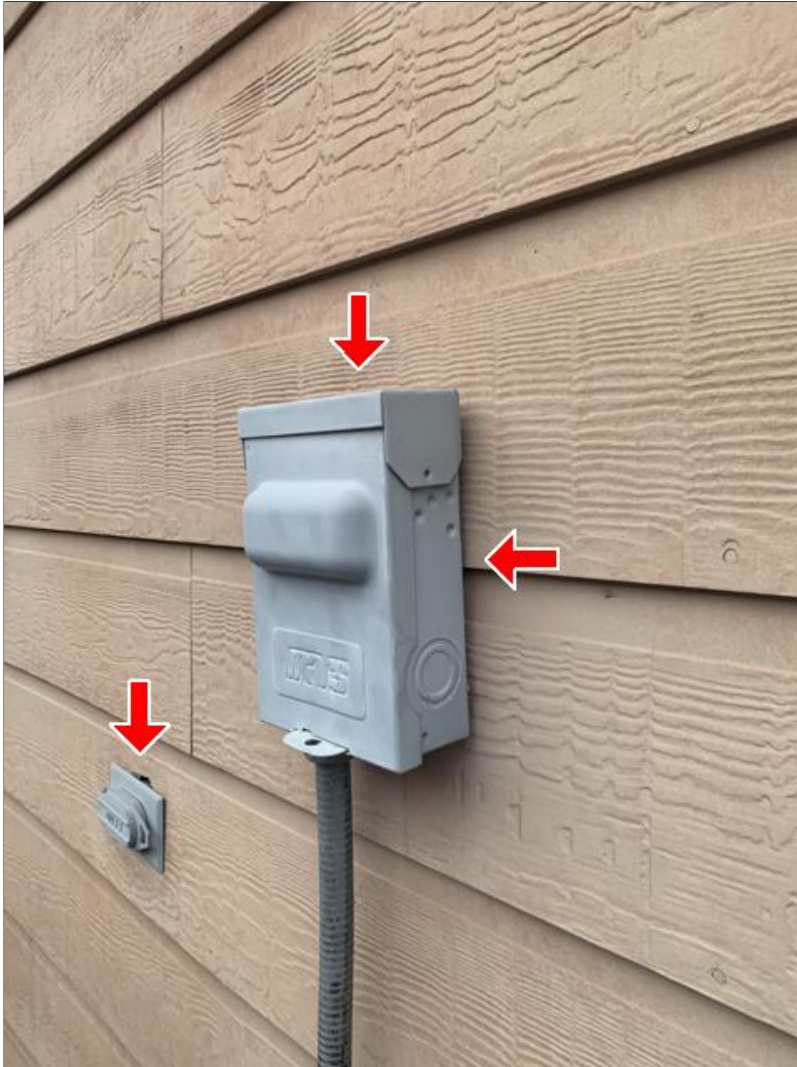
E. Photo 18(Picture) Exterior electrical wall panels, outlets and fixtures need to be sealed at the wall.

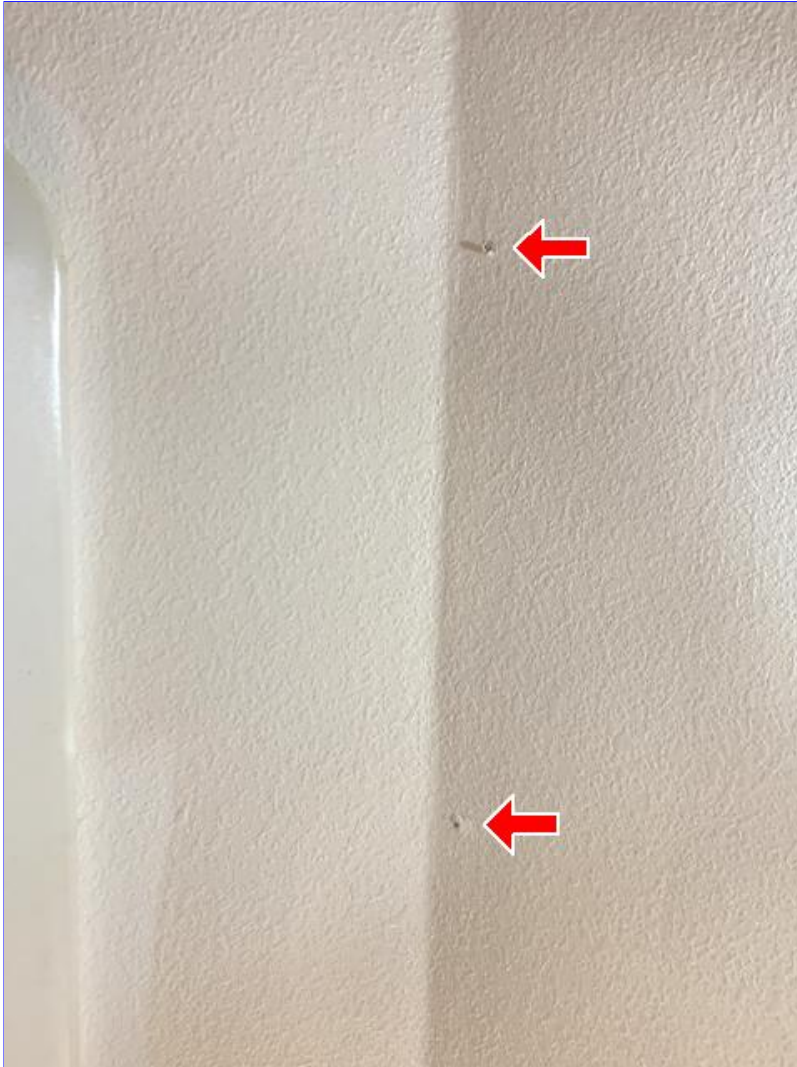
F. Photo 1(Picture) Drywall tape joint cracks and/or nail pops were observed around the home. These are cosmetic in nature, and can be repaired as needed.
