Inspection Report

Property Address:
34518 Lake Side Dr
Brookshire TX 77423

PROPERTY INSPECTION REPORT

By: S. Brad Williams TREC# 23549 / Sunbelt Inspections 1/23/2021

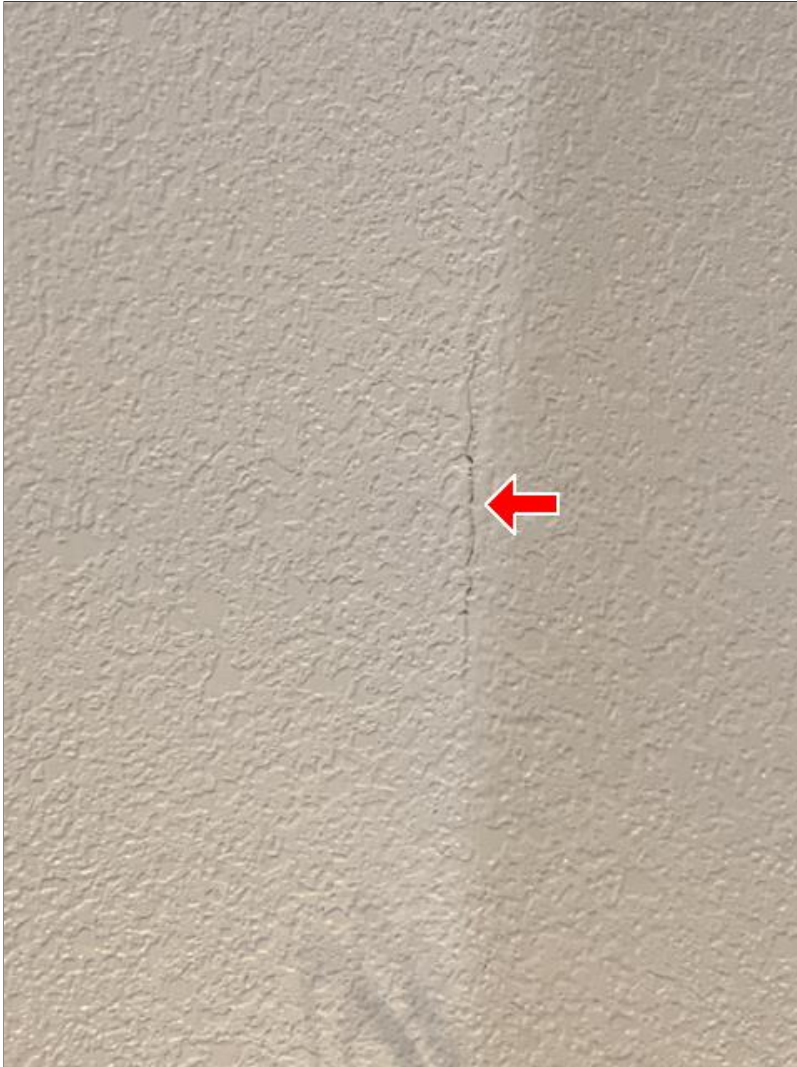
F. Photo 2(Picture) Drywall tape joint cracks and/or nail pops were observed around the home. These are cosmetic in nature, and can be repaired as needed.

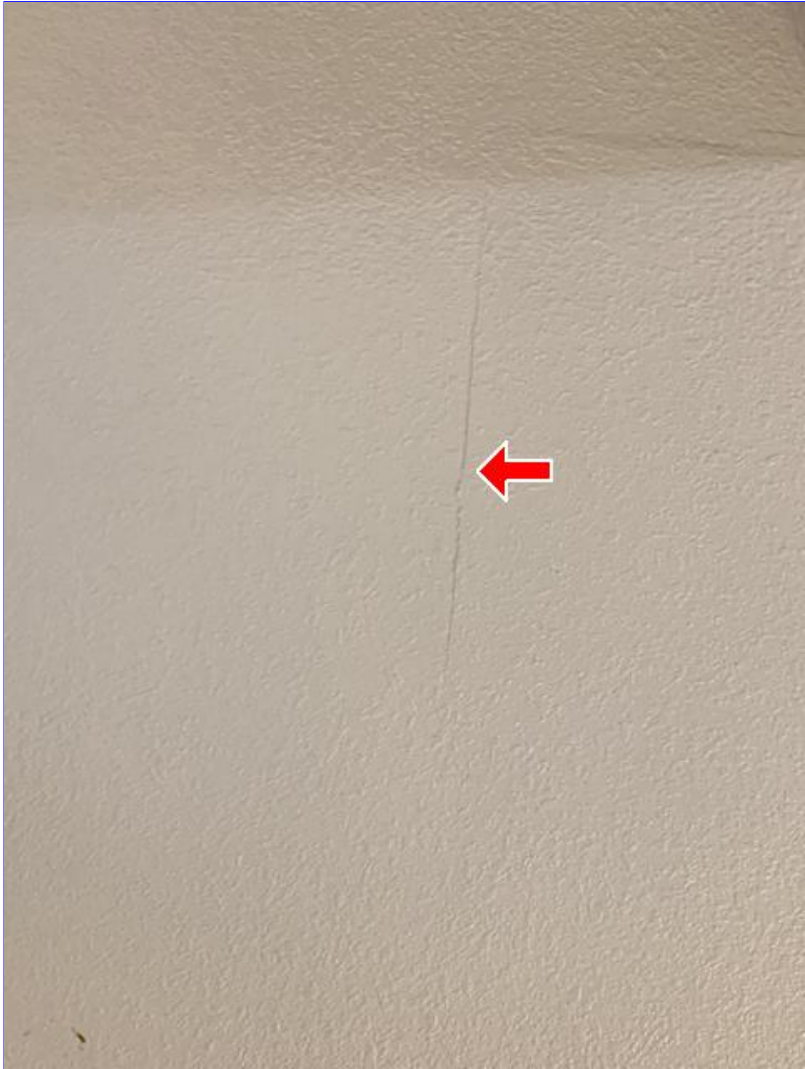
F. Photo 3(Picture) Drywall tape joint cracks and/or nail pops were observed around the home. These are cosmetic in nature, and can be repaired as needed.

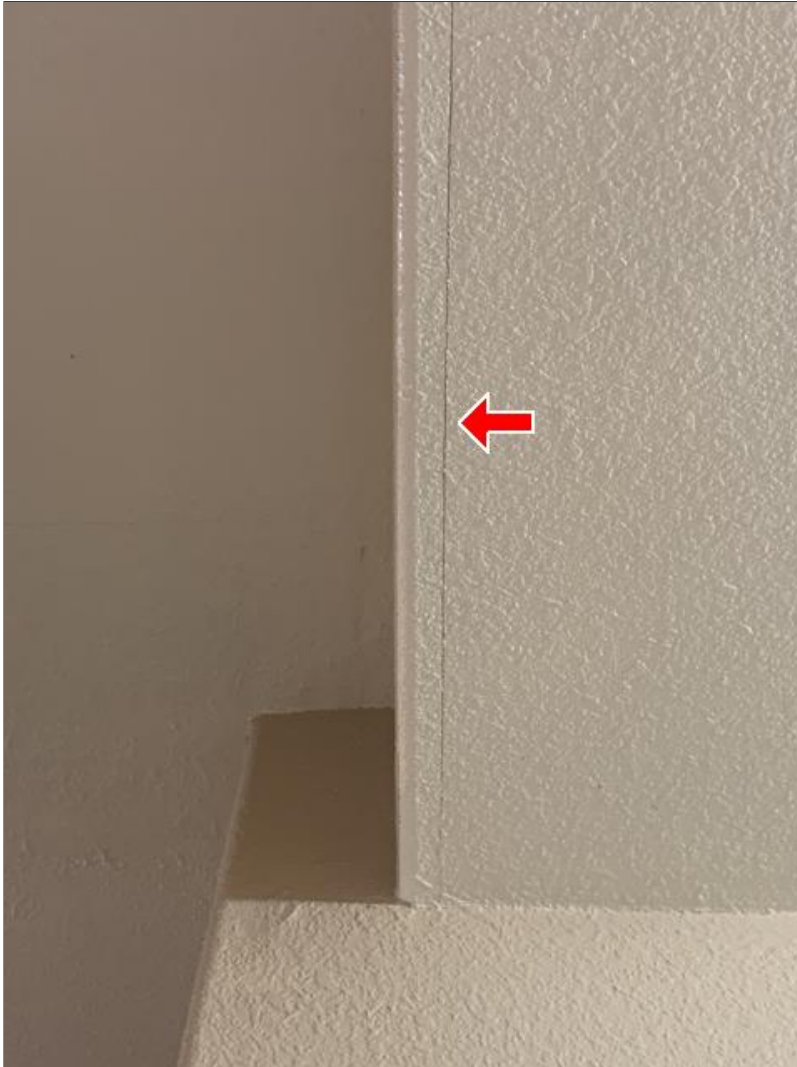
F. Photo 4(Picture) Drywall tape joint cracks and/or nail pops were observed around the home. These are cosmetic in nature, and can be repaired as needed.

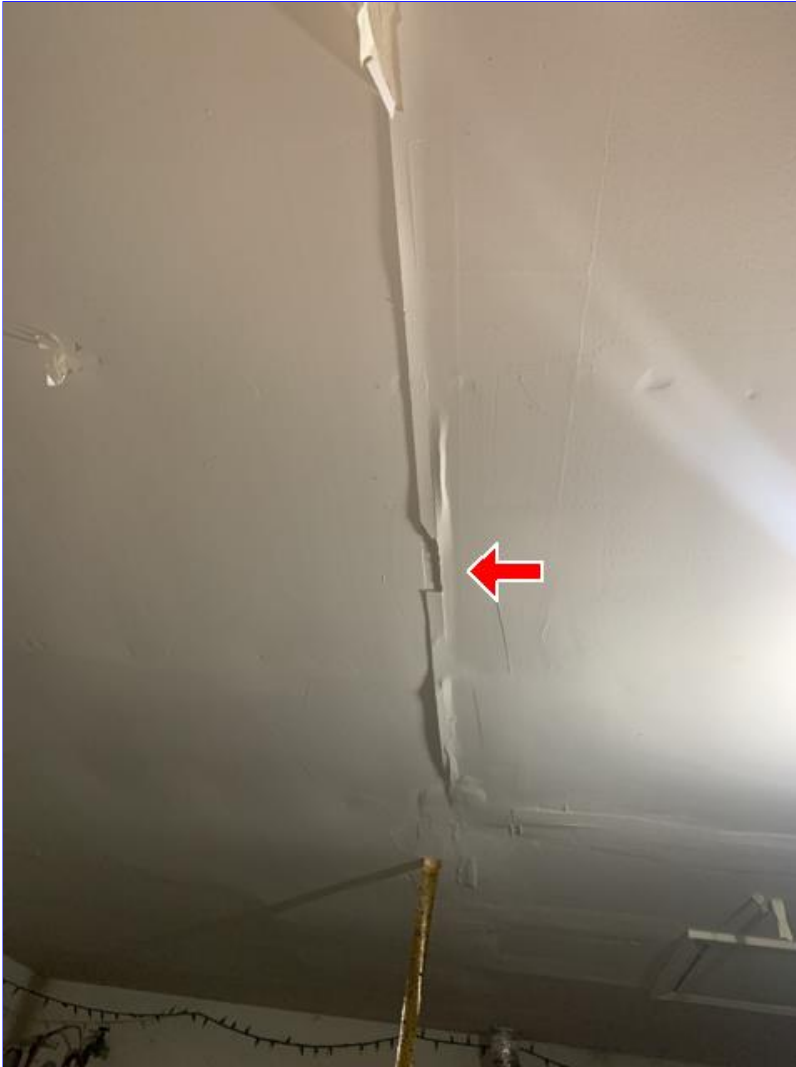
F. Photo 5(Picture) Drywall tape joint cracks and/or nail pops were observed around the home. These are cosmetic in nature, and can be repaired as needed.

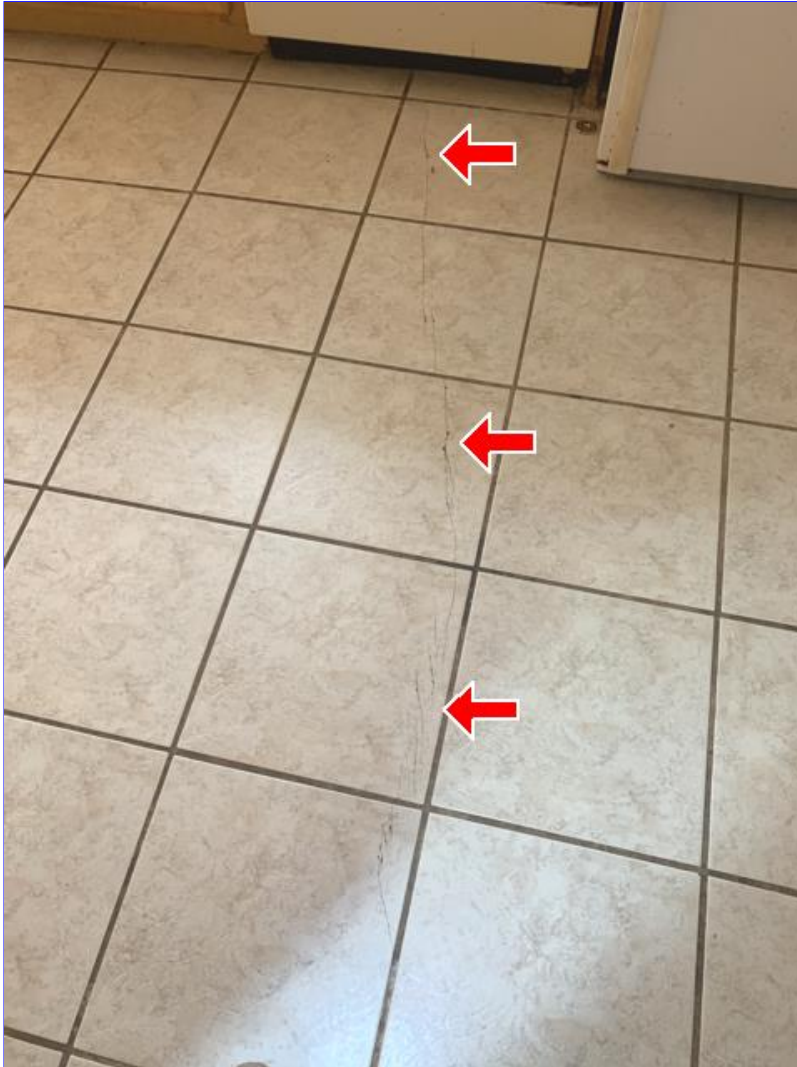
F. Photo 6(Picture) Floor tile cracks were observed throughout.

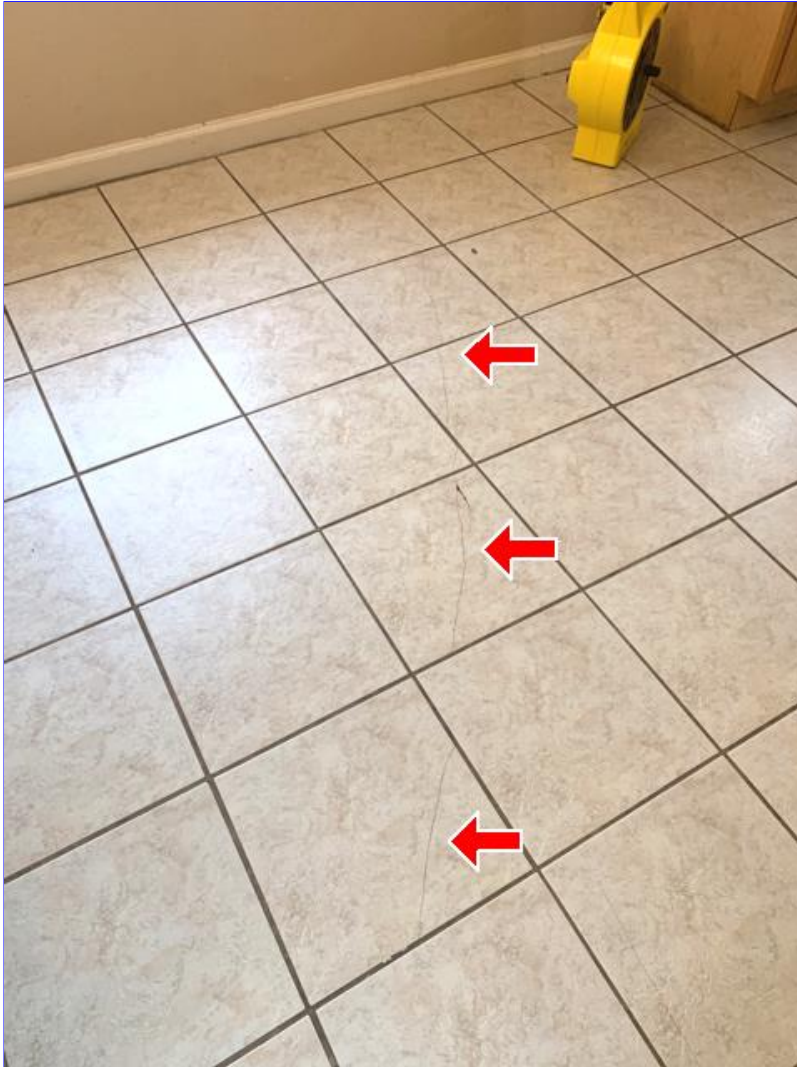
F. Photo 7(Picture) Floor tile cracks were observed throughout.

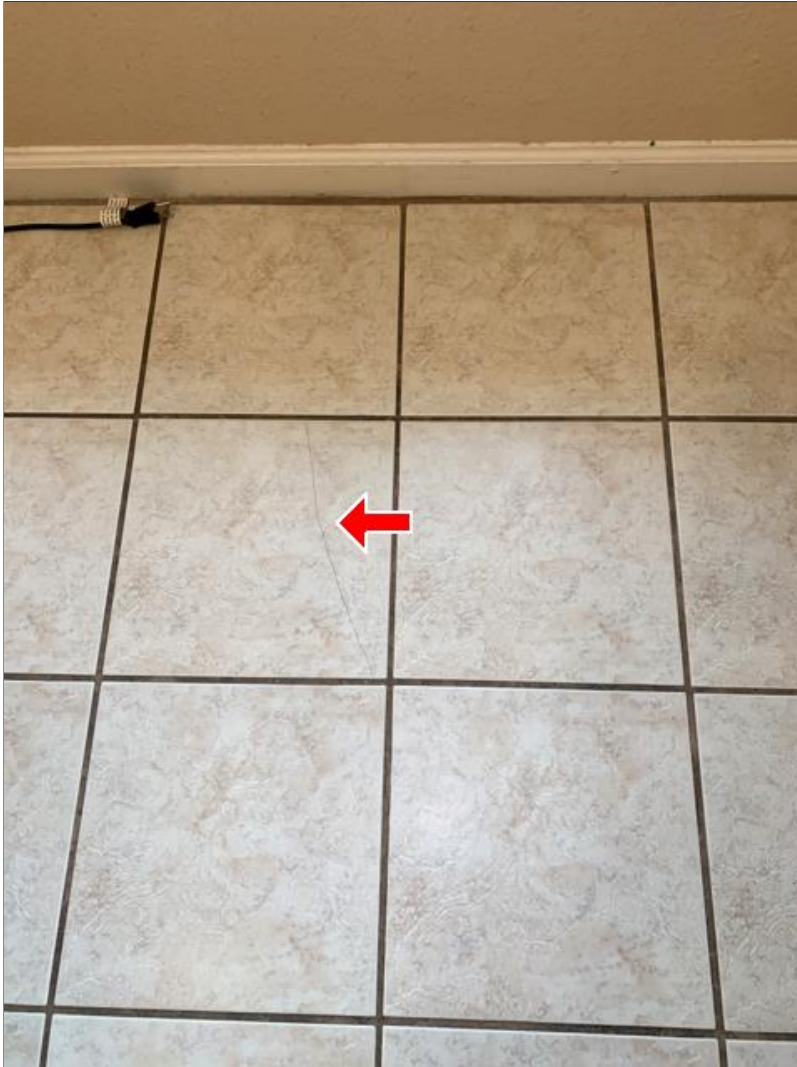
F. Photo 8(Picture) Floor tile cracks were observed throughout.

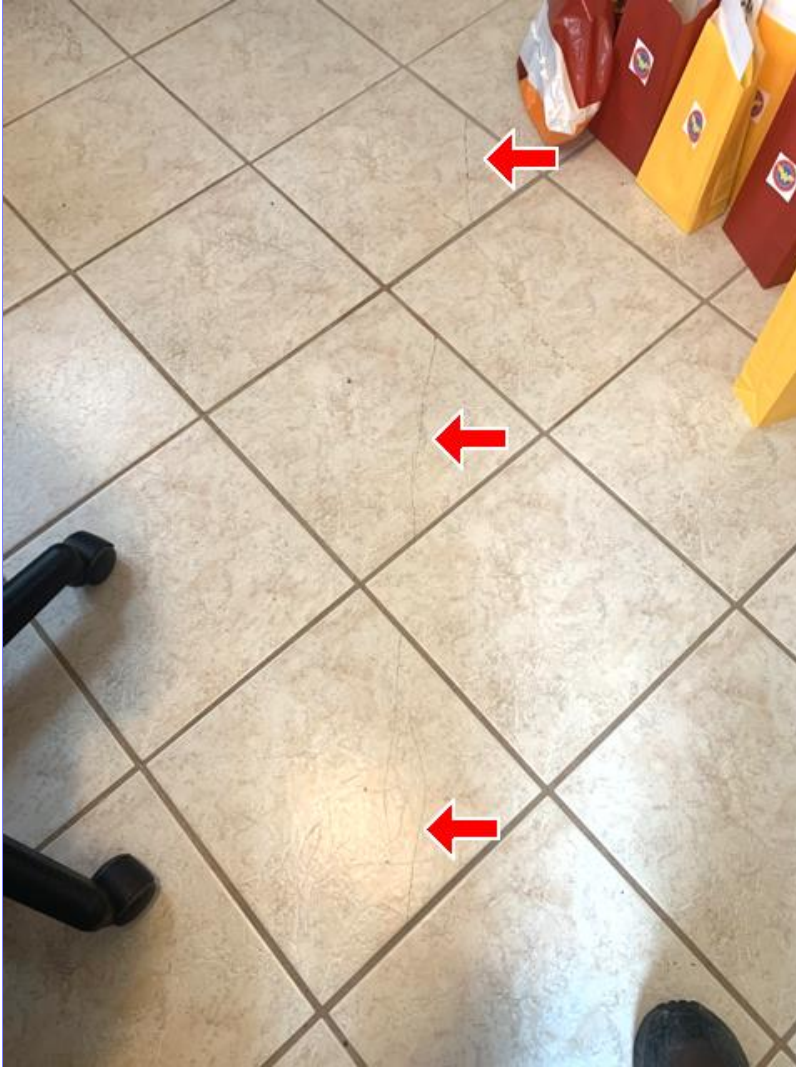
F. Photo 9(Picture) Floor tile cracks were observed throughout.

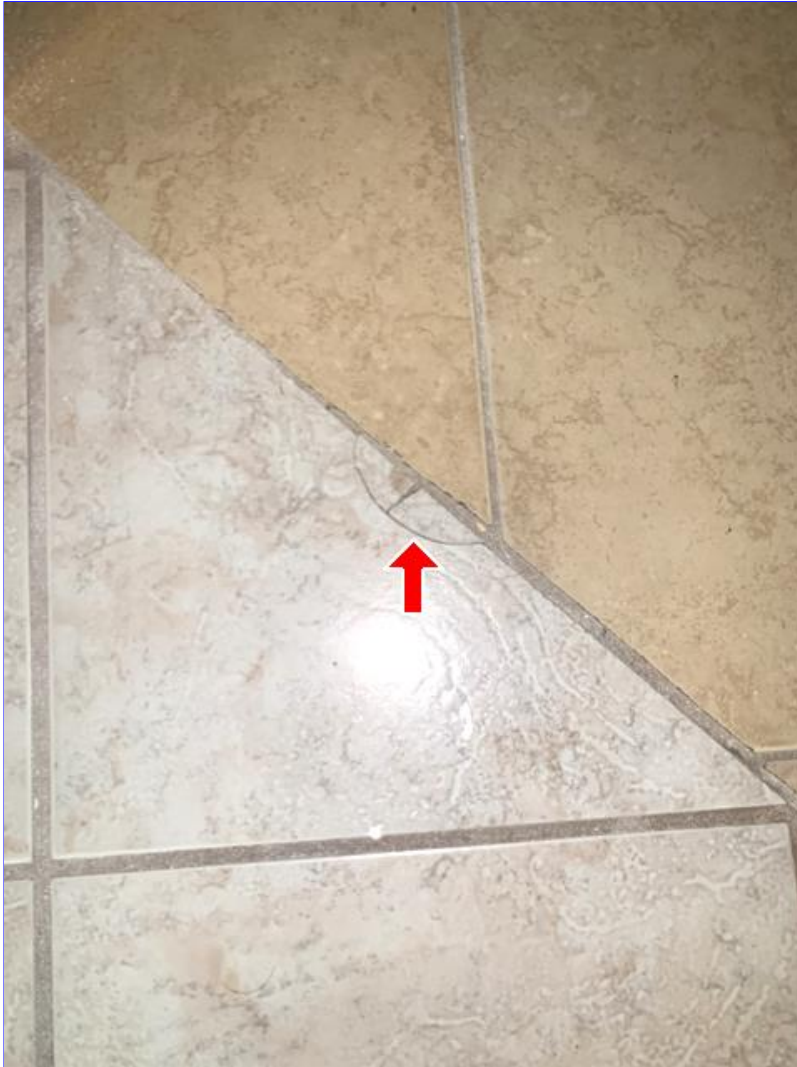
F. Photo 10(Picture) In the master bathroom, a cracked tile was observed near the left hand closet.

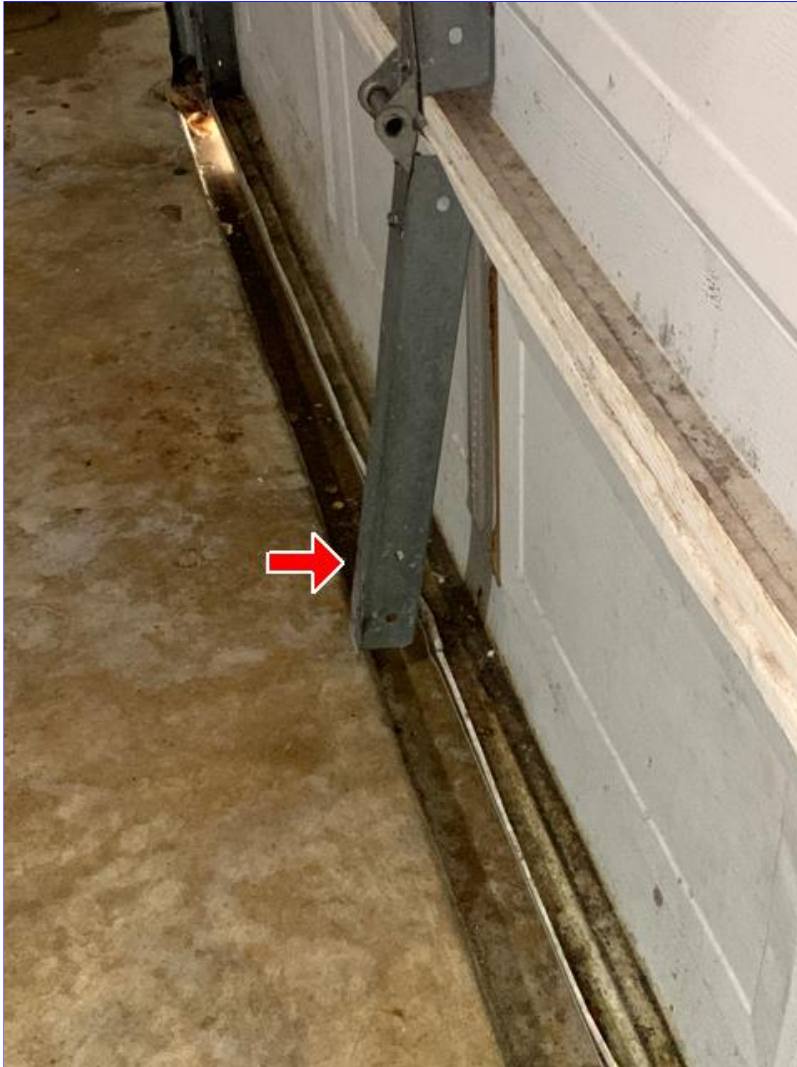
G. Photo 1(Picture) Areas of damage were observed on the garage door.

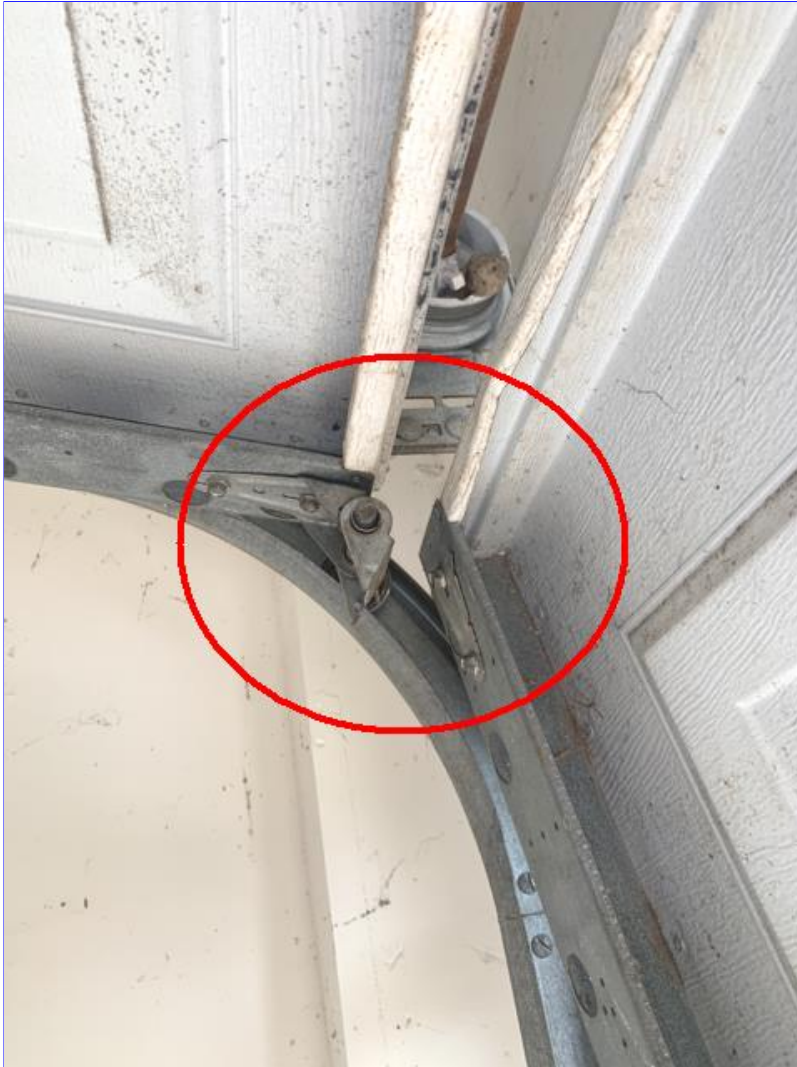
G. Photo 2(Picture) Areas of damage were observed on the garage door.

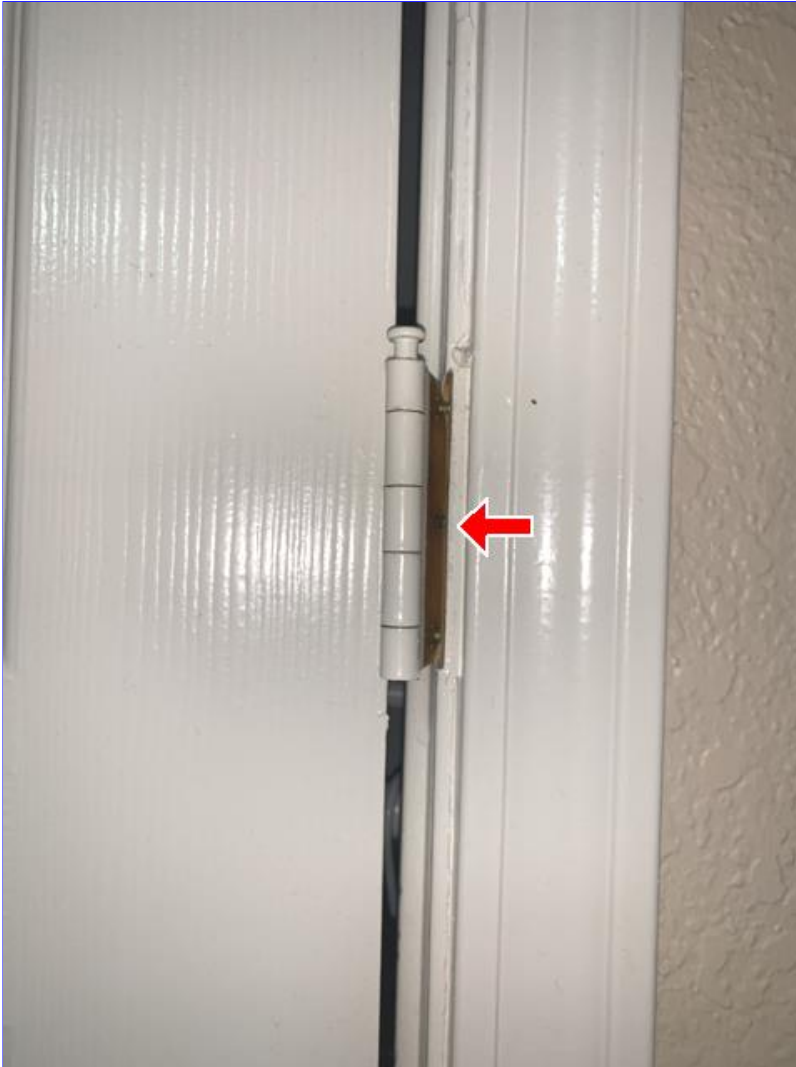
G. Photo 3(Picture) In the front right bedroom, the closet door hinge is loose at the frame.

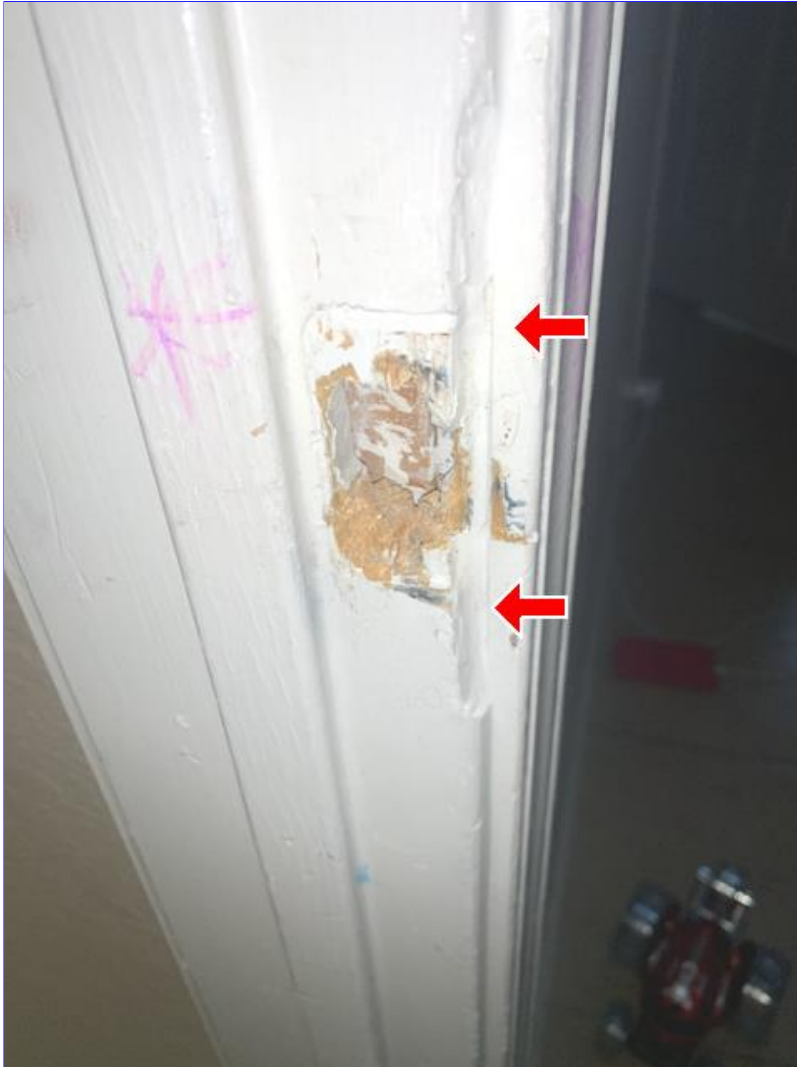
G. Photo 4(Picture) Damage was observed on the third right bedroom door frame.

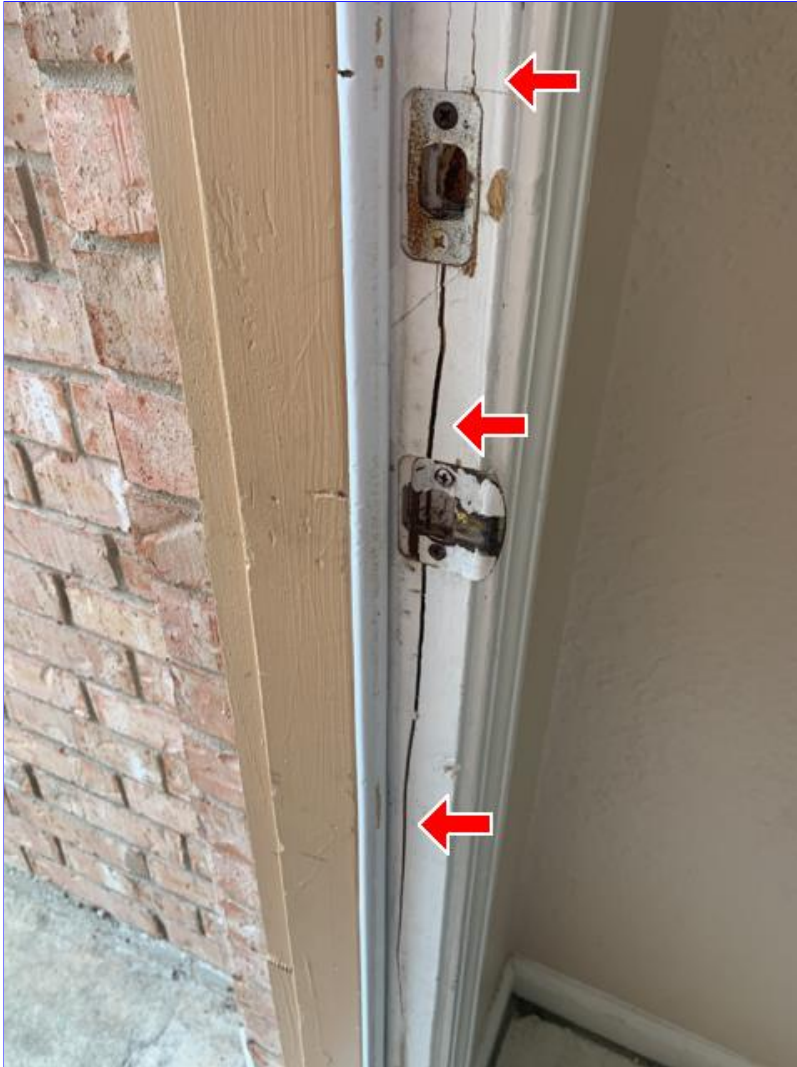
G. Photo 5(Picture) The front door frame is damaged, has wood rot, the threshold is loose and the bottom weatherstripping is loose.

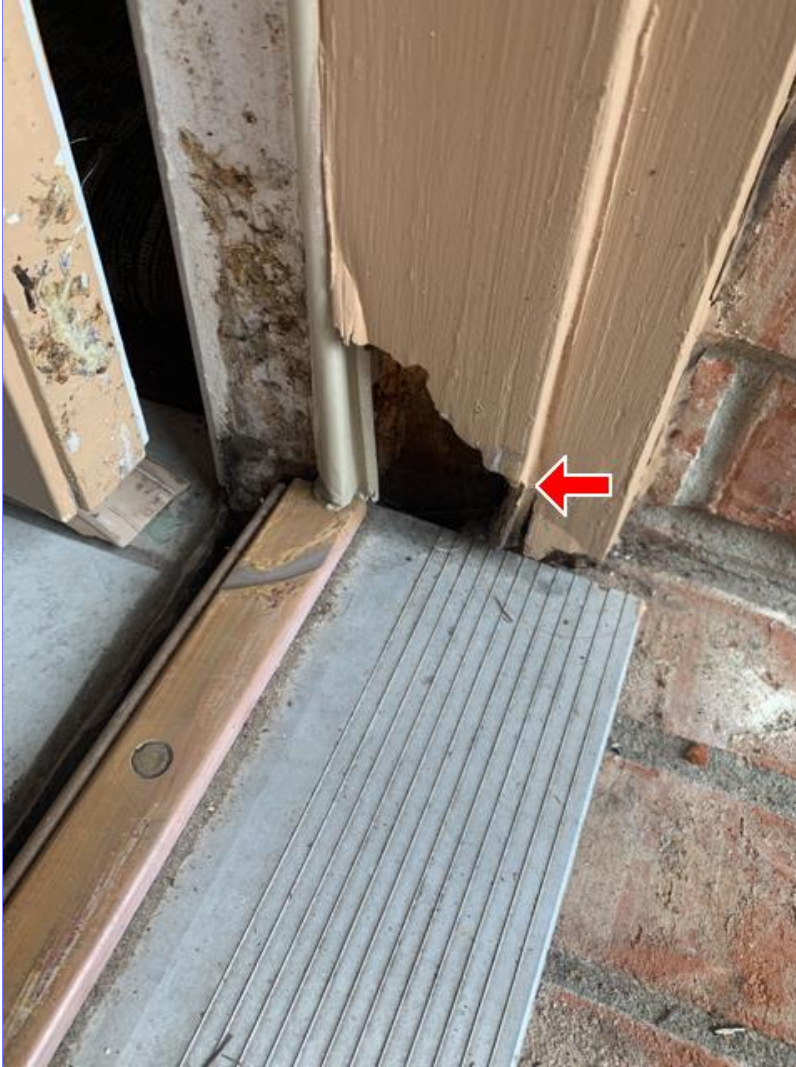
G. Photo 6(Picture) The front door frame is damaged, has wood rot, the threshold is loose and the bottom weatherstripping is loose.

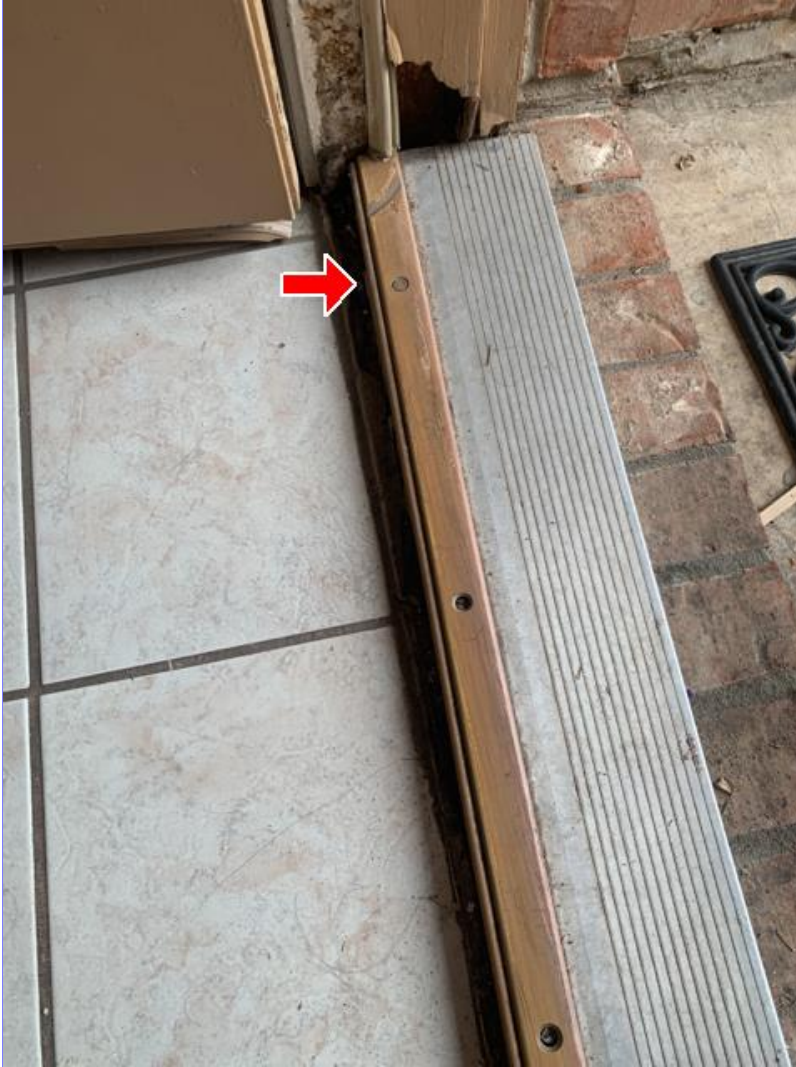
G. Photo 7(Picture) The front door frame is damaged, has wood rot, the threshold is loose and the bottom weatherstripping is loose.

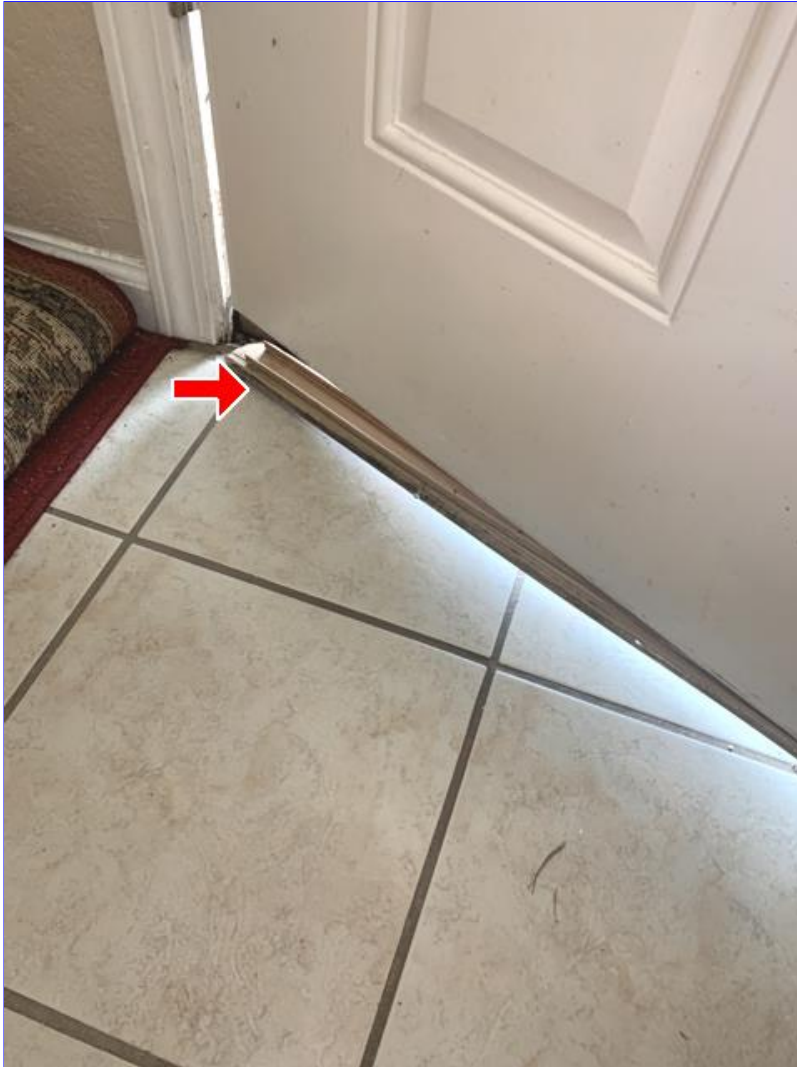
G. Photo 8(Picture) The front door frame is damaged, has wood rot, the threshold is loose and the bottom weatherstripping is loose.

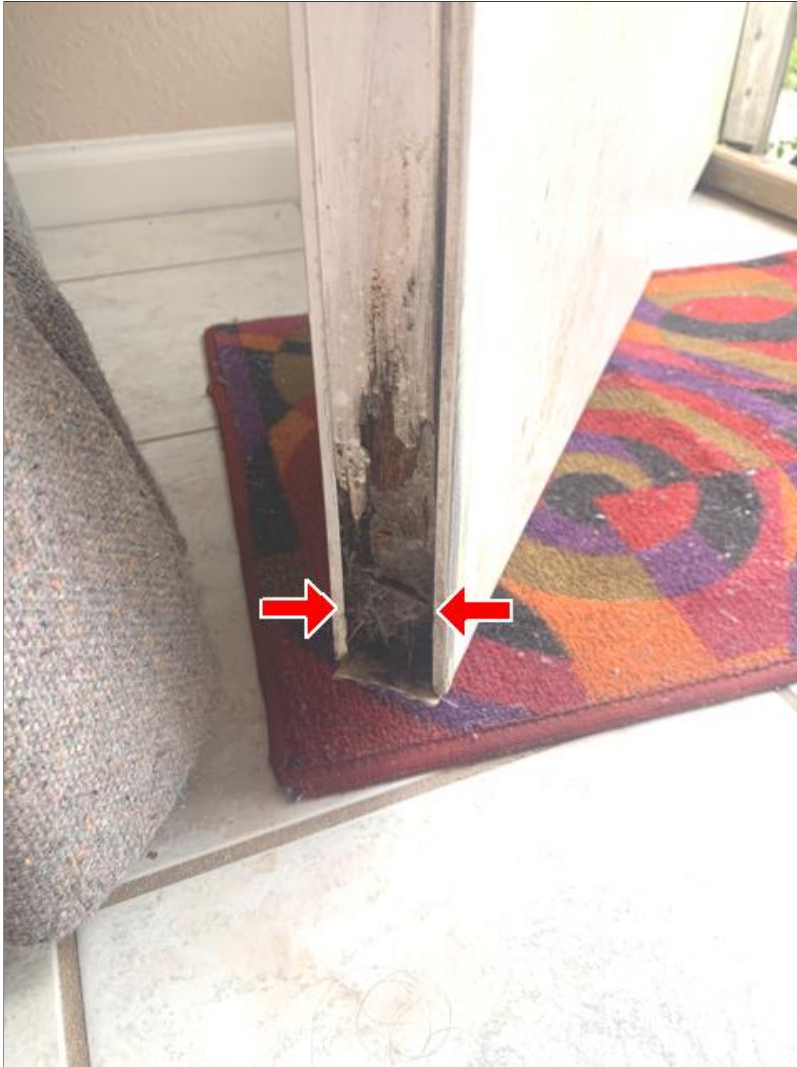
G. Photo 9(Picture) Wood rot was observed on the back door.

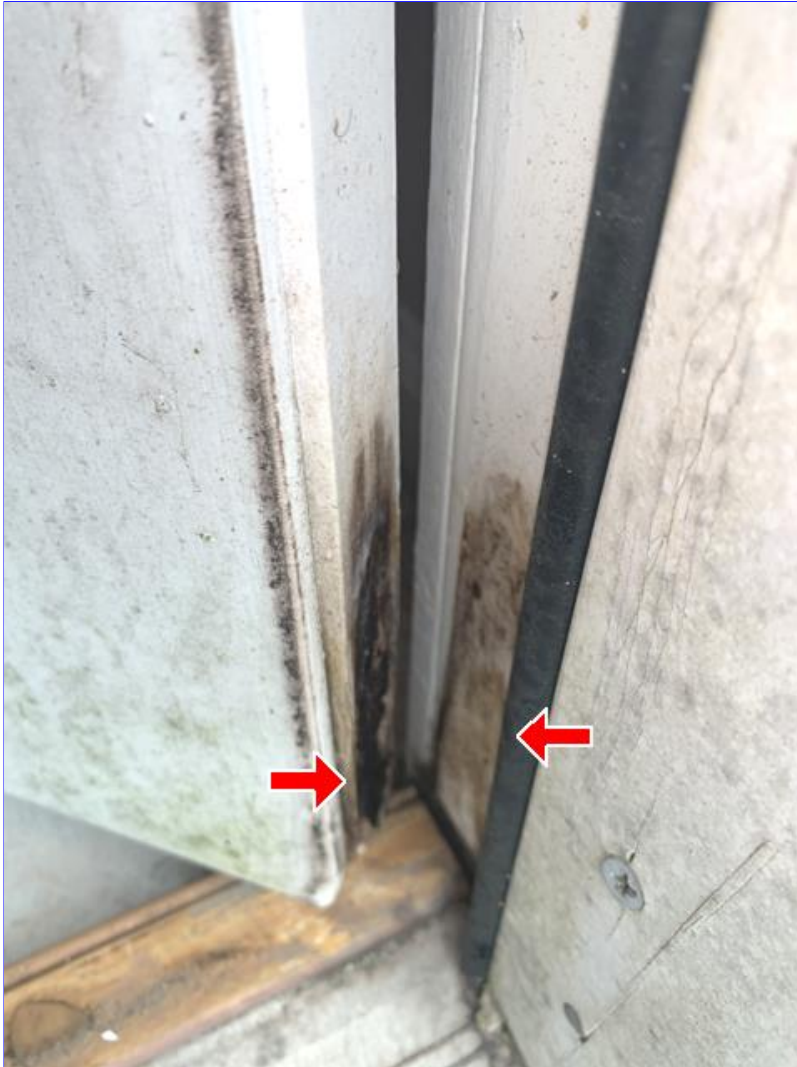
G. Photo 10(Picture) Wood rot was observed on the back door.

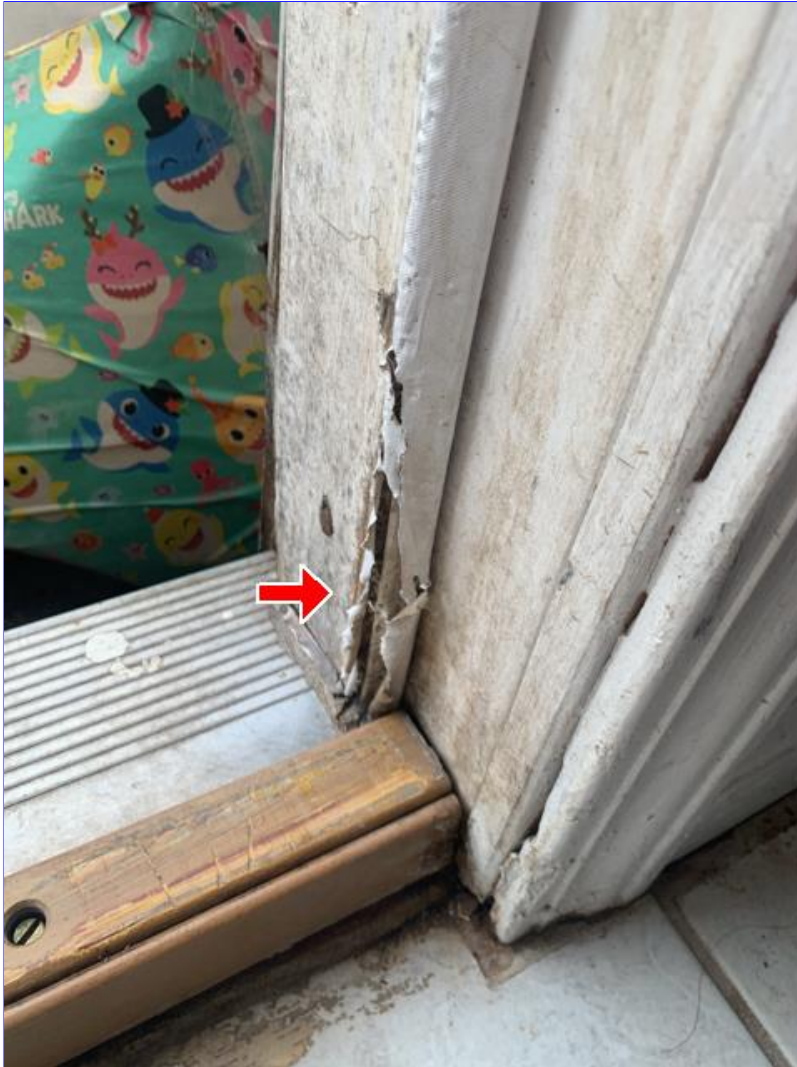
G. Photo 11(Picture) Damage was observed on the back door weatherstripping.

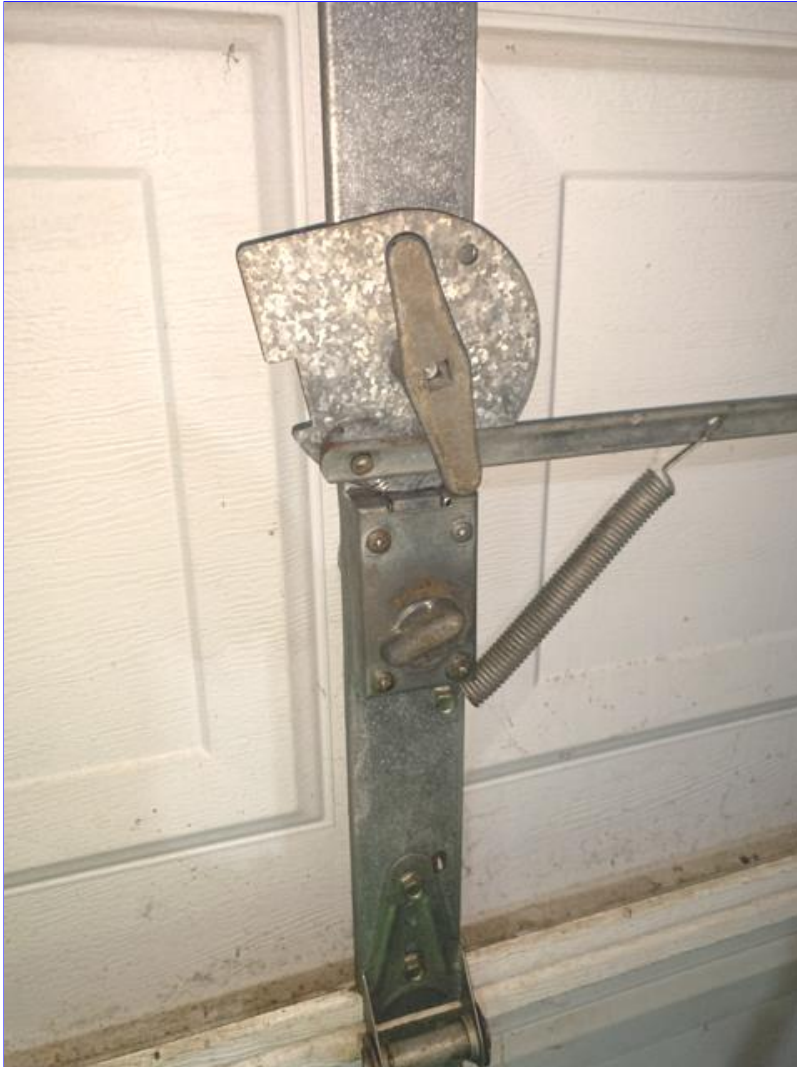
G. Photo 12(Picture) The garage door lock is inoperable.

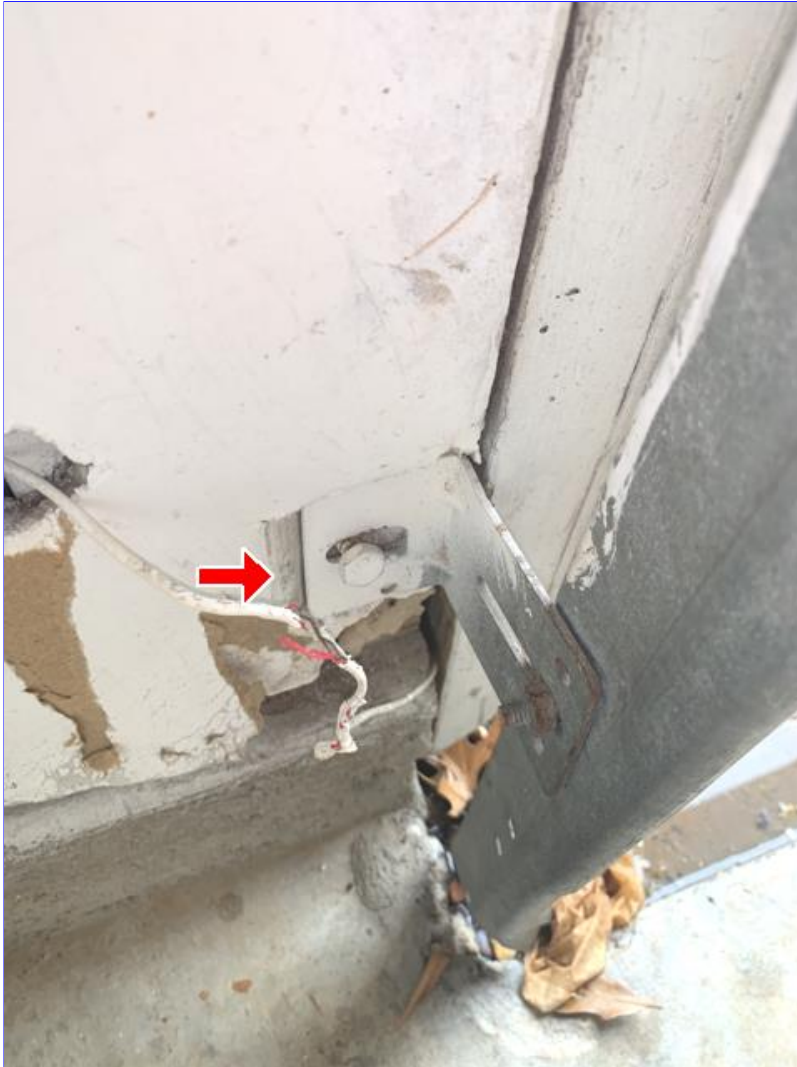
G. Photo 13(Picture) The garage door rail brackets are not properly secured.

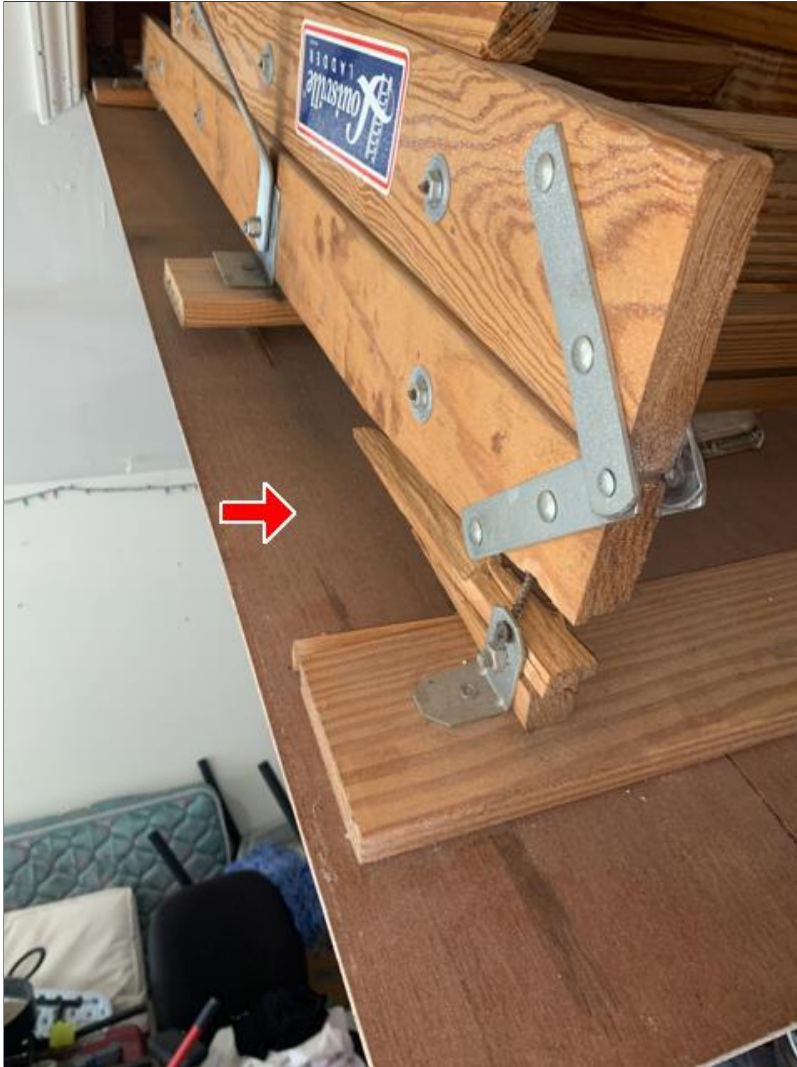
G. Photo 14(Picture) Damage was observed on the attic access ladder.

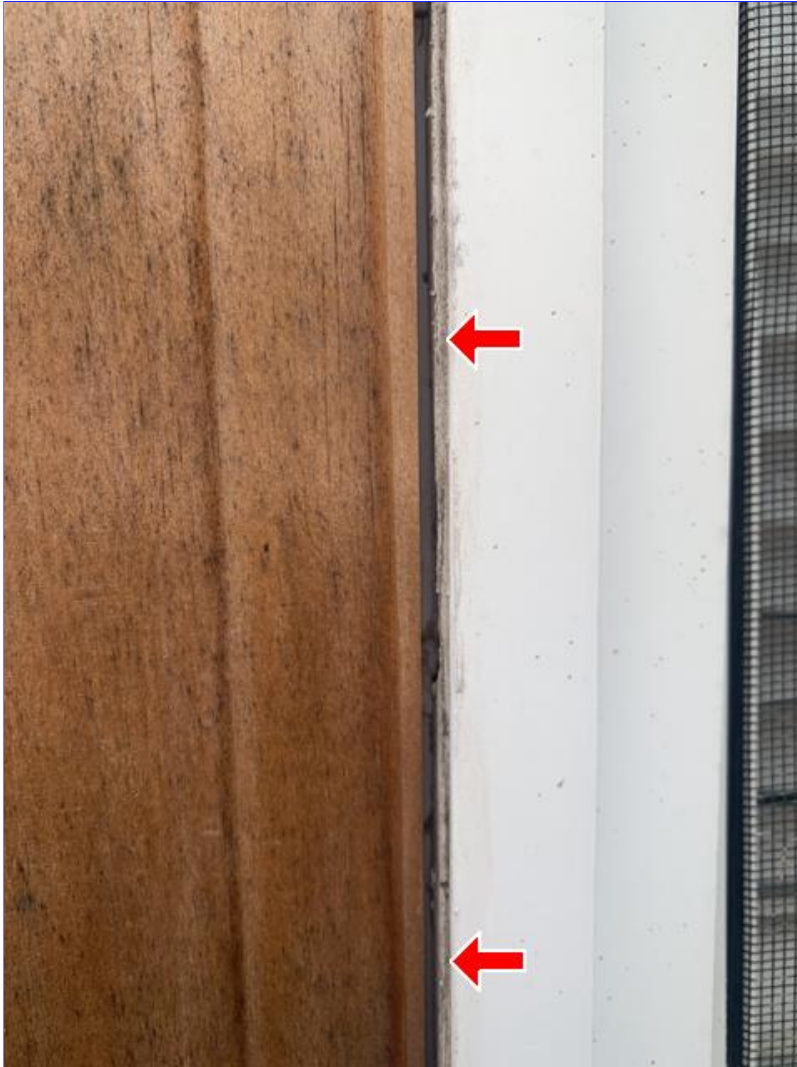
H. Photo 1(Picture) The perimeter sealant, has failed on some windows.

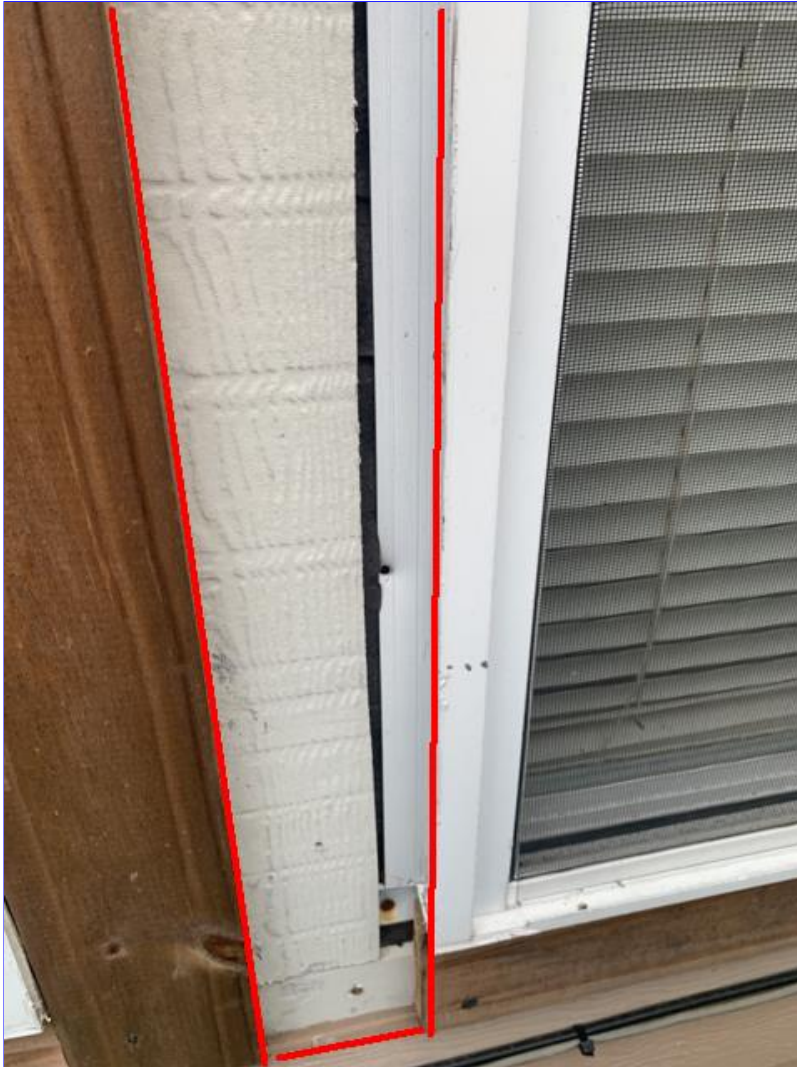
H. Photo 2(Picture) One of the windows is missing the trim board and is not sealed.

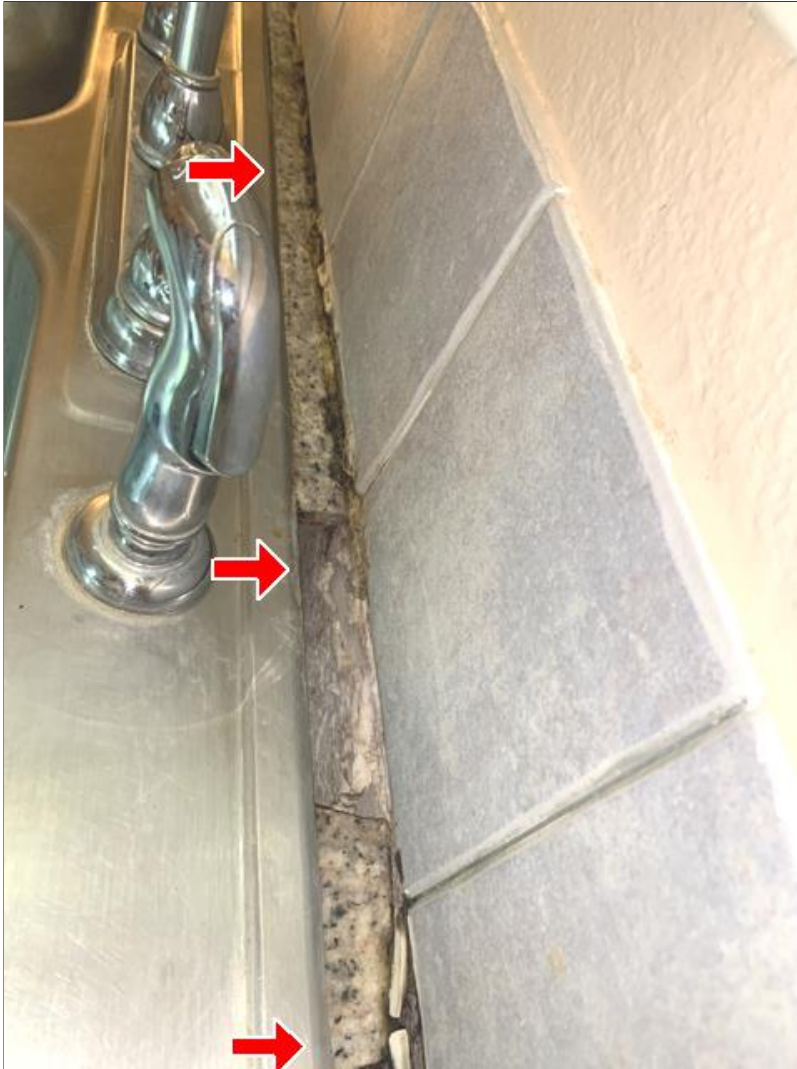
L. Photo 1(Picture) Areas of previous water damage were observed near the sink on the kitchen countertop and under the sink inside the cabinet.
