Inspection Report

Property Address:
34518 Lake Side Dr
Brookshire TX 77423

PROPERTY INSPECTION REPORT

By: S. Brad Williams TREC# 23549 / Sunbelt Inspections 1/23/2021

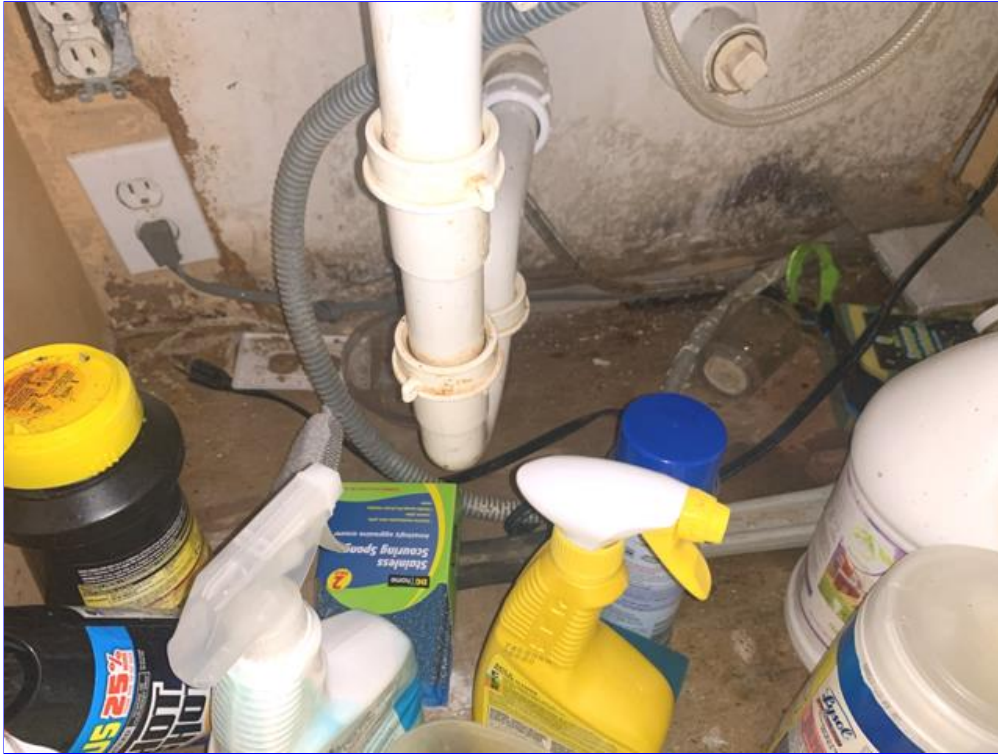
L. Photo 2(Picture) Areas of previous water damage were observed near the sink on the kitchen countertop and under the sink inside the cabinet.

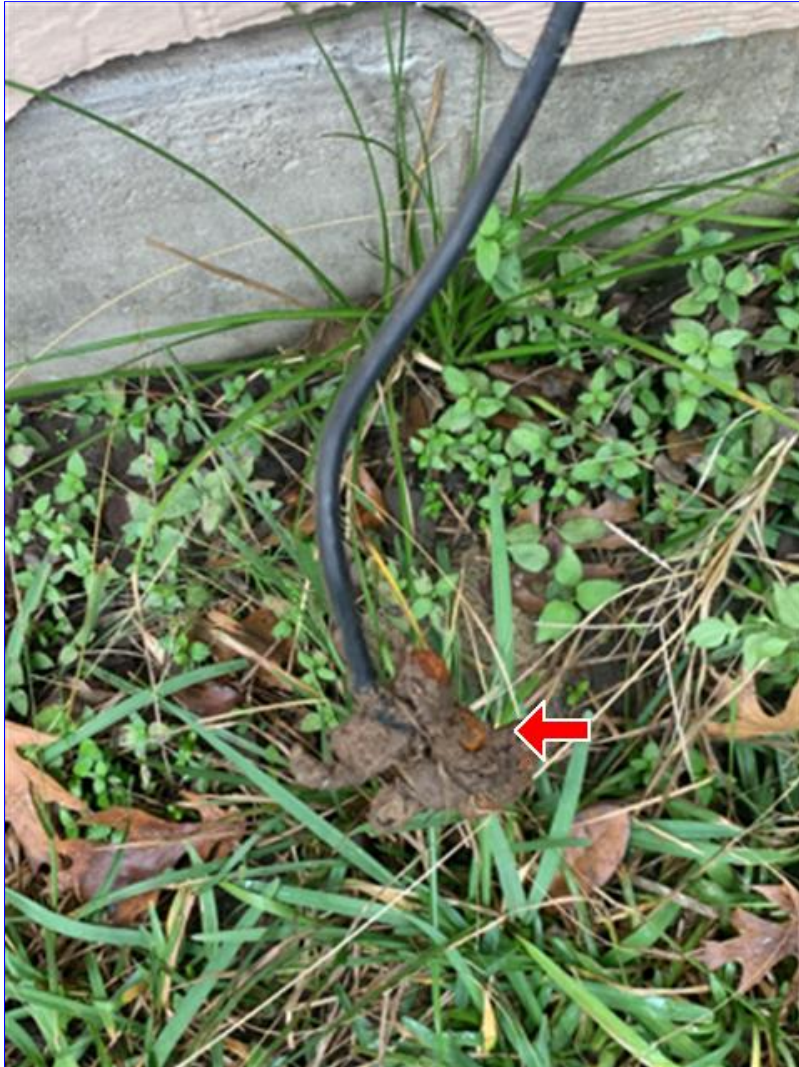
A. Photo 2(Picture) The system ground wire, is loose from the ground clamp or the ground clamp, is loose on the ground rod (electrode).

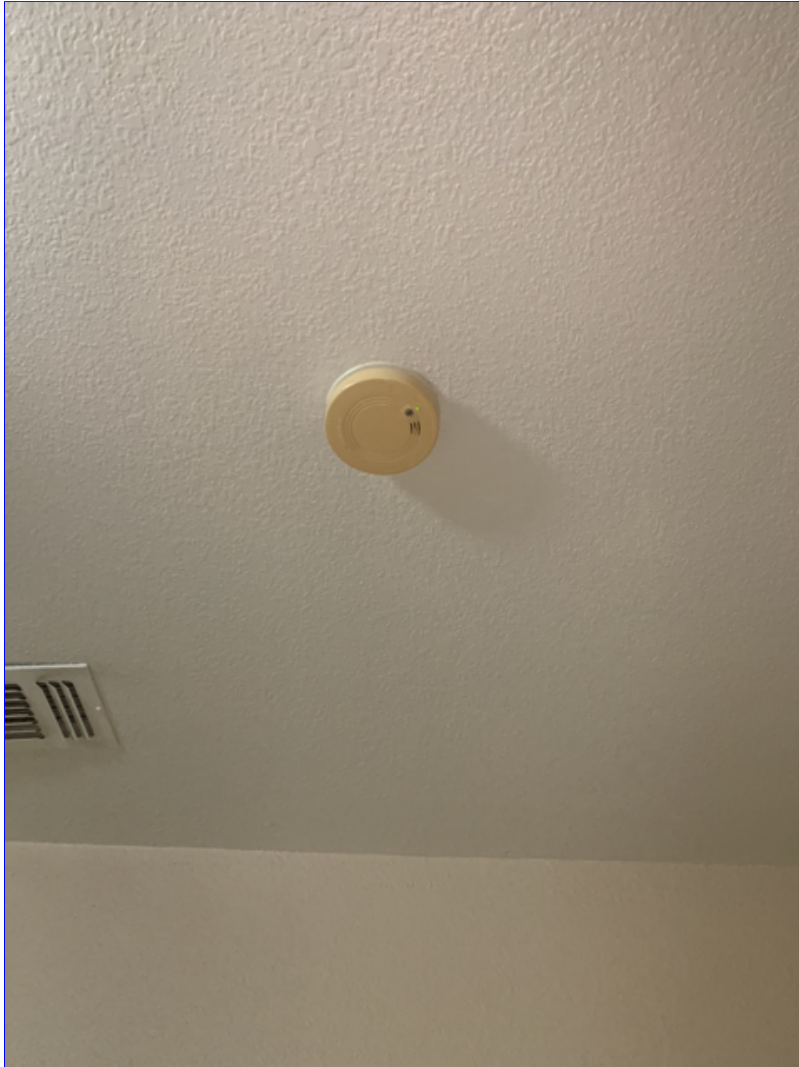
B. Photo 1(Picture) Smoke detectors are not present at all required locations, and the existing units appear to be aged. I recommend replacement of existing units, and installation of new units at all other required locations for personal safety reasons.

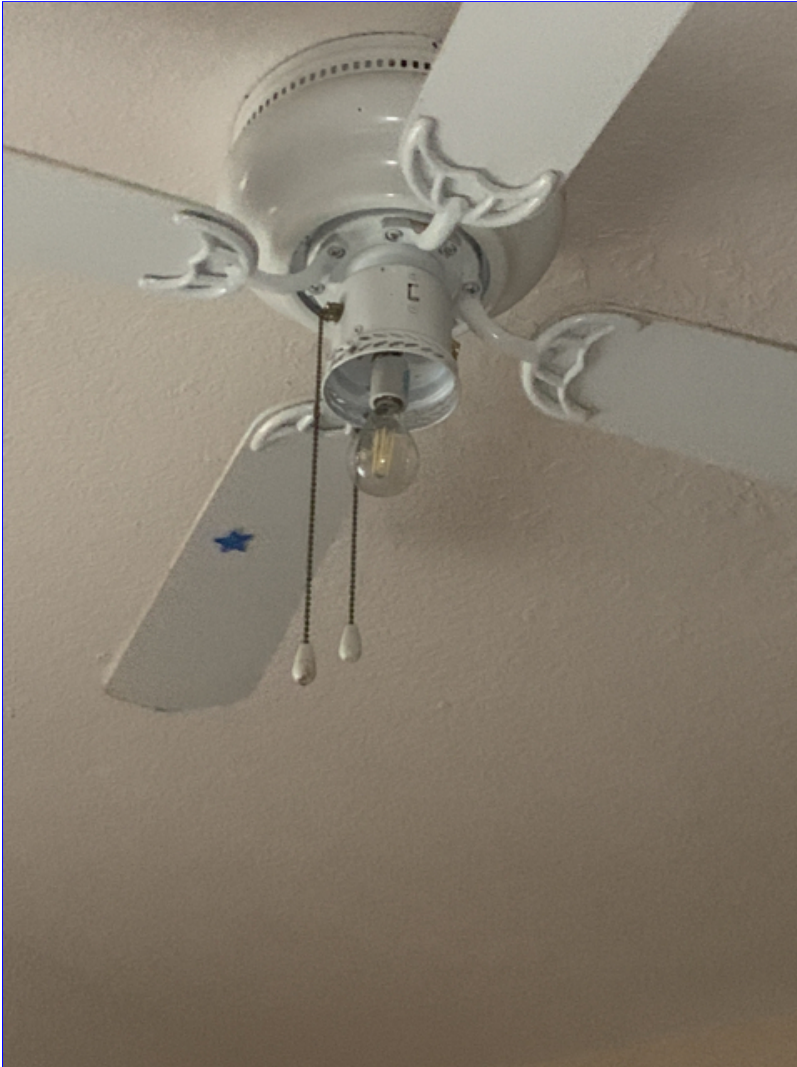
B. Photo 2(Picture) Some fixtures, are missing globes.

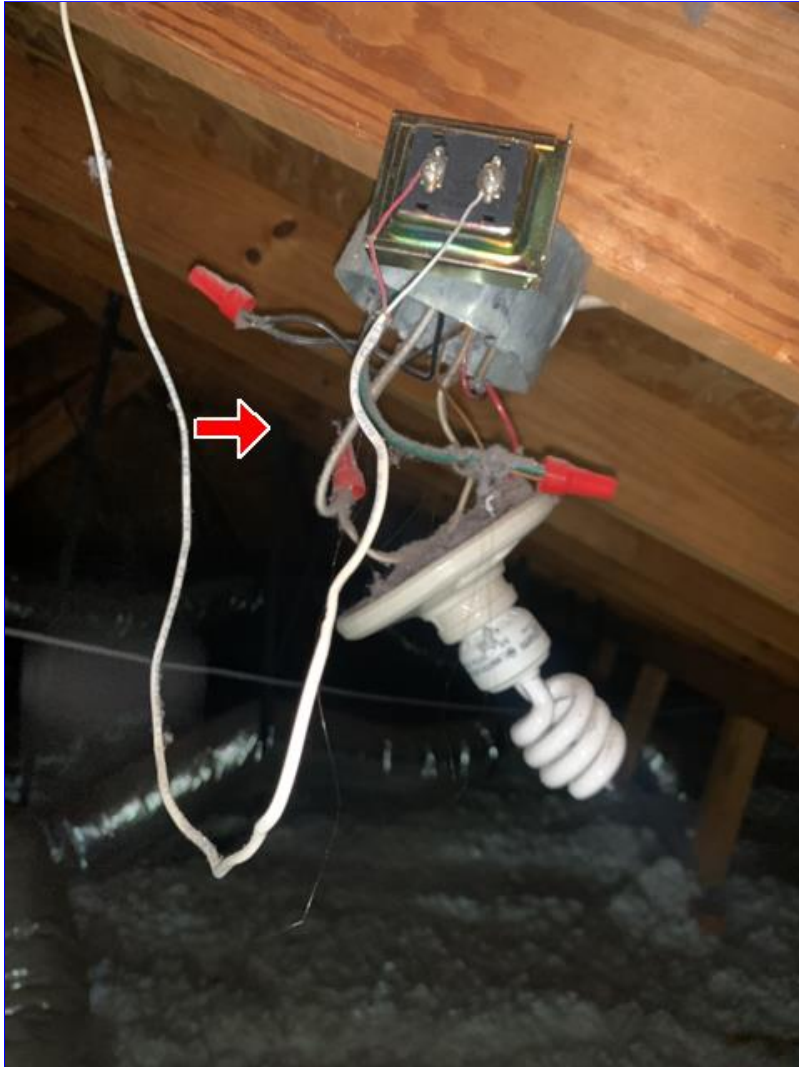
B. Photo 3(Picture) The attic light is not properly installed and the junction box is open.. They should be covered for safety reasons.

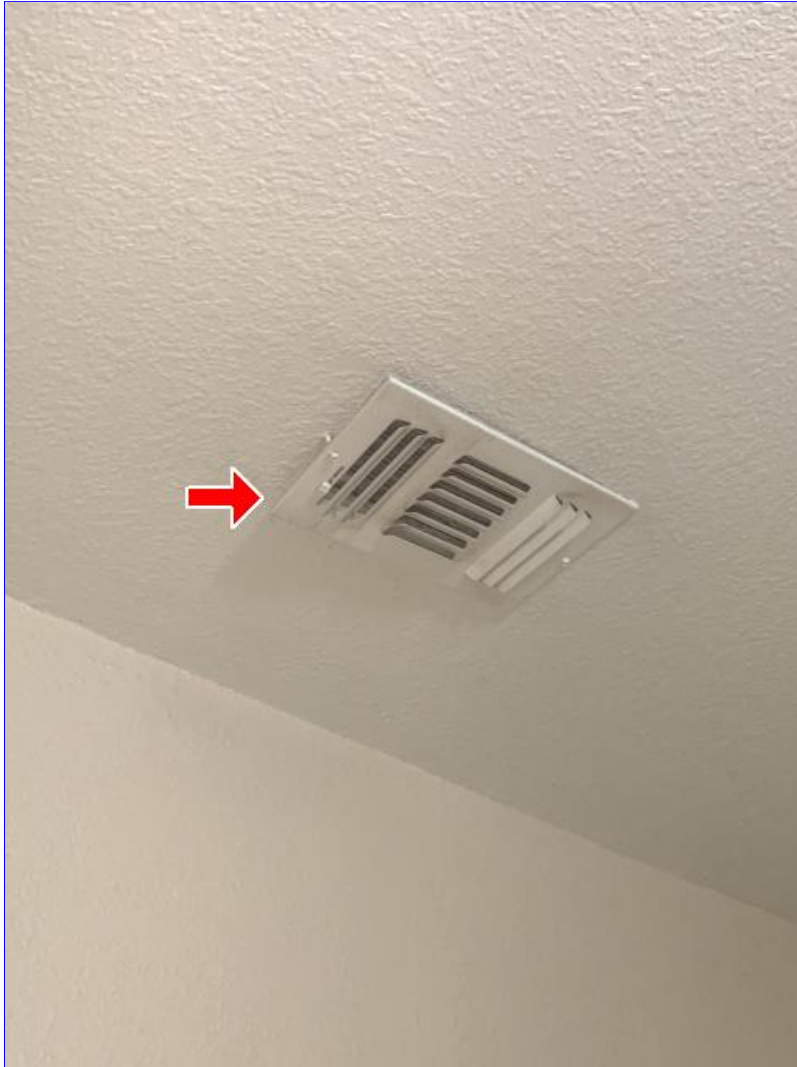
C. Photo 1(Picture) In the front right bedroom, the supply grill is loose at the ceiling.

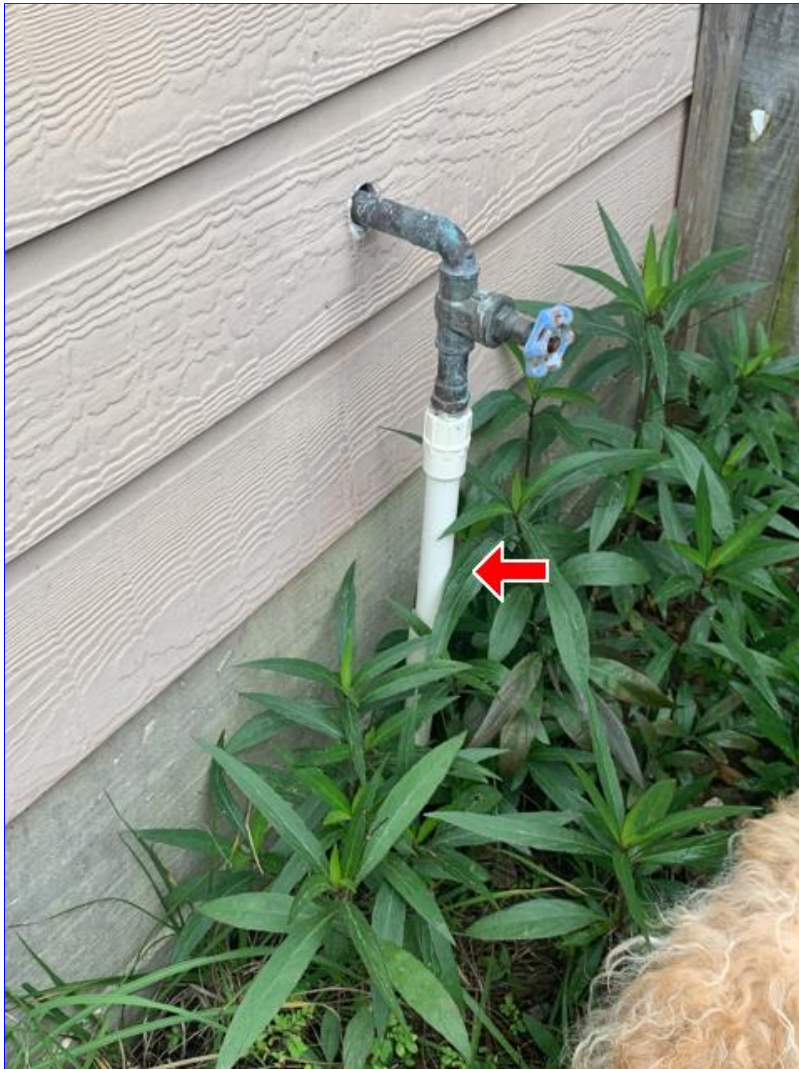
A. Photo 1(Picture) The main water supply line at the exterior, is not properly protected from freezing.

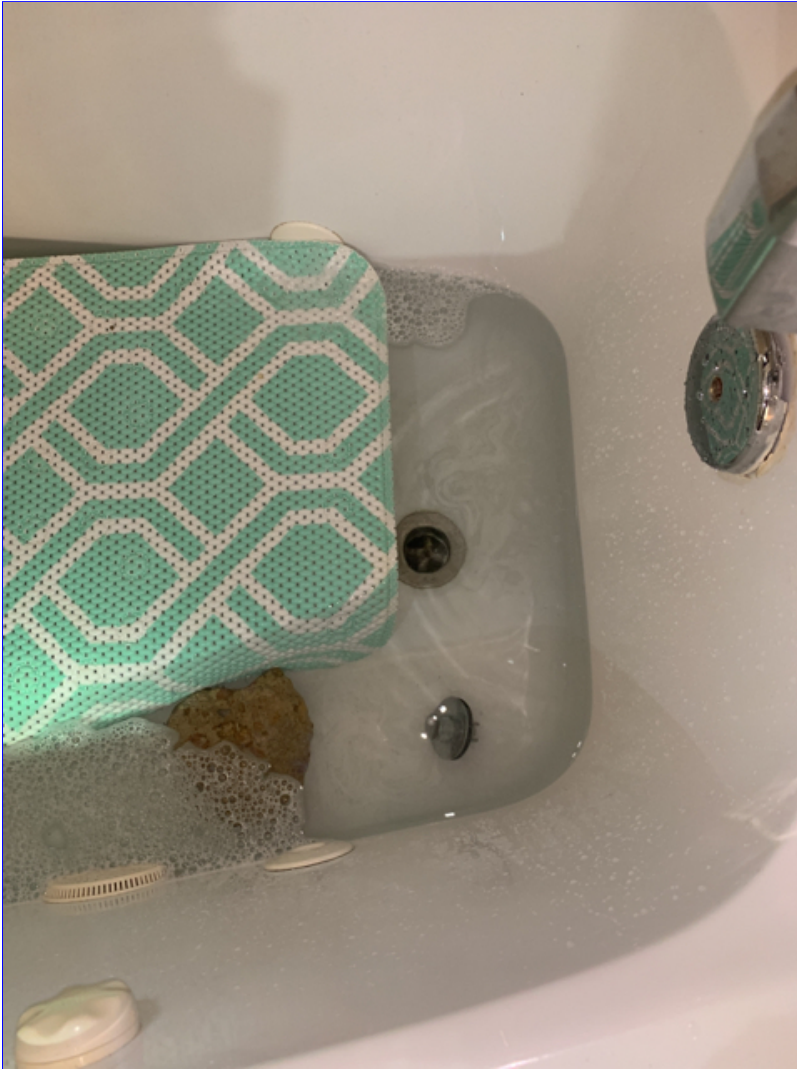
B. Photo 1(Picture) The whirlpool bath is very slow to drain.

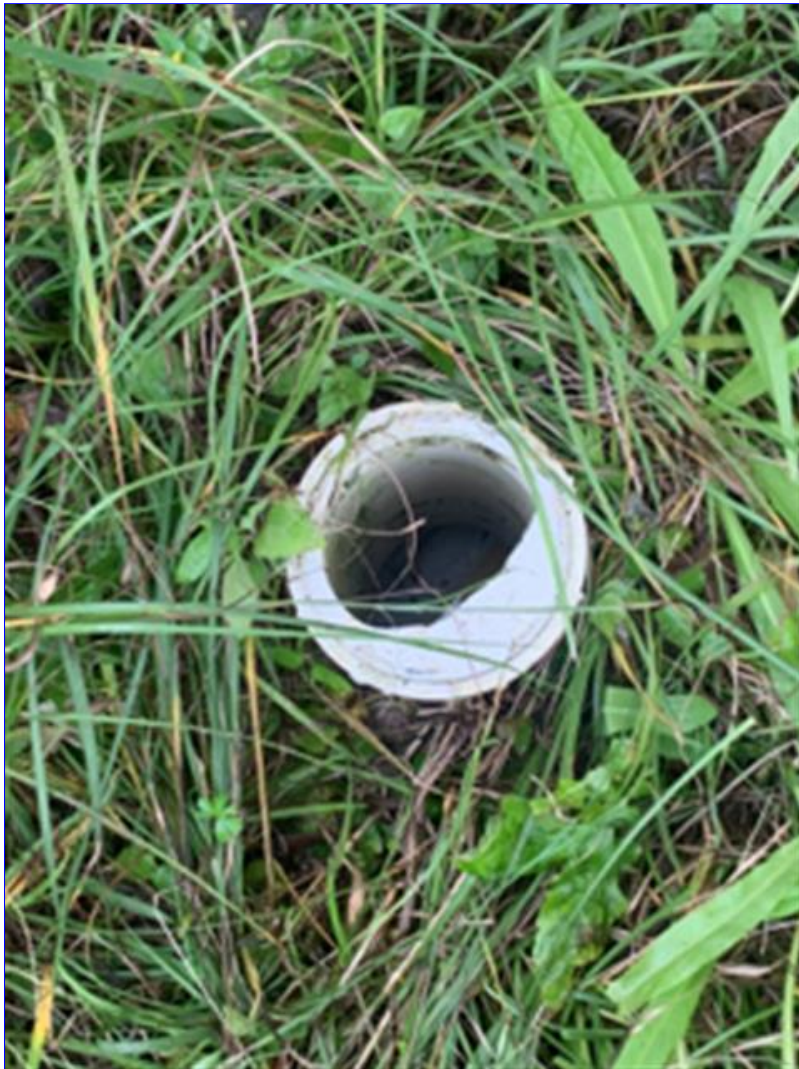
B. Photo 2(Picture) The plumbing clean out cap needs to be replaced.

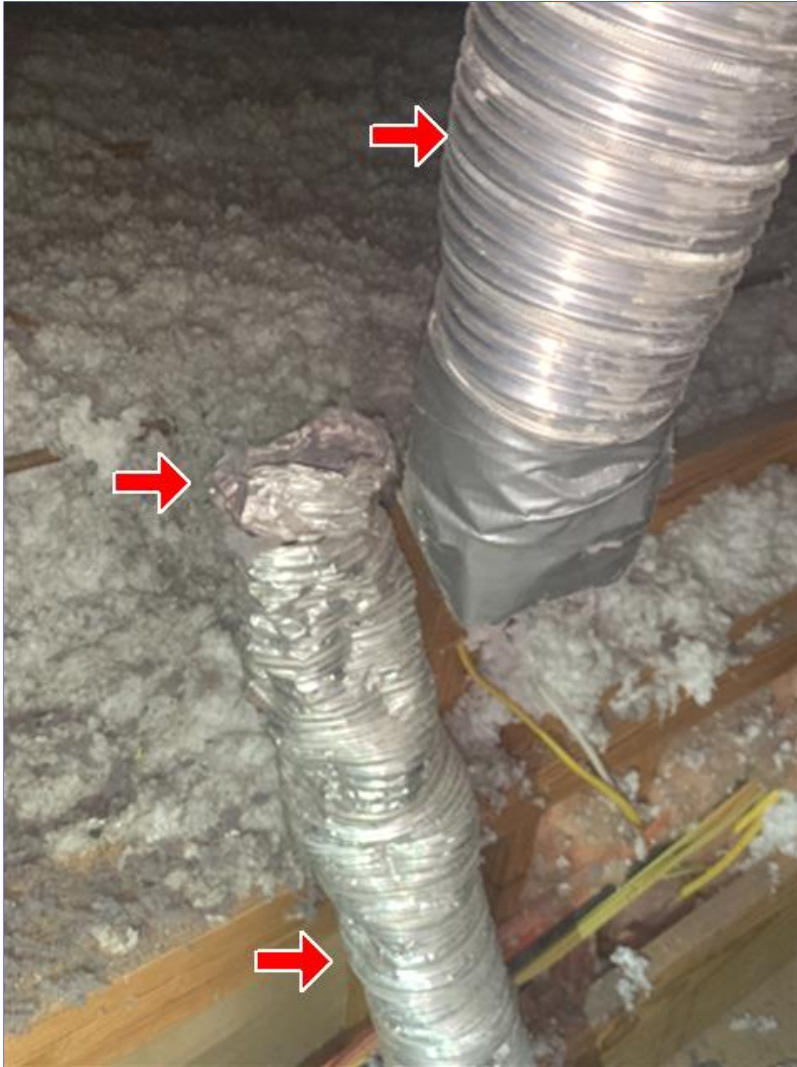
The dryer duct is not a smooth metal lined duct and it is separated in the garage.

H. Photo 1(Picture) The dryer duct is not a smooth metal lined duct and it is separated in the garage.
