PROPERTY INSPECTION REPORT

Prepared for: Hollie McKenzie
(Name of Client)

Concerning: 19415 Tocanatins Dr., Porter, Texas, 77365
(Address or Other Identification of Inspected Property)

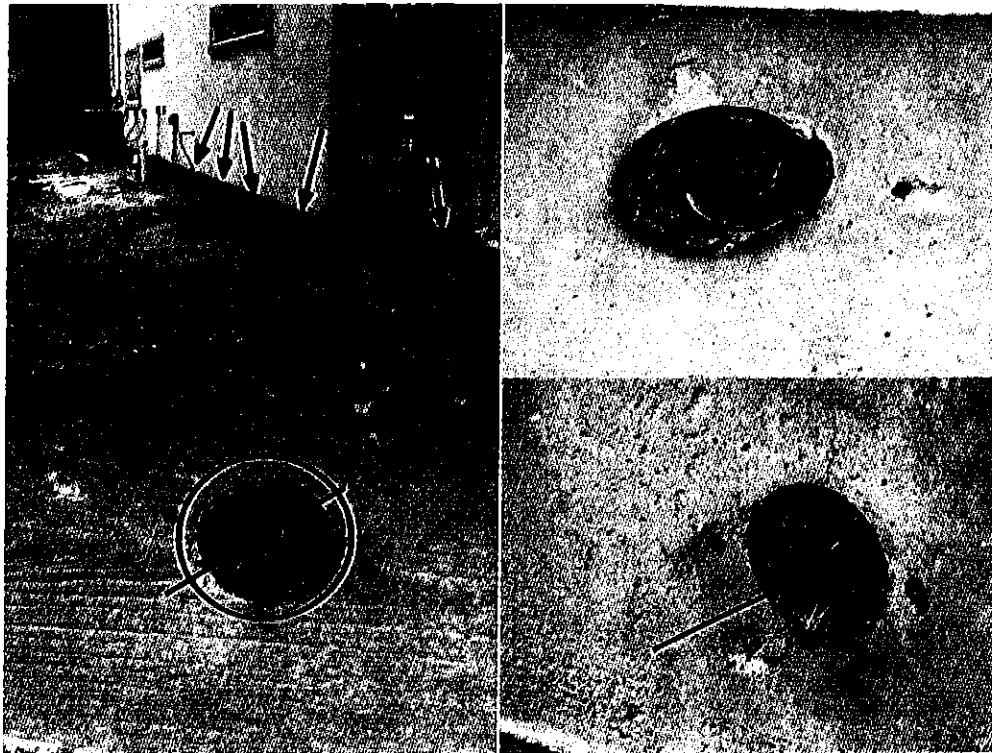
I observed one or more exposed ends of the post tension cables exposed on the surface of the grade beams with rust/corrosion. Exposure of the ends of these cables, used to reinforce a foundation, can cause rusting of the cable, which could lead to the failure of the cable anchoring system.

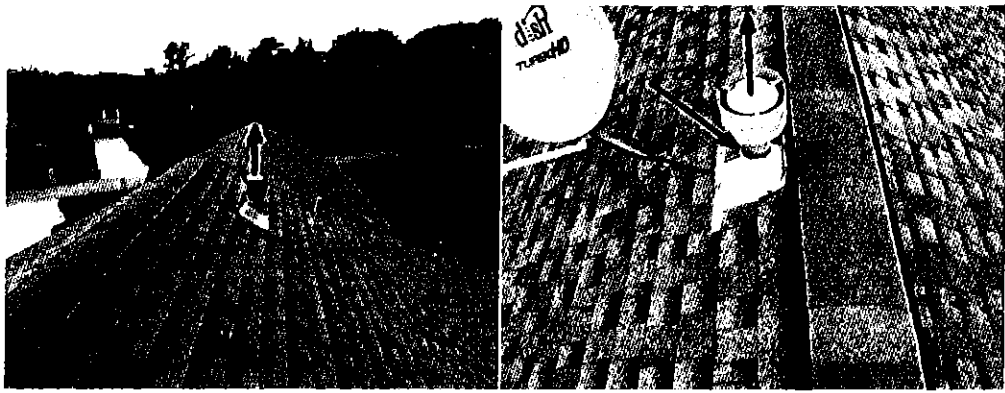
2-10 RULE 1

Observed gas vent terminations that did not appear to extend the proper height above the roof. Gas vent terminations must terminate above the highest point of the roof or be at least 2' higher than the roof within 10' of the termination.

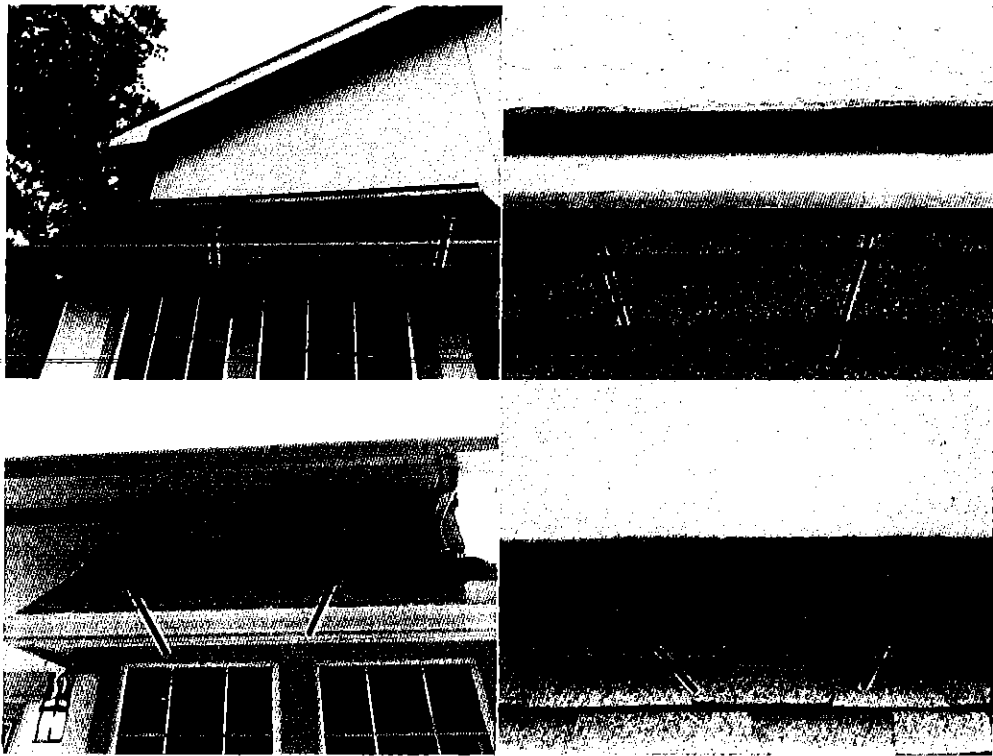
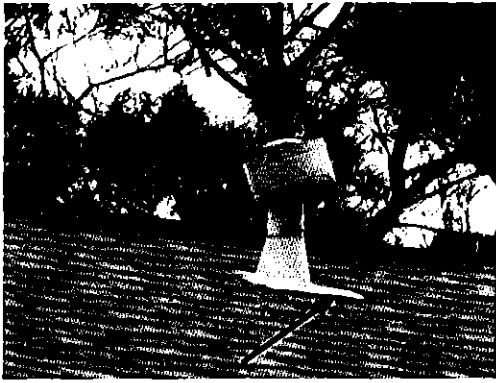
Flashing and/or roofing material was observed to be lifting and should be re-secured.

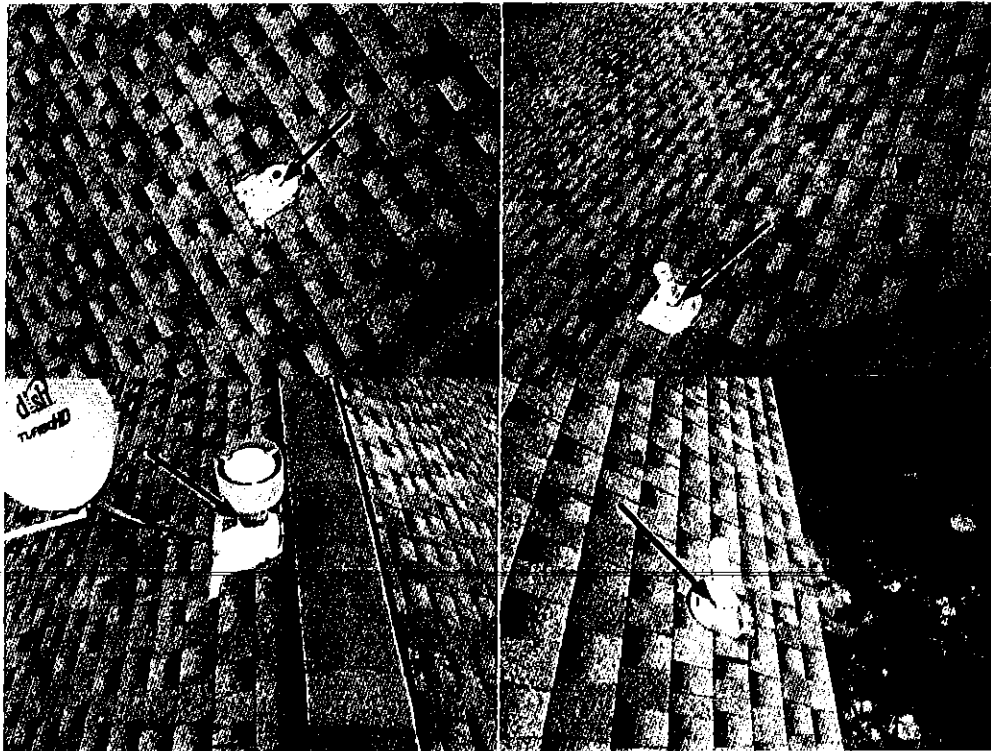
Gas exhaust vent cap and/or boot collar covering plumbing vent pipe did not appear to be sealed sufficiently which could exacerbate driven rain and moisture infiltration into the attic space. I suggest having a roofing company replace any plumbing vent boot jacks that may be leaking. This should have been done when the roof was replaced.

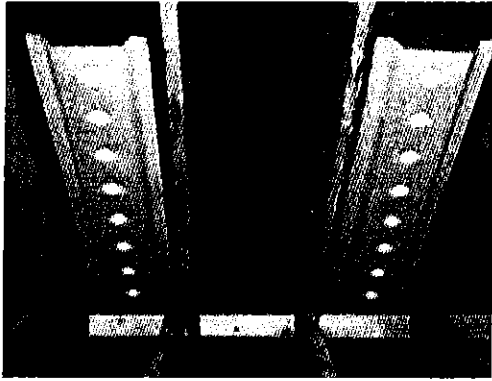
It appeared that the soffit baffles were missing between roof joists. With continuous perforated intake under the eave there must be a baffle between every roof joist to prevent insulation from closing any intake area.

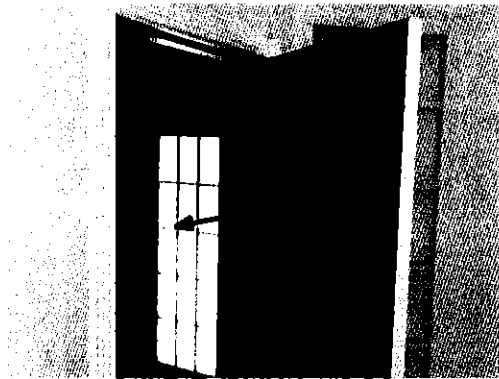
The door connecting the garage to the guest house living space did not appear to meet garage door requirements. Openings between the garage and residence shall be equipped with solid wood doors not less than 1 3/8 inches (35 mm) in thickness, solid or honeycomb core steel doors not less than 1 3/8 inches (35 mm) thick, or 20-minute fire-rated doors, that are self-closing.

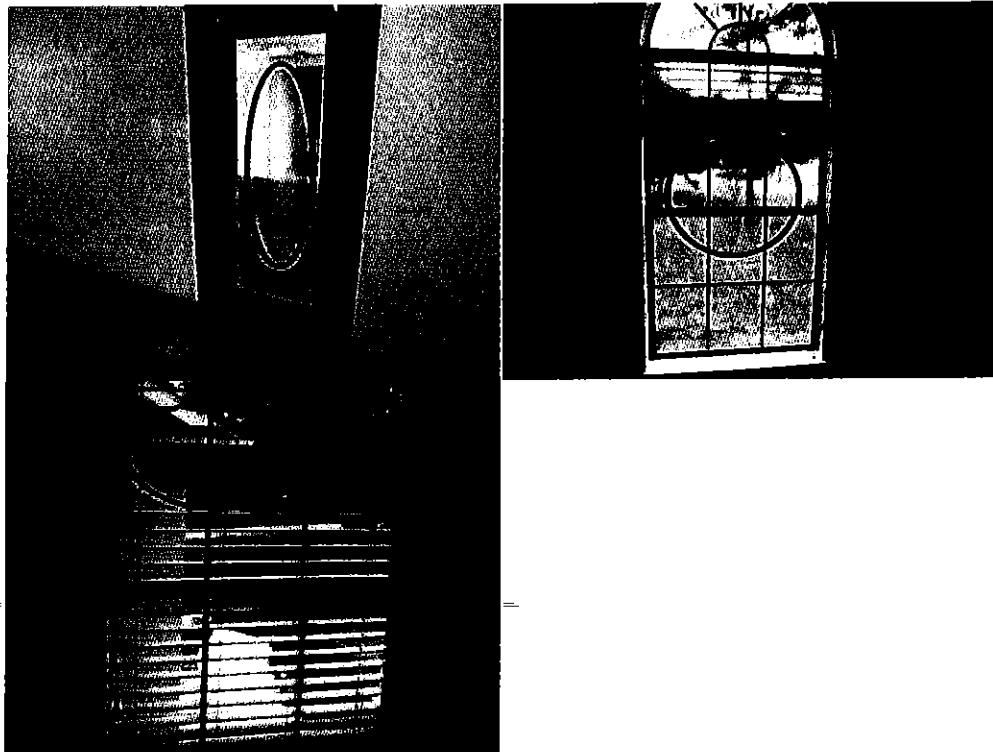
Sealant used between double panes were showing signs of failing in one or more windows. When the seal is broken in a double paned window, there is a fog or condensation that forms between the two panes of glass. These windows are no longer performing as expected.

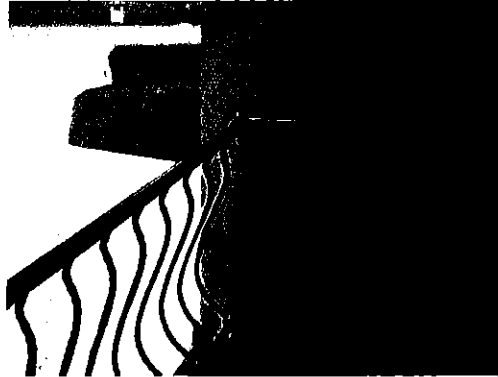
Handrail on exterior balcony did not appear to meet the minimum height requirements.

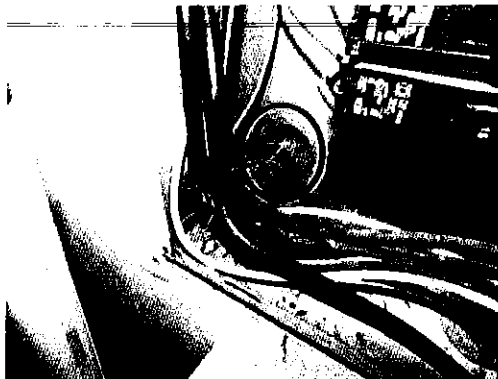
Observed wires passing through the wall of the panel not properly secured and/or protected. Wiring passing through the wall of the panel should be securely clamped to the panel as well as protected from vibrations that could rub the protective coating off of the wire, leaving it vulnerable to shorting out.

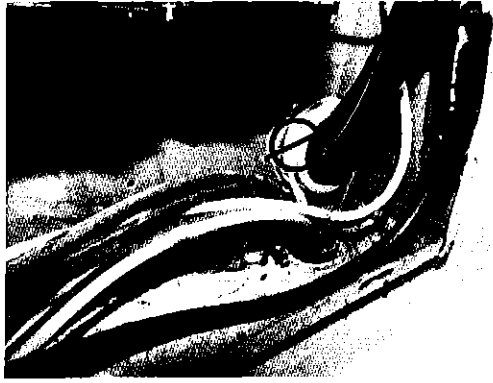
There did not appear to be a bonding jumper on the supply side of the service panel which bonds the metal panel box to the system. Non-current carrying metal parts of service equipment that are likely to become energized, shall be bonded together.
