PROPERTY INSPECTION REPORT

Concerning: 5841 Darling Street B, Houston, TX 77007
(Address or Other Identification of Inspected Property)

By: Erick Scheuermann Lic.#: 21458 03/19/2021
(Name and License Number of Inspector) (Date)

Home Inspection Report

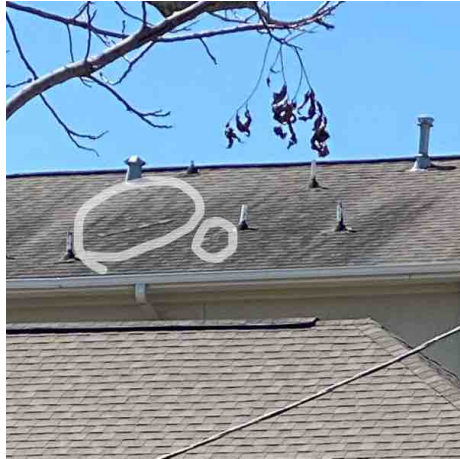
- **Missing / damaged shingles noted at backside of the home. Recommend replacing all missing damaged shingles to prevent water intrusion and related damage.**

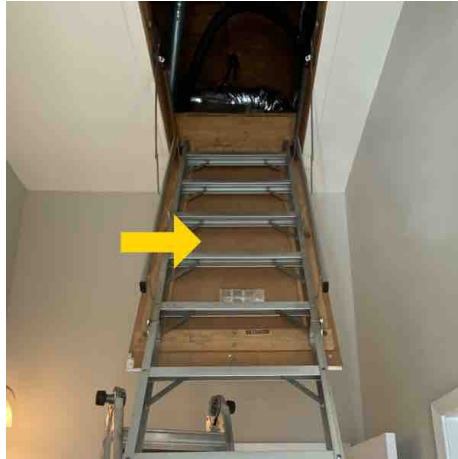
- Attic access should be weather stripped and insulated to prevent heat / cool loss

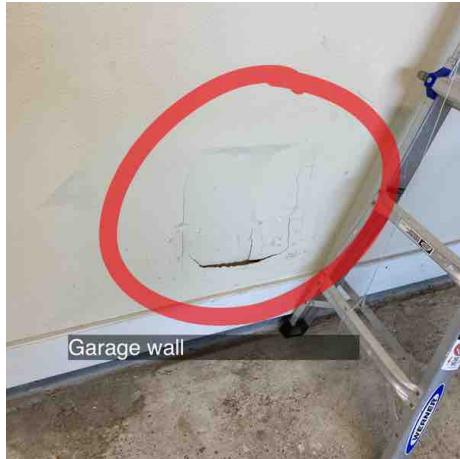
- There is damage to the wall in the garage. Recommend repair by qualified contractor.

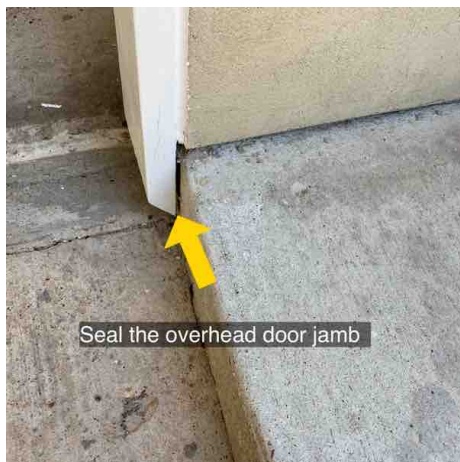
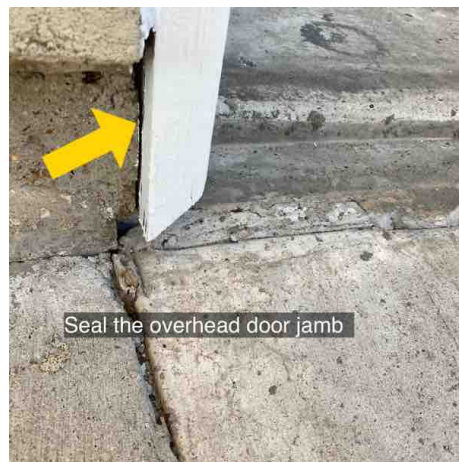
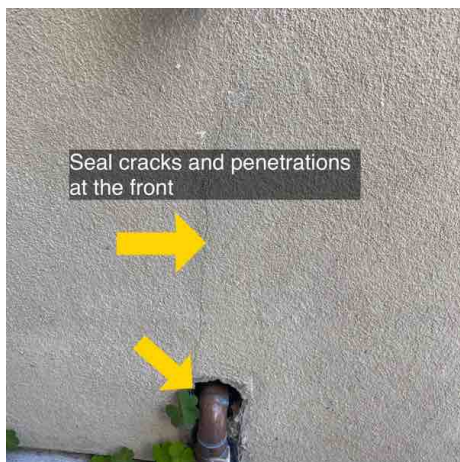
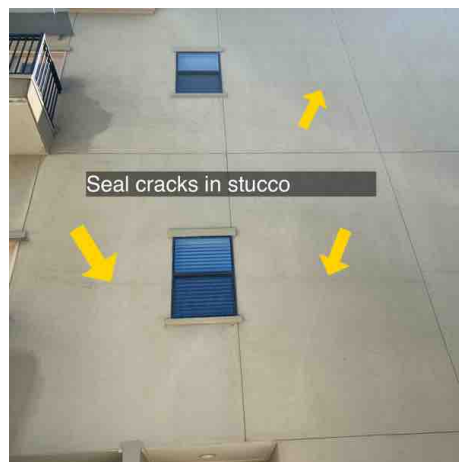
- All openings, penetrations, cracks, etc., in the exterior veneer or siding, or in any location on the exterior envelope of the building, should be caulked or otherwise sealed to prevent water or pest from entering the building.

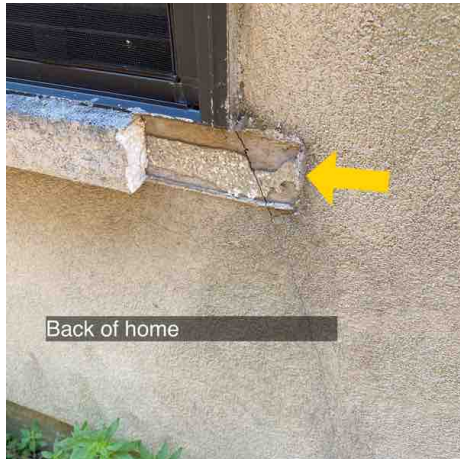
- **There is damaged trim at the backside first floor bedroom window. Recommend repair by qualified contractor.**

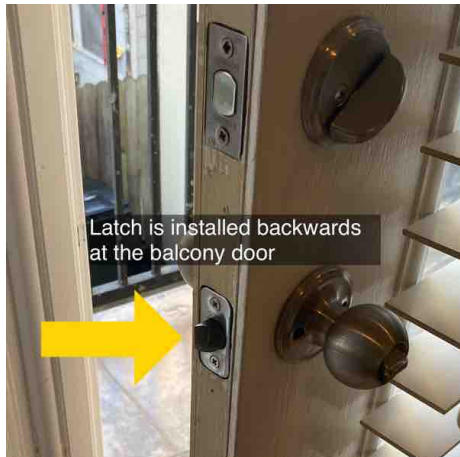
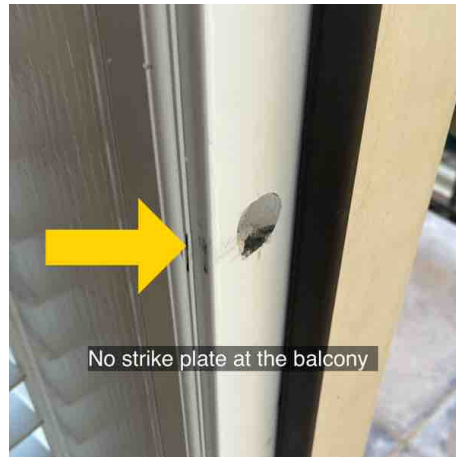
- **Door to the second floor balcony has the latch installed backwards and is missing the strike plate. Recommend repair by qualified contractor.**

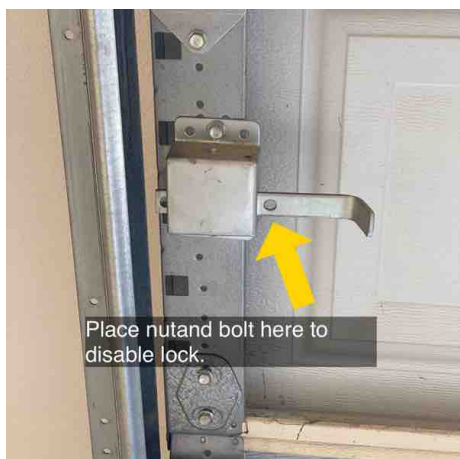
- **Permanently disable the overhead garage door lock to prevent damage to the door in the event the opener is engaged.**

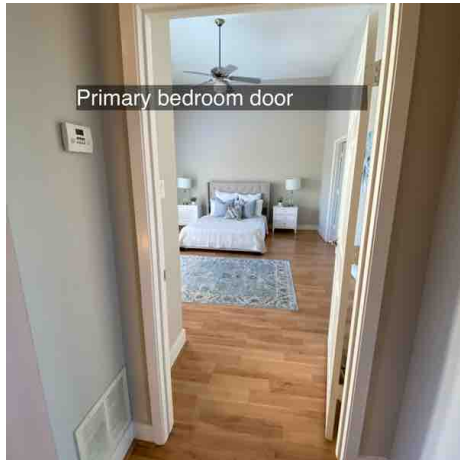
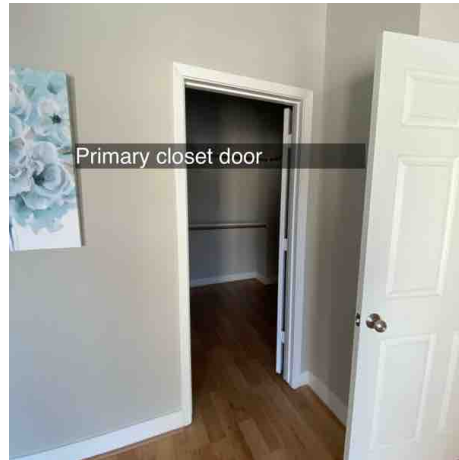
- Doors do not latch. Recommend adjusting the strike plates.

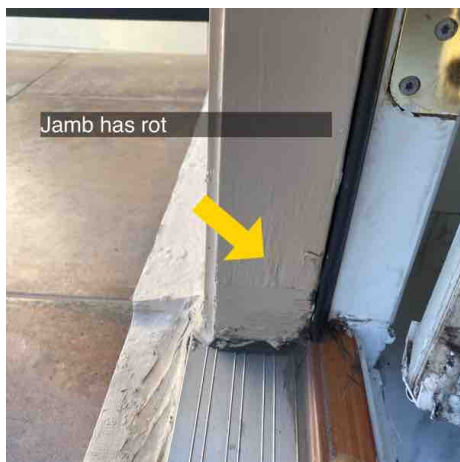
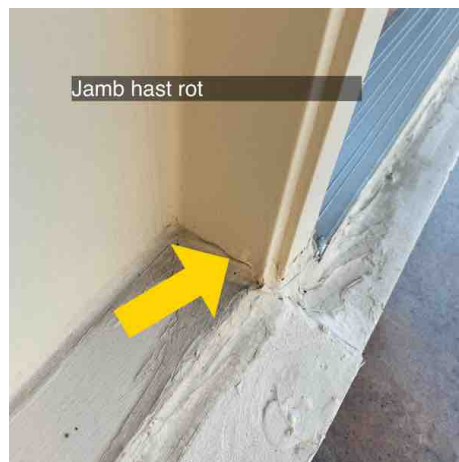
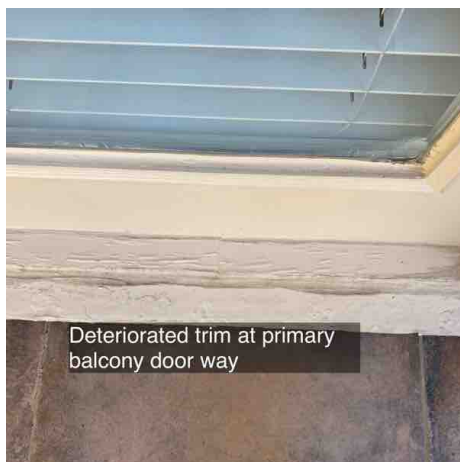
- Door jamb is deteriorated at primary bedroom balcony on the third floor. Recommend repairing / replacing the deteriorated jamb.

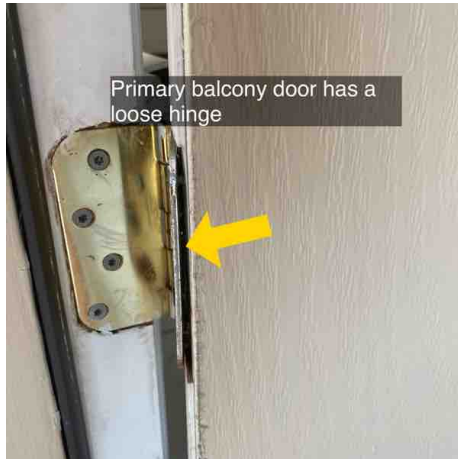
- Hinge on primary balcony door is loose. Recommend tightening the hinge.

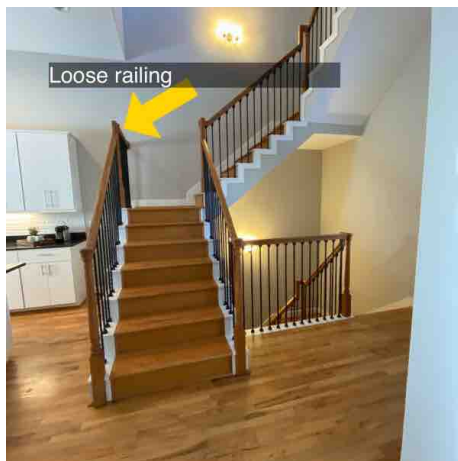
- The stairwell railing between the second and third floor is loose. Recommend repair by qualified contractor.

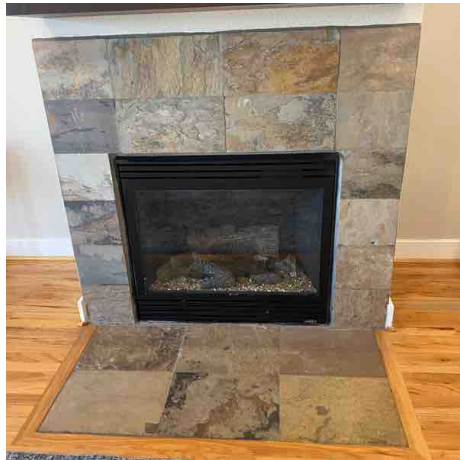
- **Fireplace is a manufactured sealed gas log, gas start metal lined chimney and was not operating properly at the time of inspection. The inspector was unable to light the fireplace. Recommend evaluation and repair as needed by qualified fireplace contractor.**

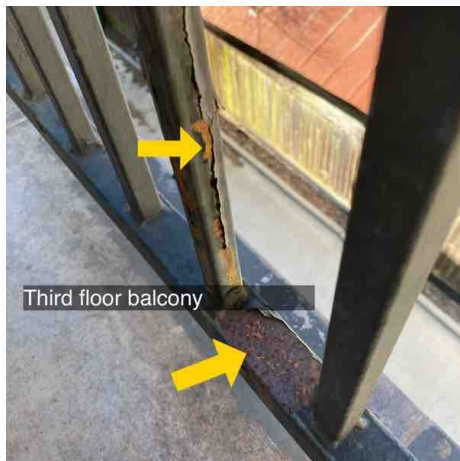
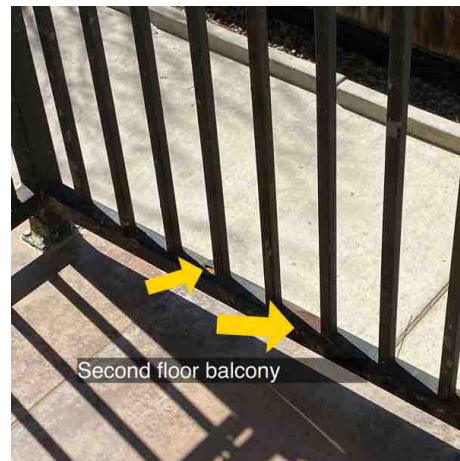
- **Railings at the balconies are rusted. Recommend repair by qualified contractor.**

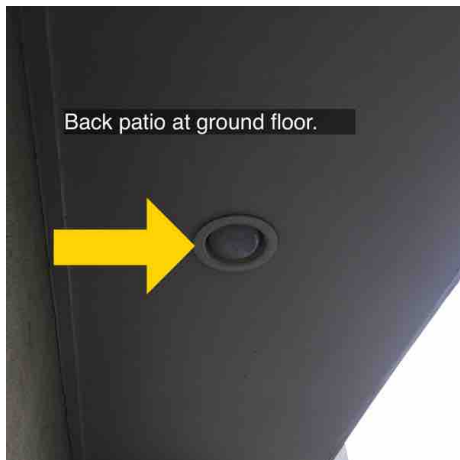
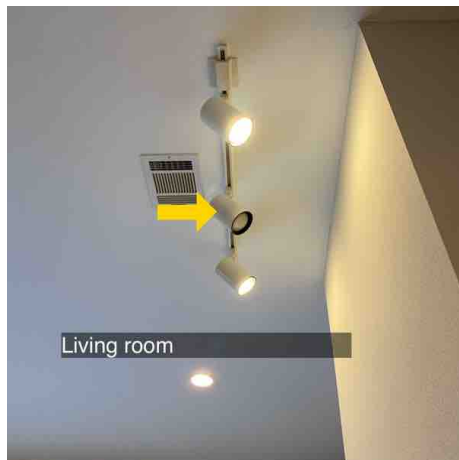
- Lights do not work. Check bulbs and if the are okay further investigation is required.

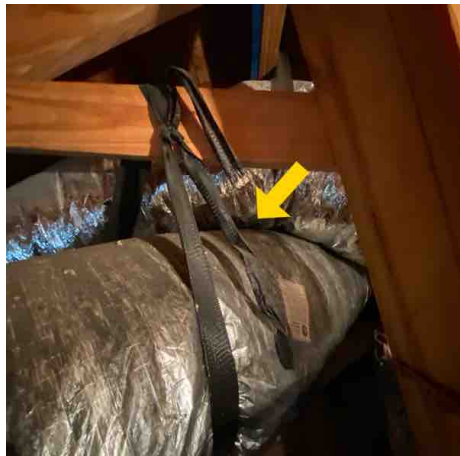
- Install batt insulation between ducts that touch each other to prevent condensation build up and premature wear of the ducts.

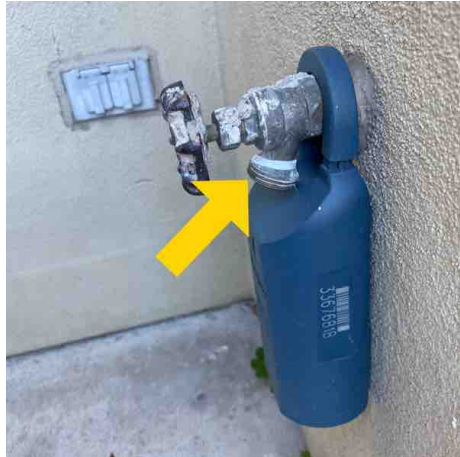
- **Back flow preventer are not installed on the outside hose bibs. Recommended installing for the safety of the water supply.**

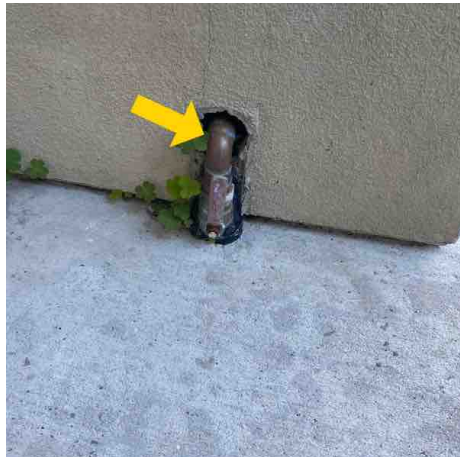
- **Insulate the main water supply line to prevent possible freezing.**

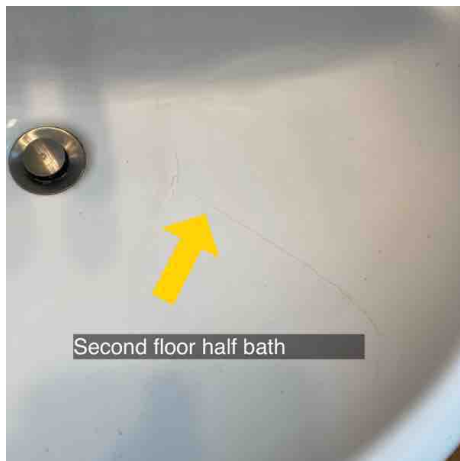
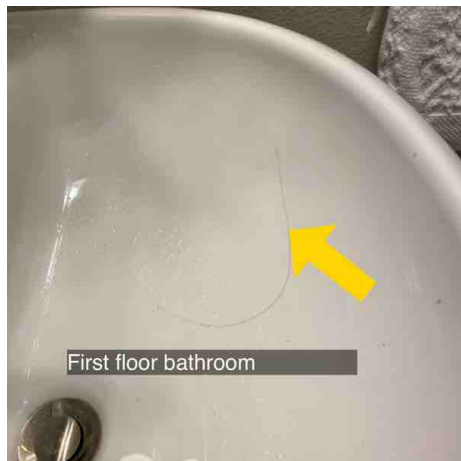
- The lavatories in the second floor half bath and first floor bathroom have a cracks in the basins. Recommend evaluation and repair as needed by qualified plumbing contractor.

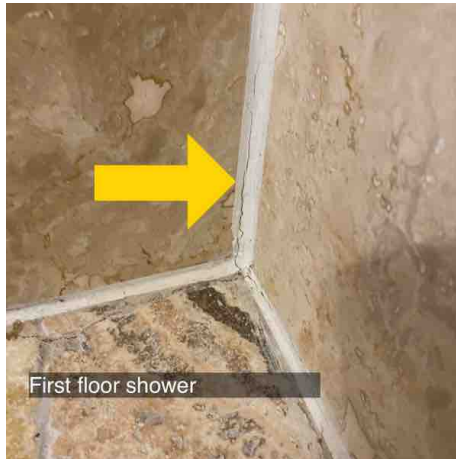
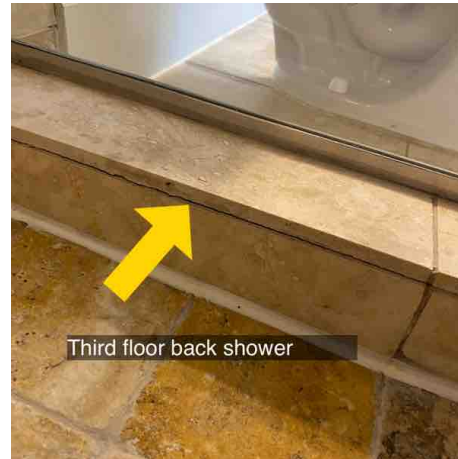
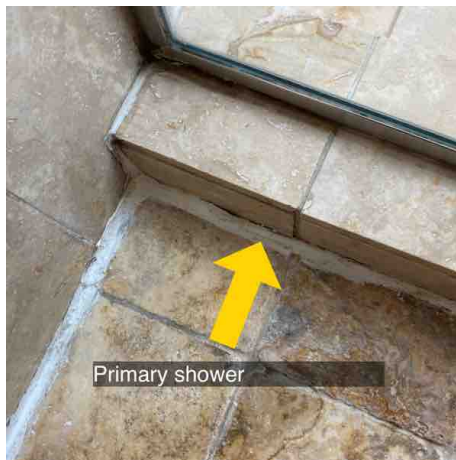
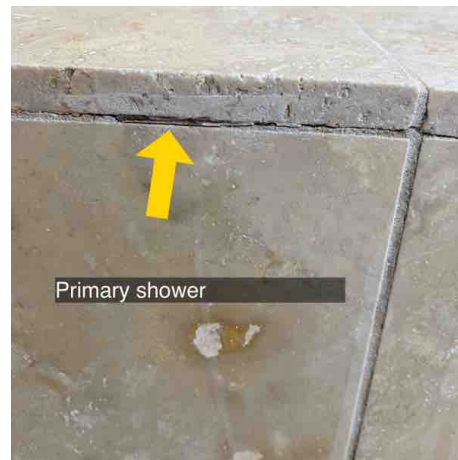
- Repair grout in fist floor shower, third floor back bathroom shower and primary shower to prevent water intrusion and related damage.

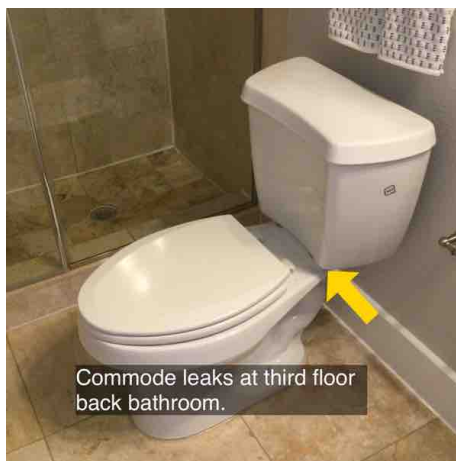
- Commode leaks at the tank in the third floor back bathroom. I left the water shut off and drained the tank. Recommend repair by qualified plumbing contractor.

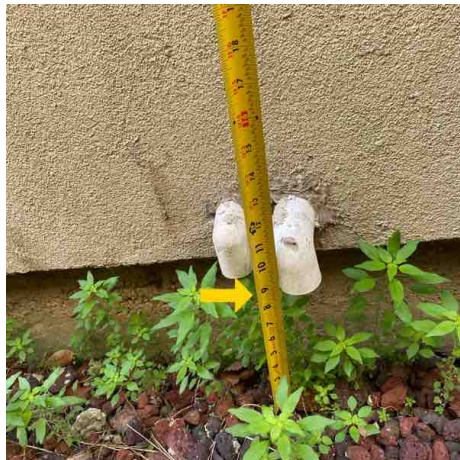
- **The emergency drain pan and temperature / pressure (T&P) drain lines that exit the home are located to high. These lines should be no more than six inches from the ground for safety reasons. Recommend extending drain lines.**

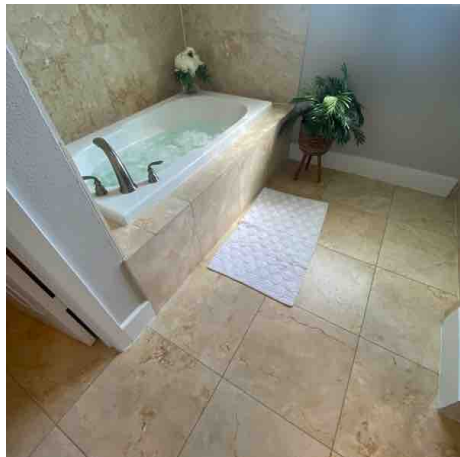
• There is no access to the motor. Recommend providing access.

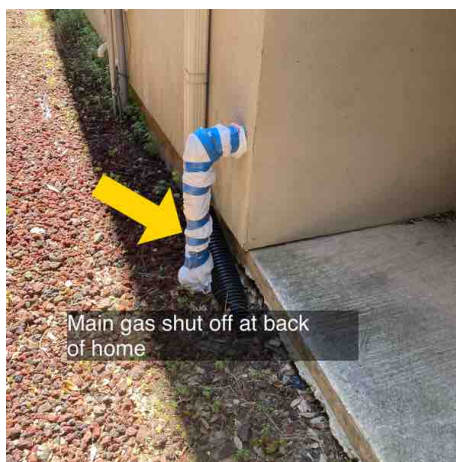
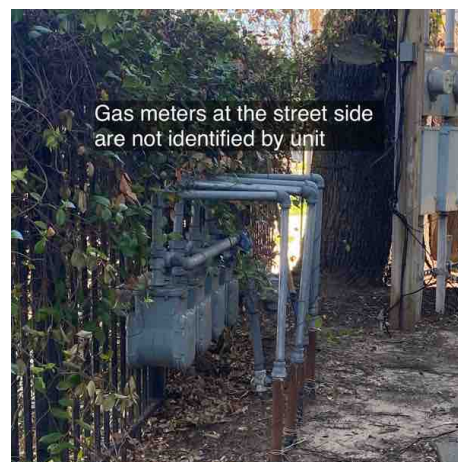
- **There are no carbon monoxide detectors present. It is highly recommended to install carbon monoxide detectors where gas appliances are being used.**
- Main gas shut off valve was located on the back side of the house. Gas lines are black steel. All gas appliances were tested at the connections for gas leaks. No leaks were found.
