PROPERTY INSPECTION REPORT

174 Almondell Way
Magnolia, TX 77354

Concerning: 174 Almondell Way, Magnolia, TX 77354
(Address or Other Identification of Inspected Property)

By: John Nobles, Lic #6907 11/15/2018
(Name and License Number of Inspector) (Date)

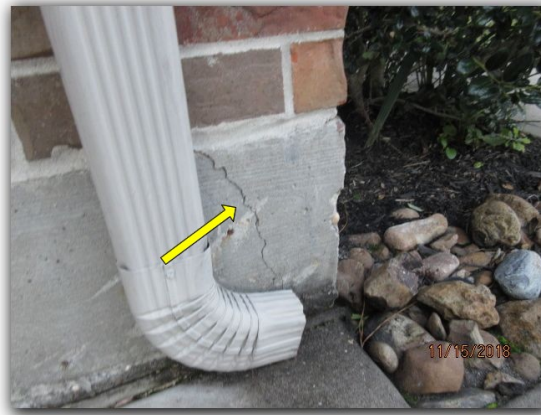
- Cracked corners were noted along the foundation (also known as a wedge or toe cracks). These cracks are common and usually occur as a result of thermal expansion and cooling of the exterior brick veneer walls. As preventative measures, the cracks should be properly sealed to reduce the risk of water penetration and insect activity.

A qualified contractor should be consulted to further evaluate these conditions and remedies available for correction.

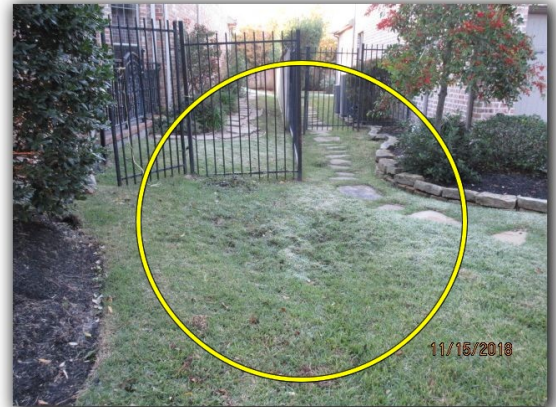
- Previous standing water was noted along the final grading/yard (Left Side of House, Right Side of House). This condition requires further investigation and repairs undertaken as necessary to ensure proper water drainage to the street and prevent water pooling.

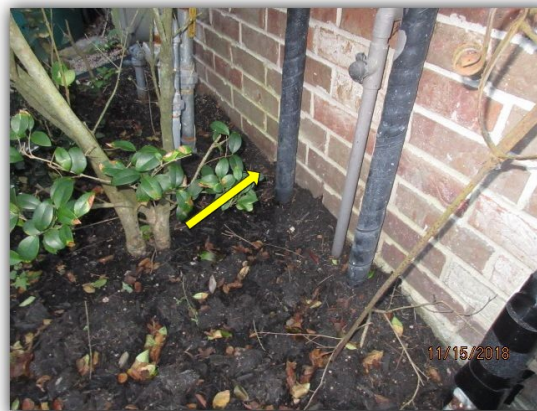
- The soil level at the foundation is too high (Various Locations). Under current building standards/practices the exposed height of the exterior perimeter beam of the foundation should be maintained a minimum of 4 inches above the soil level for concrete or masonry type siding, and a minimum of 6 inches above the soil level for wood type siding.

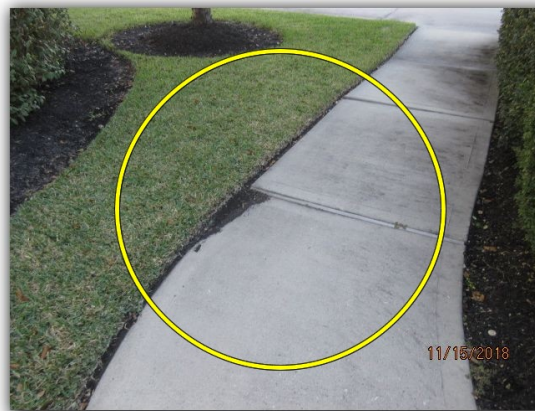
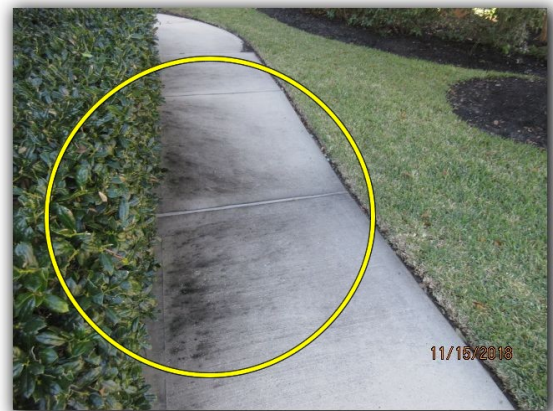
- Evidence of previous standing water was noted along some of the flatwork. This condition requires further investigation to determine the source of the effective areas and repairs undertaken as necessary to ensure proper water drainage to the street and prevent water pooling.

A qualified company should be consulted to further evaluate these conditions and remedies available for correction if necessary.

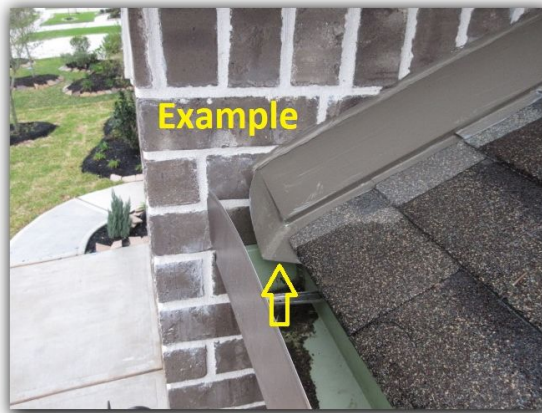
- The kick-out flashing appeared to be missing or not installed at some of the eaves and vertical wall junctions. This type of flashing helps minimize the water exposure along the walls below the roof eaves.

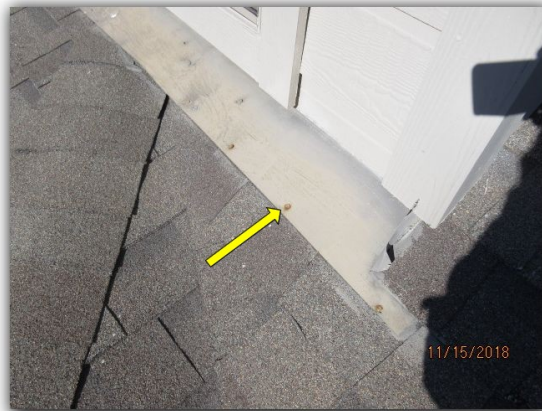
- All exposed nail heads along the roof flashing and roof jack flanges should be properly sealed to reduce the risk of water penetration.

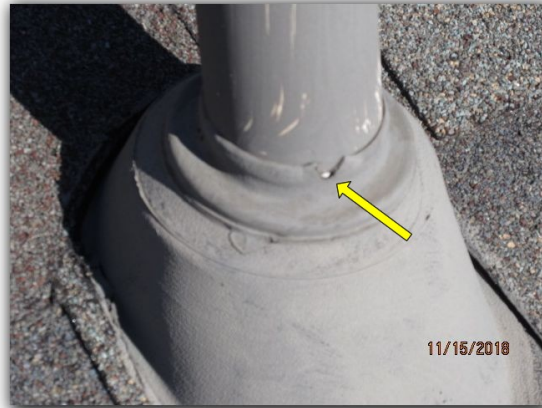
- The rubber type roof jack collars at some of the plumbing vents appear to be weathered/cracked and not properly sealing around the vent pipes. These conditions require further investigation and repairs undertaken as necessary to reduce the risk of water penetration.

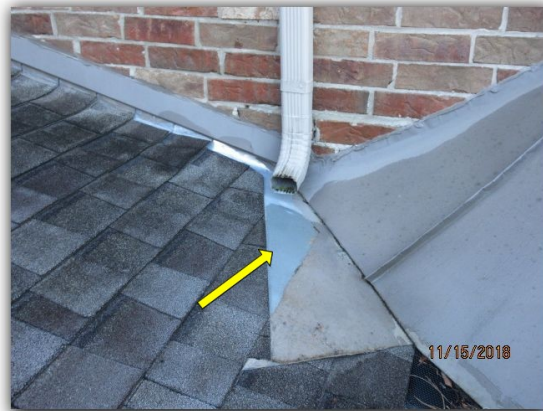
- Missing paint was noted along some of the metal flashing. All exposed metal roof flashings should be painted to reduce the risk of corrosion/degradation from weather conditions.

A qualified roofing company should be consulted to further evaluate these conditions and remedies available for correction.

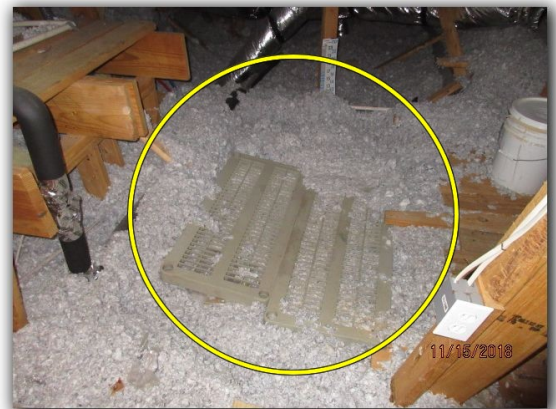
- Some of the soffit baffles in the attic area are loose and not properly secured. “Baffles” should be installed along these areas to hold back insulation and allow for free movement of air within the roof space. It is recommended that these conditions be further investigated and improved where necessary.

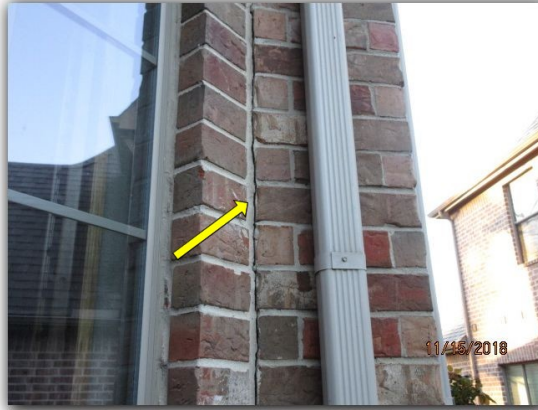
- Separations were noted along some of the brick veneer expansion joints at the time of inspection. Separations that form along the expansion joints are common, and in some cases occur with normal or abnormal settling of the structure. The separations can also be indicative of poor quality in materials and workmanship during construction. Further investigation is needed to determine the source of the affected areas. In addition, the caulking along the joints should be considered for repairs to reduce the risk of water penetration and insect activity.

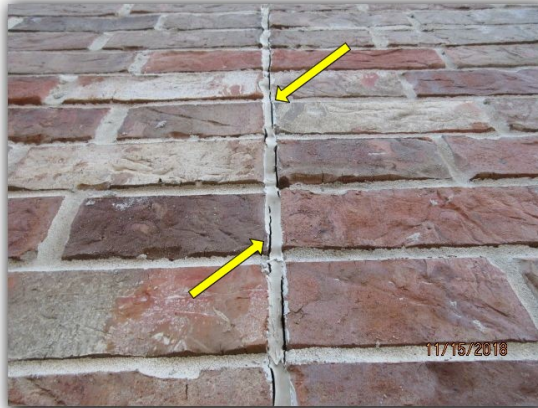
- The caulking was noted missing or not installed along some of the vertical siding junctions. These areas should be properly sealed to reduce the risk of moisture penetration.

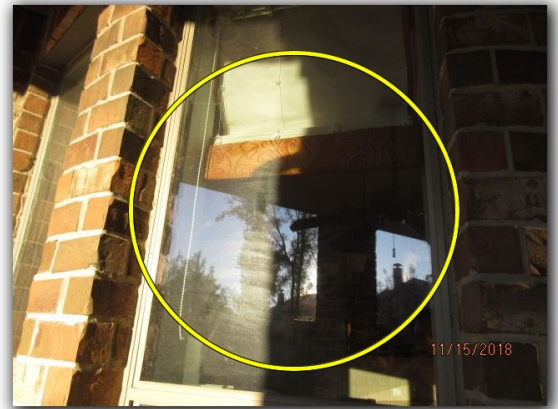
- The frame guide balances are loose/damaged and not properly secured along some of the windows (Breakfast Room). It is recommended that the guide balances at all windows be checked by a qualified company to ensure that they are installed properly and allowing for normal operation.

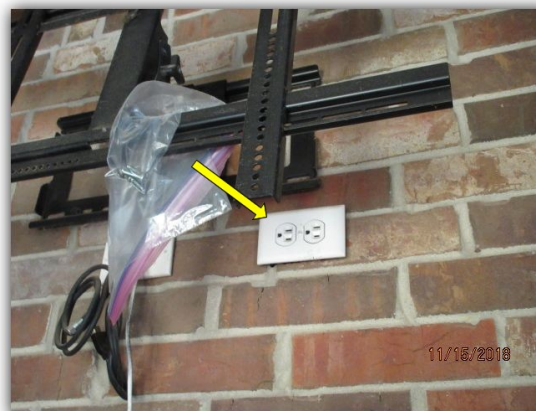
- Some of the outlets are not functioning at the time of inspection (Left Side of House). These outlets and their circuits require further investigation and repairs undertaken as necessary.

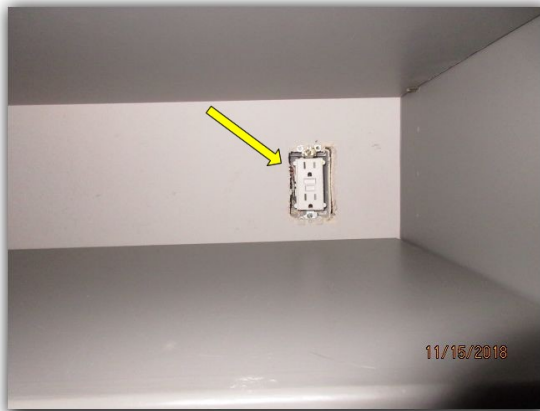
- Some of the electrical outlets/circuits are not protected by Ground Fault Circuit Interrupters (Laundry Room Sink). Under current building standards/practices, ground fault circuit interrupters are required at the following areas; 125 volt, single-phase, 15- and 20-ampere receptacles shall have ground-fault circuit-interrupter protection located in bathrooms; garage and accessory buildings; outdoors; crawl spaces; unfinished basements; kitchen receptacles that serve countertop surfaces; within 6 feet of the outside edge of a sink; located within 6 feet of outside edge of a bathtub or shower stall; laundry area; kitchen dishwasher circuit; boathouse receptacles; boat hoist receptacles; electrically heated floors in bathrooms, kitchens and in hydro-massage bathtub, spa and hot tub locations; locations of GFCI's should be installed in readily accessible locations. The builder should be consulted to confirm that this was not overlooked on the building plans.

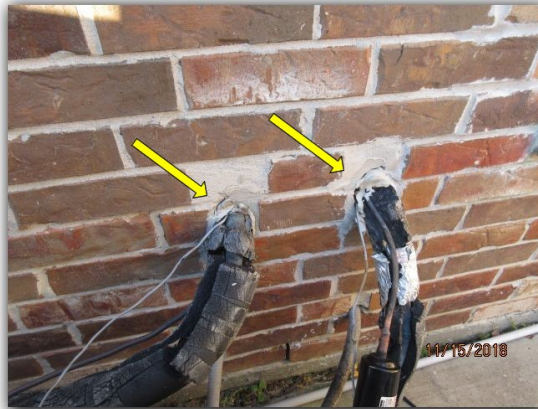
- Damaged/missing insulation was noted along the refrigerant lines at the A/C condenser unit located outside.

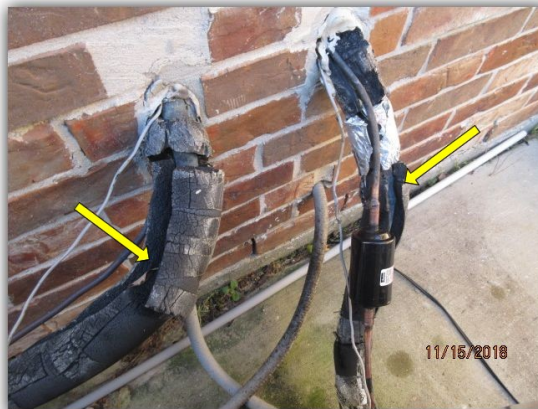
- The condenser/compressor unit of the air conditioning system appeared to be dirty and requires cleaning.

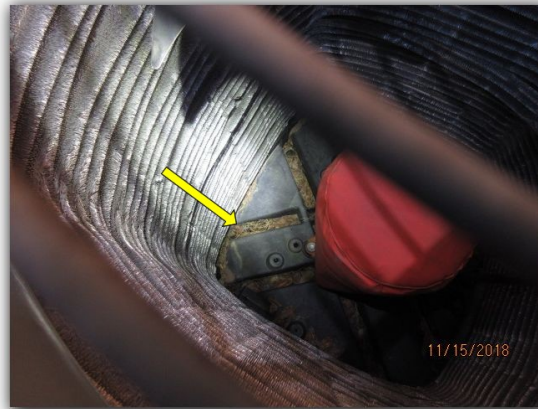
- The openings in the evaporator coil cabinet where the refrigerant lines enter should be sealed properly to reduce the risk of air leaks.

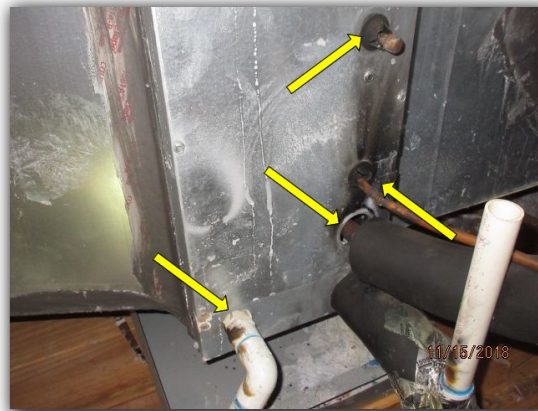
- Some of the insulation joints along the A/C refrigerant lines in the attic area are not sealed properly. Condensation forms on the exposed copper refrigerant lines when the A/C system is operating. All of the insulation joints along the refrigerant line should be properly sealed to reduce the risk of water damage to the structure.

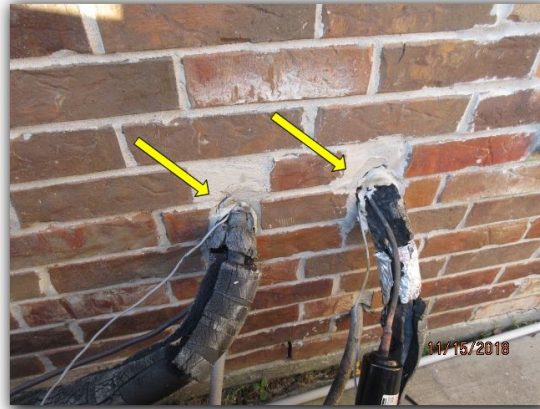
- Damaged/missing insulation was noted along the refrigerant lines at the A/C condenser unit located outside.

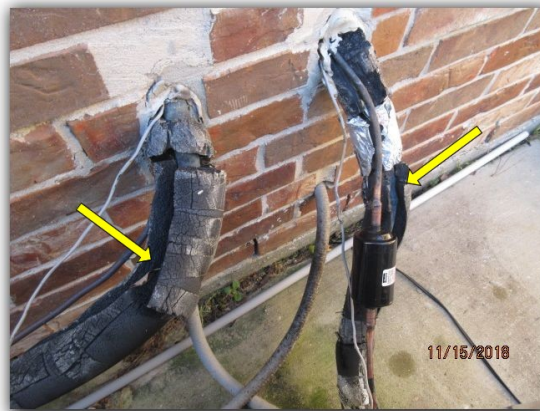
- The condenser/compressor unit of the air conditioning system appeared to be dirty and requires cleaning.

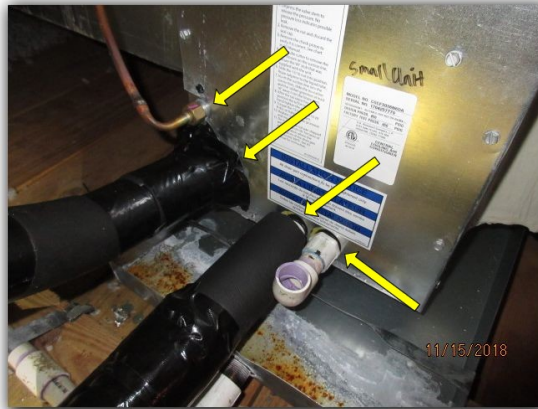
- The drain line to the over-flow opening along the evaporator cabinet does not terminate properly into the safety pan. This condition requires further investigation and repairs undertaken as necessary to reduce the risk of water damage to the structure.

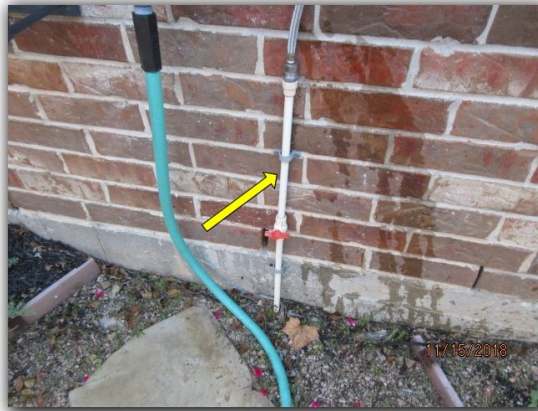
- Some of the water supply/sewage pipe systems are not properly buried in the soil. Under current building standards/practices, a water, soil or waste pipe shall not be installed outside of a building, in exterior walls, in *attics* or crawl spaces, or in any other place subjected to freezing temperature unless adequate provision is made to protect it from freezing by insulation or heat or both. Water service pipe shall be installed not less than 12 inches deep and not less than 6 inches below the frost line.

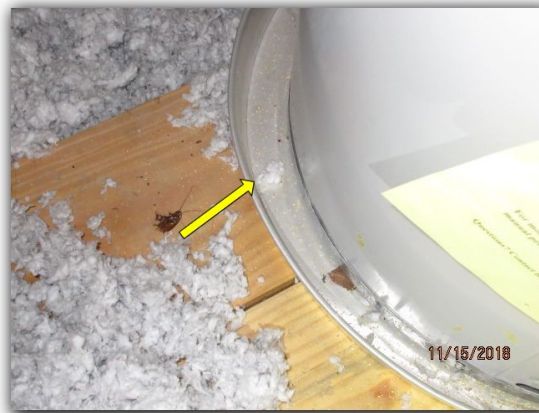
- The auxiliary (safety) drain pan installed below the water heater unit appears to be off-center of the unit and not properly installed below the tank drain valve. This condition requires further investigation and repairs undertaken as/if needed to reduce the risk of water damage in the event of a leak.

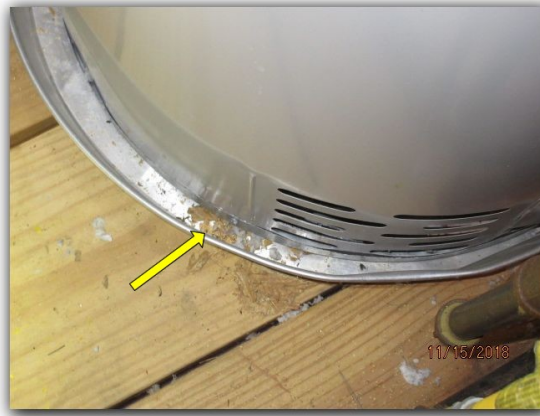
- The auxiliary (safety) drain pan installed below the water heater unit appears to be off-center of the unit and not properly installed below the tank drain valve. This condition requires further investigation and repairs undertaken as/if needed to reduce the risk of water damage in the event of a leak.

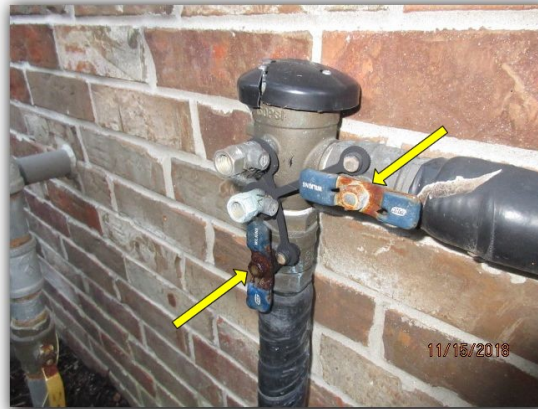
- The bell cap to the vacuum breaker appeared to be damaged at the time of inspection. It is recommended that this condition be further investigated and repairs undertaken as necessary.

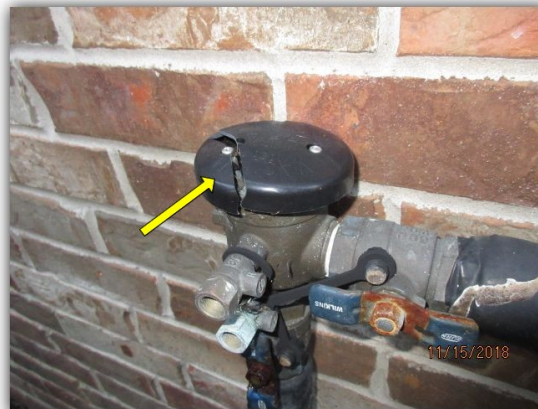
- The sprinkler system was found to be inoperative at the time of inspection. The system did not respond when the controller was actuated. The system appears to be winterized (water supply turned off). This condition should be further investigated and repairs undertaken as necessary to ensure that the system works properly.
