Property Inspection Report

20815 Bastion Settle Drive, Hockley, Texas 77447

Date of Inspection: 4/17/2018 Time: 1:00 pm
Age of Home: 2018 - new construction Size: 1,600 sq ft
Weather: Sunny & 84 degrees
This is a pre-drywall inspection.

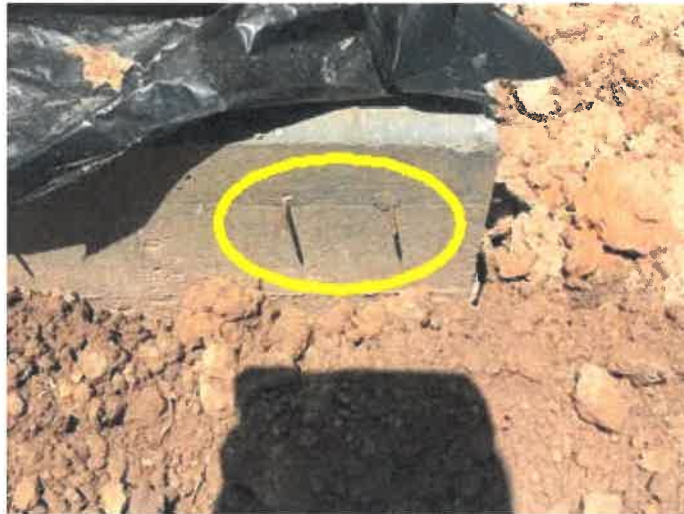
- It is the opinion of this inspector, this homes foundation appeared to be functioning as intended on the day of inspection.
- Nails were found sticking out of the foundation around this home. These nails should be cut flush with the foundation in order to prevent injury.
- Recommend consulting a general contractor for further evaluation and corrective action.

Nails sticking out of the foundation on the left front corner of this home.

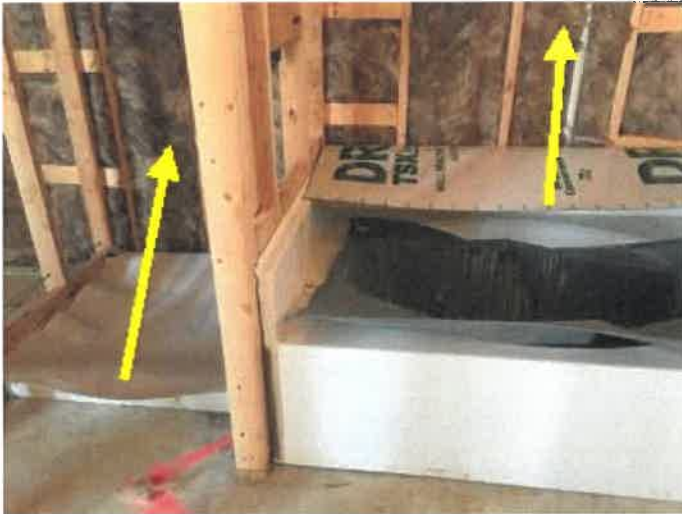
- The sheathing at the master shower and bathtub are loose. Recommend securing the sheathing to the studs.
 - Recommend consulting a general contractor for further evaluation and corrective action.

Loose sheathing at the master shower and bathtub.

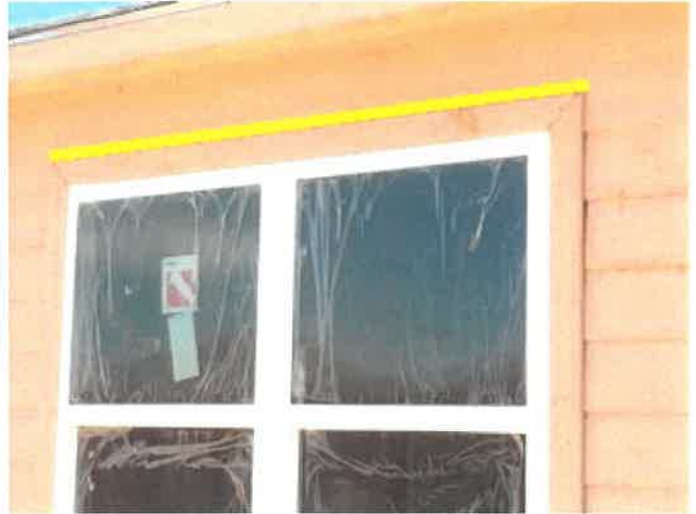
- Exterior:
 - There is no visible through wall or Z flashing at the top of the master bedroom window. Through wall or Z flashing is designed to protect the area between the trim and siding at the top of doors and windows from moisture penetration.

No visible through wall or "Z" flashing at the top of the master bedroom window.

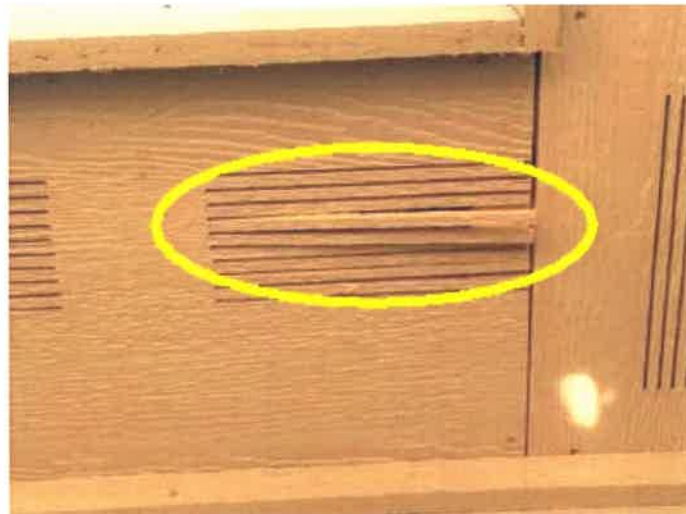
- A damaged eave was found at the front porch. Recommend replacing the damaged eave.
 - It appears a piece of siding at the master bedroom windows has been cut too short. Recommend replacing this piece of siding in order to close the gap between the siding and trim around the windows.

Damaged eave at the front porch.

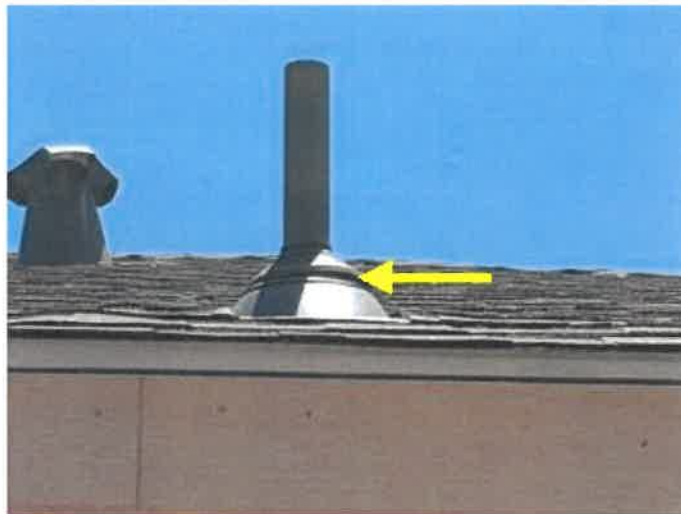
Comments:
• Lifting vent boot gaskets were found at several locations on this home.
Recommend consulting a roofing contractor for corrective action.

Lifting vent boot gasket on the right side of this home.
