PREMIER HOME INSPECTIONS

RESIDENTIAL HOME INSPECTION

3014 Dallas St Houston TX 77003

> John Lam NOVEMBER 30, 2020

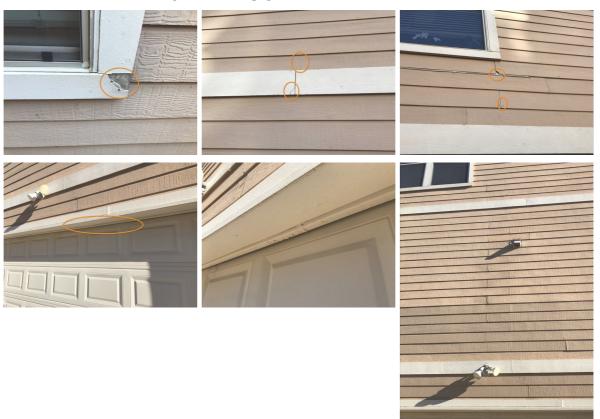
5: Siding - Minor Deterioration/Damage

Deterioration/damage (minor) was observed at the exterior siding: localized repairs are recommended.

Recommendation: Contact a qualified siding specialist.

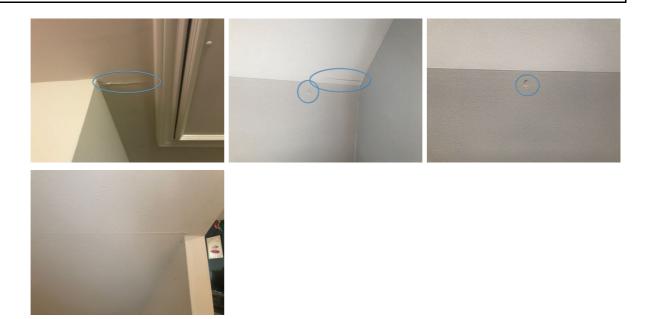
1: Minor Drywall Cracks

There were several areas that had drywall nail pops and/or minor cracks. These are usually not structural defects and are caused by differential movement of the roof structure and the wall framing. Patching and monitoring is recommended.

Recommendation: Contact a handyman or DIY project

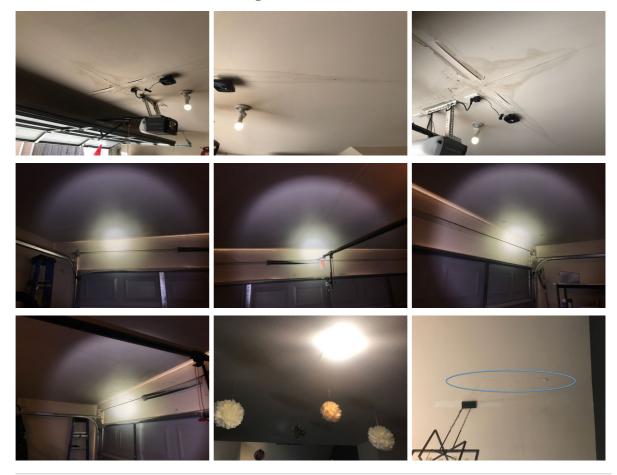
2: Water Staining

There was evidence of previous water/moisture contact on the ceiling. This should be monitored to determine if a water source continues to contribute to its presence. If so, corrective actions should be taken to stop the water source.

Recommendation: Recommend monitoring.

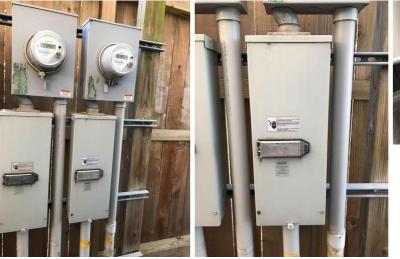
1: Missing Knock-outs

Plastic safety knockout covers should be installed on any breaker spaces missing a punch-out.

Recommendation: Contact a qualified electrical contractor.
