PROPERTY INSPECTION REPORT

Prepared For: Rohan Fernandes
(Name of Client)

Concerning: 3835 Tarragon Bend Dr, Richmond, TX 77406
(Address or Other Identification of Inspected Property)

By: Robert Waitschies TREC#5814 12/08/2017
(Name and License Number of Inspector) (Date)

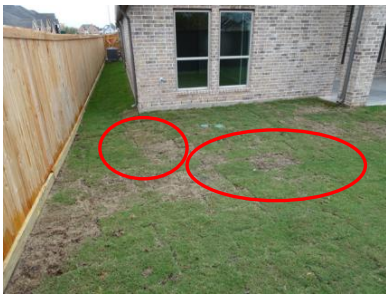
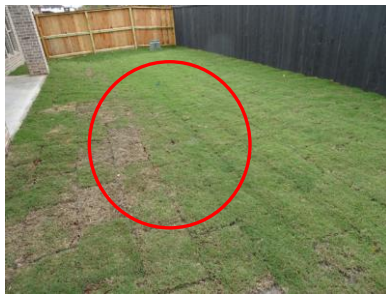
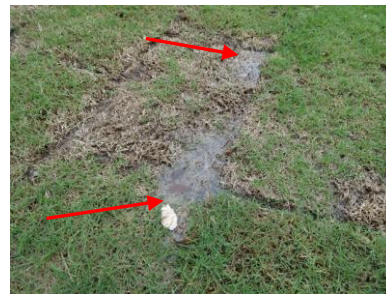
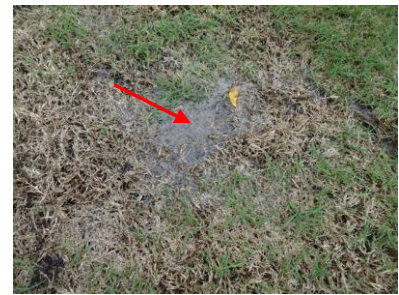
- Drainage improvements are needed at the rear of the home. Standing water was observed. All excess surface moisture should drain to the street as designed.

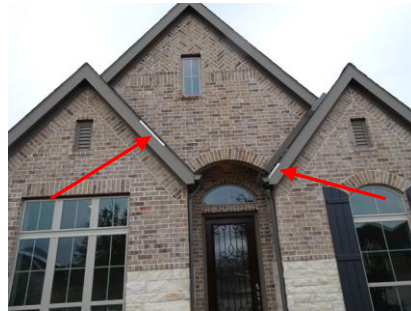
- The drip edge flashing at the front of the home is unpainted.

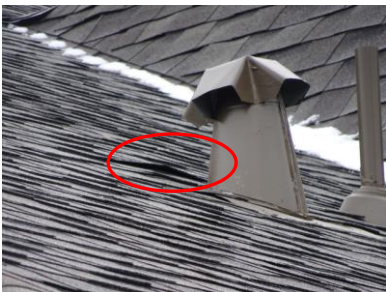
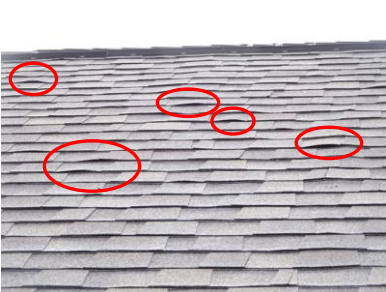
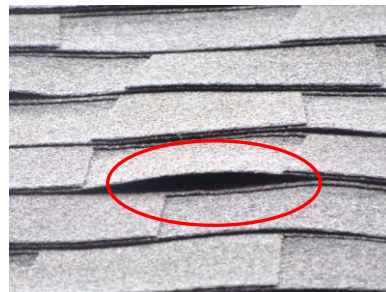
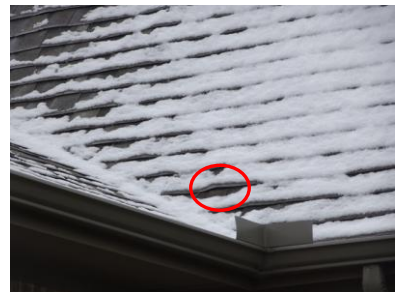
- Cupped or lifted shingles were observed on the roof in many locations. Repairs should be undertaken to allow the shingles to lay flat.

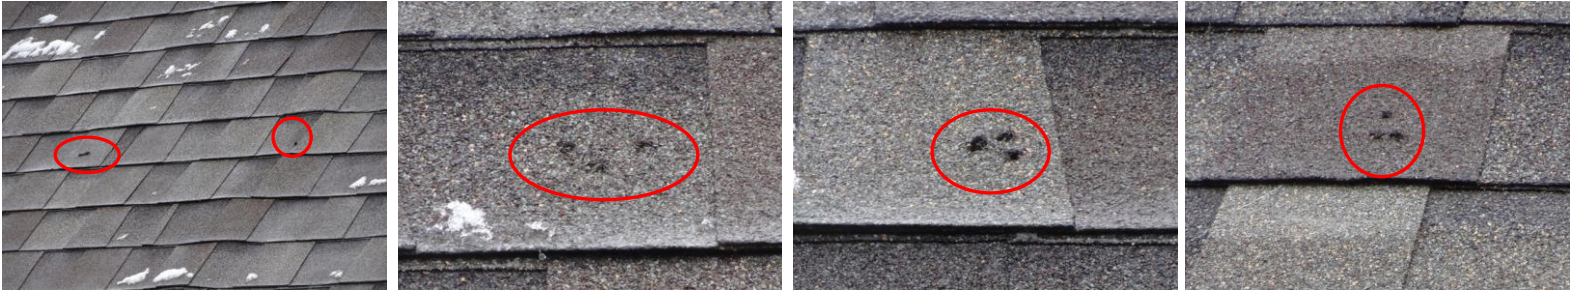
- Damaged shingles were observed at the left and right side slopes of the roof in many locations. The damage appears to have been caused by the removal of the chicken ladders installed during the roof covering construction. Many holes were observed in the shingles. Repairs should be undertaken as necessary.

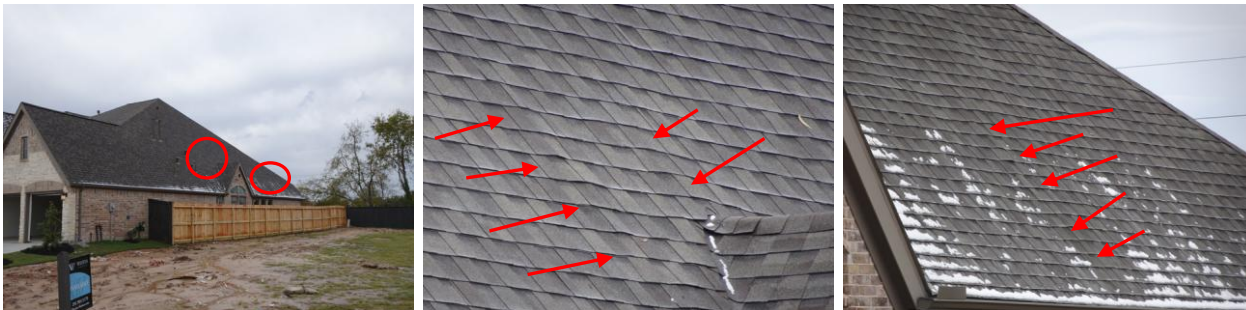
- The right side roof slope is uneven or is buckling in several locations. Repairs should be undertaken as necessary.

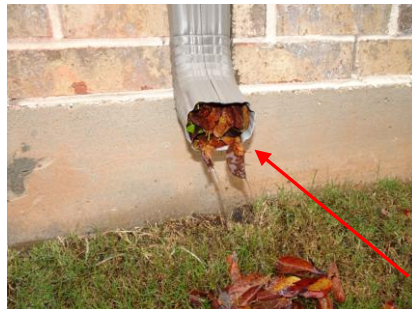
- The roof gutters and gutter downspouts should be cleaned of all leaves and debris.

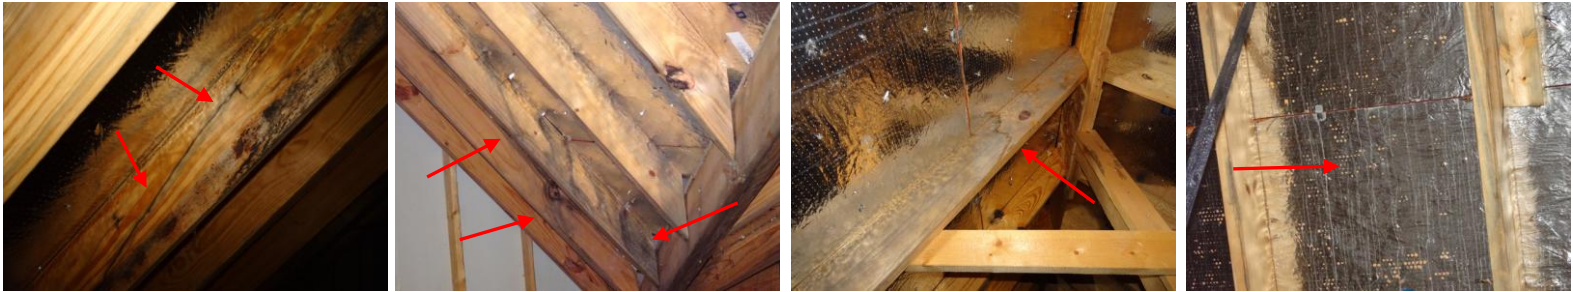
- Soffit and ridge attic ventilation was observed.
- Water staining and discoloration was observed on the attic framing and roof decking throughout the attic space. The home was likely under construction during Hurricane Harvey (late August 2017). Further investigation is recommended and repairs should be undertaken as necessary.

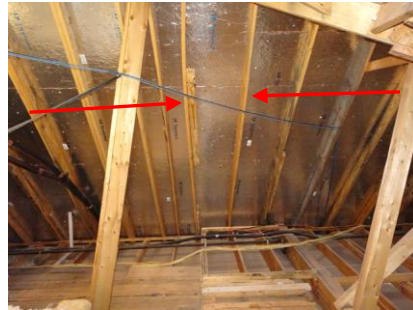
- Warped rafters were observed at the right side slope of the roof near the attic entrance.

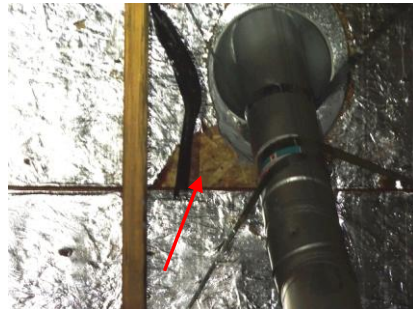
- The radiant barrier sheathing is damaged or has peeled away at the furnace vent roof penetration.

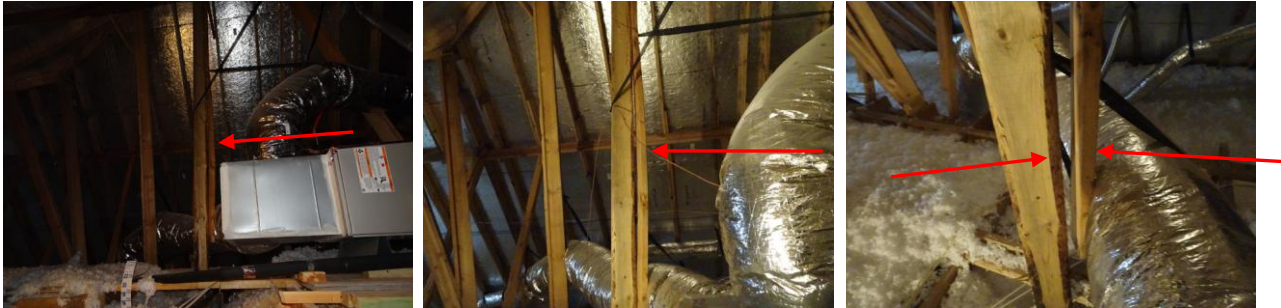
- The valley support strut left of the furnace serving the left side of the home is not properly constructed. The support strut is warped and the strong back reinforcement is not properly attached. Repairs should be undertaken.

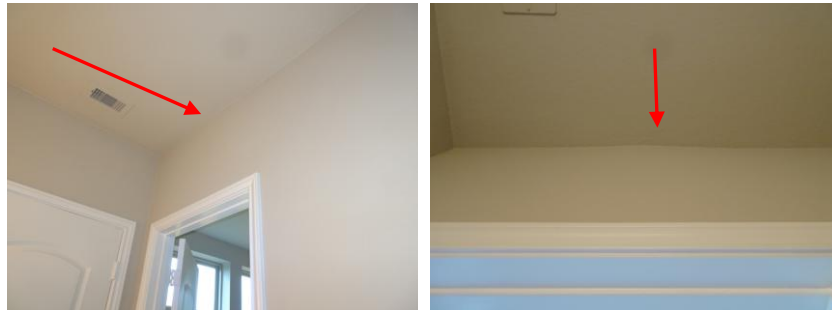
- The wall above the right rear guest bathroom door is bulging or is uneven.

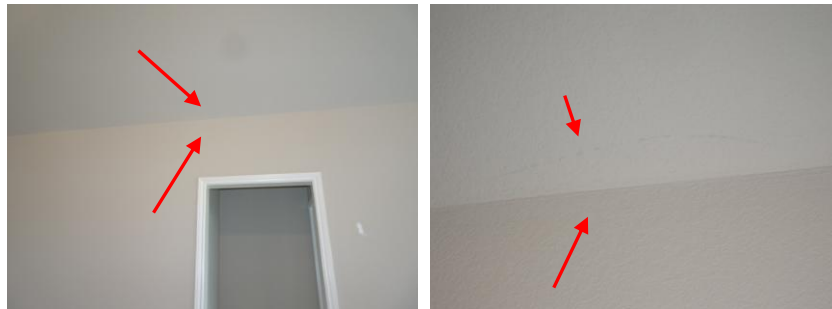
- Cosmetic markings were observed on the living room wall and ceiling above the master bedroom hallway entrance.

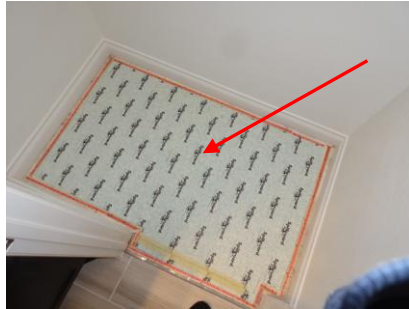
- Carpet and tile flooring was observed.
- The carpet is not installed in the right rear guest bathroom closet.

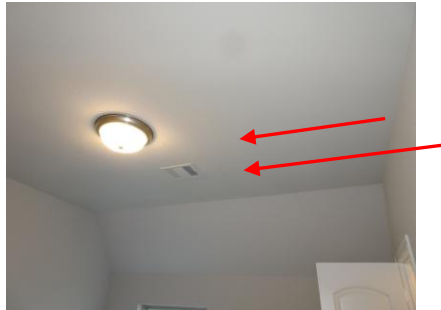
- Obvious patching was observed on the left front guest room ceiling.

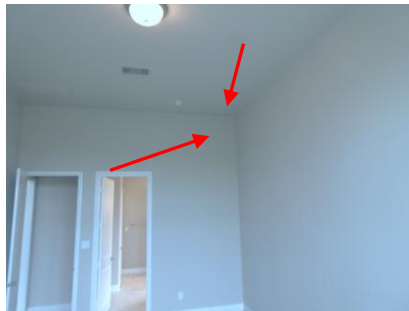
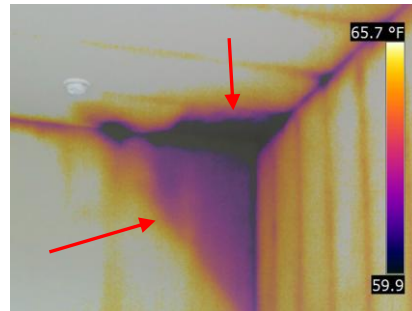
- Possible missing, inadequate or improperly installed insulation was observed at the living room ceiling (and possibly wall) at the left front corner of the master bedroom. The colder wall section is an exterior wall and may be insulated.

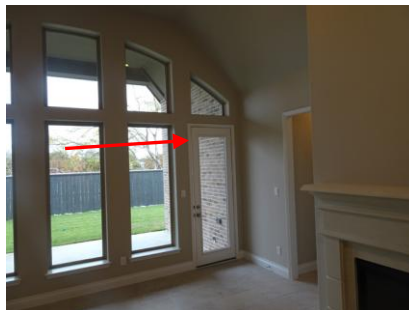
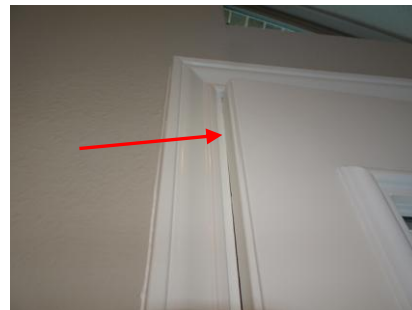
- The backdoor drags on the door frame near the top of the door.

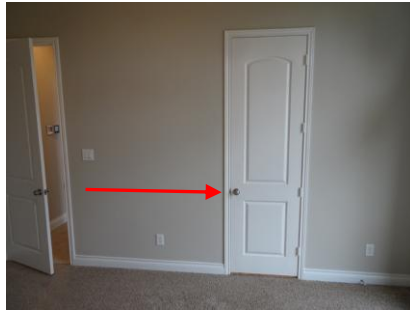
- The right rear guest bathroom door does not latch properly. The door can be opened without turning the knob.

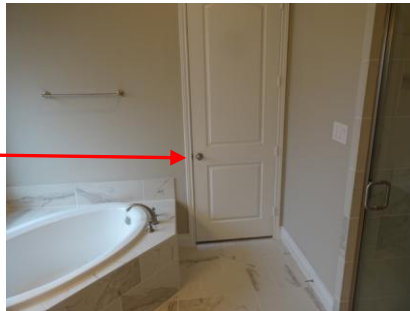
- The master bathroom door does not latch properly. The door must be pushed fully closed to latch properly. Adjustments are needed at the striker plate.

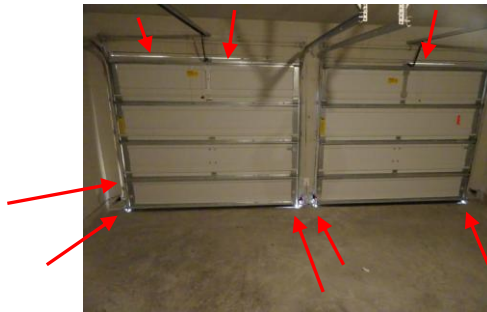
- Excessive gaps were observed around the edges of the overhead garage doors when fully closed.

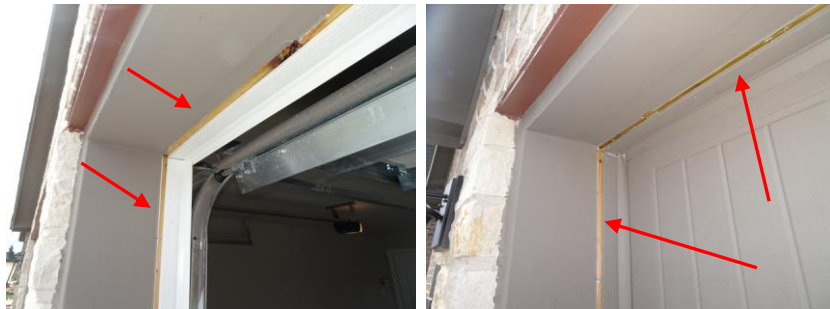
- The weather seals are unfinished around the exterior of the overhead garage doors.

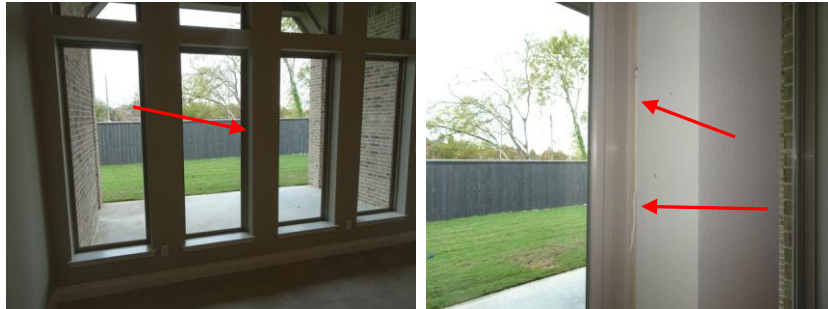
- Double pane, single hung and fixed windows
- The caulking is detached at the living room left center window.

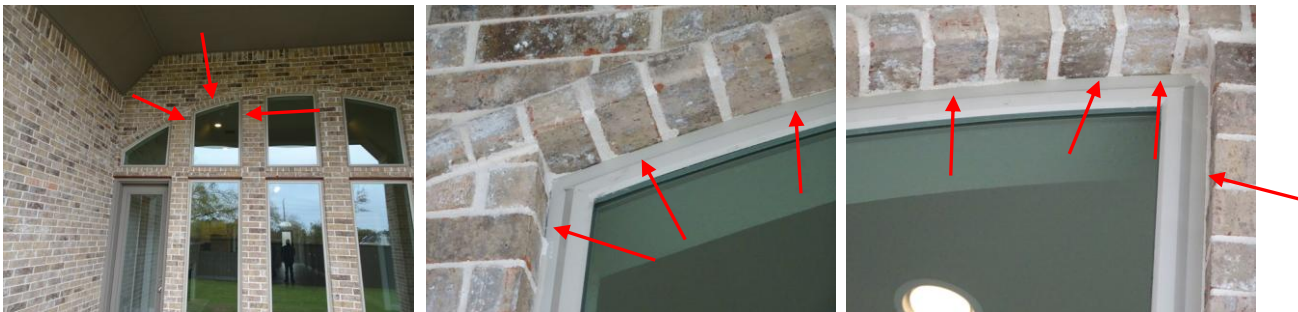
- The living room rear patio window is missing caulking around the upper edges.

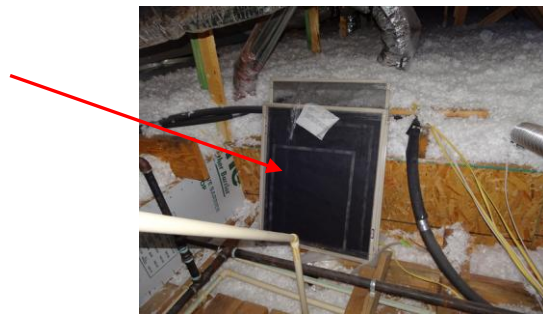
- The window screens are not installed.

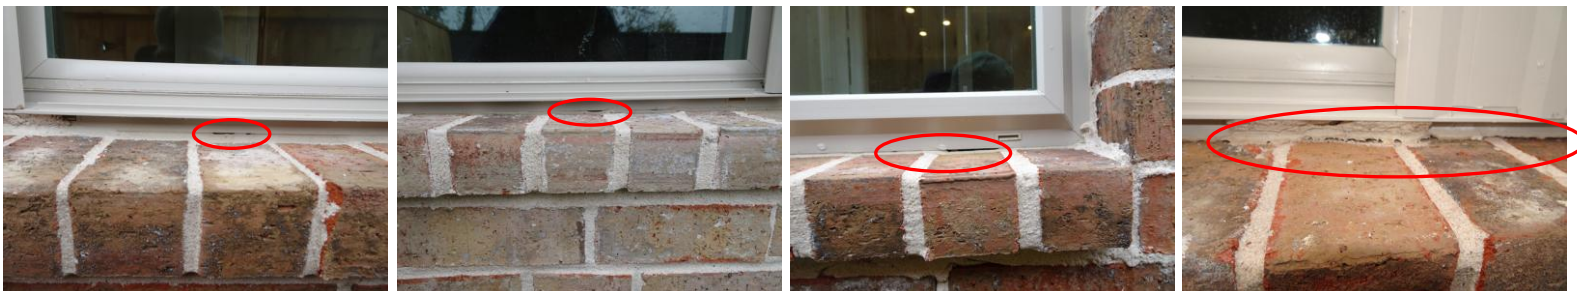
- Caulking improvements are needed around the exterior edges of the majority of the windows.

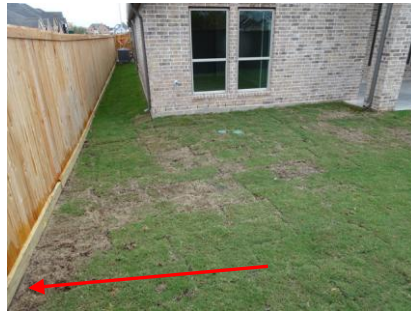
- An excessive gap was observed underneath the fence at the right side of the home.

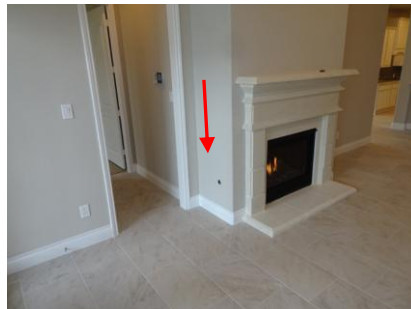
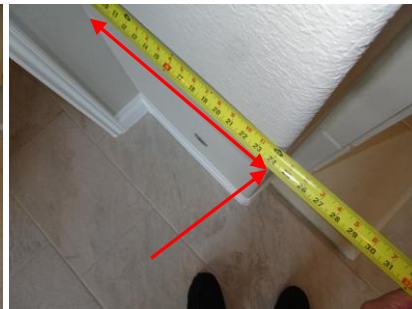
- An electrical outlet is not installed on the living room wall left of the fireplace as required. Any section of wall in the habitable room 24 inches or longer should have an electrical outlet installed. Repairs should be undertaken. **IRC-3801.2.2**

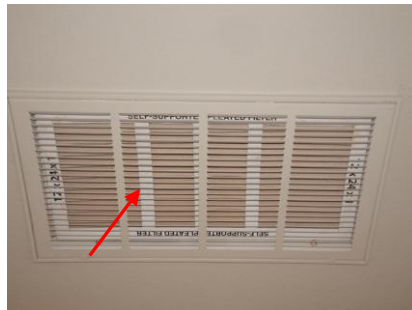
- All ducts appeared to be properly connected and were delivering conditioned air to all locations at time of inspection.
- The air filter located in the kitchen hallway is dirty and should be replaced.

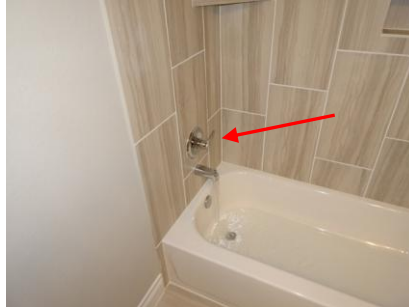
- The right rear guest bathroom tub faucet handle does not operate smoothly. Debris inside the handle assembly appears to be causing a gritty feel when turning the knob. Repairs should be undertaken.

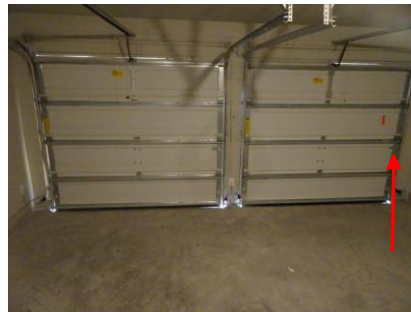
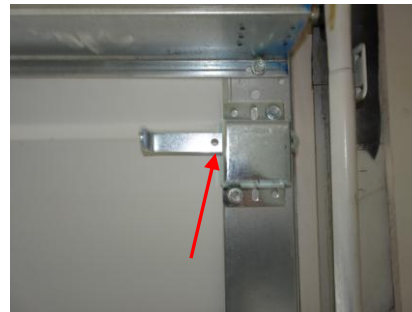
- Genie Brand (2)
- Both garage door openers operated and reversed properly at time of inspection.
- The right side (from inside the garage) overhead garage door lock is not disabled as required.

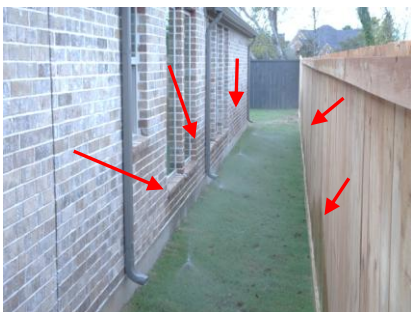
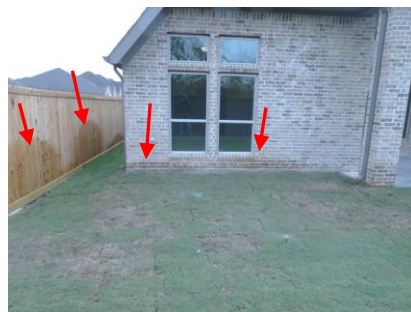
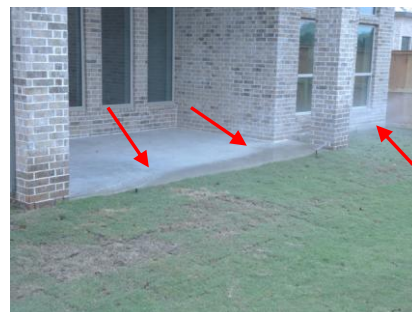
- Hunter Brand 7 zone lawn sprinkler system was operated in manual mode only.
- The water spray from the sprinkler system should be re-directed away from the structure and/or any fencing, decks, etc., to decrease the possibility of damage.
