Home Inspection Report

24922 Cactus Sage Trail, Katy, TX 77494

Saturday, October 24, 2020

Performance Inspections
507 Saguaro Way
Richmond, TX 77469

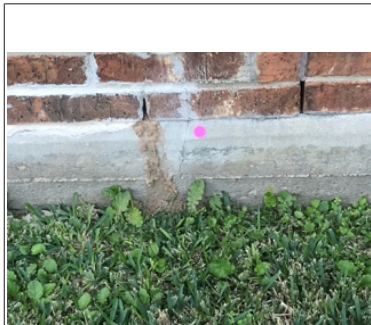
Common minor cracks were observed in the foundation walls of the house. This implies that some structural movement of the building has occurred, as is typical of most houses.

Crack on left side

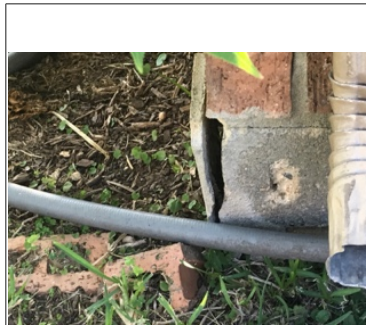
Corner pops are a common and may not be of major concern to the structural integrity of the home. With any deficiencies , repairs are always recommend to prevent further problem. Grade improvements may be needed.

Corner pop left rear

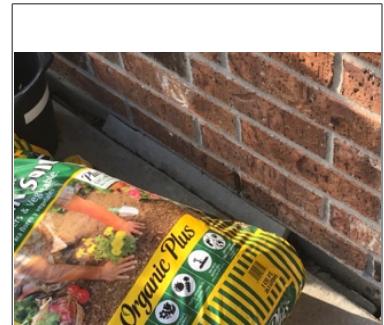
Cover up material is blocking visual inspection of foundation

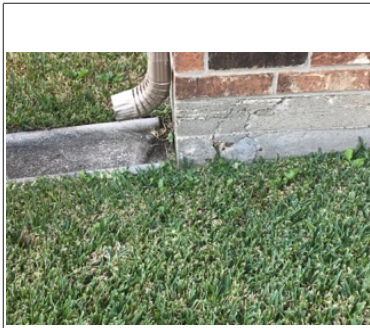
Comments: Corner(s) of foundation were broken at time of inspection. The corners for brick walls provide a ledge for the bricks to rest on. Broken corners could possibly lead to brick damage during settlement of home. It's recommended that the corner(s) be repaired.

Broken right rear corner

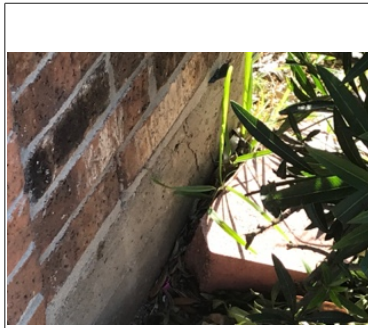
Broken right front corner

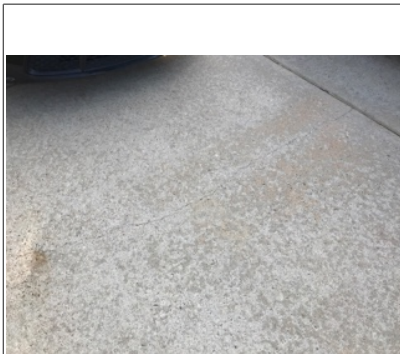
Comments: Driveway cracks were noted and its recommended to seal these cracks to protect against further damage to surface.

Driveway cracks

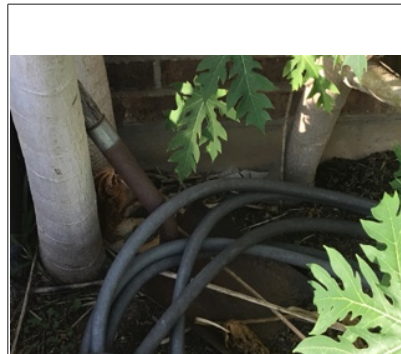
Tree roots are beginning to encroach driveway, walkway and or foundation. Roots can cause damage to structures and flat work. Repair may what to be considered before occurs.

Root encroachment

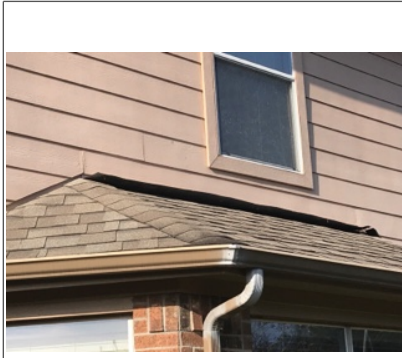
Nail heads are exposed at the flashing. They should be sealed to reduce risk of leaks.

Roof jacks are in need of repairs. Nails lift over time which is common occurrence. Roof jacks need to be sealed and re secured to prevent moisture and or pest entry.

Repair and seal all flashings

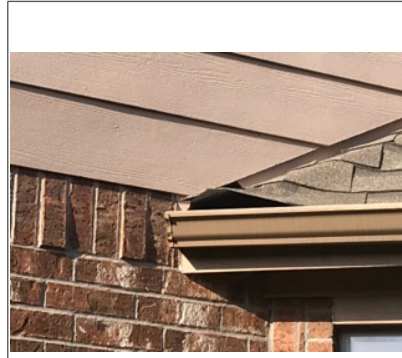
Uplifted shingles

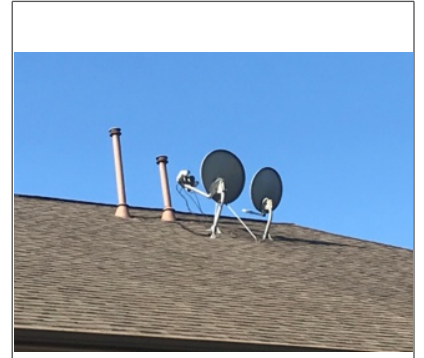
Installation of dish systems mounted to a home may be cause of concern. Installation is normally with the use of large fastening bolts or screws. If not properly installed water penetration is possible.

Satellite dish mounted on roof

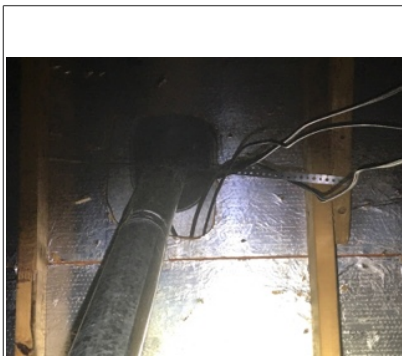
Comments: Cables routed under a roof jack and laying against vent pipe are a safety hazard and increasingly high potential of water entry. Installing company may be responsible for and damages to home.

Cables run under roof vent should be corrected

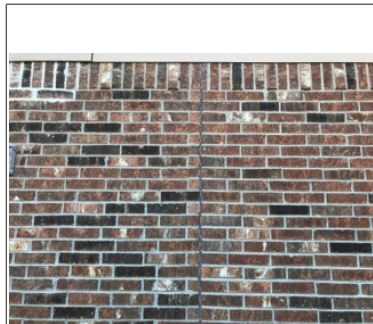
Comments: Brick seams and or gaps at siding require new or updated seal to prevent moisture or pest entry.

New brick seam seals needed

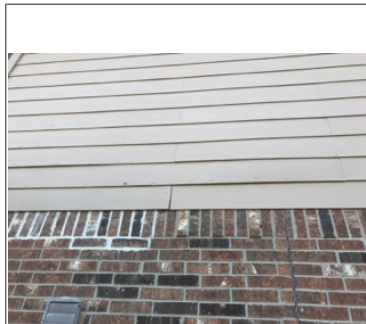
Due to settlement of home siding materials have separation at the seams and should be repaired to prevent moisture damage.

Siding needs repairs and seals at seams

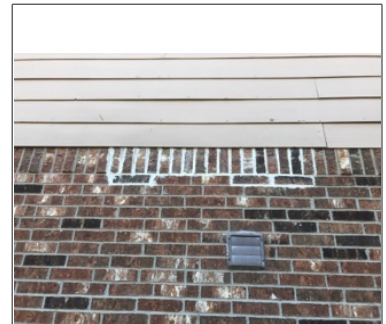
Patching on left side

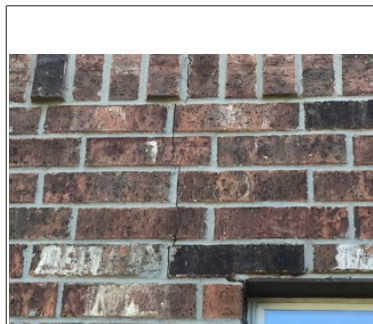
Exterior wall cracks above a lintel (in effect, a beam supporting the brickwork above an opening in the wall) suggests that the lintel may be marginally adequate. This condition is not uncommon.

Lintel movement cracks

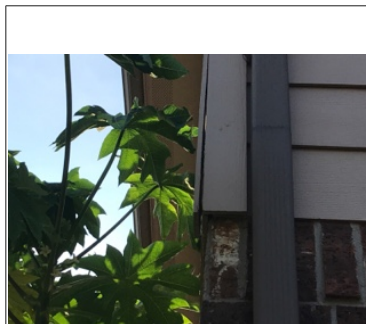
New seal needed at trim boards and or siding to brick.

Repair and seal trim boards

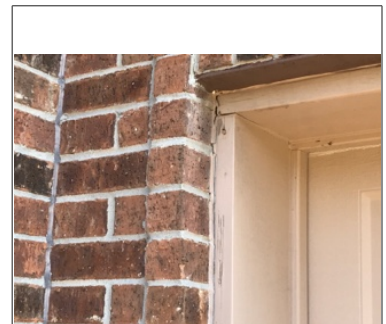
Trim board seals needed

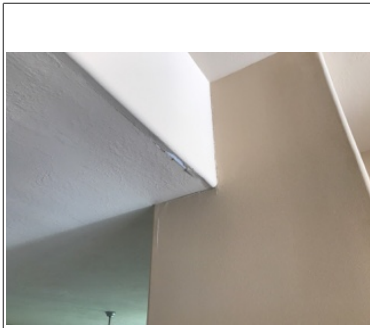
Seam failures on second floor

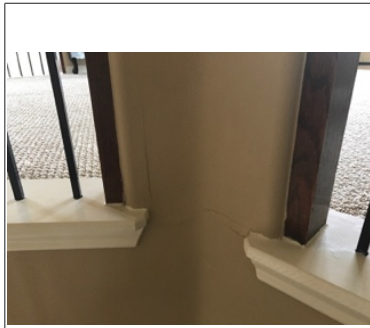
Seam failures at stairway

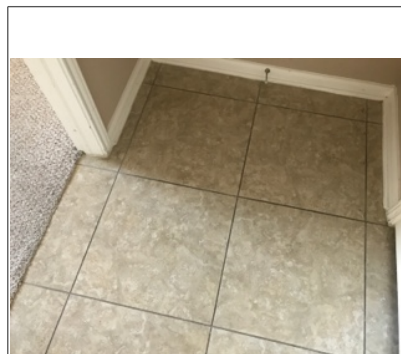
The tile floor is cracked and should be repaired.

Broken tiles

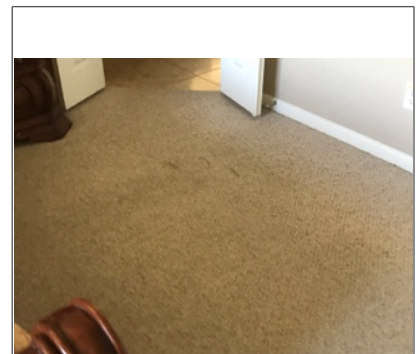
Comments: Stains were noted on the carpet.

Carpet staining

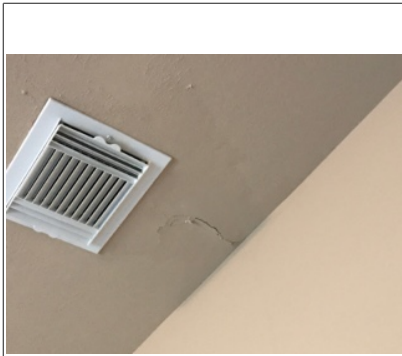
Water damage was observed. Corrective action is required as thus can lead to further damage and possible mold which is a health hazard.

Water damage in center front bedroom

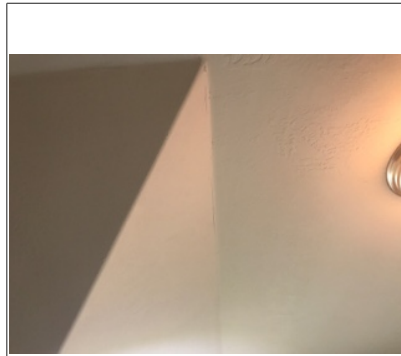
Seam failure in center front bedroom

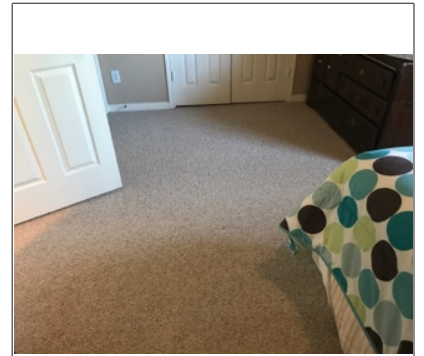
Slopped flooring in right front bedroom

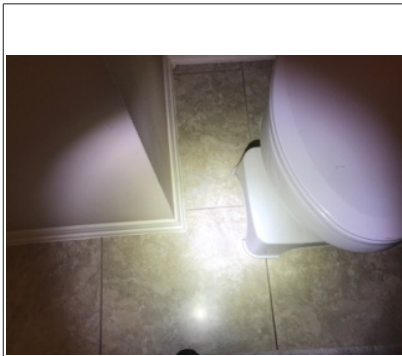
broken tiles in J and J bathroom

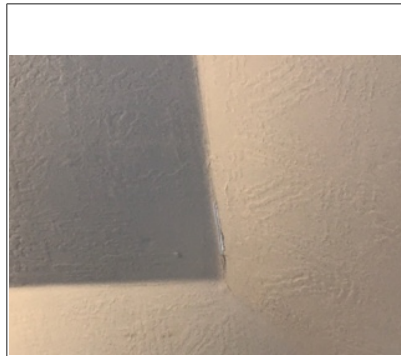
Seam failure in right front bedroom and nail pops

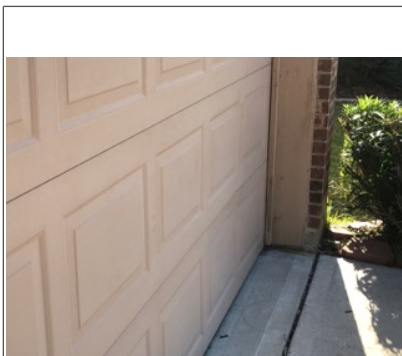
Damaged panels

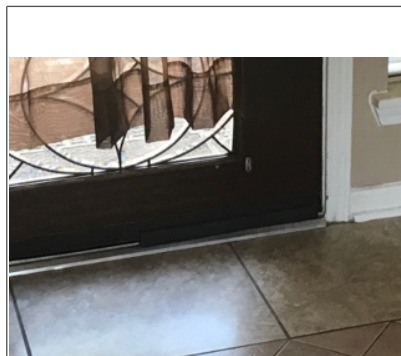
New door seals needed

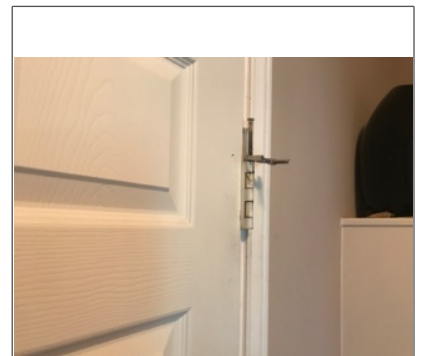
Damaged hardware

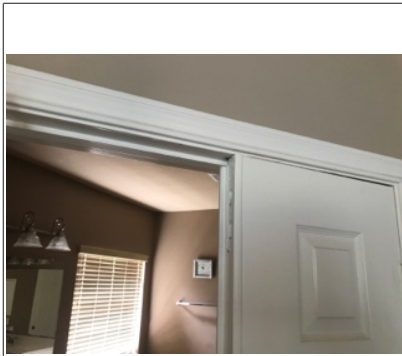
Repair needed at primary bathroom doors

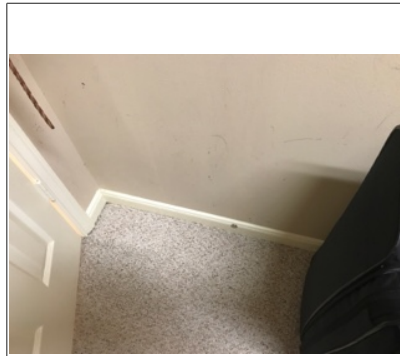
Doorstops needed

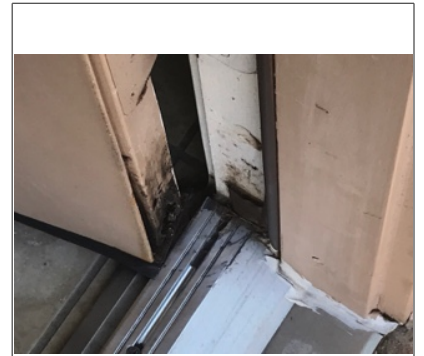
Decaying backdoor

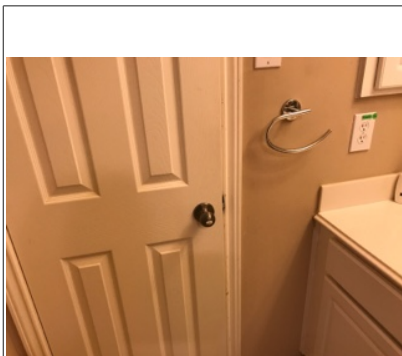
Doors don't latch

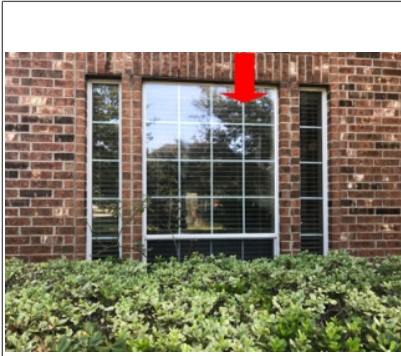
The window(s) have lost their seal. This has resulted in condensation and or dirty film developing between the panes of glass and can cause the glass to loose its insulating properties. The glass should be repaired or replaced.

Lost seal

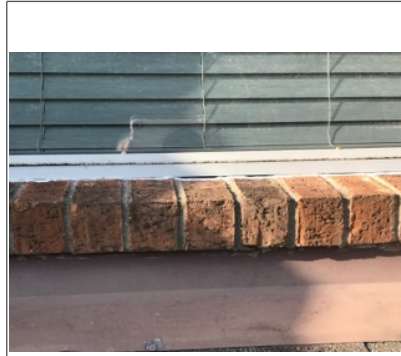
Seal around windows are recommend to be resealed to prevent possible water penetration. .

Exterior caulking improvements needed

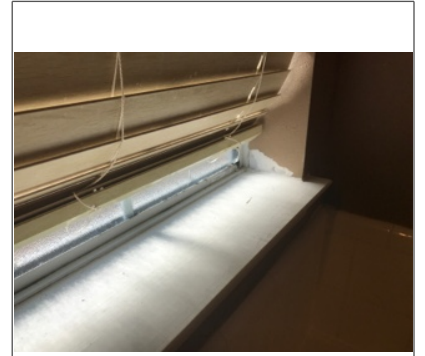
Window sills show signs of moisture damage. Repairs may be needed.

Moisture damage at primary window

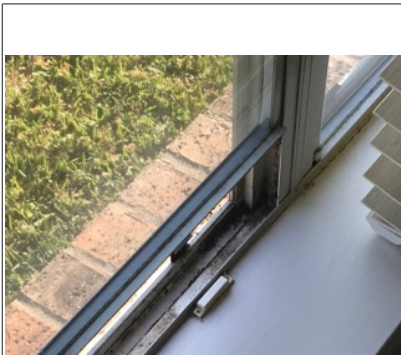
Balance spring(s) in window(s) are in need of repairs and or replacement. These allow the window to safely remain in a open position. Sprung units can be a potential hazard.

Sprung balance spring

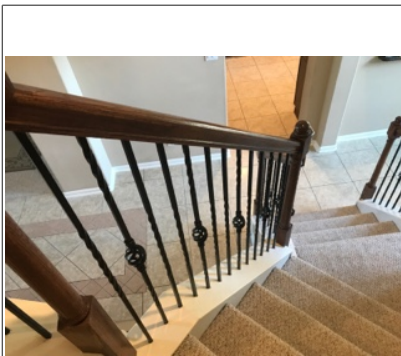
Comments: Spindle(s) loose in one or more locations. Repairs needed as the spindles add structural strength to railings.

Loose spindles

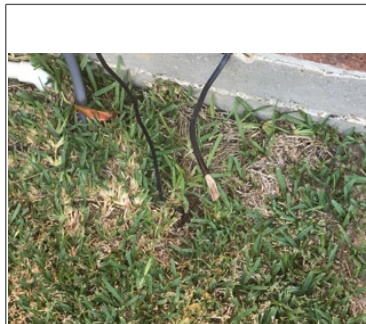
Ground wire requires repairs

Repair damaged ground wire

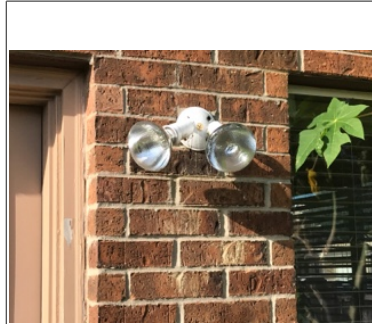
Outdoor light fixtures mounted on home require seal to protect against moisture.

Light seals needed

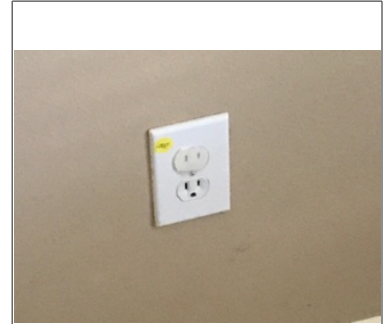
Loose outlet(s) were found. Repairs are need to secure outlet(s)

Loose outlets

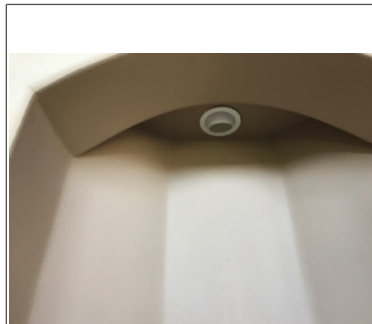
The light is inoperative. If the bulbs are not blown, the circuit should be investigated.

Inoperative light

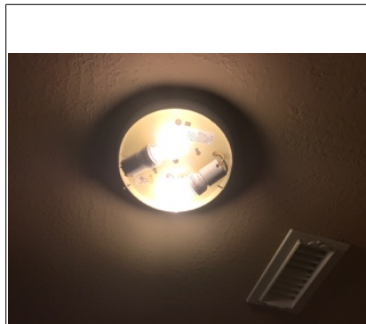
Comments: The damaged light fixture should be repaired or replaced.

Damaged light

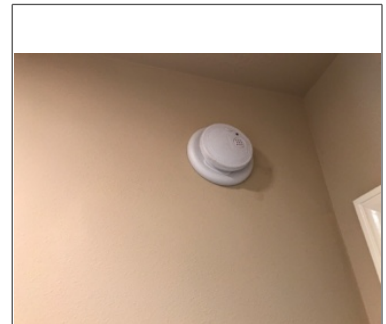
A smoke detector is inoperative. This item should be repaired as it poses a potential safety hazard.

Inoperative smoke detectors

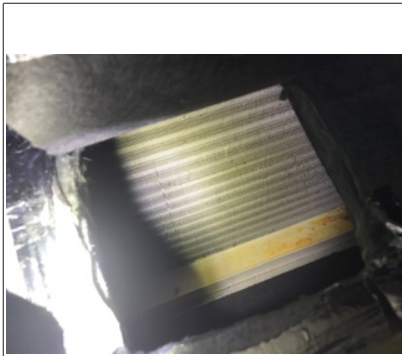
Evaporator coil(s) are dirty and need to be serviced / cleaned.

Dirty evaporator coil

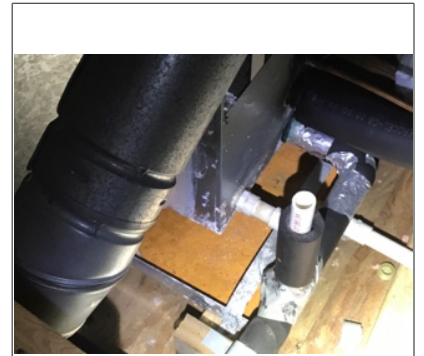
Rust was observed in drip pan. This can be a sign of a rusted evaporator coil and further investigation may want to be considered or recommend having unit serviced.

Clean rust in pan

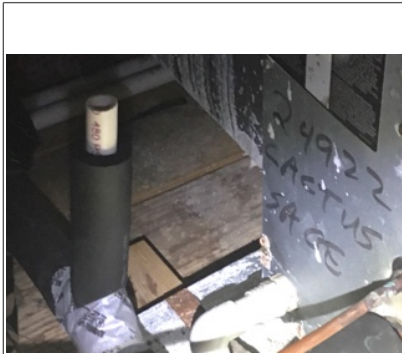
Comments: Condensation leaks observed outside drip pan area. Recommend correcting to prevent possible ceiling damage.

Condensation leaking outside drip pan

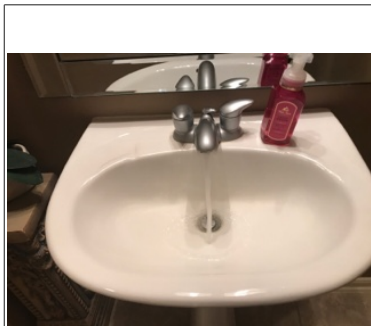
The drainstop for the sink is inoperative and should be repaired.

Inoperative stopper

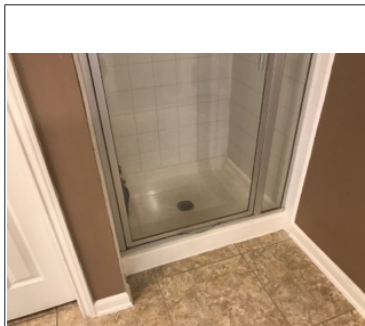
Repair shower door

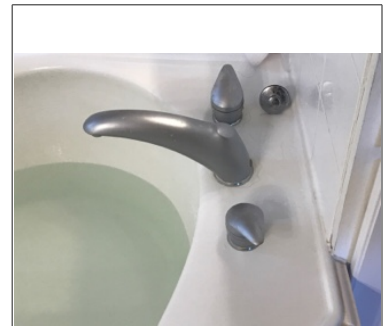
Faucet(s) damaged and may need to be replaced

Damaged faucet at primary tub

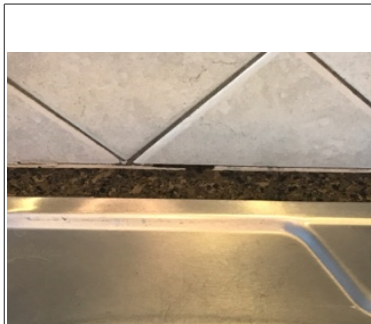
Seals at counter tops and or vanity tops need improvements to prevent water leaking. Failure to improve may lead to wall, floor or sink base damage

Caulking improvements needed at counters and vanity's

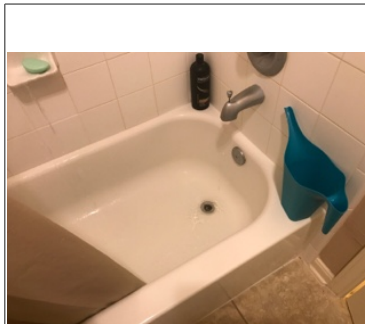
The drainstop for the tub is missing and should be repaired.

Stopper missing

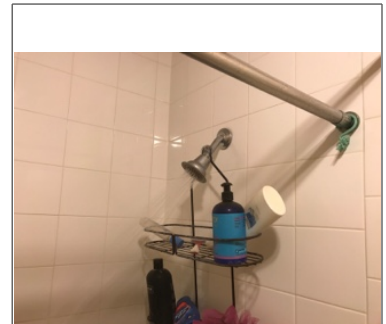
Supply line at shower head was found to be loose and requires repairs to prevent possible leaks at head or in wall.

Shower supply line is loose in wall. Recommend repairs

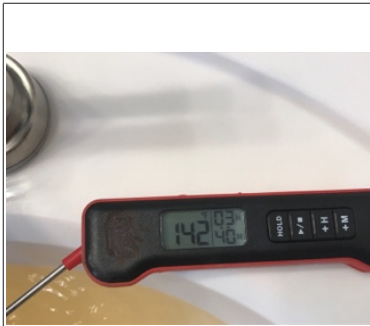
Water temperature was found to be height than recommend temperature of 120 degrees. Recommend corrections for safety

Safe water temperature of 120 degrees is recommended

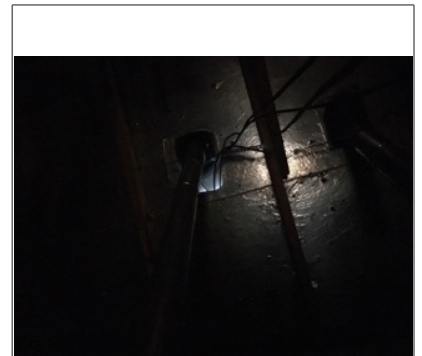
Comments: Flue pipe(s) are in need of seal (s). Daylight is coming through around roof jack which could potentially be a water or pest entry point.

Roof jacks and flue pipes need seals

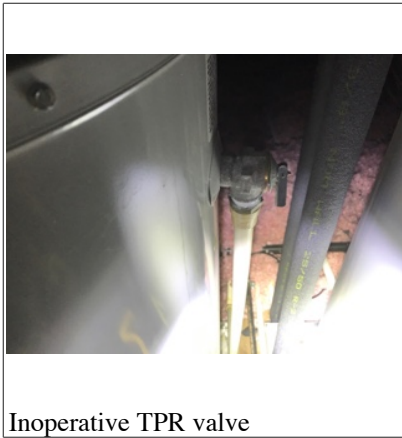
The Temperature and Pressure Relief (TPR) Valve serving the water heater is inoperative. This condition should be repaired.

Inoperative TPR valve

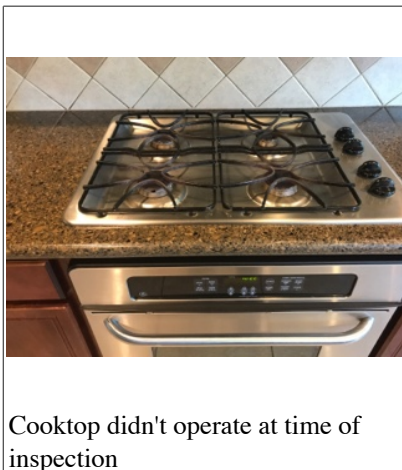
Comments: The burners on the gas range need servicing. All burners on the gas cooktop is inoperative and is in need of repair.

Cooktop didn't operate at time of inspection

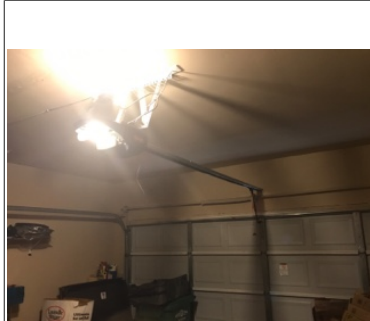
Comments: The garage door opener(s) were inoperative. Repairs or replacement of unit(s) may be needed.

Inoperative opener

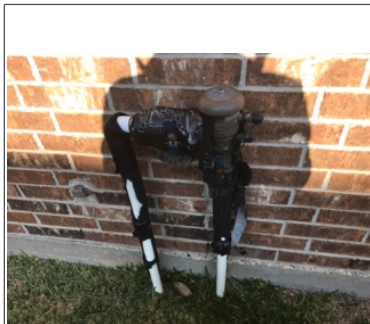
Comments: Damaged/ leaking valve assembly needs replacing

Damaged/ leaking valve assembly needs replacing
