REXER Home Inspection Services

Property Inspection Report

5211 Eigel St. Unit C, Houston , TX 77007
Inspection prepared for: Omar Garza & Adolfo Garza
Date of Inspection: 2/20/2017 Time: 11:00AM
Age of Home: 2009 Size: 2219

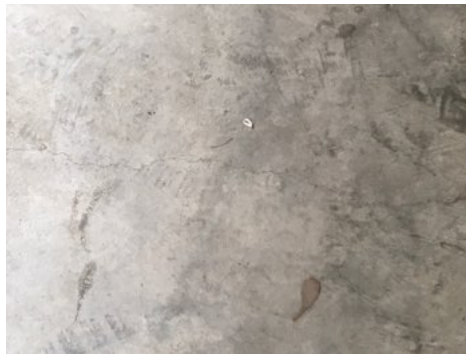
A.1. NOTE: Small cracking noticed in foundation finish at porches and garage. These are common and do not require any correction. They should however be monitored.

Crack

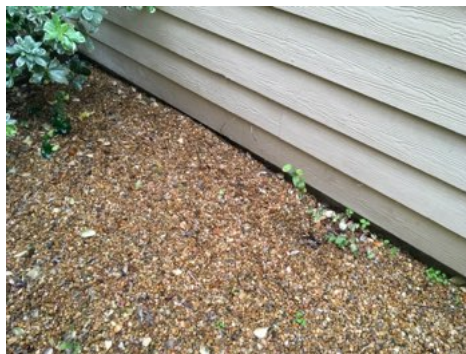
B.2. NOTE: Siding should have a minimum of 6" of slab exposure

Inadequate clearance to grade

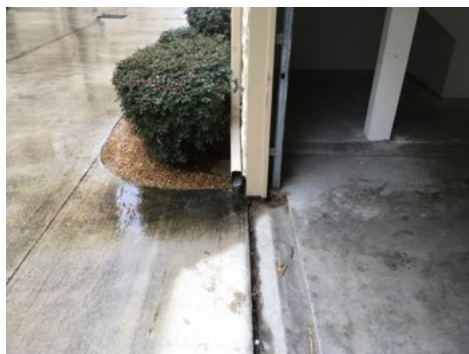
C.2. NOTE: Gutters should discharge away from the foundation.

Should discharge away from foundation

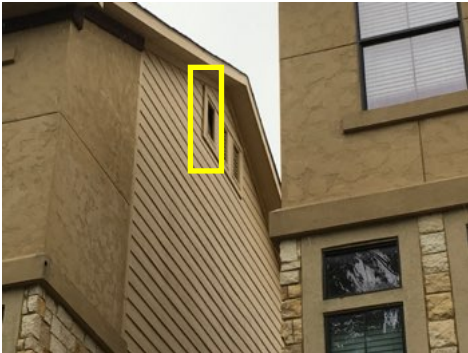
D.3. Right side attic vent not secured

Vent not secured

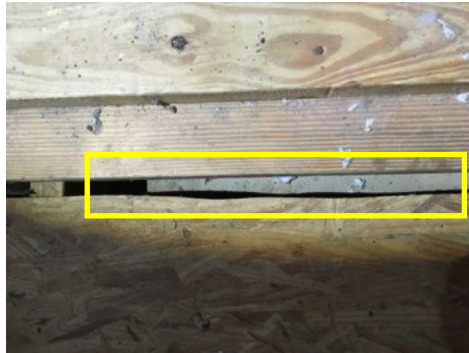
D.1. Areas of missing or displaced insulation throughout attic

Missing insulation below platform

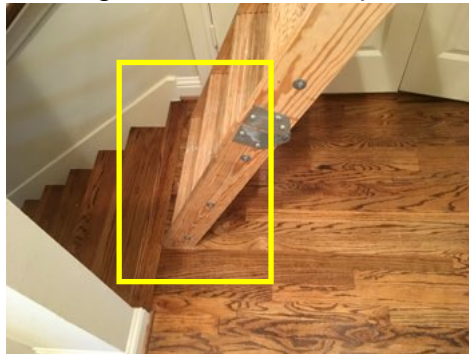
D.2. Attic access door unit is awkward to open and close due to the proximity to the stairway

Awkward location

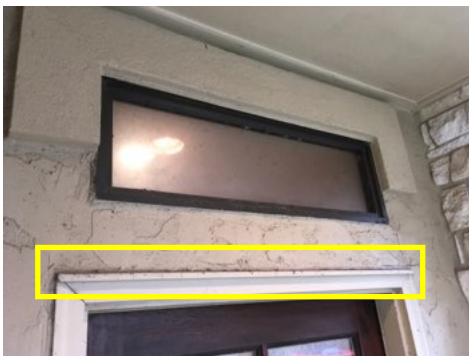
E.4. NOTE: Stucco - flashing drainage openings appears sealed to wall

Wall sealed to flashing

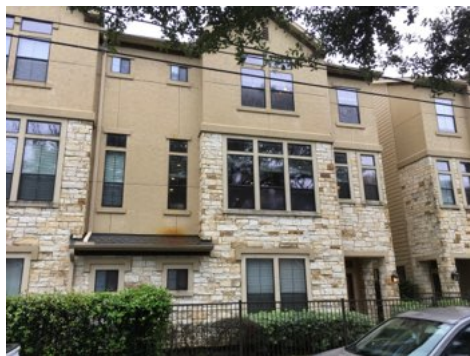
E.5. NOTE: Stucco wrapped beams has no visible drainage plane at the transition from vertical to horizontal. it is recommended that this be addressed to prevent moisture damage to the beam.

No visible drainage

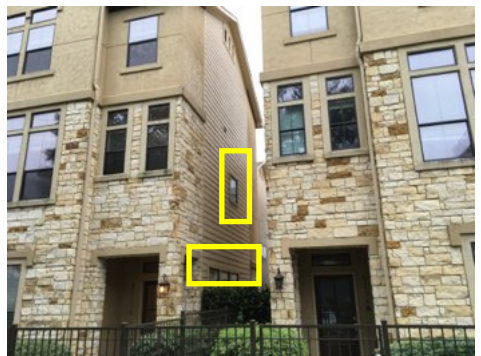
E.1. NOTE: Flashing should be installed at the top of the horizontal trim. The lack of flashing over the trim requires additional monitoring and maintenance to prevent moisture intrusion.

Flashing not over horizontal trim

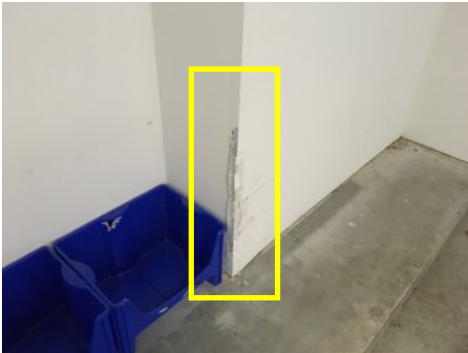
E.6. Garage wall damage

Garage wall damage

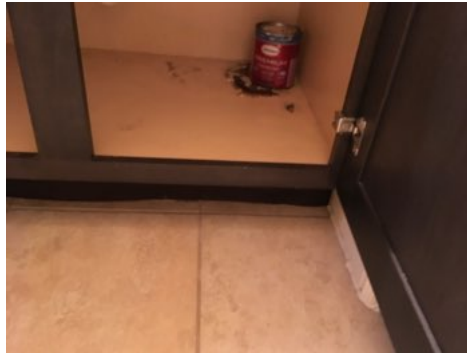
E.8. First floor vanity base damaged

First floor vanity cabinet

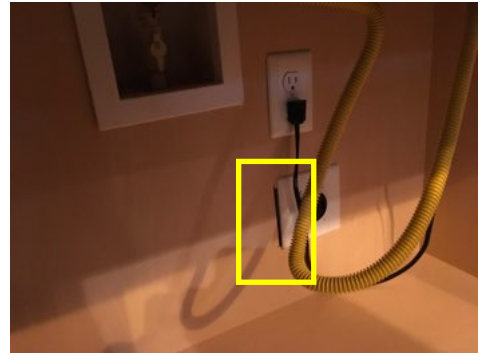
E.7. Gaps at wires and pipes in cabinets should be sealed

Gap at outlet

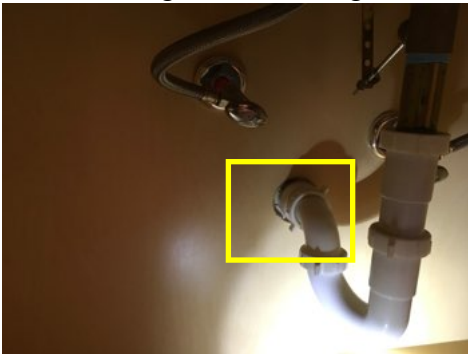
Gap at pipe

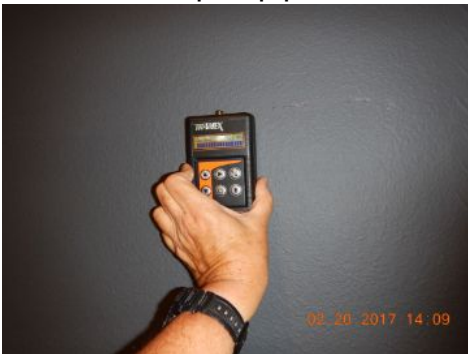
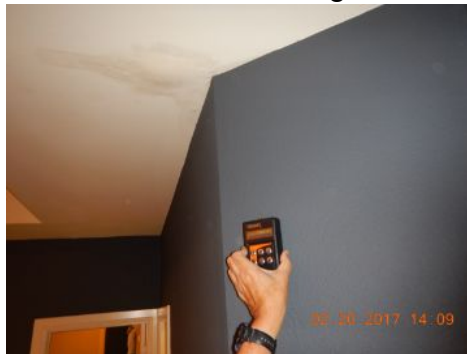
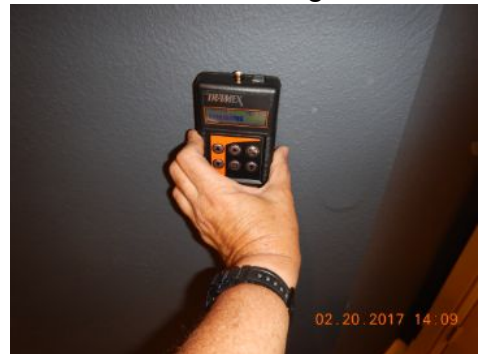
E.9. There were elevated moisture readings below the wet spot in the ceiling of the third-floor front bedroom

Elevated moisture reading

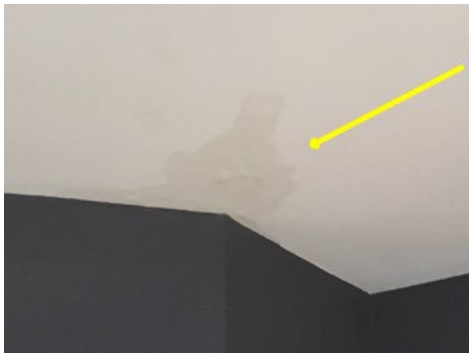
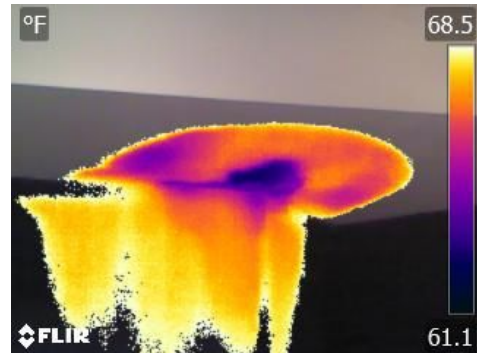
F.1. Ceiling is damaged Master bedroom front

Evidence of moisture intrusion

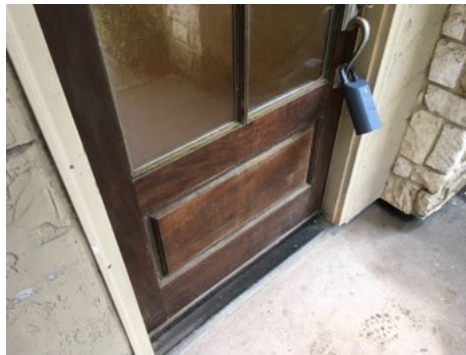
G.1. Front door finish weathered

Weathered

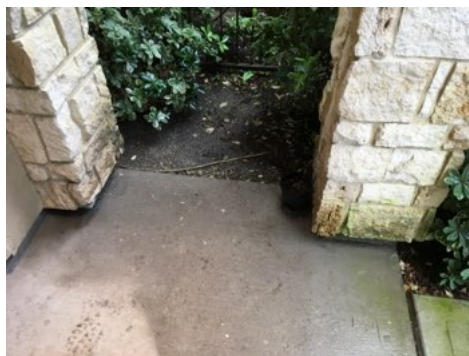
K.2. NOTE: Columns too close to grade

Too close to grade

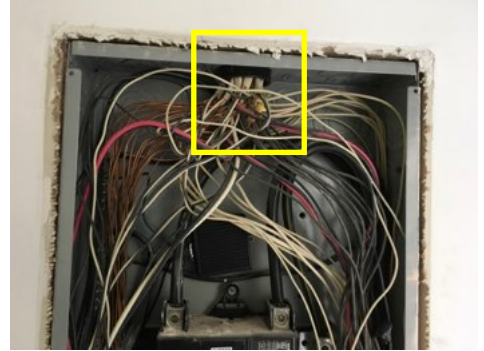
A.6. Load side wires should be individually (maximum two small wires together) secured and protected entering into the panel box. E3907.8 Cables. Where cables are used, each cable shall be secured to the cabinet, panelboard, cutout box, or meter socket enclosure.

Bundled wires

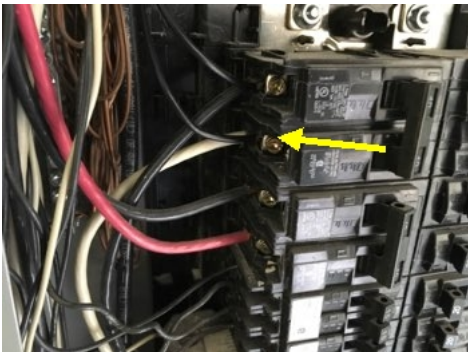
A.10. White insulated wire to the breaker for the A/C should be labeled as hot

Not labeled as hot

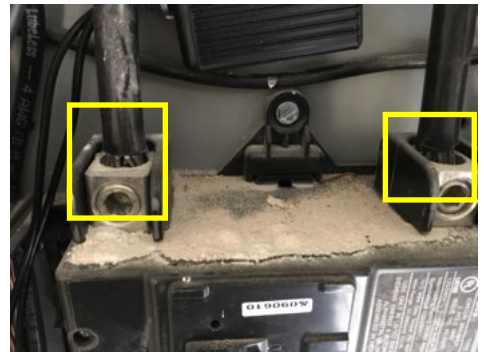
A.3. Anti oxidant protective paste not visible at the aluminum lead wire connections

No visible antioxidant paste

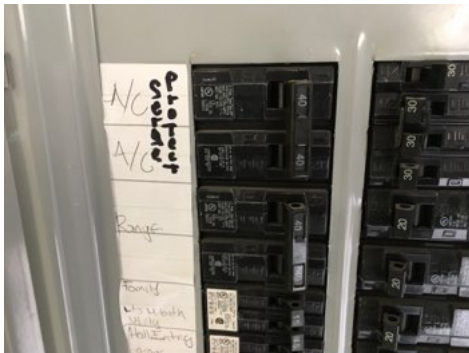
A.2. A/C listed over current and installed breaker are mismatched

A/C compressor labeled as 40 amp

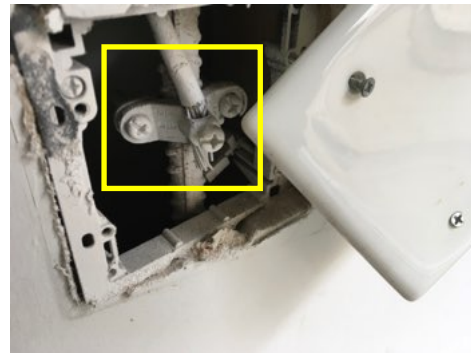
A.4. Concrete encased electrode located in the garage. This type of grounding system is used where the concrete is in direct contact with the earth. The moisture barrier for the foundation nullifies the effectiveness of this system. It is my recommendation that the CEE be disconnected and a 2nd ground rod be installed at a distance of > 72" from the existing ground rod.

CEE in garage / connection painted

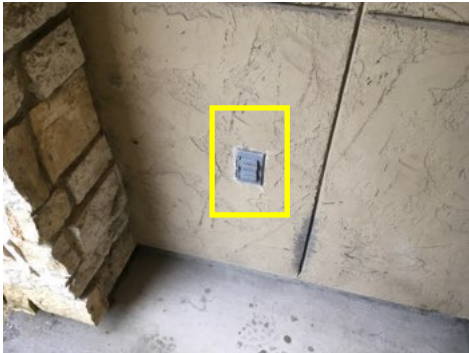
B.6. Current building standards require the exposed exterior electrical outlets have in use covers

Not an in use cover

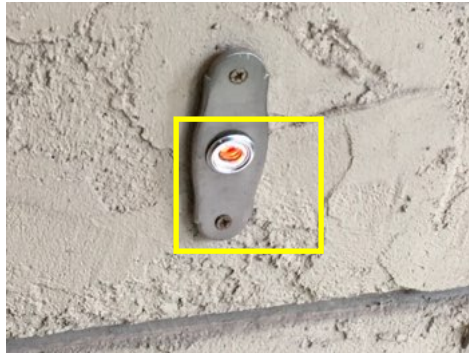
B.7. Door bell button damage

Damaged

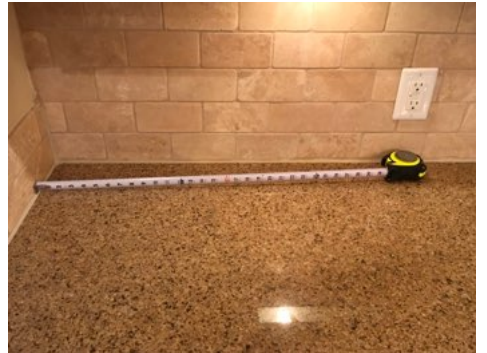
B.3. *Outlet spacing and location are not to current building standards. They are installed as to what would have been customary at the time of construction

Example of over-spanned outlets

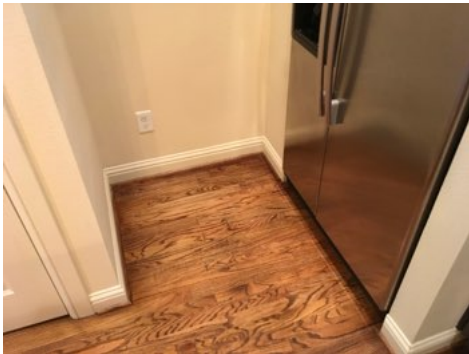
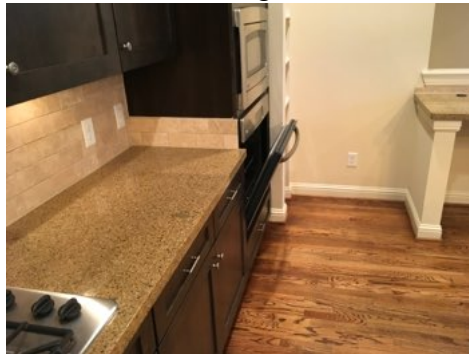
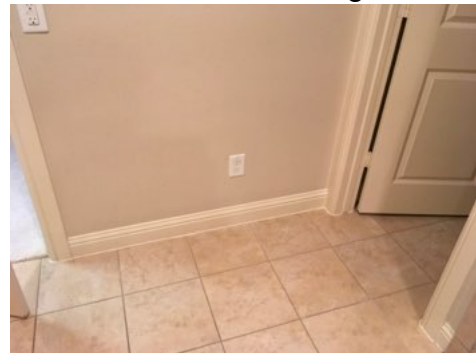
B.10. Current building standards require all outlets in the kitchen and food service areas to be GFCI protected

B.11. Outlet right wall right wall not GFCI protected

Not GFCI protected

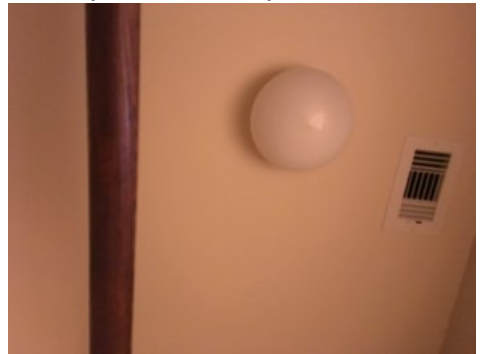
B.4. Closet light fixture is in an improper location by current building standards

Example of improper location - closet light fixture

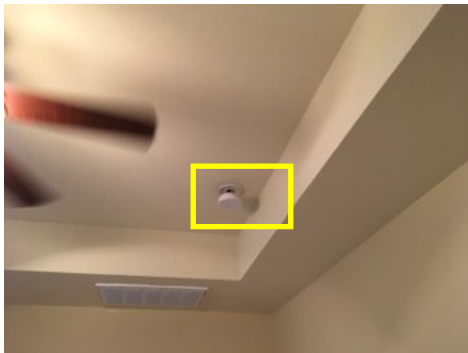
B.8. Smoke alarm third floor rear bedroom not secured

Not secured

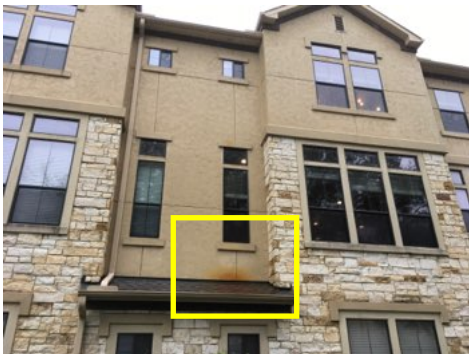
B.3. Exterior front left staining on roof under AC secondary condensate discharge

Evidence of AC condensation discharge issues

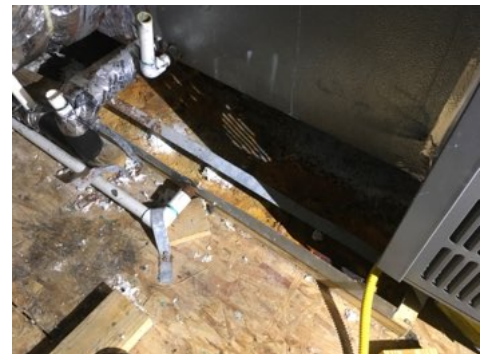
B.2. Rust observed in condensate drip pan

Rustin AC condensate drip pan

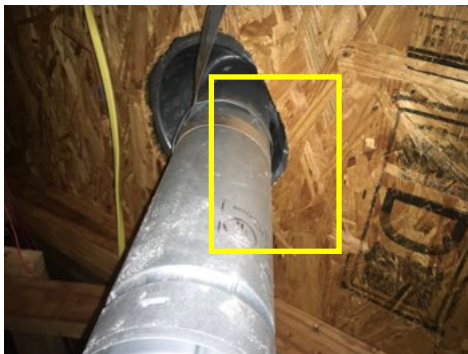
C.2. Furnace vent does not have proper clearance to combustibles

To close to roof sheathing

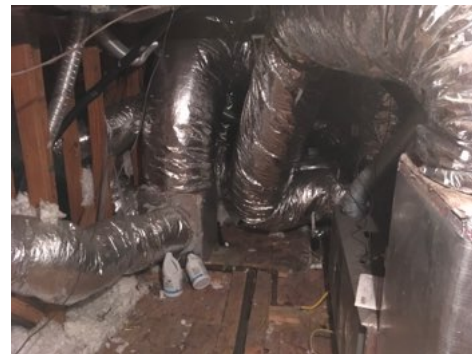
C.1. Ducts should not be in contact with other ducts, this can cause condensation resulting in moisture problems

Ducts touch

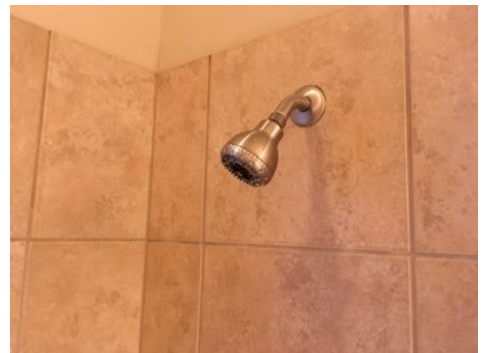
A.8. Fixtures not secured - first floor showerhead; upstairs right bath faucet; upstairs front bath rear vanity

Showerhead loose

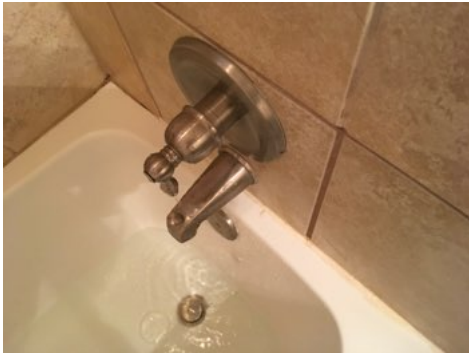
A.4. All plumbing fixtures should be properly sealed to the wall tile to prevent moisture damage

Fixture should be fully sealed to wall

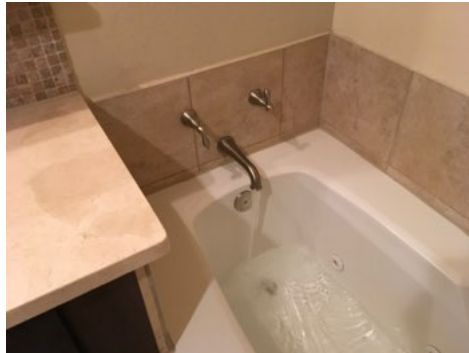
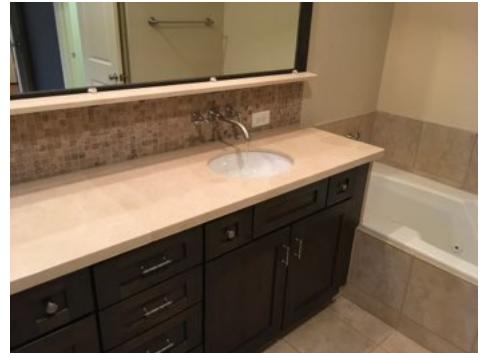
Loose

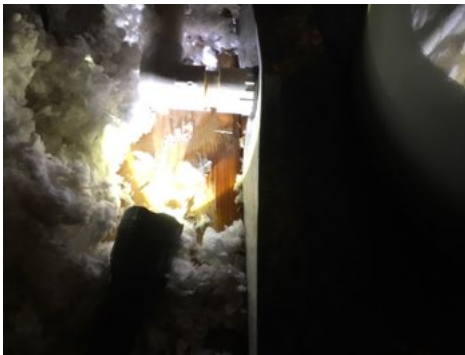
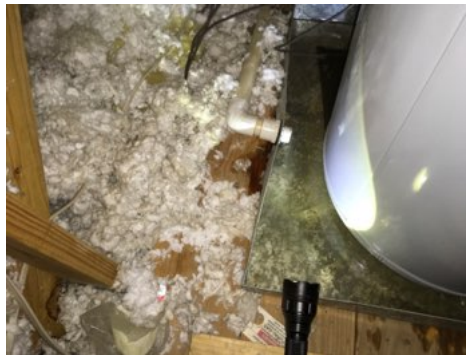
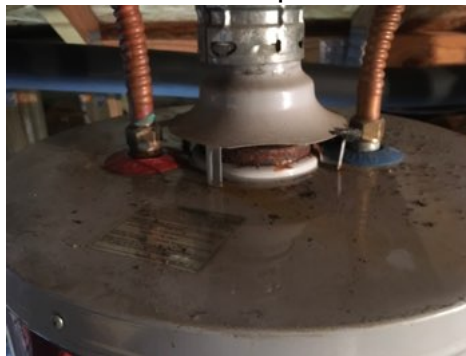
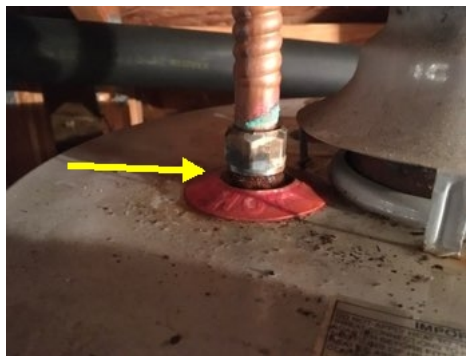
C.4. Leak at where water heater at water connection. Agent for the buyer turned the water off to structure prior to leaving to avoid further moisture problems to the ceiling and wall below.

Leak at water heater safety pan

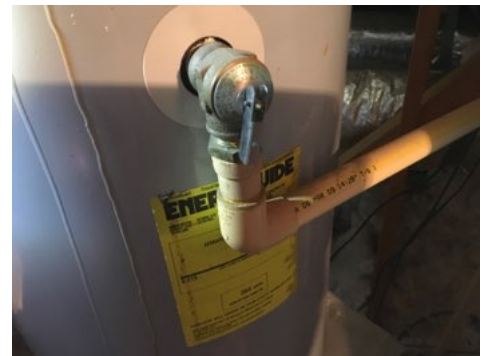
C.1. Temperature and pressure relief valve was not tested. Testing older valves can result in the valve not sealing properly and water continuing to run though the discharge with the potential for damage. These should be tested yearly by the occupant and by a plumber every three years for repair or replacement. If information on the maintenance records cannot be obtained from the seller I recommend the valve be evaluated or replaced by qualified personnel.

Not tested

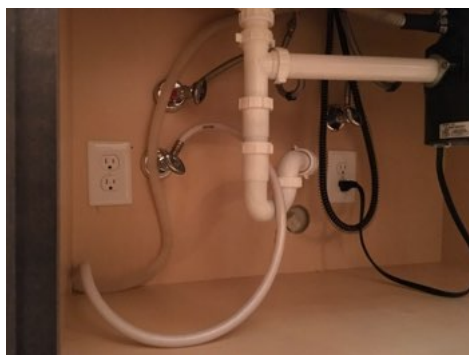
Dishwasher drain

A.1. No air gap or loop in drain line present.

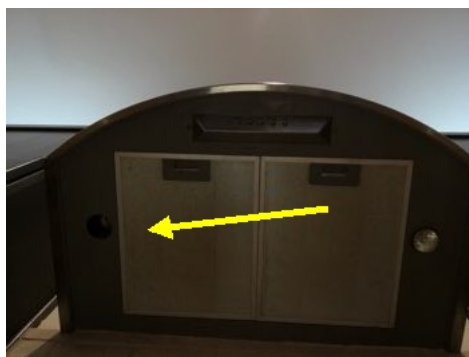
Range hood

C.1. Left bulb missing

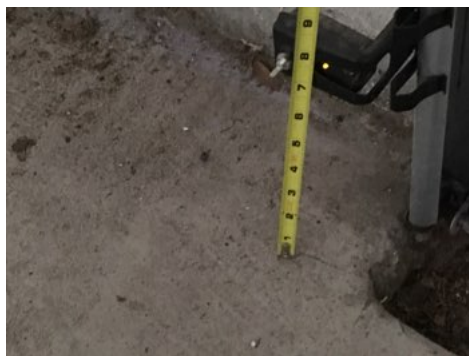
G.1. *Sensor beam >6" above surface

To high
