PROPERTY INSPECTION REPORT

Concerning: 5211 Eigel Street, Unit C, Houston, TX 77007
(Address of Inspected Property)

By: Bill Hurley, TREC PI: 20283 12/21/2020
(Name and License Number of Inspector) (Date)

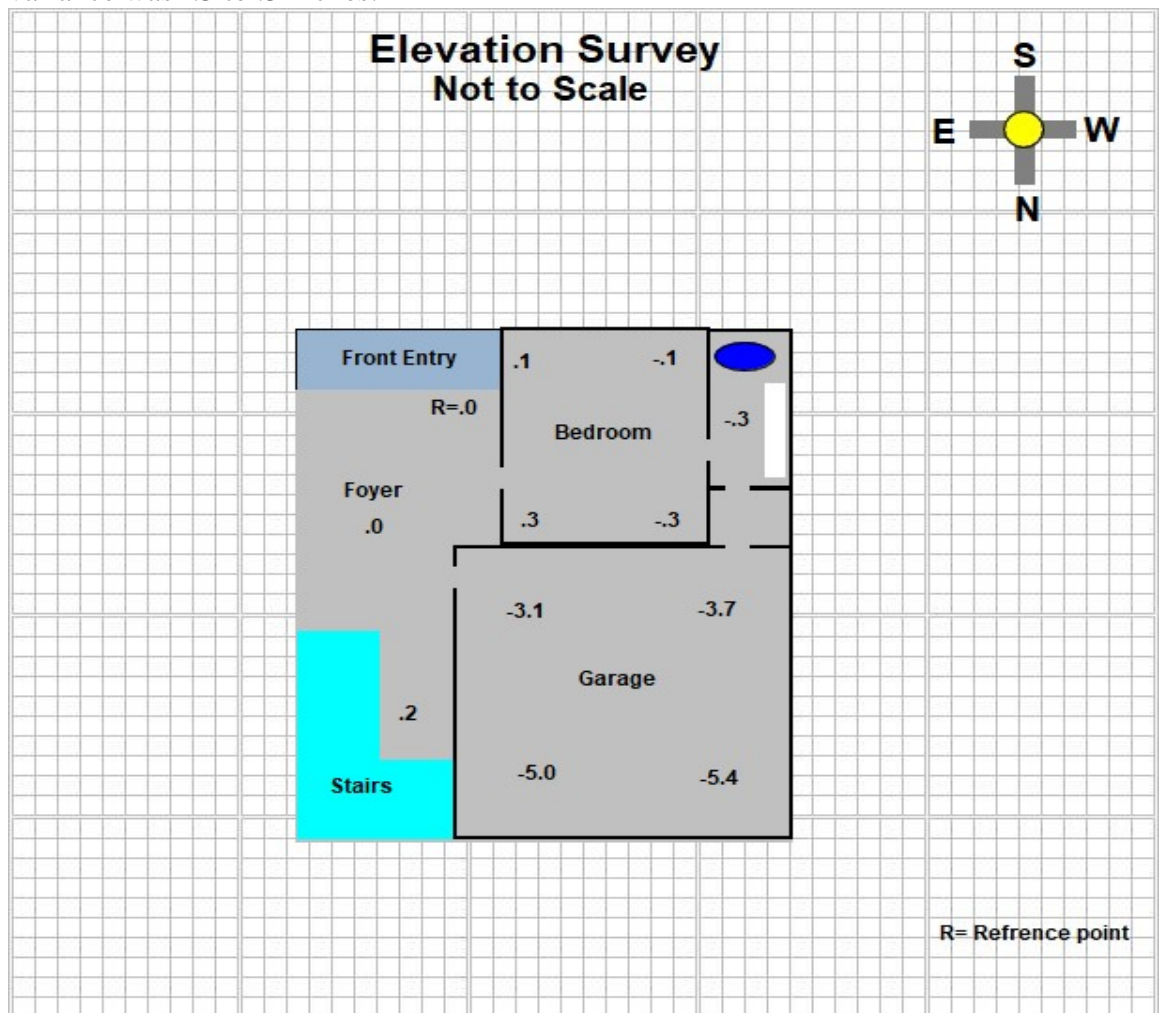
A foundation elevation survey was conducted during the inspection. The floorplan below represents data gathered using a Zip Level or similar instrument and adjusting for floor covering height differences. i.e. differences between tile, carpet and wood flooring(except step down to garage). Measurements are listed to the nearest 1/10th of an inch. Greatest variance was -.3 to .3 inches.

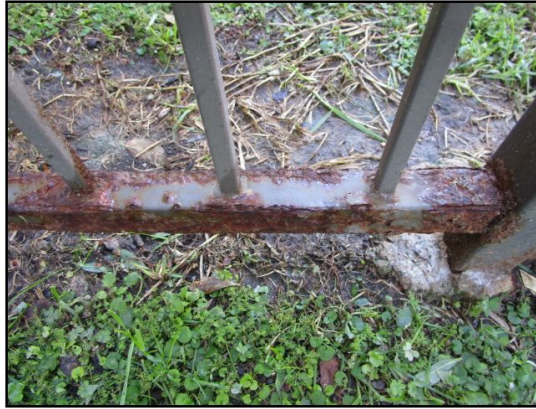
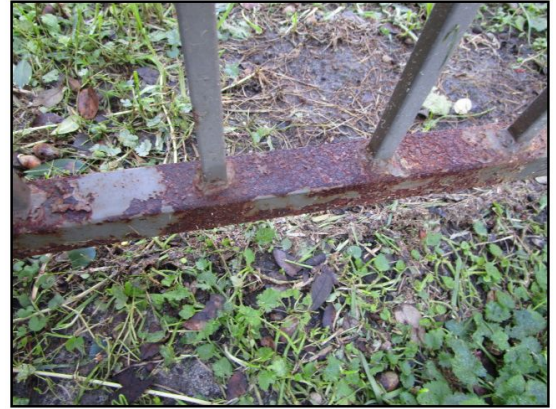
Note: Front entry gate does not latch.

Recommend client consider painting exterior metal fence/gate in the near future.

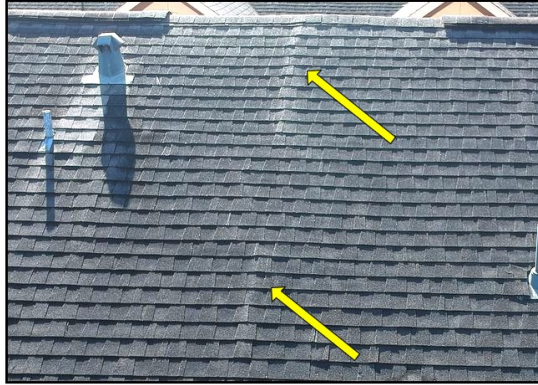
Ridge(s) on planes of roof surface observed. This is an indication that the addition/adjoining unit was not perfectly tied into the existing structure.

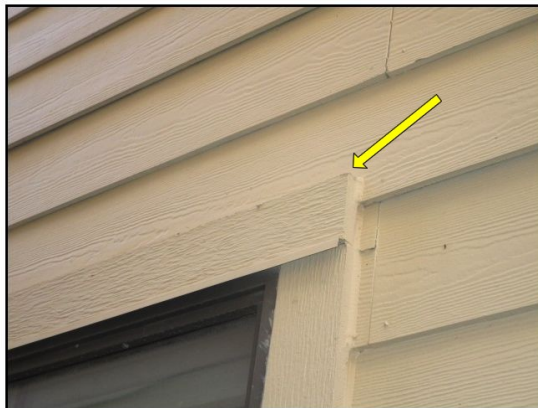
Head flashing missing over window/door trim pieces. Without head flashing over window trim, sealing must be maintained as a defense against water penetration.

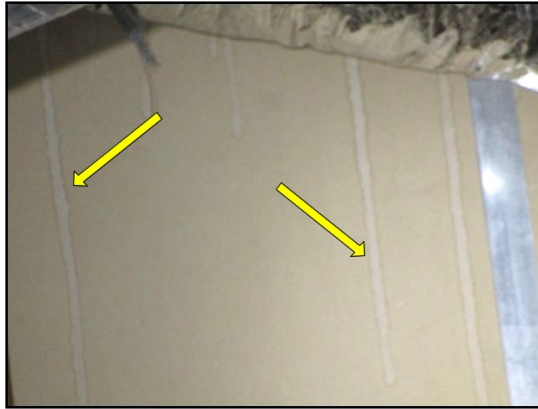
Water stain(s) observed in the attic at **fire wall between units.**

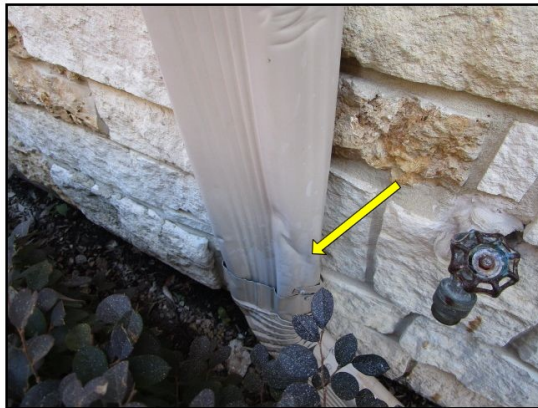
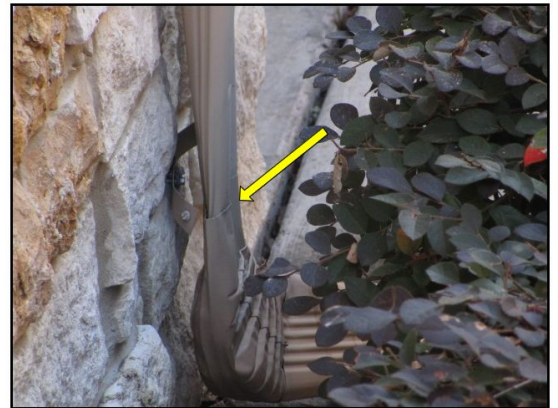
Observed one or more area(s) of damaged gutters.

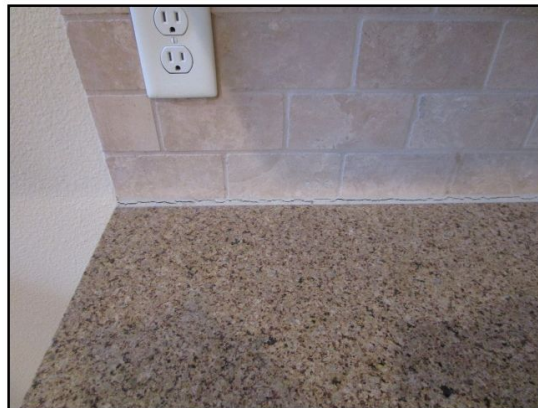
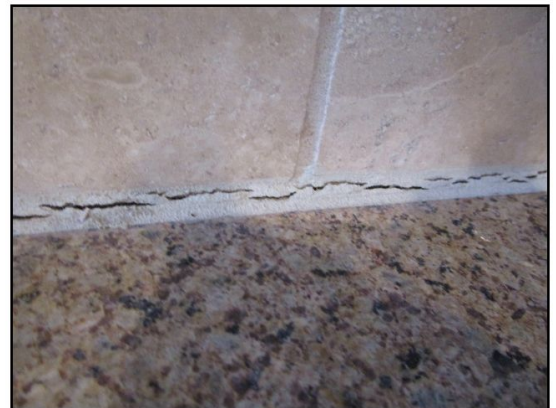
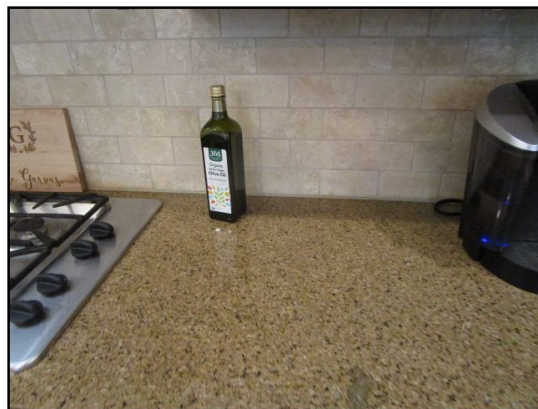
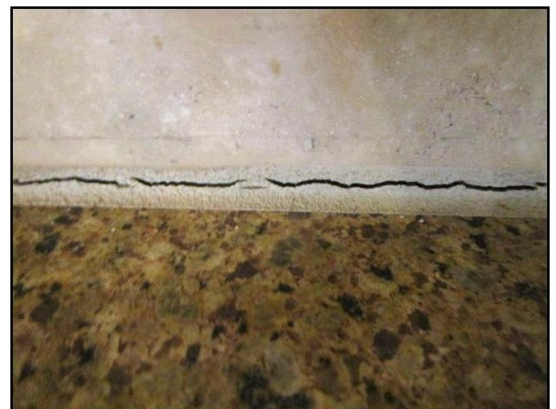
Back splash at counter top intersections need caulk/sealing to prevent possible water penetration.

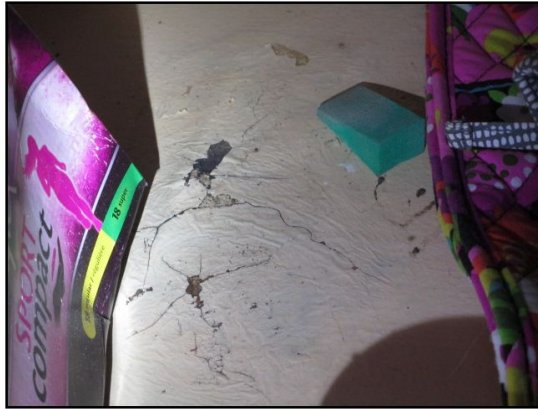
Water damage to the base of the cabinet below the sink.

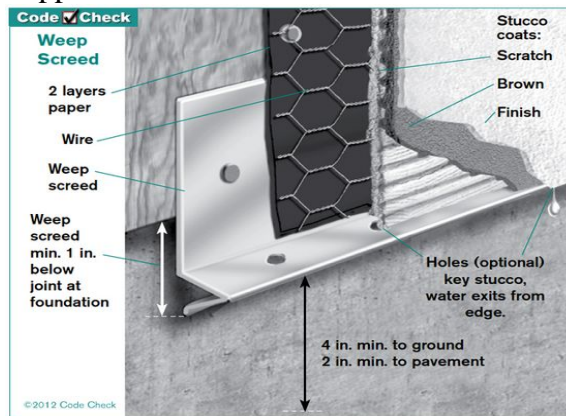
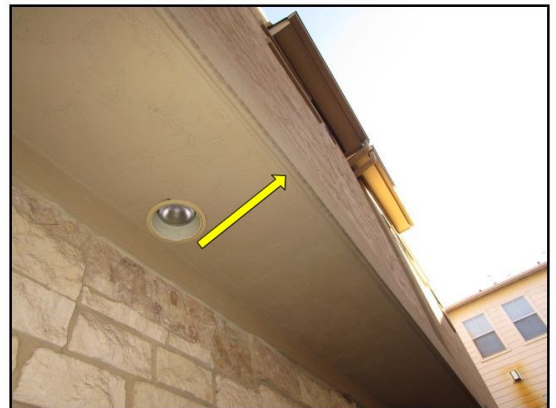
Inadequate space and/or missing weep screed at the base of the stucco. “Corrosion-resistant weep screed or plastic weep screed, with a minimum vertical attachment flange of 3 ½ inches shall be provided at or below the foundation plate line on exterior stud walls per the ASTM C 926. The weep screed shall be placed a minimum of 4 inches above the earth or 2 inches above paved areas and shall be of a type that will allow trapped water to drain to the exterior of the building.” Per IRC R703.6.2.1.

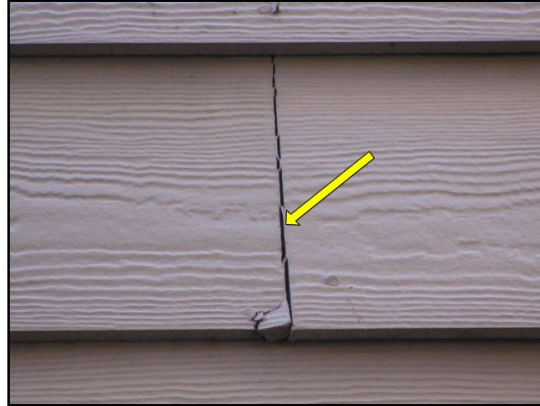
Caulking missing and/or deficient at vertical joints in the siding; may allow wind-driven rain entry.

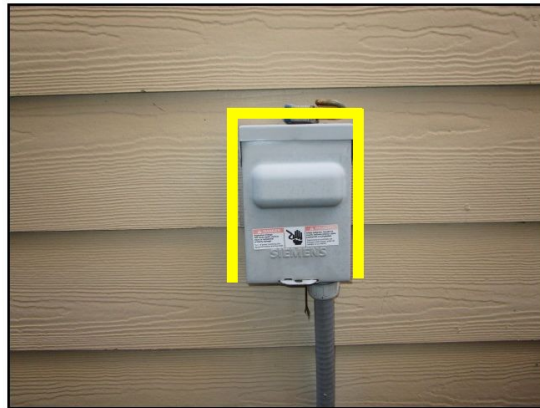
Recommend caulking around electrical disconnect box(s) of A/C unit(s) to prevent water entry behind disconnect(s).

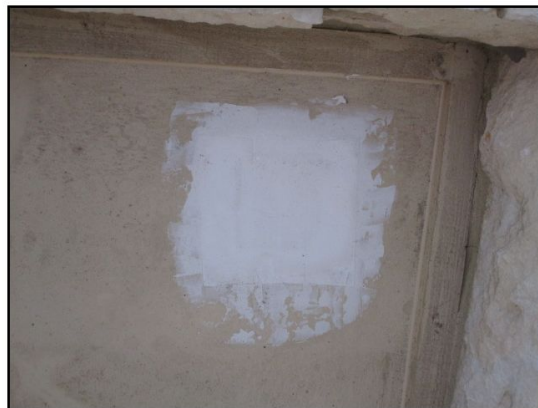
Observed cosmetic cracks and/or repaired cracks in sheetrock observed in ceiling at one or more areas of house.

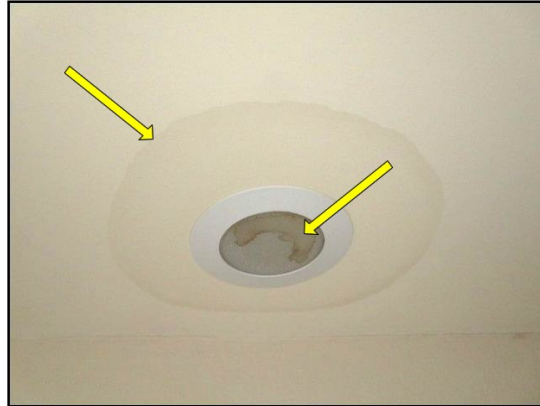
Water stains observed inside light fixture globe, an indication of previous, possibly current/active water leak from undetermined source; first floor shower ceiling; not wet at time of inspection.

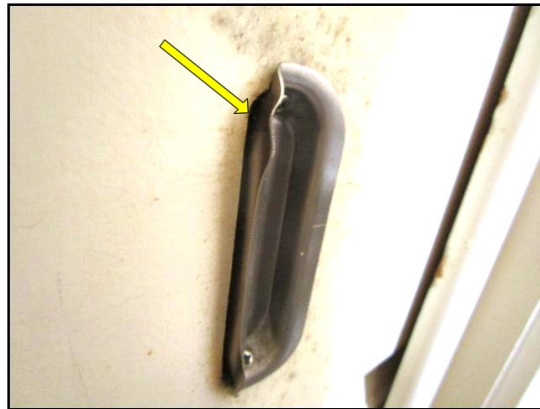
Pocket door hardware in third floor bedroom closet is damaged.

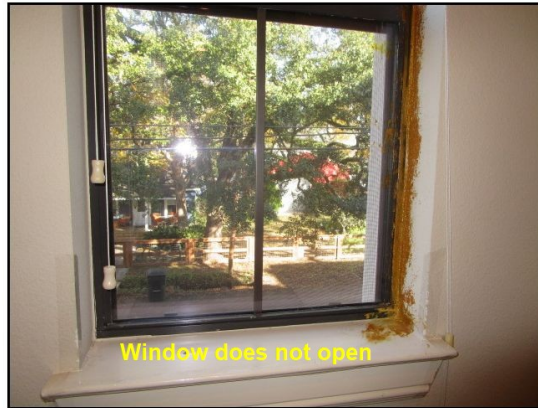
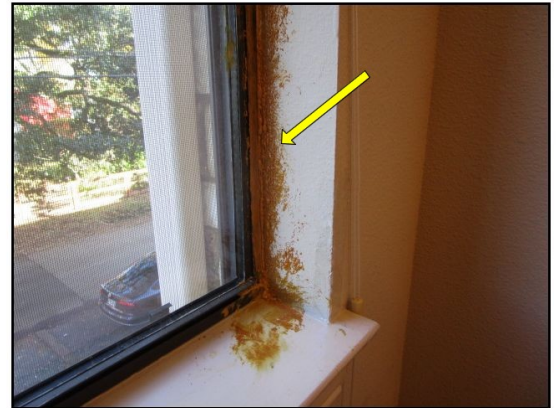
Observed one or more windows that were not operational.

Handyman repair of previous water leak; not wet at time of inspection.

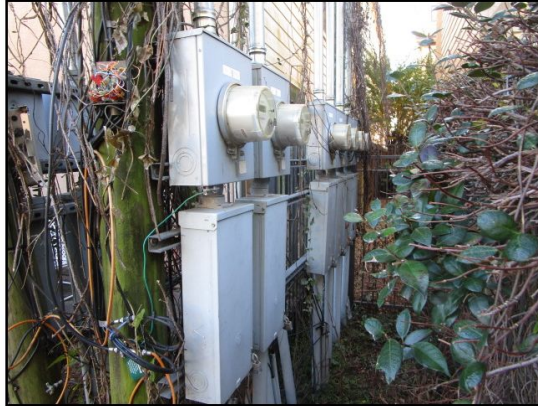
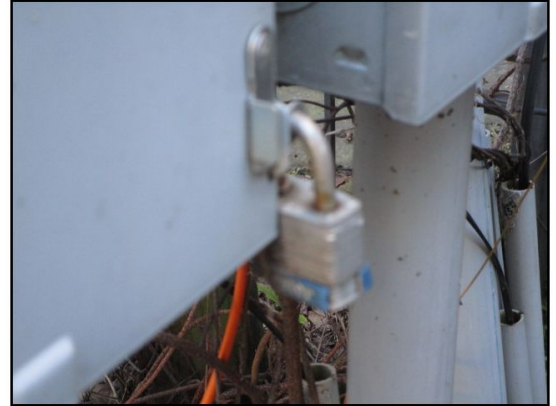
The service panel dead-front cover was not removed. Not checked/inspected. Units were not labeled and all were locked.

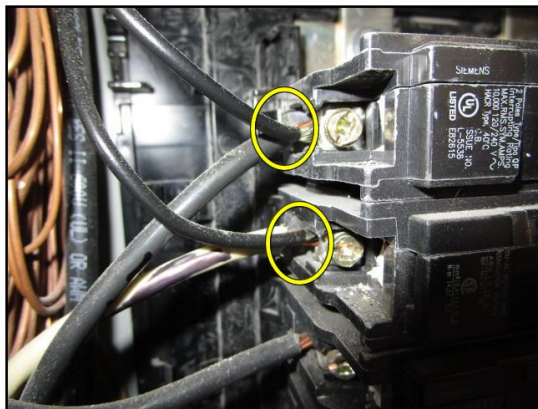
Double lugged breaker(s), [two wires improperly on 1 breaker] observed.

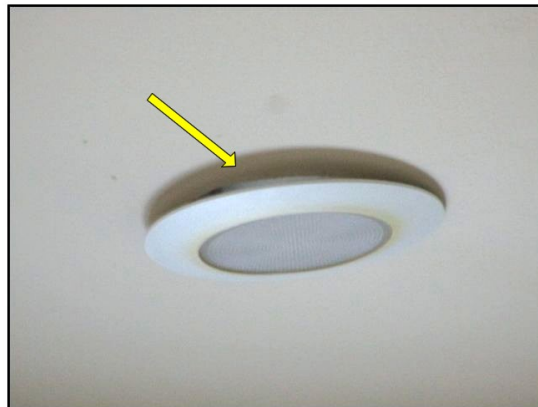
Master shower light needs adjustment at ceiling.

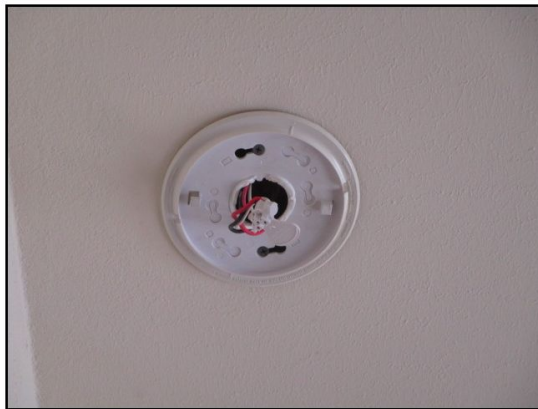
Smoke alarm(s) did not sound when the test button was pushed;third floor guest bedroom.

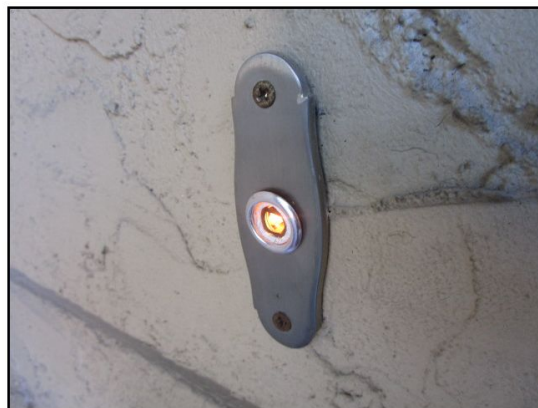
Doorbell damaged.

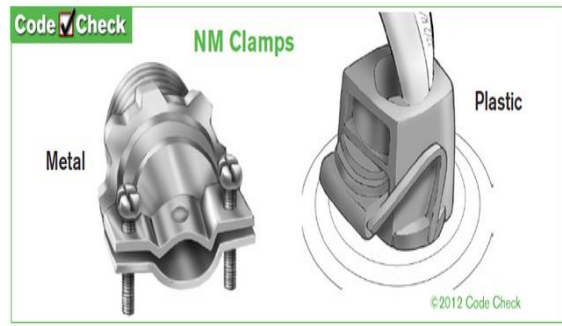
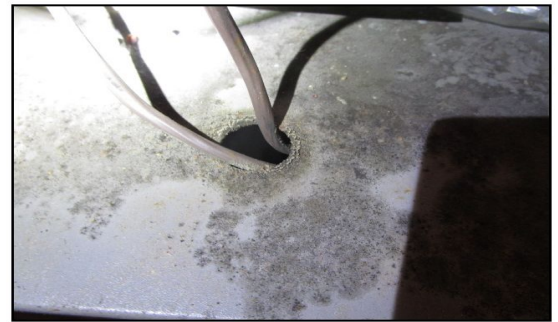
Thermostat wiring not secured to attic unit(s), missing small fitting that secures wiring to the cabinet to prevent pulling loose by service personnel or homeowner.

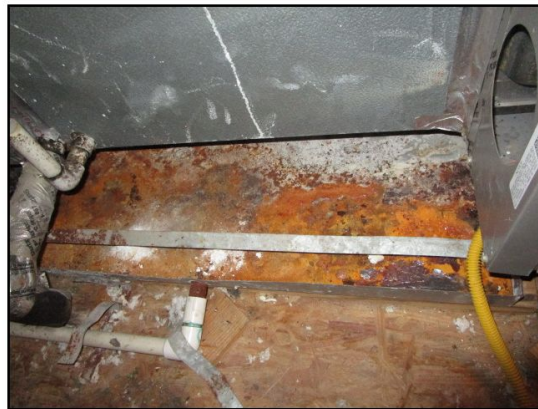
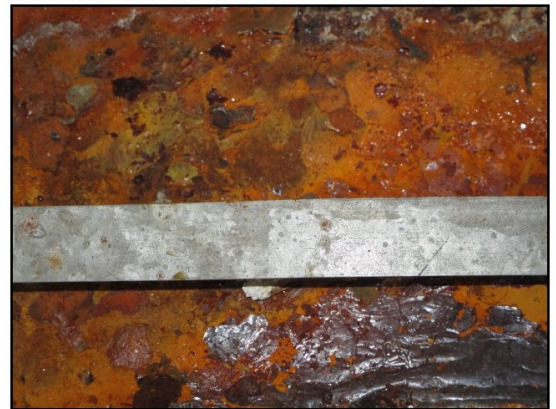
Secondary drain pan is very rusted, recommend replacement.

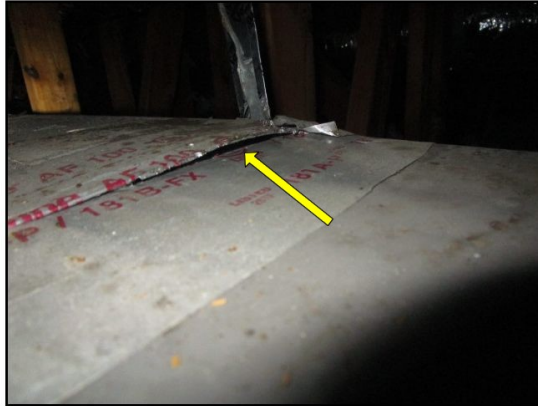
Excessive air loss around transition/coil/heater/plenum and/or damaged/loose ducts.

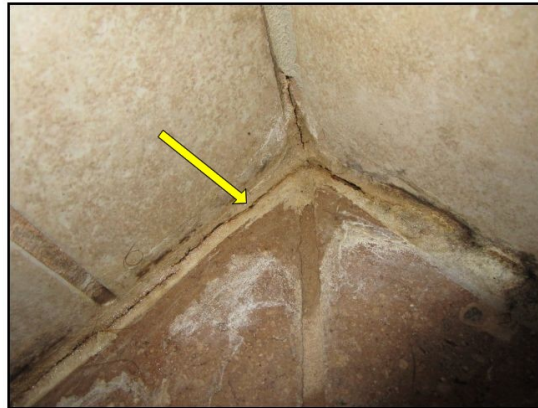
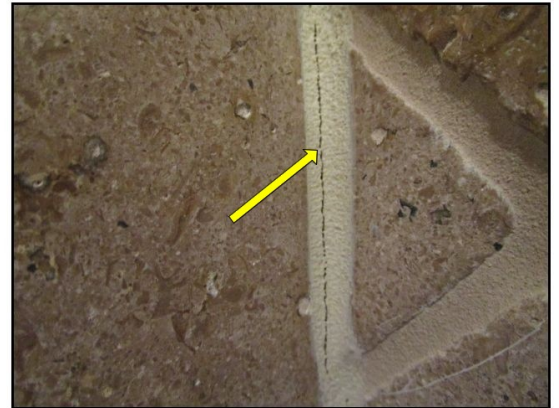
Showerhead not secured in the wall.

Grout/caulking needed at vertical tile corners, cracks in tile and/or mortar between tiles, to prevent water entry behind the wall.

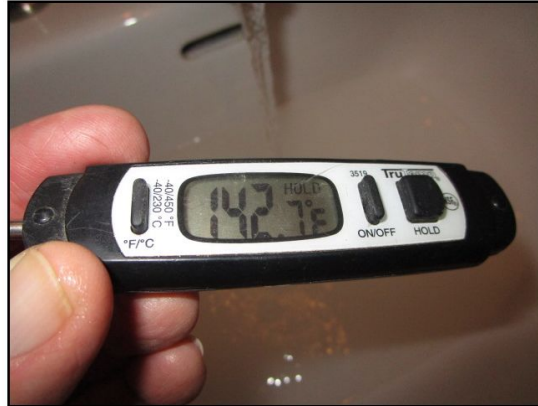
Water temperature is too hot, scalding hazard, the temperature was measured above 140 degrees. The following temperatures will produce 2nd & 3rd-degree burns on adult skin:

130°F in about 30 seconds

120°F takes more than 5 minutes.

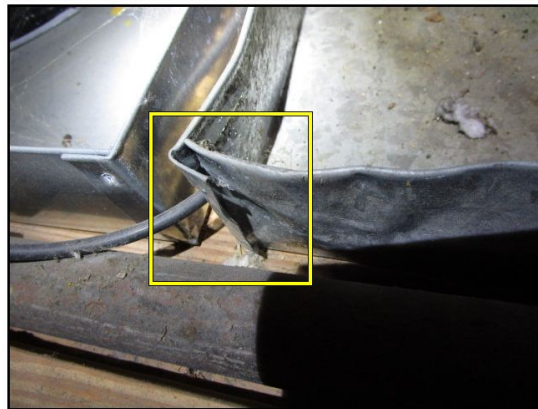
Drain pan sides are bent, probably stepped on. Pan will leak water at seam.

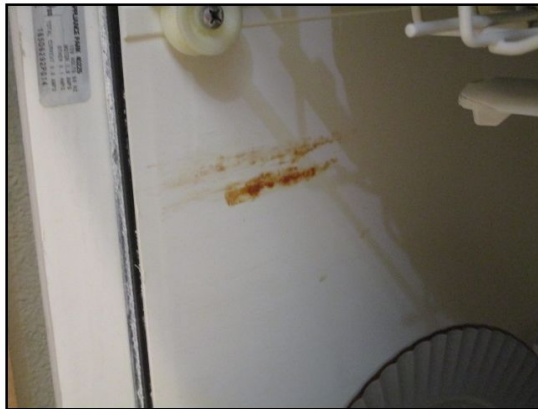
Rust observed on the interior of the cabinet and/or dish racks.

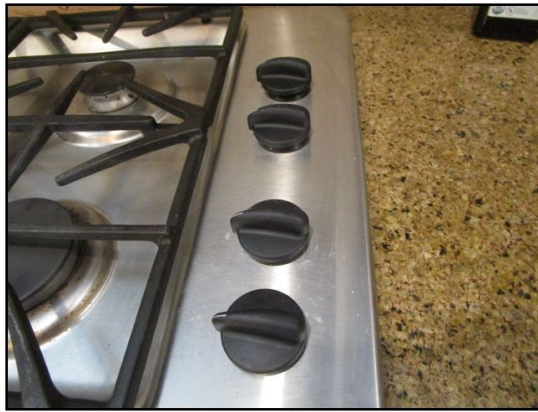
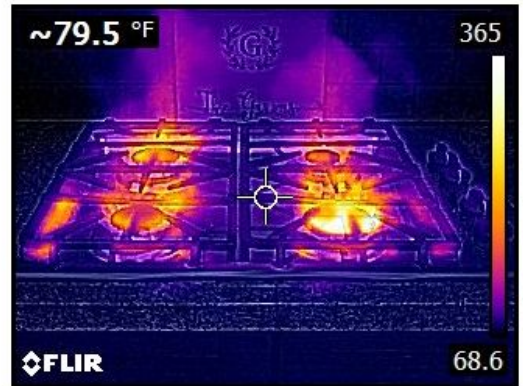
Control knob(s) markings are not legible.

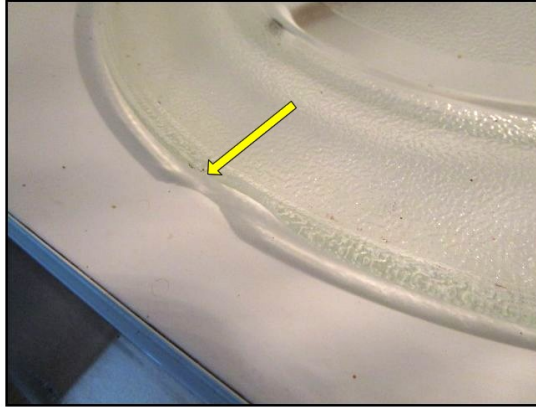
Glass turntable in unit is chipped; possible hazard.
