FIG Services LLC d/b/a FOX INSPECTION GROUP  
Property Inspection Report #201221JO-5211 Eigel Street, Unit C  
8616 Daffodil Street Houston, TX 77063  
(Office)713.723-3330 (Email) [office@foxinspectiongroup.com](mailto:office@foxinspectiongroup.com)

### **Stucco Moisture Inspection Report Prepared For: Allison Saxby**

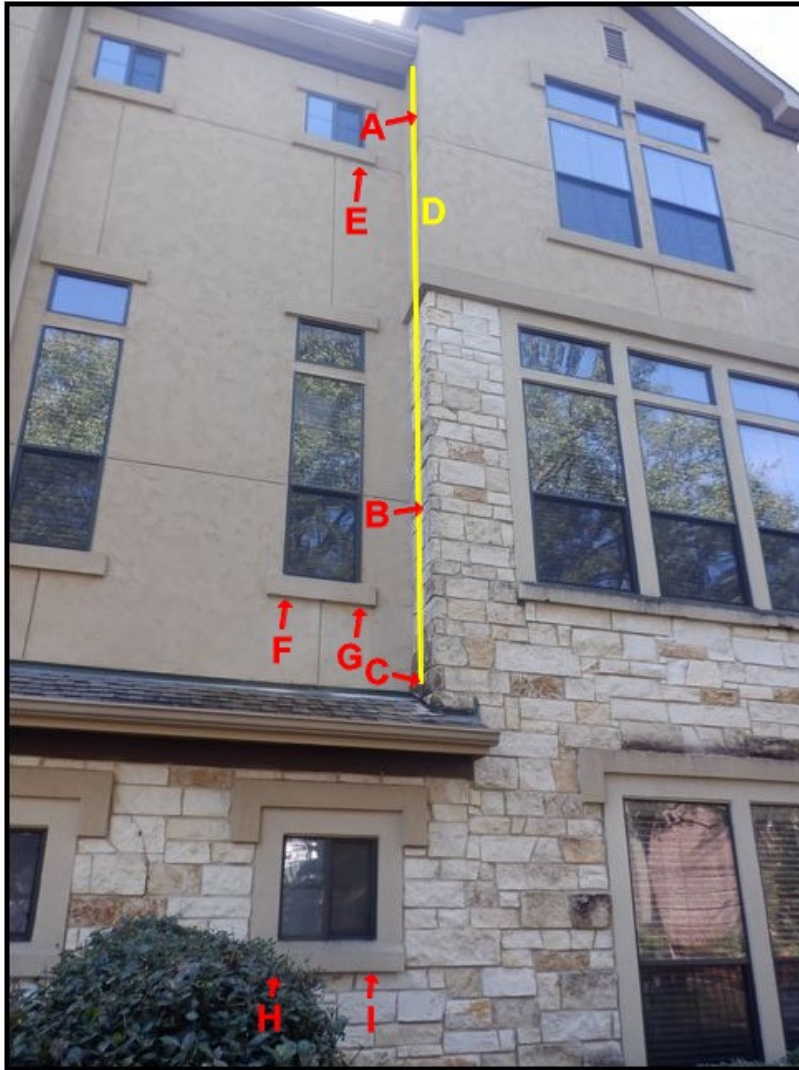
# Front Elevation 1

Location	Item Description	Moisture Readings	Observations
A	Below roof-wall intersection	40.0	Substrate observed to be soft
B	Below "A"	15.3	Substrate observed to be soft
C	Below "B"	17.7	Substrate observed to be soft
D	Yellow line	NA	Suspected substrate damage
E	Window	9.3	
F	Window	17.9	
G	Window	19.2	
H	Window	19.7	
I	Window	16.2

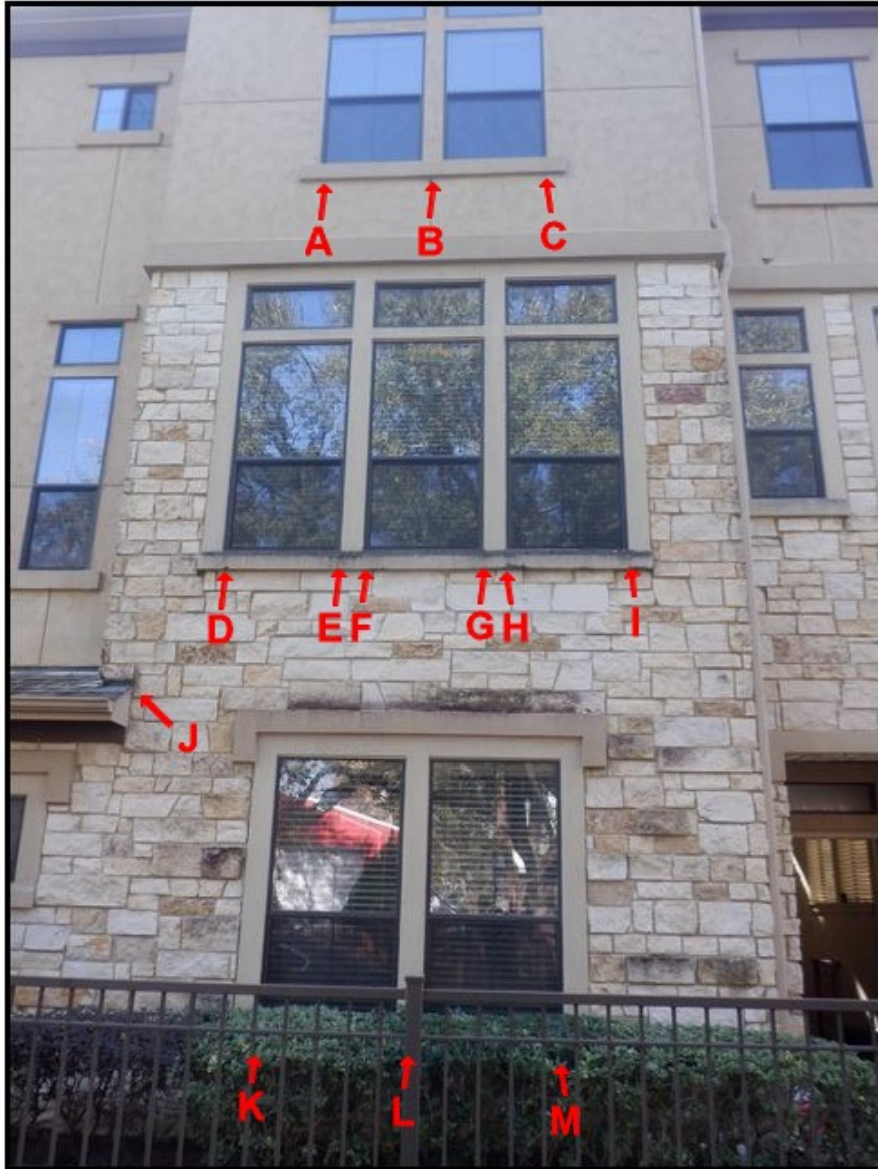
## Front Elevation 2

Location	Item Description	Moisture Readings	Observations
A	Window	17.4	
B	Window	18.5	
C	Window	12.5	
D	Window	22.4	
E	Window	19.3	
F	Window	15.0

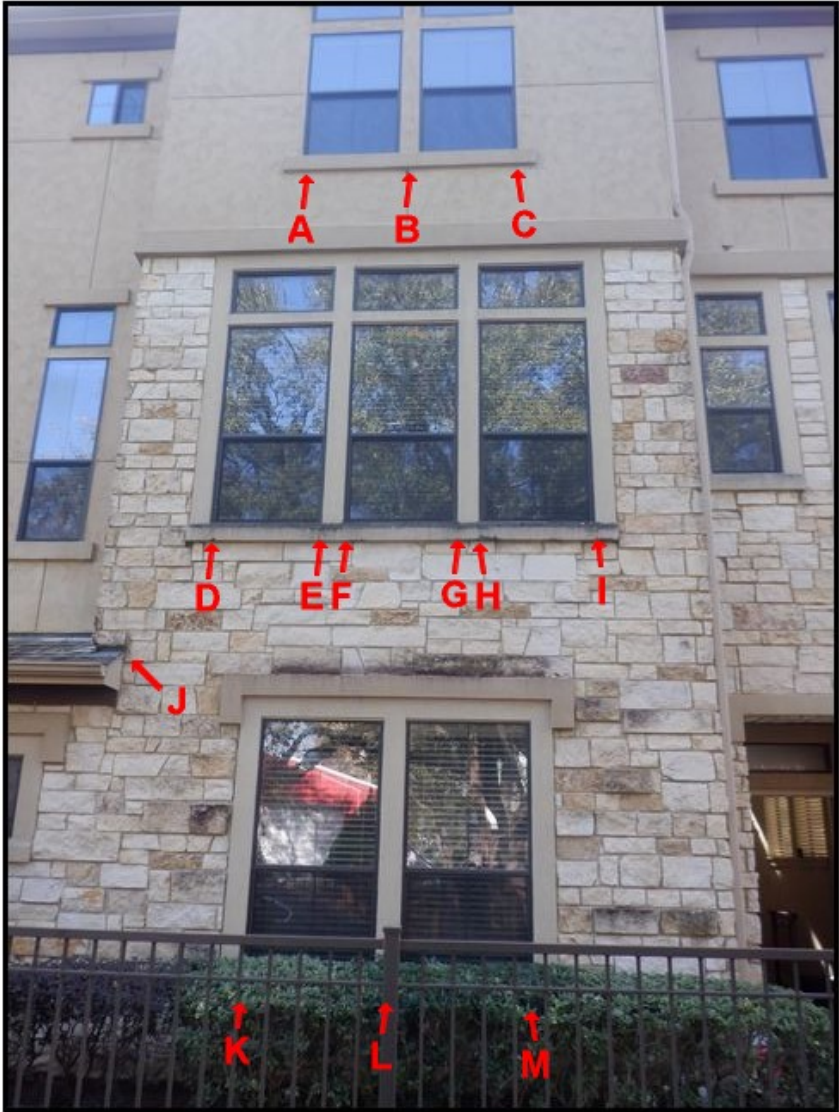
# Front Elevation 2 (continued)

Location	Item Description	Moisture Readings	Observations
G	Window	11.4	
H	Window	9.9	
I	Window	26.3	
J	Roof-wall intersection	11.4	
K	Window	9.7	
L	Window	18.4	
M	Window	13.3

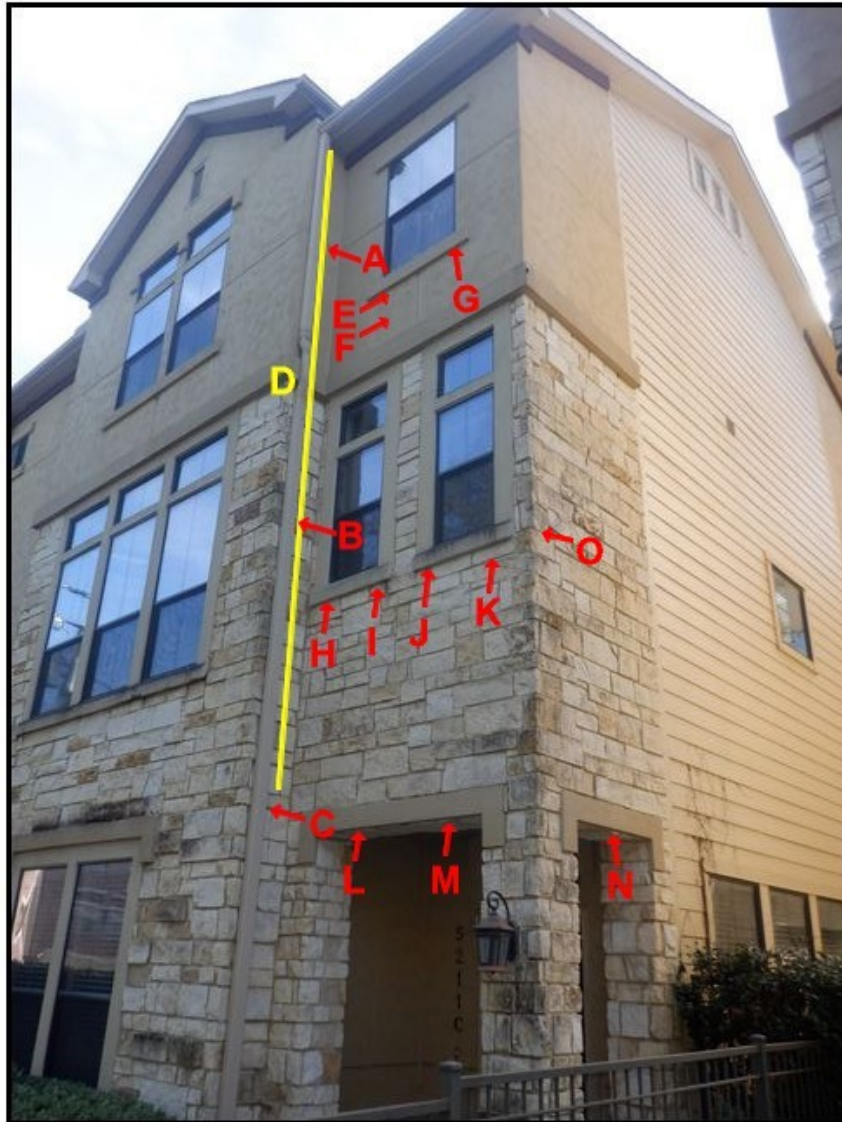
## Front Elevation 3

Location	Item Description	Moisture Readings	Observations
A	Below roof-wall intersection	21.8	Substrate observed to be soft
B	Below "A"	23.1	Substrate observed to be soft
C	Below "B"	16.4	Substrate observed to be semi-firm
D	Yellow line	NA	Suspected substrate damage
E	Window	23.4	Substrate observed to be soft
F	Below "E"	16.5	
G	Window	29.1

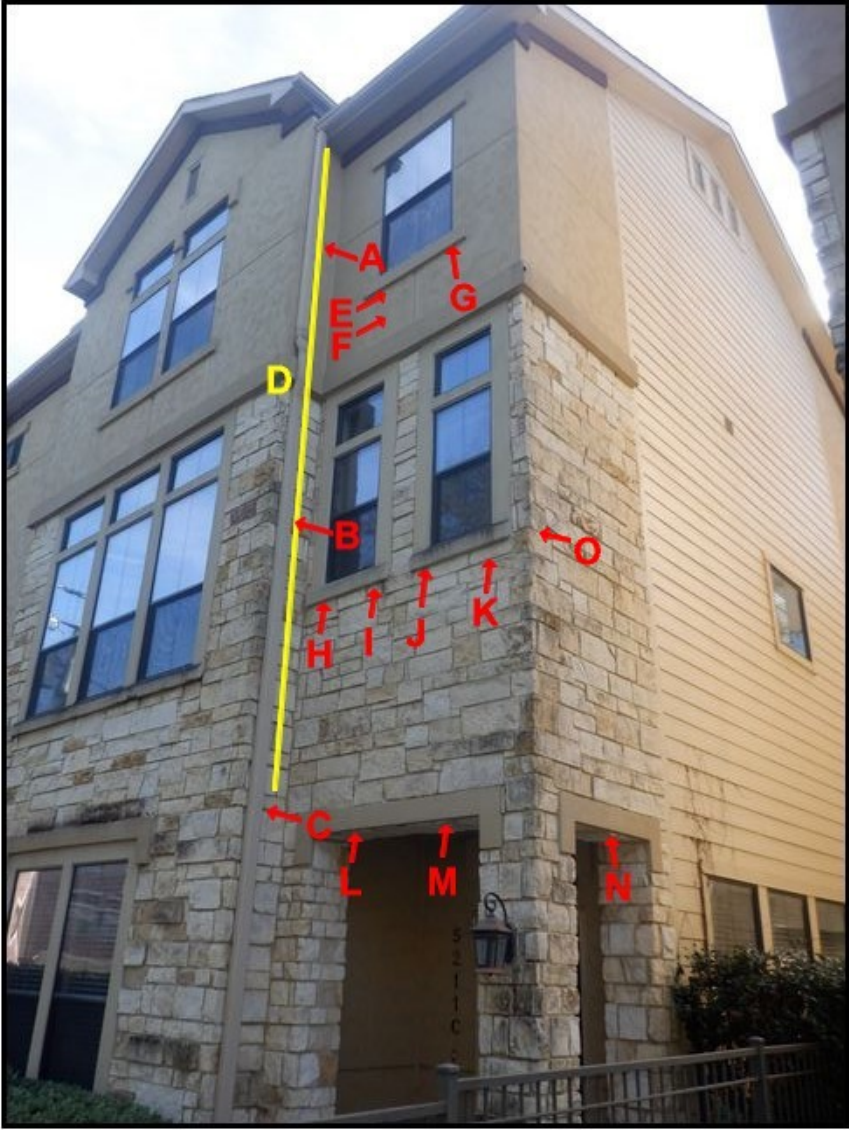
### Front Elevation 3 (continued)

Location	Item Description	Moisture Readings	Observations
H	Window	24.7	
I	Window	18.4	
J	Window	39.7	
K	Window	8.9	
L	Soffit	12.7	
M	Soffit	7.6	
N	Soffit	9.7	
O	Corner	14.2

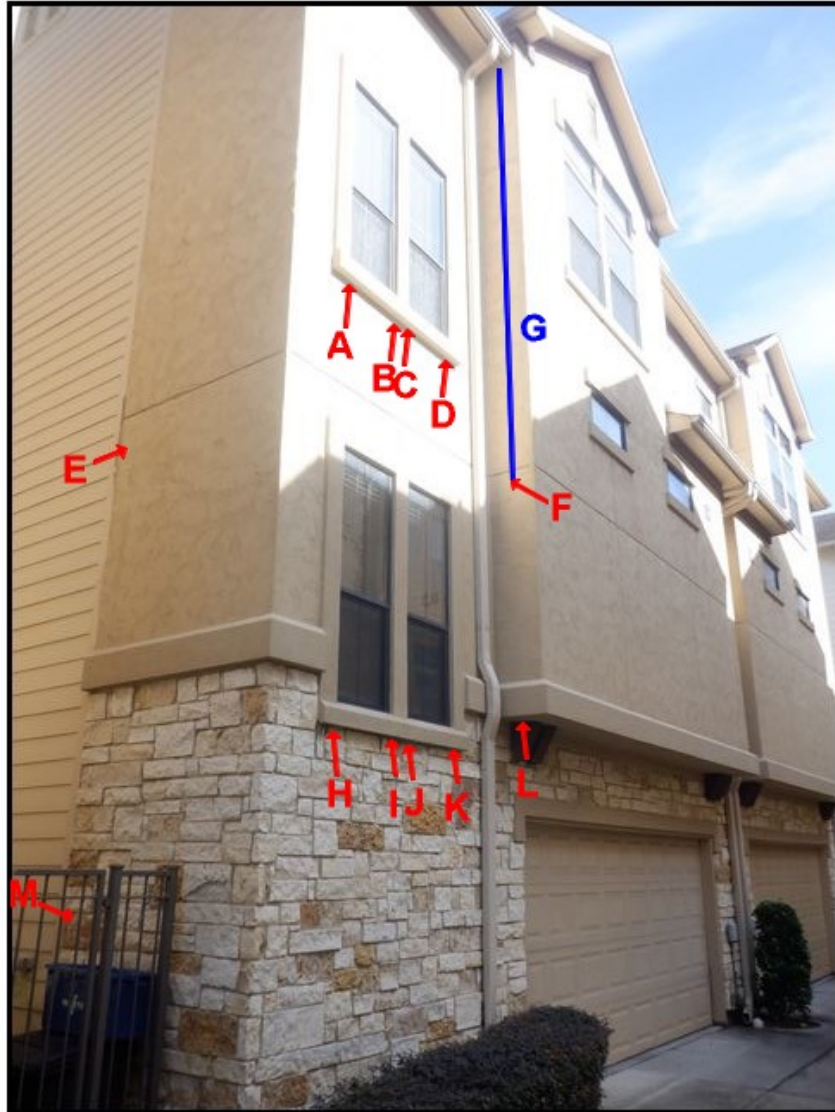
## Back Elevation 1

Location	Item Description	Moisture Readings	Observations
A	Window	11.5	
B	Window	11.1	
C	Window	11.3	
D	Window	14.8	
E	Joint in siding	14.4	
F	Below roof-wall intersection	8.9	
G	Blue line	NA	Condition of substrate unknown

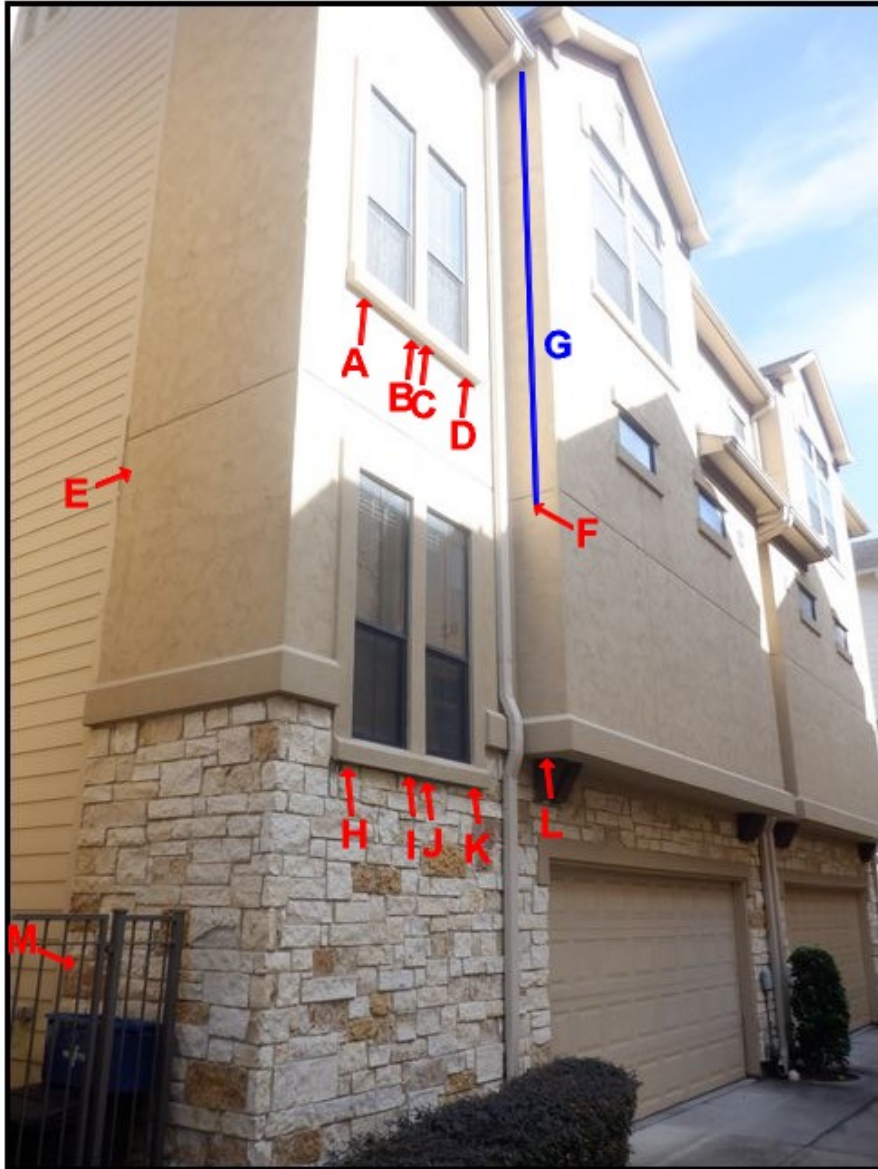
## Back Elevation 1 (continued)

Location	Item Description	Moisture Readings	Observations
H	Window	13.2	
I	Window	17.7	
J	Window	13.1	
K	Window	15.2	
L	Soffit	11.2	Substrate observed to be semi-firm
M	Joint in siding	15.0

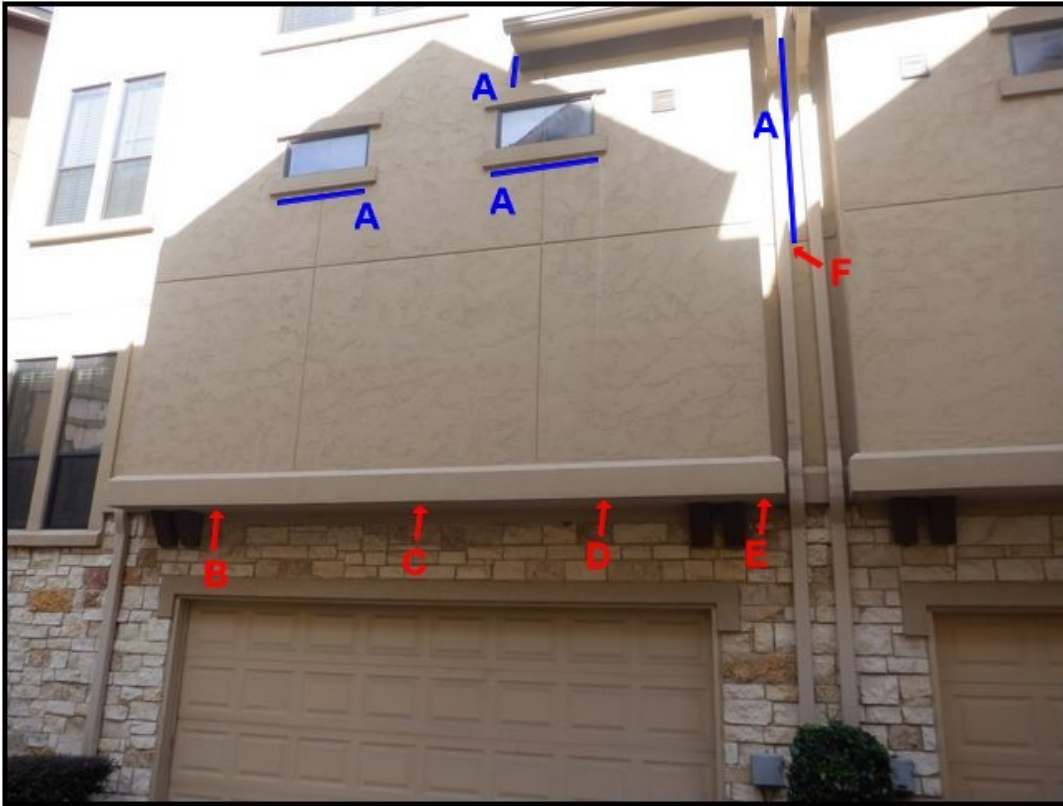
## Back Elevation 2

Location	Item Description	Moisture Readings	Observations
A	Blue lines	NA	Condition of substrate unknown
B	Soffit	10.1	
C	Soffit	15.7	
D	Soffit	11.3	
E	Soffit	7.9	
F	Below roof-wall intersection	9.6

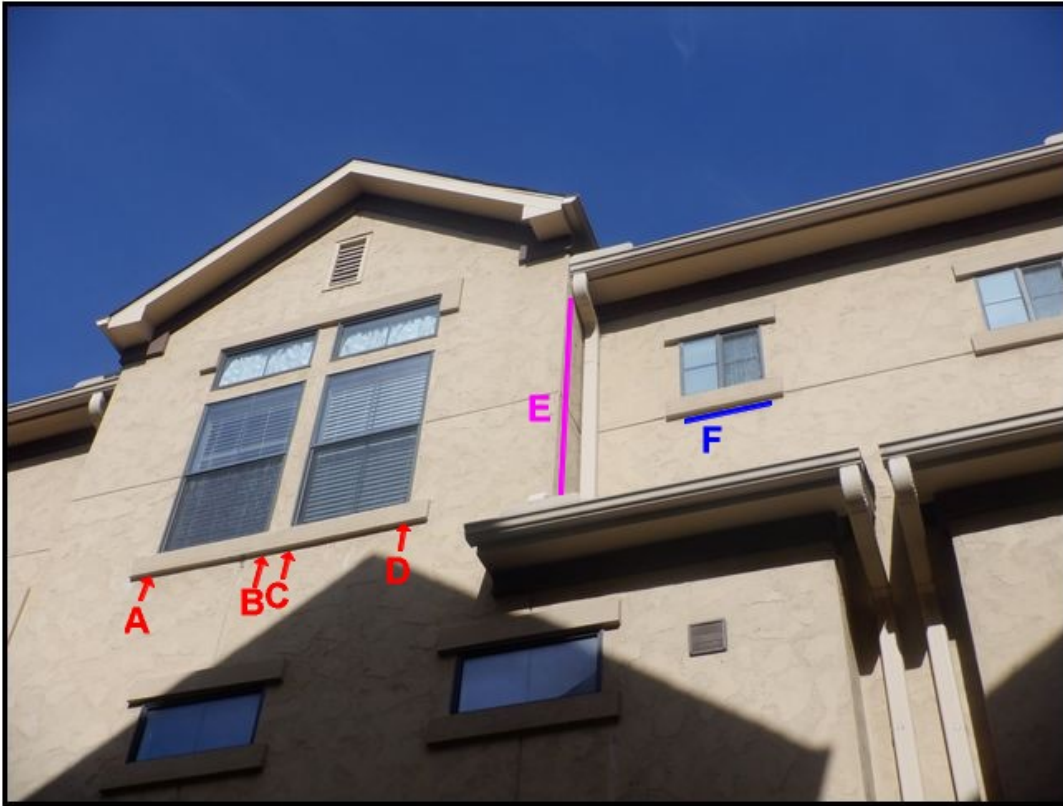
## Back Elevation 3

Location	Item Description	Moisture Readings	Observations
A	Window	18.3	
B	Window	12.3	
C	Window	10.0	
D	Window	11.4	
E	Fuchsia line	NA	Possible substrate damage
F	Blue line	NA	Condition of substrate unknown

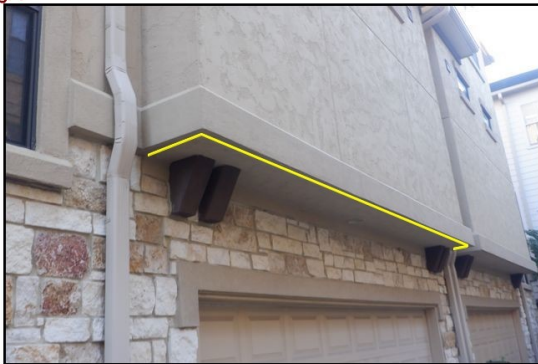
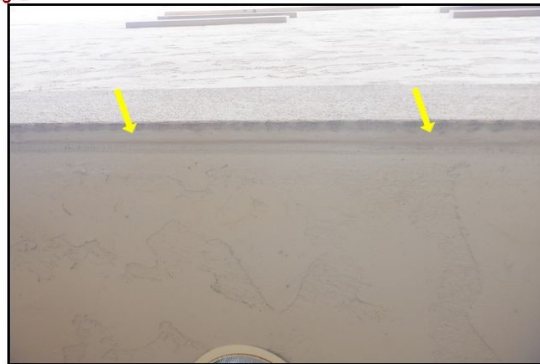
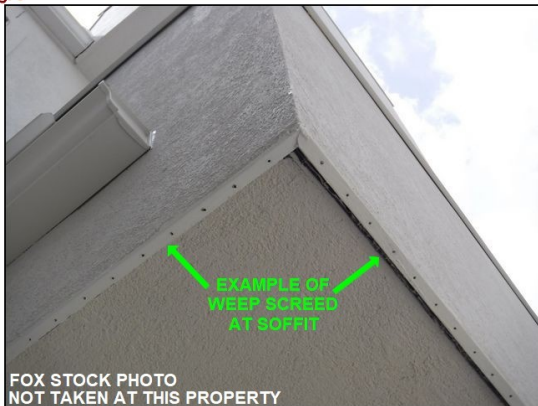
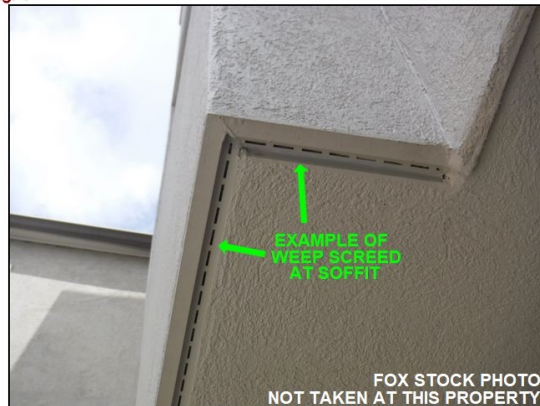
Did not observe drip screed (drainage relief accessory) at bottom of the stucco wall, where it intersects with the soffit. The following diagram depicts a “best practice” procedure as defined in the Texas Lathing and Plastering Contractor's Association (TLPCA) Stucco Resource Guide. This detail provide a means for moisture to exit from behind the stucco if the wall assembly leaks (we seldom see a drip screed at these locations on most stucco homes / buildings). Due to moisture / soft substrate observed in these areas (see pages 12 & 13 above), installation of a drip screed is recommended.

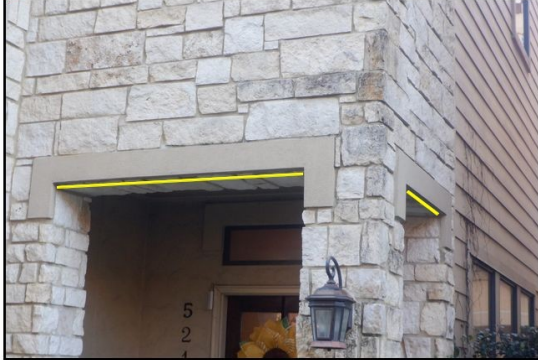
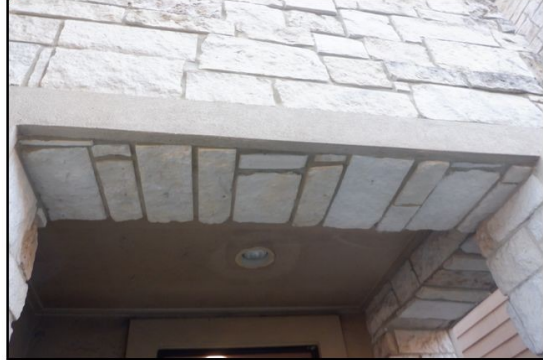
Although no drainage relief accessory was observed at front entry soffits, no active moisture / soft substrate detected in these areas (see page 10 above). Recommend consulting with a licensed stucco contractor as to the necessity and/or urgency of installation.

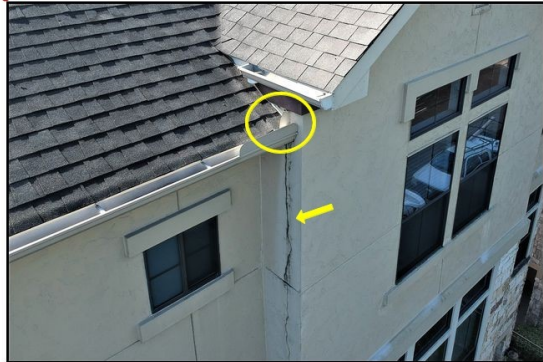
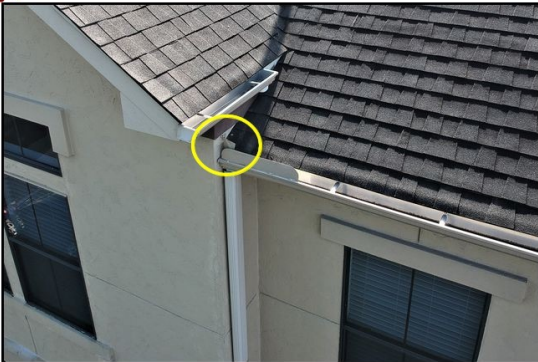
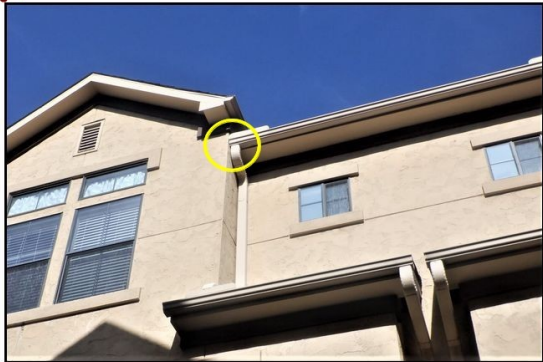
Active moisture / soft substrate detected and / or suspected below one or more roof-wall intersections (see pages 6, 9, 11-12 & 14 above). Recommend further investigation by a qualified stucco contractor for repair of damaged substrate and re-work "kick out" flashing to prevent further water entry.

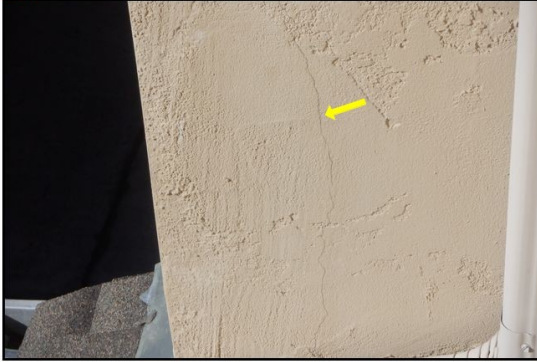
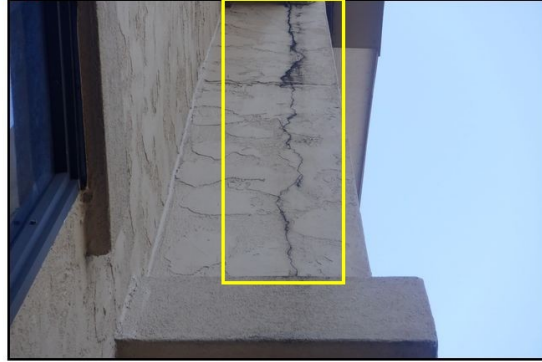
Multiple cracks observed around the structure. Hairline cracks are considered typical and can be addressed the next time the house is painted. It is the inspector's opinion that the larger (thicker) cracks be sealed to prevent the expansion of the crack / water entry.

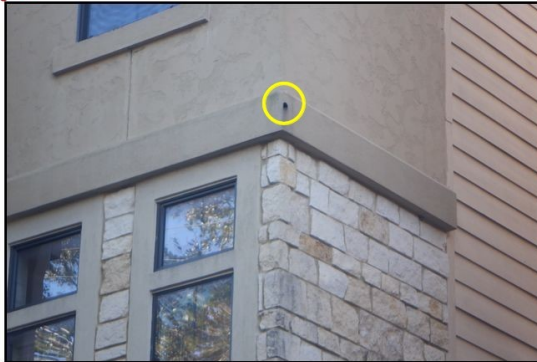
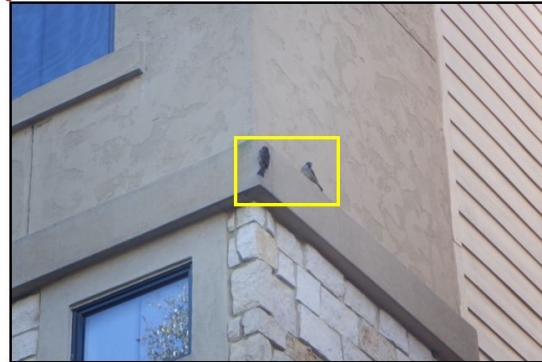
Observed hole in EIFS trim piece over adhered stone above front entry. It appears that birds have built a nest inside the trim. No active moisture detected in substrate below this area (wall was tested as high as was safely accessible - see page 10 location O above).

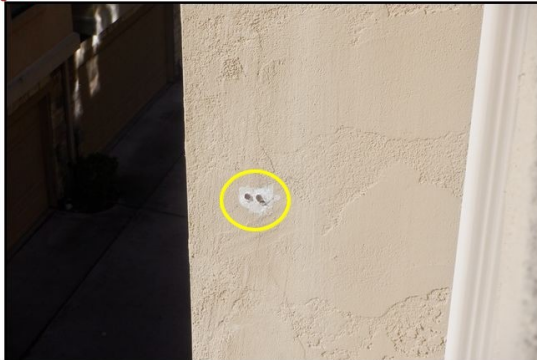
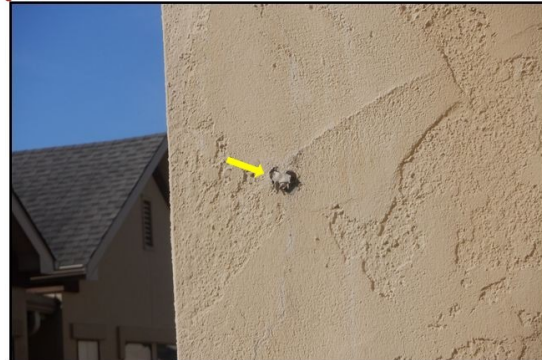
Nail heads left behind from previously mounted hardware - Recommend ensuring that the nails are sealed with the appropriate exterior grade sealant. Observed on back elevation from third floor bath window.

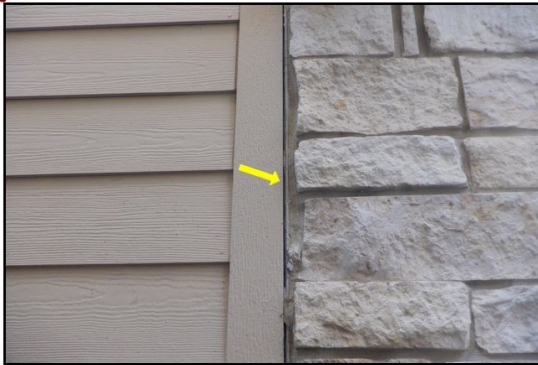
Caulking missing/deficient at joints in the siding; may allow wind-driven rain entry.

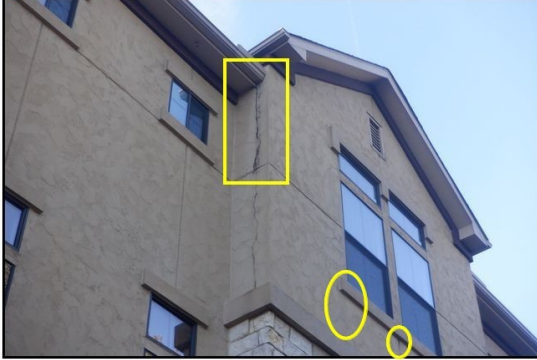
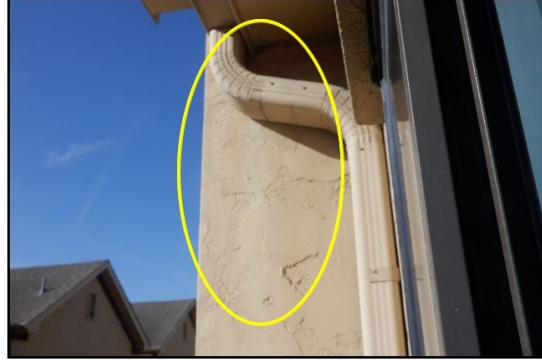
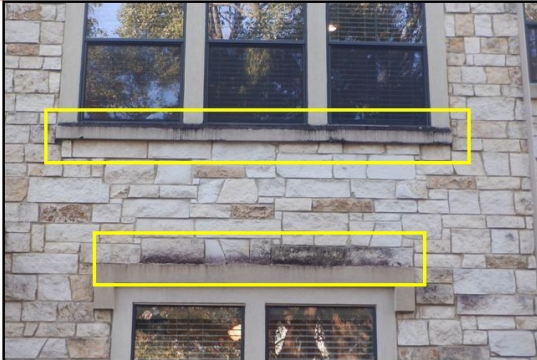
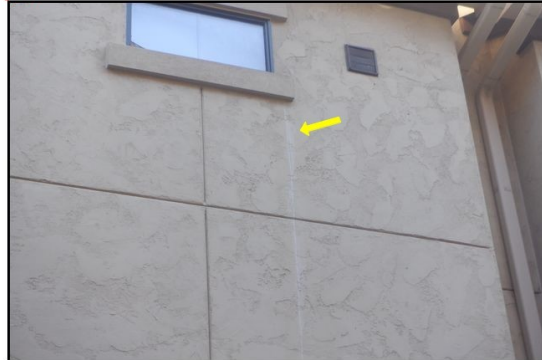
Observed one or more areas of staining on stucco veneer. Staining indicative of water moving persistently across stucco and / or exiting from behind wall which is conducive to water penetration to structure beneath. See Elevations section above for moisture readings taken at the safely accessible areas during course of inspection.

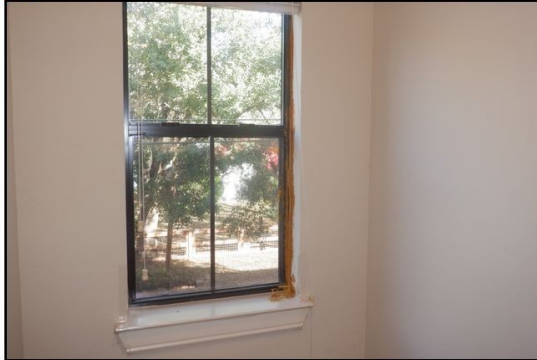
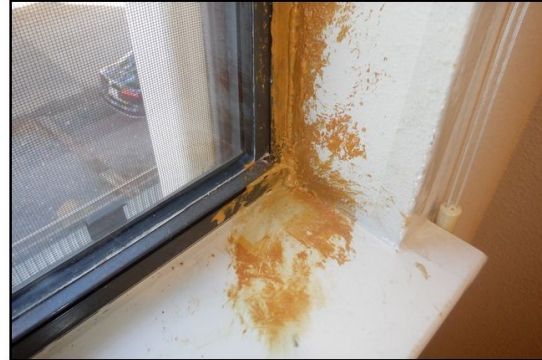
Previous patches / repairs were observed on interior of second floor window. Recommend consulting with the owner as to and documentation concerning the repairs.
