MECHANICAL INSPECTION

16230 Jersey Dr
Jersey Village TX 77040

FEBRUARY 8, 2021

PROPERTY INSPECTION REPORT

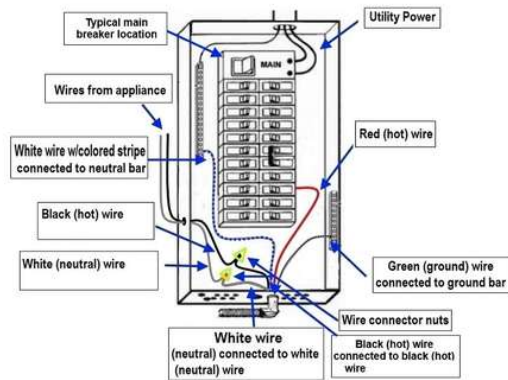
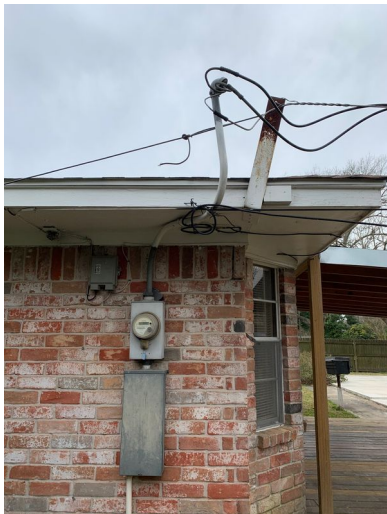
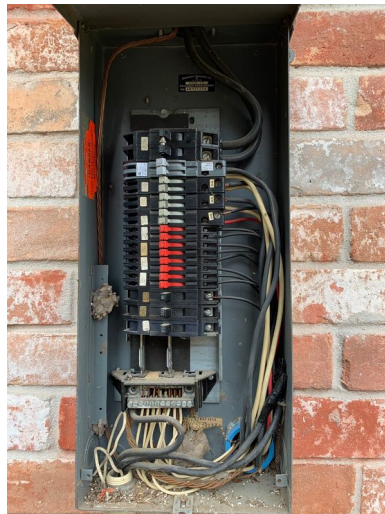
It is a general recommendation that all circuit breakers be tripped off and on several times a year to ensure that they are still physically able to trip off. Occasionally, the points on a breaker will deteriorate at the point where it connects to the electrical bus in the panel, causing the panel/breaker to overheat. Zinsco and Sylvania panels have a reputation for this condition. Consideration should be given to replacing the breaker panel. It is recommended that you perform an online search of Zinsco breaker panels and Sylvania breaker panels.

We observed one or more white wires that were used as a power wires, and were connected to a circuit breaker. Typically, the white wires are the grounded/neutral conductors, and if they are used as a power conductor, they must be permanently marked or wrapped with black or red tape to identify them as a "hot" ungrounded conductor.

Foreign material was observed in the panel box, which can be a safety hazard, and it is recommended that the panel be cleaned

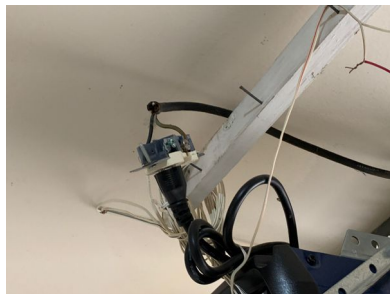
2: Outlet - Loose in wall

An outlet was loose on the wall and needs to be secured in a junction box.

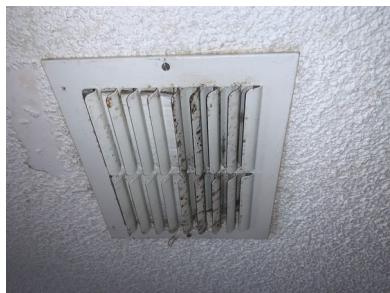
1: Registers - Microbial growth observed

Some of the registers were covered with mildew/debris. It is recommended that a service company be contacted to check the inside a of the duct work to determine if there is a build-up of debris/mold/mildew inside, and make any needed repairs. Further investigation is recommended.

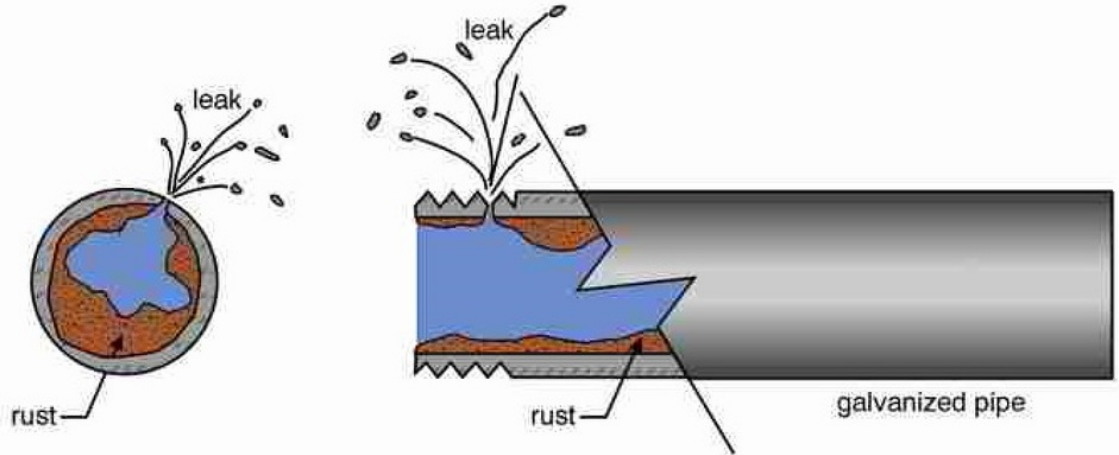
All or portions of the water piping for the property was observed to be the original galvanized piping. It is pointed out that the galvanized piping will deteriorate with time, and will corrode on the inside of the piping, thereby reducing the inside diameter of the pipe, and restricting the flow of the water through the pipe. In addition, the piping will corrode through to the outside of the pipe and will eventually deteriorate to where the pipe will start leaking. It can be anticipated that the galvanized water piping throughout the house will need to be replaced when it is causing reduced water pressure or is corroded enough to start leaking.

rusting of galvanized pipe can greatly reduce water pressure and will eventually cause leaks as rust creates holes in the pipe walls

problems are likely to occur soonest on pipes carrying hot water, horizontal pipes and at threaded (thinner) sections

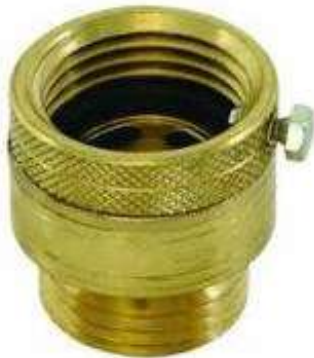
2: Vacuum Breaker - Missing

The atmospheric vacuum breaker devices were missing at one or more of the hose bibbs, and it is recommended that they be installed to prevent cross connections, which can allow contaminated water to enter the potable water supply.

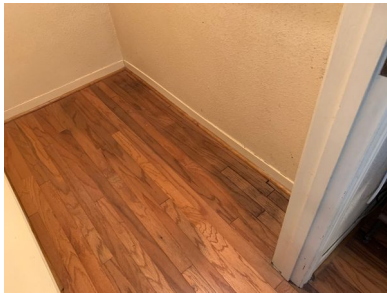
6: Shower Pan - Evidence of leak

Evidence of a shower pan leak was observed where materials in the adjacent closet of the shower were stained/damaged. it is recommended that a plumber be contacted for further investigation and to provide a cost estimate for any needed repairs. A shower pan leak test should be performed.

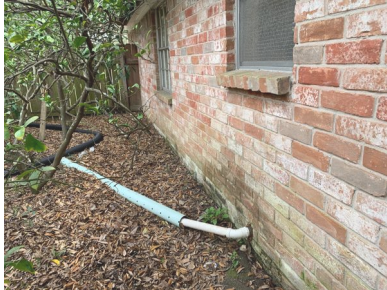
1: Cleanout drains to yard

The kitchen clean out was open and had a drain line running into the yard. Further investigation with a service company is recommended to determine if the drain line is clogged and to make any necessary repairs to route the water back into the sewer system.

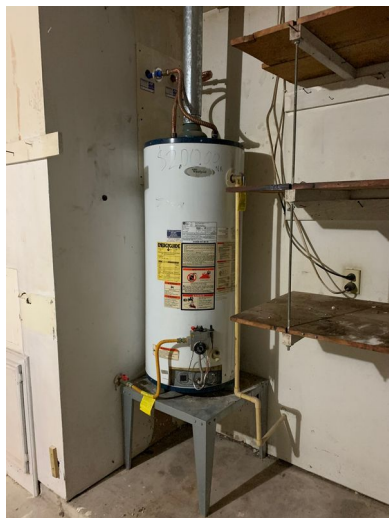
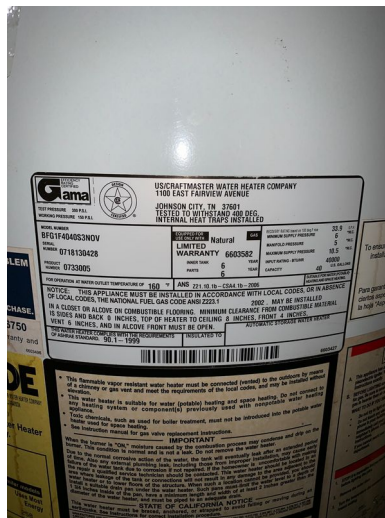
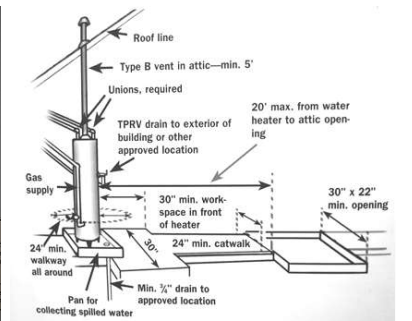
Due to the age and/or condition of the equipment, it is our opinion that the equipment has only a limited amount of life remaining. Normal life expectancy for a water heater in the Houston area is approximately 10-12 years.

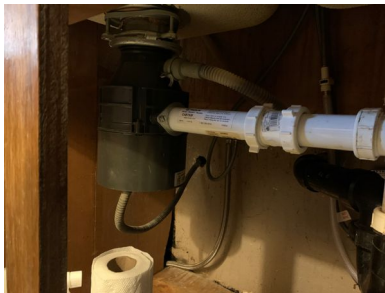
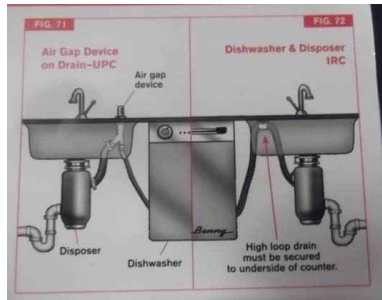
1: Leaking Water

Water was observed to be leaking from around the door during the running cycle. Have a service company find the source of the problem, and make any necessary repairs.
