STRUCTURAL INSPECTION

16230 Jersey Dr
Jersey Village TX 77040

FEBRUARY 8, 2021

REF: CONDITION OF PROPERTY SURVEY

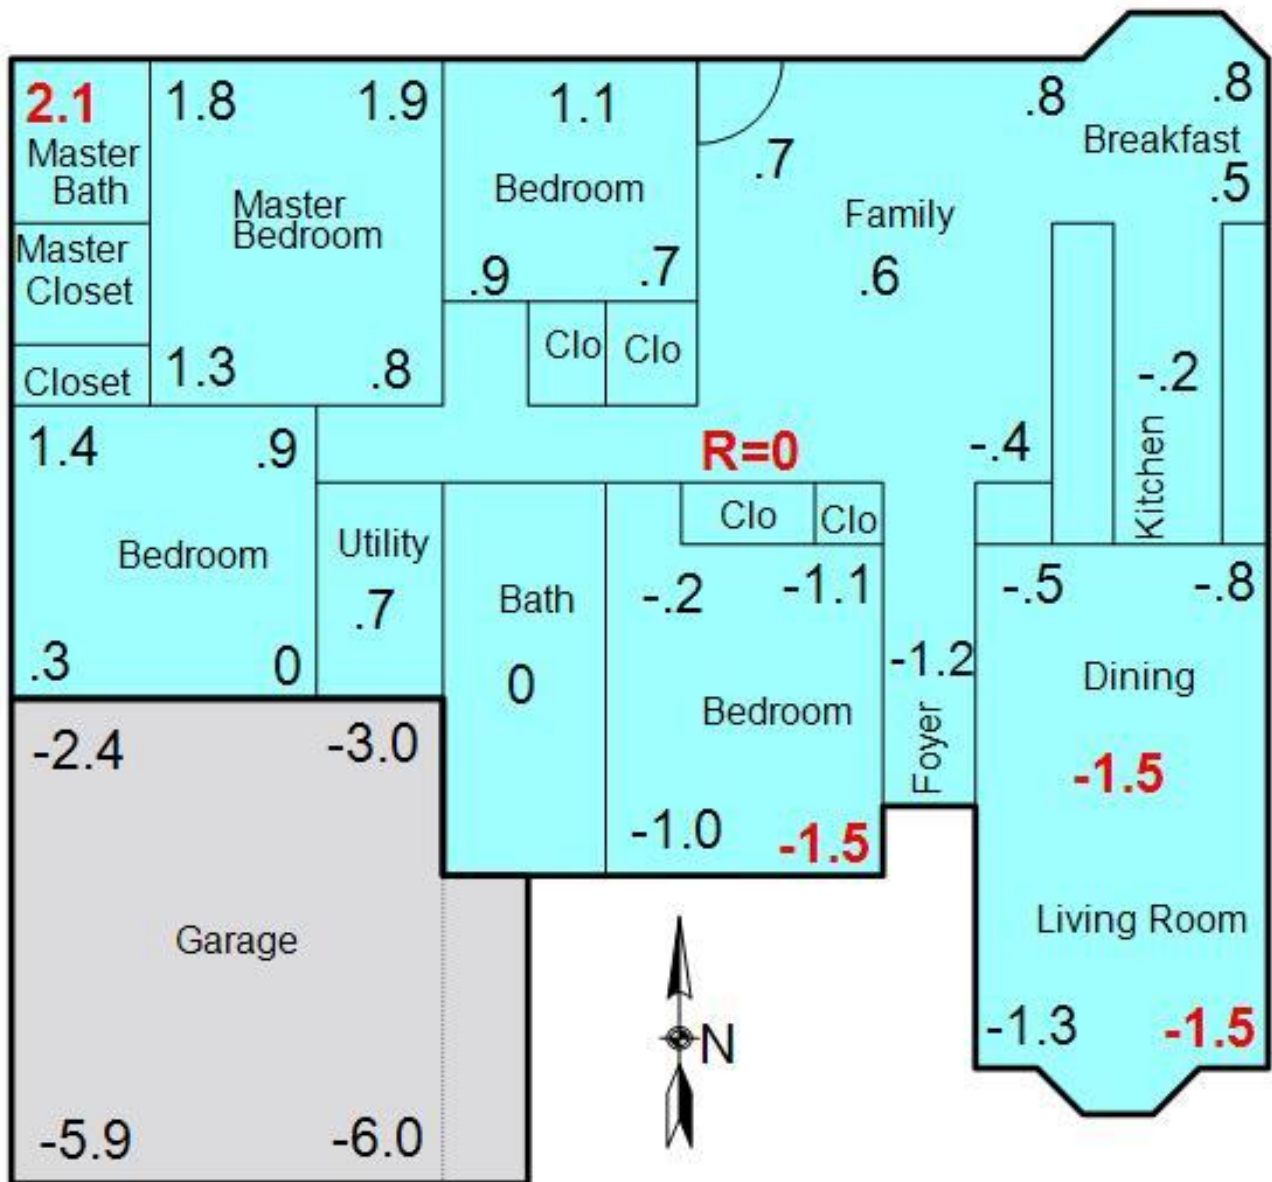
Elevation Readings
16230 Jersey Drive

The floors were checked with an electronic level, and were observed to be sloping a more than normal degree from the master bathroom towards the front east area of the house. The difference in elevation between the high point and low point was 3.6 inches. The high point was located at the master bathroom, and the low points were located at the living room and the front bedroom. The unlevelness takes place over a horizontal distance of approximately 60 feet.

Due to the more than acceptable amount of movement of the foundation of this structure, it is our opinion that releveling of the foundation is needed at this time. It is recommended that at least three foundation repair contractors be contacted in order that they may make their own assessment of the scope and cost of the work needed to bring

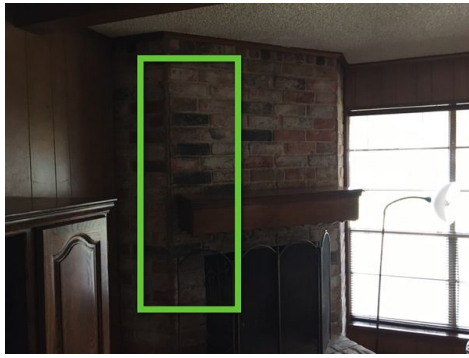
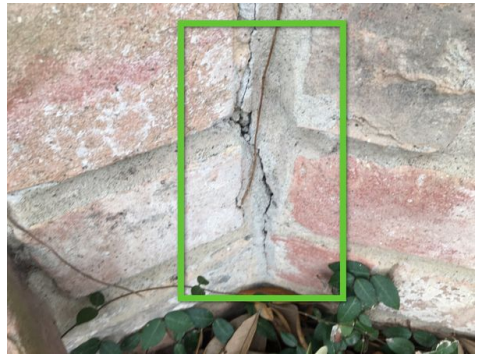
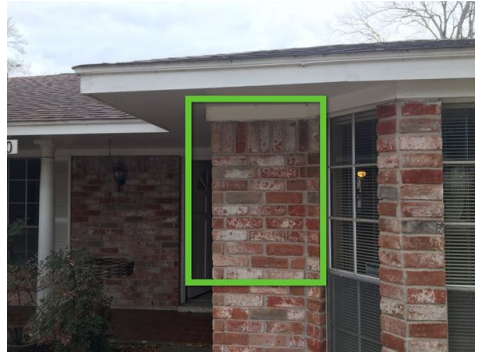
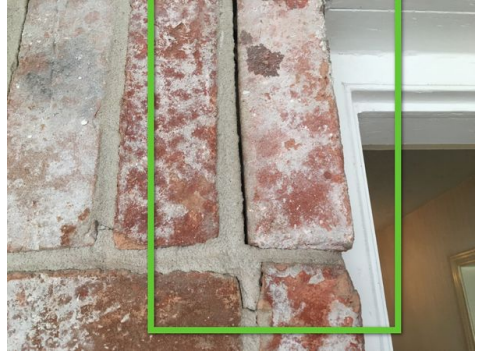
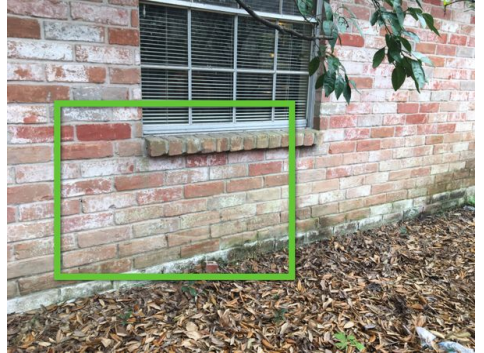
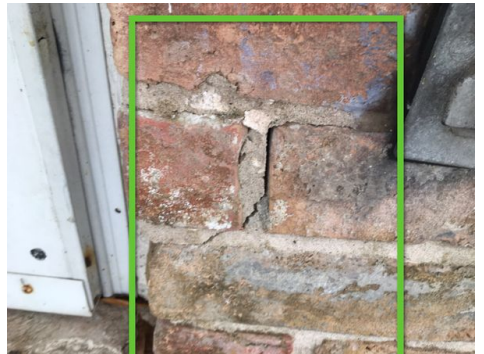
Differential Movement: Veneer - Cracks/Patches

Cracks and/or patches were observed in the exterior veneer at the time of the inspection.

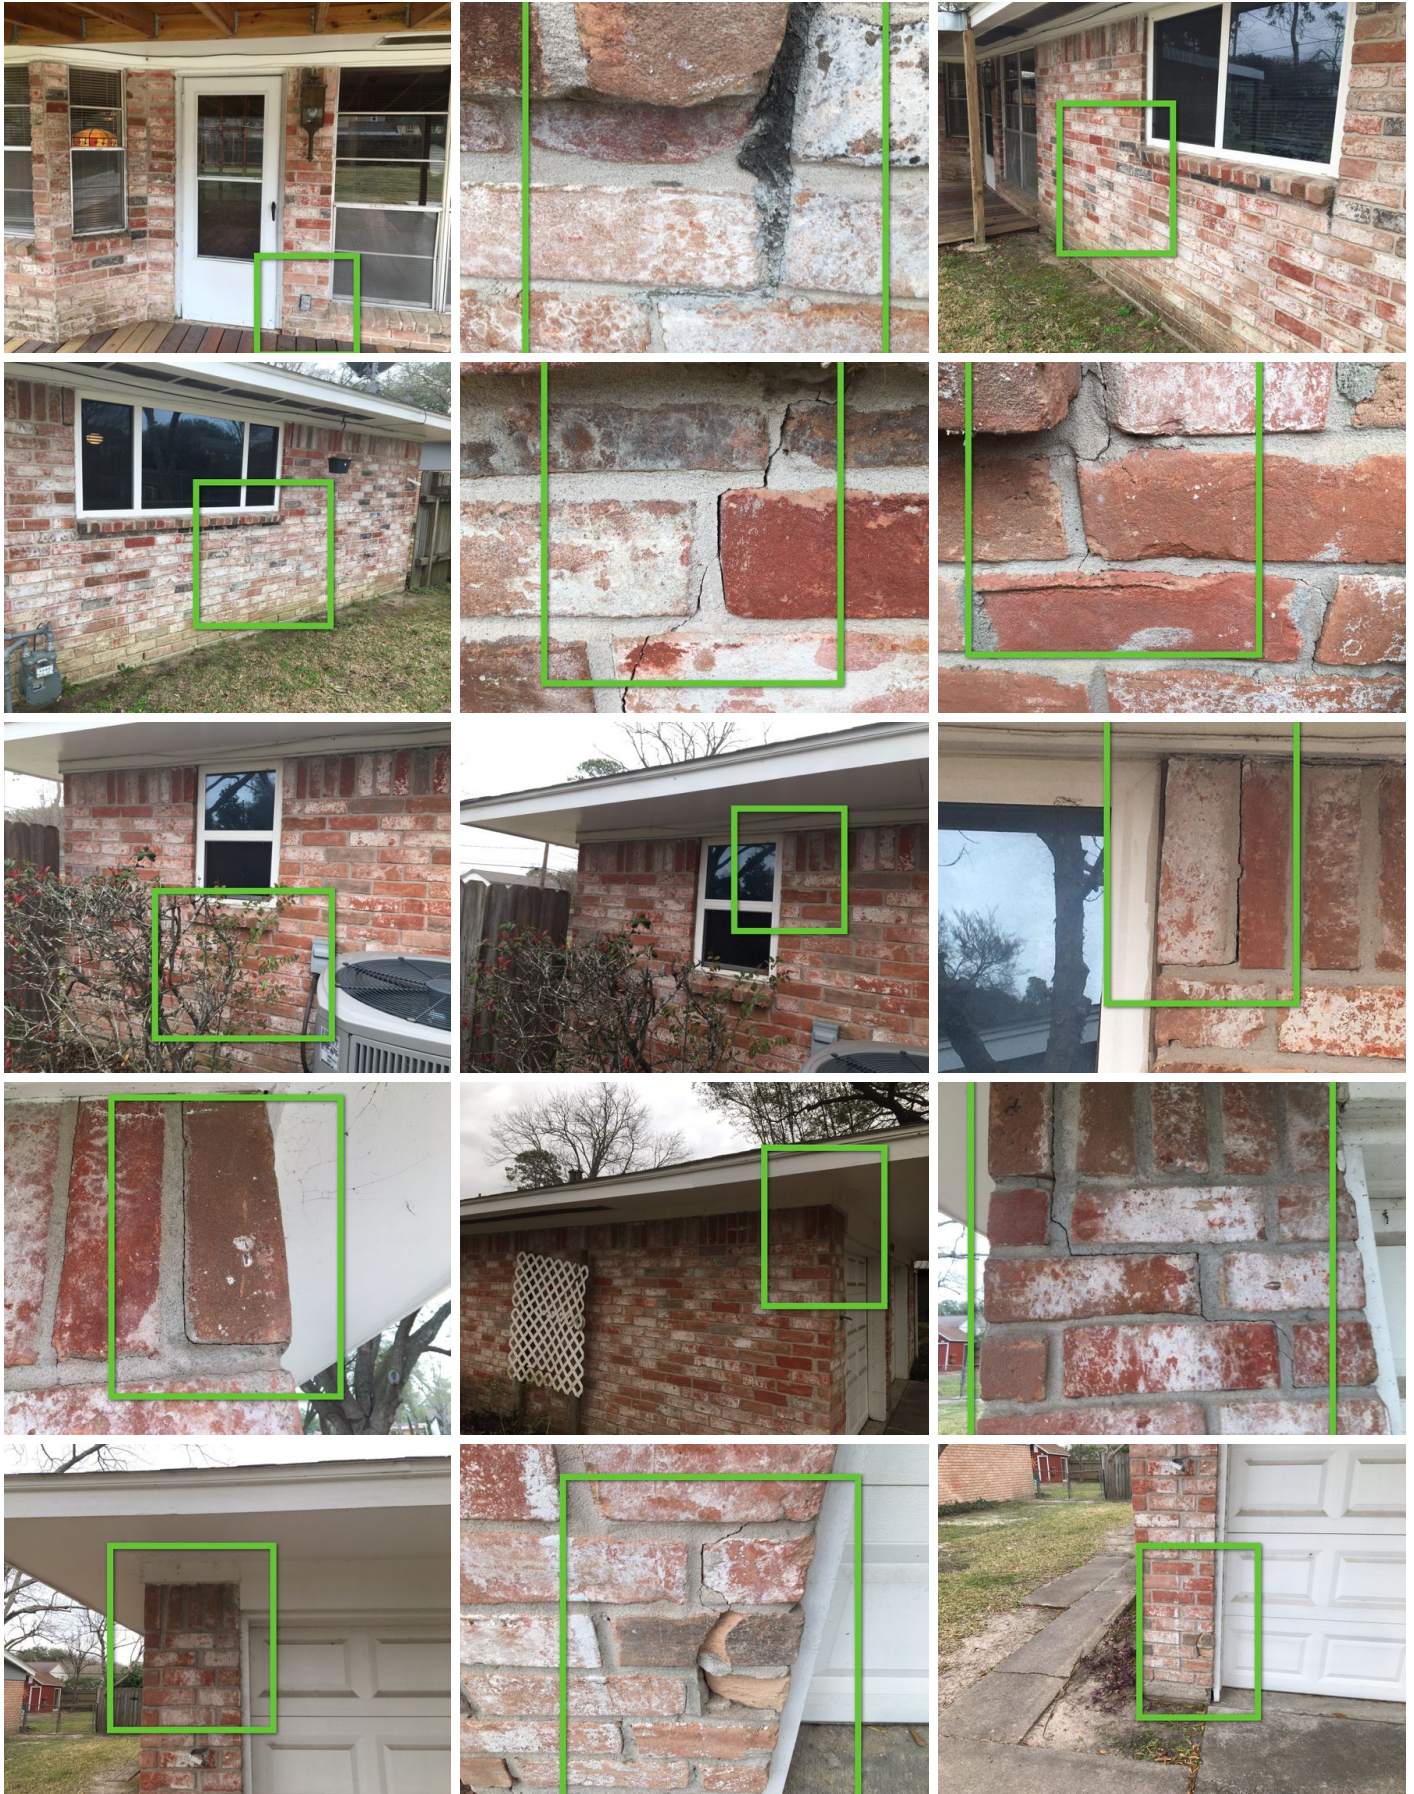
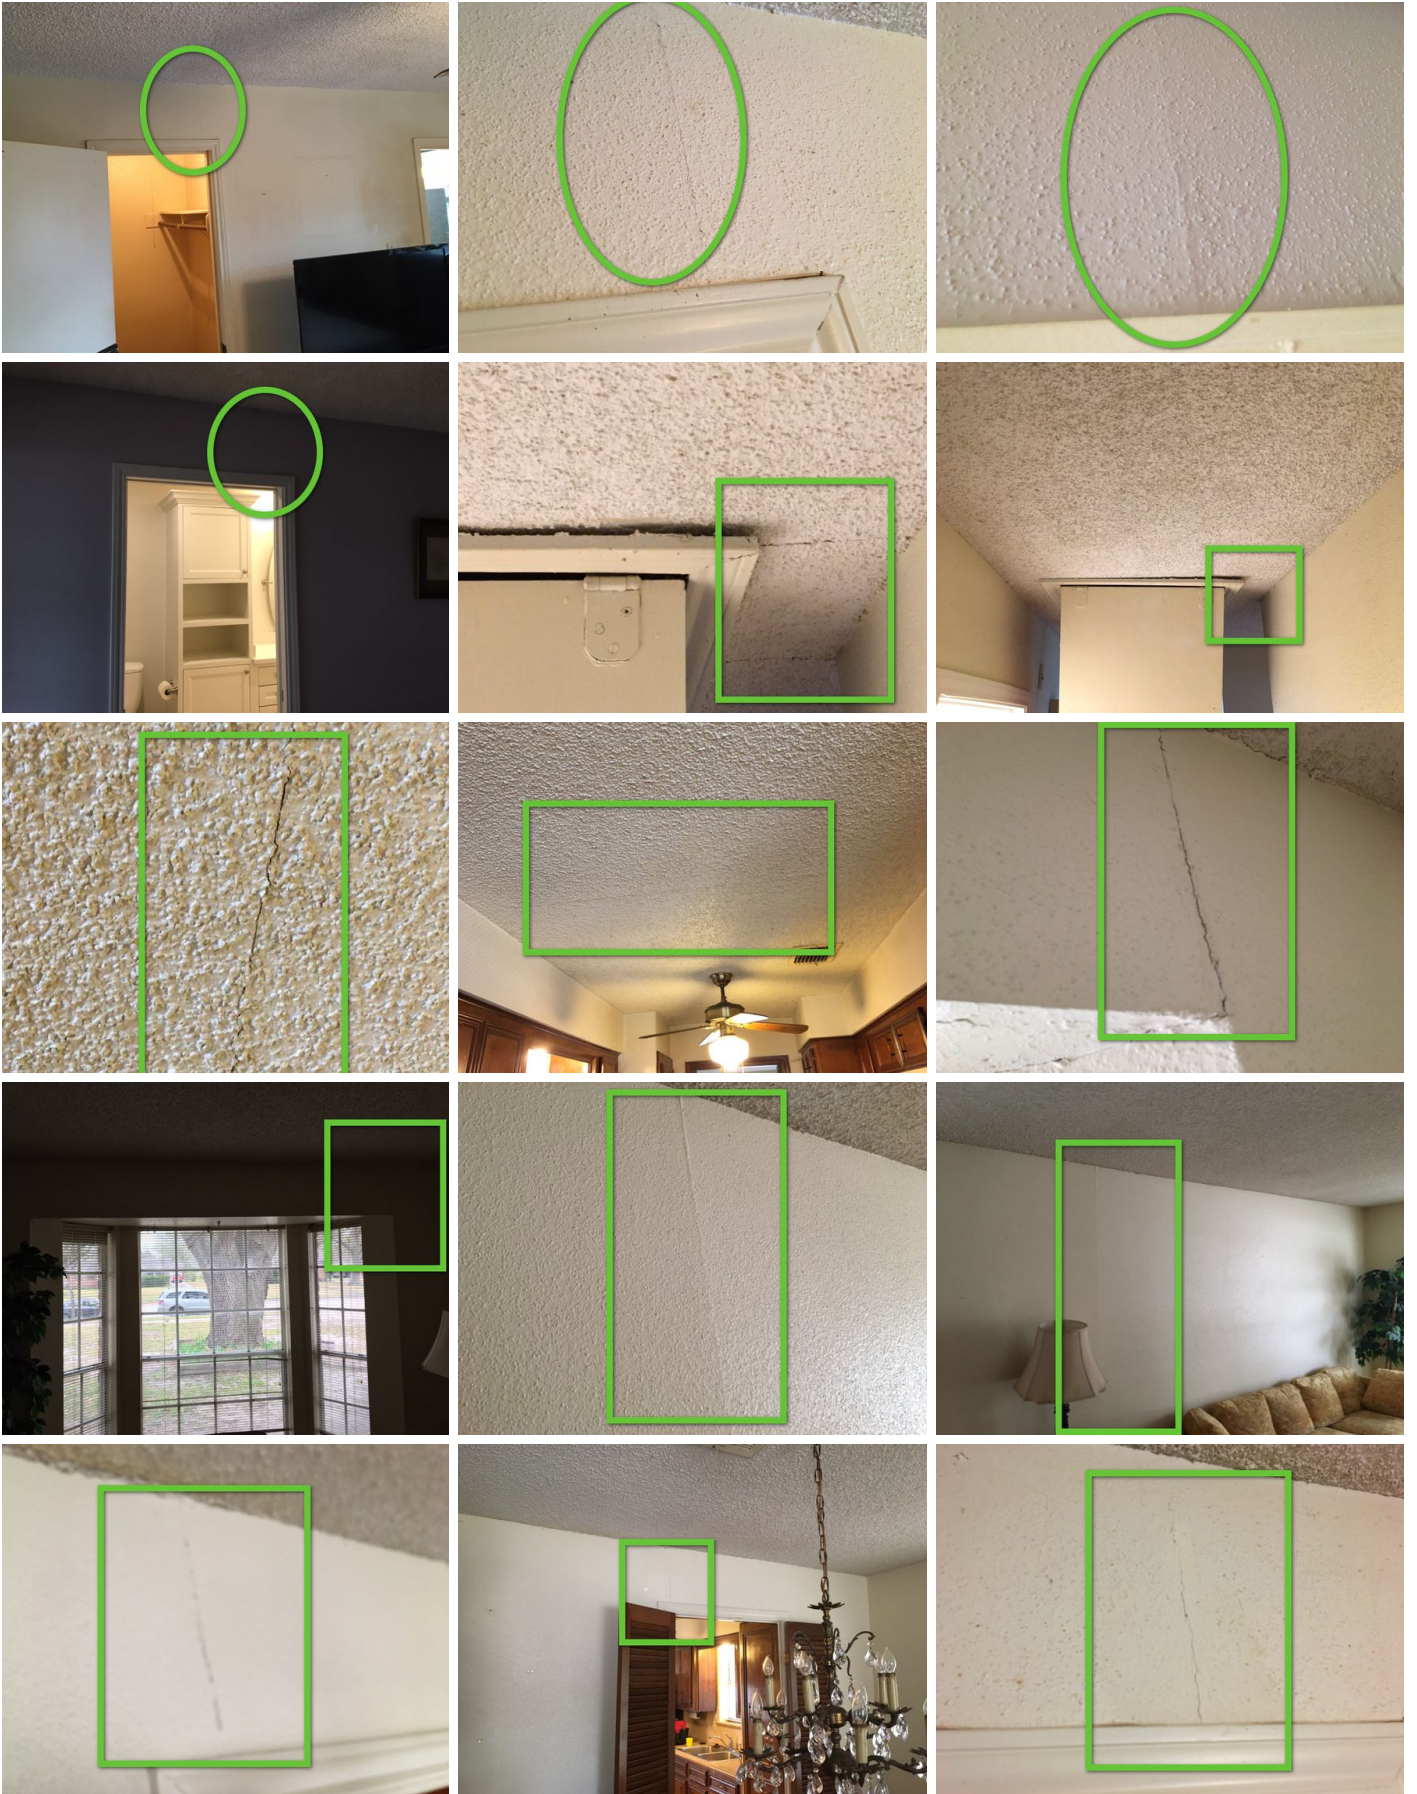
Differential Movement: Sheetrock Cracks/Patches/Compression ridges

Living room, west bedroom, hallway, south bedroom, north bedroom, master bedroom, west bedroom, and the garage.

Sheetrock cracks, patches, and/or compression ridges were observed in the house during the inspection, including at the above locations.

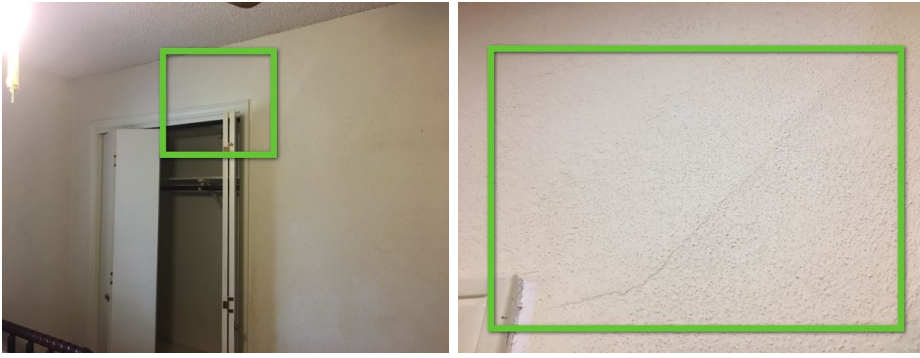
Differential Movement: Sheetrock - Nail pops

Master bedroom

Nail pops were observed in the surface of the sheetrock at the time of the inspection including at the above locations.

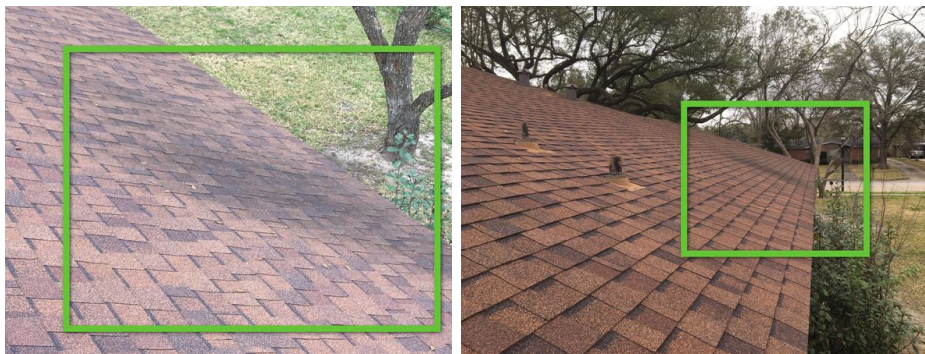
Wear and Deterioration: Composition - Some

Discolored

The composition roof surface was showing evidences of some deterioration of the roof surface as described above and shown below.

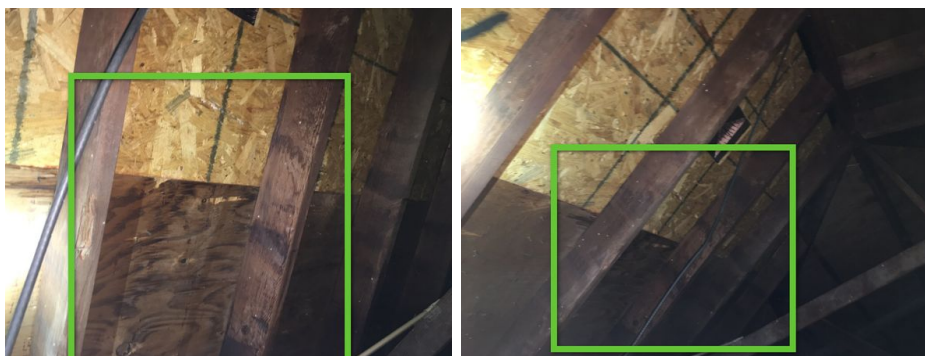
Roof Leaks: Attic stains appear to be from previous leaks

Near the rear static roof vent

Some stains were visible in the attic, but the stains appeared to be related to previous roof leaks. It is recommended that you check with the owner and/or a service company concerning the stains.

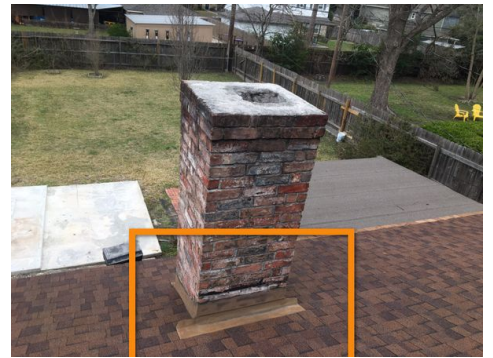
5.5.4 Roof Details

NO CRICKET

No cricket has been installed behind the chimney to divert the roof runoff around the chimney. Since the chimney is more than 30 inches wide, it is recommended that a cricket be installed.

Obtain Cost Estimate

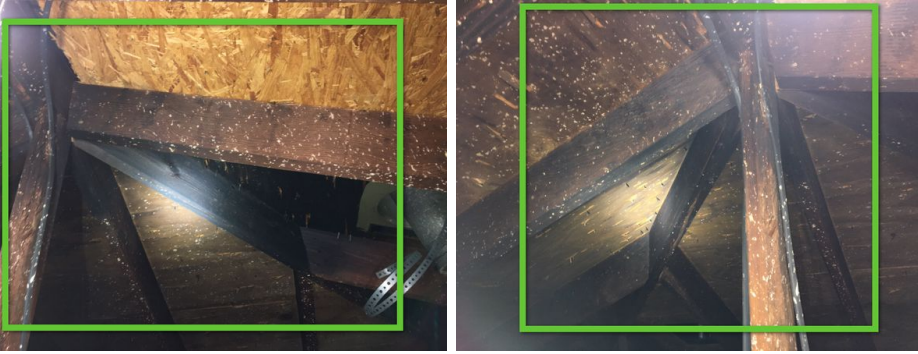
Miscellaneous Framing: Previous Heat Damage - Minor

The framing members and roof decking in the attic were darkened near the furnace flue pipe. This appeared to be related to a previous heat damage from the furnace flue that was not venting properly. The degree of the damage was minor, and consisted of slight scorching of the outer layer of the wood. The cross sectional area of the framing

members has not been significantly reduced and, therefore, their load carrying capability has not been significantly affected. No repairs or replacement of materials is recommended at this time.

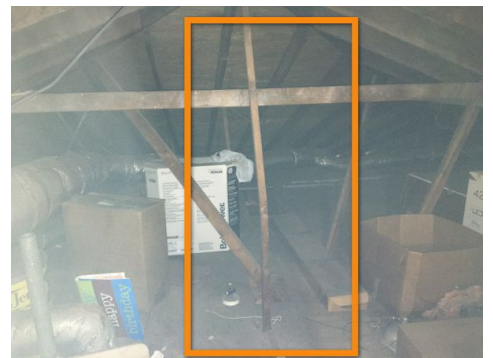
6.6.1 Vertical Braces

REPAIR - BUCKLING

One of the vertical bracers was buckled and needs to be reinforced or replaced.

Contact a qualified professional.

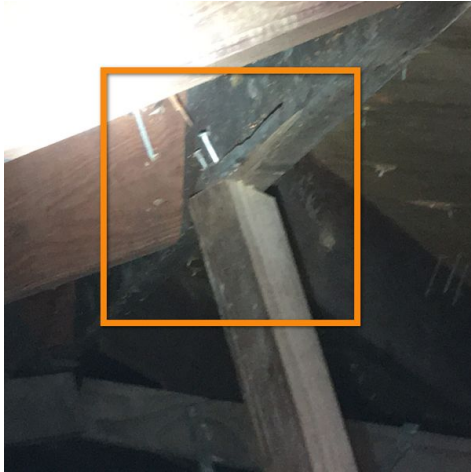
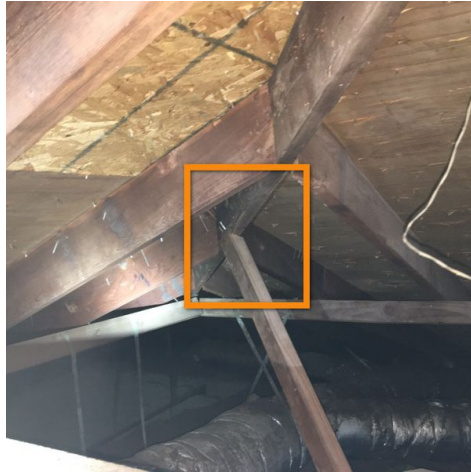
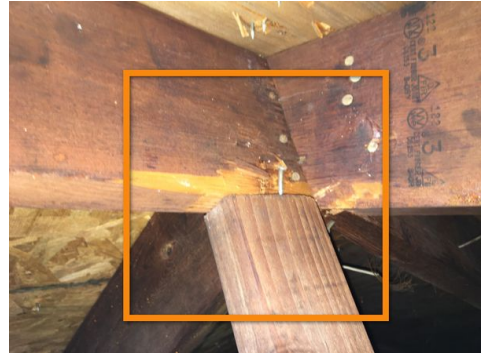
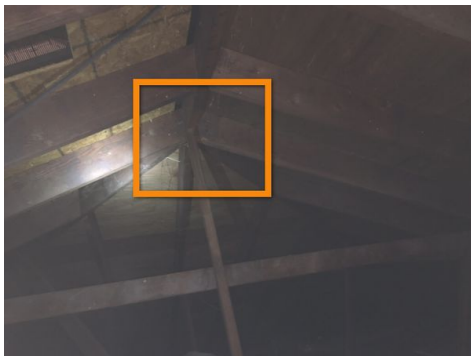
6.6.2 Vertical Braces

REPAIR - BRACE LOOSE

Two of the vertical braces were loose and need to be secured.

Contact a qualified professional.

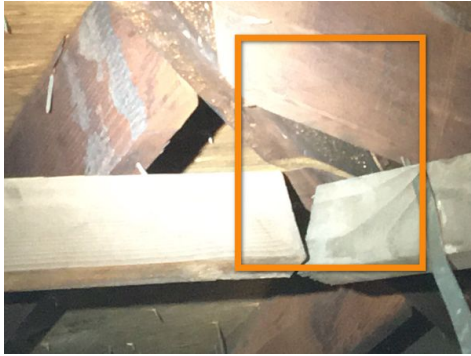
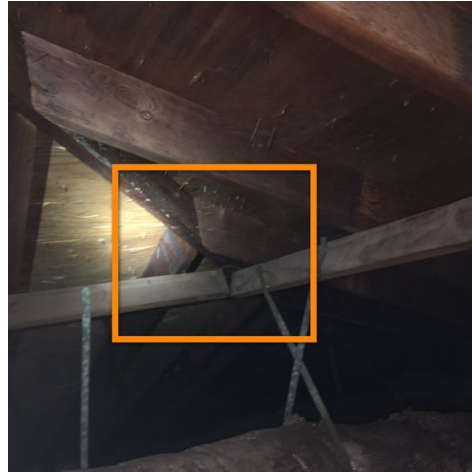
6.8.1 Hip Rafter

REPAIRS - SEPARATED

The hip rafter was spliced and the joints have separated. It is recommended that the joint be reinforced/ supported.

Contact a qualified professional.

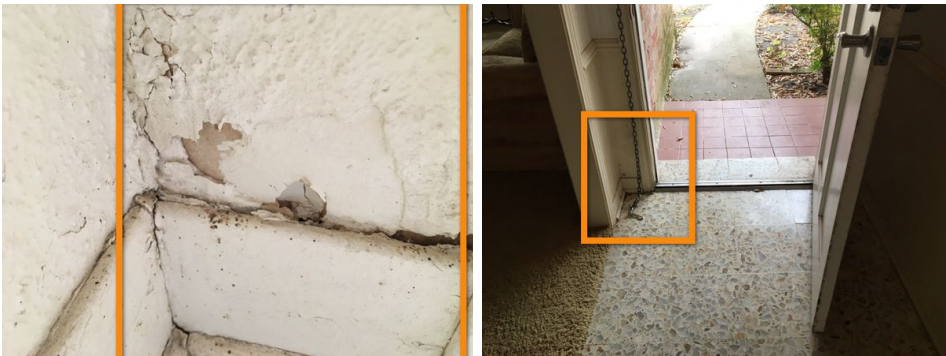
7.1.2 Water Penetration

Evidences of water penetration to the interior of the structure were observed, including water stains/water damaged materials. Further investigation is recommended with service companies to determine the source(s) of the water penetration along with any secondary damages, and also to provide a cost estimate for any needed repairs.

Water damage was observed on the wall near the front entry door. The source of the water penetration appeared to be related to a lack of proper sealant around the exterior joints of the door. Further investigation and repairs are recommended.

Contact a qualified professional.

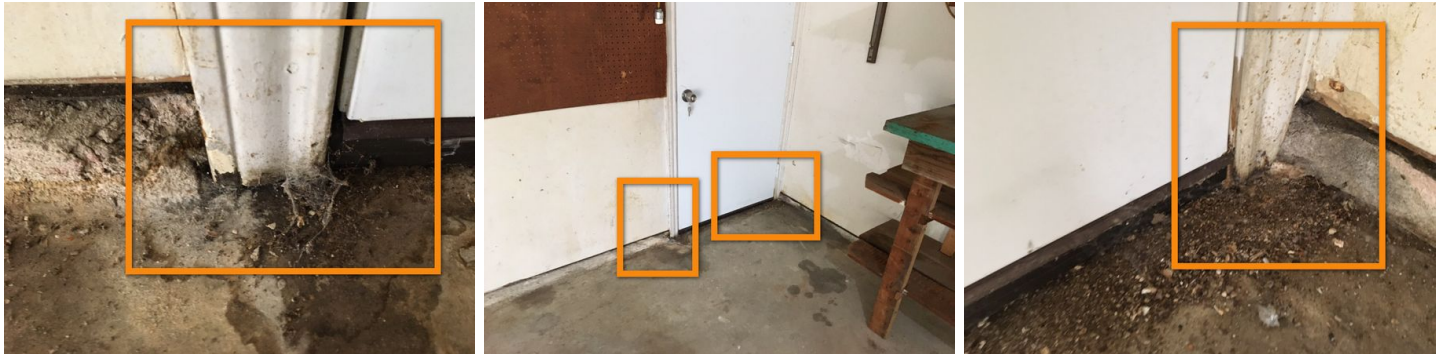
7.1.3 Water Penetration

Evidences of water penetration to the interior of the structure were observed, including water stains/water damaged materials. Further investigation is recommended with service companies to determine the source(s) of the water penetration along with any secondary damages, and also to provide a cost estimate for any needed repairs.

Water damage was observed on the wall and door trims near the front garage patio door. The source of the water penetration appeared to be related to a lack of proper sealant around the exterior joints of the door. Further investigation and repairs are recommended.

Contact a qualified professional.

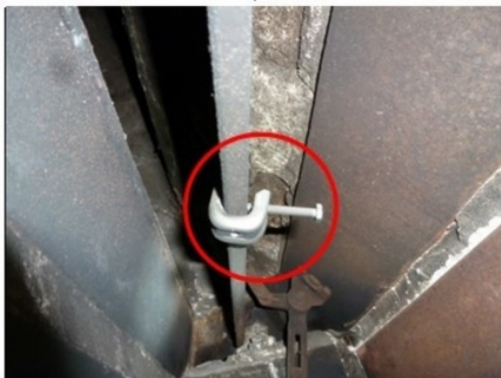
HEI file photo showing c-clamp in masonry fireplace

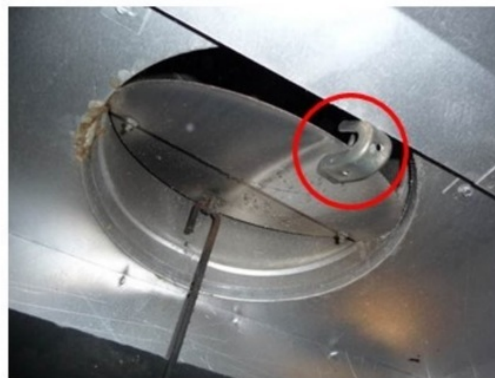
HEI file photo showing c-clamp in metal fireplace

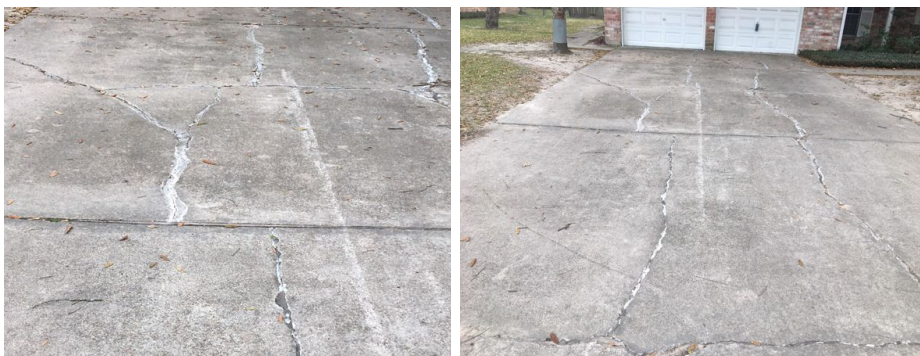
Flatwork Concrete/Patios/Walkways: Cracks Driveway

Cracks and some separations were observed in the driveway concrete. In our opinion, the driveway is still in serviceable condition at this time.
