PROPERTY INSPECTION REPORT

Prepared For: Lee Palmer
Concerning: 2903 Greens Ferry CT Report #2005012 Richmond, TX 77406
Inspection Date: 05/01/2020
By: Inspector Name: Kirk Long License Number: 6026 Date: May 1, 2020
Phone: 281-731-9089 E-Mail: klong@longstarservices.com

House is a vacant (staged) 2 story brick and wood trim home with a 2 car attached garage.,

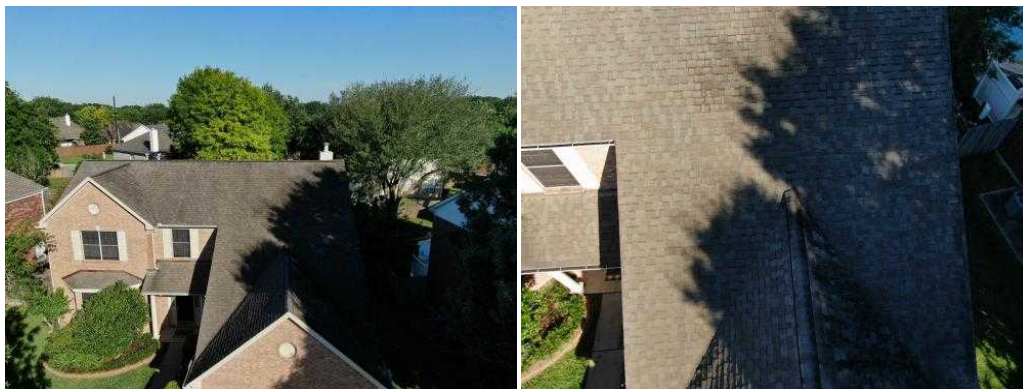
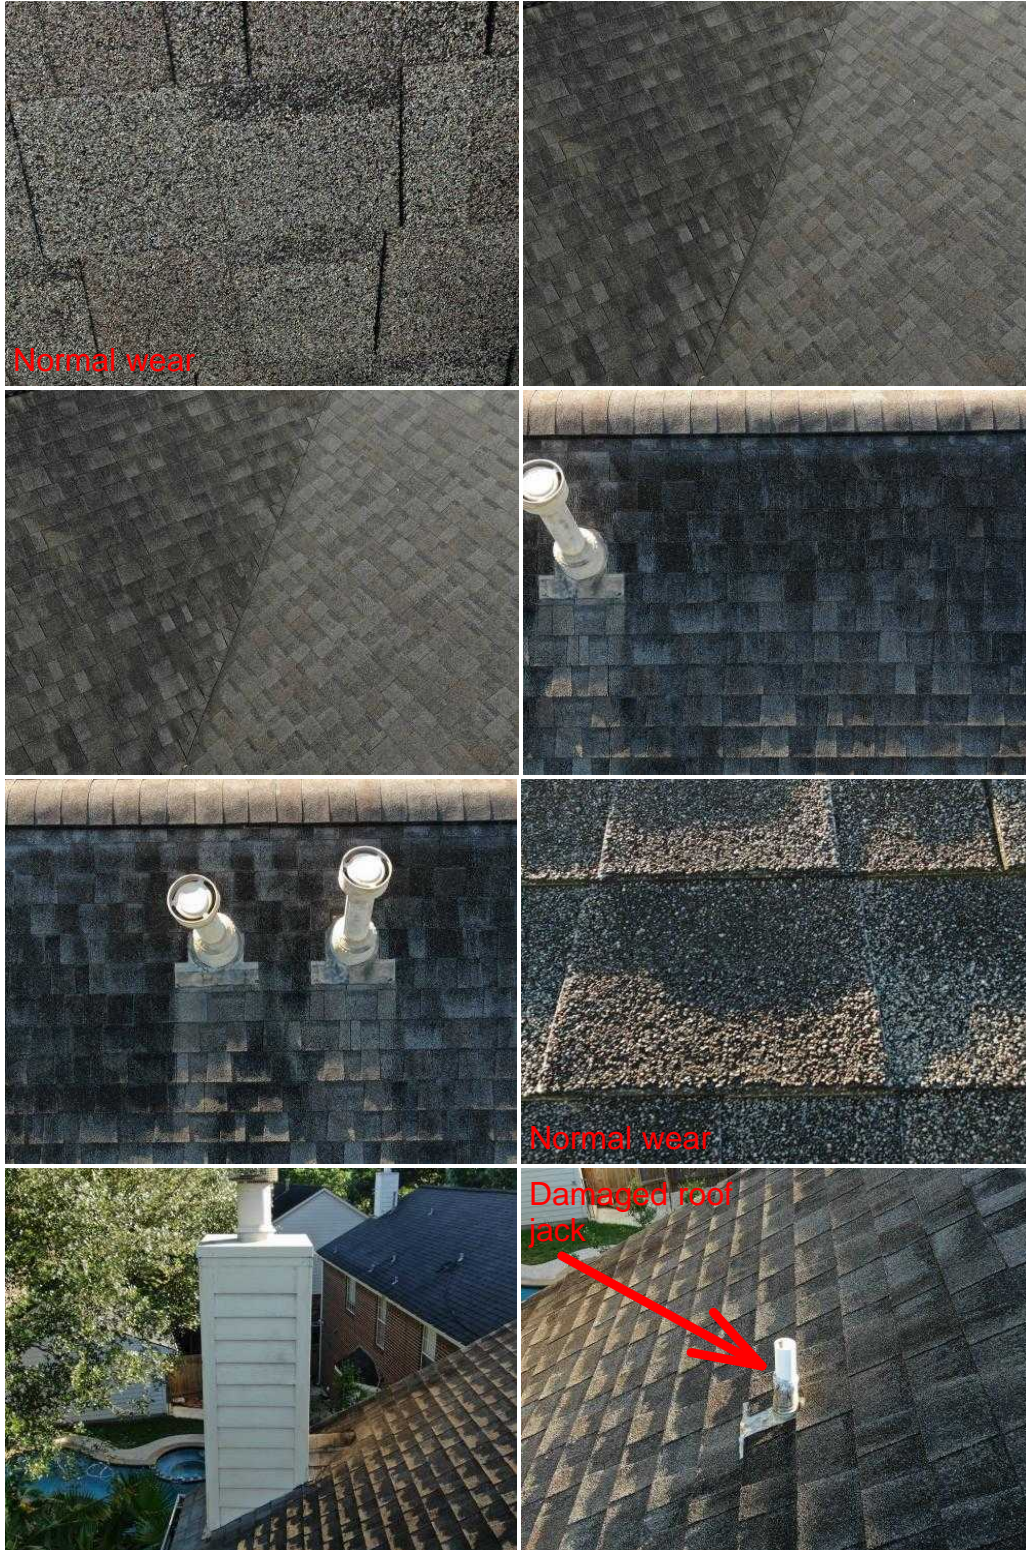
The lead roof jack vent pipe flashing was noted to be damaged around the top of the roof jack. These protective flashings prevent moisture from leaking around the vent pipe that is penetrating the roof. Often times squirrels or other animals chew on these resulting in this type of damage. This damage should be corrected.

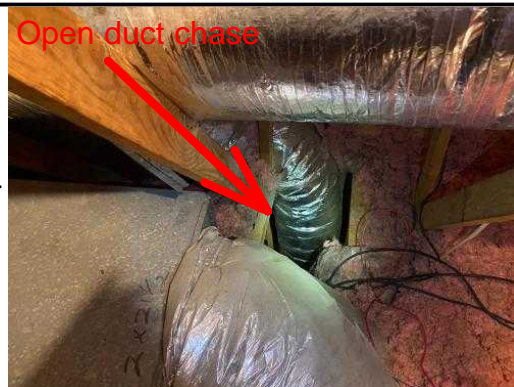
Proper fireblocking is needed to form an effective fire barrier between the top floor and the attic per IRC Section R602.8. An open air duct chase was noted in an area in the attic which is not sealed with proper firestopping material resulting in exposed studs and structural members between the attic and the second floor. Fire-blocking provides a potential 30 minute fire stop to prevent the spread of fire through open spaces such as this. Fire stopping should be installed in the attic over this opening using appropriate material such as sheetrock, metal, or 2" thick lumber. In addition the chase is not insulated resulting in thermal loss through the interior sheetrock walls which are exposed to the high temperature extremes of the attic. Sealing this opening and covering the seal with insulation will correct this condition.

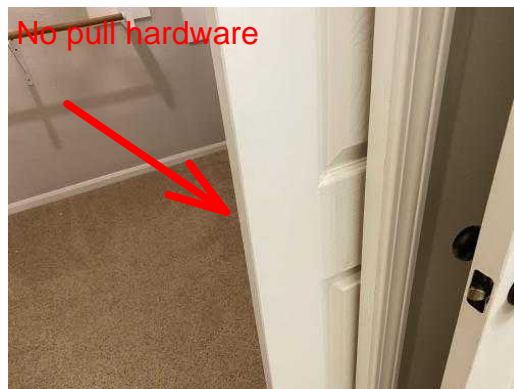
The master closet pocket door does not have door pull hardware.

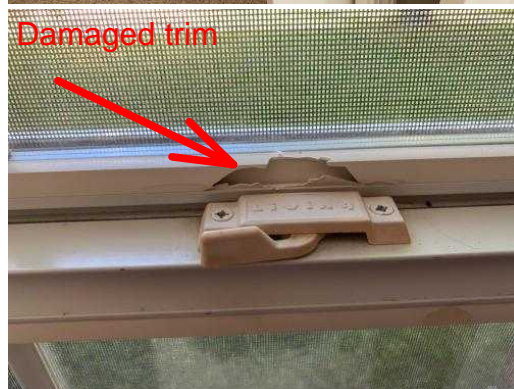
Vinyl window trim damage was noted on several windows at the latches. This has resulted from the latches hitting the trim. This does not have an adverse affect on the window operation.

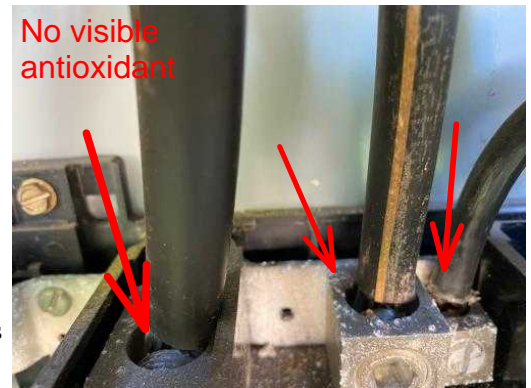
The main aluminum electrical service connections in the breaker panel are not covered with an antioxidant that protects the wiring connection from corrosion.

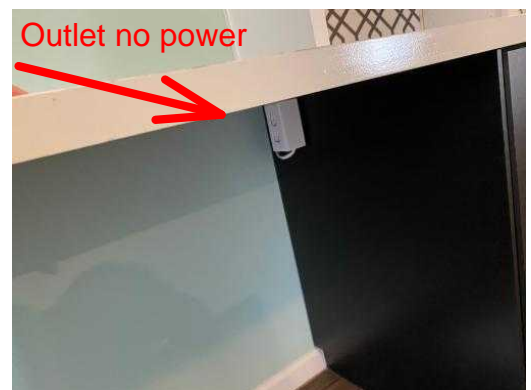
The outlets below the dining room shelf unit are inoperable.

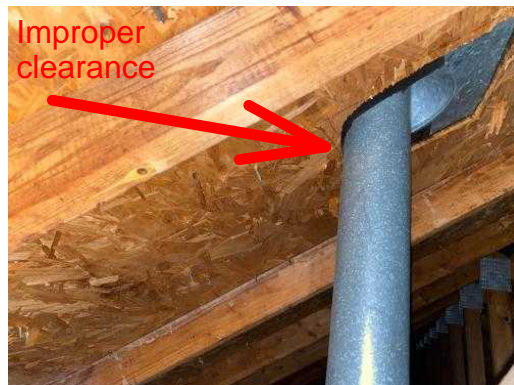
Improper clearance was observed between the water heater exhaust vent piping and the wood roof decking. Current code required a minimum 1" clearance between the piping and any combustible material.

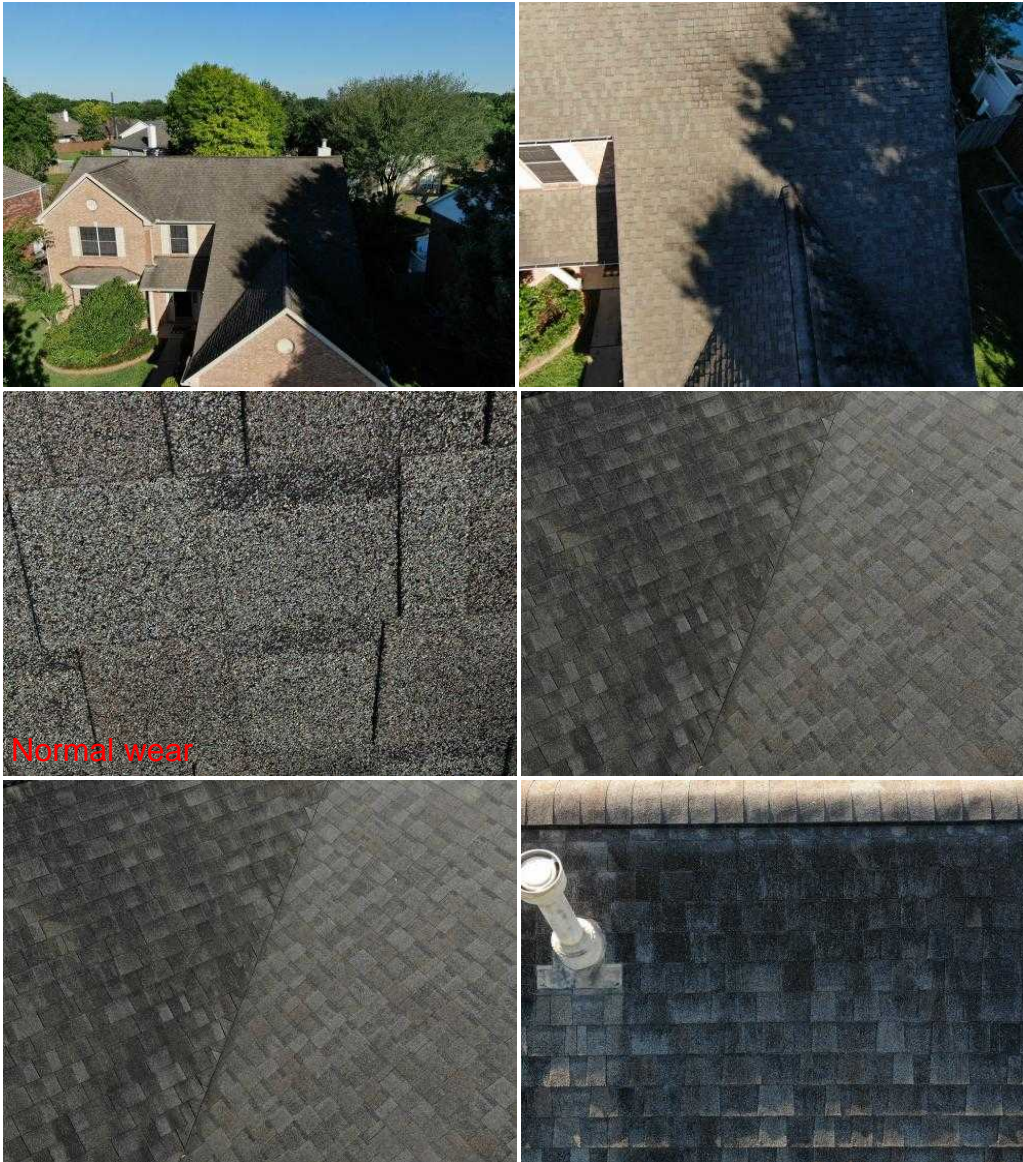
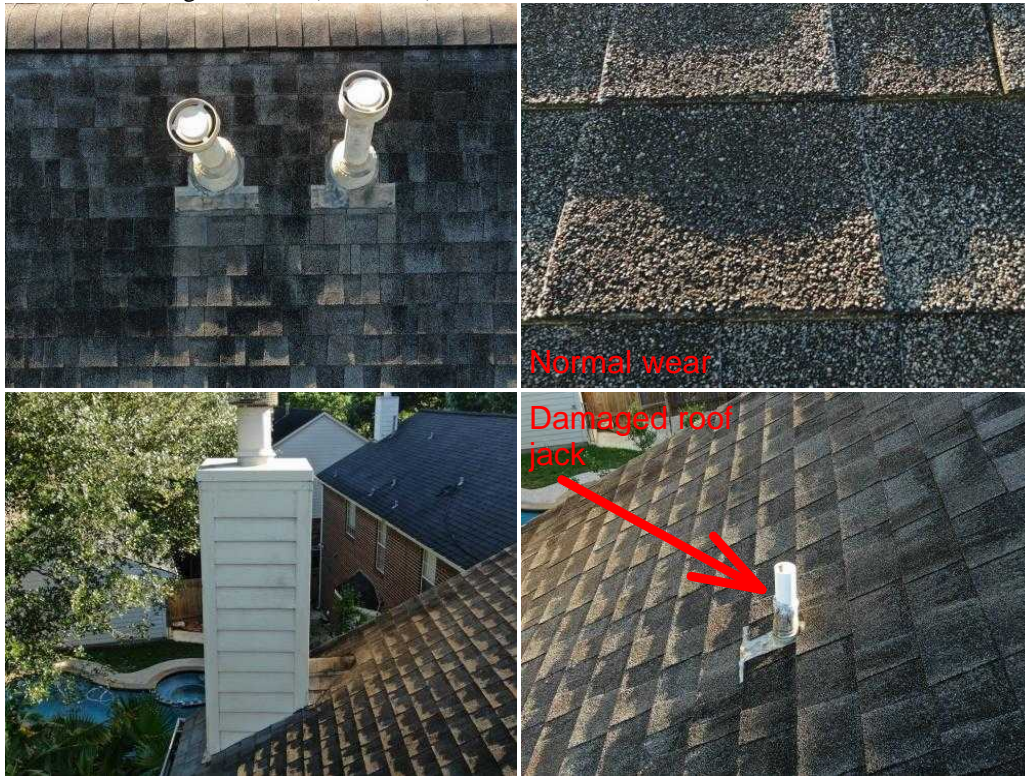
The lead roof jack vent pipe flashing was noted to be damaged around the top of the roof jack. These protective flashings prevent moisture from leaking around the vent pipe that is penetrating the roof. Often times squirrels or other animals chew on these resulting in this type of damage. This damage should be corrected.

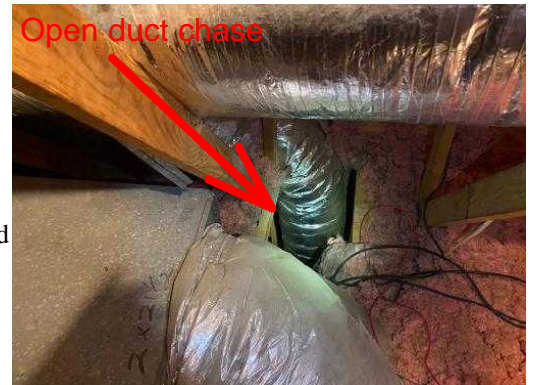
Proper fireblocking is needed to form an effective fire barrier between the top floor and the attic per IRC Section R602.8. An open air duct chase was noted in an area in the attic which is not sealed with proper firestopping material resulting in exposed studs and structural members between the attic and the second floor. Fire-blocking provides a potential 30 minute fire stop to prevent the spread of fire through open spaces such as this. Fire stopping should be installed in the attic over this opening using appropriate material such as sheetrock, metal, or 2" thick lumber. In addition the chase is not insulated resulting in thermal loss through the interior sheetrock walls which are exposed to the high temperature extremes of the attic. Sealing this opening and covering the seal with insulation will correct this condition.

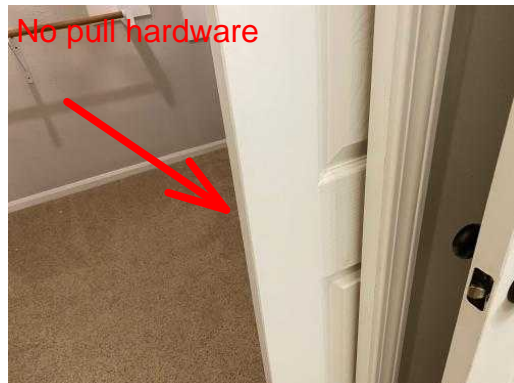
The master closet pocket door does not have door pull hardware.

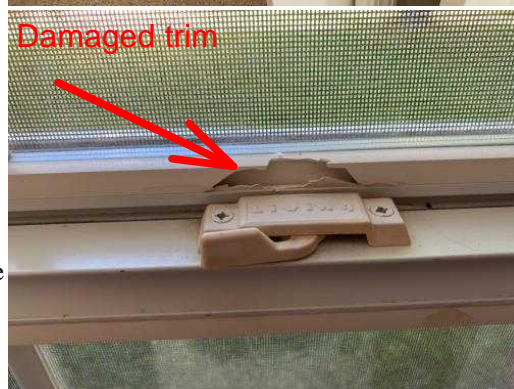
Vinyl window trim damage was noted on several windows at the latches. This has resulted from the latches hitting the trim. This does not have an adverse affect on the window operation.

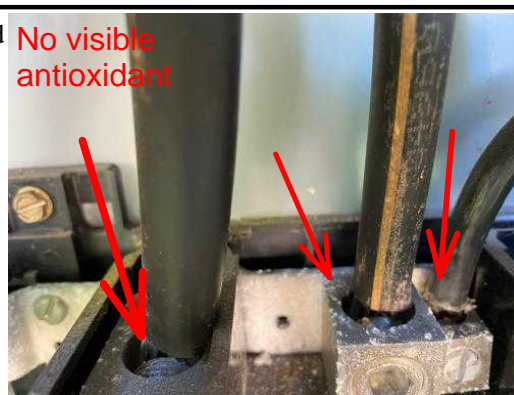
The main aluminum electrical service connections in the breaker panel are not covered with an antioxidant that protects the wiring connection from corrosion.

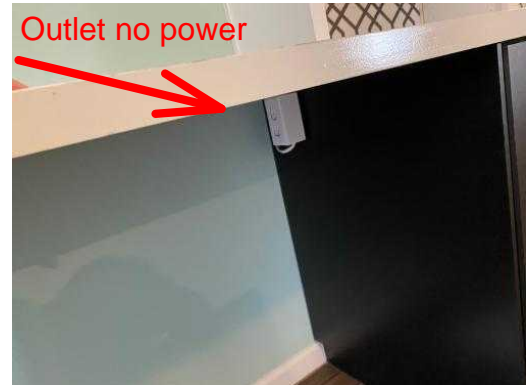
The outlets below the dining room shelf unit are inoperable.

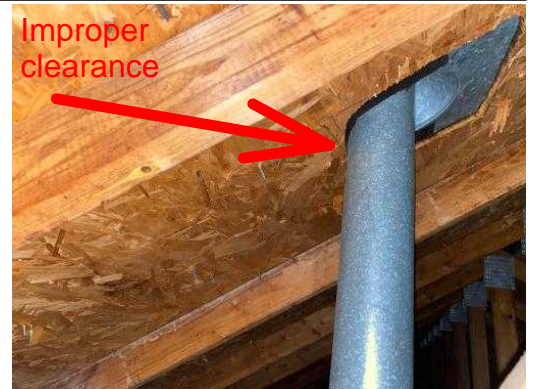
Improper clearance was observed between the water heater exhaust vent piping and the wood roof decking. Current code required a minimum 1" clearance between the piping and any combustible material.
