INSPECTION REPORT

Property Address: 2903 Greens Ferry Court, Richmond, TX 77406
Inspection Date: 03/05/2020

Inspection Number: 20200305-1
Inspection Type: REI-7-5

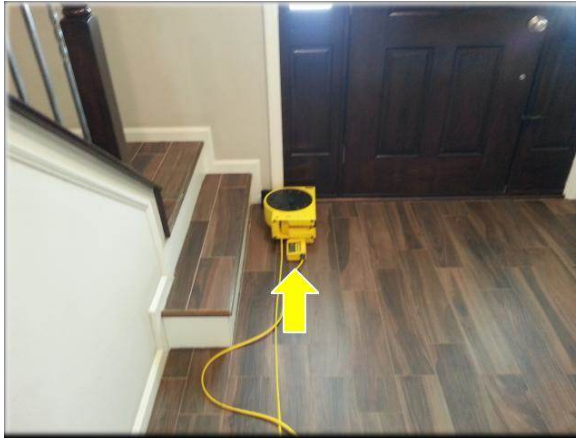
Zero reference point shown below.

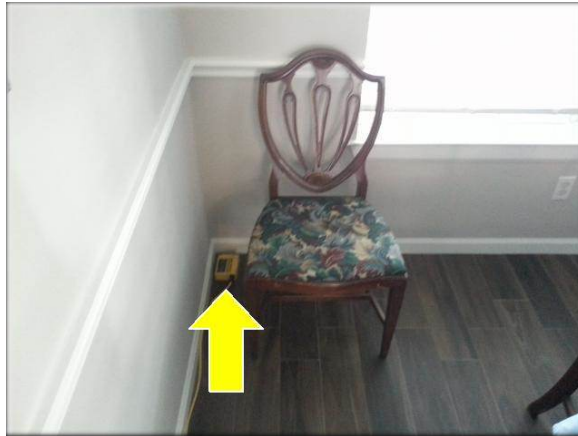
The Back and Right of the home and living room is 0.2 inches.

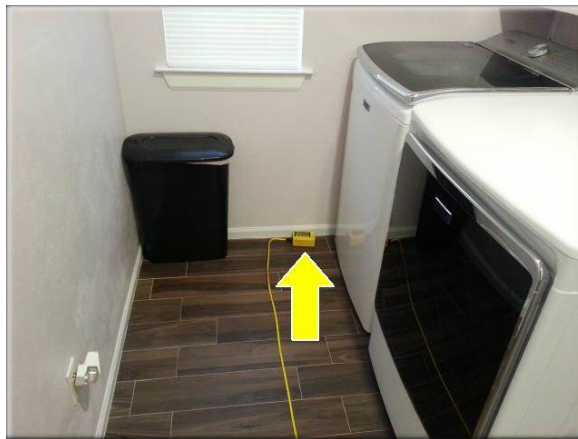
The Right and middle of the laundry room is -0.1 inches.

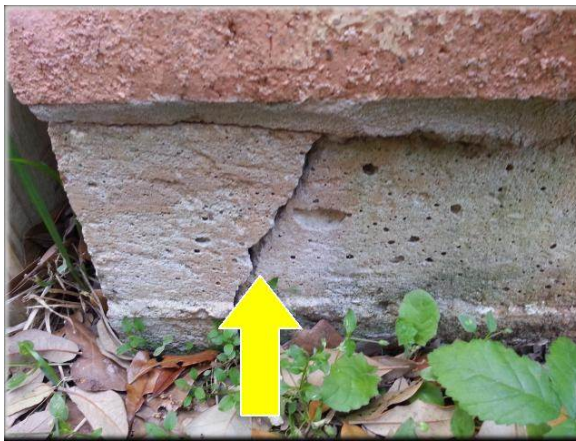
Foundation "corner pops" are common (a hairline crack at the corner of the slab) were noted, which is commonly the result of differential movement between the masonry walls/foundation and radially transmitted forces from the home structure. (The corners are the weakest part) This condition did not appear to adversely affect the structure at this time. The corners should be examined periodically and if the crack worsens or the corner breaks off, then the brick veneer may lack proper support and repair would be needed. See example photo below.

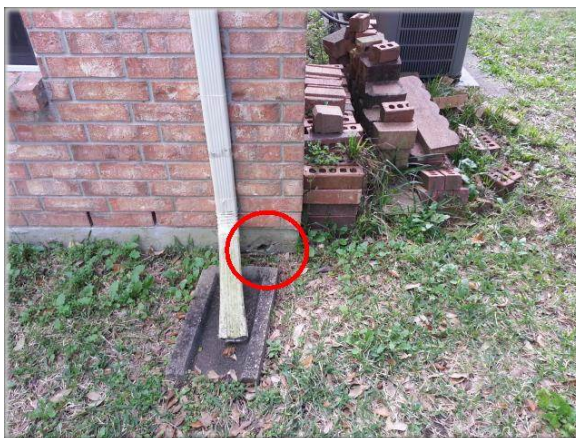
Open tendon cable tensioning ports were noted at one or more locations around the exterior foundation grade beam. The minimum grout cover to the tendon tail from the finished concrete slab edge shall be approximately 1 inch, as shown in the figure below. It is also permissible to reduce the grout cover to the tendon tail to 1/8 inch provided that the tendon tail is covered with a protective cap, that results in a minimum cover of 1 inch. We recommend proper cleaning and sealing of any open tendon ports to protect the cable ends from corrosion, which may allow moisture to wick into the cable causing it to rust and possibly losing its connection from the support clamp.

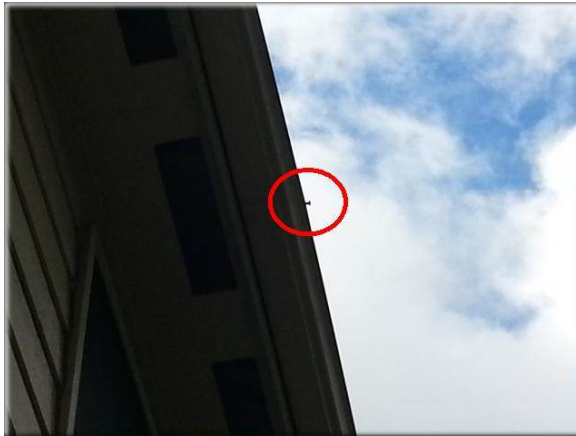
The gutters nails are coming loose/pulling out in several locations; recommend corrections to prevent further damage to the fascia trim.

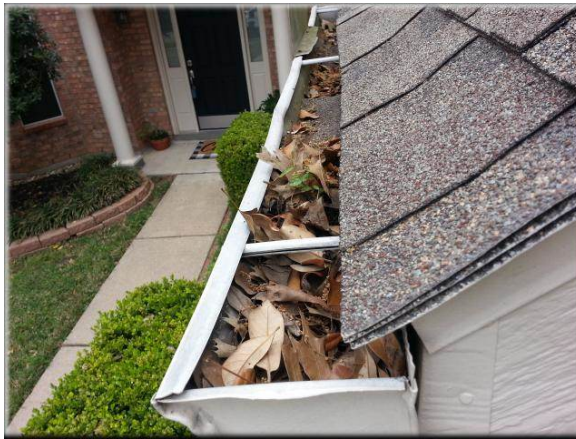
Recommend leaves and debris be cleaned from gutters and downspouts as necessary for more effective drainage of roof run-off water.

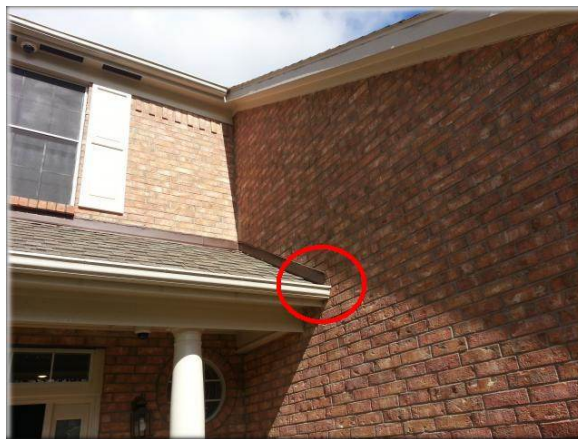
Kick-out flashing was not installed where the vertical wall and roof plane meet on the home. Flashing is important for shedding water; recommend review by qualified roofing contractor for corrections as needed to prevent moisture intrusion behind the wall.

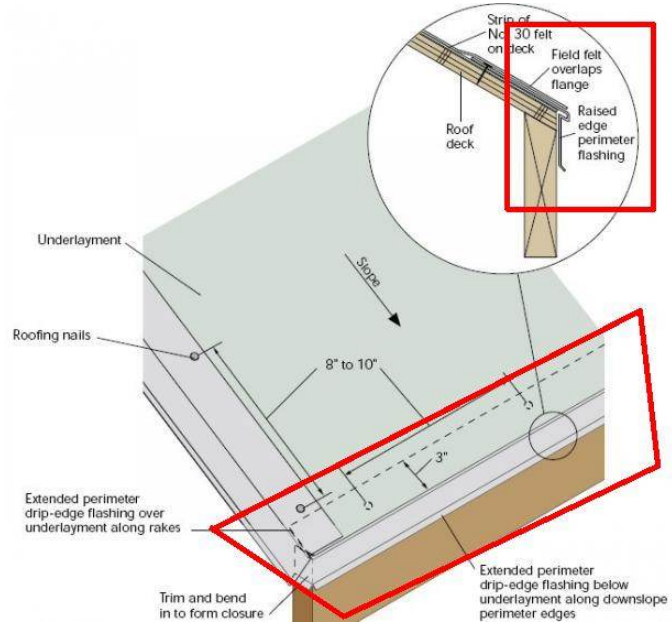
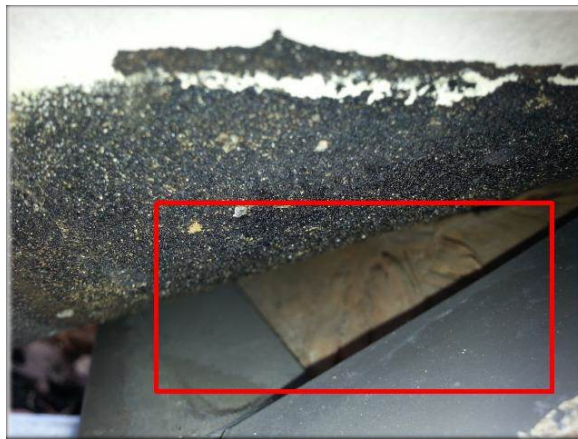
The roofing paper underlay was either short or installed under the drip edge around the eave of home. The roofing paper underlay should be on top of drip edge at the eave and under rake edge to avoid moisture penetration; recommend review by a qualified roofing contractor. In some areas, felt paper did not appear present.

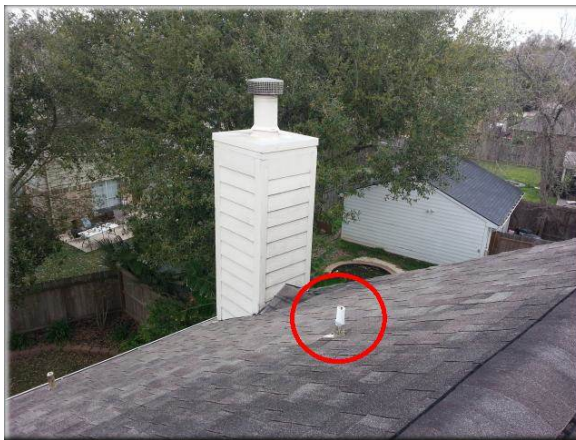
The lead roof jacks covering the waste stacks were not folded over or are deteriorated around the vent pipe openings, which will allow water to run down the outside of the pipe into the attic; recommend corrections to prevent moisture intrusion to the attic.

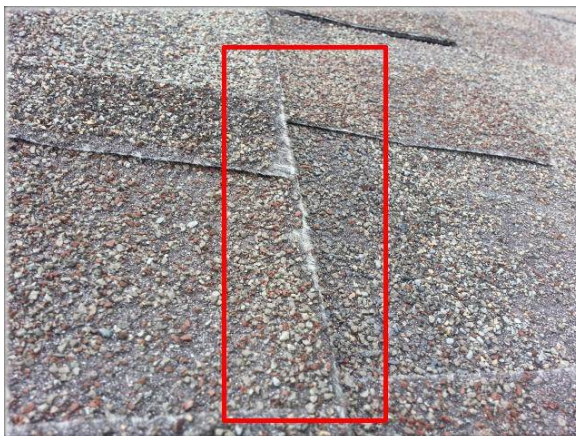
Aggregate was missing and the underlying fiber material is exposed at multiple locations on the roof shingles. The aggregate helps protect the underlying asphalt material from the sun's UV rays. Without it, the shingle will crack and wear much faster. Recommend roof maintenance to preserve remaining roof life.

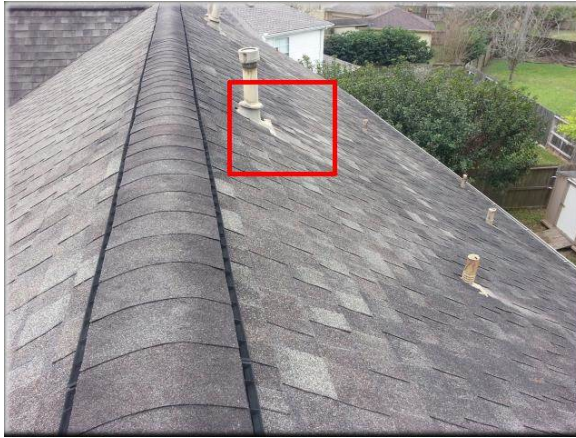
Some of the flashing at the Back and middle of the roof is lifted and should be resealed/re-secured to ensure leak free conditions; recommend review for correction by a qualified roofing contractor.

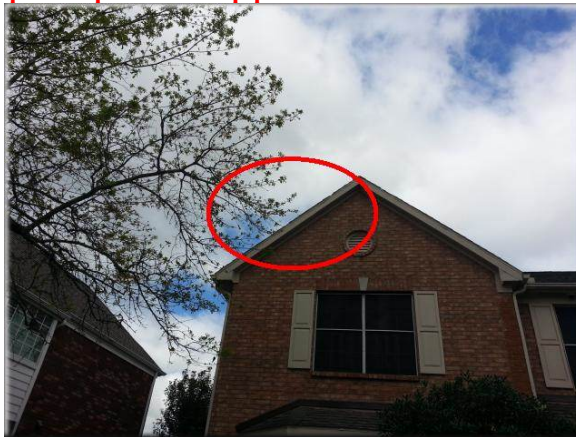
The edges of the roof shingles are damaged at several locations at the front left of the home from possible prior tree rubbing. Roof repair required to help prevent leaks.

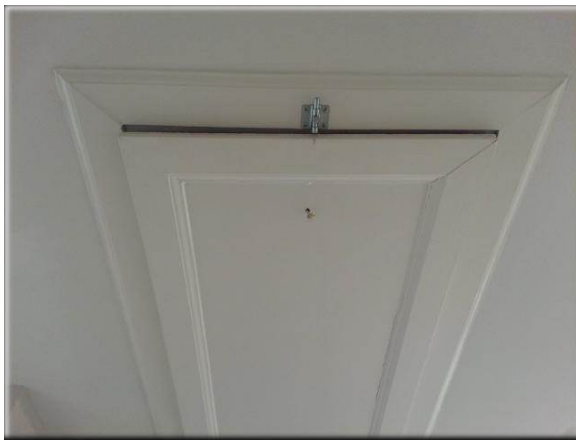
The attic stair assembly does not close flush with the ceiling; recommend adjustment/repair to prevent conditioned air in the home escaping into the attic.

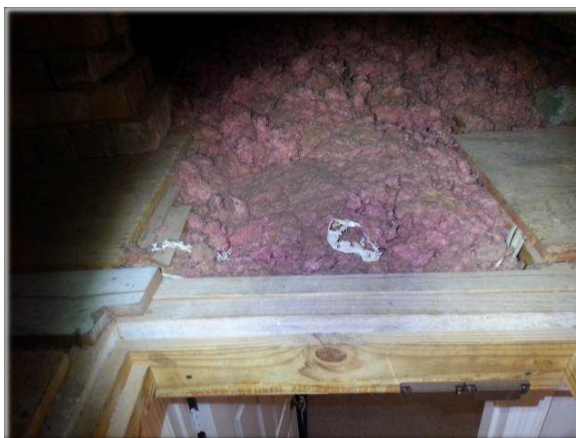
The insulation provided in the attic has poor coverage at various small patches from disturbances; recommend review by a qualified contractor to level the insulation.

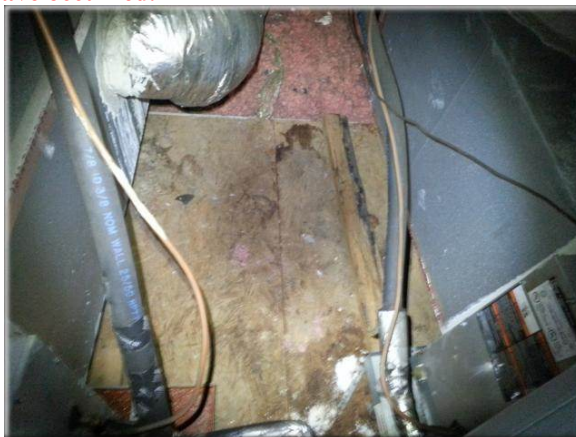
The attic flooring does not comply with accepted industry specifications for floor sheathing. Accessing the attic could result in injury. The attic should have an unobstructed passageway from the access to the service side of all equipment. The flooring should be solid (minimum 3/4 floor decking), continuous, and not less than 24 inches wide. On the control side of the equipment and on other sides where access is necessary for servicing, a level work platform extending a minimum of 30 inches from the edge of equipment with a 36-inch high clear working space should be provided. This should be repaired for safety so a worker or anyone else does not fall through the ceiling while working on equipment.

Dry staining present on the attic flooring suggests prior leaks. Recommend consulting the seller to determine if known leaks have occurred.

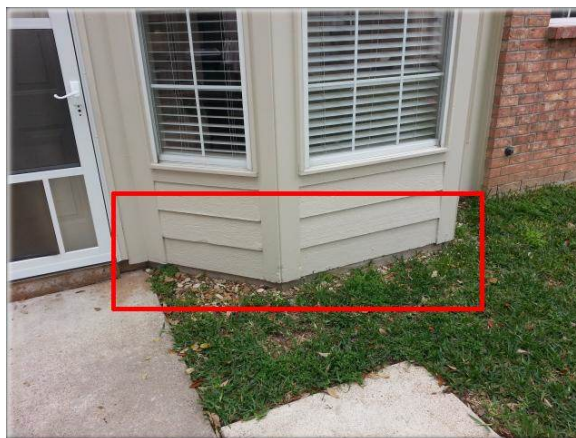
The siding is weathered. Location - Back and middle of the home; recommend repairs/replacement as needed to help prevent moisture intrusion.

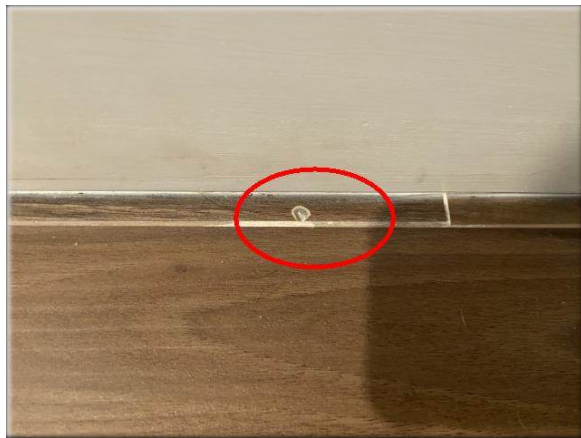
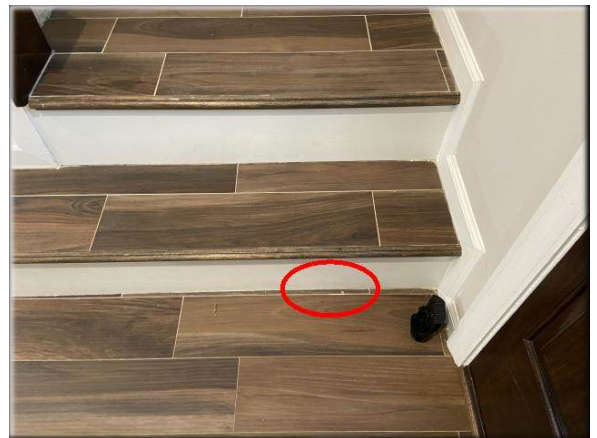
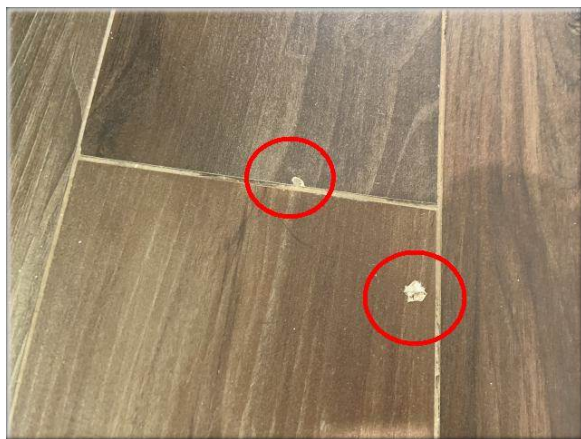
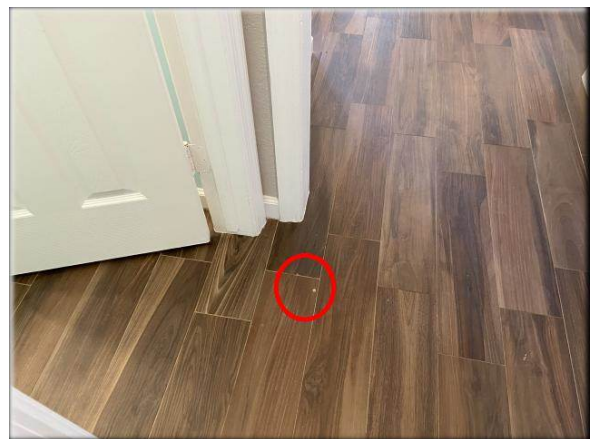
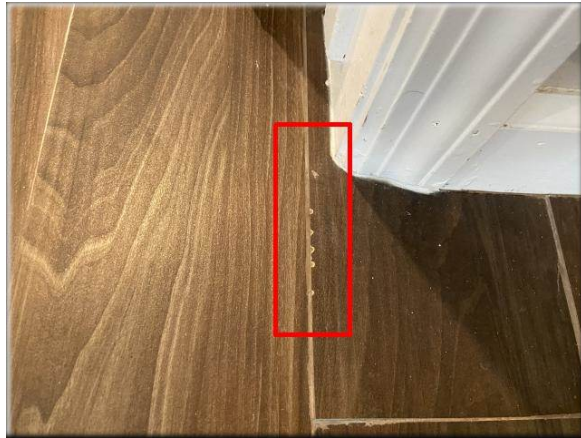
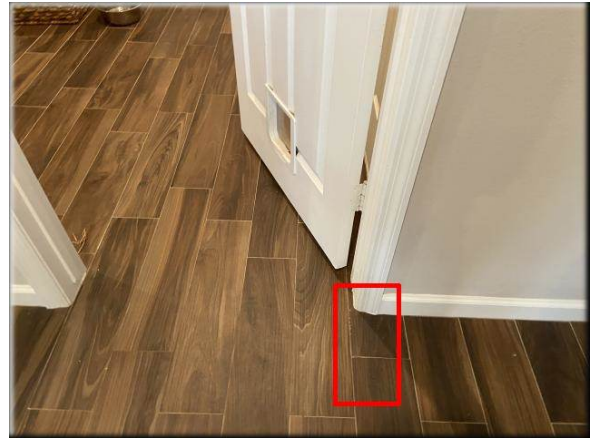
Observed cracked or damaged tiles on the floor in the first floor of the home; recommend repairs as needed.

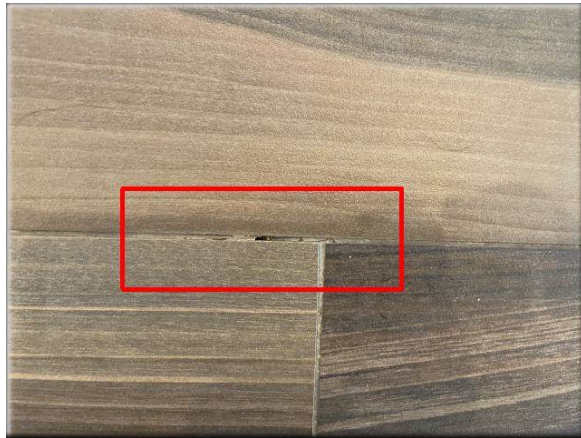
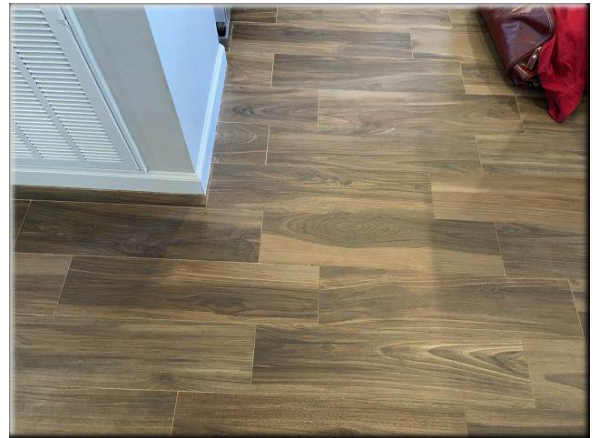
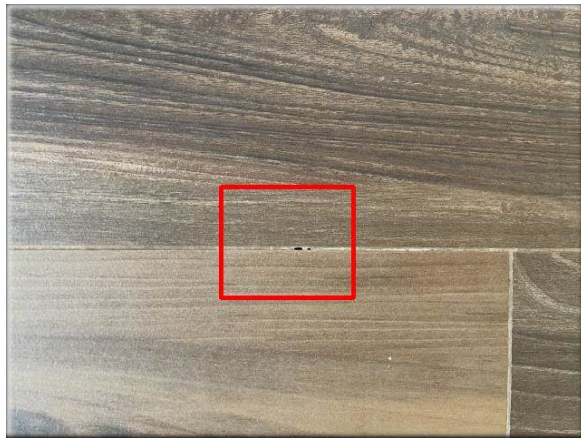
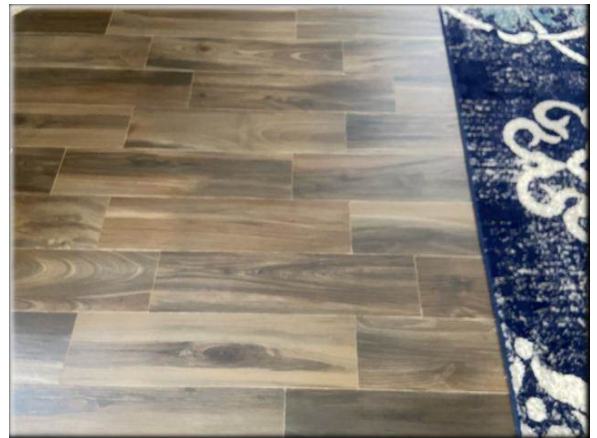
Grout is missing between the floor tile at various locations in the first floor; recommend repairs by a qualified contractor.(minor)

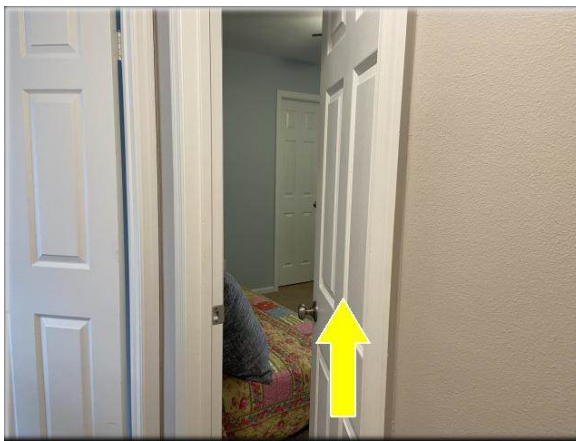
The door does not latch properly in the upstairs back left bedroom; recommend adjusting the strike plate for proper operation at minimum.

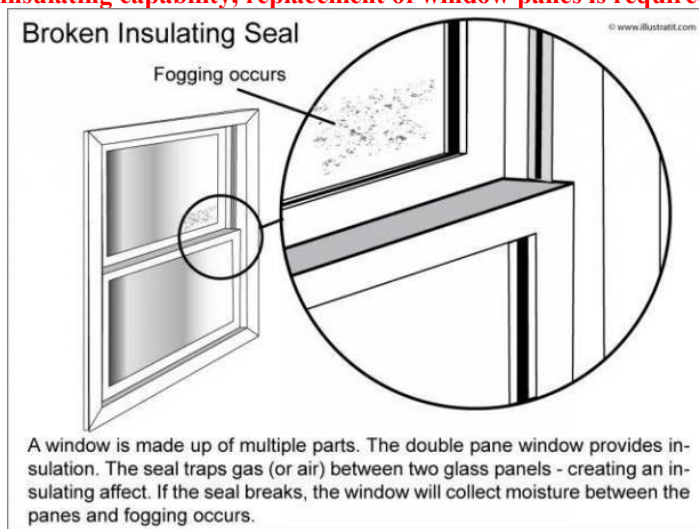
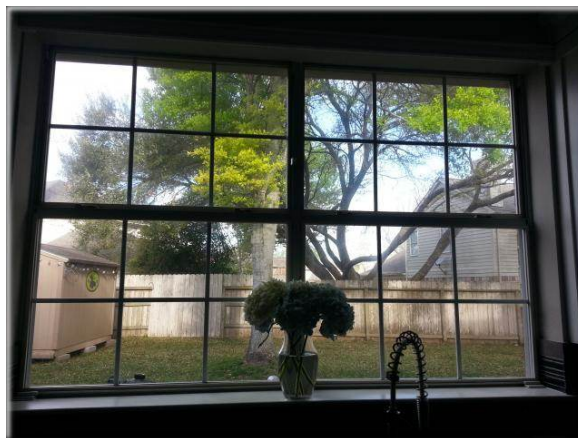
Discoloration was noted between the window panes for some of the windows in the kitchen. This indicates a broken seal which will reduce visibility and the insulating capability of this window. To restore visibility and regain the insulating capability, replacement of window panes is required.

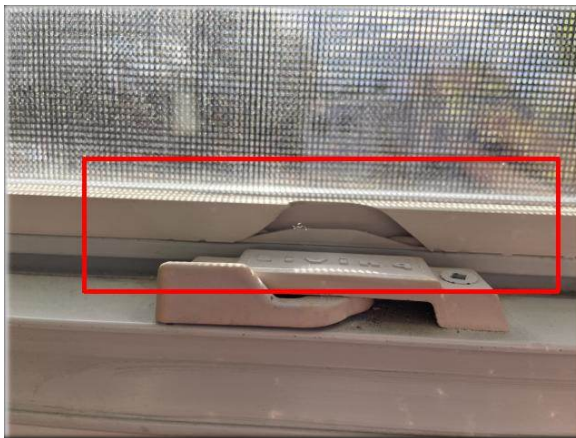
The vinyl glazing strip was cracked, missing, or loose on some of the windows; recommend replacing.

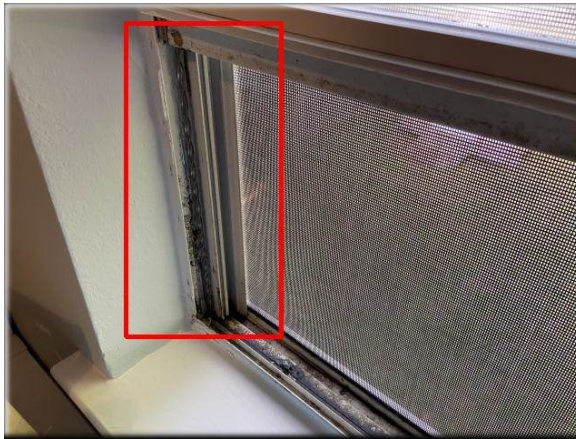
Some of the window spring(s) in the home were disconnected or broken; recommend repairs to restore proper operation. Present throughout the home. Example photo of a broken spring found during inspection.

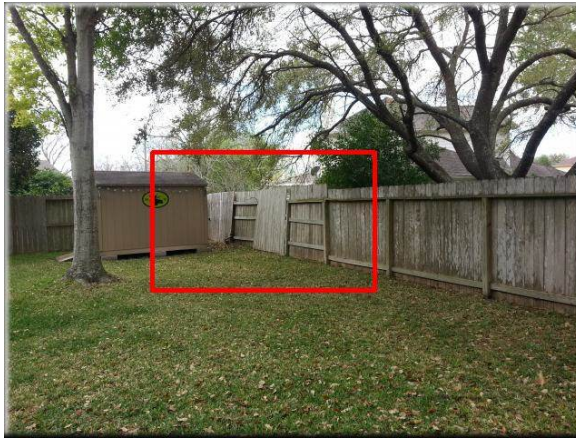
The fence around the property is recommended for repair to gate hardware/leaning and loose sections of fence at various areas.

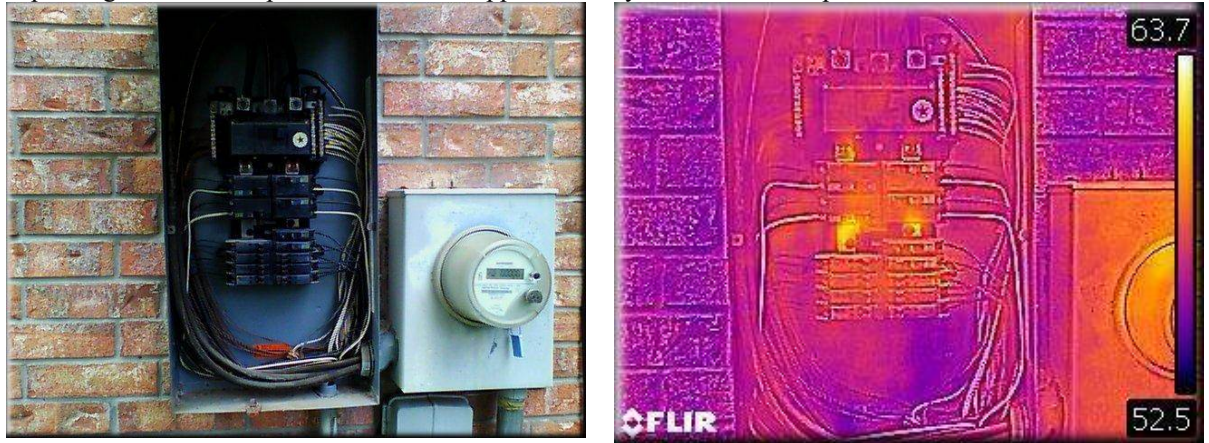
A thermal imager was used to help determine no excessive "hotspots" in the electrical panel were found at the time of inspection. In general, breakers should not reach over 120-130 degrees under full load/on a hot day, depending on where the panel is mounted. Applicable only at the time of inspection.

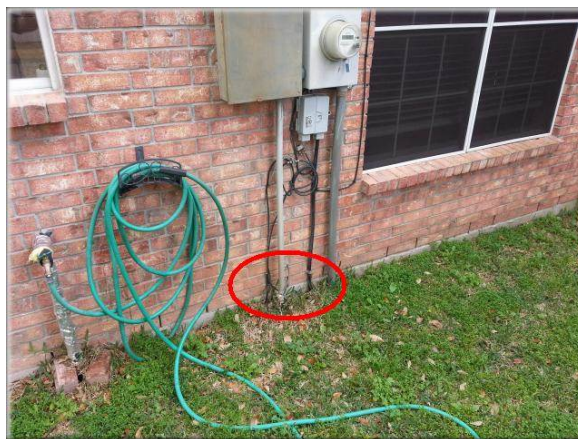
The grounding electrode conductor is connected to a clamp that is approved for piping attachment and not approved for attachment to a ground rod. Recommend replacing with a proper clamp, commonly known as an "Acorn" style clamp.

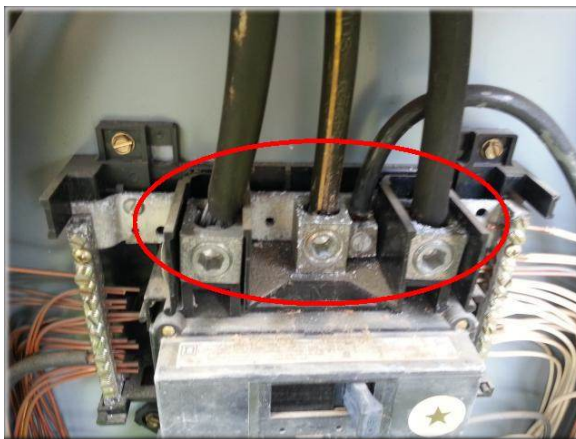
(simple maintenance for an electrician) Anti-oxidizing compound was not used for the service wire connections to the main breaker in the main panel. Most manufacturers recommend using a corrosion inhibiting compound like, Blackburn CONTAX paste, Burndy Pentrox paste, and Pen-Union CUAL-AID. Anti-oxidizing compound is recommended by NECA/AA 104-2000 and National Electrical Installation Standard published by the National Electrical Contractors Association, which calls for anti-oxidant in section 3.1.2(c) of that standard or follow the manufacturer recommendation, This is a common problem found with aluminum connections in the service panels inspected; recommend contacting a licensed electrician for opinion.

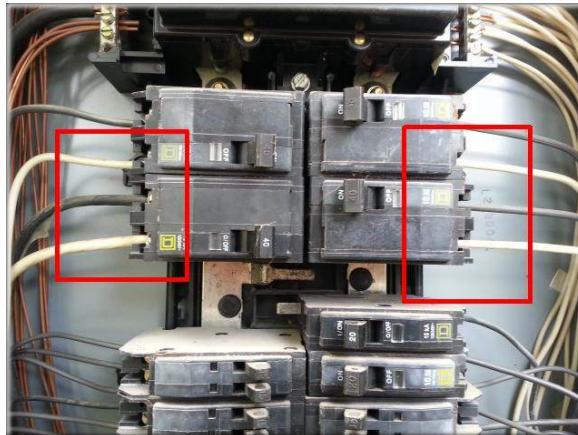
(simple maintenance for an electrician) Some white insulated wires in the breaker box are being used as “hot” for the 240 volt circuits. This is a common wiring practice, but the white insulated “hot” wire should be permanently identified at each end to indicate its use as hot. Normally black or red paint/plastic tape may be used to identify these wires as “hot”.

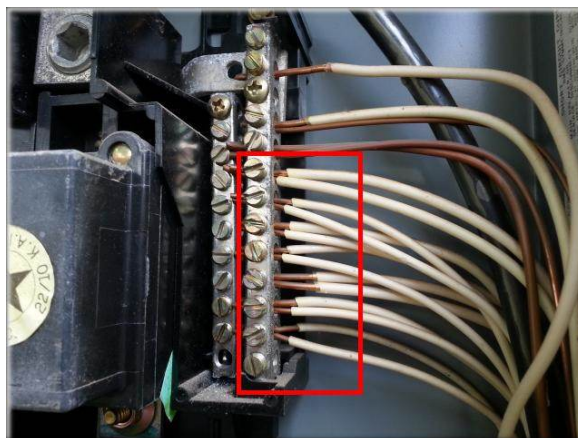
(simple maintenance for an electrician) The 2002 NEC [National Electrical Code], section 408.21 states with regard to grounded [neutral] connections: Each grounded conductor shall terminate within the panel board in an individual terminal that is not also used for another conductor. While doubling of the neutrals was, and still is a very common practice among electricians, it has been found to cause problems due to poor connections. The remediation is not expensive, and can be done quickly by a licensed electrician.

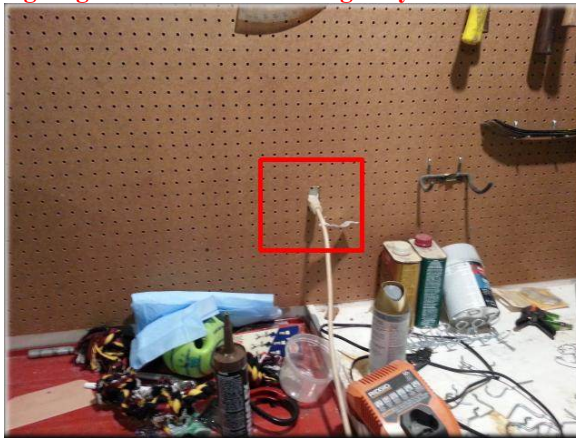
Receptacle obstructed in the garage. Recommend making fully accessible.

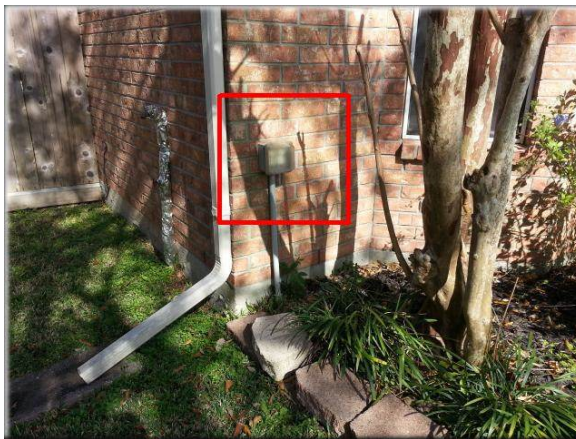
The GFCI protected outlet was not functioning as required in/at the exterior (front left exterior). Recommend review and repair by a licensed electrician.

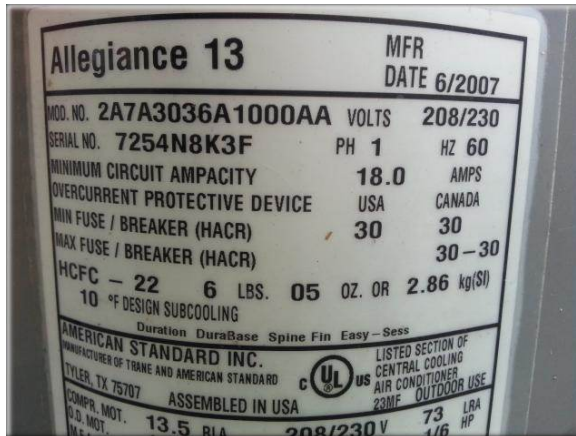
Condenser information below for your reference. Brand: Trane, Manufacture Year: 2007.

These units appear to use older R-22 refrigerant which is being phased out of production. This may result in high repair costs. Consult your licensed HVAC professional for more information.

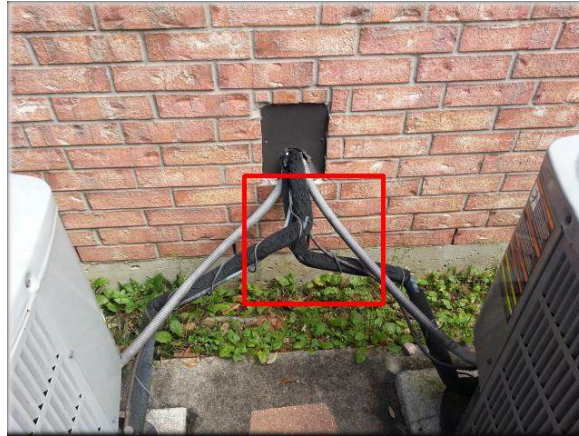
The insulation at the condenser freon line is deteriorated. Replacement of the insulation is recommended.

Seal the refrigerant line entry area(s) to help prevent moisture/pest intrusion.

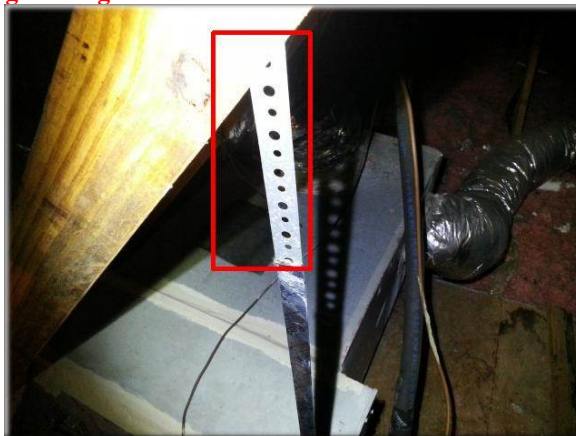
The Attic evaporator coil cabinet is suspended from the roof framing with perforated straps which are not intended for this use. If the strapping fails, then the equipment will shift causing the plenum to detach and possibly creating a refrigerant leak.

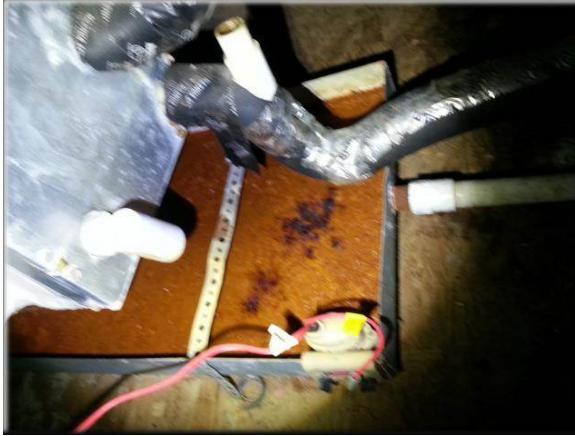
Rust stains observed in the emergency overflow pan under the Attic evaporator coil. Unable to determine if leak is present at A/C coil condensation pan/drain line, clogged condensate drain line or if due to previously corrected problem; suggest client consult with seller to determine if or when repairs were completed or a qualified contractor should be called for further review.

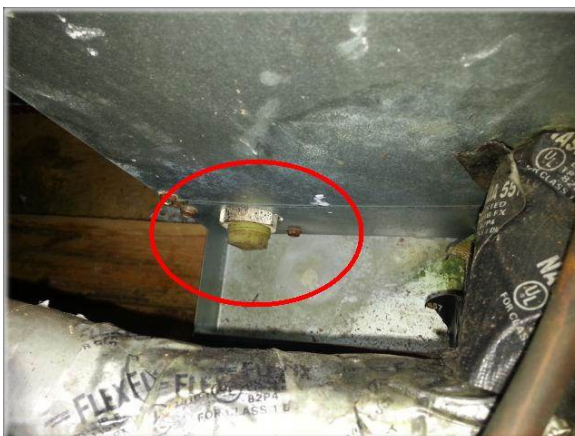
The evaporator coil overflow pan drain appears to be installed incorrectly/plugged. The overflow may not work properly. Recommend a licensed HVAC professional review and repair. (rear unit)

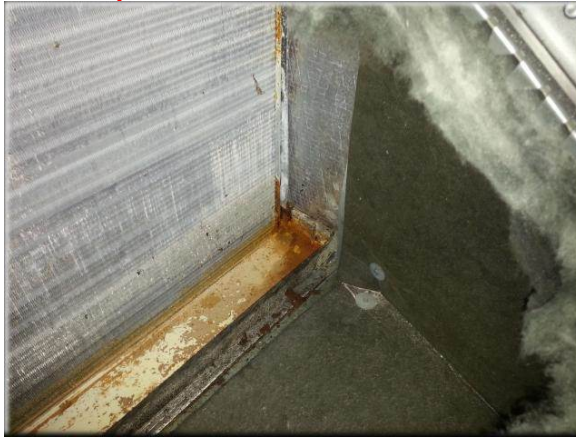
Partial corrosion observed inside evaporator coil areas.

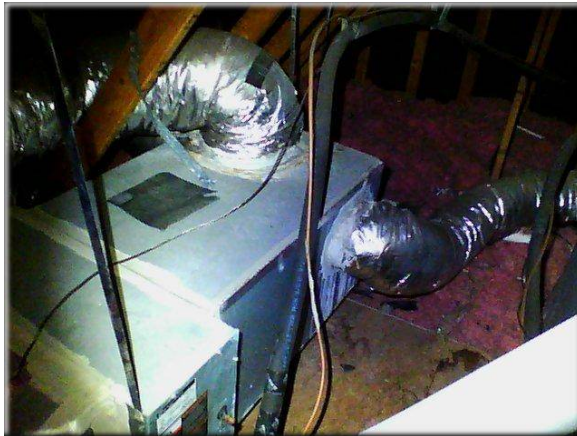
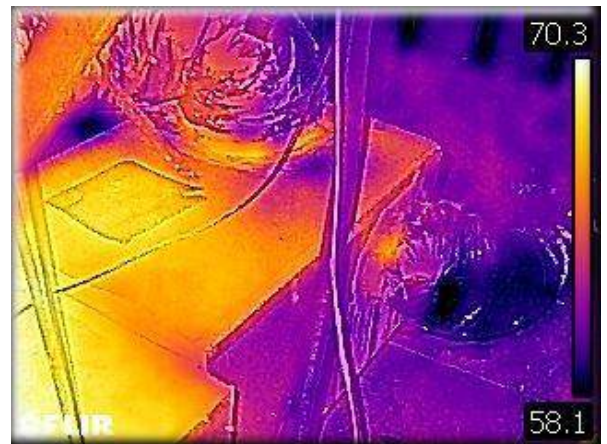
As part of duct maintenance, it is recommended to add additional insulating tape/mastic to help prevent cold areas in the attic at the duct connections/plenum to help prevent condensation which can cause discoloration, duct connection damage over time and potential growth.

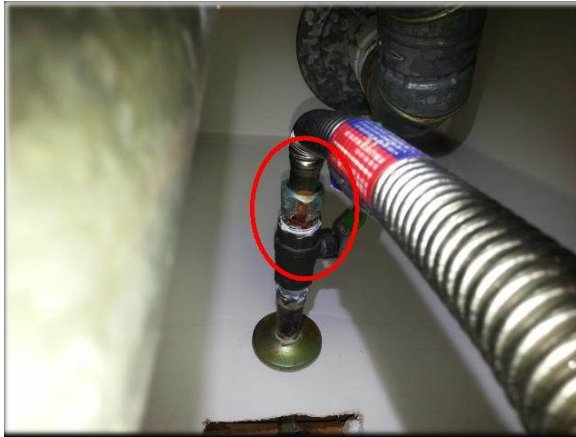
Minor corrosion present on water heater connections.
