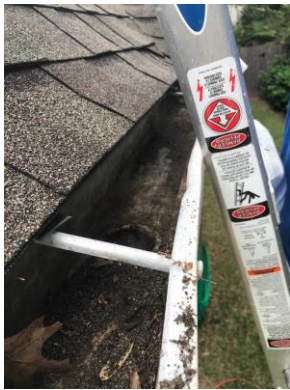
Issues: Recommend leaves and debris be cleaned from gutters and downspouts as necessary for more effective drainage of roof run-off water.

Resolved: Gutters have been cleaned out of debris.

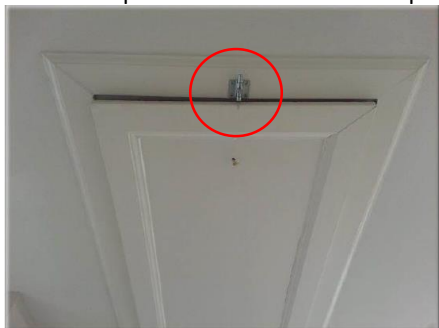
Issues: The attic stair assembly does not close flush with the ceiling; recommend adjustment/repair to prevent conditioned air in the home escaping into the attic.

Resolved: This was resolved by previous owner. There is a latch that was installed to tightly hold the attic door closed. Inspector did not latch when picture was taken. Latch can be seen in inspector's picture.

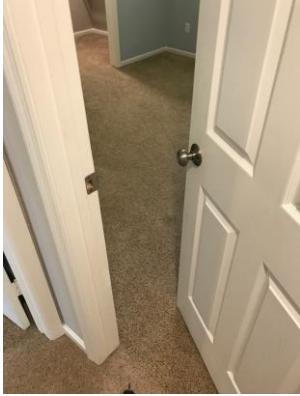
Issues: The door does not latch properly in the upstairs back left bedroom; recommend adjusting the strike plate for proper operation at minimum.

Resolved: Strike plate adjustments have been made so door latches properly.

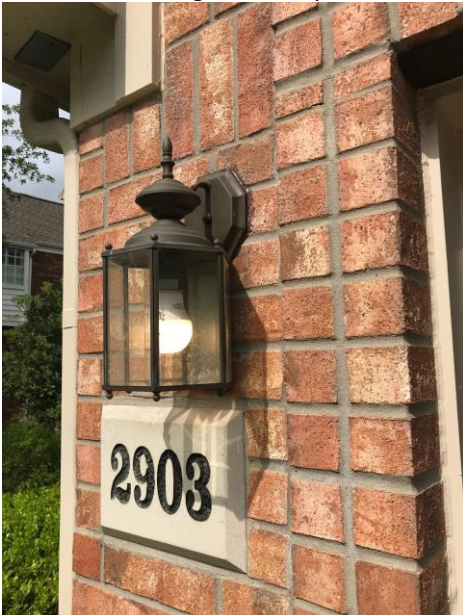
Issues: Recommend sealing around all exterior light fixtures and exterior electrical receptacles to prevent moisture from entering into the electrical junction boxes. Even small holes can contribute to moisture damage over time.

Resolved: Caulking has been put around all exterior light fixtures.

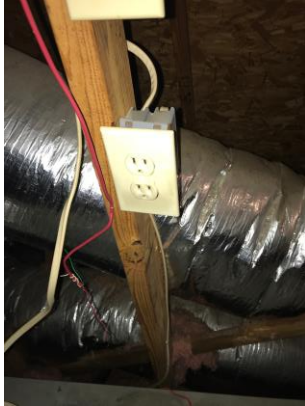
Issue: The electrical cover plate in the Attic is damaged/missing. Recommend replacement.

Resolved: Cover plate put on attic electrical outlet

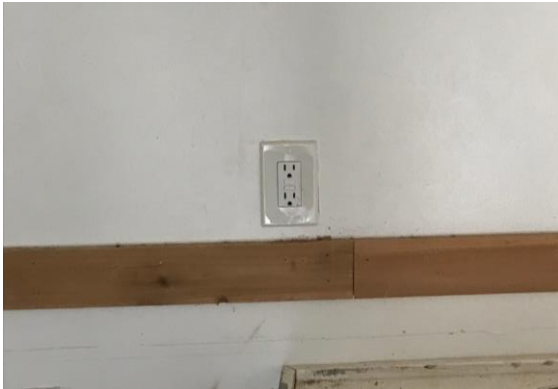
Issue: Receptacle obstructed in the garage. Recommend making fully accessible.

Resolved: Obstruction removed allowing for full access to outlet.

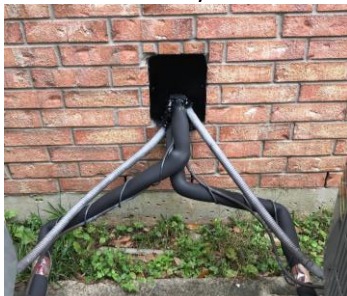
Issue: The insulation at the condenser freon line is deteriorated. Replacement of the insulation is recommended.

Issue: Seal the refrigerant line entry area(s) to help prevent moisture/pest intrusion.

Resolved: Insulation on condenser line has been replaced.

Resolved: AC entry into house has been completely sealed.

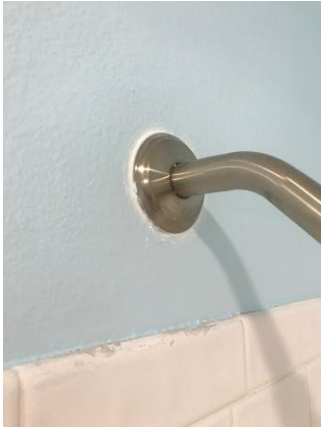
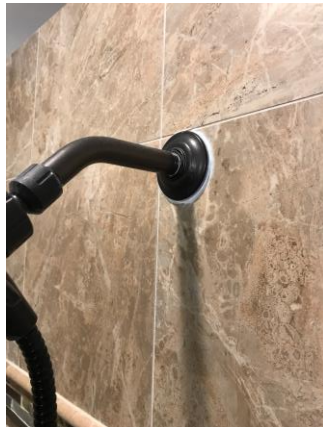
Issue: The shower head trim is not caulked at the shower walls, which may result in water penetration to the interior structure and deterioration of the wall; recommend caulking around shower heads, faucets and tub spouts to prevent wall damage. Failure to keep these areas sealed can cause deterioration and moisture damage to the interior walls, which is not visible to the inspector at the time of inspection.

Resolved: Both shower heads have been caulked.

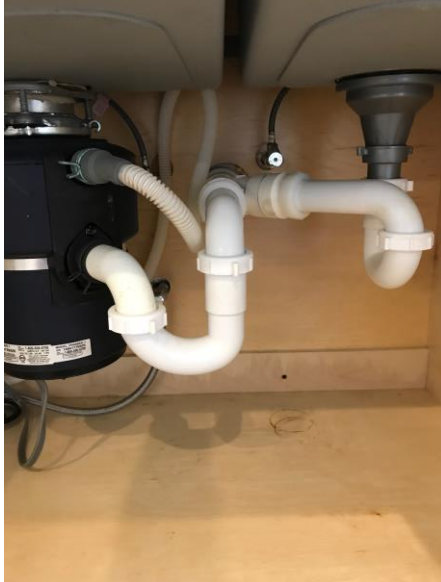
Issues: The drain line does not have a high loop or an air gap was not installed for the dishwasher drain line. The dishwasher drain line should be looped upward and connected to the underside of counter (or have an air gap installed above the counter if there is a slot for one) to prevent the possible contamination of clean dishes, which can occur if water from the sink flows into the dishwasher.

Resolved: Drain line has been looped up high.
