Property Inspection Report

241 Lake Livingston Blvd., Livingston , TX 77351
Inspection prepared for: Dori Rhodes
Real Estate Agent: Sara Jimenez - RE/MAX Signature The Mosely Team

Date of Inspection: 3/29/2021 Time: 9:00 am
Age of Home: 46 yrs - 1975 yr built - Size: 816 sq ft
Weather: Clear and Sunny

One story pier & beam frame house built on grade having 2 bedrooms, 1 bathroom and detached Carport.

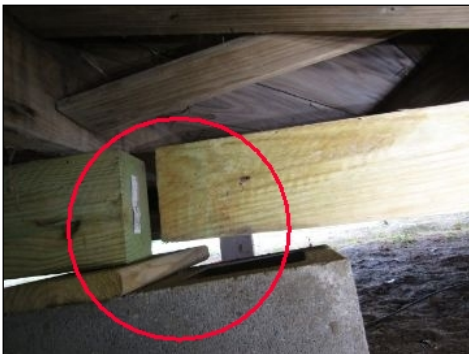
Not properly supported or installed

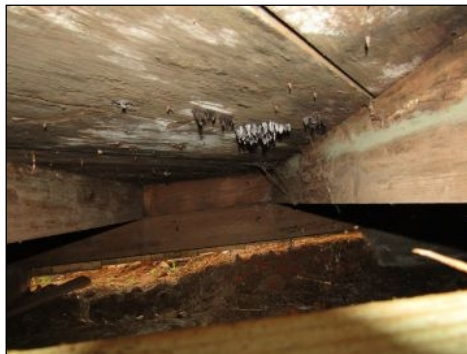
Evidence of floor joist and sub floor decay, fungal activity.

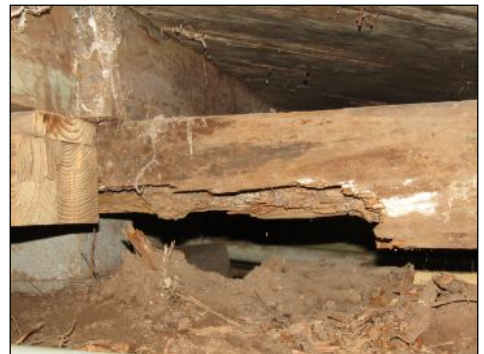
Possible past or present wood destroying insect activity.

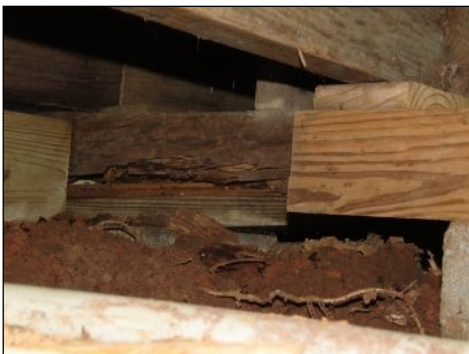
Sill beams and floor joist are too close to soil.

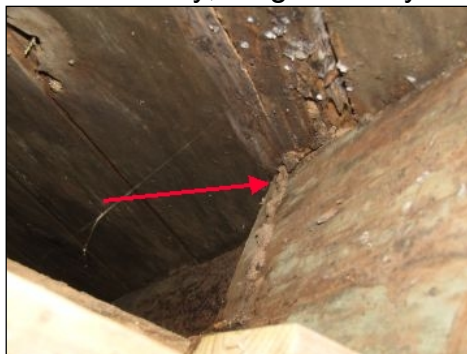
Mud tubes may indicate wood destroying insect activity.

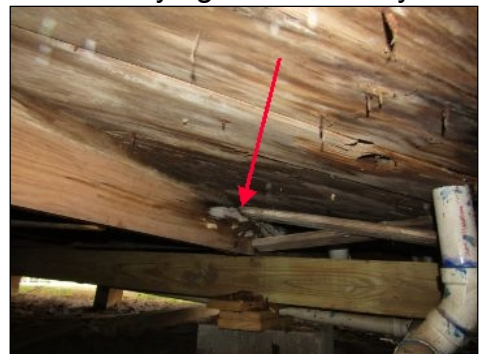
Decaying and damaged floor joist in crawlspace.

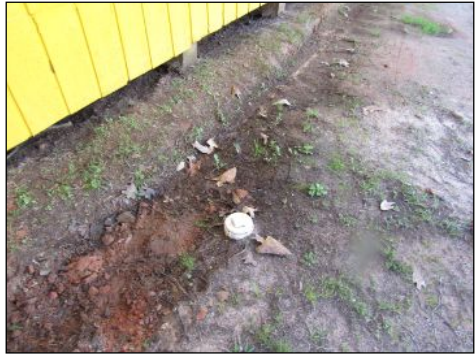
Drip edge erosion because of lack of gutter system.

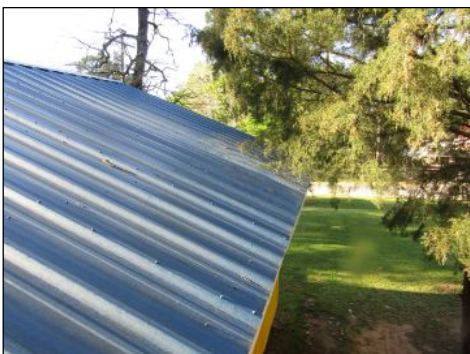
Tree limbs growing towards roof.

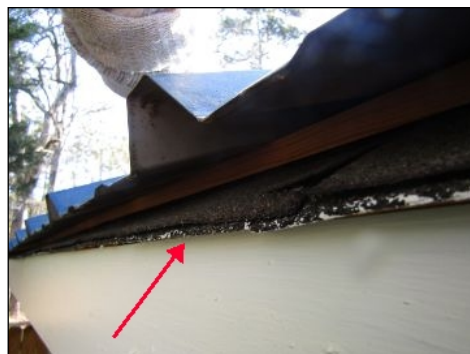
Medal ends close to fascia board without any drip flashing on left side. In need of improvement.

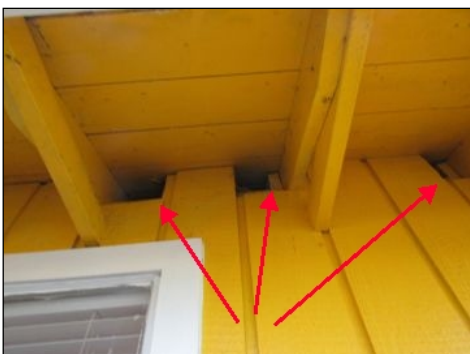
Missing bird blocking will allow animal and insect entry to attic.

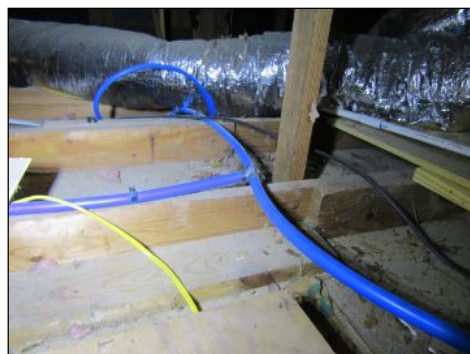
Needs insulation.

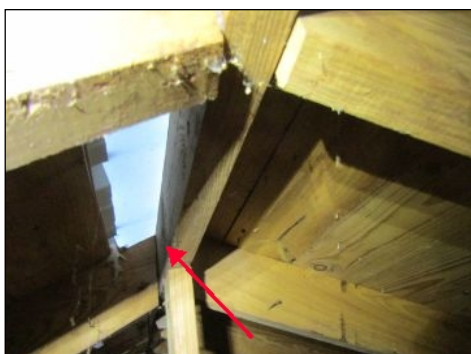
No insect screen at ridge vent area.

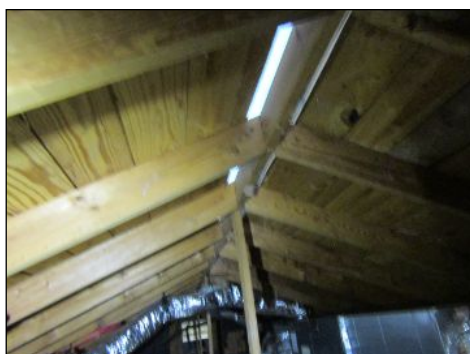
Missing collar tie and purlin bracing in attic

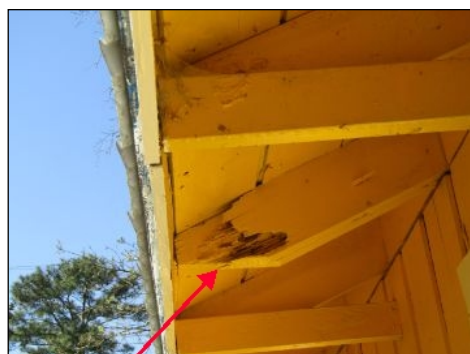
Rafter tail decay.

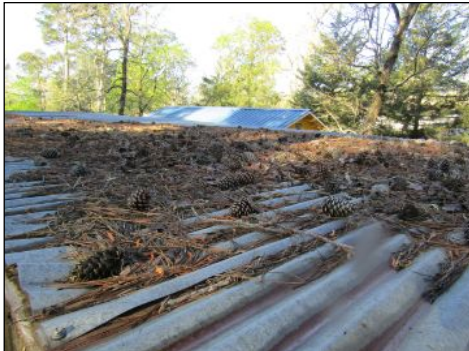
Much leaf litter and pine straw on roof.

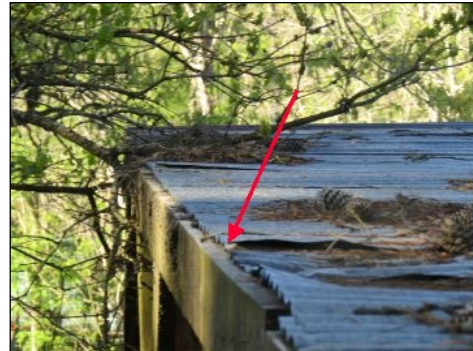
Metal roof for carport has damage and undersized over hang at framing. Water runs into framing.

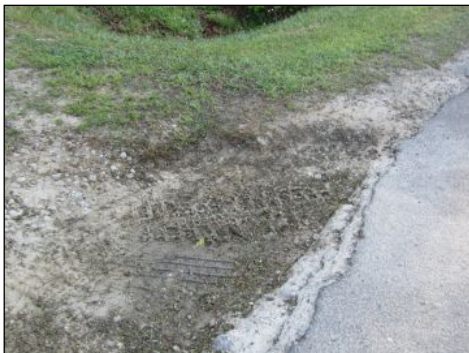
Pot hole forming at street.

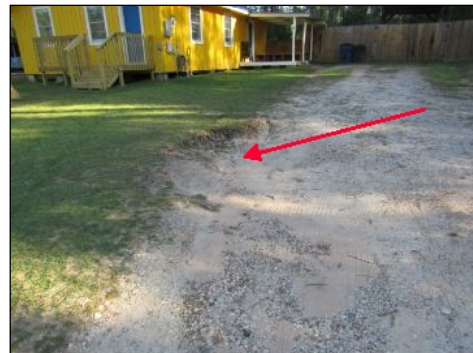
Needs pot hole filled and grading.

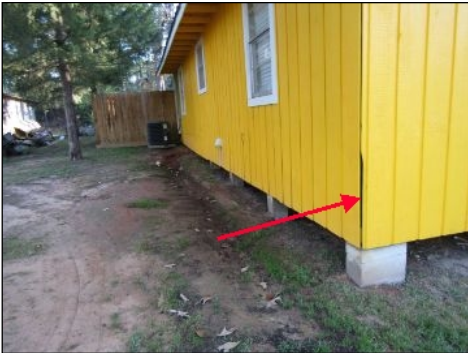
Missing corner trim with open gaps.

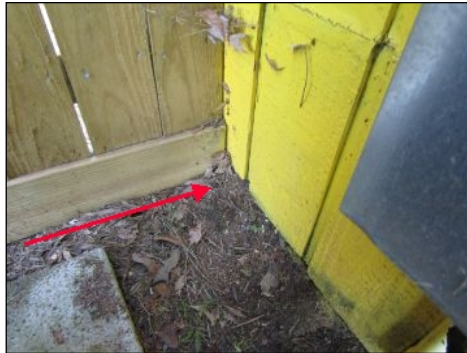
High soil left back corner.

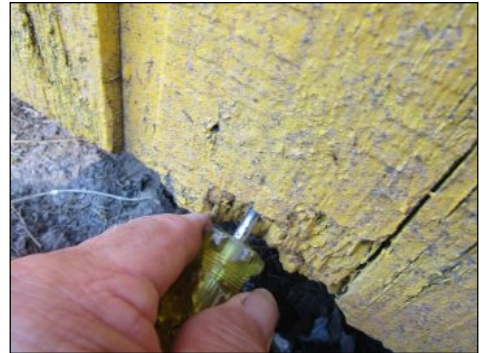
Exterior siding has wood decay at several rain splash areas.

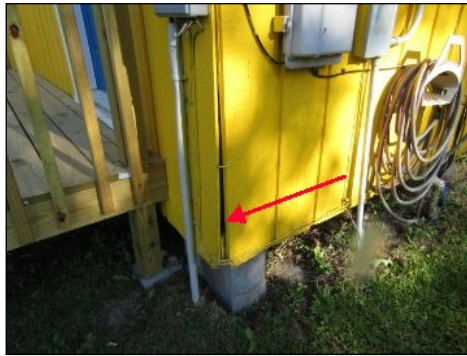
Open gap at missing corner trim.

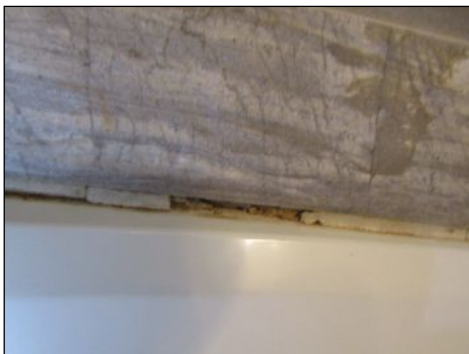
Grout damage in bathroom shower.

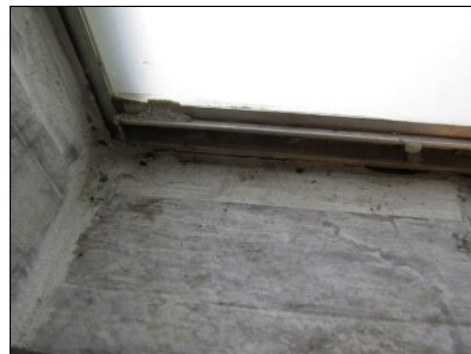
Poor quality tile installation.

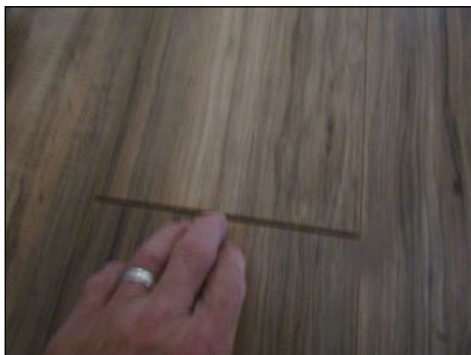
Open gaps. Cosmetic.

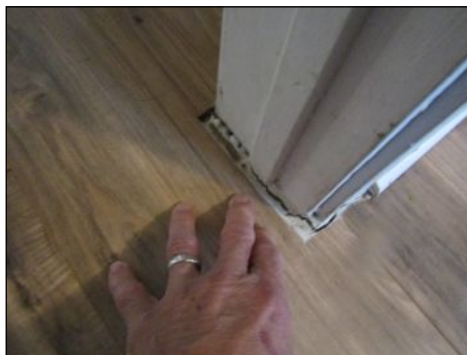
Exposed cuts. Cosmetic.

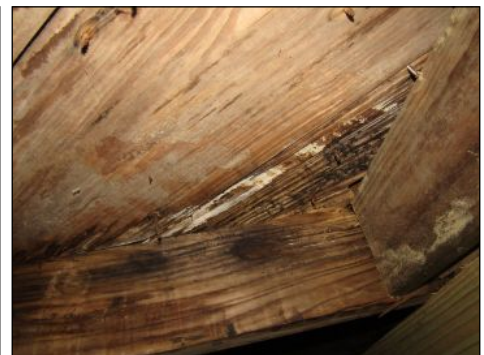
Sub floor decay.

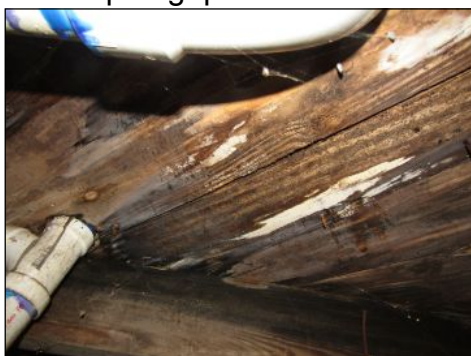
Sub floor under bathroom has decay.

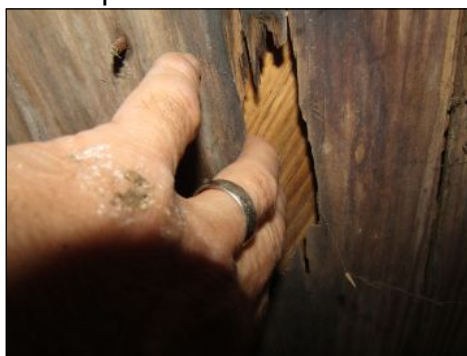
Sub floor decay

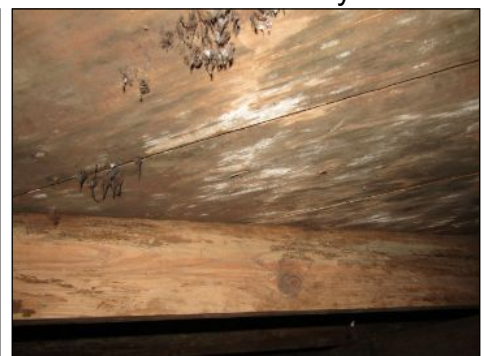
Appears to be mold and fungal activity on sub floor.

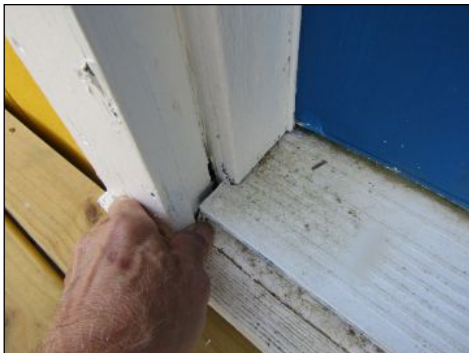
Caulk needed at several areas around framing.

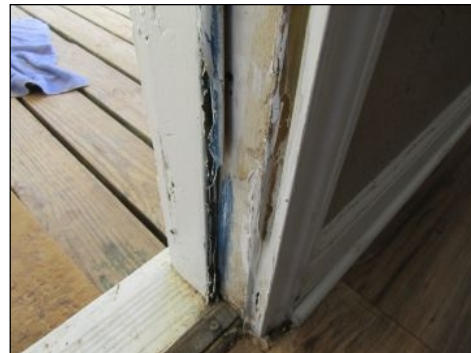
Gasket damage.

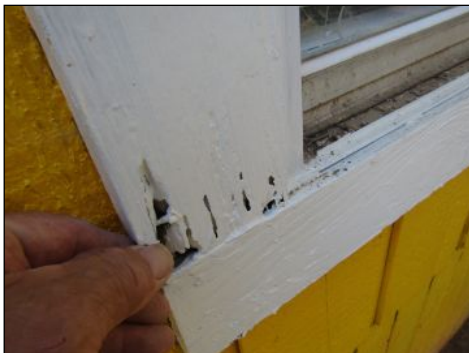
Wood frames have damage.

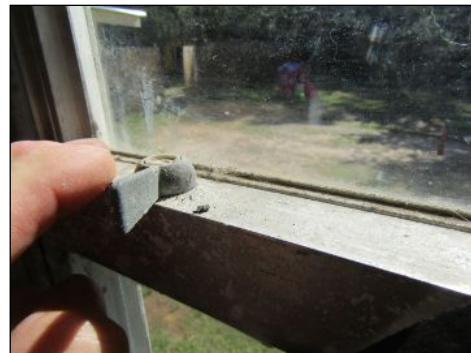
Several window hardware does not latch because of window frame twist.

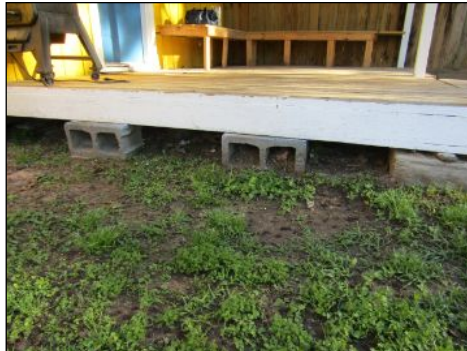
Side deck board has improper placed sideways concrete block supports.

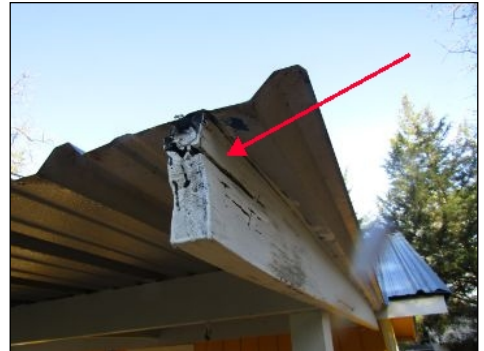
Exposed wood is rotting at tail end.

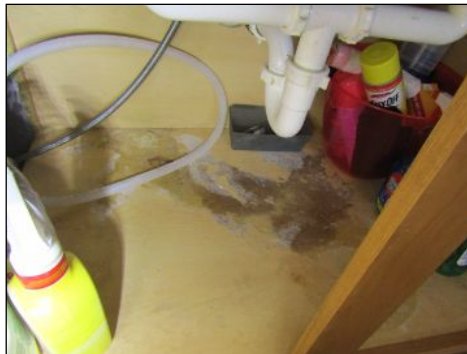
Damaged cabinet floor under sink.

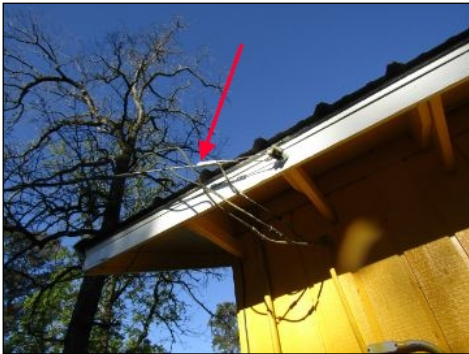
The service entry weather head does not have adequate clearance from the roof. Minimum distance of 3 ft. in all directions from edge of roof is required.

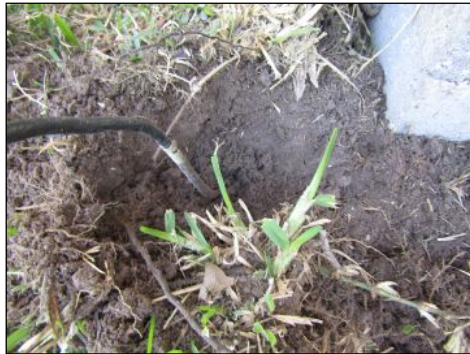
Ground rod not visible.

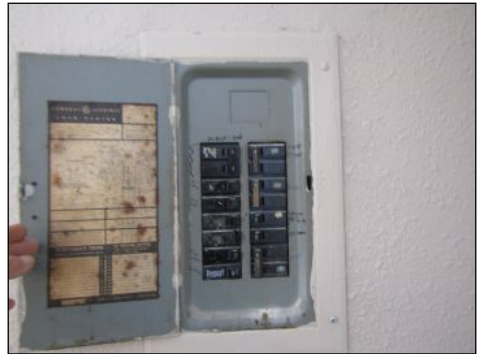
No main disconnect.

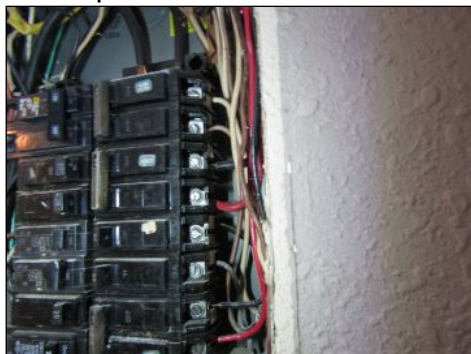
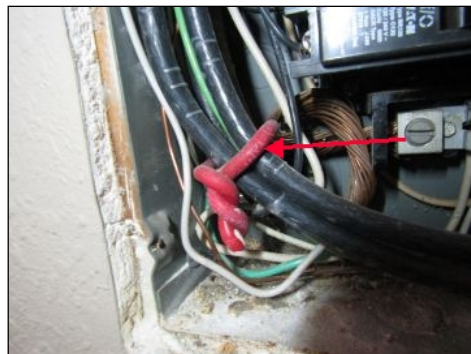
Conductive wire is not permitted to be used to bundle circuit wires.

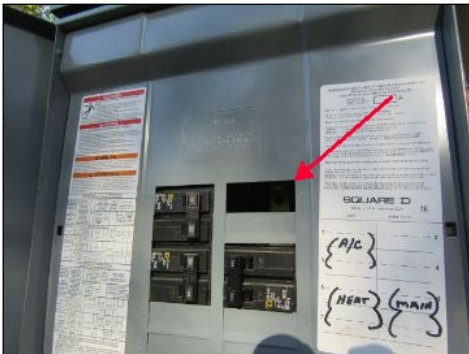
There are open breaker slots in the panel. This is a safety hazard.

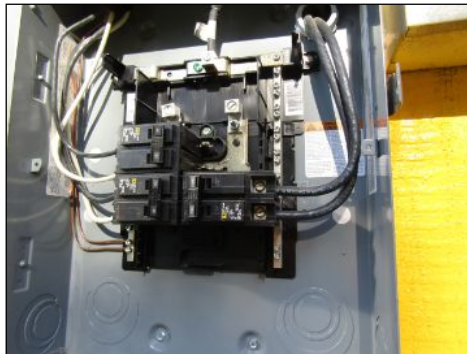
No separate ground present to main panel.

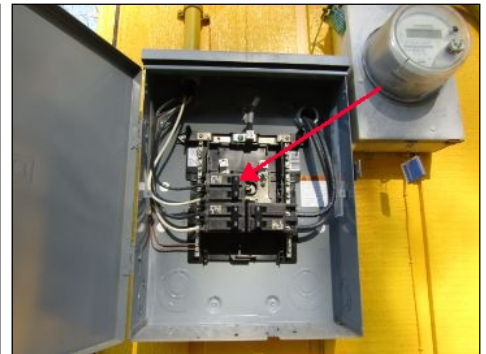
Over sized breaker for A/C condenser.

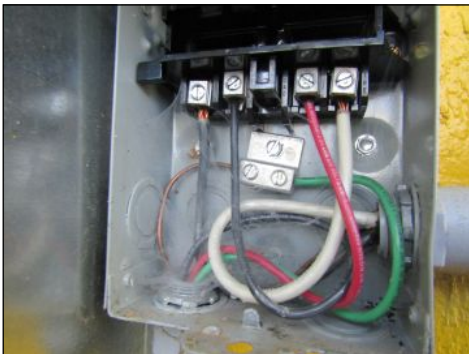
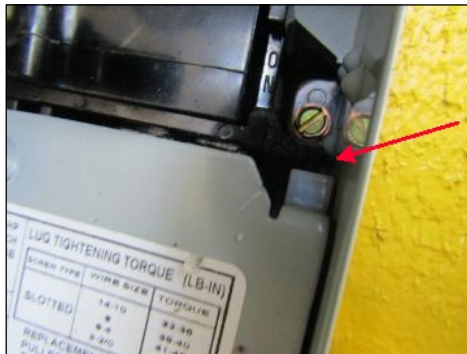
Damage to cover clip at A/C disconnect.

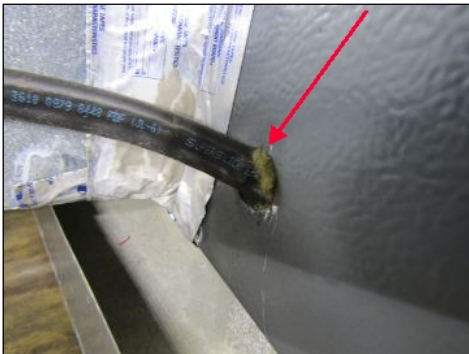
Missing protective bushing at air handler electrical entry.

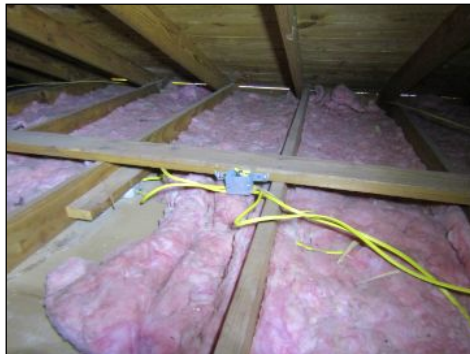
Electric box needs cover plate.

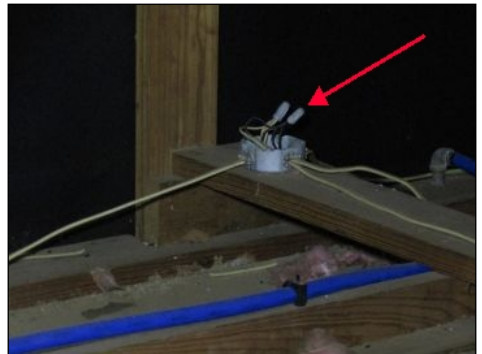
Exposed electrical connections in attic.

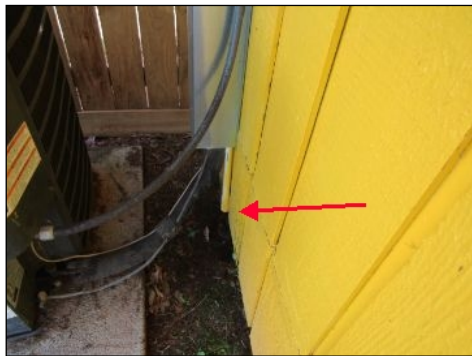
Condensation drain line terminates at exterior onto ground.

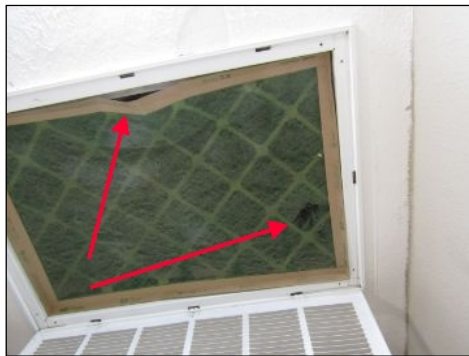
Filter is damaged and needs replacement.

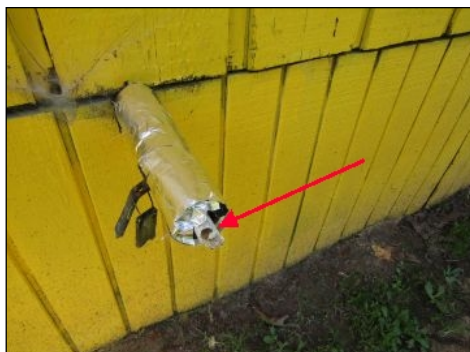
Abandon pipe with broken area at backyard.

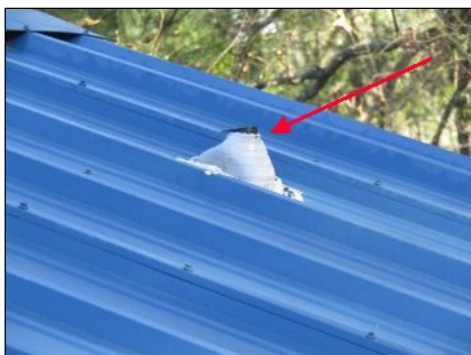
Plumbing vent pipe shall be minimum of 6 inches above roof covering at penetration.

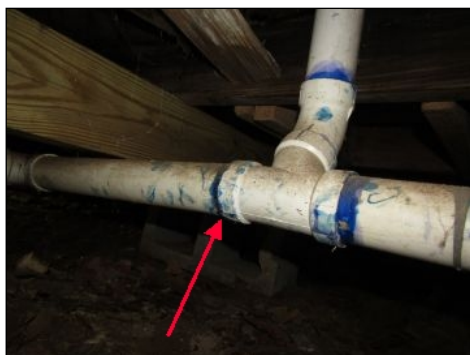
Observed slow leak/drip at "T" fitting in crawlspace. Bathroom Lavatory is missing gasket at drain connection.

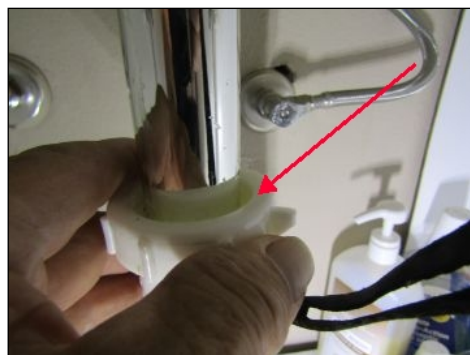
Bathroom Lavatory is missing gasket at drain connection.

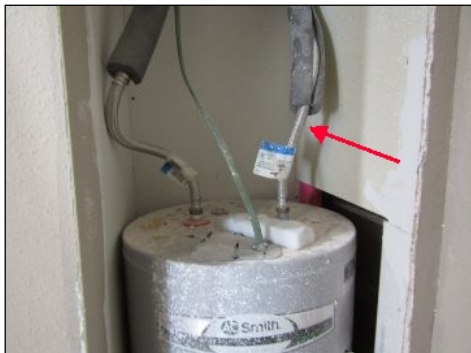
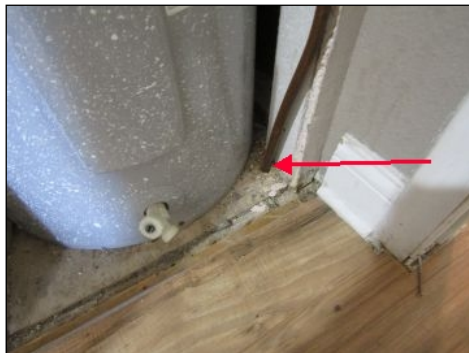
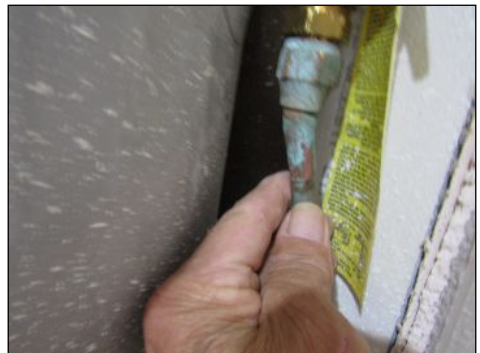
Water heaters are to have cold water shut off.

T & P drain pipe must have a visible discharge location.

Kinked and improper T & P pipe.

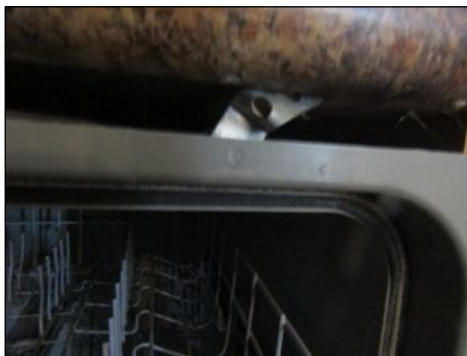
Not properly anchored to counter.

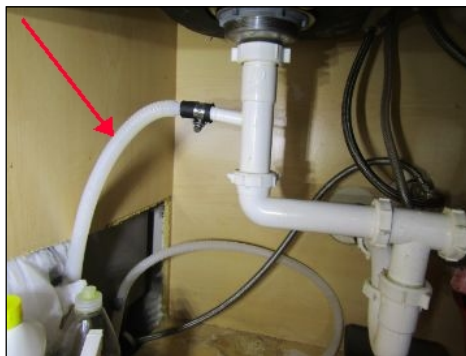
Drain line not properly installed.

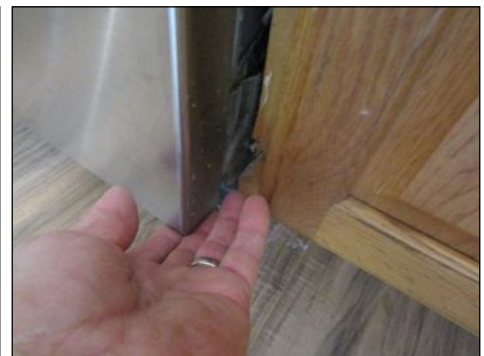
Dishwasher has seal leak and drip on to floor at bottom right side.

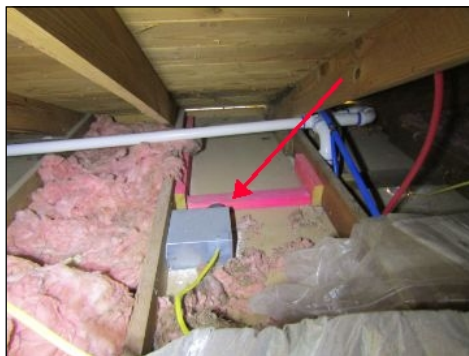
Bathroom fan vents in attic.
