# MasterCraft Home Inspections

## PROPERTY INSPECTION REPORT

Concerning: 12003 Belle Court, Pinehurst, TX 77362  
(Address or Other Identification of Inspected Property)

By: Scott Weible, Lic #10293 05/17/2018  
(Name and License Number of Inspector) (Date)

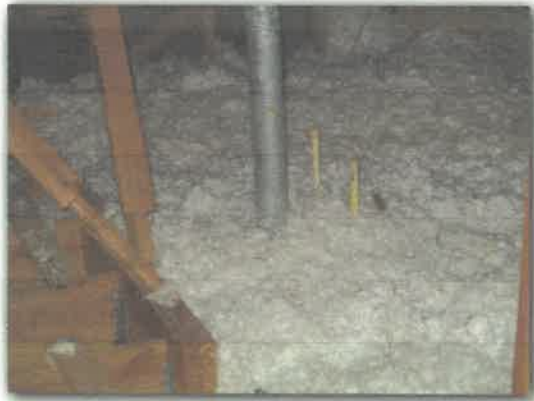
**There is insulation in contact with the water heater vent where it passes through the floor in the attic. Recommend providing the required clearance between the vent and combustible materials as noted by the manufacturer.**

There is insulation in contact with the water heater vent where it passes through the floor in the attic. Recommend providing the required clearance between the vent and combustible materials as noted by the manufacturer.

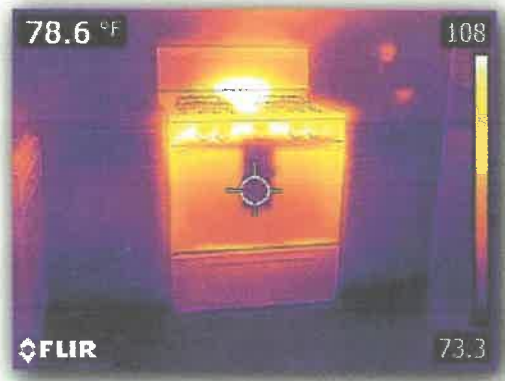
A thermographic scan of the interior of the house was performed with an infrared camera to detect problems such as water penetration, electrical overheating, and insulation issues.

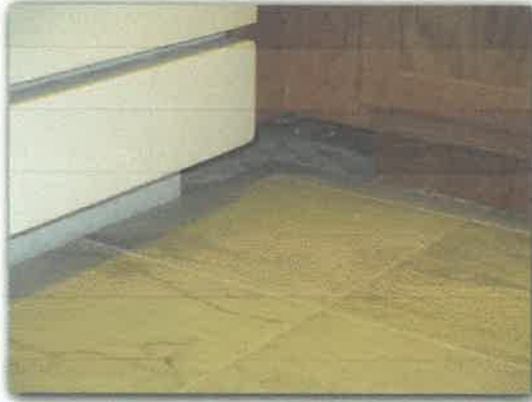
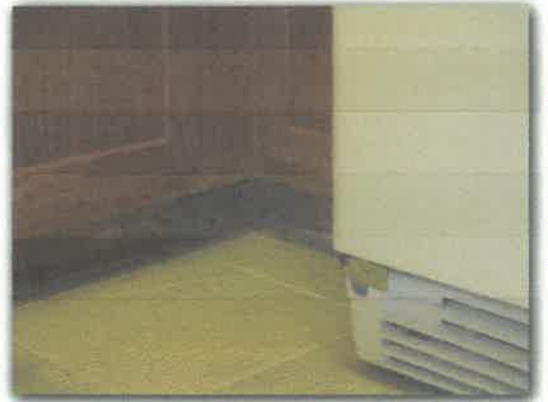
**The kick boards are missing from the bottom corners of the cabinets at both sides of the range.**

The kick boards are missing from the bottom corners of the cabinets at both sides of the range.

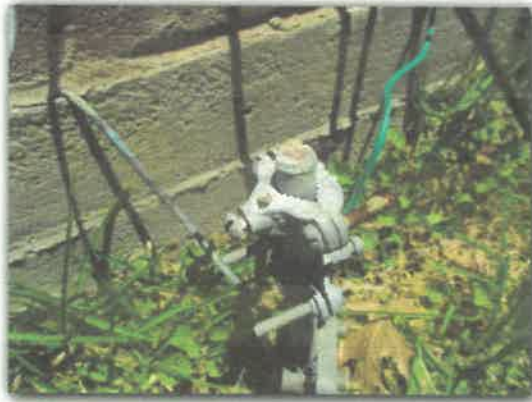
**The clamp that connects the ground wire to the ground rod is the incorrect type. It should be a clamp that is listed and approved for a ground rod, such as an acorn clamp.**

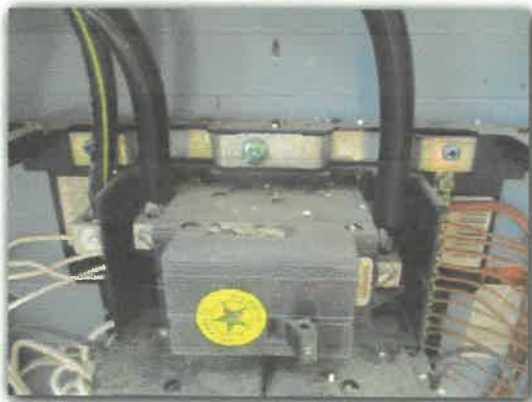
**There is no antioxidant paste on the aluminum service entrance wires where they connect to the main breaker and the neutral bus.**

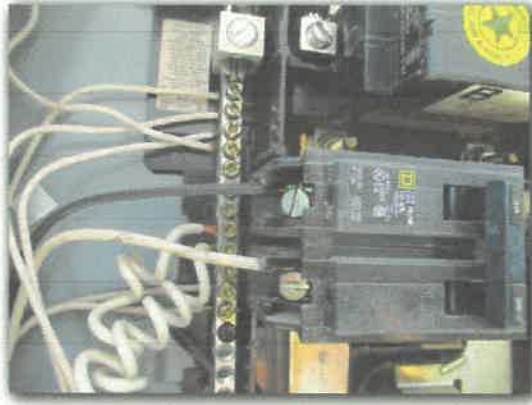
**There is a white wire used as a hot conductor connected to the breaker for the A/C system. Normally the white wires are neutral. When used as a hot conductor, the white wires should be color coded.**

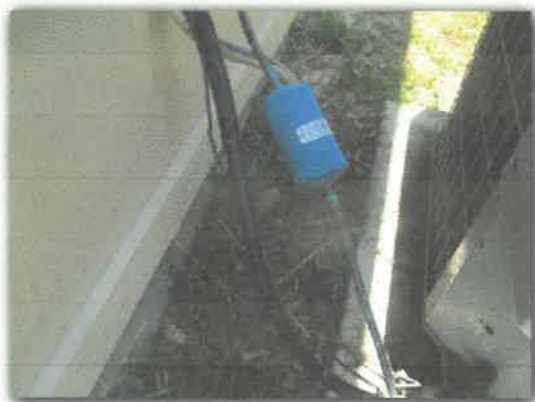
**Recommend replacing the insulation on the suction lines to the condensing unit.**

Recommend replacing the insulation on the suction lines to the condensing unit.

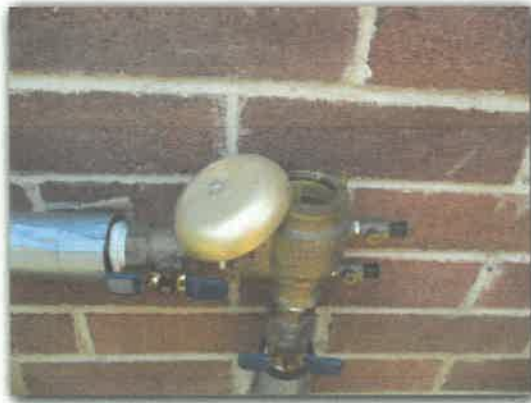
**The anti-siphon for the sprinkler system has froze and broke. The sprinkler system could not be tested.**
