BRYAN & BRYAN INSPECTIONS

Inspection Report For:
307 Sorrelwood, League City, TX 77573

Inspection Date: 3/24/2017

Prepared By: Rene Guajardo TREC#5945

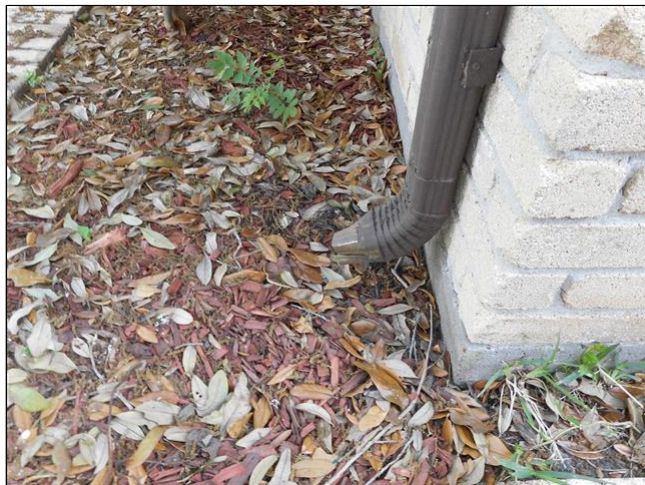
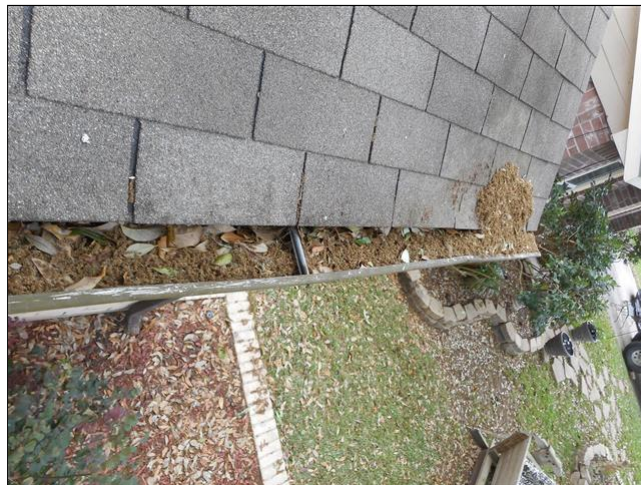
Replacement of any missing splash blocks at the base of all guttering downspouts is recommended to prevent soil erosion.

Gutters should be cleared of debris for proper drainage.

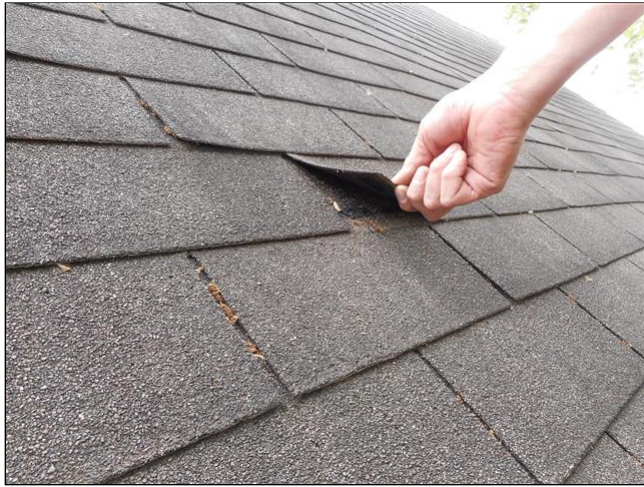
(3) There is physical evidence of shingle lift at multiple areas of roof covering. This is typically caused by high winds that lift the shingles but do not rip them off. These shingles do not re-adhere leaving them vulnerable to additional lift in high wind situations.

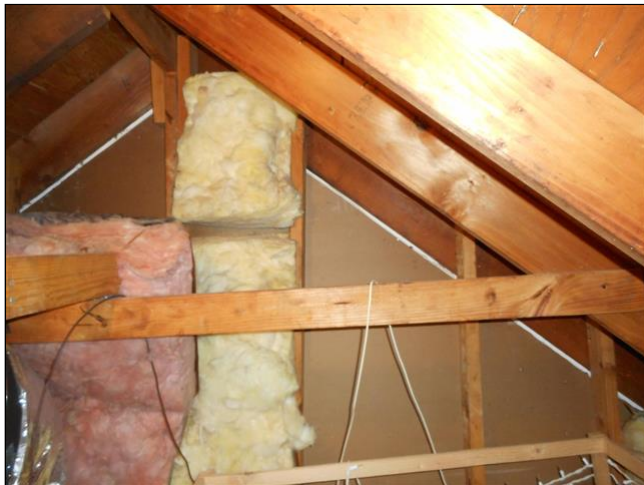
Location(s): random areas

(3) Noted vertical batt insulation that appears to have pulled away from the wall. For maximum R value, the insulation should be installed flush to the drywall.

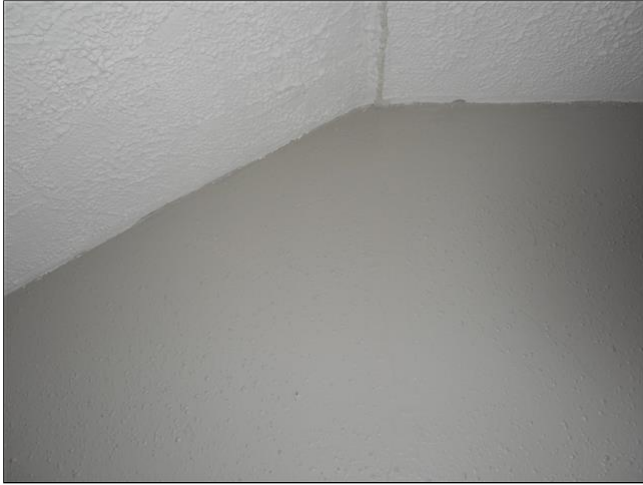
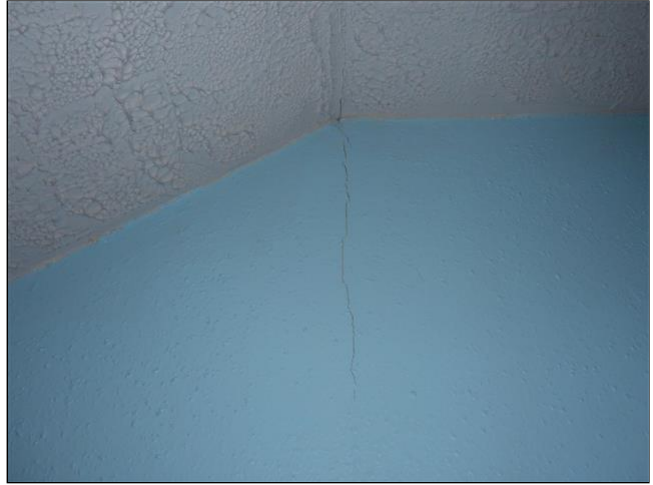
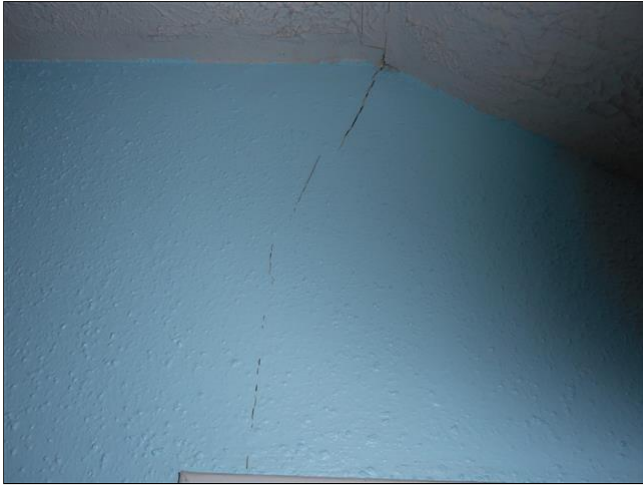
Location(s): Multiple Locations

(4) Stress cracks are observed on the interior drywall. This is consistent with the structural movement of the home.

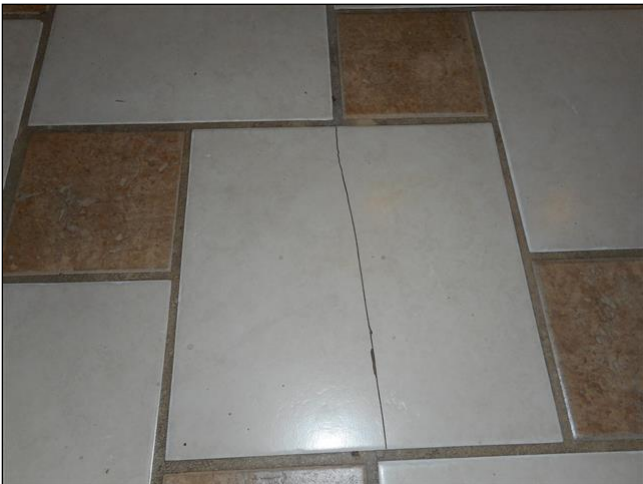
Cracked floor tile and grout was observed at kitchen area.

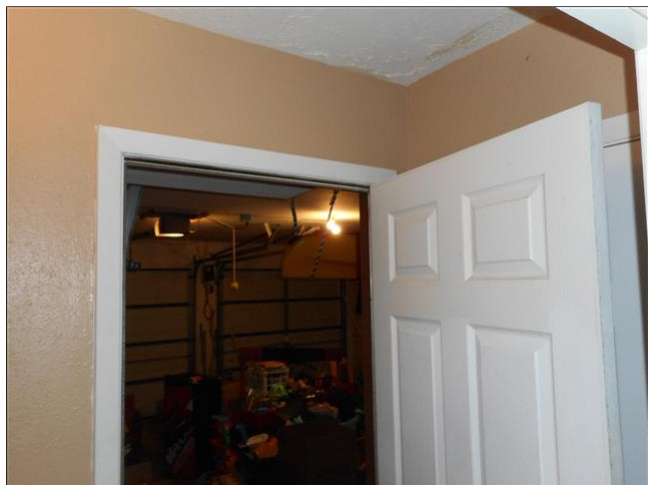
(1) Doors between the garage and residence should be equipped with a self-closing device to secure the door without the use of manual force.

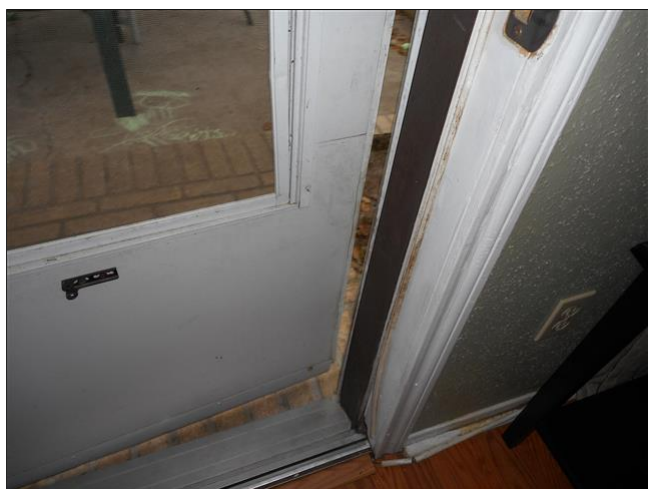
(2) Rear exterior storm door does not shut properly.

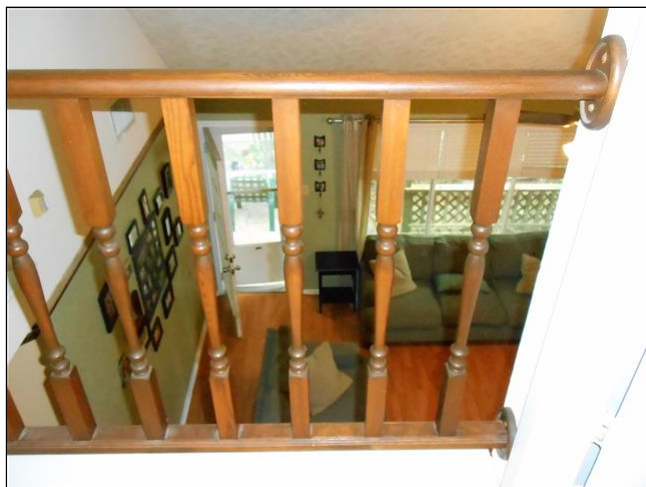
Stairway handrails should turn in towards the wall at the upper end of the handrails as a safety measure to prevent an individual from getting caught on the open end of the handrail (safety).

Stair railing balusters are spaced greater than the recommended maximum spacing of 4" apart.

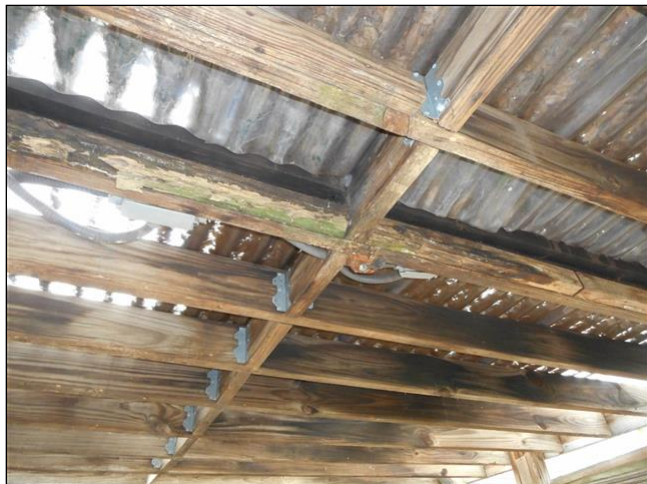
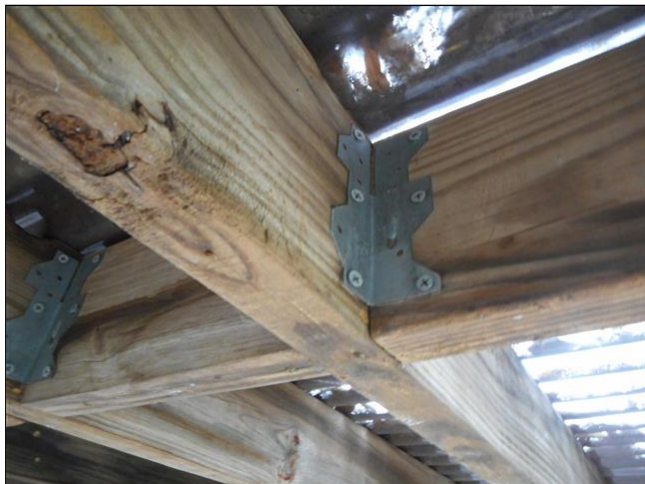
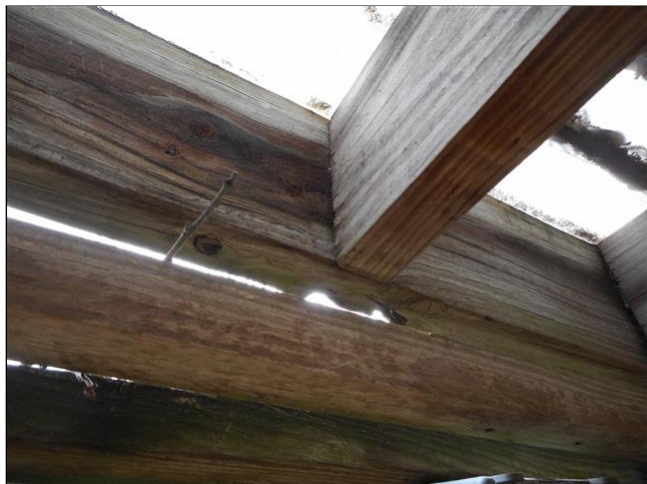
Rear patio structure shows signs of water penetration and wood decay. Hanger brackets should be installed with nails specified by manufacturer. Recommend installation of rafter hangers for additional support and stability.

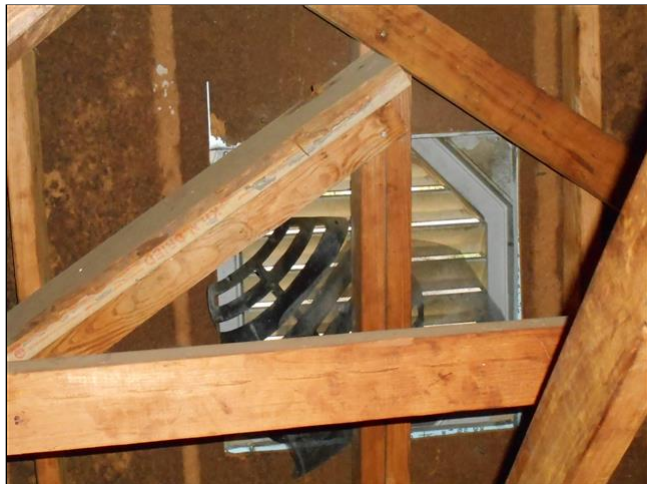
(5) The screening on the attic gable vent has been damaged. This may allow access to rodents or other pest.

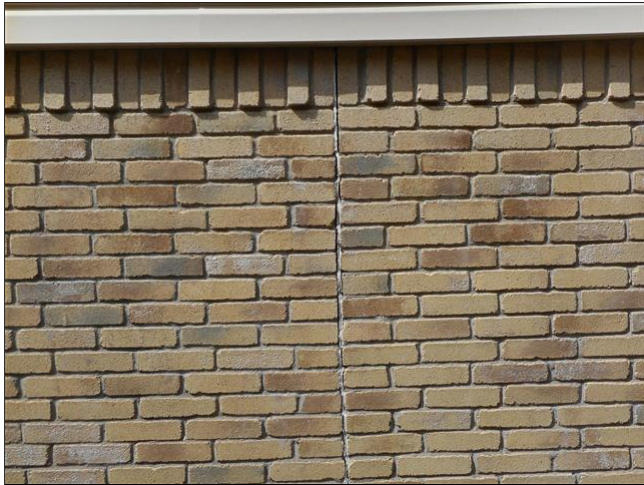
(2) Cracks in exterior brick veneer consistent with normal settlement was observed at various areas of exterior. These are considered cosmetic at this time. Monitor as needed. Monitor. If the cracks continue to widen, consult a qualified contractor or professional engineer

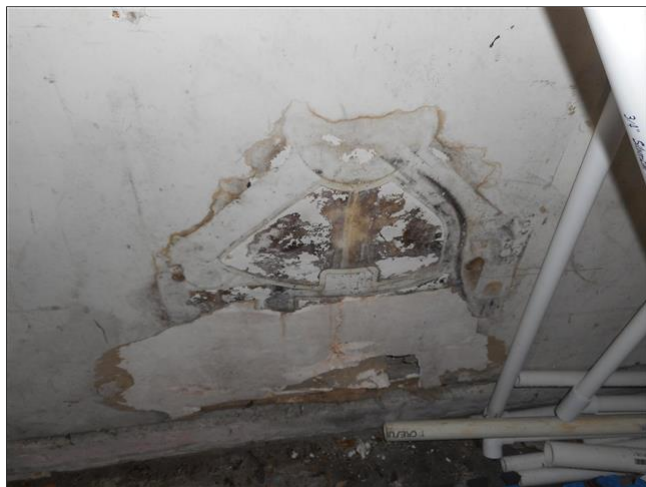
(3) There is evidence of prior possible wood destroying insect activity on garage left wall. Recommend inquiry with seller for any treatment or warranty documentation.

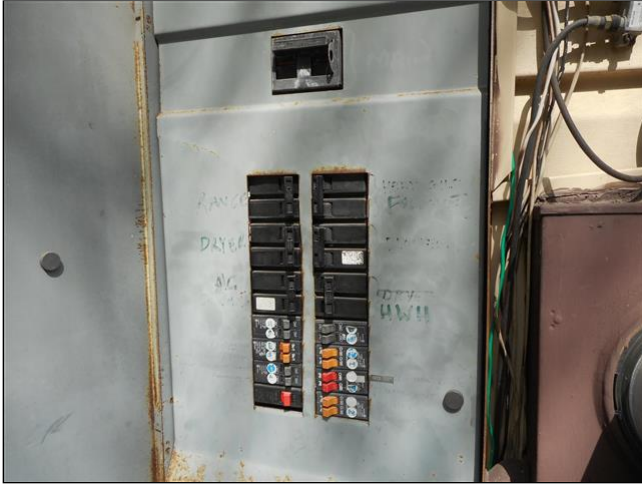
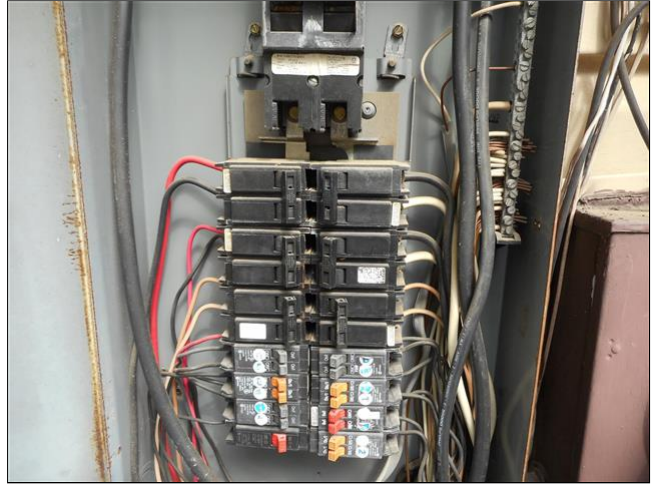
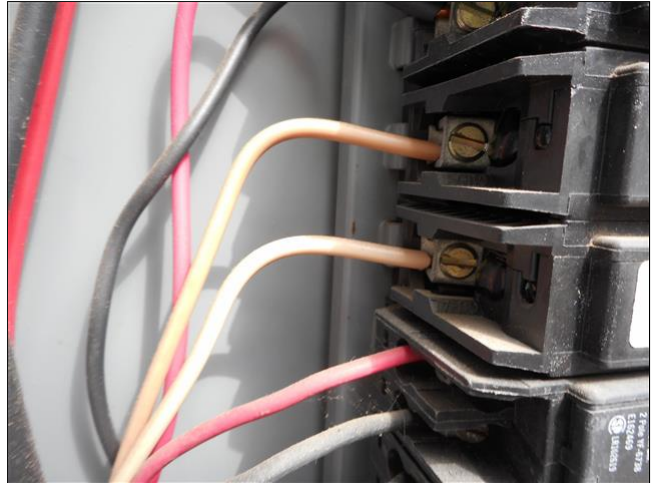
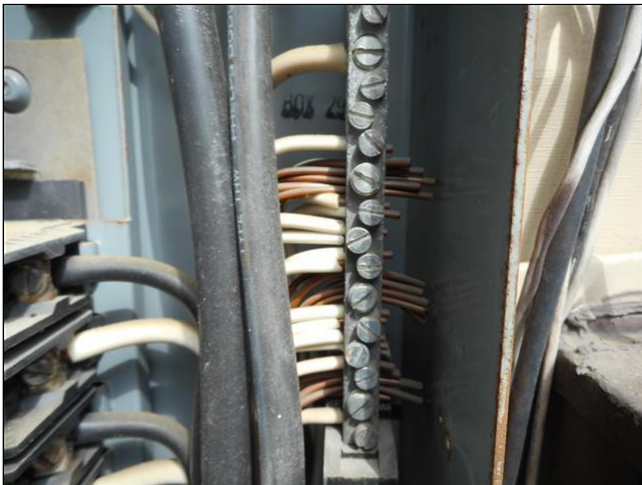
(1) General Photo of the Distribution Panel Arc-fault safety protection is not installed for all of the living and bedroom areas. This protection was required by the National Electric code for homes built after 2008. The Texas Real Estate Commission requires inspectors to list as "deficient" any arc-fault protection not installed in these areas; regardless of the homes age.

White wires connected to breakers should be marked as hot with black or red electrical tape.

"Double lugged" neutral wires on the breaker box neutral bar observed (improper): one neutral wire per connector is allowed.

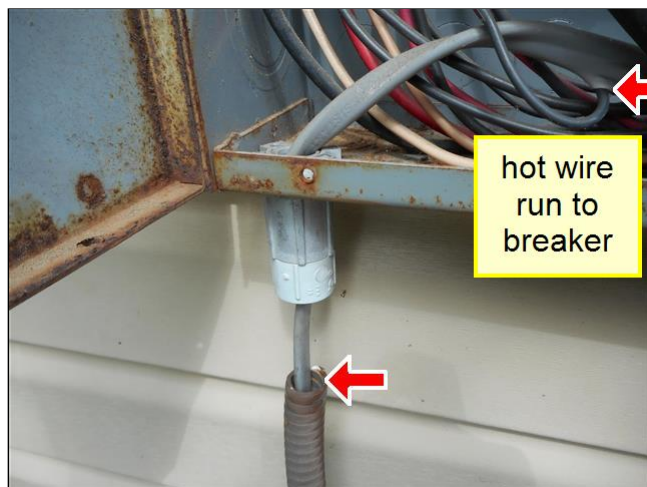
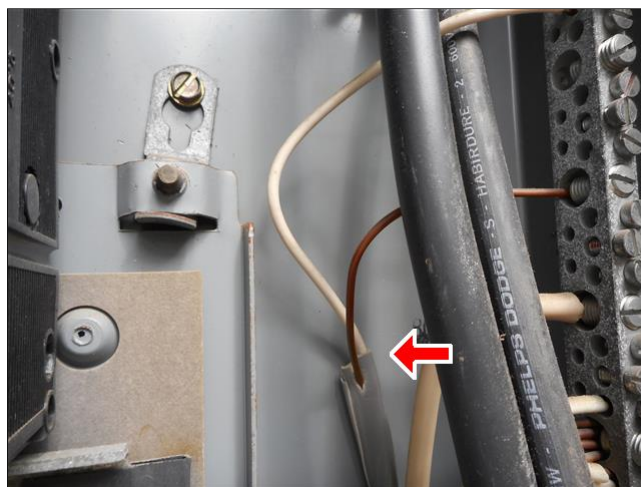
(2) Conduit is not sealed under service panel.

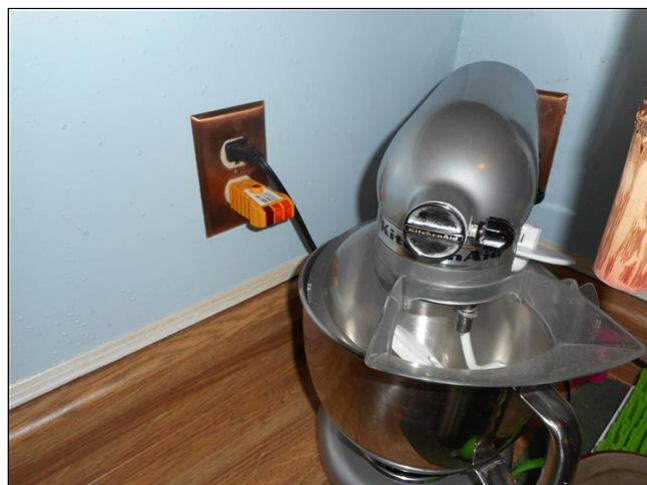
(2) Current building standards recommend installation of ground fault protection at all receptacles including, but not limited to; all wet areas (within 36" of plumbing fixtures), kitchen, bathrooms, garage, and exterior. NO gfi protection was observed at kitchen.

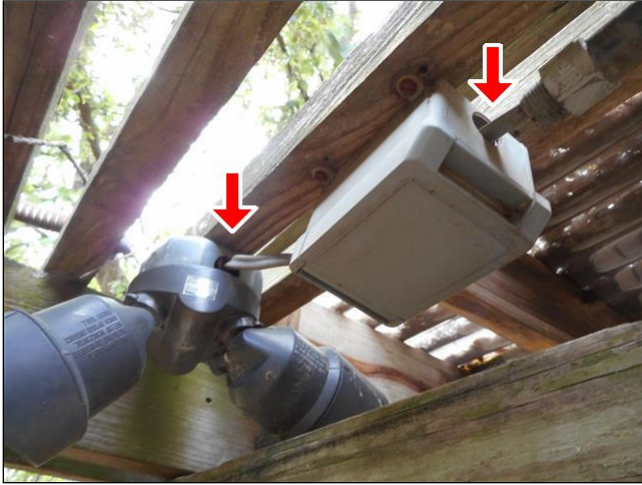
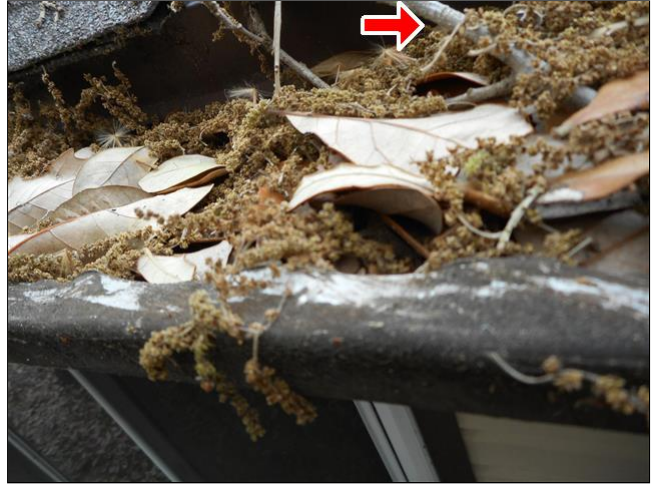
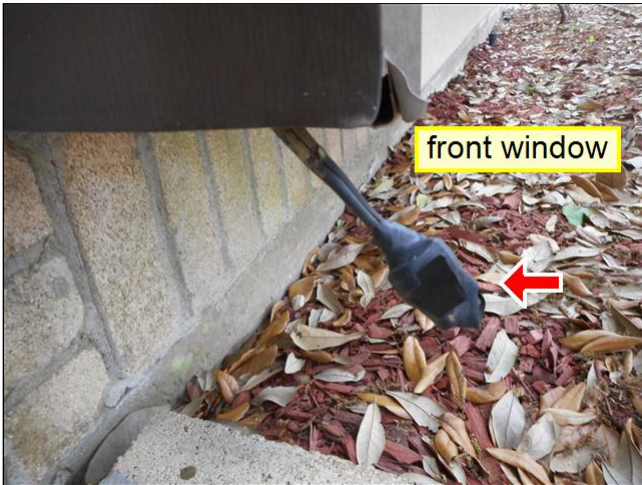
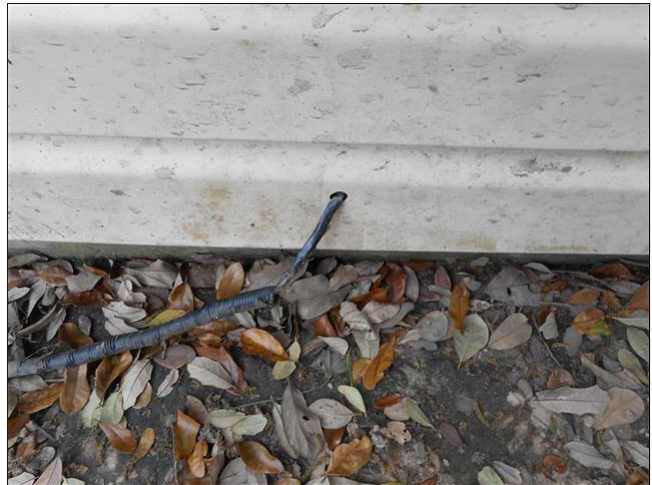
(3) A full evaluation and repair costs estimates by an electrician is recommended due to multiple exterior light fixtures and conduits. Power source for rear patio light fixtures was not located. The fixtures do not appear to be functional. Various wires were improperly run through walls or gutters at rea patio and front and right exterior walls.

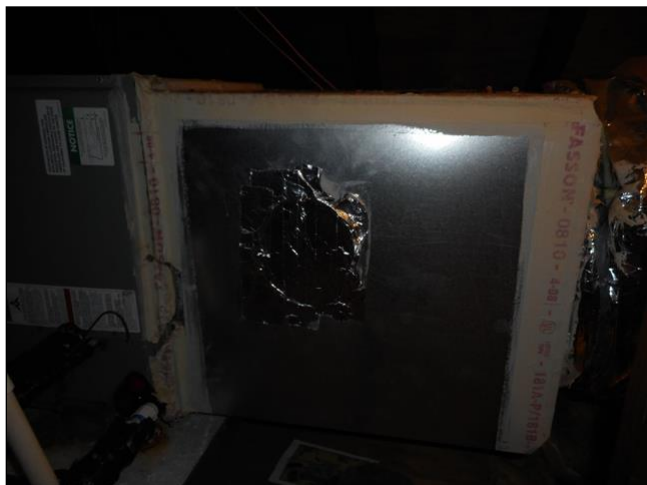
Hole on side of return air plenum should be properly sealed to prevent penetration of unfiltered air from the attic.

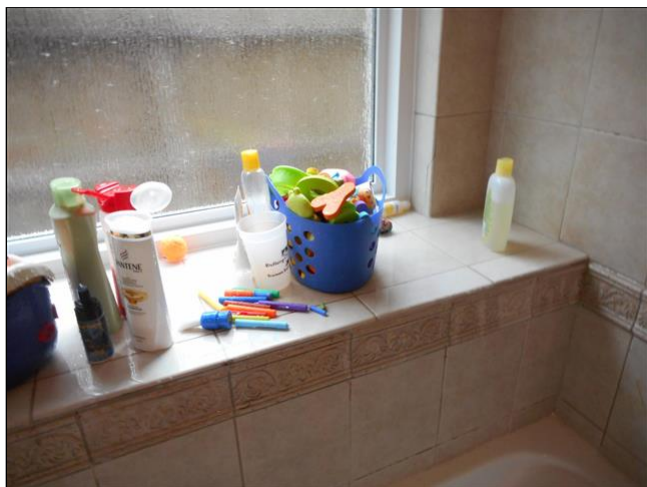
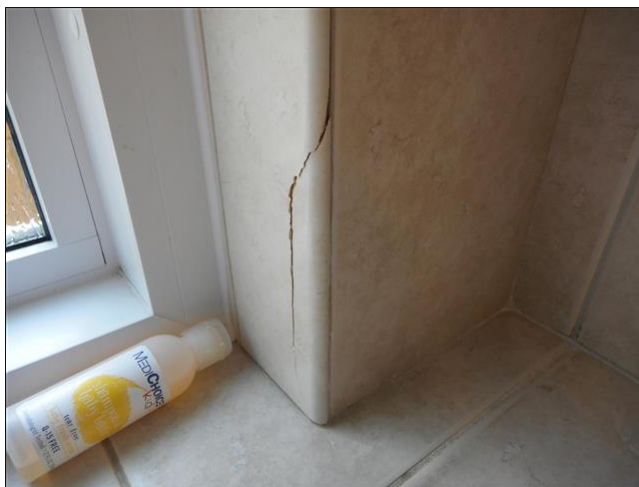
(3) The master shower window stool does not have proper slope towards the tub to direct water away from the window. Water was observed penetrating through window frame during shower use. Cracked tile was observed at right side of window.

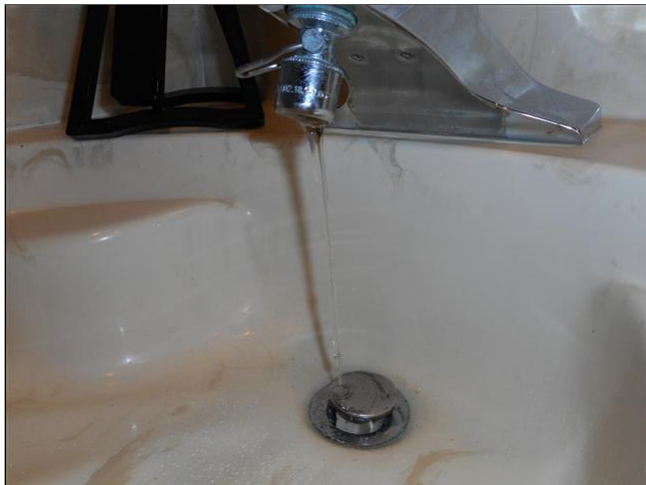
(4) Water flow is very weak at master bath left lavatory.

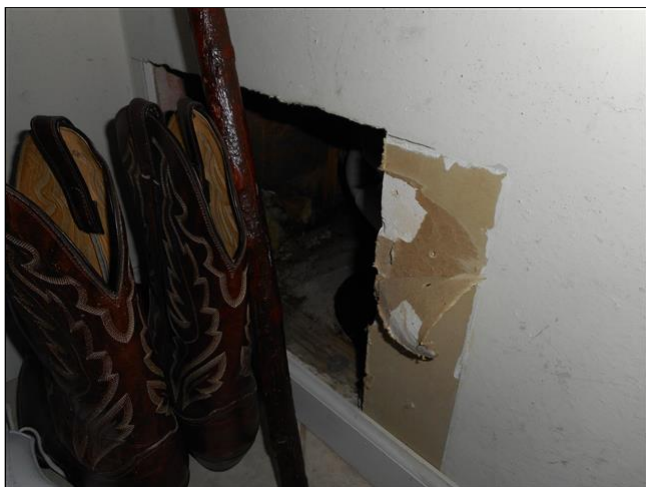
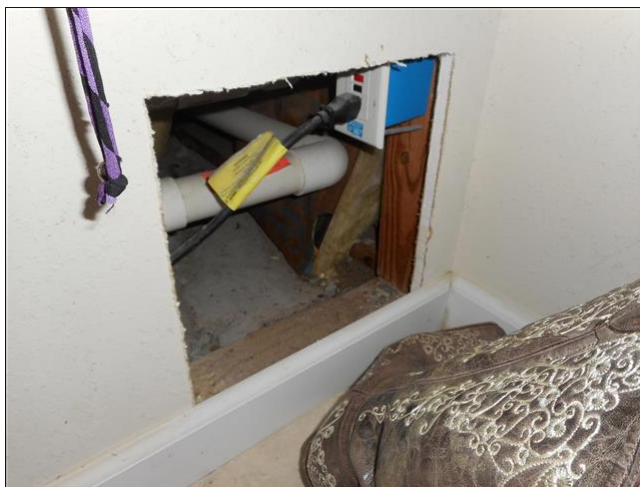
(5) Access panel covers are missing from master bathtub area.

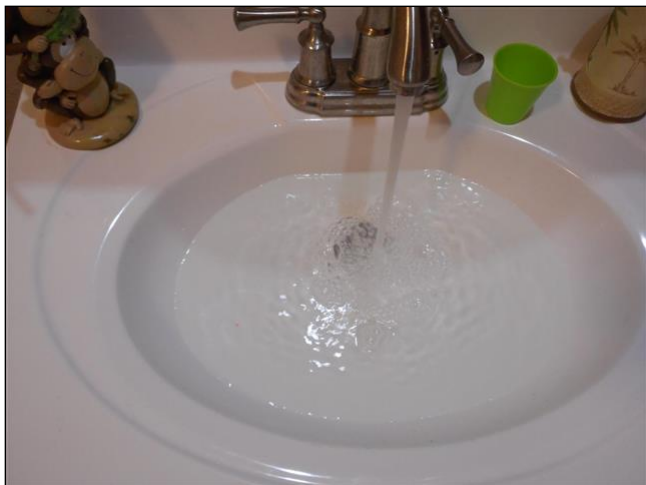
Location(s): hall bath lavatory

(2) Slow drainage was indicated. The cause could not be determined. Evaluate and remedy as needed.

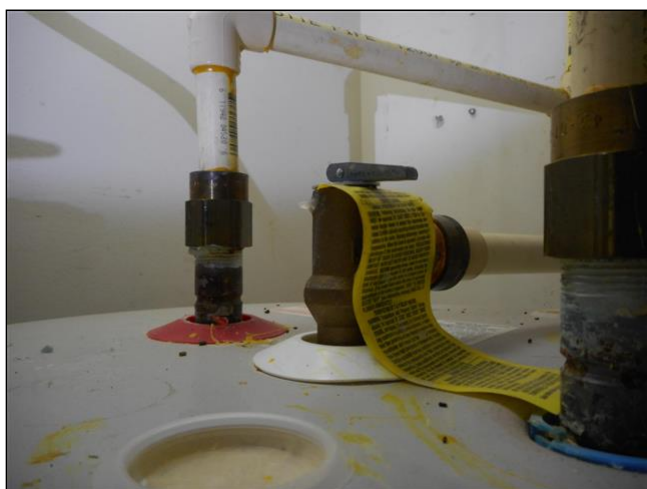
(3) Note: The manufacturer recommends replacement of the TPR valve every three years to ensure proper emergency function. Inspection company does not test TPR valves due to safety hazard or possible damage to unit.

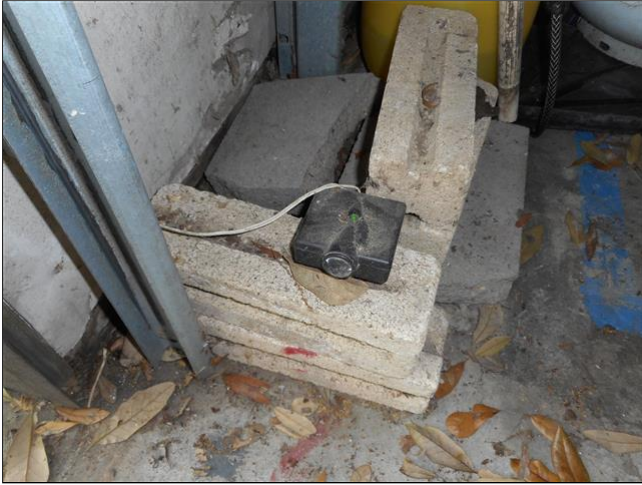
The safety beam sensors are improperly located.

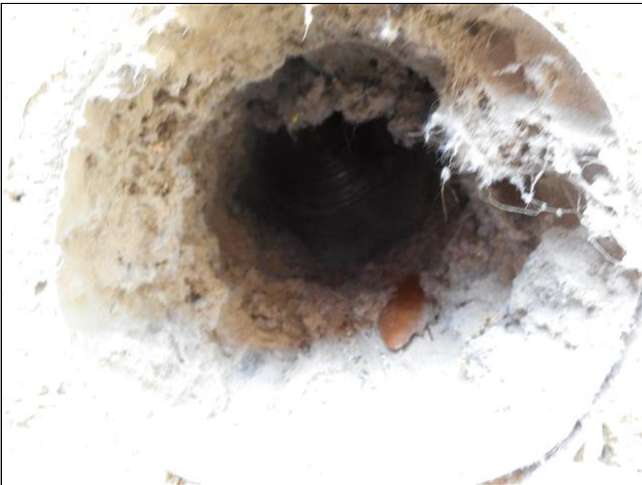
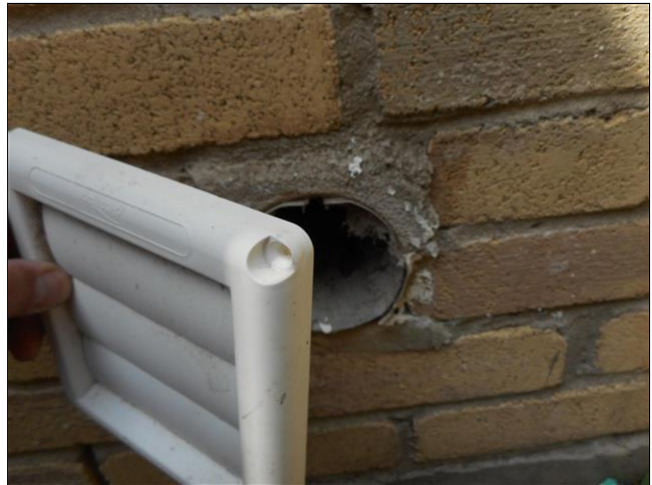
Cleaning of the dryer exhaust vent is recommended as normal maintenance and to prevent excessive lint build-up in the line. Vent cover should be secured.

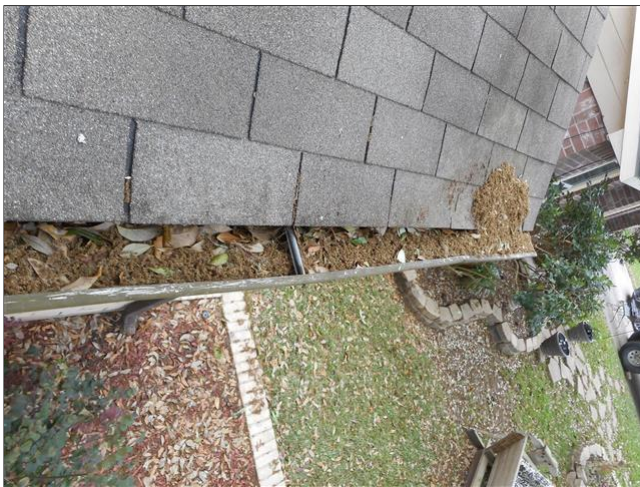
Replacement of any missing splash blocks at the base of all guttering downspouts is recommended to prevent soil erosion.

Gutters should be cleared of debris for proper drainage.

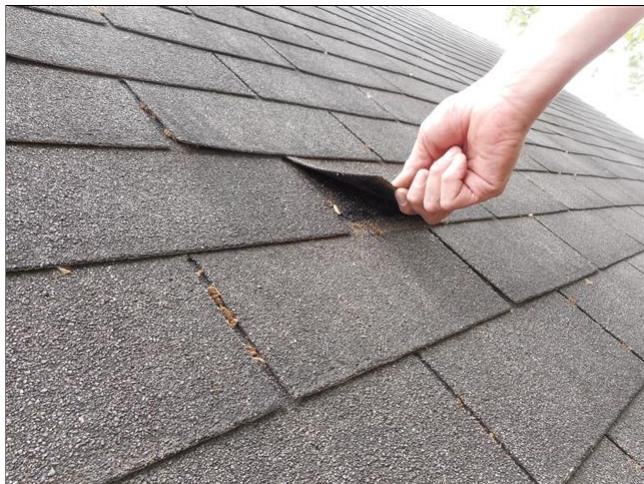
(3) There is physical evidence of shingle lift at multiple areas of roof covering. This is typically caused by high winds that lift the shingles but do not rip them off. These shingles do not re-adhere leaving them vulnerable to additional lift in high wind situations.

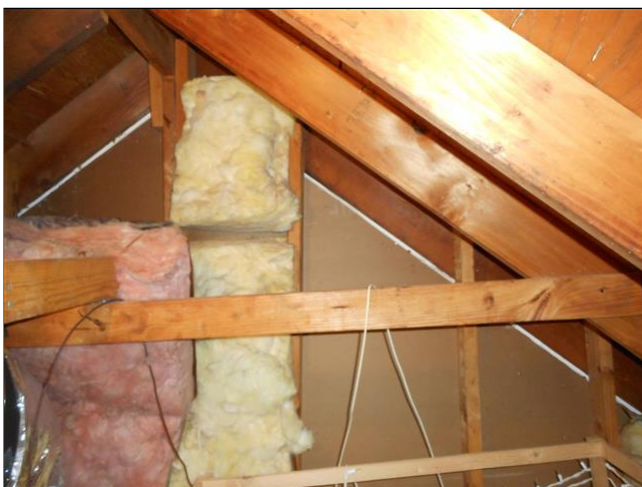
Location(s): random areas

(3) Noted vertical batt insulation that appears to have pulled away from the wall. For maximum R value, the insulation should be installed flush to the drywall.

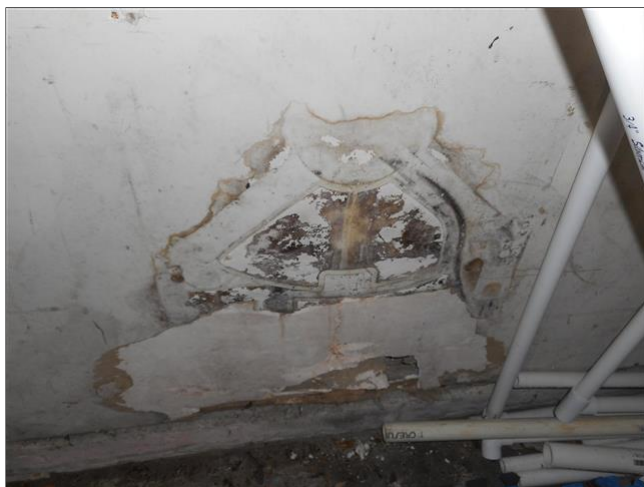
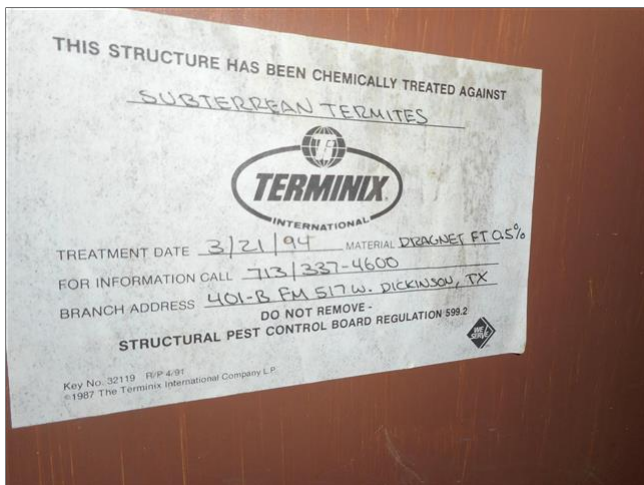
(3) There is evidence of prior possible wood destroying insect activity on garage left wall. Recommend inquiry with seller for any treatment or warranty documentation.

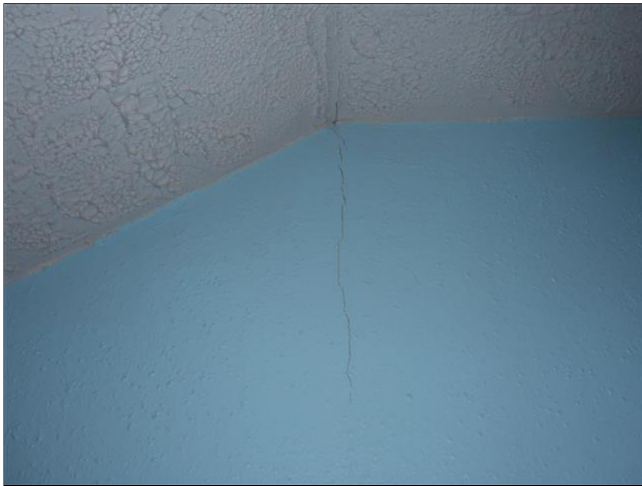
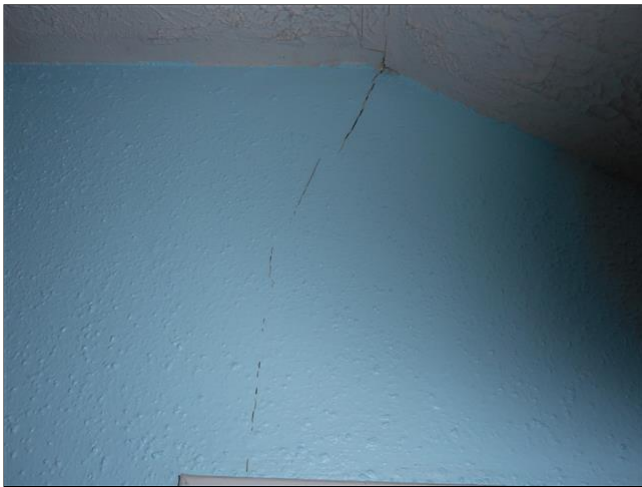
Location(s): Multiple Locations

(4) Stress cracks are observed on the interior drywall. This is consistent with the structural movement of the home.

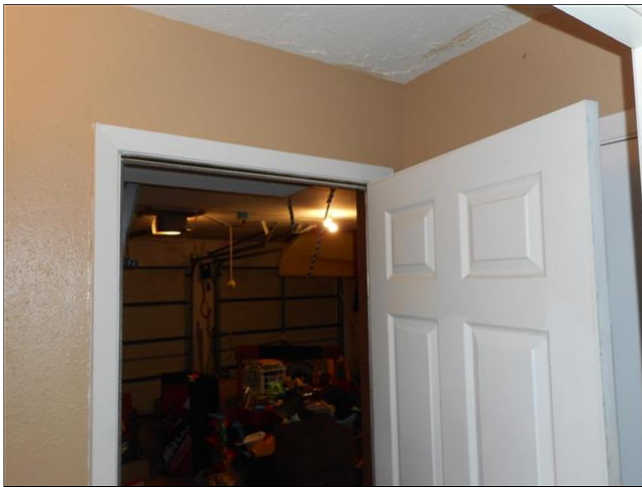
(1) Doors between the garage and residence should be equipped with a self-closing device to secure the door without the use of manual force.

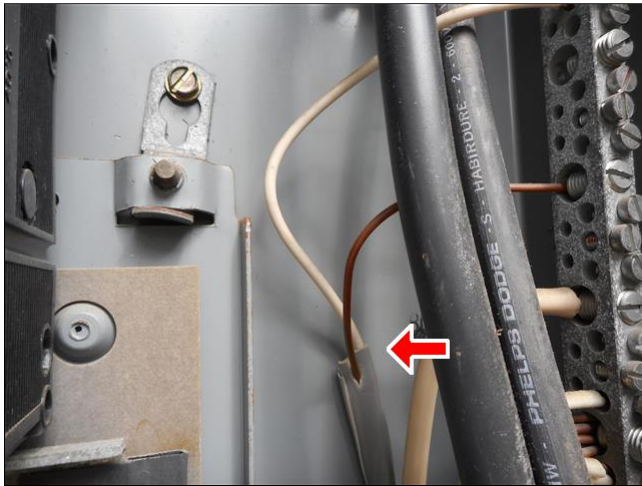
(2) Conduit is not sealed under service panel.

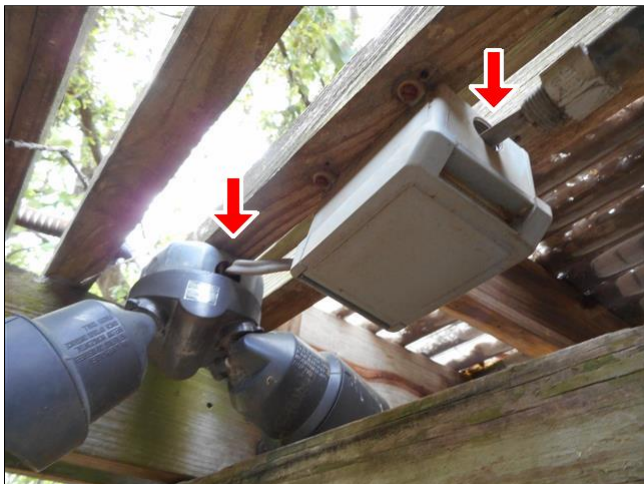
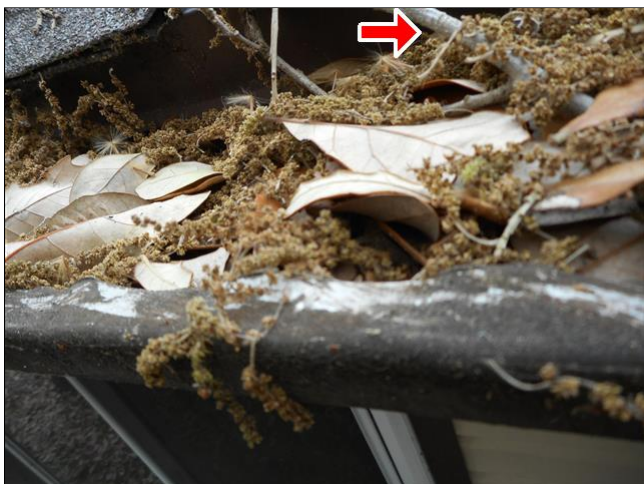
(3) A full evaluation and repair costs estimates by an electrician is recommended due to multiple exterior light fixtures and conduits. Power source for rear patio light fixtures was not located. The fixtures do not appear to be functional. Various wires were improperly run through walls or gutters at rea patio and front and right exterior walls.

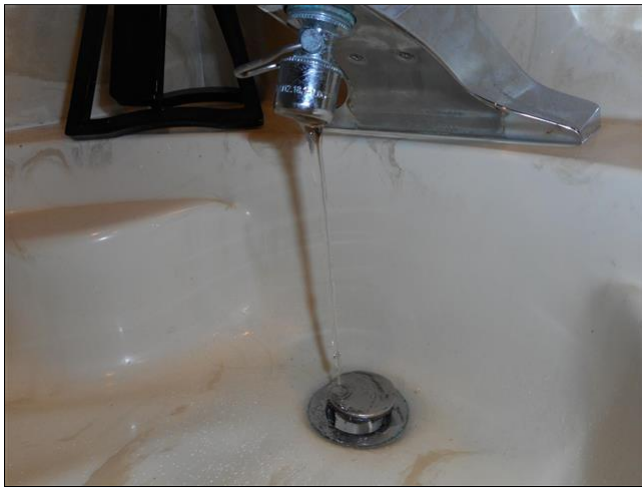
(4) Water flow is very weak at master bath left lavatory.

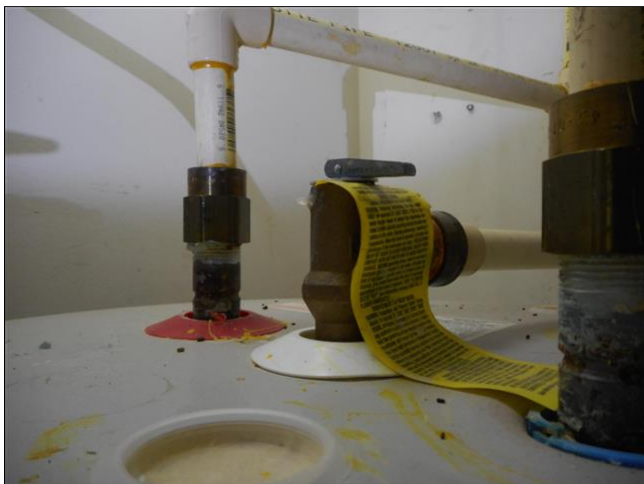
(4) The overflow pan and tpr drain lines should be routed to terminate at exterior.

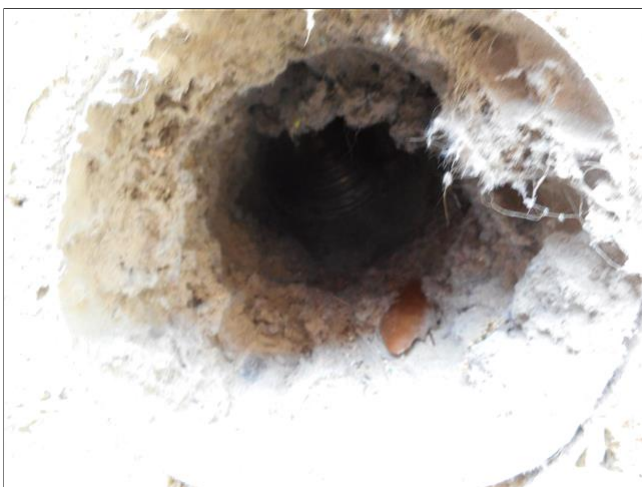
Cleaning of the dryer exhaust vent is recommended as normal maintenance and to prevent excessive lint build-up in the line. Vent cover should be secured.
