PROPERTY INSPECTION REPORT

Concerning: 2412 Helena St., Houston, TX. 77006
(Address or Other Identification of Inspected Property)

By: Rudolph Depena & Martha Kaplan Lic. 5191/5863 04-10-2018
(Name and License Number of Inspectors) (Date of Inspection)

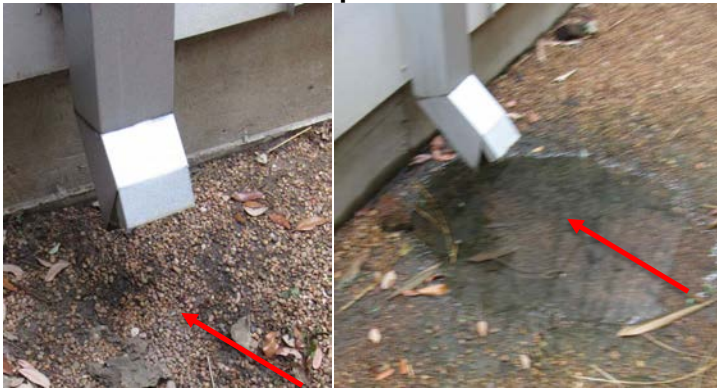
D - The rear gutters downspouts elements are in need of a splash box and/or extension vinyl drain pipe, or connection to a drainage system if one is installed. Currently they are discharging to the ground creating depressions/dips too close to the foundation perimeters.

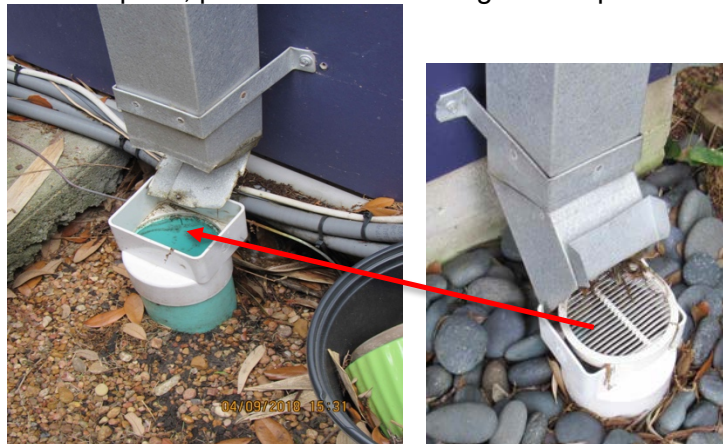
- The underground drain system standing pipes lacks a grate over it, to prevent debris entering the pipe. The north downspout at the garage is discharging directly to the drain pipe. Recommended to place the grate as visible at the north side close to the covered patio, preferable in a rectangular shape to fit the adapter.

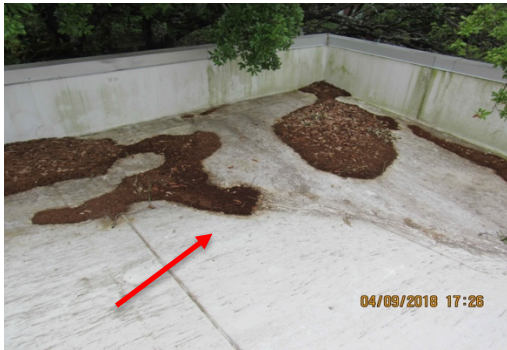
Debris needs to be cleaned at all times and observation of those areas of retention for proper storm water discharge. Cut tree branches over the roof area. **Professional in the field to further assess roof surface when debris is removed.**

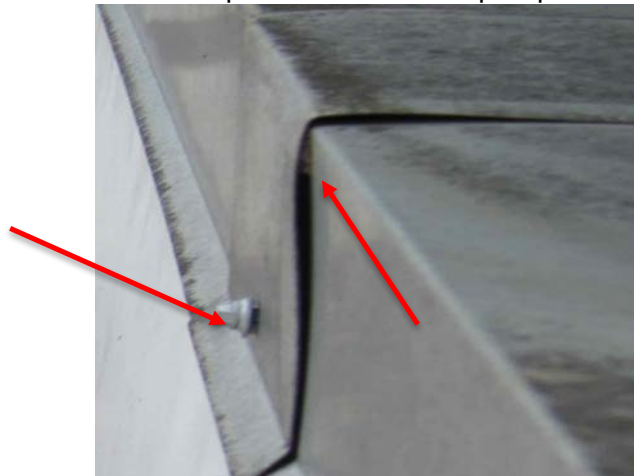
- Parapet metal caps in some areas are not properly fasten (loose) and unseal joints/lifted where gaps are visible. Avoid water intrusion to other components of the wall/parapet.

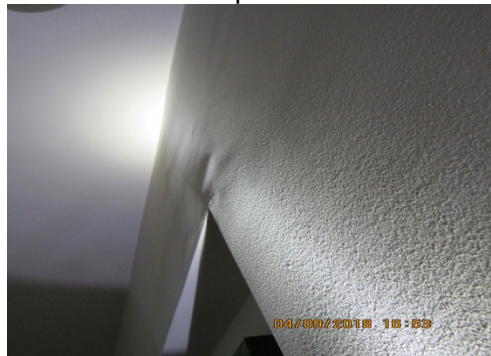
NOTE: It is view that some interior walls have not been finished with plumb installation of sheetrock. This area was visible with small humps. It is always recommended to finish with level 5 any high and large areas of drywall, to obtain aesthetic acceptable interior envelope-wall surface.

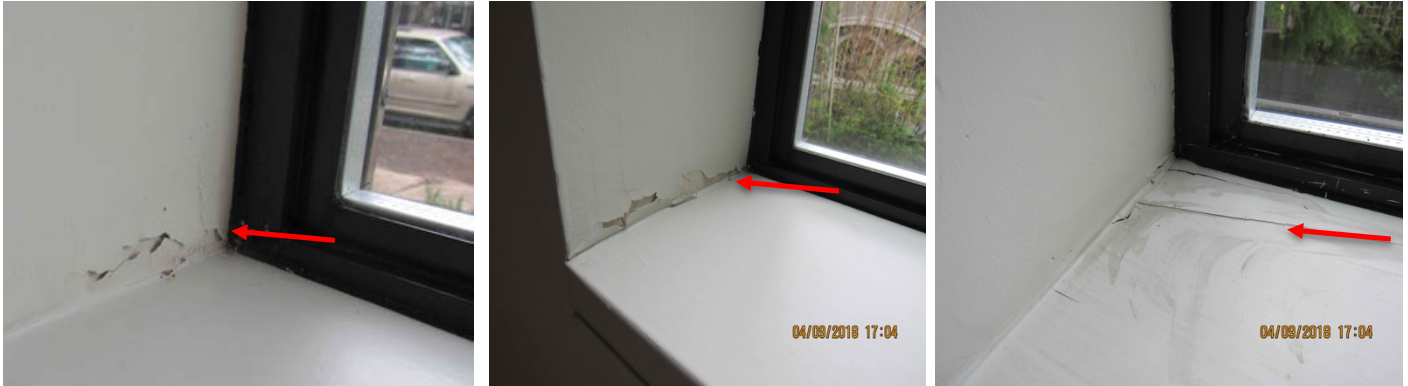
D - Peeling/flake of sheetrock paint is not noted at 1st floor dining room window jamb area and to most of the windows and stools of the second-floor hallway north windows. These appear to be moisture build-up due to change of temperature and/or lack of seal around window frame.

- Re-seal around all windows (exterior and interior is highly recommended, due to the moisture exhibit at the window jambs in different areas. See exterior wall section for further comments.

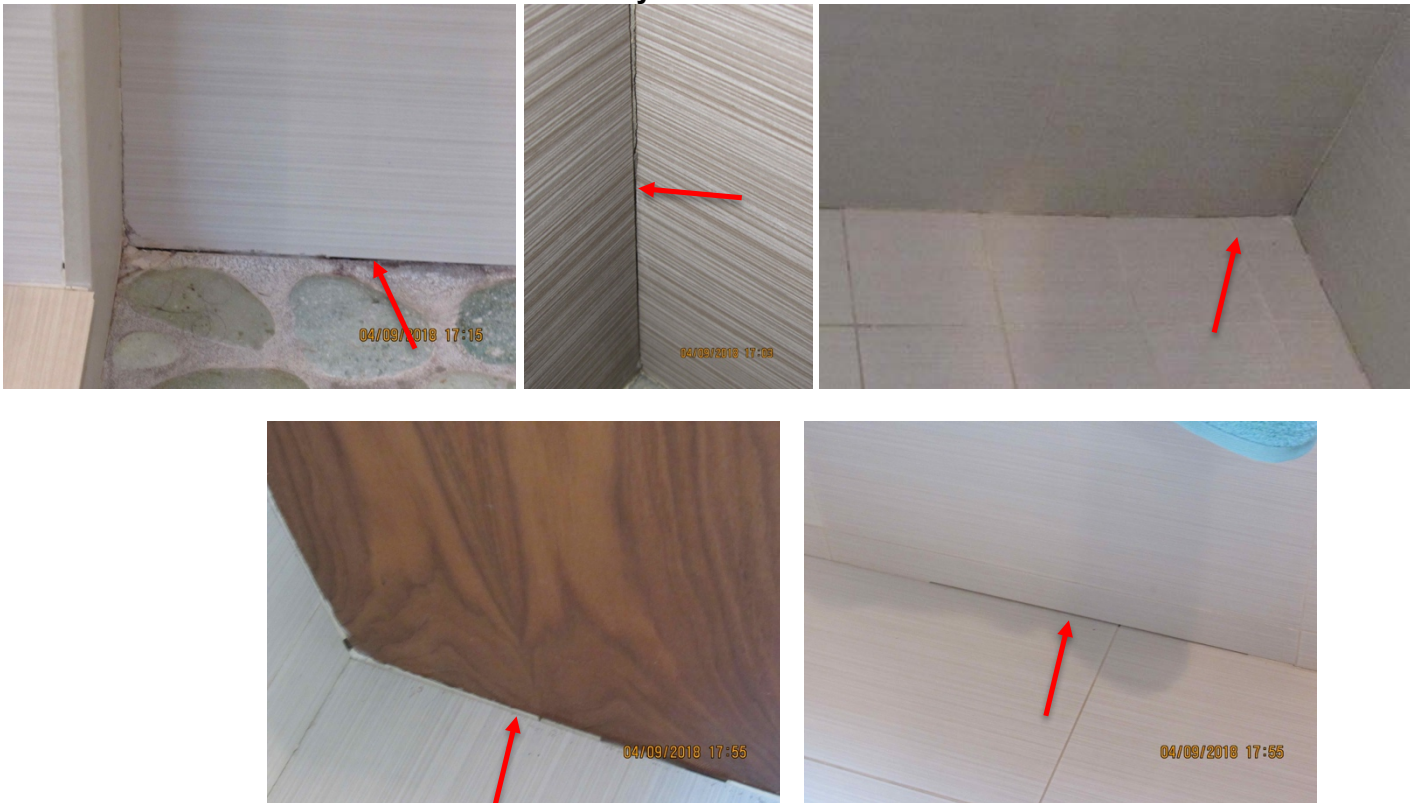
- Seal and/or re-grout all showers pan and inside corners tile surround at the bathrooms, including floor/tile transitions at the master bathroom against the wall and base cabinet. Avoid water seepage and deterioration of other interior components of the wall/floor systems.

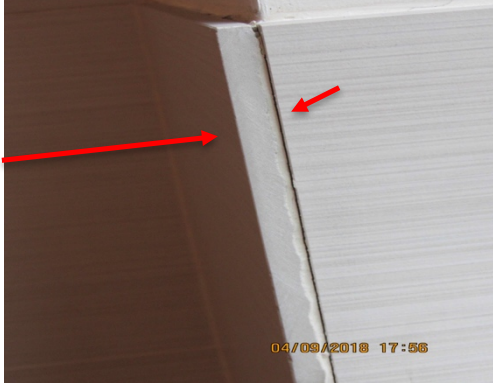
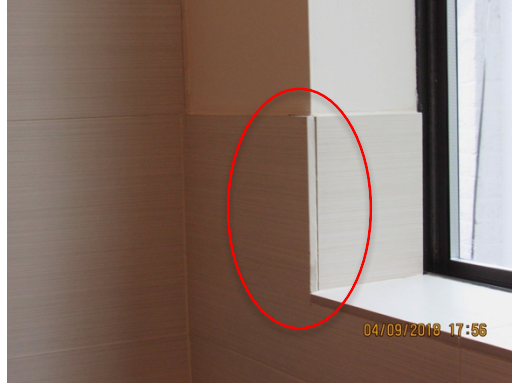
D - Loose tile close to the window at the master bathroom.

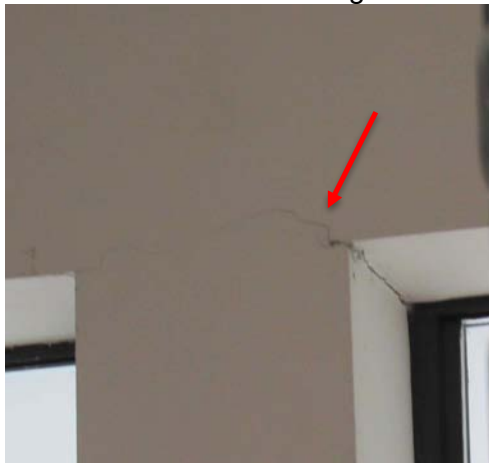
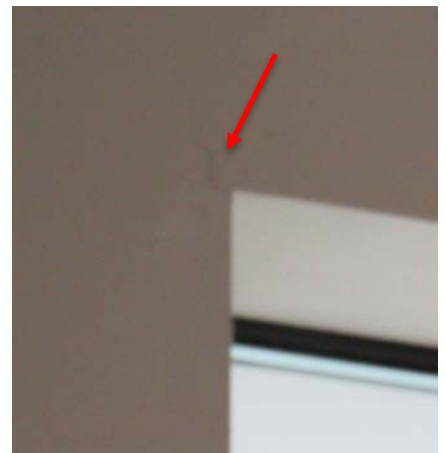
- Fractures is noted to the wall between top area and left side of the window at the west wall of the main entry. This may be considered related to common settlement of foundation, not limited to expansion and contraction of wood framing with changes of temperature.

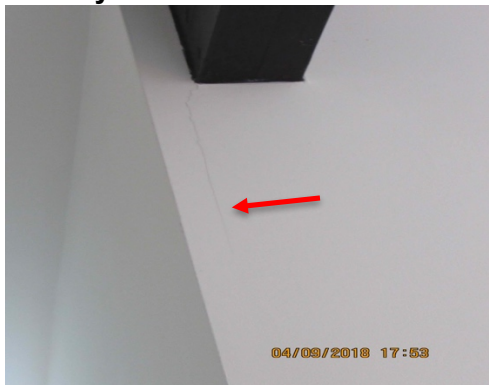
- Corner bead with minor fracture at the wall of the second-floor hallway area.

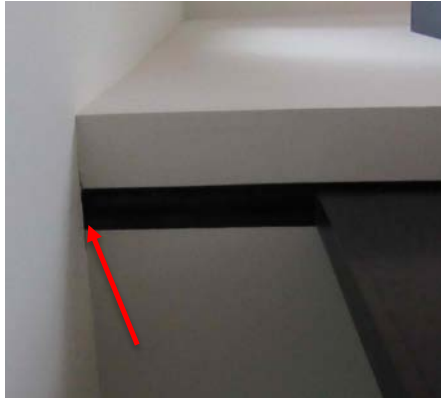
D - Fracture at transition of the pony wall/ceiling and south wall between living and media room over the pocket doors. Appear to be cause by pocket door striking the wall. Recommend door stopper control at floor level.

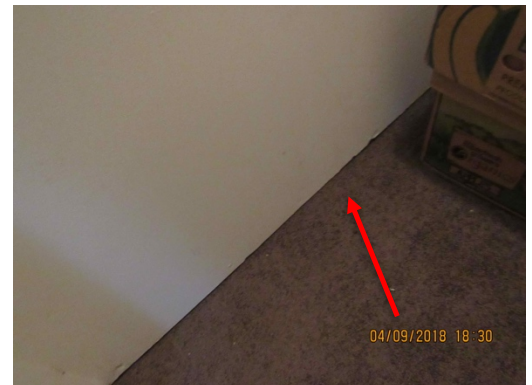
- **Damage to the paint surface at a master closet shelves.** Restore surface as needed.
- **Interior closet located next to the door from house to garage is in need of base molding element.**

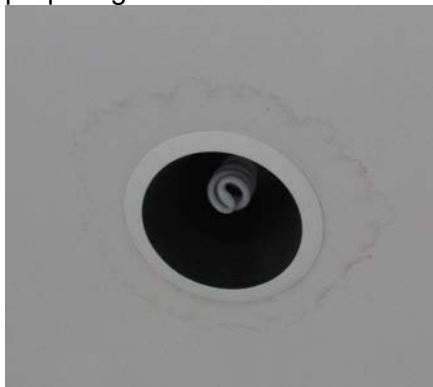
D - Soffit over the N.E. balcony above the garage around a recess light has moisture stain. This may be a reaction of the drywall with changes in temperature offer by the type of bulb in place with concentration of moisture in the area. Recommend to restore soffit surface and place proper light bulb for exterior use.

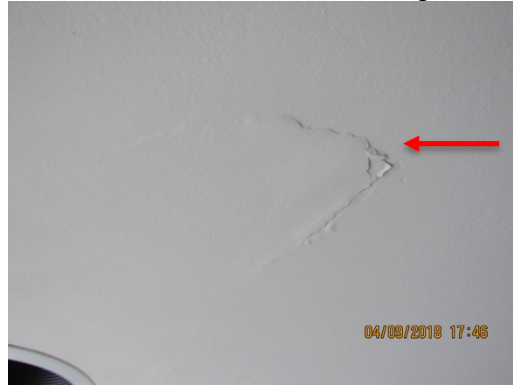
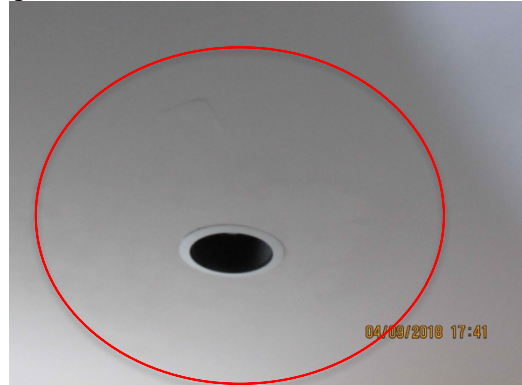
D - Improper repaired patch finish is noted at the N.E. bedroom ceiling.
Damage to the ceiling from undetermined condition may have occurred around the ceiling recess light at the N.W. area.

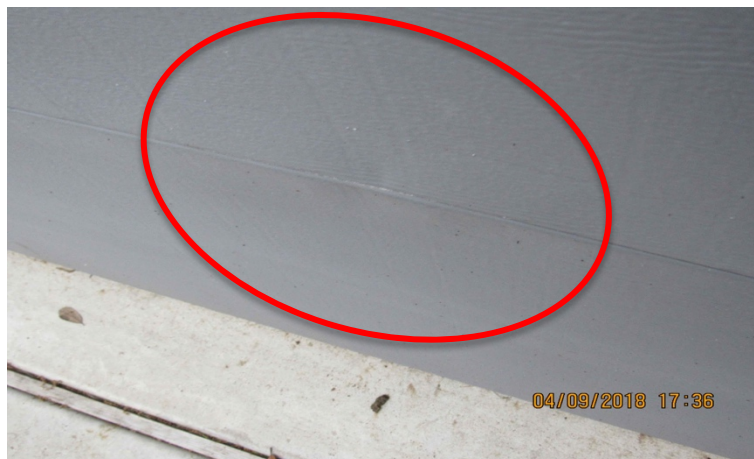
- Garage door buckled/damaged is noted at the bottom panels. Replace/restore door panels as needed.

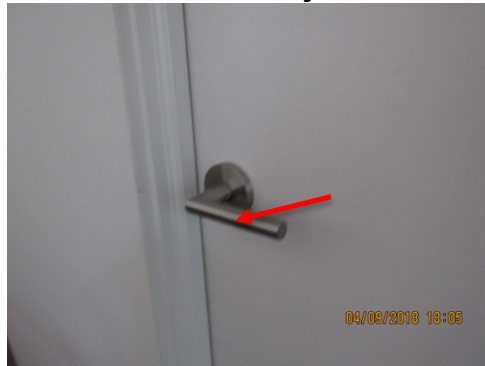
- Handle to the Laundry door is loose. Secure handle.

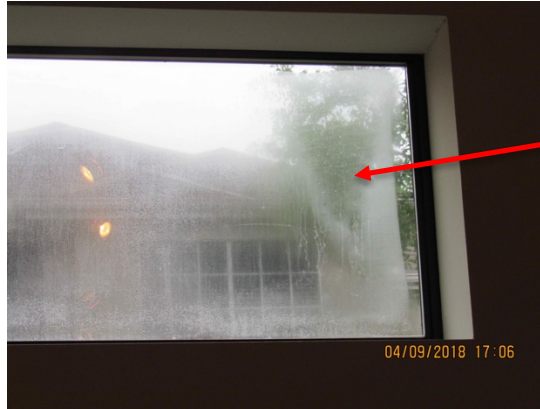
D - Air leak (fogging or moisture) indication is noted between panes at the master closet window. Professional in the field to replace unit.

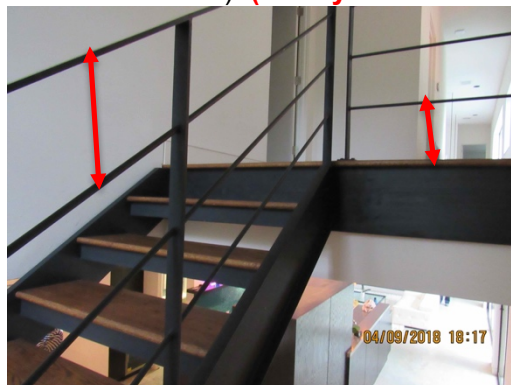
D - Stairway railing spacing are approx. 7" in between. Per Current codes required railing guards on stairways and porches shall be constructed to not allow passage of a 4 inches diameter sphere (to be 4" in between). **(Safety for children)**

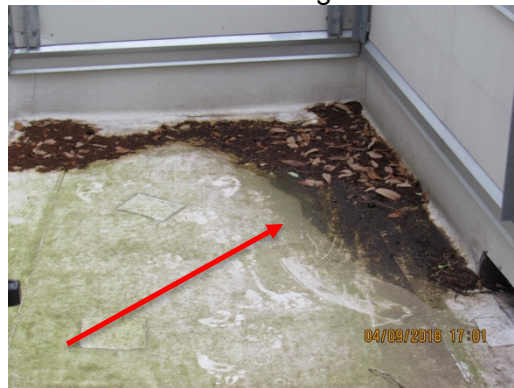
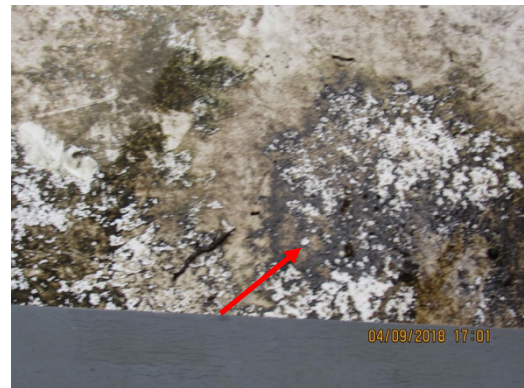
D - The Northeast balcony floor cover with white rubber/plastic membrane material is visible with water retention at the N.W. corner of this mention area. It is highly recommended to clean the debris first. If water and debris continues to accumulate during heavy storms, it is highly recommended to contact a specialist to re-slope the balcony floor for proper drainage to the present Scupper. Specialist to check rubber plastic membrane roofing material under debris for damage at this location.

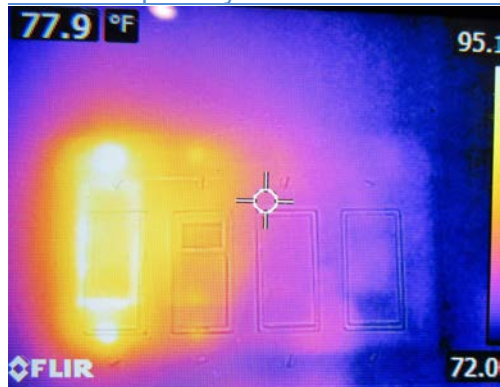
OBSERVATION: Dimmers plate visible with infrared and felt hot when touched indicated increase in temperature in at least two switches at the first floor. Consultation with a Licensed electrician may be recommended to verify the wattage rating of the present dimmers and what is serving. See General Information of "AFCI" ARC-FAULT circuit interrupter breakers under Service Entrance and Panels. [ARC-FAULT BREAKER is for Safety or Fire hazards of the electrical system circuit adopted by NEC current standards.](#)

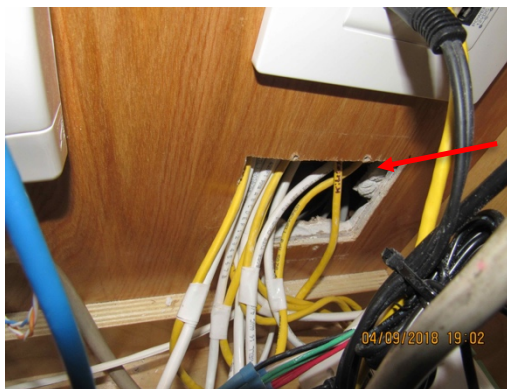
- Within the S.E. closet built in cabinet, the communication wiring does not have adequate box for wires to traveling from interior of the wall into the cabinet.

Electrical system Repairs and Evaluation are to be done with a Licensed Master Electrician.

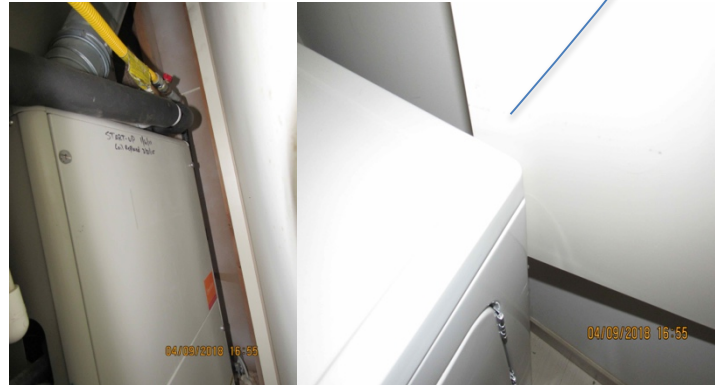
FURNACE.

Drip leg is not visible on the gas line of the furnace. An inverted "⊥" connection to the gas line close to the flex line. (manufactures requirements)

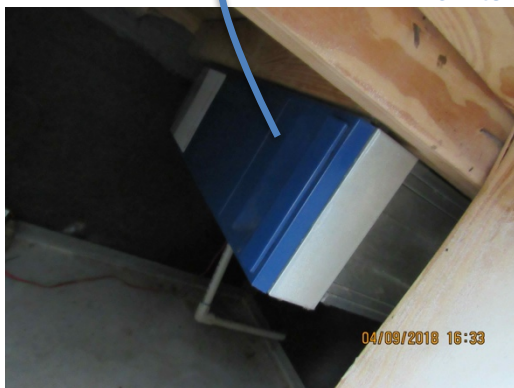
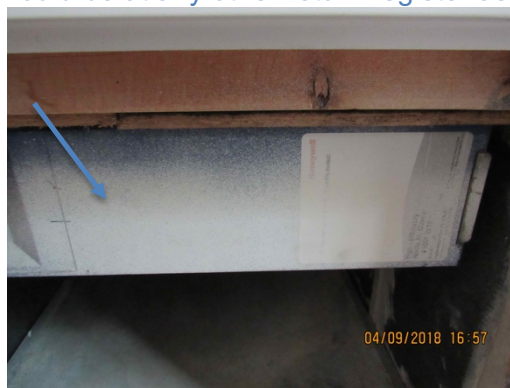
No filter should be at any other return register as visible at the N.E. bedroom.

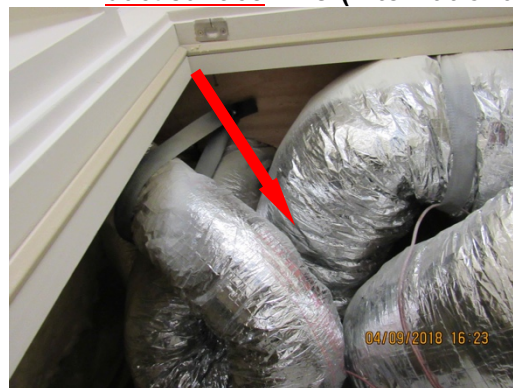
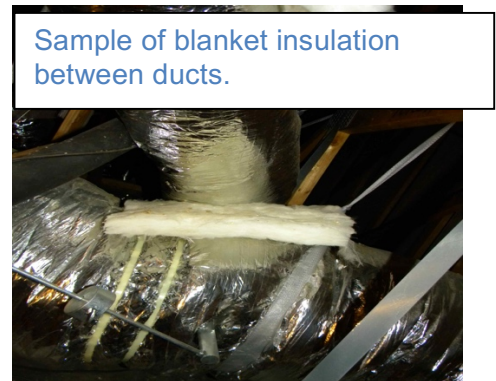
D - At the intersection of the condition air ducts in contact it is recommended to place a piece of blanket insulation. Aluminum flex ducts in contact with each other in the hot humid environment of the attic transmit electrostatic heat flow (heat transfer) throughout the aluminum surface of the duct promoting the cold ducts in contact causing moist air to drop below dew point dropping condensation in a water form from the duct surface. IRC (International Residential Code) M1601.2

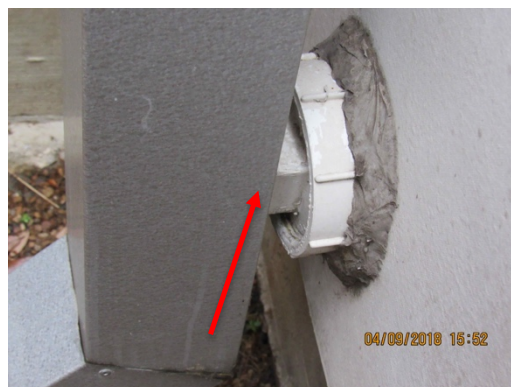
OBSERVATION: Wall cleanout at the south side is obstructed for any access due to the gutter system downspout element, placed in front.

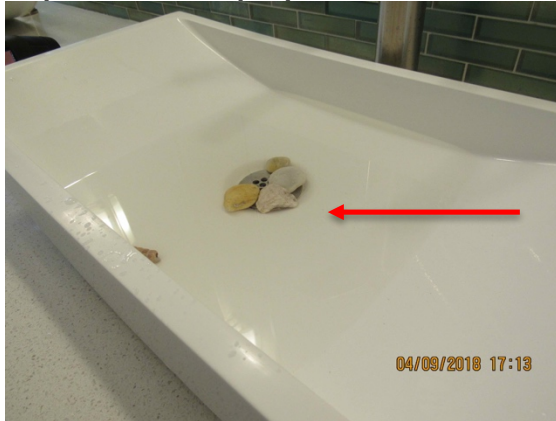
D - Minor clog is present when the right master lavatory was tested. Flow of water into the lavatory exceeds the rate of drainage. Clean trap first. Check proper connection of the drain stopper lever.

A Licensed Plumbing technician should conduct evaluation and repairs when needed.

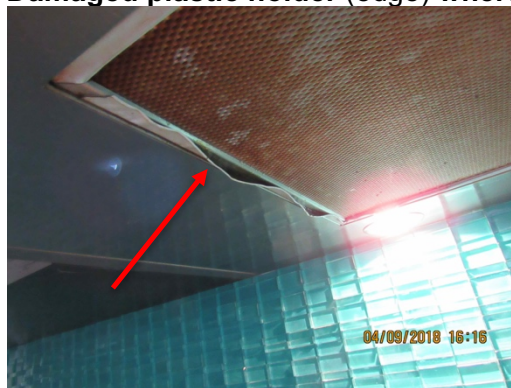
D - Damaged plastic holder (edge) where Range hood filter rest.

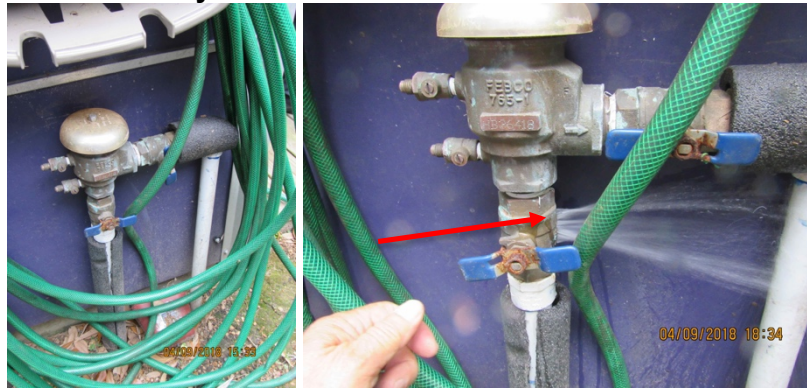
D - Replace the vacuum breaker and insulate fully the entire piping of the system.

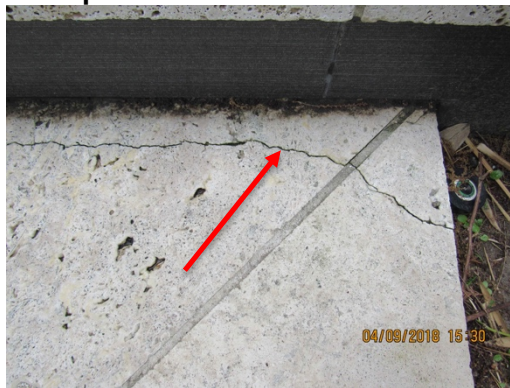
D - Multiple Coping stones-tiles with fractures are in need of seal or replacement.

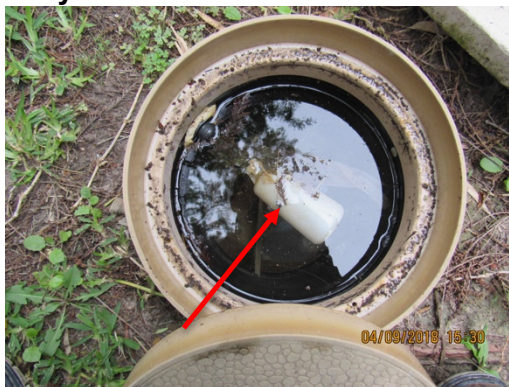
- Dirty Skimmer.
