SEC PROPERTY INSPECTION SERVICE**7457 HARWIN DRIVE STE. 230 HOUSTON, TX. 77036, PH:- DIRECT(713)-498-6393, OFF: (713)-510-4461****PROPERTY INSPECTION REPORT****Prepared For: NICHOLAS PAGE**
(Name of Client)**Concerning: 2241 N. MACGREGOR WAY HOUSTON, TEXAS 77004**
(Address or Other Identification of Inspected Property)**By: HENRY I. IJOMAH, CEI, CEC** **04/28/2021**
Civil/Structural Engineer
Professional Inspector Lic. # 4459
(Name and License Number of Inspector)

PROPERTY INSPECTION SERVICE ADDED COMMENTS FOR REI 7A-0 2241 N. MACGREGOR WAY HOUSTON, TEXAS 77004

Date: April 28, 2021.

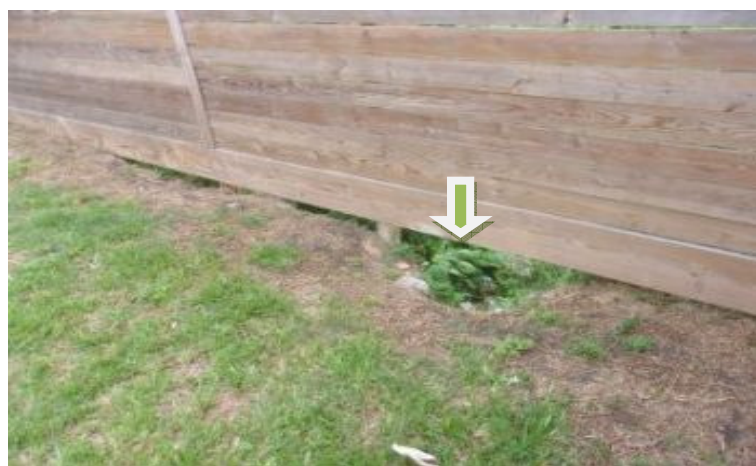
Photo #3

- ▶ The grade at front right side by the fence is gradually eroding away. Needs to be improved. (Photo #3)

The grade at right by the fence is eroding away. Needs to be improved.

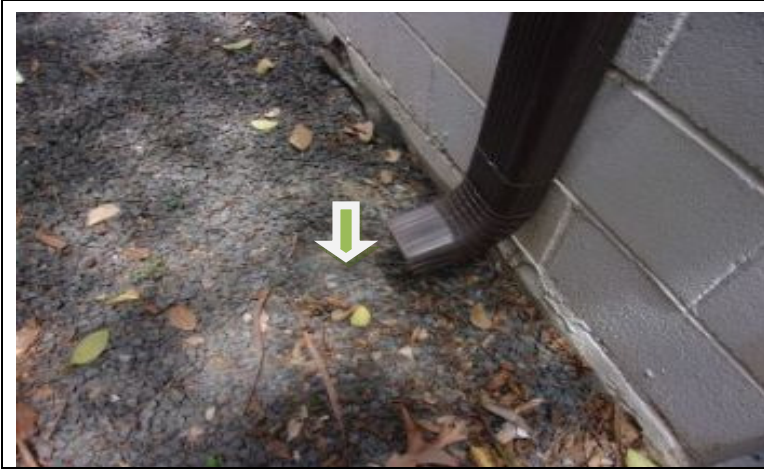
- ▶ The downspouts at front and rear are missing splash plates. Install splash to channel rainwater away from the foundation. (Photo #4)

Photo #4
All the downspouts around the house are missing splash plates. Needs to be installed.

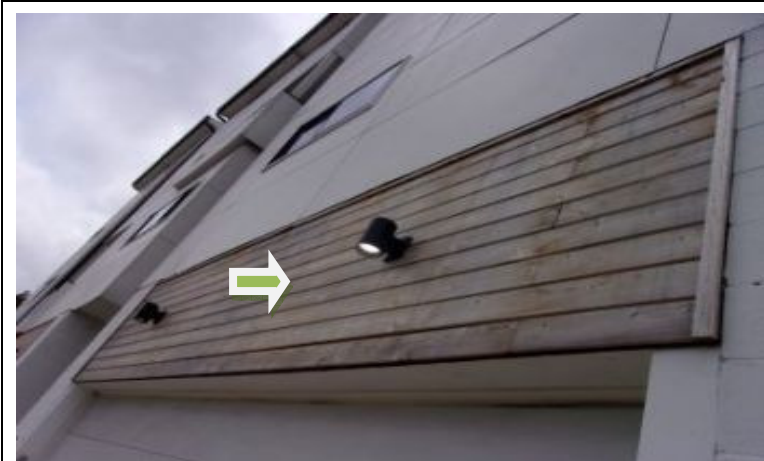
- ▶ The wood siding above garage door needs to be painted/treated to protect against rots. (Photo #5)

Photo #5
Wood siding above garage door needs to be painted/treated to prevent rots.

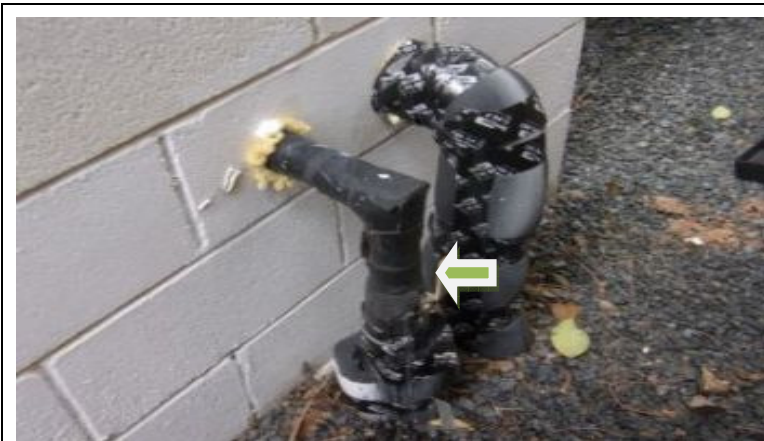
- ▶ Main water supply pipe is broken. Needs to be repaired. (Photo #6)

Photo #6
Broken pipe at main water supply line.

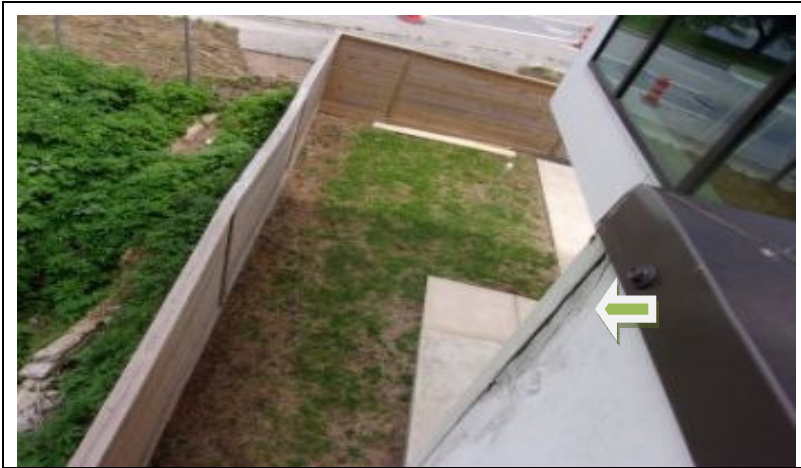
Photo #7

- ▶ Rotted wood at side of second floor balcony. (Photo #7).
 - ▶ Moisture stains/damage at balcony. (Photo #8)
-

Rotted/damage siding at 2nd floor balcony.

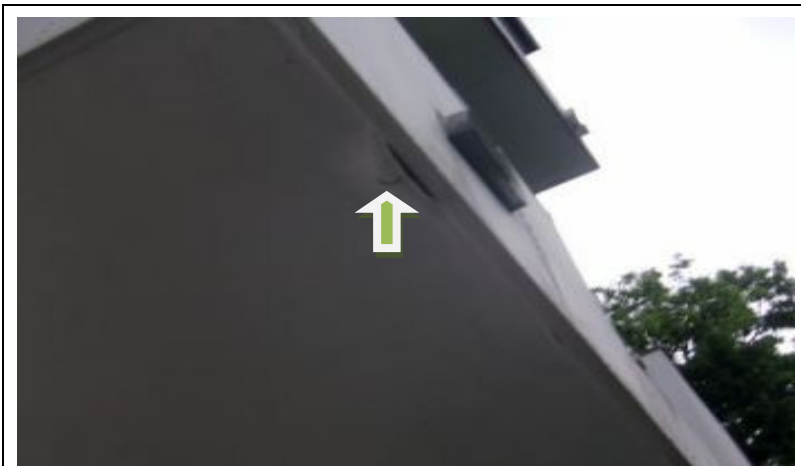
Photo #8

Damaged 2nd floor balcony deck.

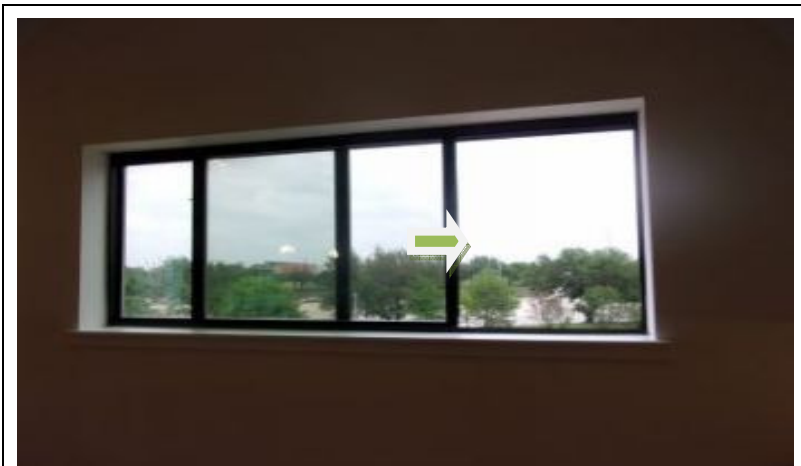
Photo #9

- ▶▶ **General** ▶ All the windows in the house are missing screens. Needs to be installed.
(Photo #9)

All the windows in the house are missing screens.

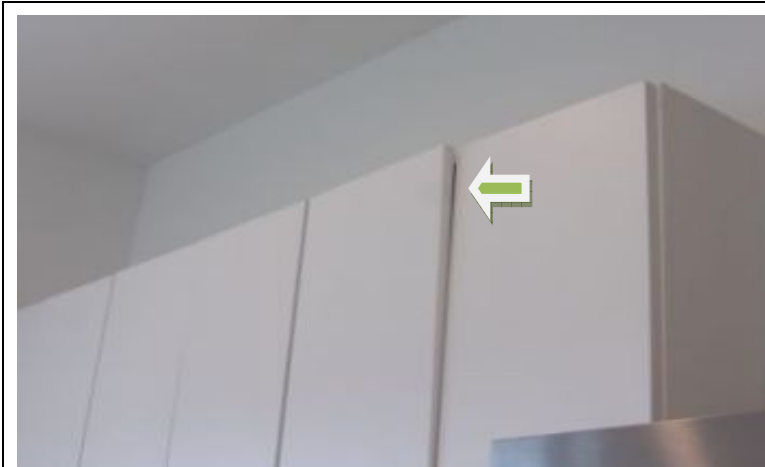
- ▶ The kitchen storage door does not close properly. Improperly installed. (Photo #10)

Photo #10
Kitchen storage door does not close properly. Improperly installed.

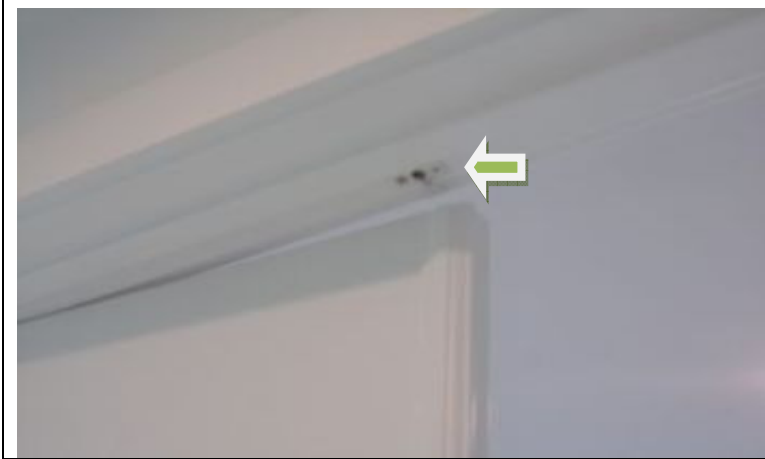
Photo #11
Dead bolt to double door does not lock.

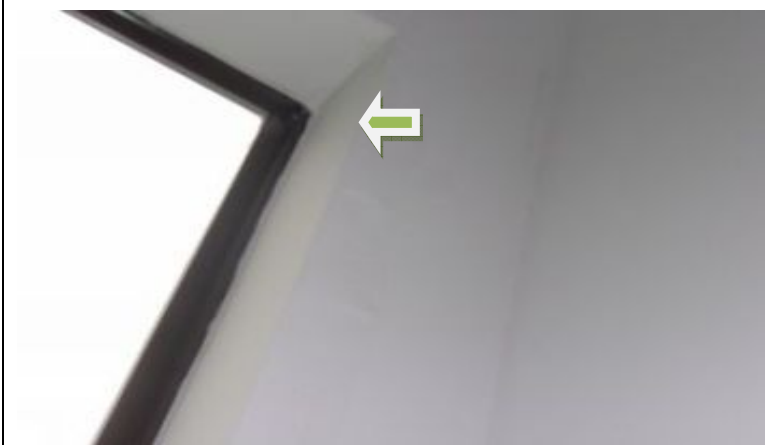
Photo #12
Evidence of moisture stains at master bedroom left window.

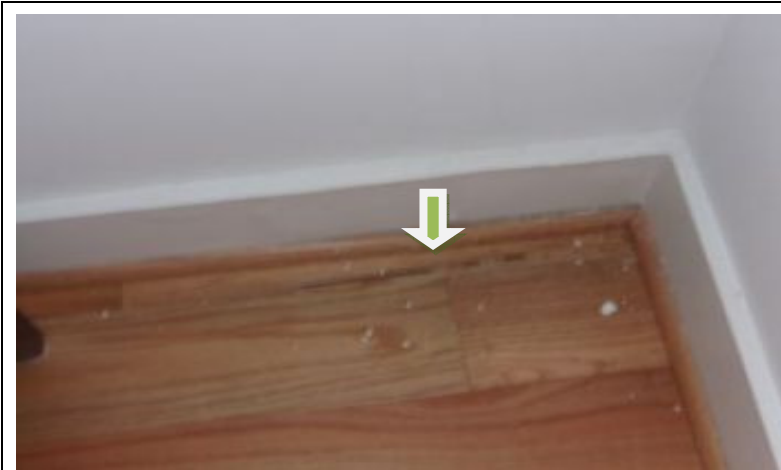
Photo #13

Cracked/damaged wood floor at front left corner of master bedroom.

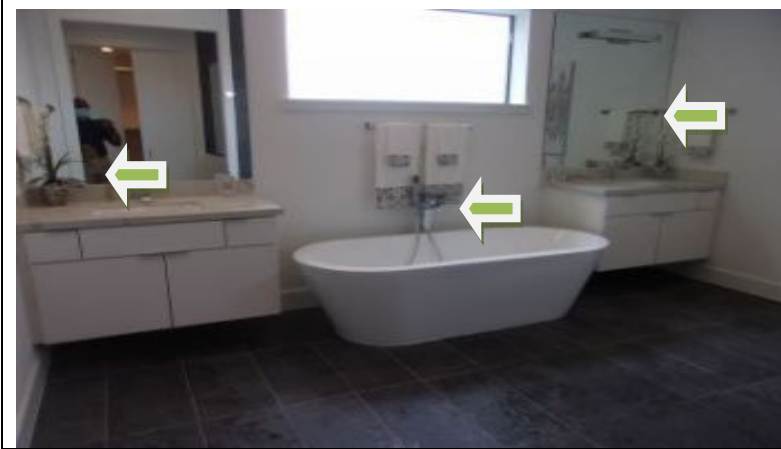
Photo #14

- ▶ The faucets at master tub and sinks shoots water to the floor. Needs to be repaired by a plumber. (Photo #14)

Faucets at master bathroom sinks and tub shoots water to the floor.

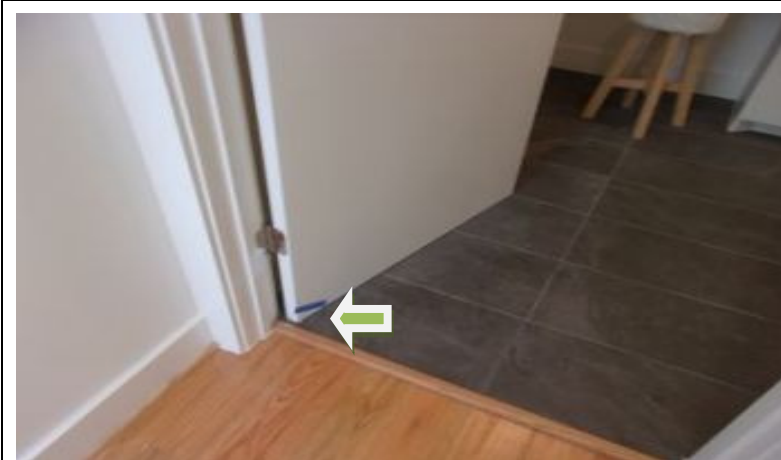
Photo #15

- ▶ Door to the utility room (W/D) does not close. (Photo #15)

Door to utility room (W/D) does not close.

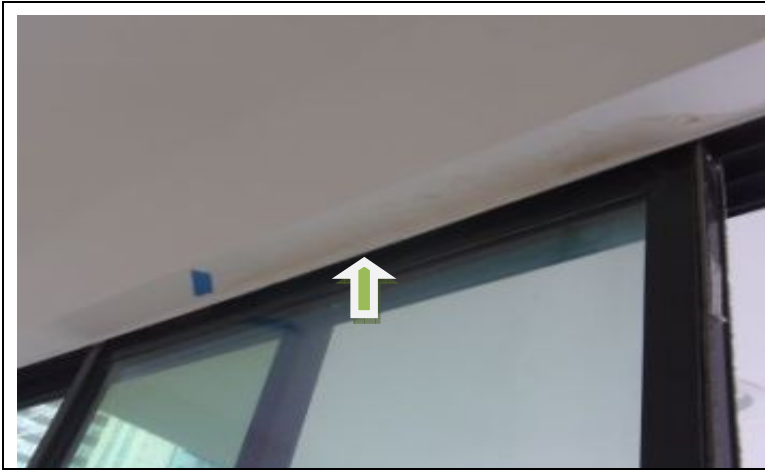
Photo #16

Moisture stains above door to balcony.

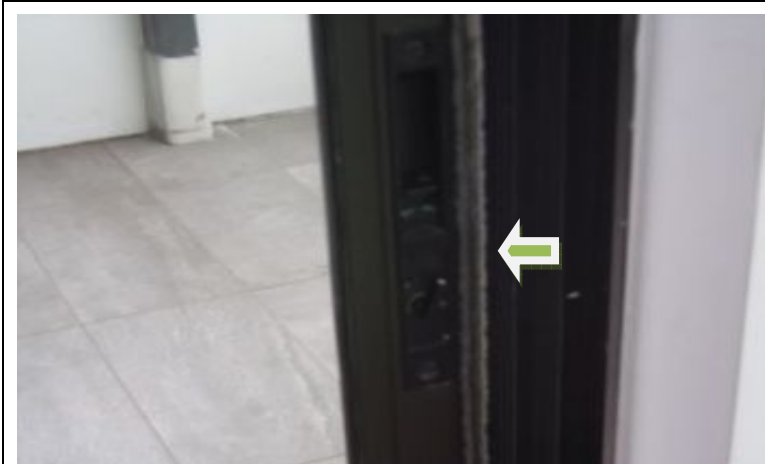
Photo #17

Door to balcony does not lock.

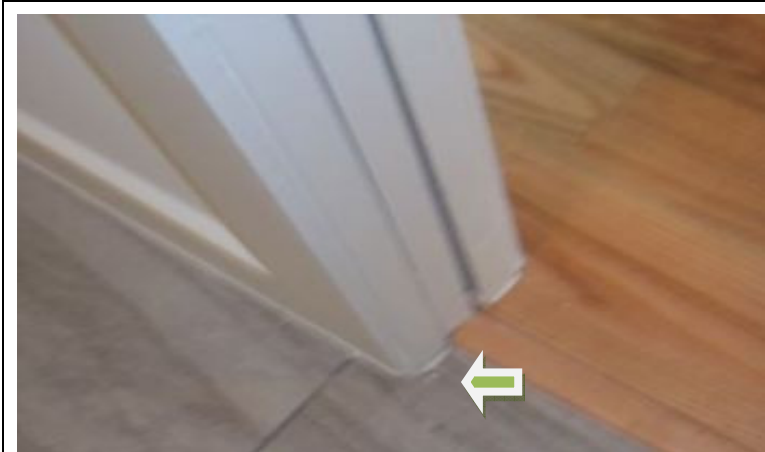
Photo #18

- ▶ Door does not close. Improper installation. (Photo #18)

Door to bedroom #2 bathroom does not close.
