PLUMBING
FOUNDATION REPAIR
AIR CONDITIONING & HEATING

LIFETIME SERVICE AGREEMENT

*Re: Lot 18 Village of Indian Springs
Woodland, Texas 77381
Job No: 20669-2*

FOUNDATION INSPECTION OF
7 Dakota Ridge
Job # 201658

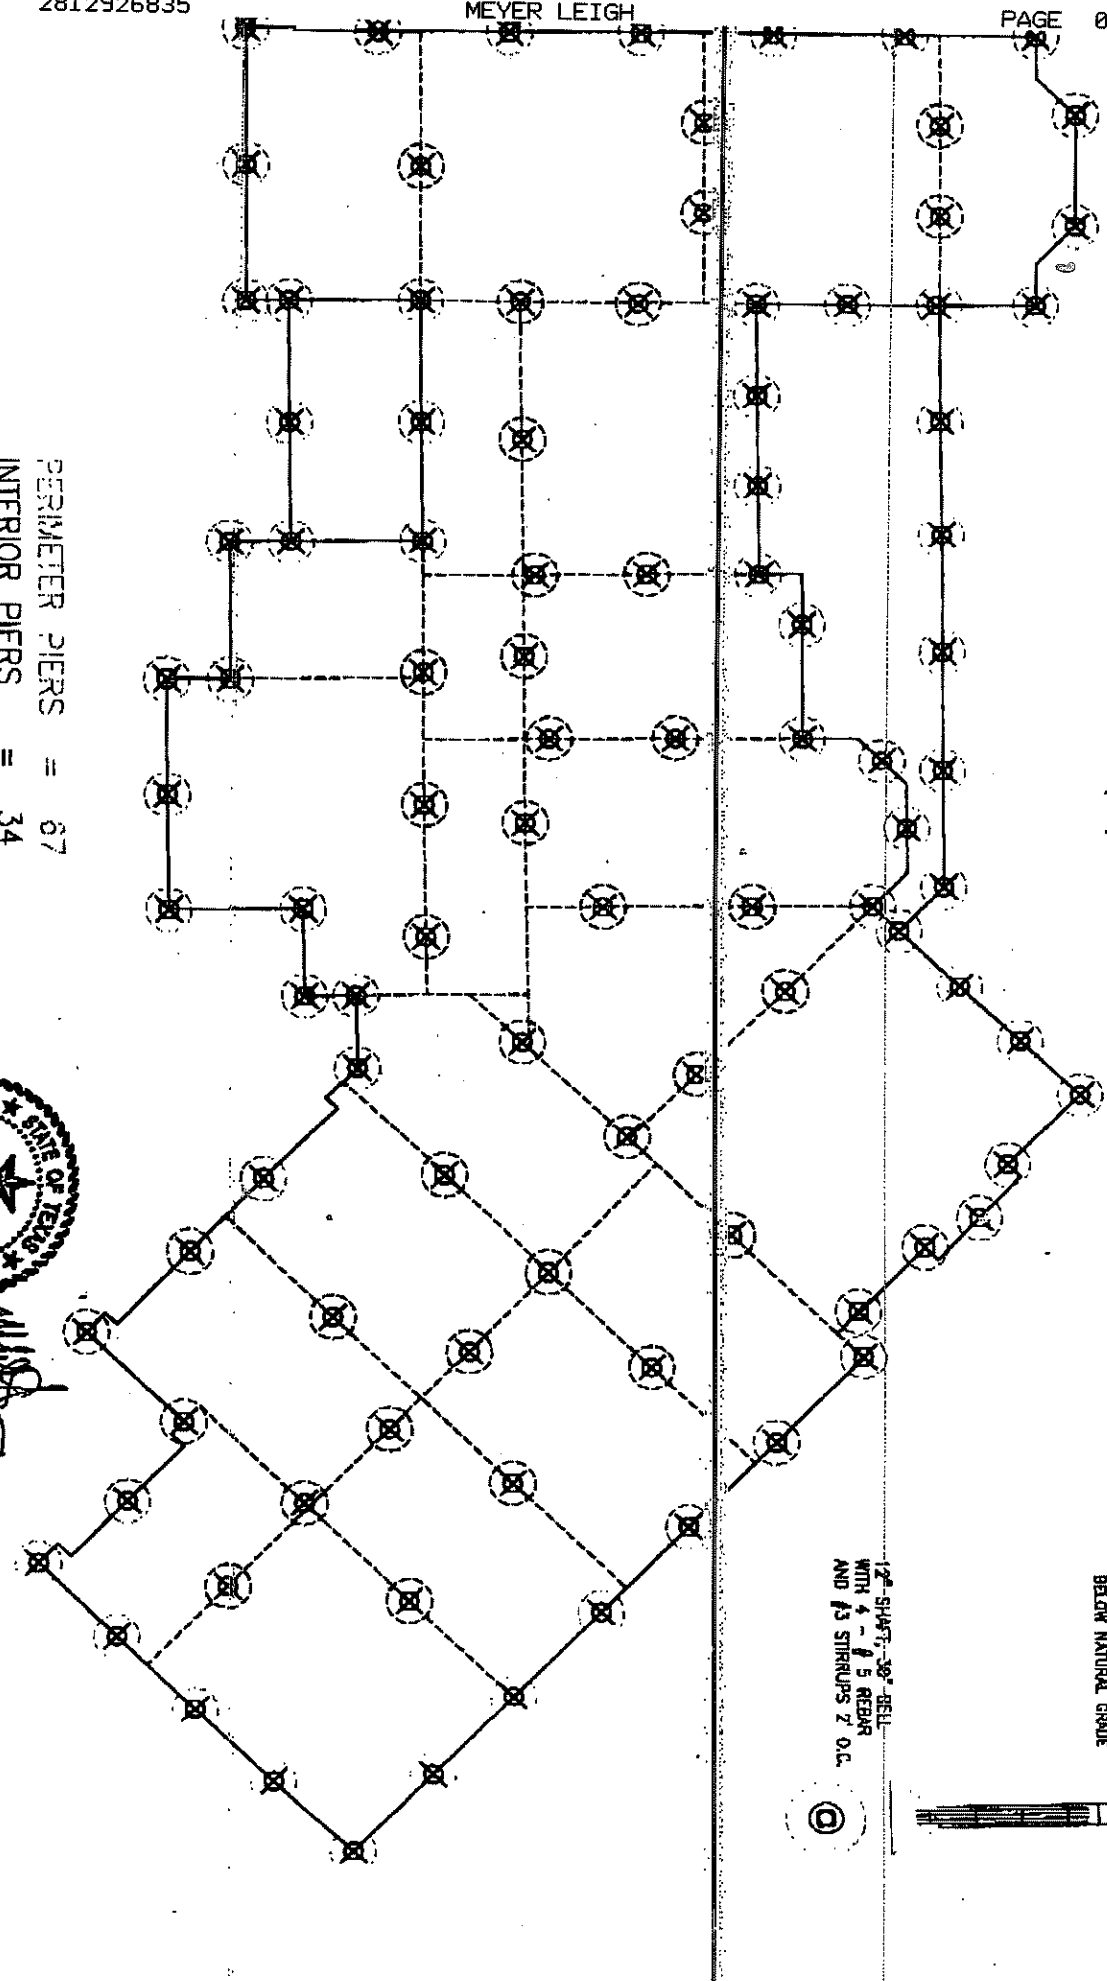
MUD PUMP ALL AREAS WHICH REQUIRE
 LIFTING OF MORE THAN ONE (1") INCH.

PERIMETER PIERS = 67
 INTERIOR PIERS = 34
 TOTAL PIERS = 101

12" DIA. 30" BELL
 WITH 4 - # 5 REBAR
 AND 43 STIRRUPS 2' O.C.

PER DEPTH = 8 FEET
 BELOW NATURAL GRADE

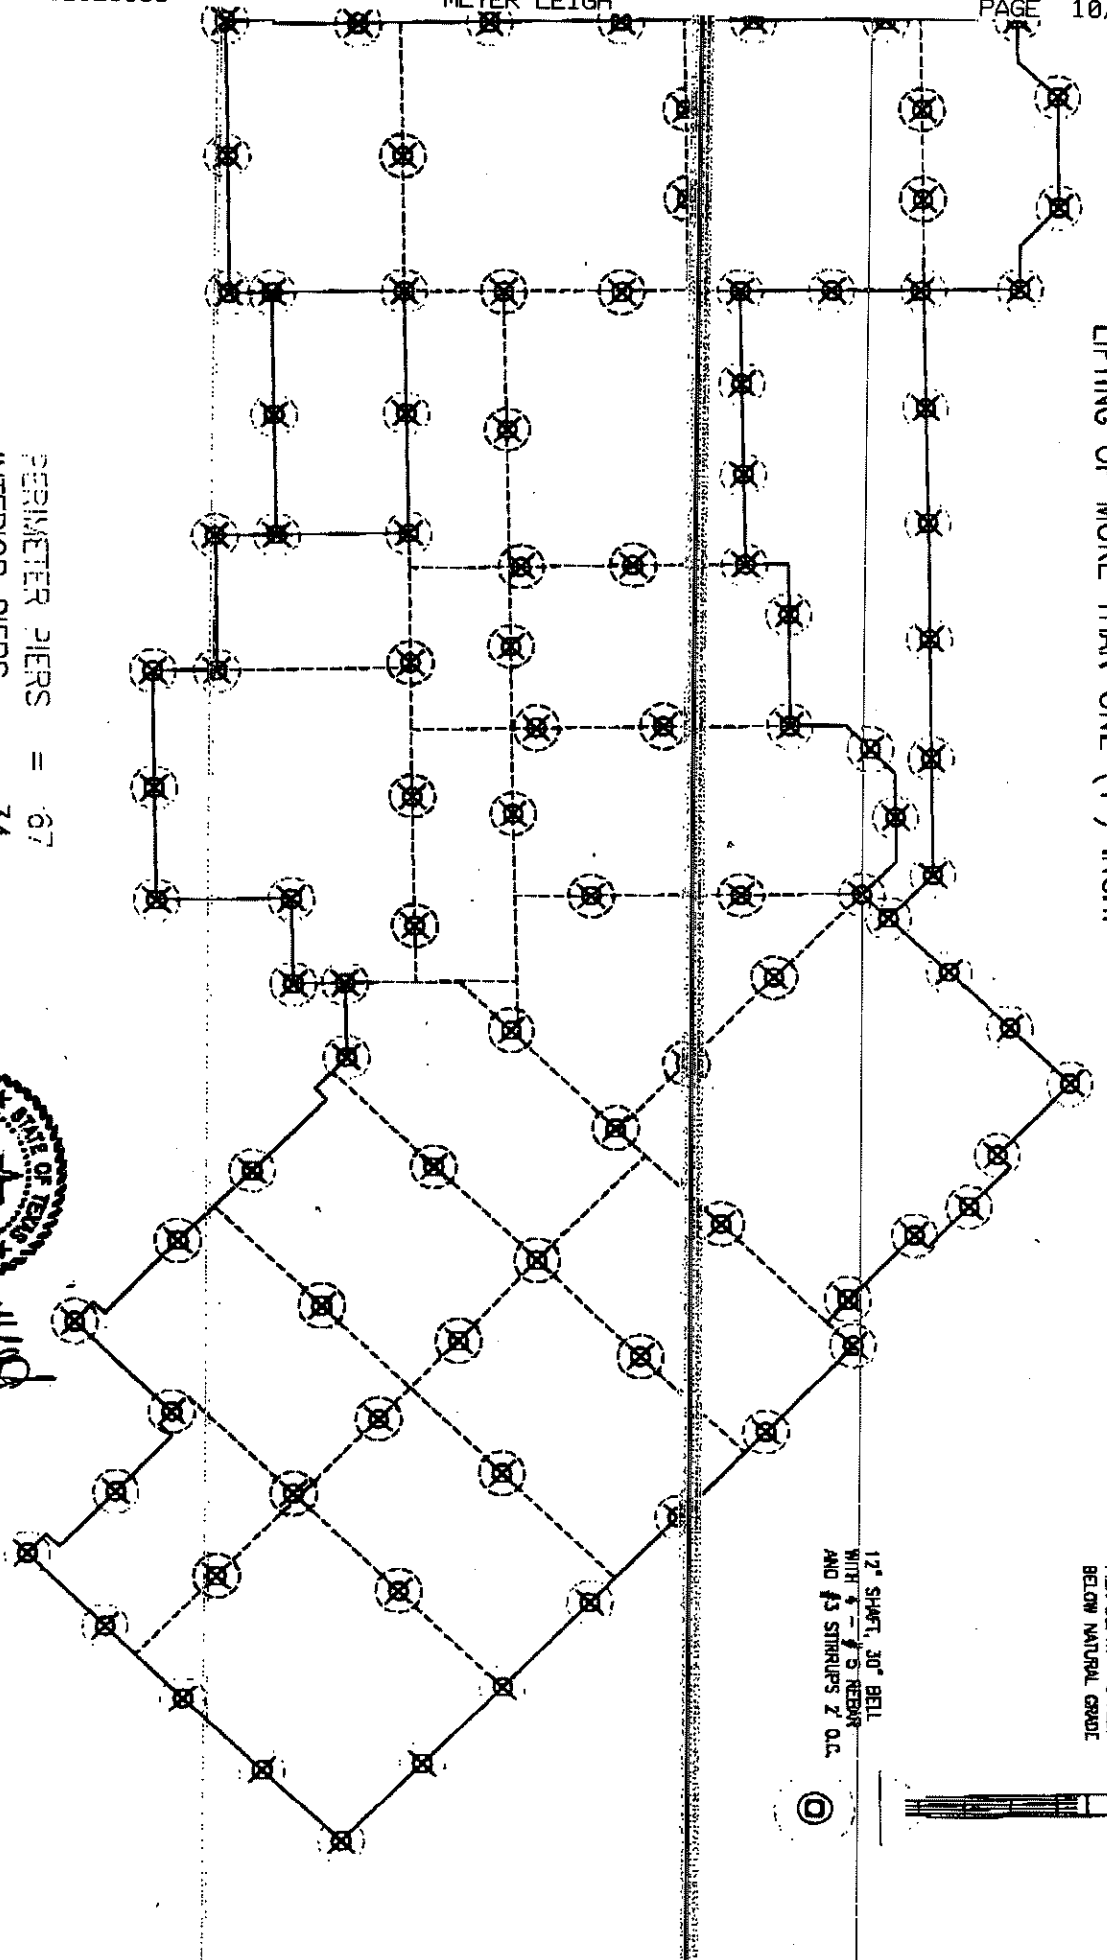
MUD PUMP ALL AREAS WHICH REQUIRE LIFTING OF MORE THAN ONE (1") INCH.

PERIMETER PIERS = 67
 INTERIOR PIERS = 34
 TOTAL PIERS = 101

12" SHWTL, 30" BELL
 WITH 4 - #5 REBAR
 AND #3 STIRRUPS @ O.C.

PIER DEPTH = 8 FEET
 BELOW NATURAL GRADE

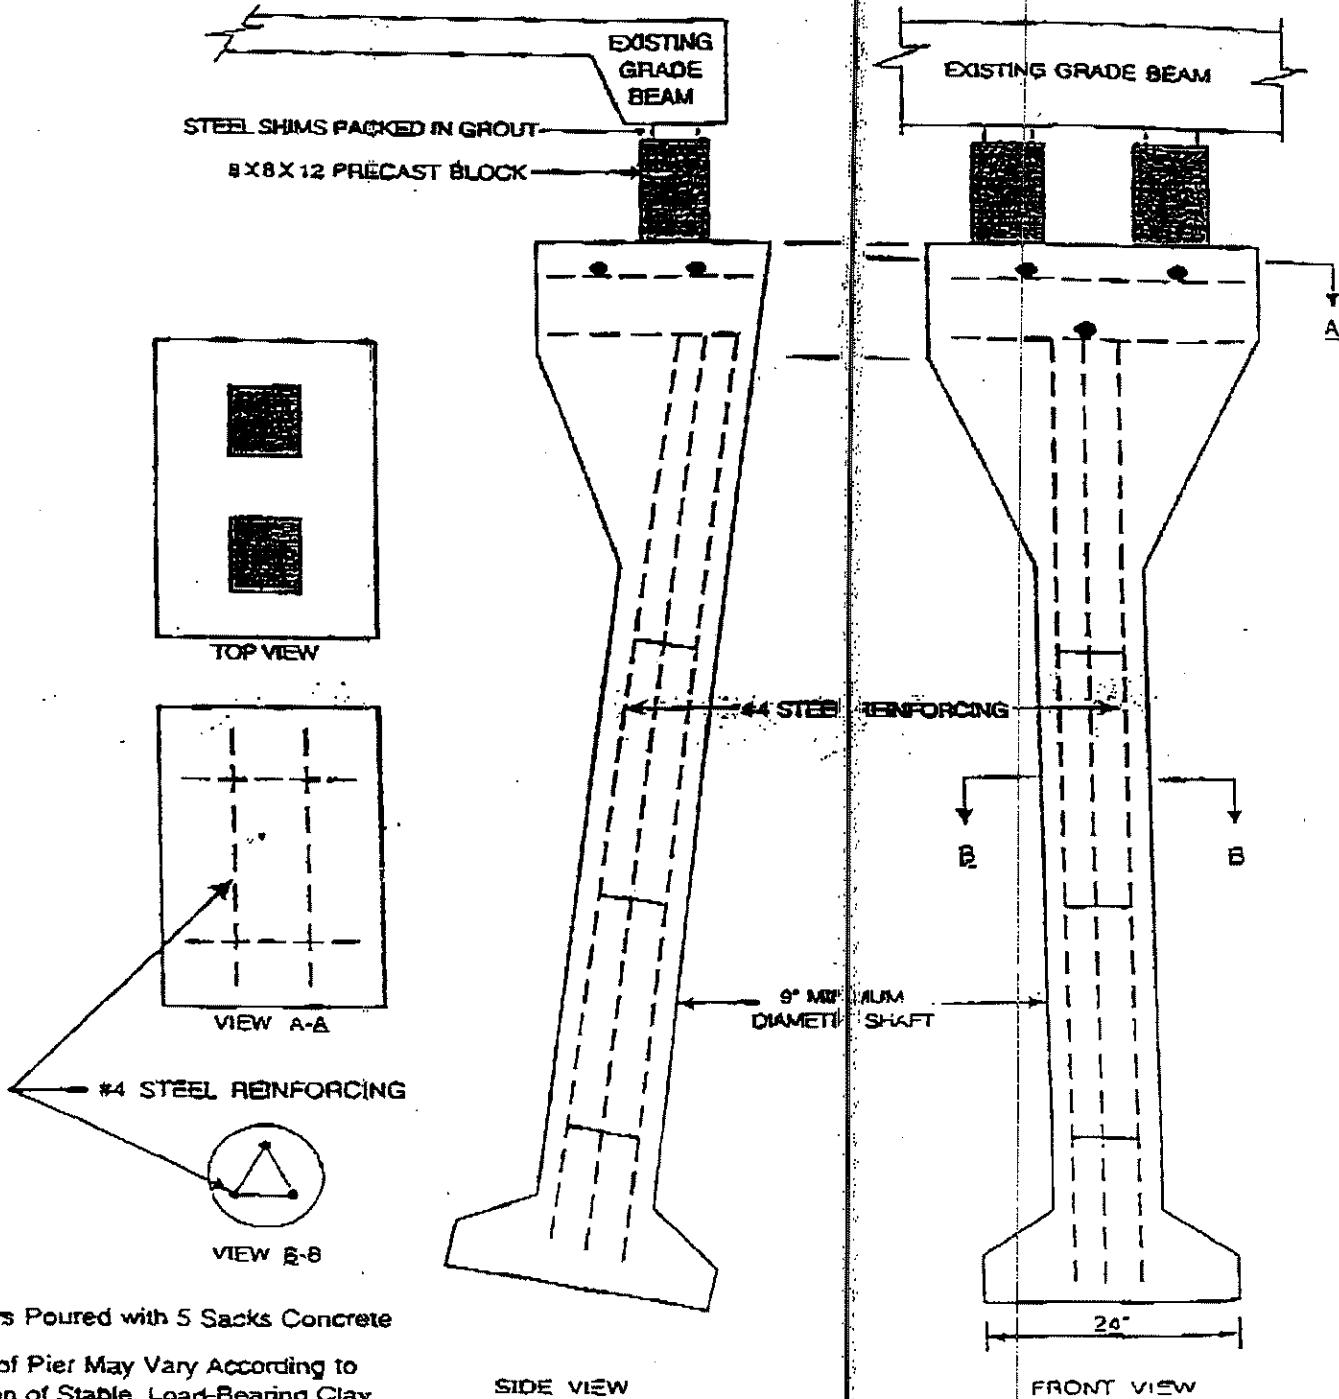
PIER DIAGRAM

All Piers Poured with 5 Sacks Concrete

Depth of Pier May Vary According to
Location of Stable, Load-Bearing Clay.
