Home Inspection Report

5101 Bataan Road
Houston, Texas 77033

Semora Inspections LLC

Prepared For: Mike Thomas
Concerning: 5101 Bataan Road Houston, Texas 77033
Inspection Date: 09/14/2018

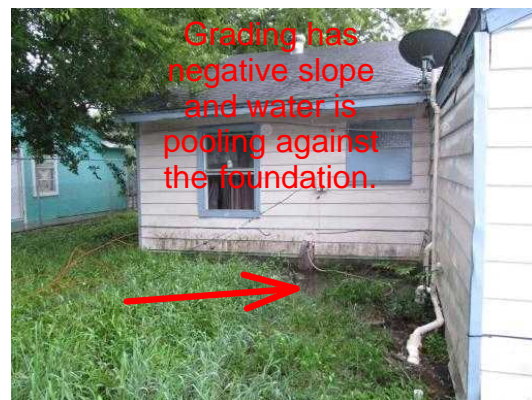
-Grading has negative slope and water is pooling against the foundation.

-Gutters recommended all around the house.

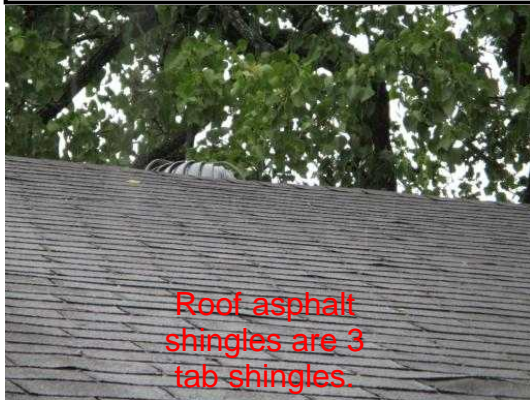
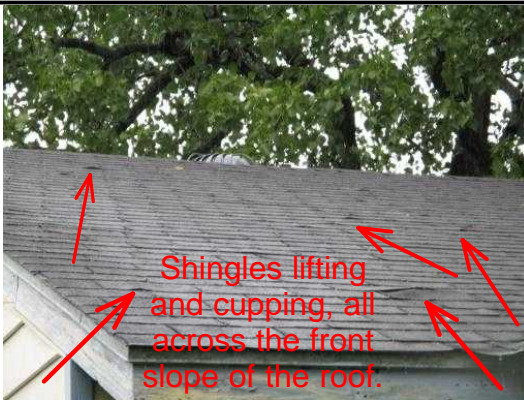
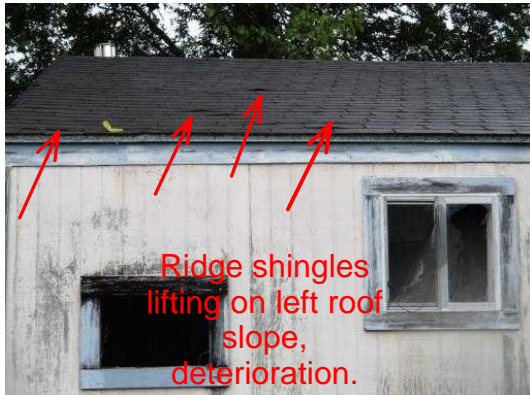
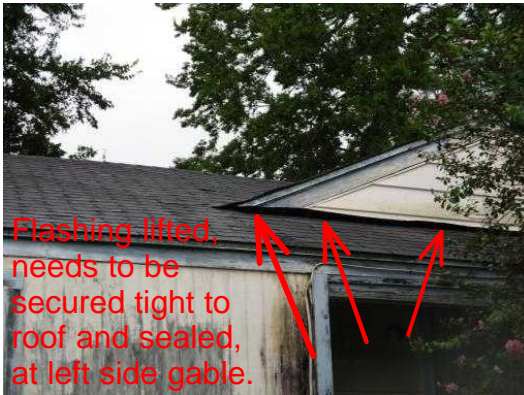
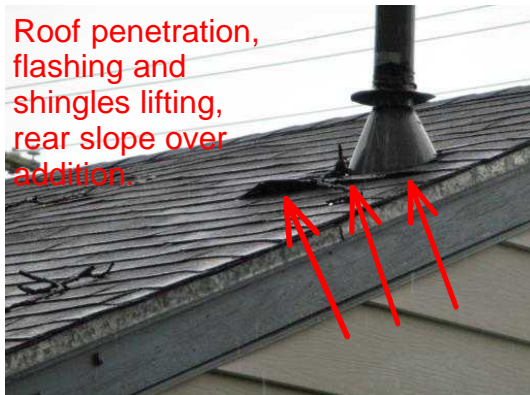
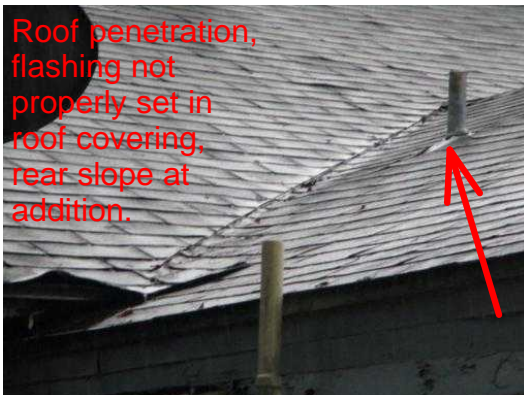
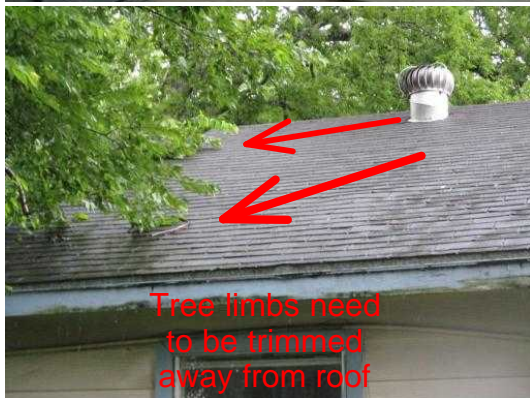
-Roof covering appears to be in overall poor and deteriorating condition, with zero years serviceable life.

-Shingles lifting and cupping, all across the front slope of the roof.

-Ridge shingles lifting on left roof slope, deterioration.

-Flashing lifted, needs to be secured tight to roof and sealed, at left side gable.

-Roof penetration, flashing and shingles lifting, rear slope over addition.

-Roof penetration, flashing not properly set in roof covering, rear slope at addition.

-Tree limbs need to be trimmed away from roof.

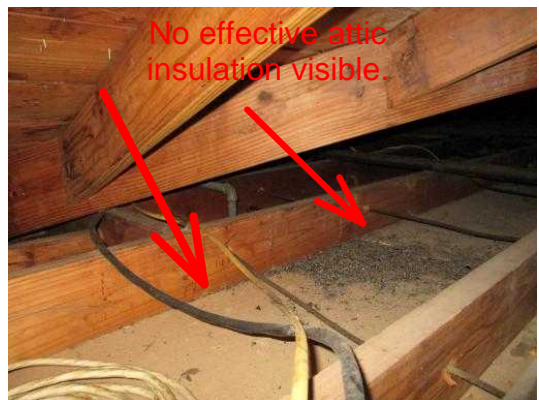
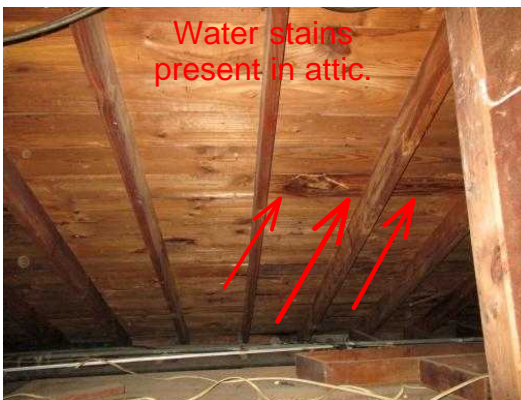
- No effective attic insulation visible.
- Water stains present in attic.

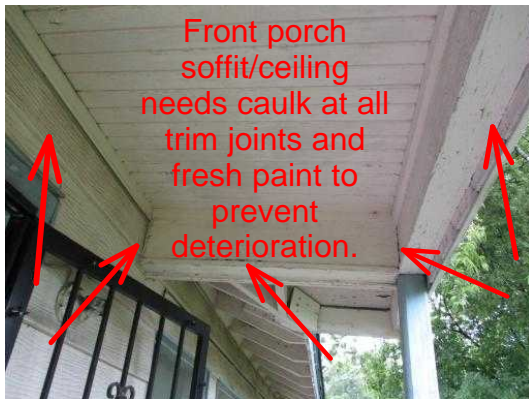
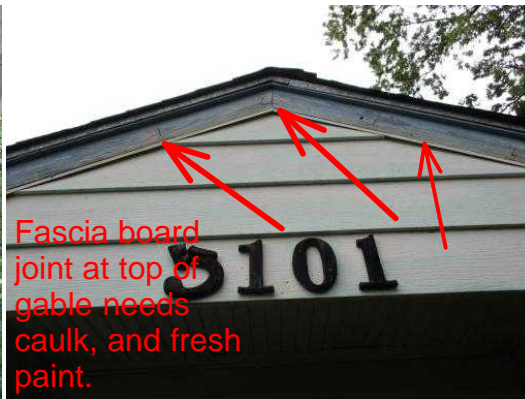
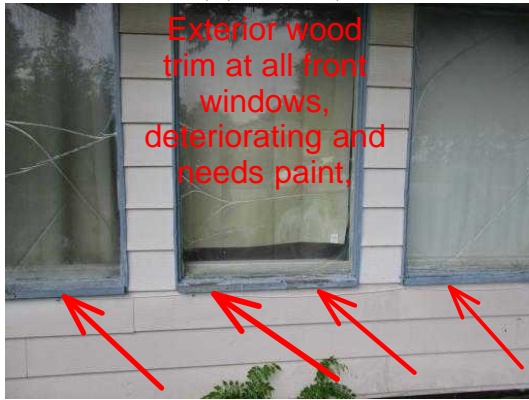
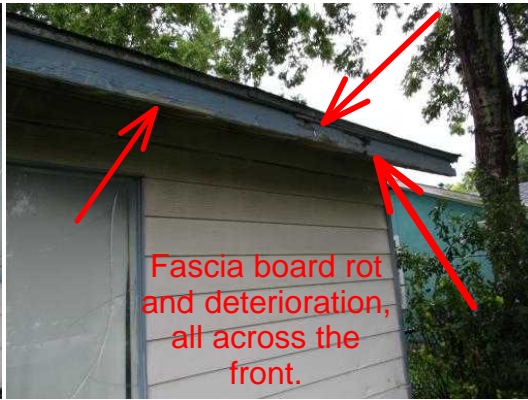
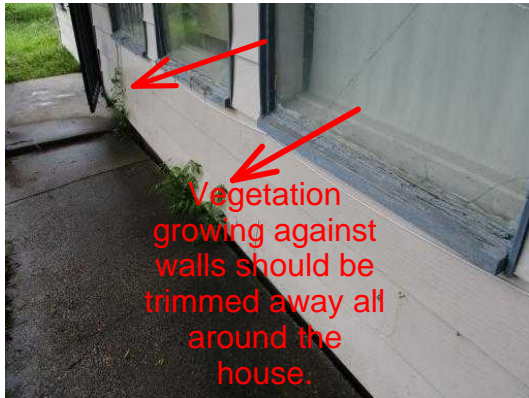
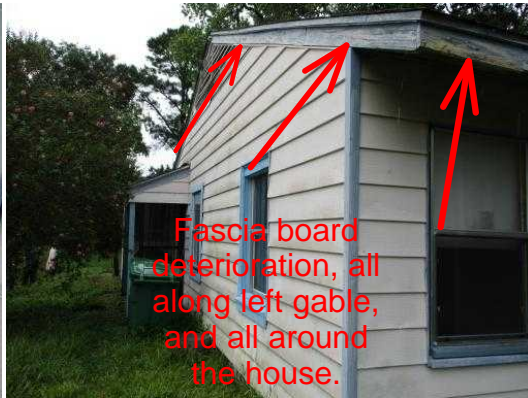
- Front porch soffit/ceiling needs caulk at all trim joints and fresh paint to prevent deterioration.
- Fascia board joint at top of gable needs caulk, and fresh paint.

- Exterior wood trim at all front windows, deteriorating and needs paint,
- Fascia board rot and deterioration, all across the front.
- Vegetation growing against walls should be trimmed away all around the house.

- Fascia board deterioration, all along left gable, and all around the house.
- Aluminum siding covering missing, top of left gable.
- Aluminum siding junction with trim at window loose, left side of house.

- Exterior wood trim at window sill, needs caulk and paint.
- Exterior wood trim at window, gaps need caulk and paint, left side and all around the house.

- Exterior wood siding deteriorating and rot, left side entry porch.
- Exterior wood siding, T1-11 siding, deteriorating and rot, on addition at rear of house.

- Exterior trim deterioration and rot, all around back door on addition.
- Exterior wood trim at corners, rot and deterioration on corners, all around the house.

- Frieze board, rot and deterioration, all around rear addition.

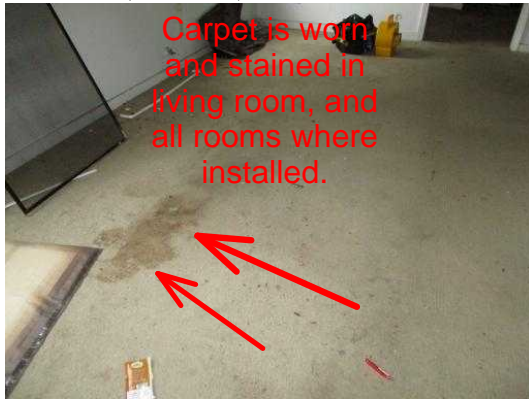
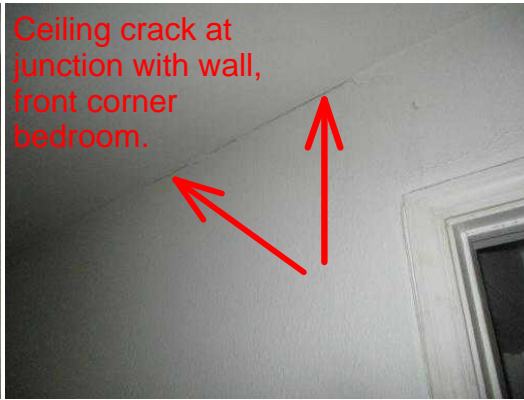
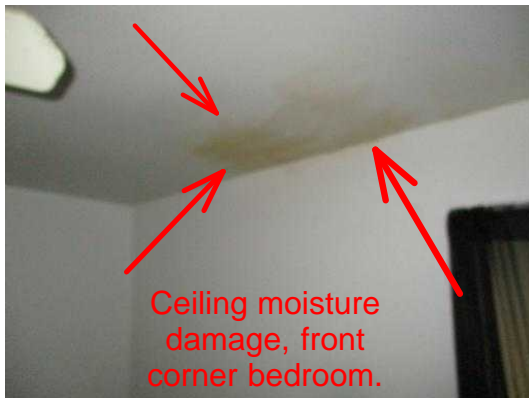
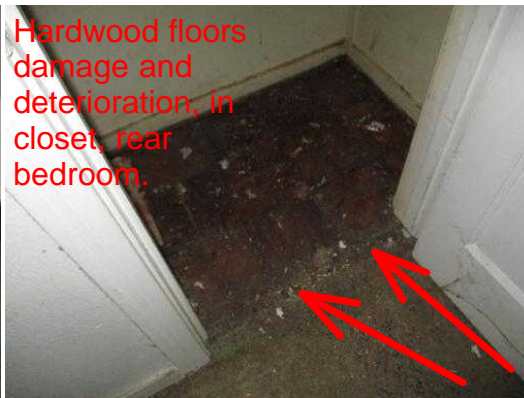
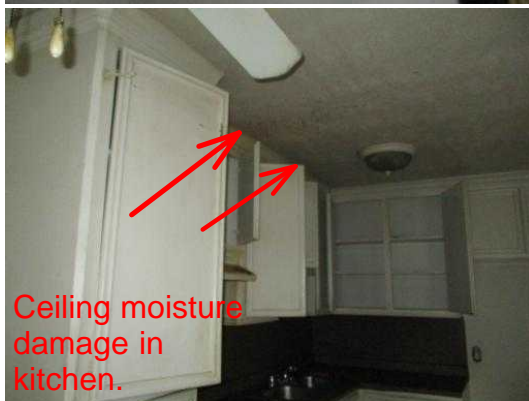
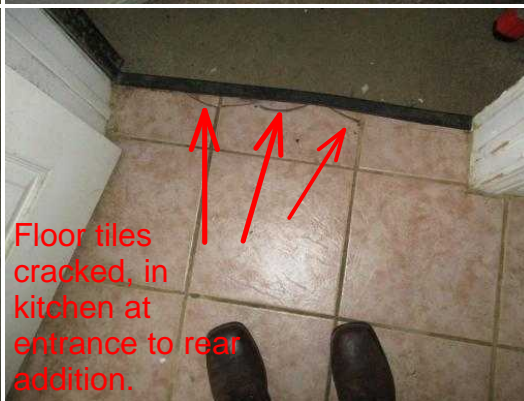
- Carpet is worn and stained in living room, and all rooms where installed.
- Ceiling crack at junction with wall, front corner bedroom.
- Ceiling moisture damage, front corner bedroom.
- Hardwood floors damage and deterioration, in closet, rear bedroom.
- Ceiling moisture damage in kitchen.
- Floor tiles cracked, in kitchen at entrance to rear addition.

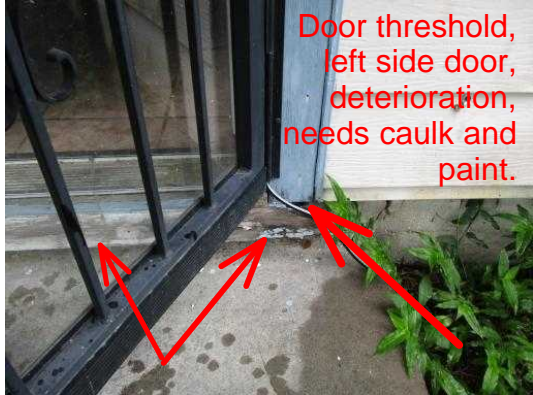
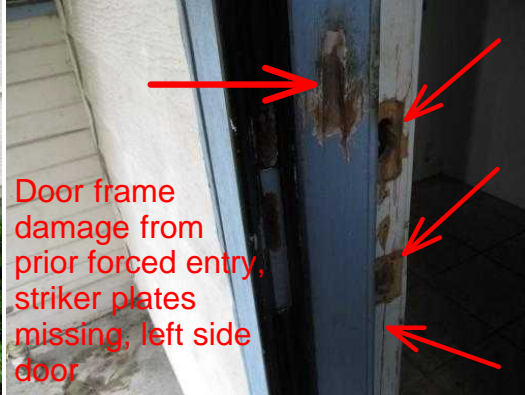
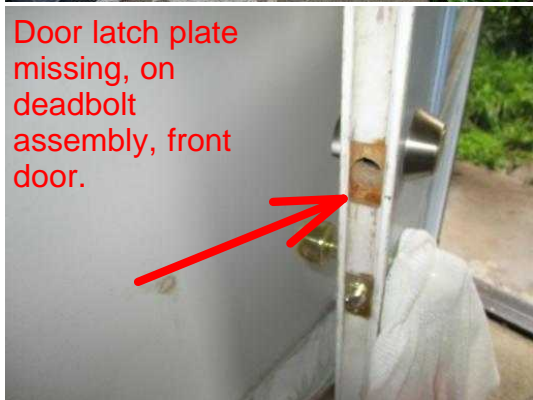
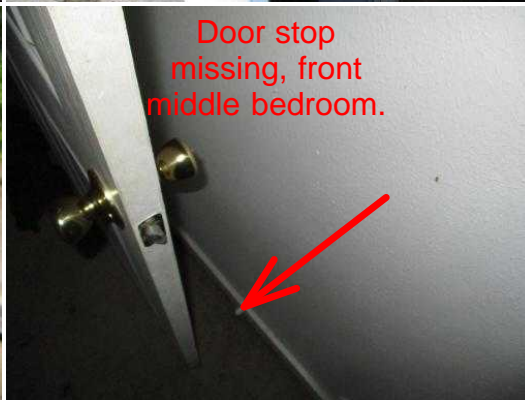
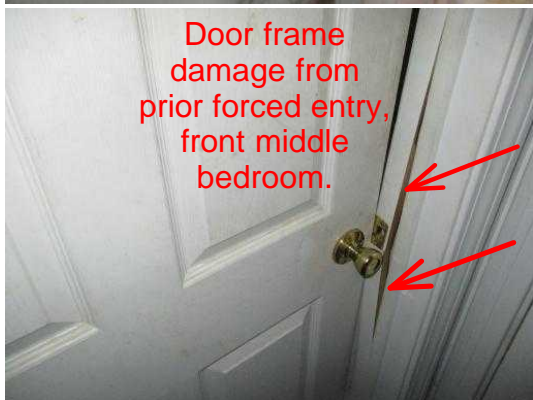
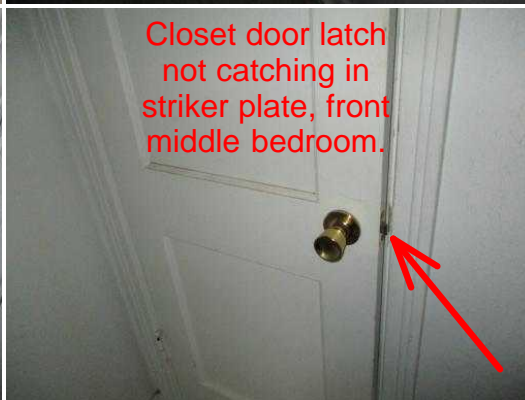
- Door threshold, left side door, deterioration, needs caulk and paint.
- Door frame damage from prior forced entry, striker plates missing, left side door
- Door latch plate missing, on deadbolt assembly, front door.
- Door stop missing, front middle bedroom.
- Door frame damage from prior forced entry, front middle bedroom.
- Closet door latch not catching in striker plate, front middle bedroom.
- Door latch not catching in striker plate, front right corner bedroom.

-Door out of alignment, sticking or will not close, rear corner bedroom.

-Door latch not catching in striker plate, on entrance to rear addition.

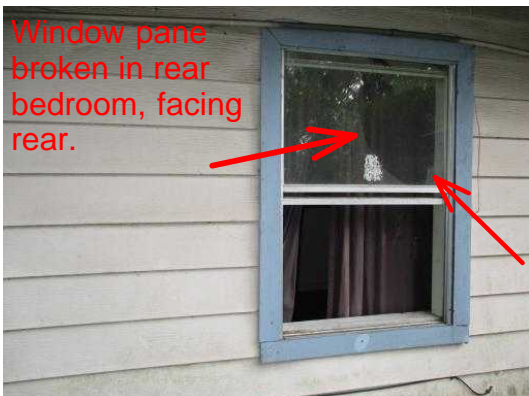
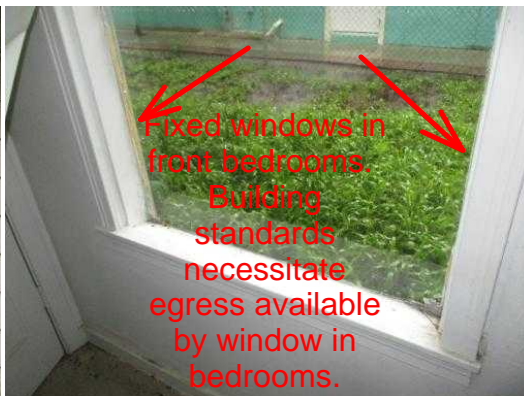
-Window pane broken in rear bedroom, facing rear.

-Fixed windows in front bedrooms. Building standards necessitate egress available by window in bedrooms.

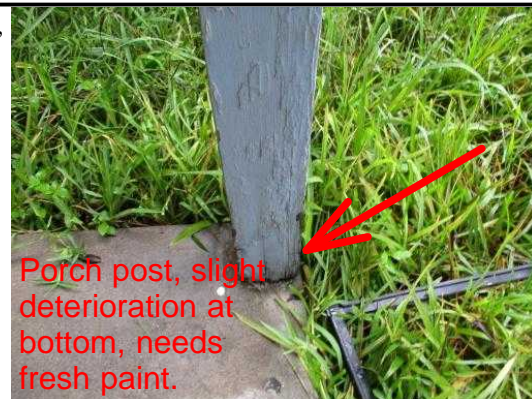
-Porch post, slight deterioration at bottom, needs fresh paint.

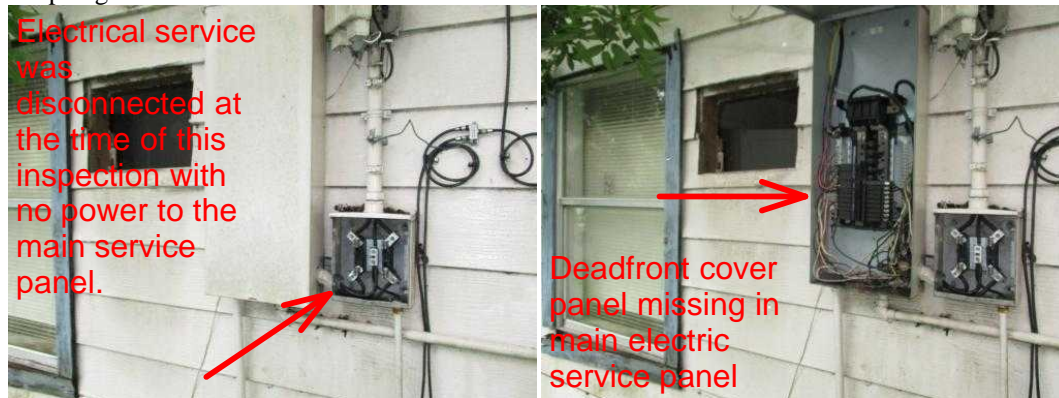
-Deadfront cover panel missing in main electric service panel.

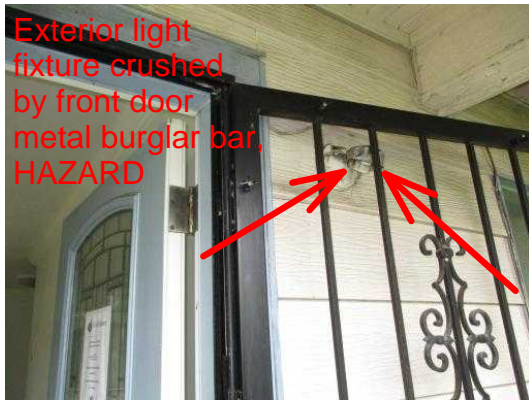
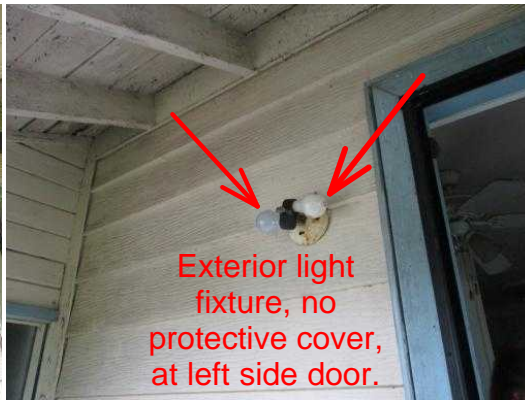
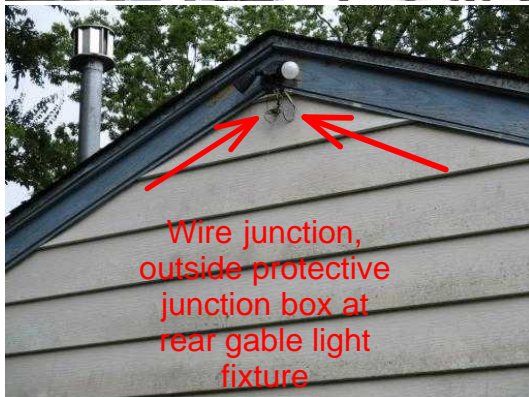
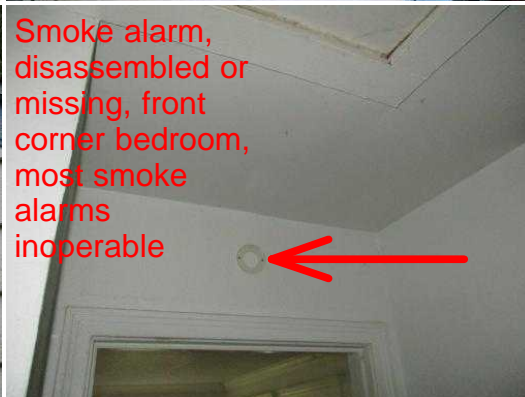
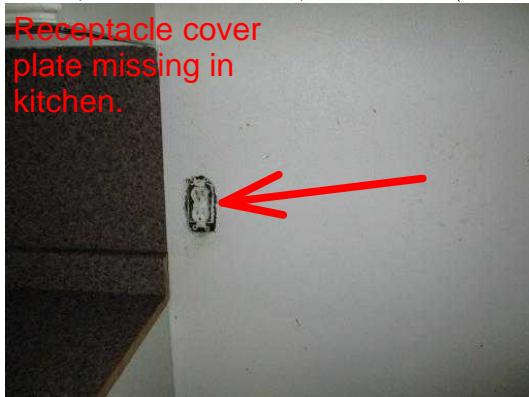
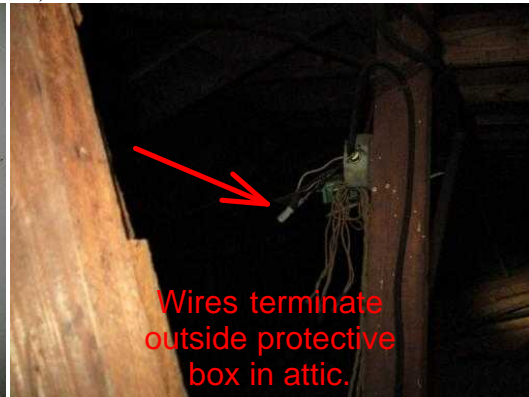
-Exterior light fixture crushed by front door metal burglar bar, HAZARD. This needs repair to prevent electric shock prior to restoring electrical power.

-Exterior light fixture, no protective cover, at left side door.

-Exterior receptacle missing weather proof cover plate, front porch.

-Wire junction, outside protective junction box at rear gable light fixture.

-Smoke alarm, disassembled or missing, front corner bedroom, most smoke alarms inoperable. Working smoke alarms should be in every bedroom, hallway, and common areas.

-Receptacle cover plate missing in kitchen.

-Wires terminate outside protective box in attic.

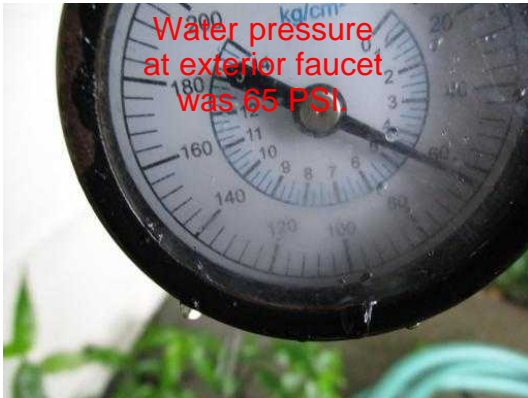
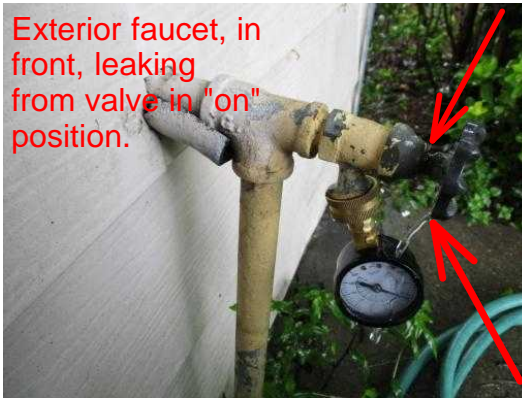
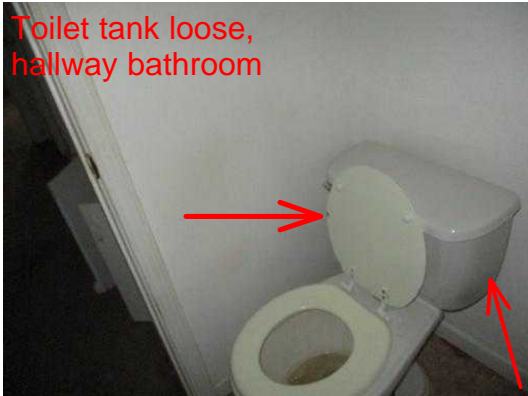
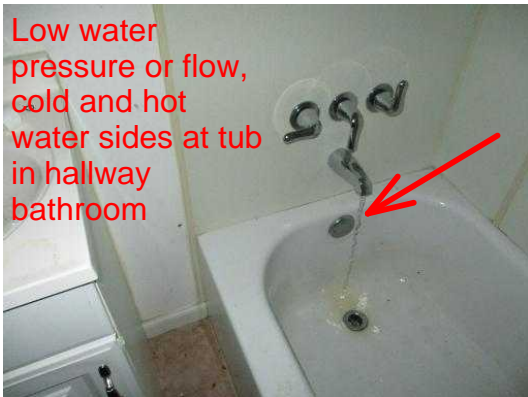
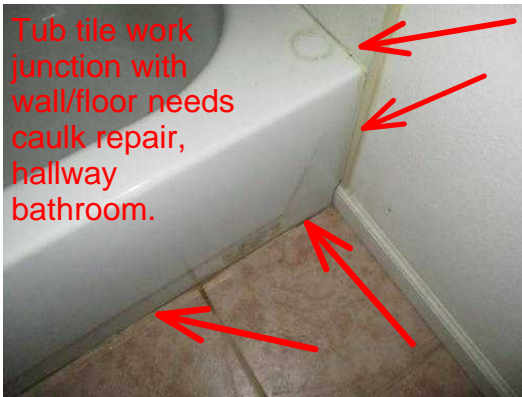
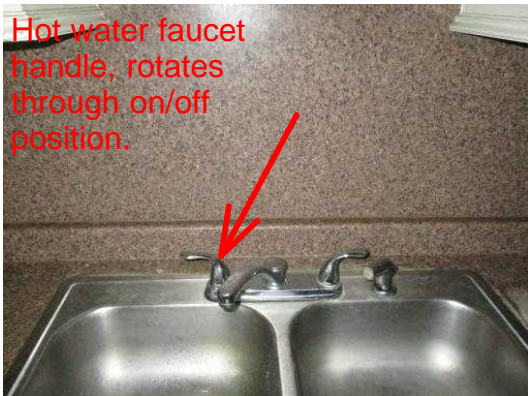
-Exterior faucet, in front, leaking from valve in "on" position.

-Toilet tank loose, hallway bathroom.

-Tub tile work junction with wall/floor needs caulk repair, hallway bathroom.

-Kitchen sink faucet assembly loose, should be secured tight to sink.

-Toilet loose at base, rear addition bathroom.

-Vanity cabinet base under rear addition bathroom sink, damage from prior leaks.

-Shower surround junction with wall shows moisture damage, rear addition bathroom.

-Shower faucet assembly loose, rear addition bathroom.

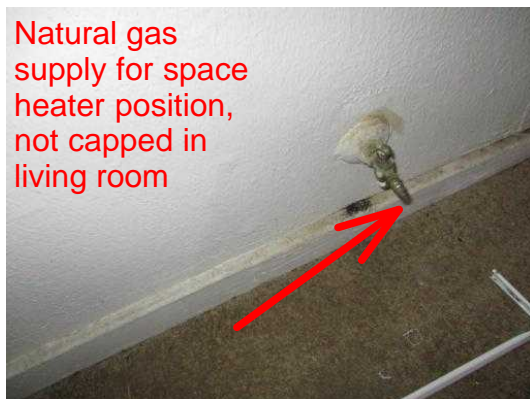
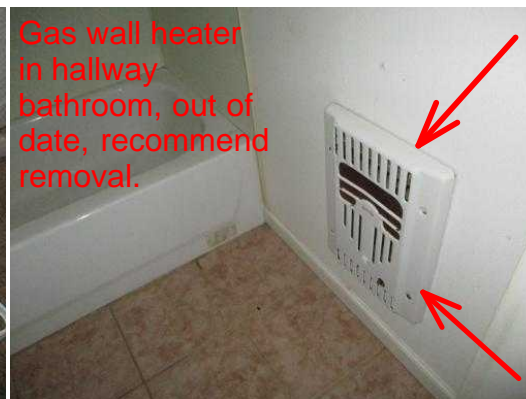
- Natural gas supply for space heater position, not capped in living room.
- Gas wall heater in hallway bathroom, out of date, recommend removal.
- Natural gas supply valve for stove position not capped in kitchen.
