PROPERTY INSPECTION REPORT

Concerning: 1135 Buescher Dr, Columbus, TX 78934
(Address or Other Identification of Inspected Property)

By: Roy Brashier, Lic #22407 01/09/2021
(Name and License Number of Inspector) (Date)

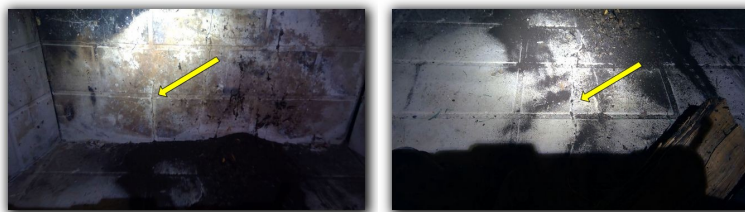
Firebox area has common gaps and/or cracks. Cracks in the firebrick or gaps in the mortar can result in house fires. Most small openings can be sealed using a temperature rated fireplace caulk.

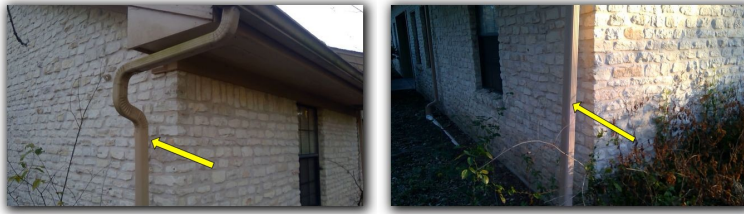
The gutter system down spouts are not secured properly to the exterior walls.

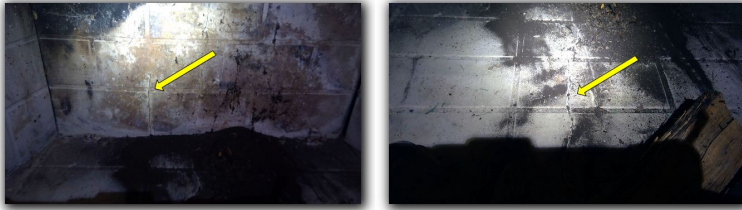
Firebox area has common gaps and/or cracks. Cracks in the firebrick or gaps in the mortar can result in house fires. Most small openings can be sealed using a temperature rated fireplace caulk.

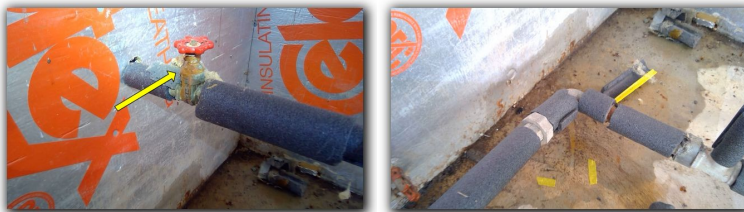
A water leak was noted in the supply piping inside the well house. Repairs are needed.
