HOME INSPECTION REPORT

Prepared For:	Ken Valka <small>(Name of Client)</small>
Concerning:	6878 Kingston Cove Ln, Willis, TX, 77318 <small>(Address or Other Identification of Inspected Property)</small>
By:	Mickey Oetken - SI <small>(Name and License Number of Inspector)</small>
	2-23-2021 <small>(Date)</small>
	Jeff Oetken Trec License Number 23908 <small>(Name, License Number of Sponsoring Inspector)</small>

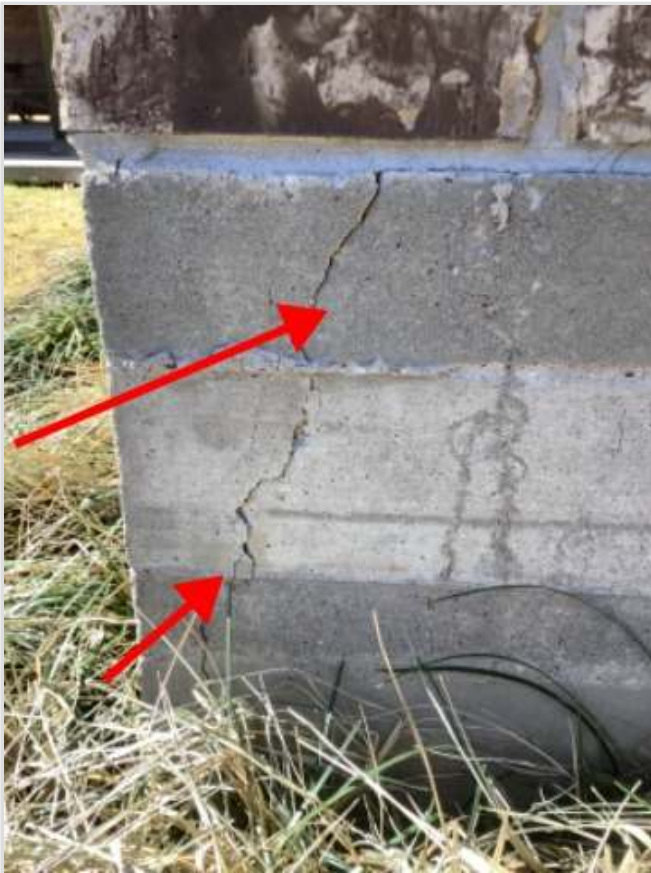
Corner pop on foundation left front of house

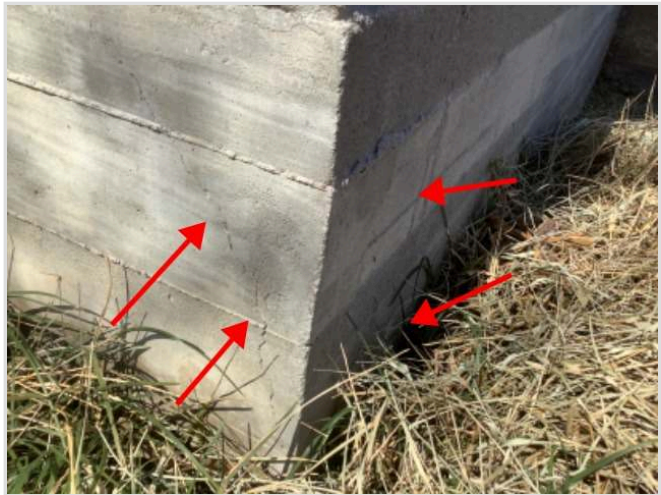
Corner pop on foundation left front of house on both sides.

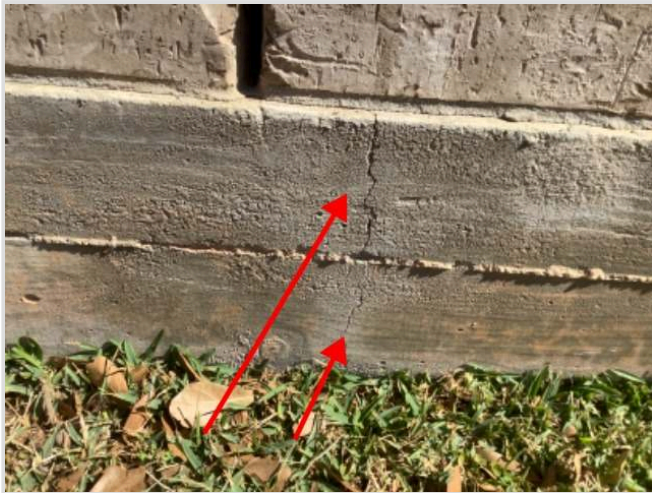
Minor cracking at rear of house

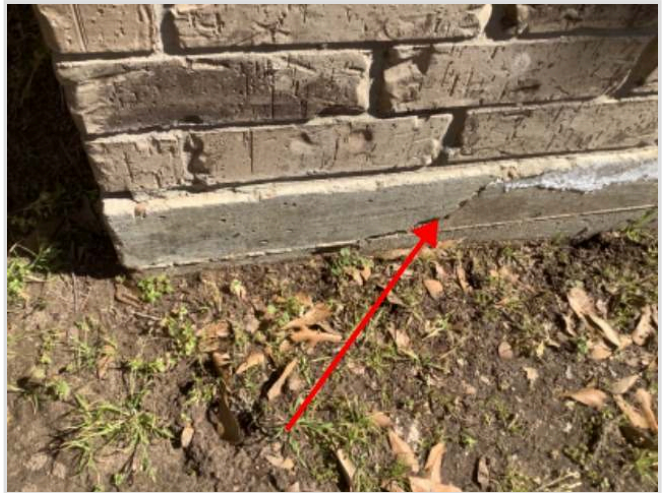
Corner pop right rear of home

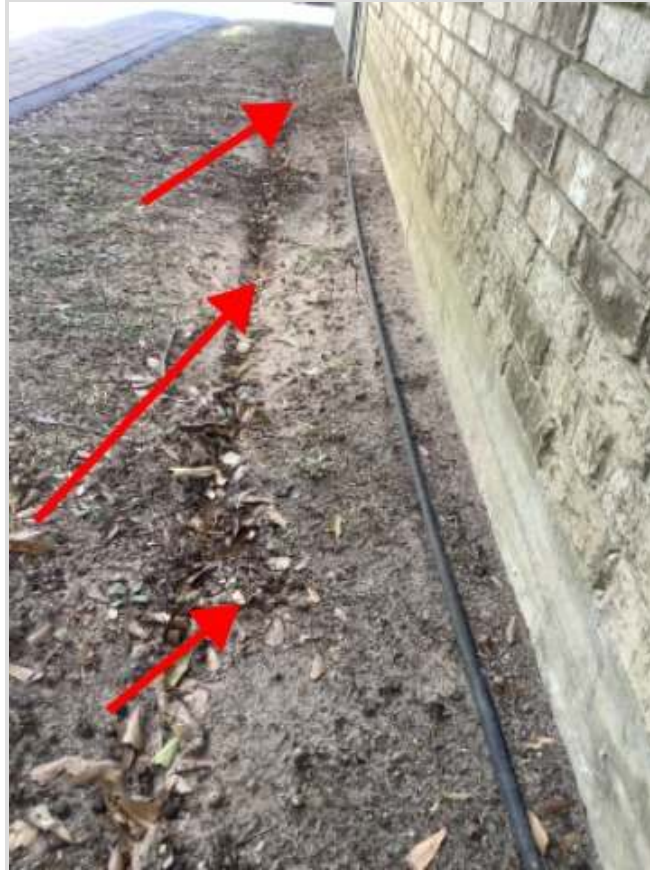
Right side of house

The grading appeared inadequate for proper drainage, as it pertains to the foundation. The area between the home and the neighbors walkway is narrow and appears as if it would hold water. We recommend installing gutters at the front, back and sides to help prevent excess moisture around the foundation and ensure proper drainage. Note: grading and drainage was only inspected within 10 feet of the foundation and other inspected systems or structures. Deficiencies: There is an obvious drip line on the right side of the house from water runoff, it goes right on the air conditioning unit.

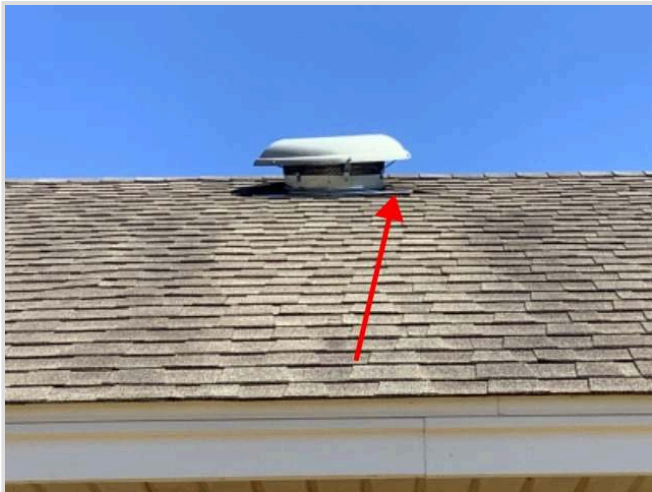
Flashing lifting on rear of house

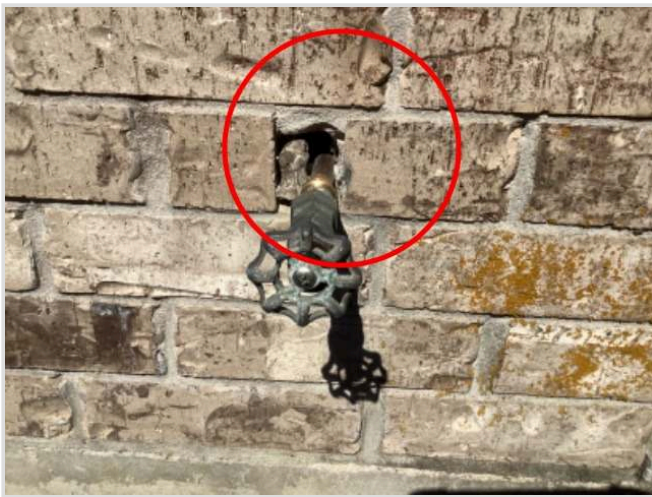
Area around faucet needs to be sealed to prevent intrusion of insects left side of house

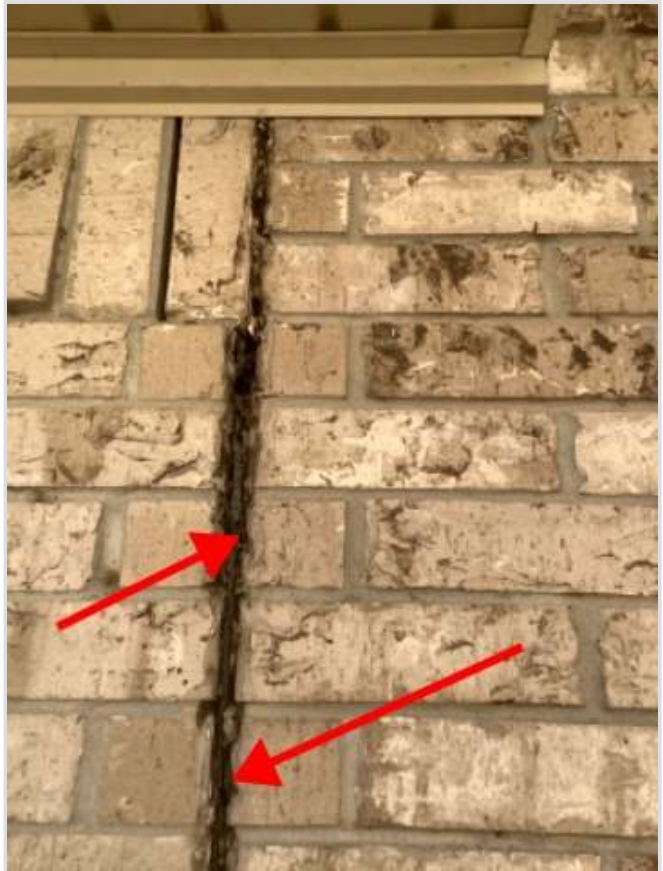
Expansion joint sealant is deteriorated and needs to be replaced

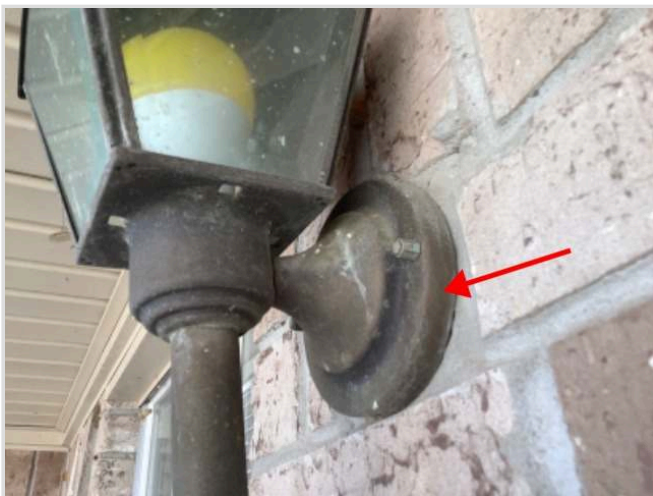
Area around base of all light fixtures on the exterior need to be sealed to prevent water intrusion

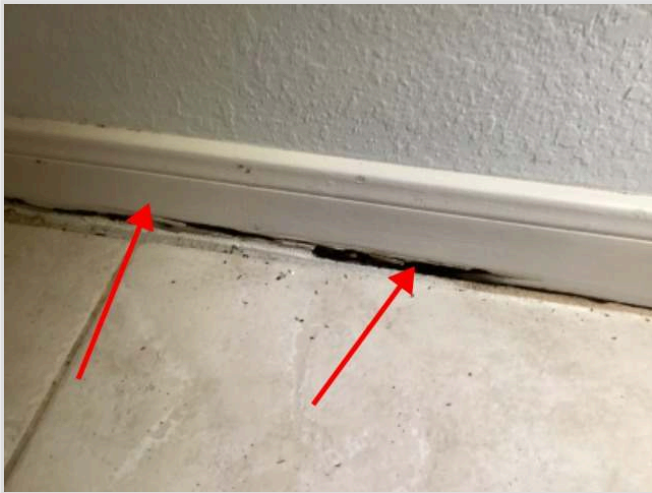
Trim board around flooring in kitchen is rotten.
Recommend replacement

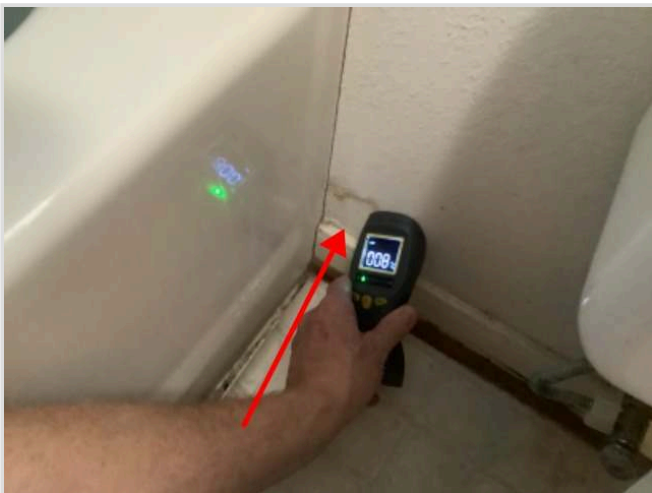
Evidence of past moisture damage in master bathroom

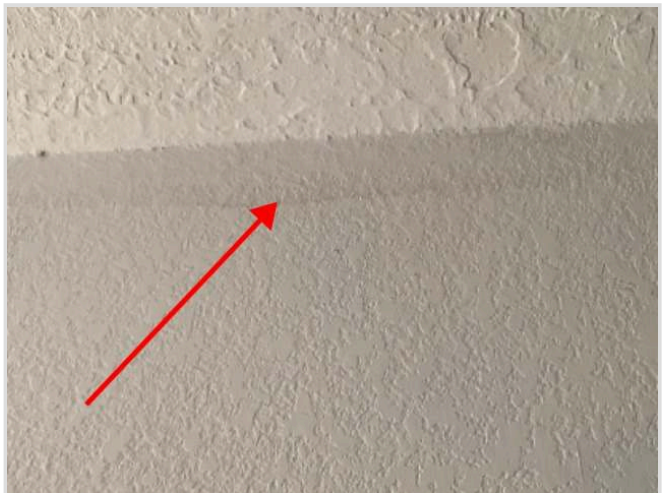
Evidence of past moisture in wall in converted garage room

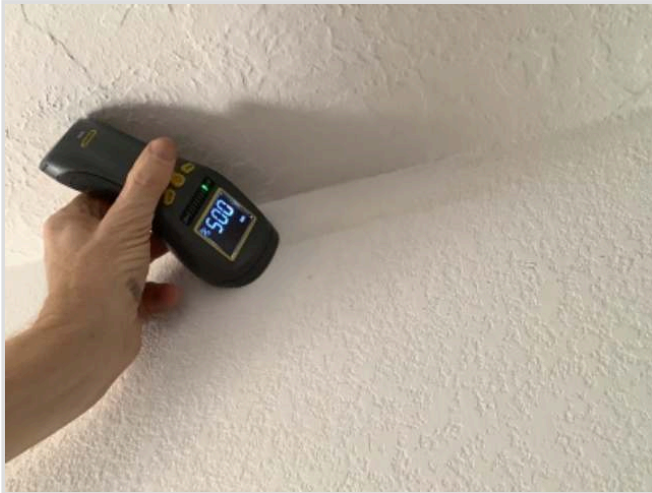
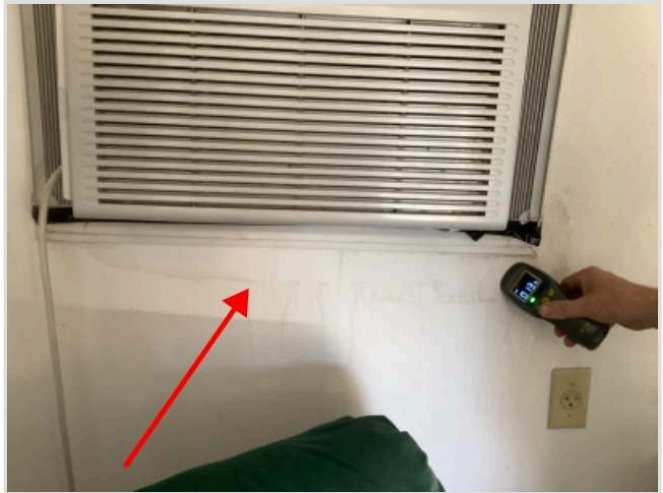
Evidence of past water damage around window air unit and converted garage room

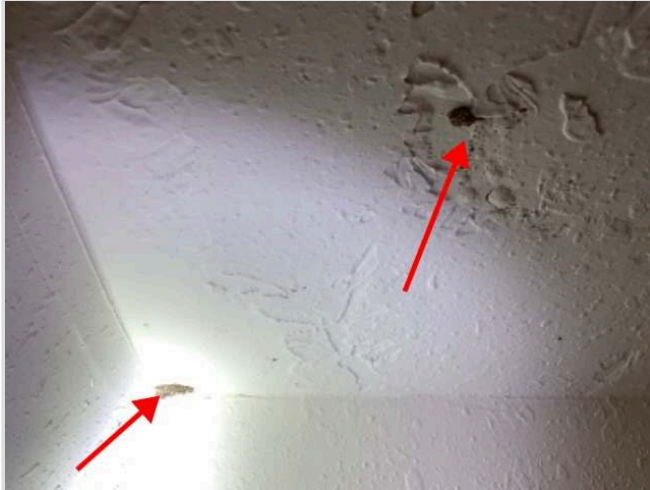
Possible wood destroying insects in the hall closet

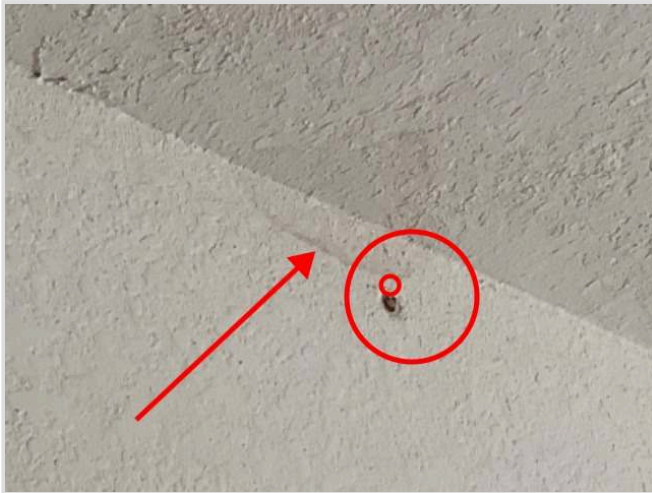
Evidence of past moisture damage in master bedroom ceiling and wall. Nail pop

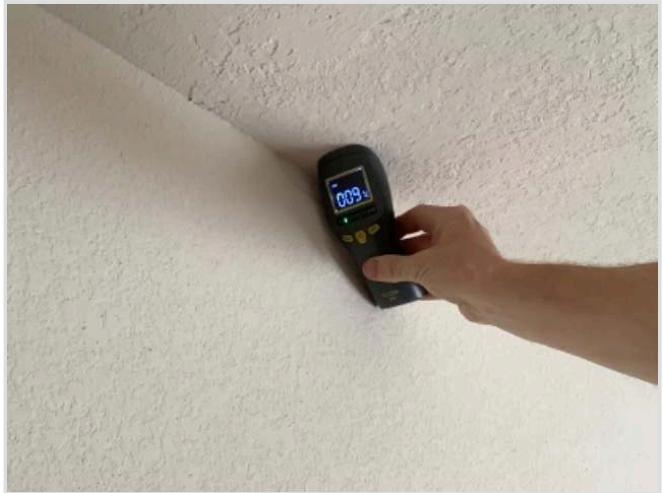
No current moisture noticed in ceiling

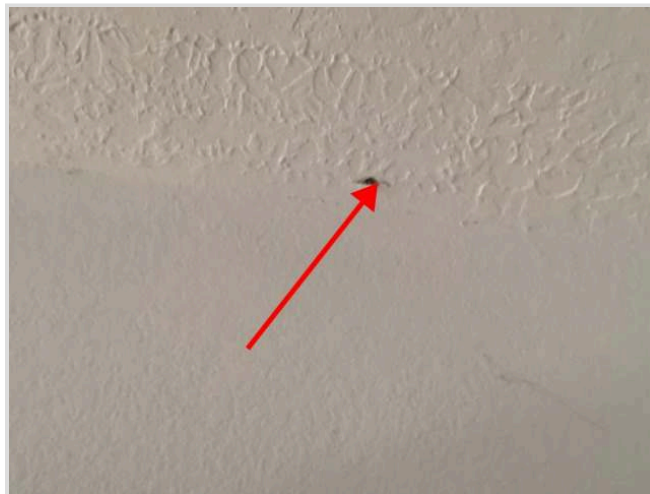
Nail pop in ceiling in converted garage room

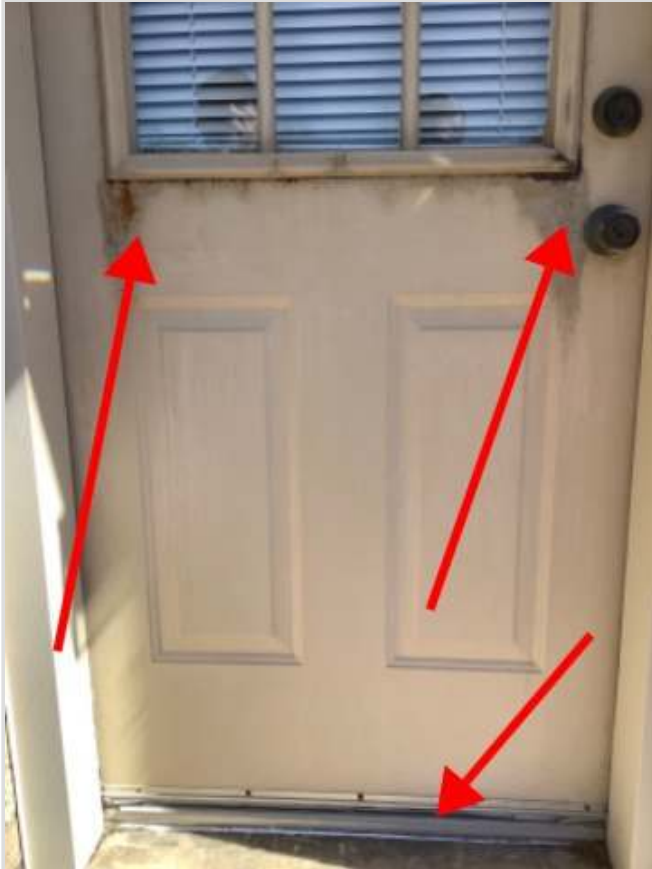
All doors were inspected and were working properly at the time of inspection. Back door to house is metal and is corroded and is lacking weatherstripping around door. Door trim around interior of the back door is decayed. Recommend replacement. The lock on the door to the garage was in operable. Recommend replacement.

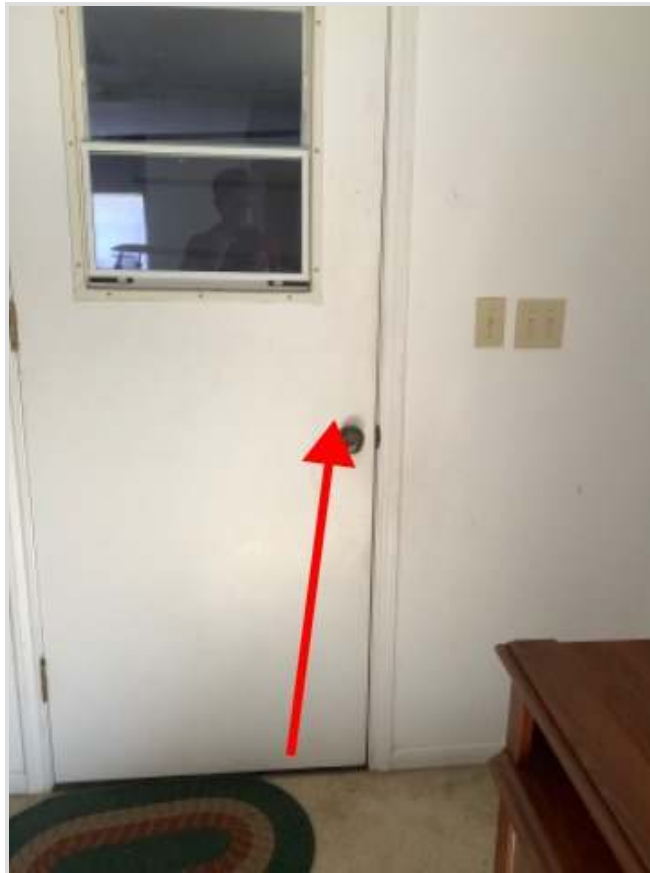
Door lock does not work

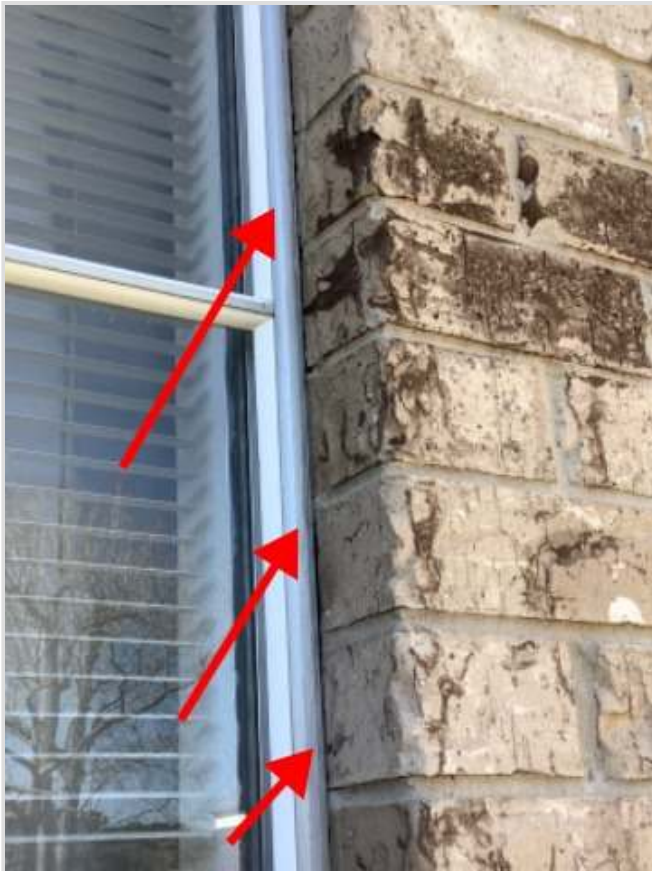
Gaps around windows that need to be caulked

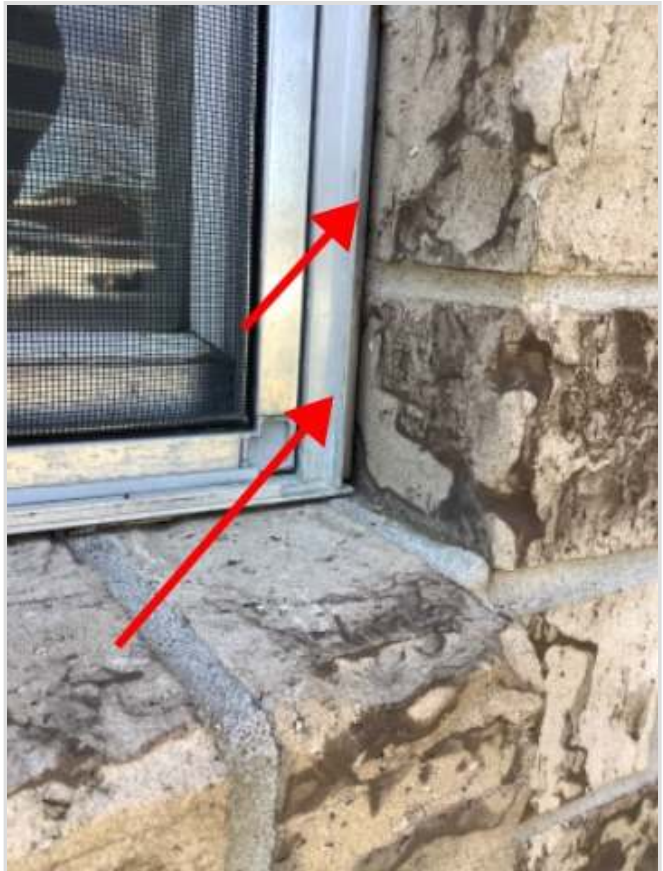
Gaps around windows that need to be caulked

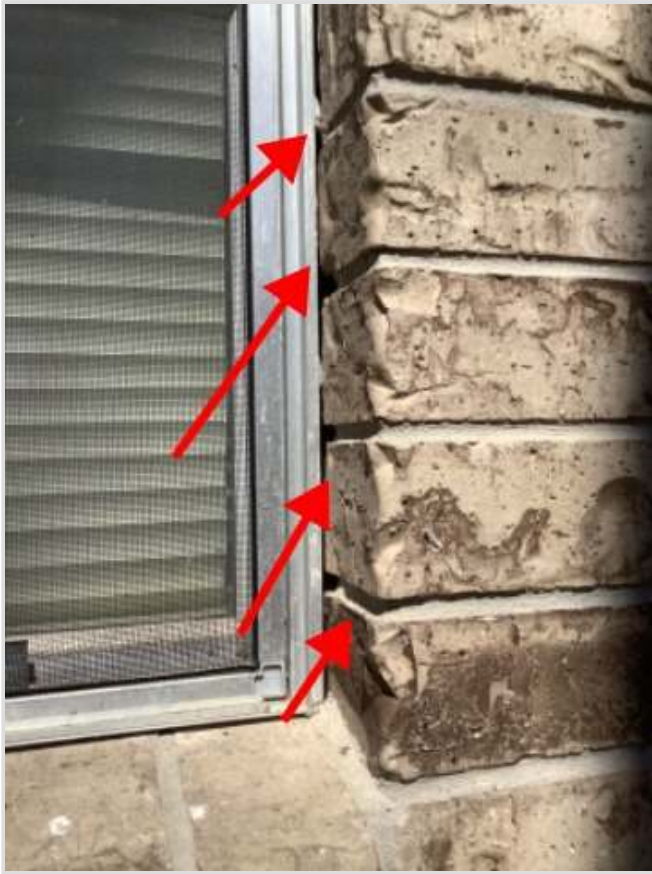
Gaps surround windows that need to be caulked

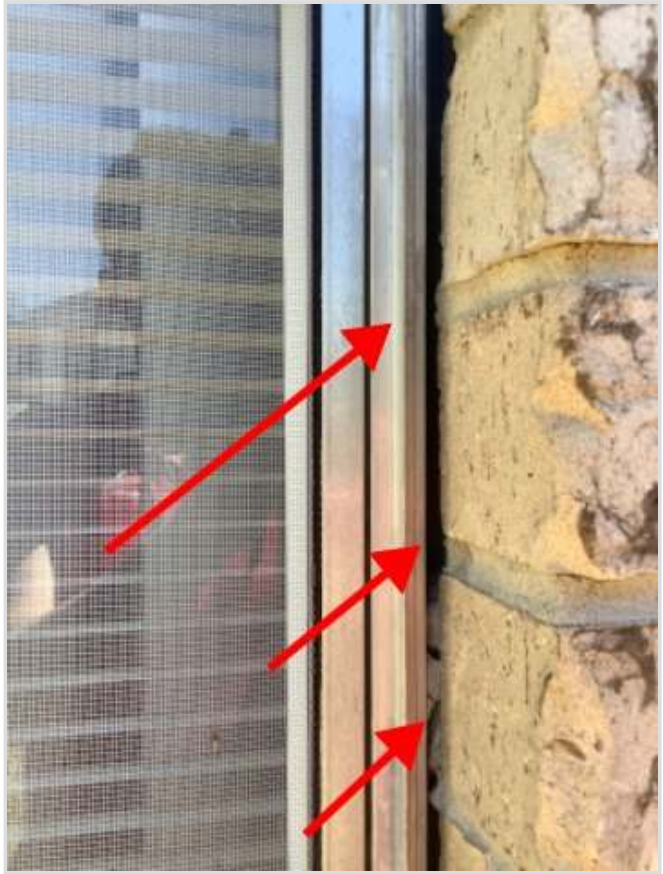
Gaps round window needs to be caulked

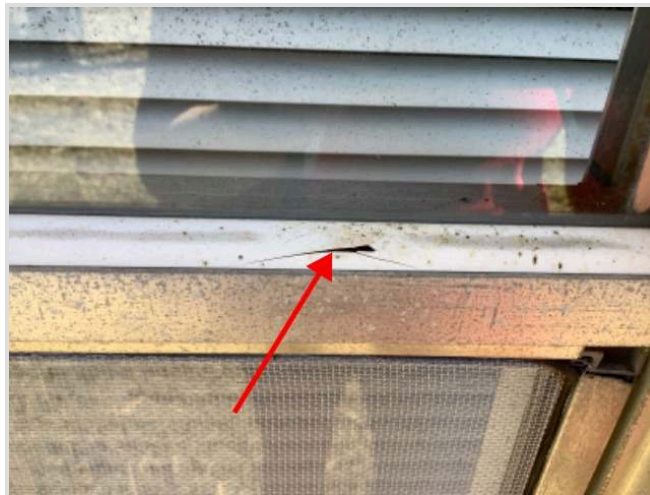
Window pane plastic trim is cracked on right rear of home

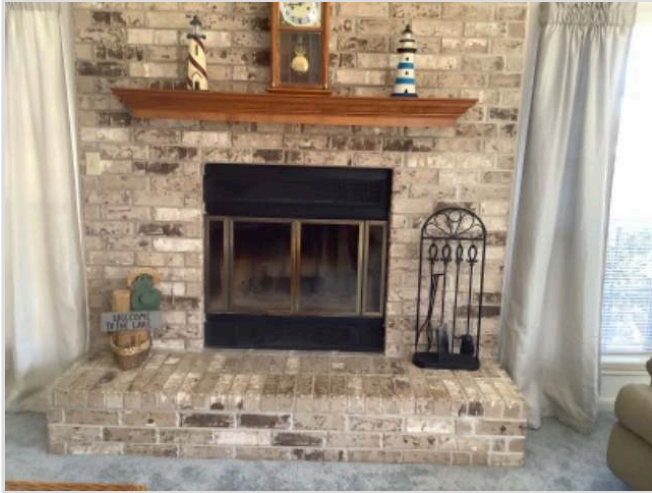
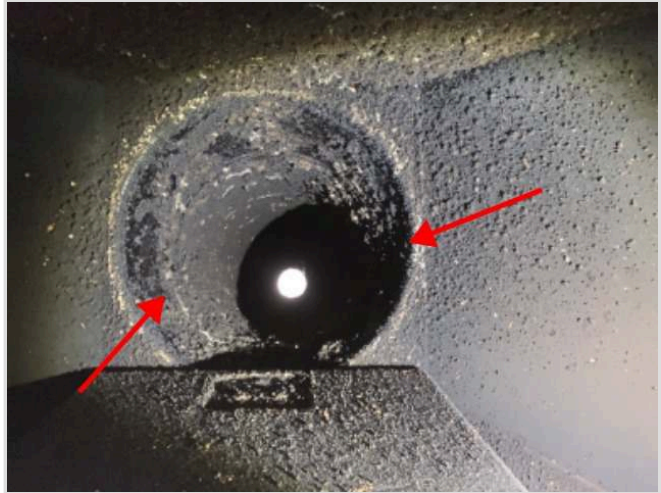
Built up creosote in chimney

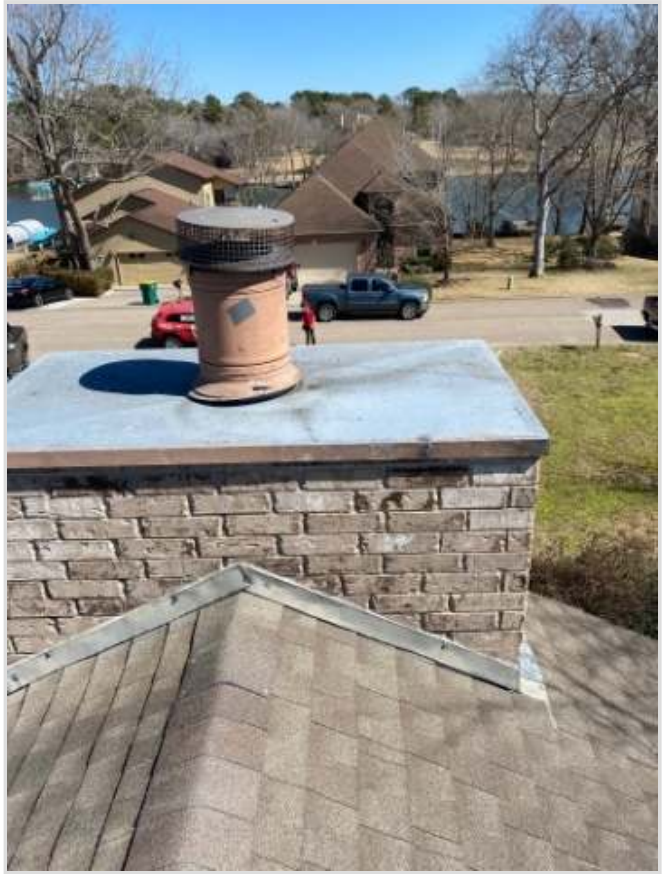
Sparker rest I'm not seated properly

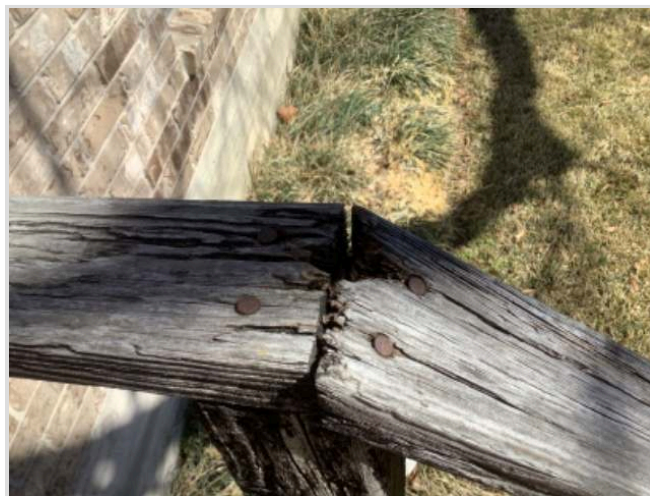
The exterior handrail from the breakfast nook area is deteriorated and should be replaced for safety purposes.

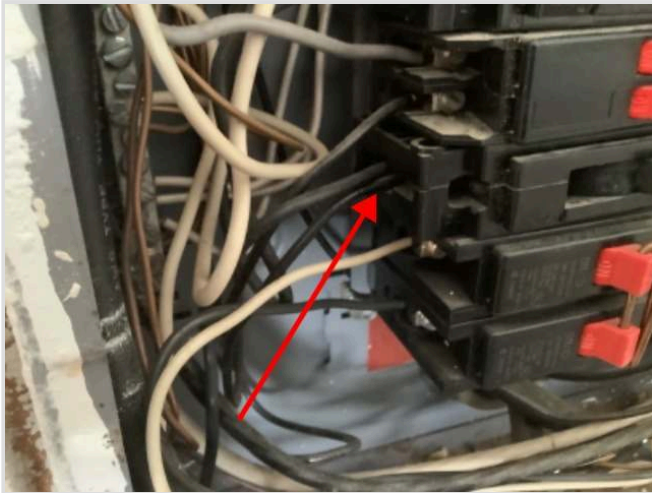
Double tapped wire

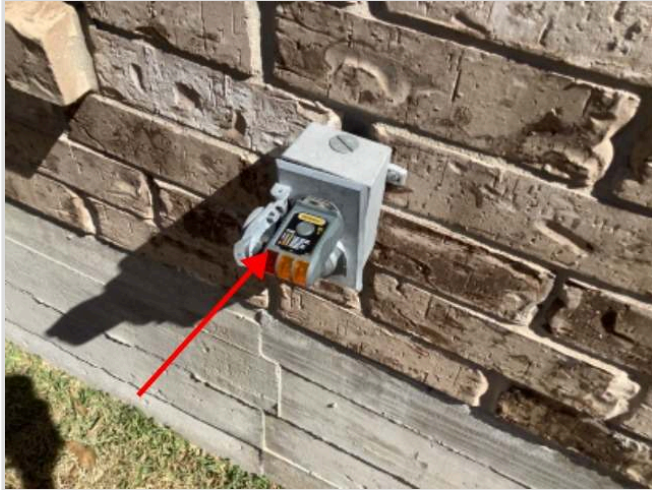
No GFCI protection on exterior walls

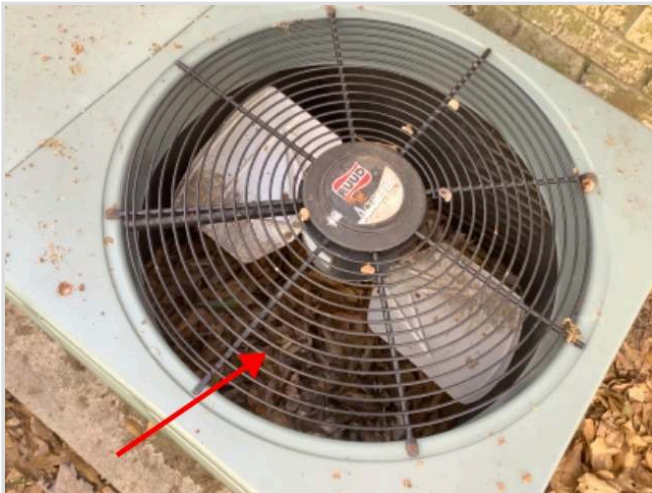
Full of leaf debris

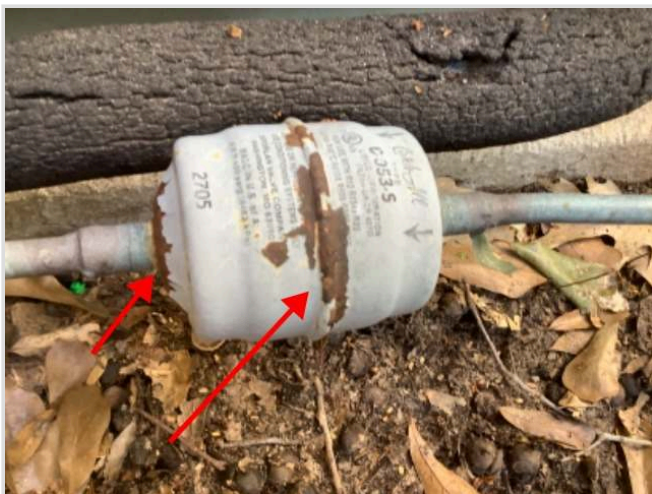
Rusted dryer filter at condenser

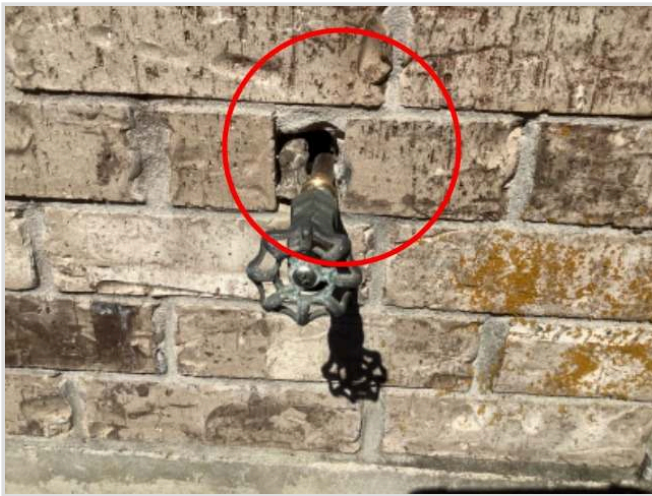
Area around faucet needs to be sealed to prevent intrusion of insects left side of house

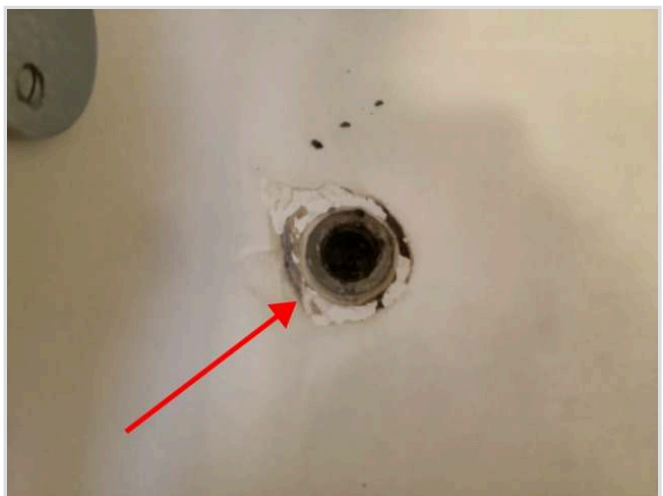
Corroded tub drain

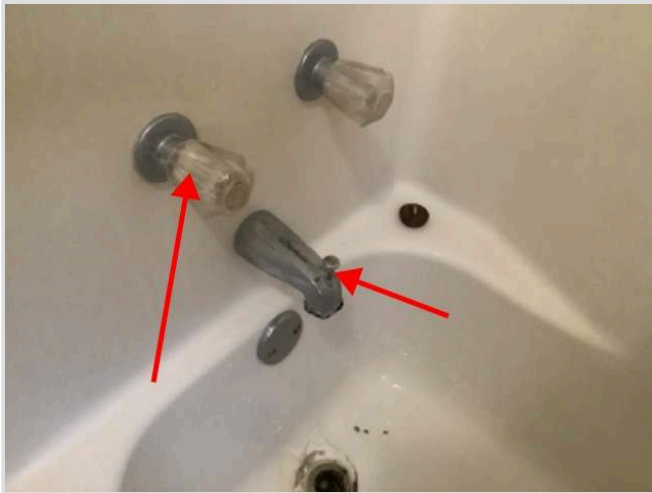
Hot water handle in master bathroom turns 360.
Diverter on faucet is stuck and will not turn off

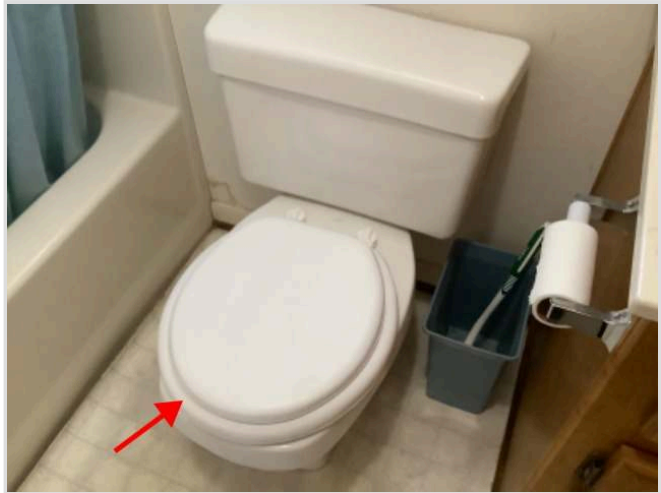
Toilet in master is loose

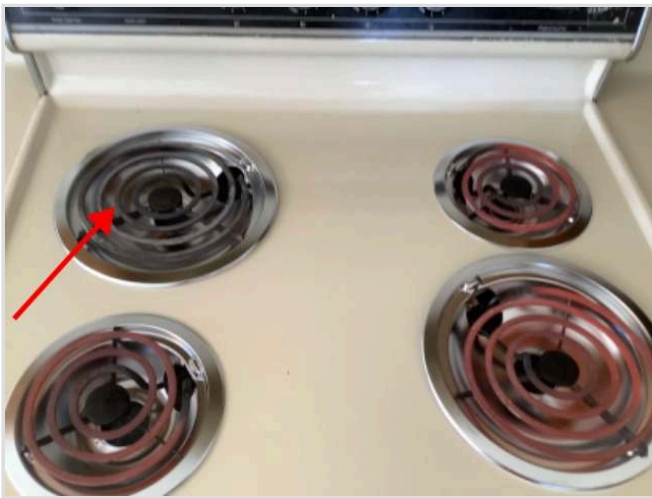
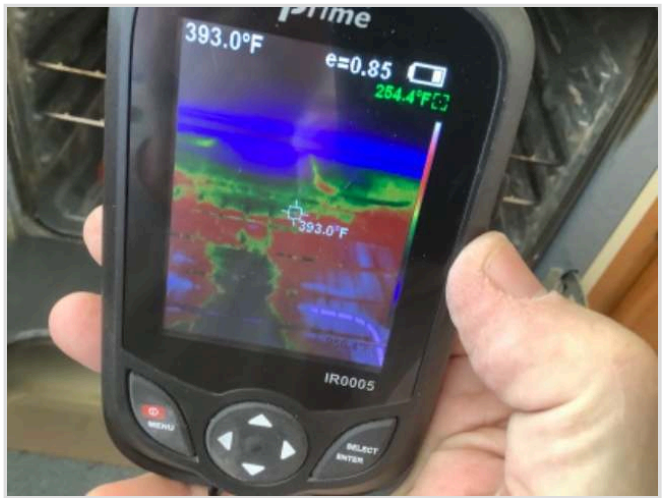
A freestanding electric range was present. The oven temperature was measured at 393 degrees when set on 350 degrees; the standard for proper oven operation is +/- 25 degrees, recalibration or oven repair is recommended. Burners on cooktop do not heat evenly.

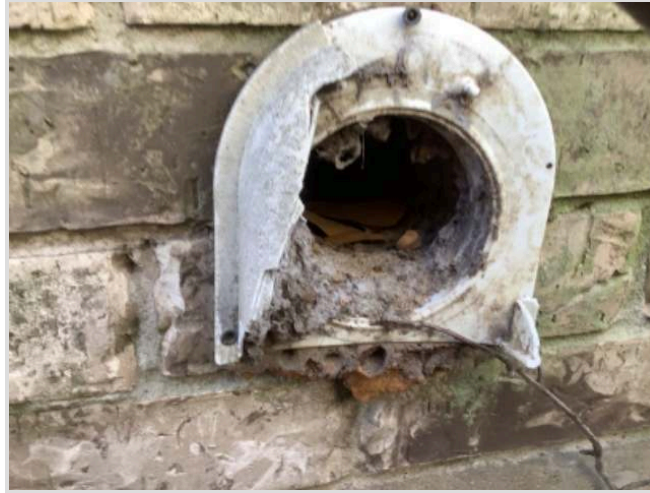
The dryer vented to the exterior through the wall. The dryer vent is dirty and also uncovered, the flap is broken.
