Web Presentation

Property Address: 12511 Wickwild Circle, Montgomery, TX 77356

JASE Home Inspections

**Jason Autrey T.R.E.C. #20981
15529 Queen Elizabeth Ct.
Montgomery, Tx. 77316
281-906-7168**

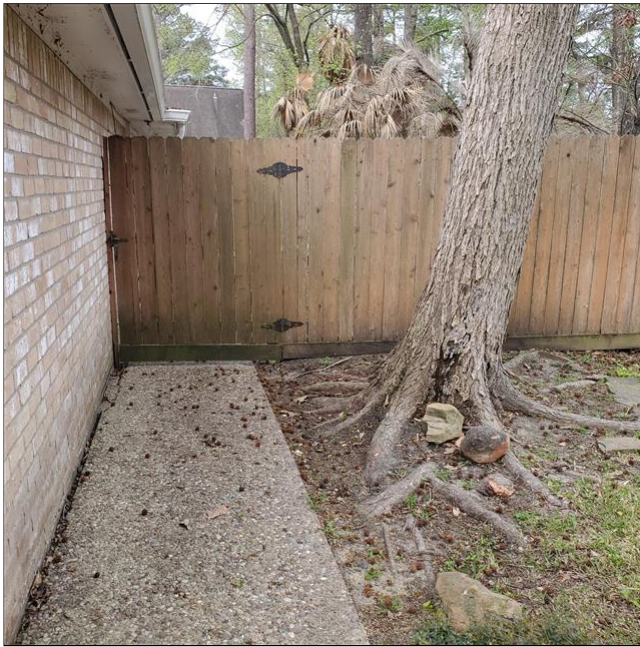
(3) Roots from a tree located near the foundation may cause foundation damage as the tree grows and the root system expands. Monitor this area of the foundation during the growing season (usually May through September) for signs of damage. If signs of damage appear (such as cracks) the tree may need to be removed. The potential for damage from tree roots varies with tree species. Consider evaluation by a qualified arborist.

A. Item 1(Picture) Trees at the front and right sides were close to the home.

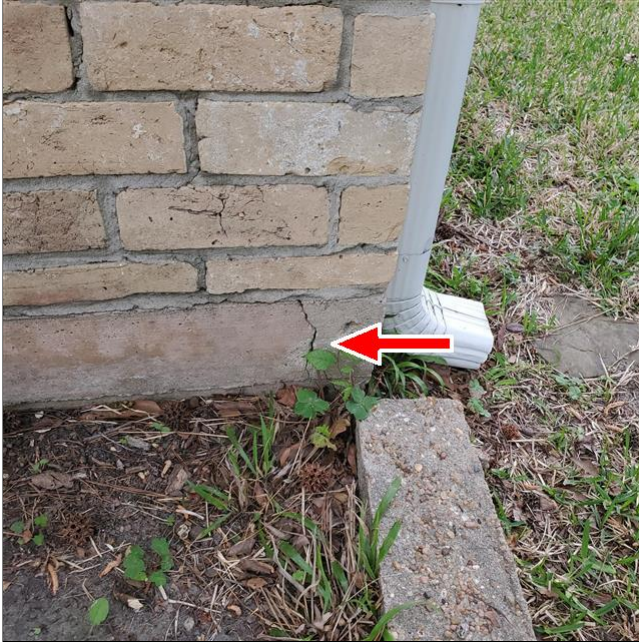
(4) It was noted that the house had cosmetic corner pops at the corners of the foundation. Corner pops are not structural and can be patched as needed. Corner pops on foundations are areas where it is difficult to add reinforcement into the concrete foundation forms and the lack of reinforcement allows the corners to crack and sometimes pop loose. I recommend patching the corners to prevent further deterioration.

A. Item 2(Picture) Photo of one of the corner pops.

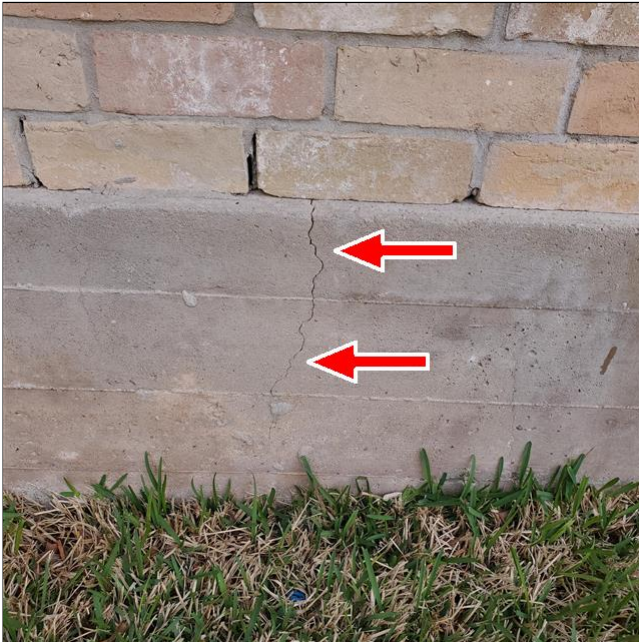
(5) A hairline crack was noted at the concrete foundation at the back of the home. The inspector is not sure if this was present prior to the repairs being completed or if this is new. The crack is not large. A professional engineer can perform an evaluation as needed.

A. Item 3(Picture) Photo of crack in foundation at the rear.

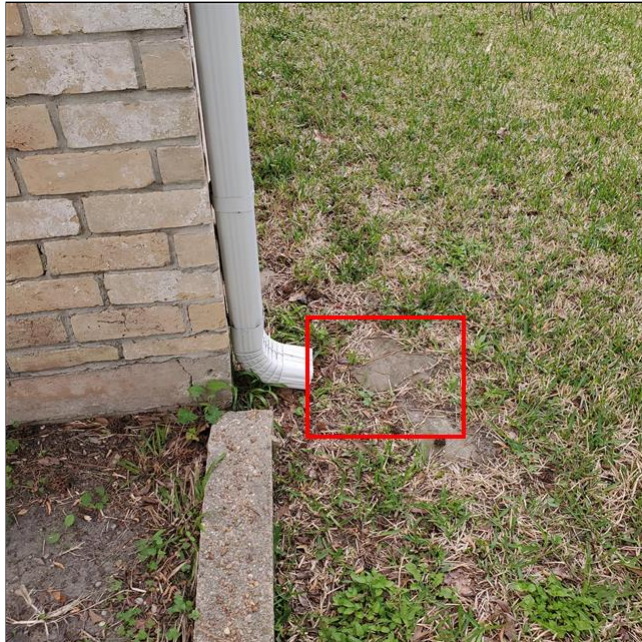
(2) Splash blocks were missing around the home under the downspouts. Splash blocks need to be installed under all downspouts to assist in forcing rain water at least 5 feet away from the foundation of the home.

B. Item 1(Picture) Need splash blocks under all downspouts.

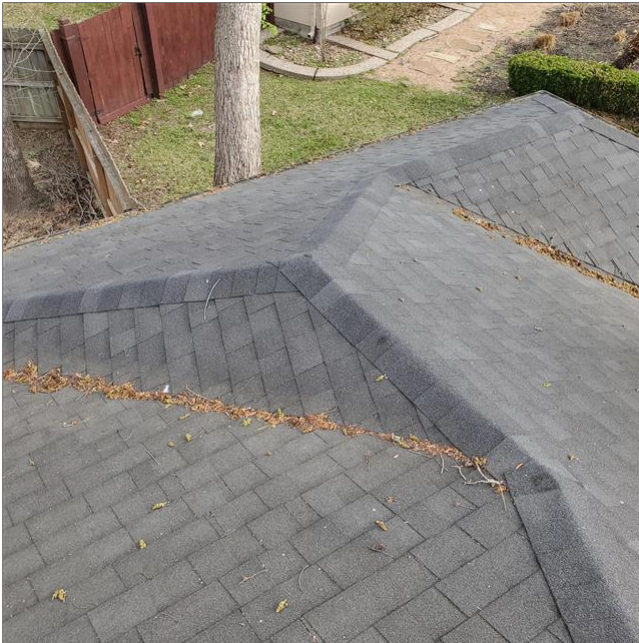
(2) There is a large amount of debris from trees on the roof. The roof will need to be cleaned off periodically eze the shingles may experience premature deterioration if left unattended.

C. Item 4(Picture) Debris should be cleaned off of the roof.

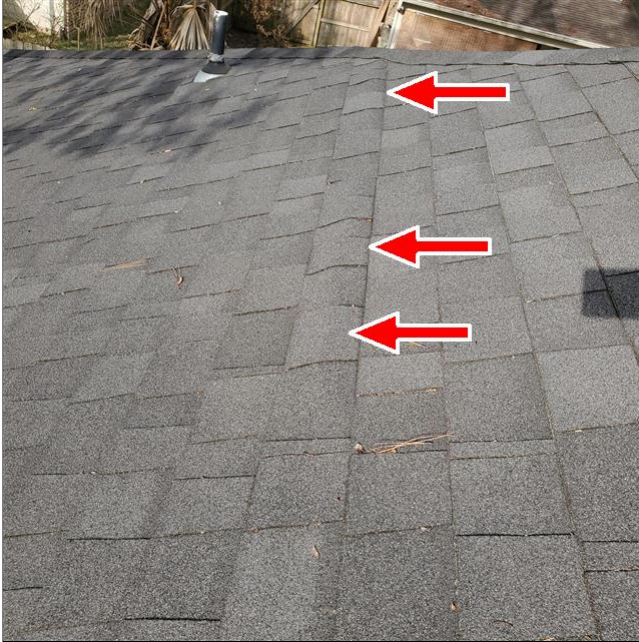
(3) There are two buckled shingles at the left side of the roof near the back left corner that are in need of repair.

C. Item 5(Picture) Photo of buckled shingles.

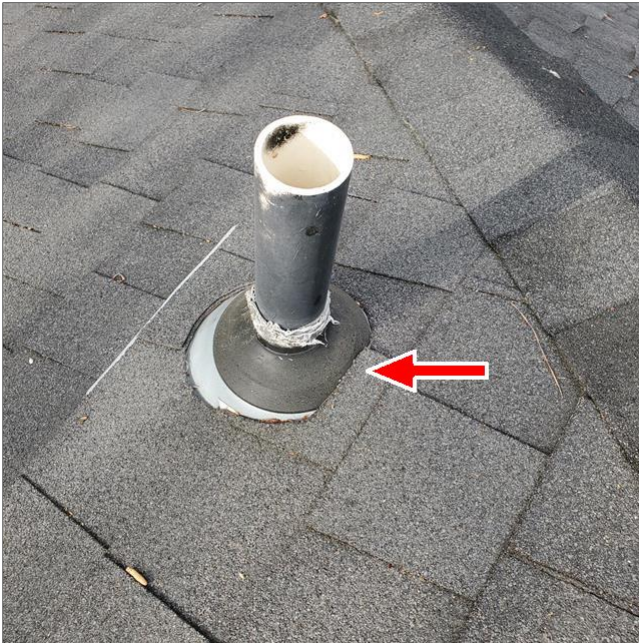
(4) Shingles are not properly cut around the roof jacks of the vent stack pipes at the left slope of the roof. A roofer should repair.

C. Item 6(Picture) Shingles should not be lifted over the back of the boots. The shingles should be cut around the boots.

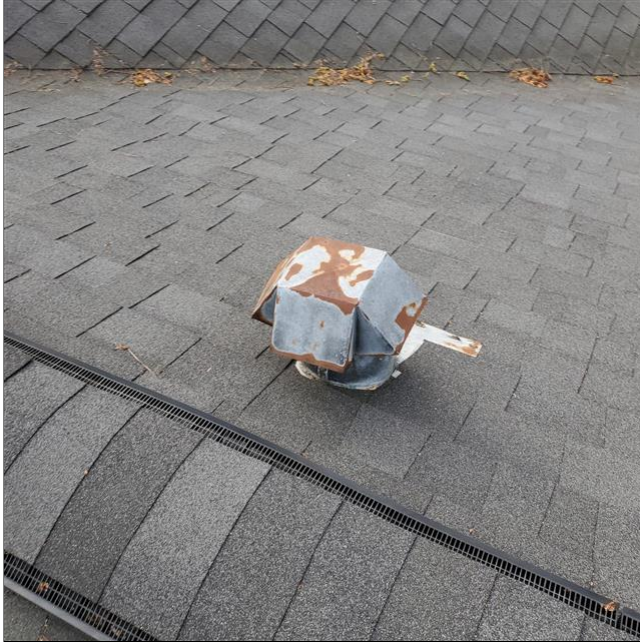
(5) An exhaust cap at the left side of the roof is rusted and should be replaced.

C. Item 7(Picture) Exhaust cap should be replaced.

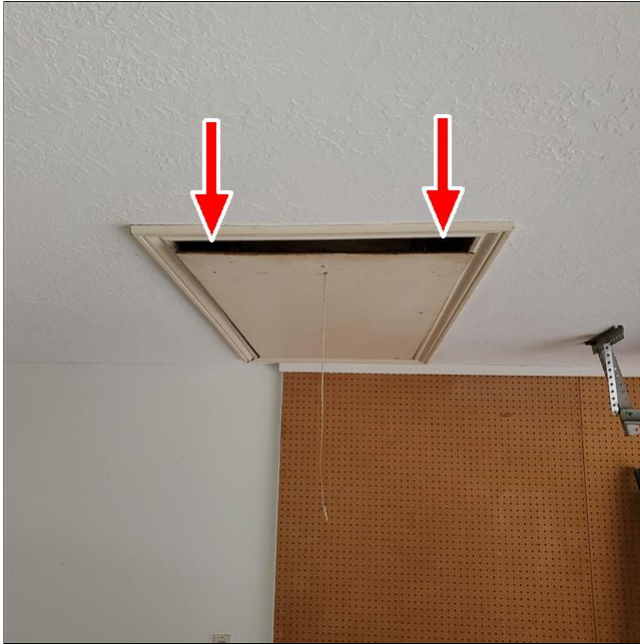
(1) The attic pull down in the garage does not properly seal at the ceiling when closed. Repairs need to be made to restore proper fire separation between the garage and attic space.

D. Item 1(Picture) Pull down does not close properly.

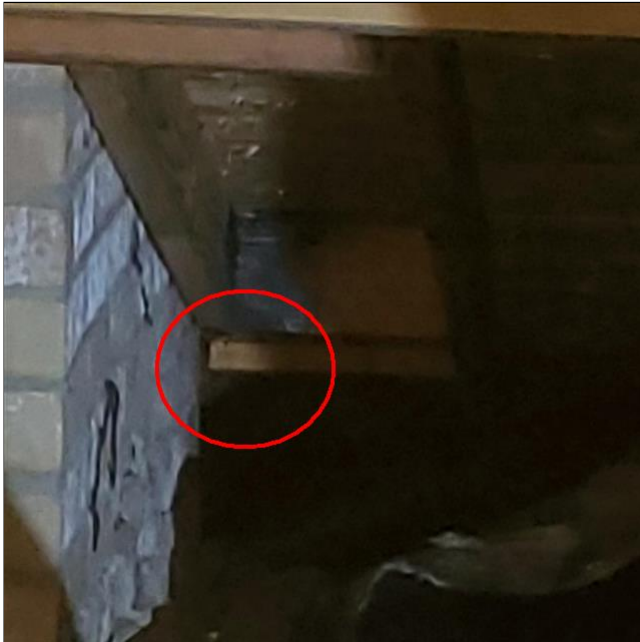
(2) A burn mark was observed on the wood framing near the chimney in the attic space. This is an indication that there is a potential problem with the chimney flue that is not visible to the inspector. A qualified fireplace/chimney professional should investigate.

D. Item 2(Picture) Light was shining during picture and the burned framing is not visible in photo.

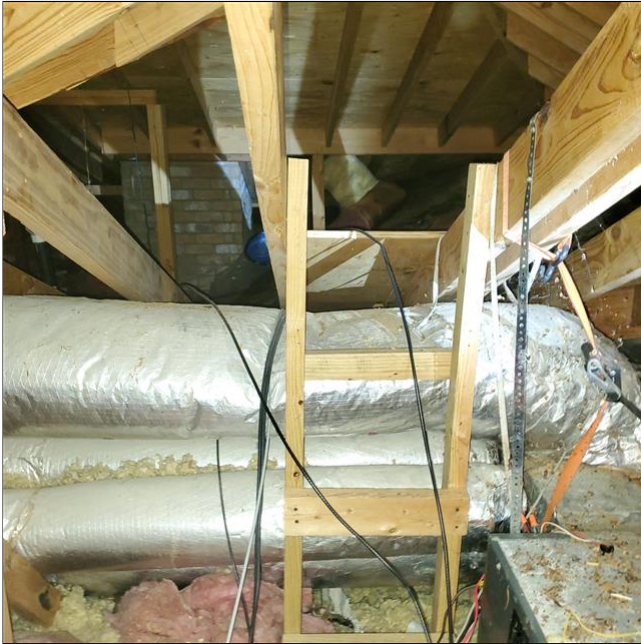
(3) There is no adequate access to the heating system/evaporator coils for the unit that is installed above the gameroom area. The steps and ramp that is installed is a safety hazard. Current standards indicate that all appliances in the attic should be installed within 20' of an attic access. It is strongly recommended

D. Item 3(Picture) These steps and the ramp on the other side of the ducts is a safety hazard.

that an additional attic access be installed for ease of access to the heating system/evaporator coils over the gameroom.

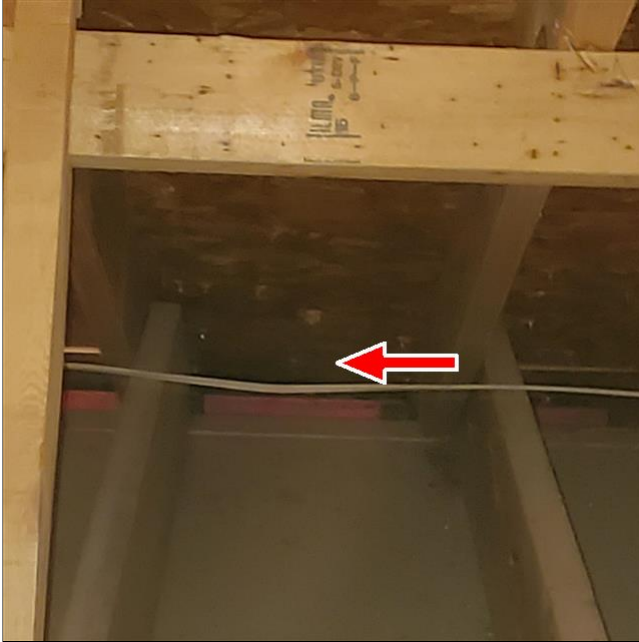
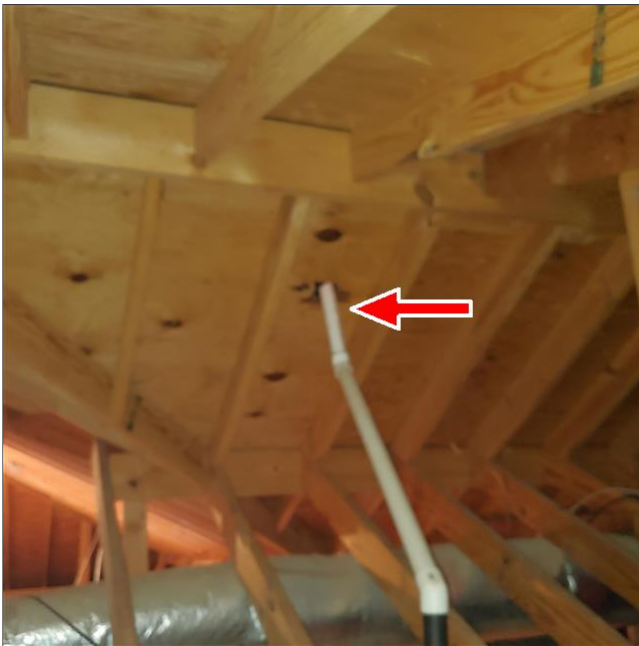
(5) There were signs of water penetration into the attic at the time of the inspection. The inspector was unable to determine if this is due to a current or past leak. I recommend a qualified roofing professional investigate and make repairs if needed.

D. Item 4(Picture) Sign of leak at the eave at the left side.

D. Item 5(Picture) Stain around plumbing vent pipe at the left side.

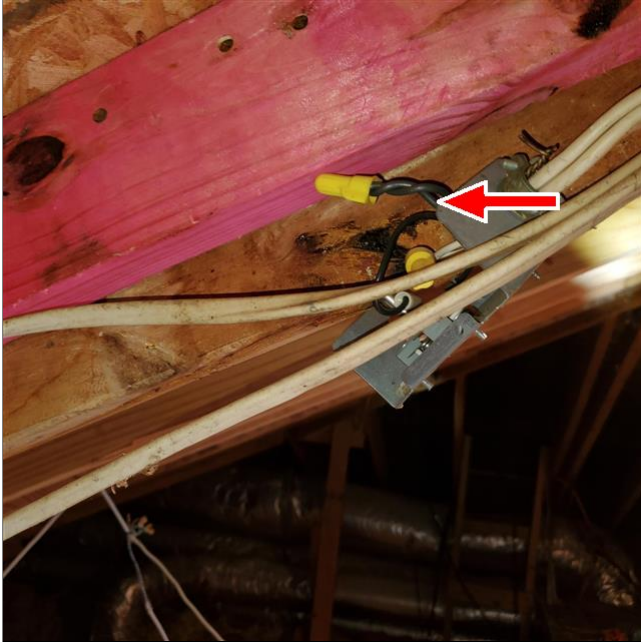
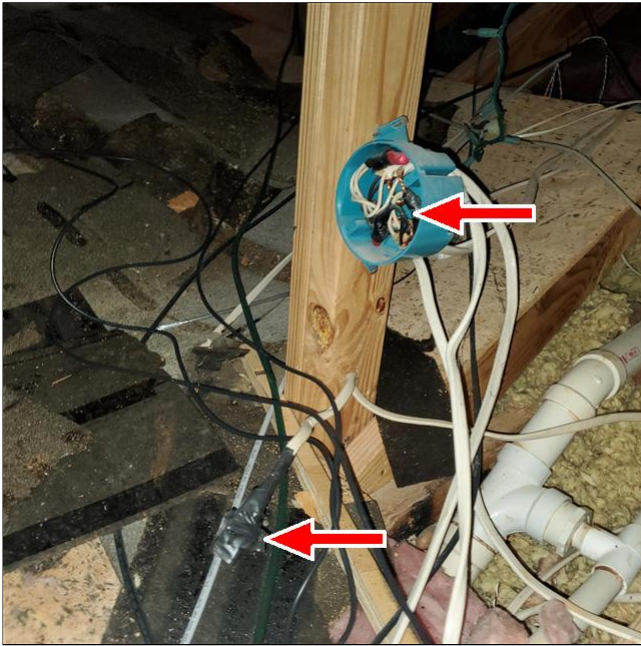
(6) Energized electrical splices not contained within a junction box and exposed to touch were visible in the attic at the time of the inspection. Electrical splices should be contained within an approved junction box with a cover plate installed. This condition is a shock/electrocution and potential fire hazard and should be corrected by a qualified electrical contractor.

D. Item 6(Picture) Splices not contained in junction box.

D. Item 7(Picture) Missing cover at junction box here. Lower arrow points to wires that have electrical tape over the copper.

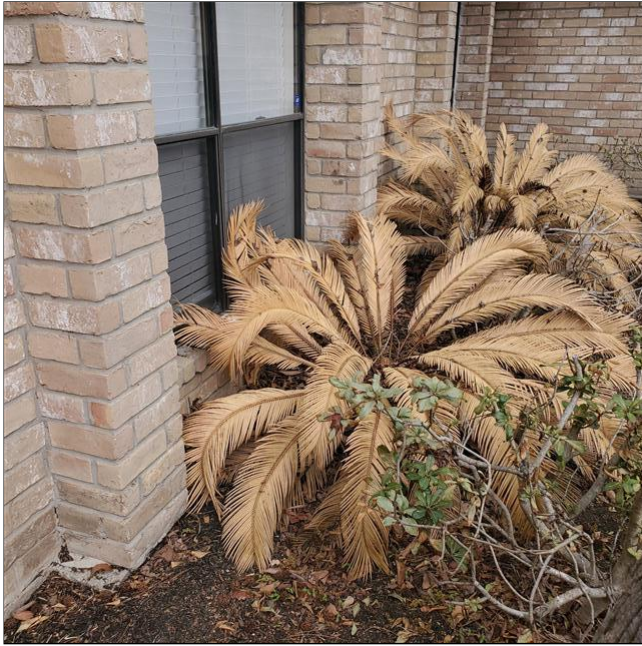
recommend trimming back all overgrowth and foliage. Over grown vegetation and foliage against a wall can hold moisture in that area and may damage the siding or brick. It can also provide a good avenue for insects to penetrate the wall.

E. Item 1(Picture) Vegetation should not be against exterior walls. These plants appear to be dead.

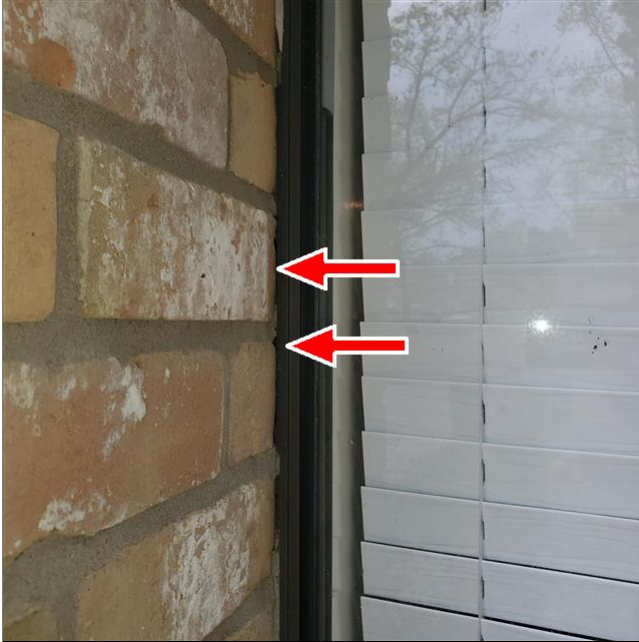
(2) All wall penetrations at the exterior of the home need to be sealed to the walls to keep unwanted moisture from entering the walls at these locations. The following photos are not inclusive of all wall penetrations that need to be sealed.

E. Item 2(Picture) Windows need to be caulked and sealed.

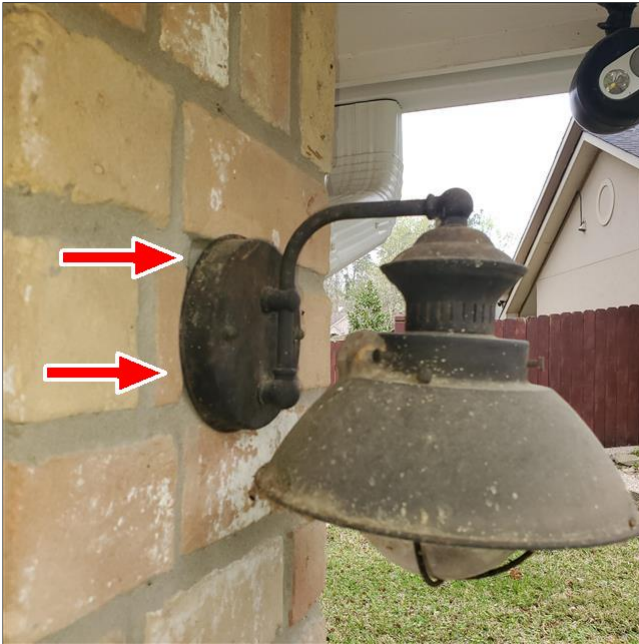
E. Item 3(Picture) Need to seal all wall penetrations to brick.

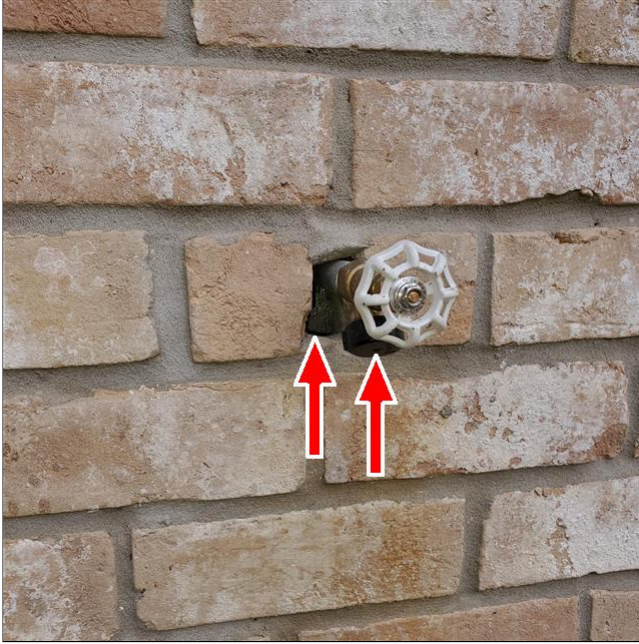
E. Item 4(Picture) Large gap around hose bib at the back.

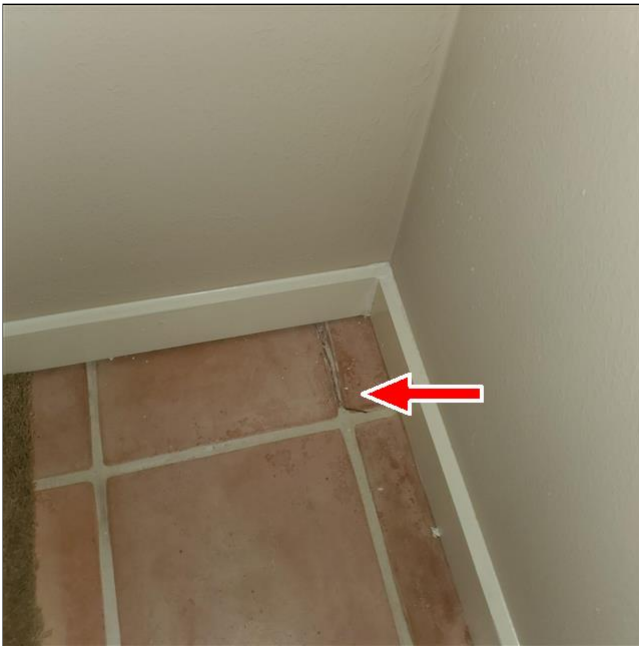
(1) There are damaged floor tiles in the left side master bedroom closet

F. Item 1(Picture) Tile was damaged at the back corner.

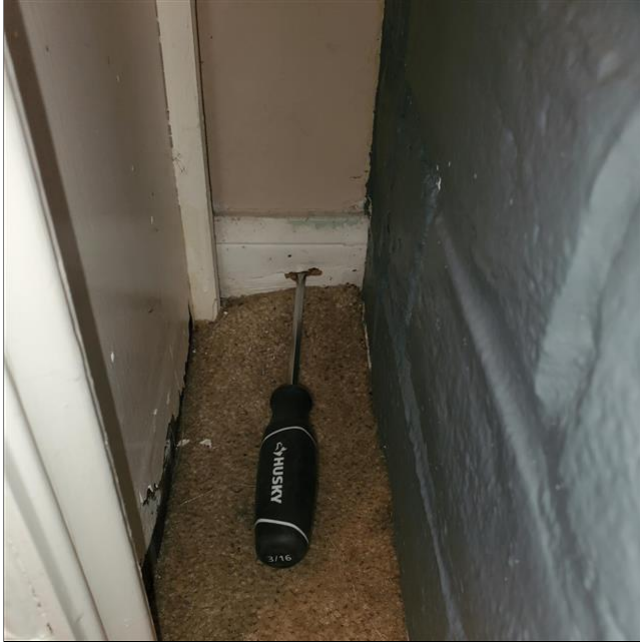
(2) A damaged baseboard was noted at the left side of the fireplace in the living room. The inspector was able to easily puncture the baseboard. (baseboard was soft and already damaged). The inspector is not a licensed termite inspector but recommends that the buyer obtain the services of a termite inspector to determine if wood destroying insects are present.

F. Item 2(Picture) Baseboard was soft and was damaged.

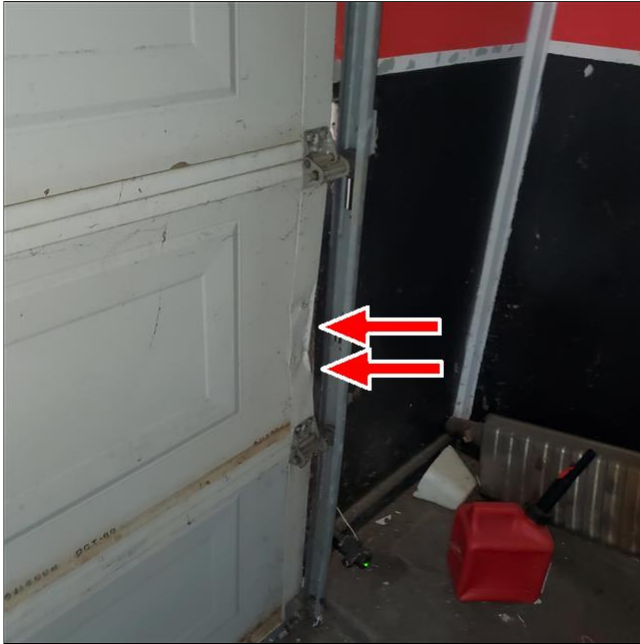
(1) The garage door is damaged at the interior. Replacement of the affected panel could be completed as needed.

G. Item 1(Picture) Door is damaged.

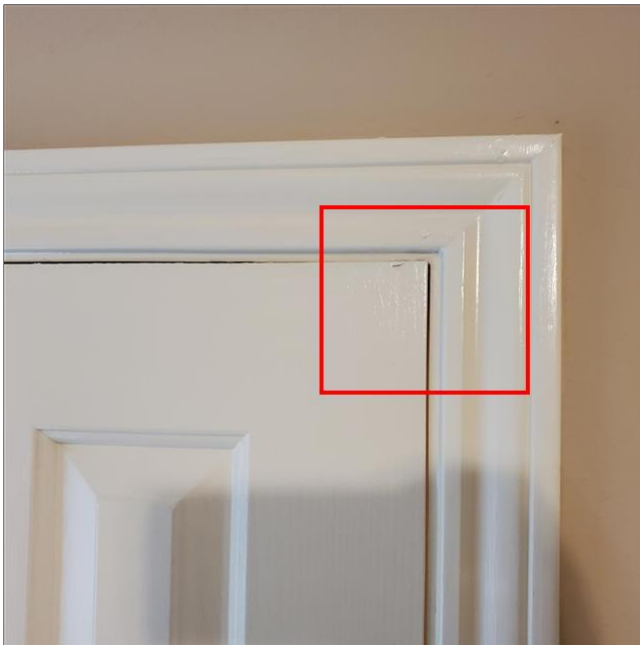
(2) The back master bedroom closet door was binding slightly at the top when tested. Corrections are recommended.

G. Item 2(Picture) Door was sticking at the top.

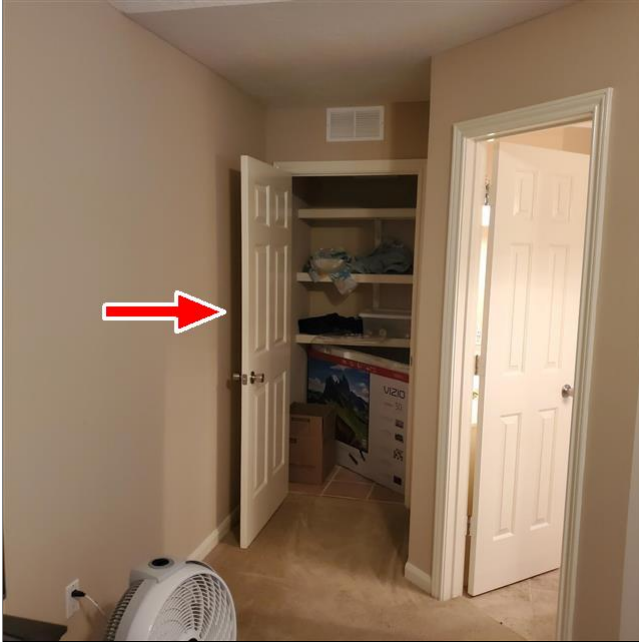
(3) The door to the left side master bedroom closet was out of square, dragging the carpet, and would not close properly. Repairs to the door are needed.

G. Item 3(Picture) This door needs repair.

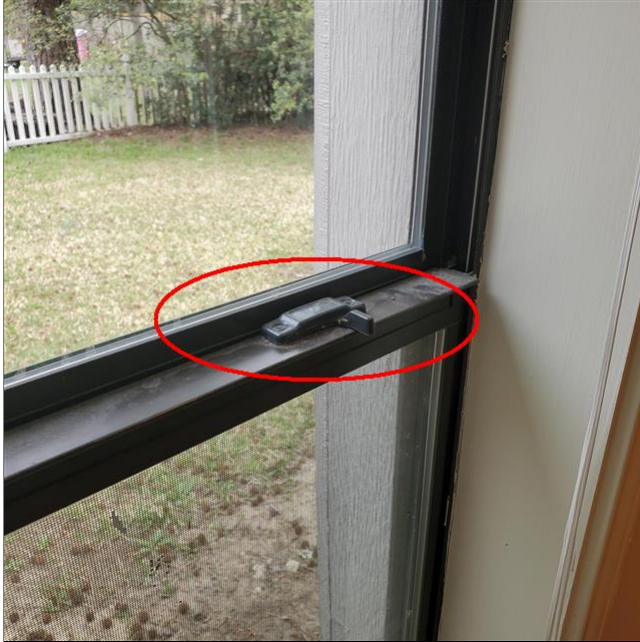
(2) The window in the front left bedroom was slightly out of square and the right side lock was unable to lock. A window professional should repair.

H. Item 1(Picture) Right side of window was unable to lock.

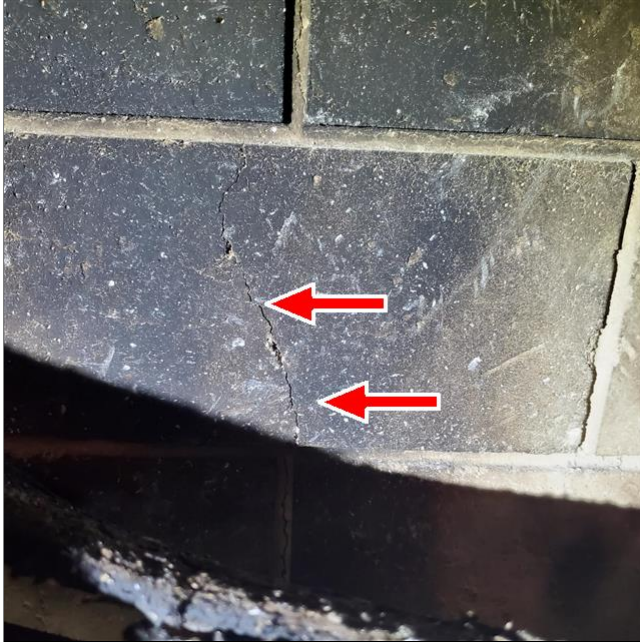
(1) There is a hairline crack in the back metal wall of the fireplace in the living room. This crack is not large enough to warrant replacing the back metal wall at this time but should be monitored for growth for potential replacement in the future.

J. Item 1(Picture) Photo of hairline crack at back wall.

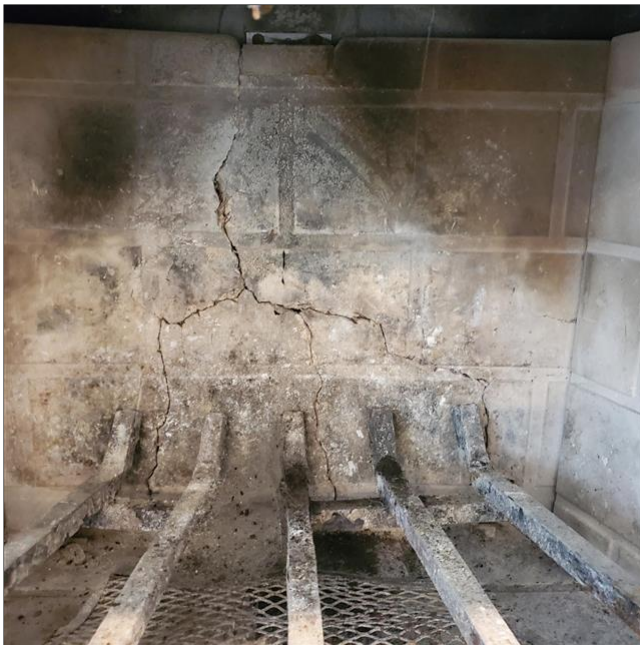
(2) The back metal wall of the game room fireplace is damaged and should be replaced prior to the next use.

J. Item 2(Picture) Photo of large cracks in metal wall.

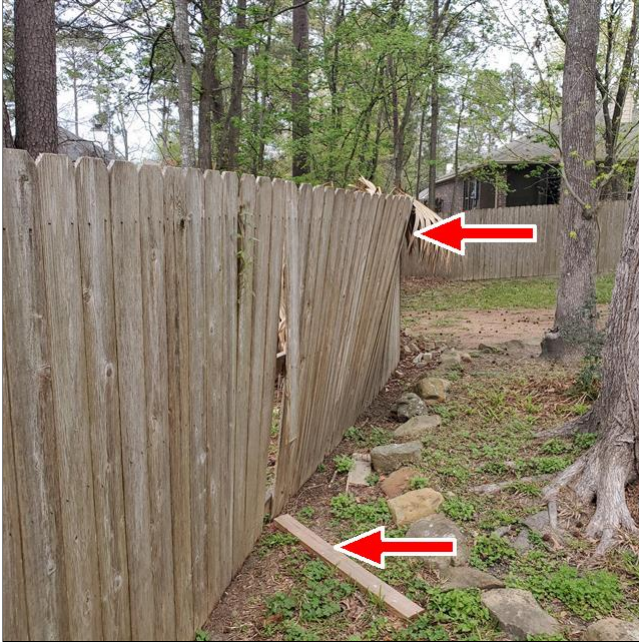
The fence was damaged and leaning at the back. Repairs should be completed as this represents a safety hazard.

L. Item 1(Picture) Photo of damaged and leaning fence.

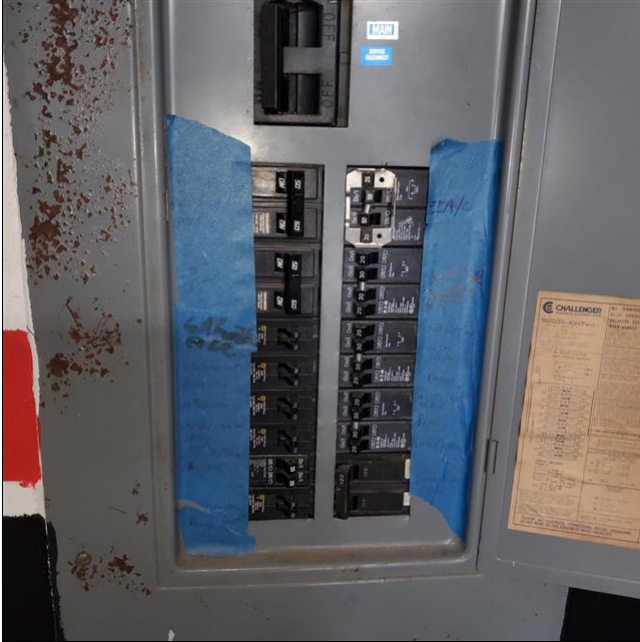
A. Item 2(Picture) Breakers at all panels were not labeled.

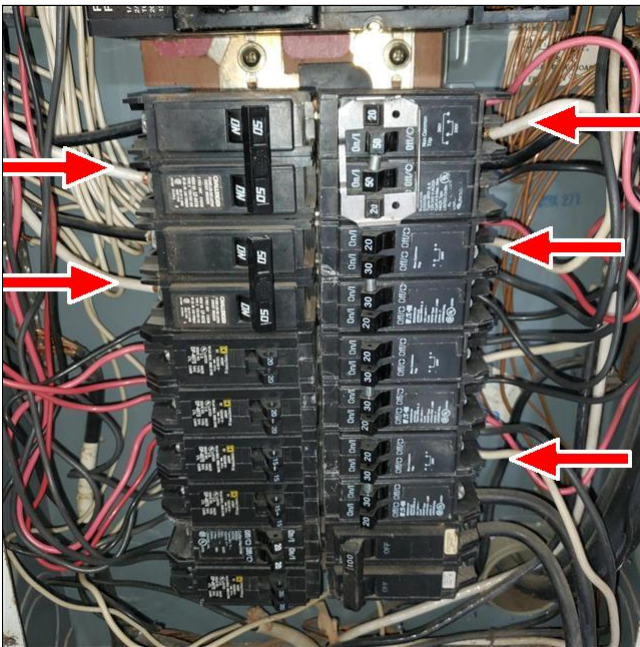
(3) At least one white wire terminated at a breaker in the main service panel. White wires are typically used as neutral wires and terminate at a bus bar. White wires may be used as hot wires as in this case but should be marked with a black marking to indicate they are hot.

A. Item 3(Picture) White wires to breakers should be marked with black markings.

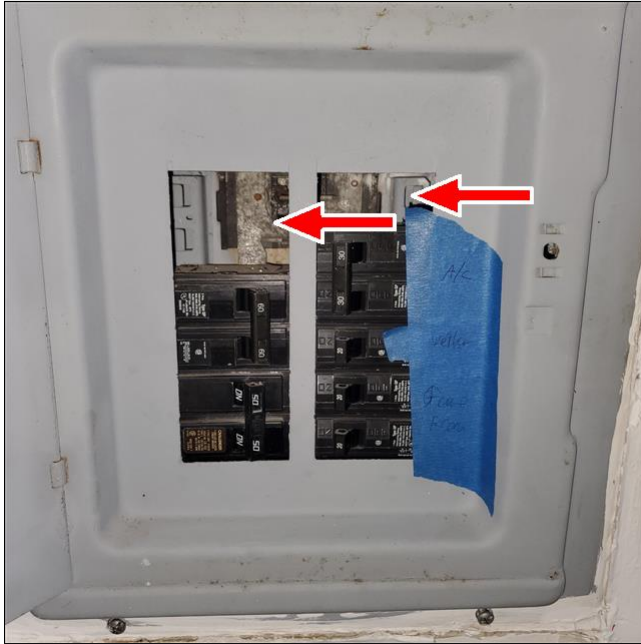
(4) One or more openings in the dead front cover of the sub panel in the garage where circuit breakers were not installed were not properly covered. This condition may allow a person to come into contact with

A. Item 4(Picture) Need filler plates.

energized electrical components and is a potential shock/electrocution hazard. Filler plates made for this purpose should be installed by a qualified electrical contractor.

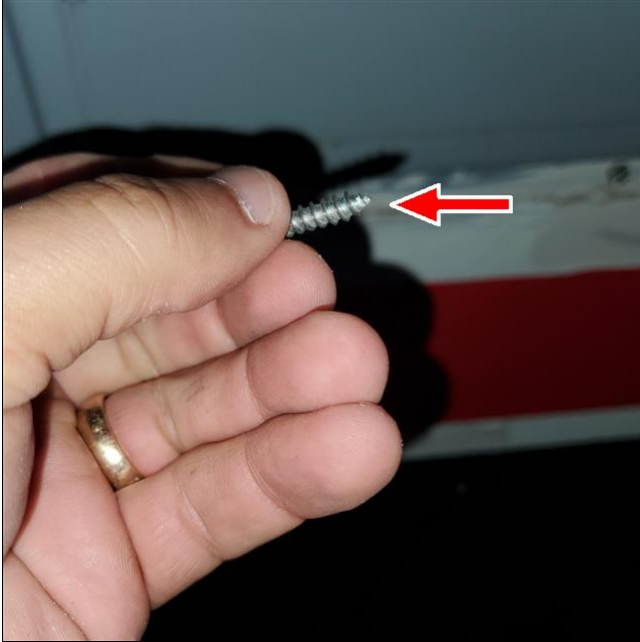
(5) There are currently sharp pointed screws securing the panel to the sub panel in the garage. Sharp pointed screws should not be used to secure panels to breaker boxes due to the possibility of the screw piercing the wires inside the box. I recommend replacing all sharp pointed screws with blunt tipped screws.

A. Item 5(Picture) Sharp screws should not be used.

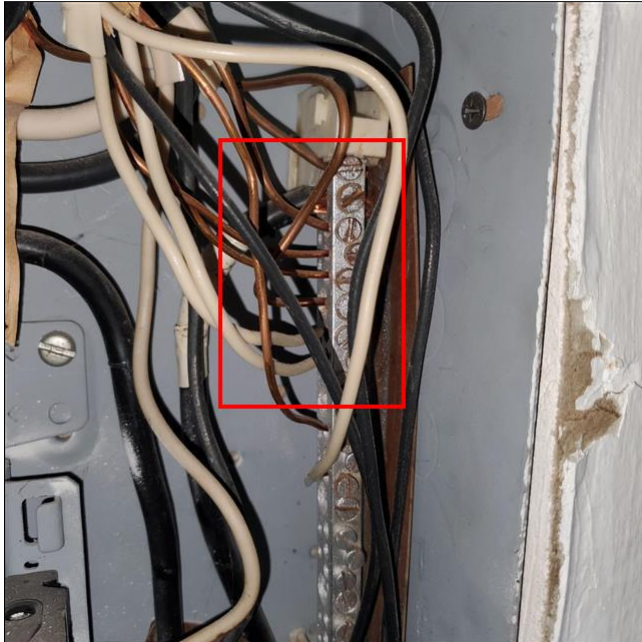
A. Item 7(Picture) White wires and bare ground wires terminate at same bus bar.

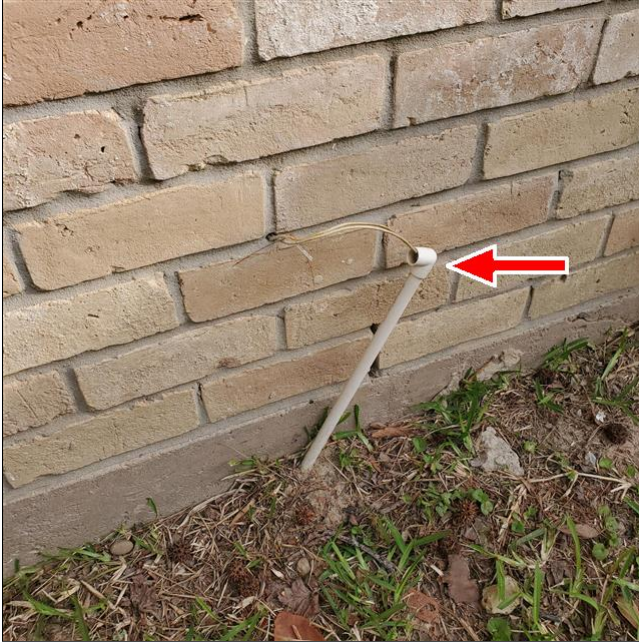
(2) An electrical conduit at the left side of the home was not properly secured and sealed to the exterior wall to protect the wiring.

B. Item 1(Picture) Conduit not secured to wall.

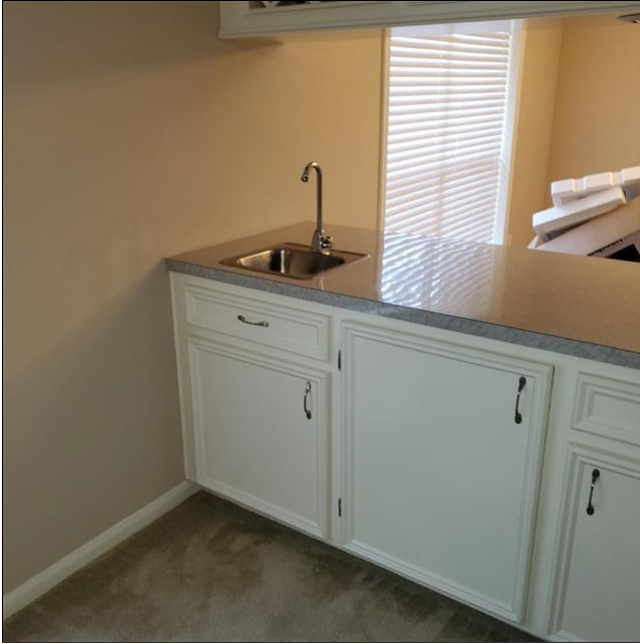
(5) Current building standards state that there should be a GFCI protected wall receptacle within 3 feet of the outer edge of all sinks. The living room wet bar sink was missing a wall receptacle. Upgrades can be completed by a licensed electrician.

B. Item 2(Picture) There is no outlet close to this sink.

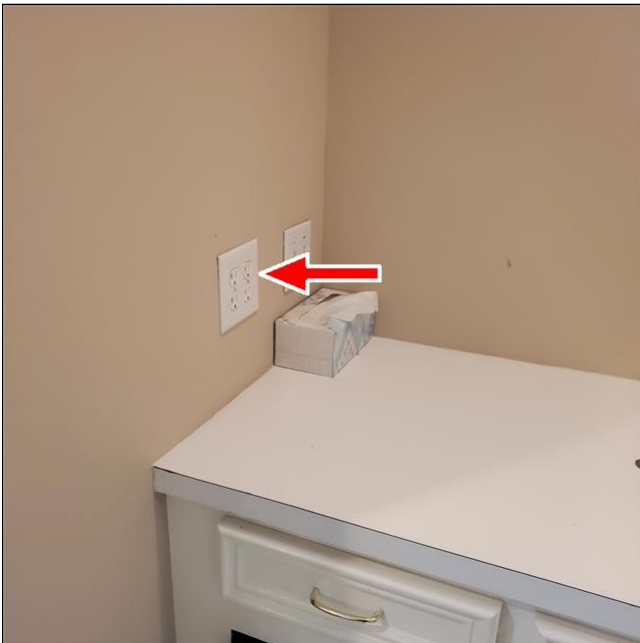
(6) The game room wet bar outlet is not GFCI protected as required by current standards.

B. Item 3(Picture) Outlet is not GFCI protected.

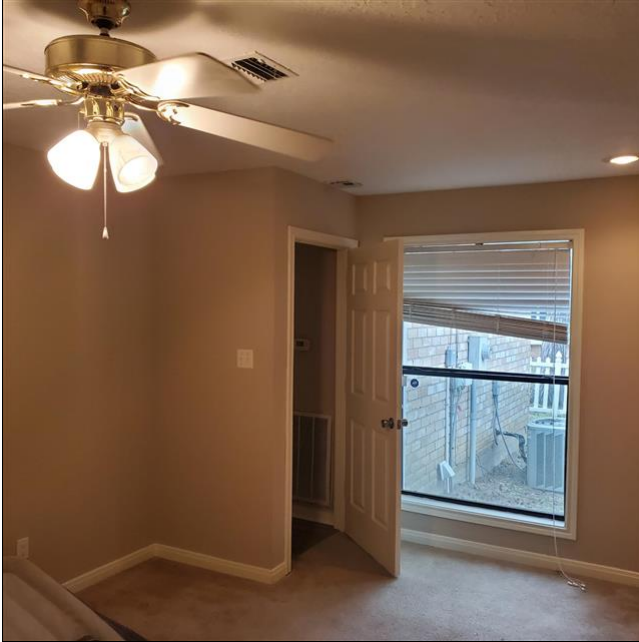
(7) Current building standards state that interconnected smoke detectors should be installed inside all bedrooms and in the hallways outside each cluster of bedrooms. These smoke detectors should also be hard wired and interconnected to allow all alarms to sound if a single alarm is sounding. A licensed electrician can upgrade.

B. Item 4(Picture) There were no smoke detectors inside the bedrooms.

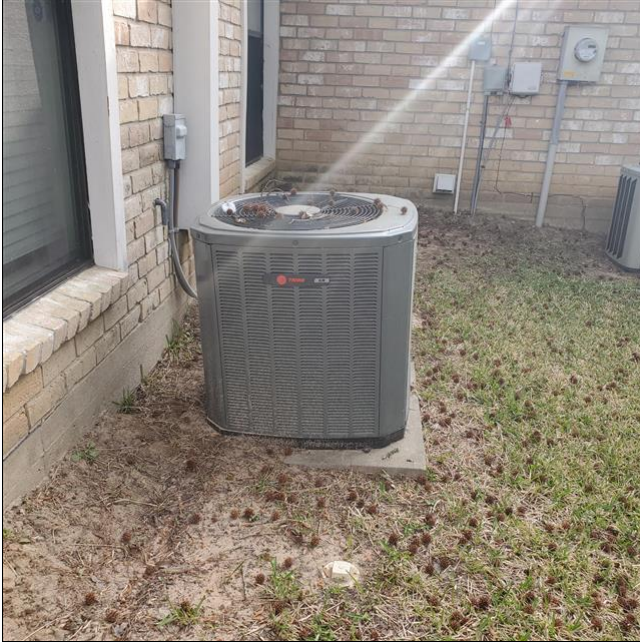
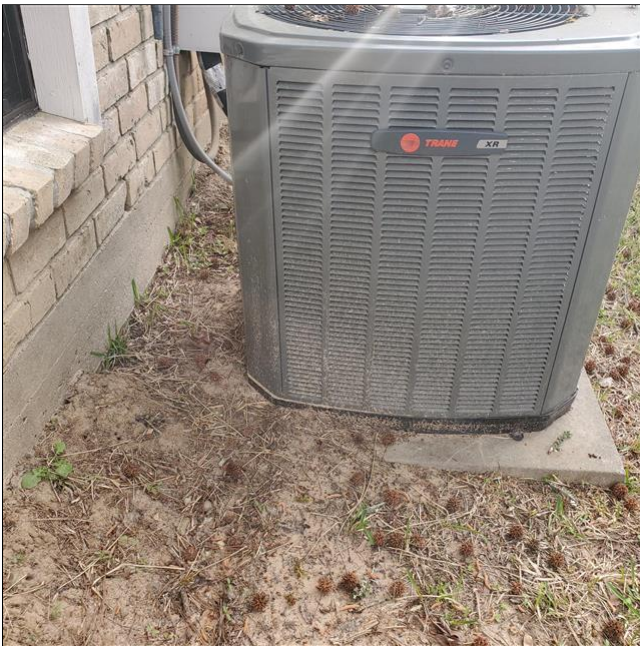
(2) Both air conditioners are not installed on a pad that is elevated 3" above the ground. Repairs are recommended.

B. Item 3(Picture) Pad does not elevate unit 3" above the ground.

B. Item 4(Picture) Back of unit is at ground level.

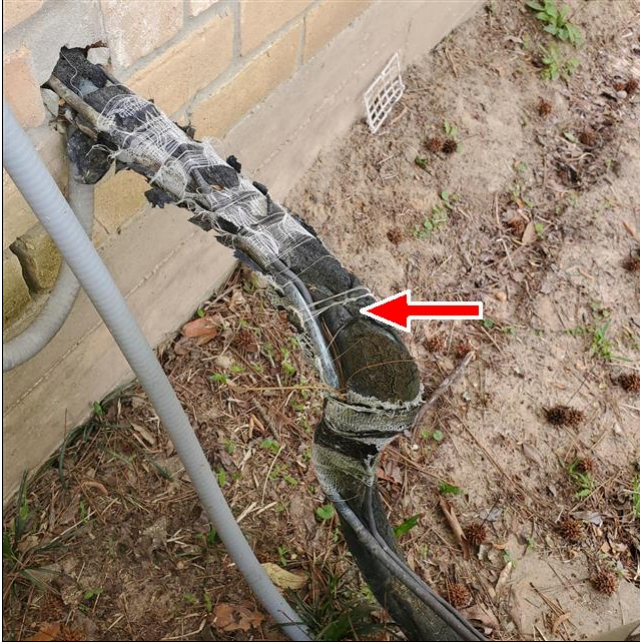
B. Item 5(Picture) Suction line for older unit needs to be re-insulated.

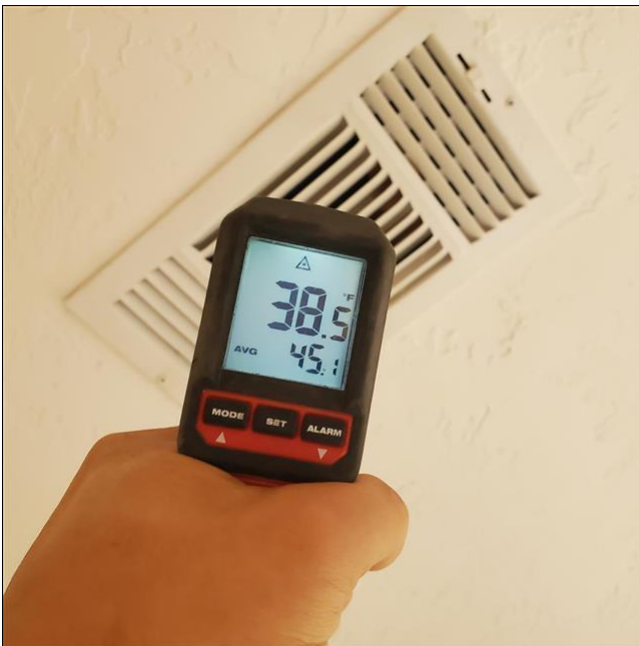
(4) The unit that serves the gameroom area and master suite was loud inside the home when tested. This may be related to the air intake (return) being too small. It was also noted that this unit was providing cold air that was approximately 38 degrees during the inspection which is too cold. The inspector recommends having a licensed HVAC professional perform an evaluation of both units. The HVAC professional should also make recommendations as to if the units are properly sized for the home as there is a total of 7 tons of cooling which is typically what is installed for a 4,000 square foot home.

B. Item 6(Picture) 38 degree air supplied.

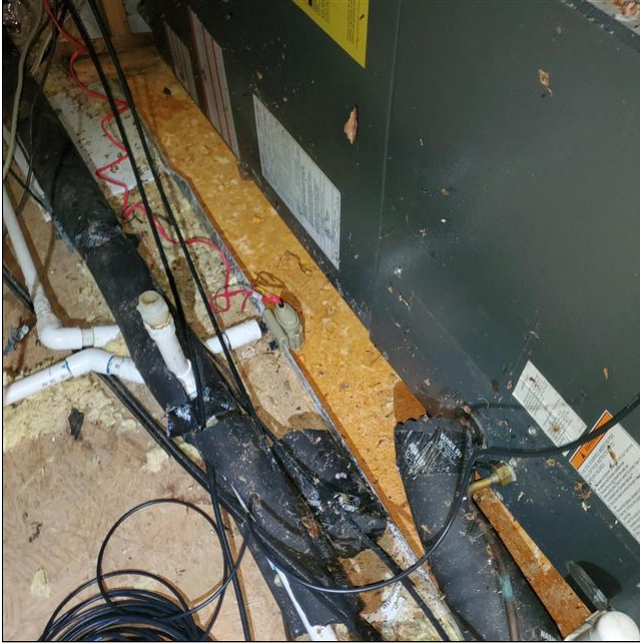
(5) The emergency drain pan under the unit near the attic entry is rusted. A licensed HVAC professional can replace as needed.

B. Item 7(Picture) Photo of rusted pan.

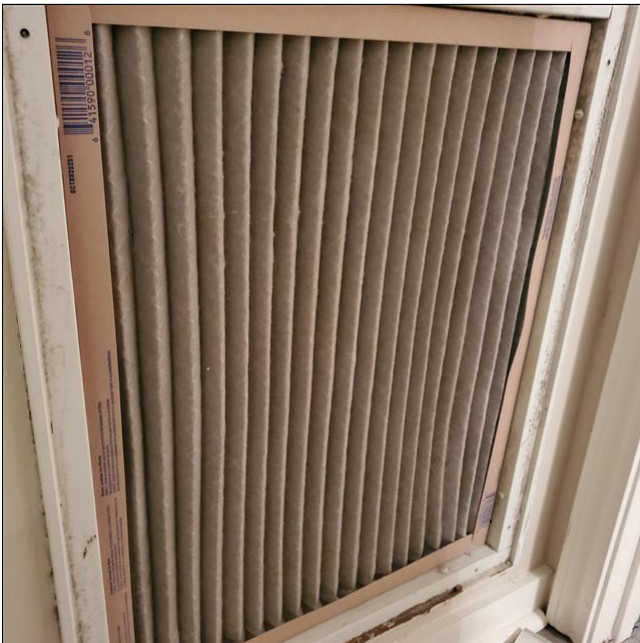
(1) Air filters inside the home are very dirty and are in need of replacement.

C. Item 1(Picture) Filters were dirty.

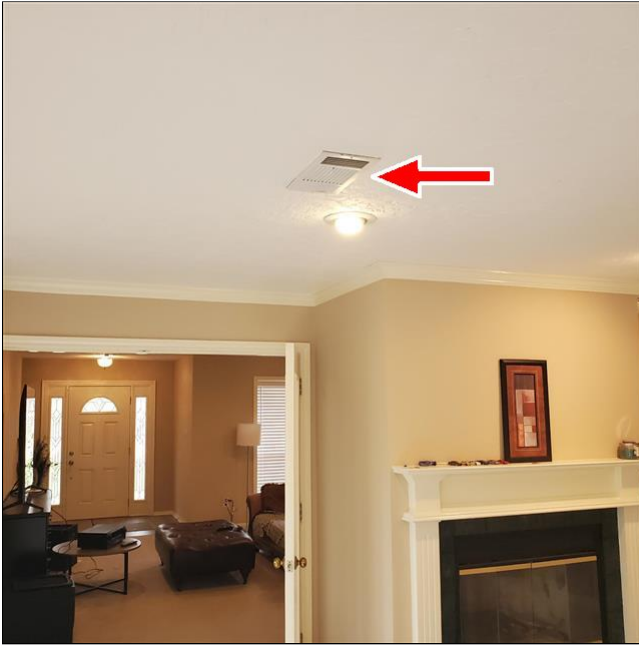
(2) An air vent in the gameroom was rattling when the unit was tested. A licensed HVAC professional should investigate to determine what repairs are needed.

C. Item 2(Picture) This vent was rattling.

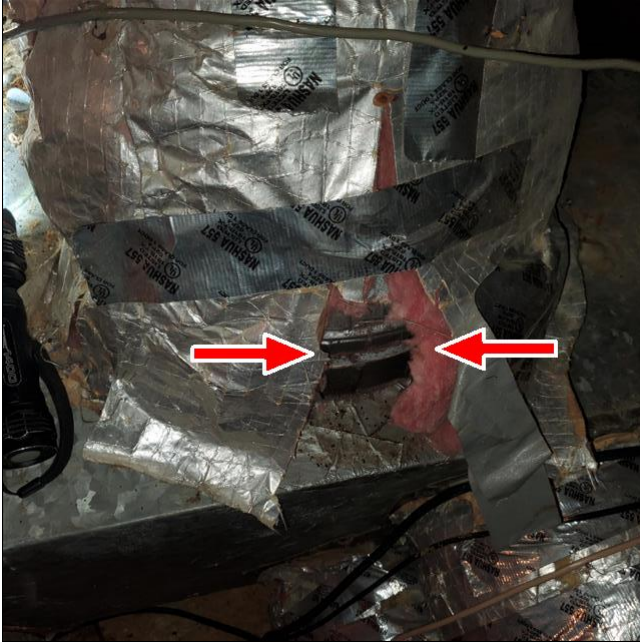
C. Item 3(Picture) Insulation was loose around vent at plenum.

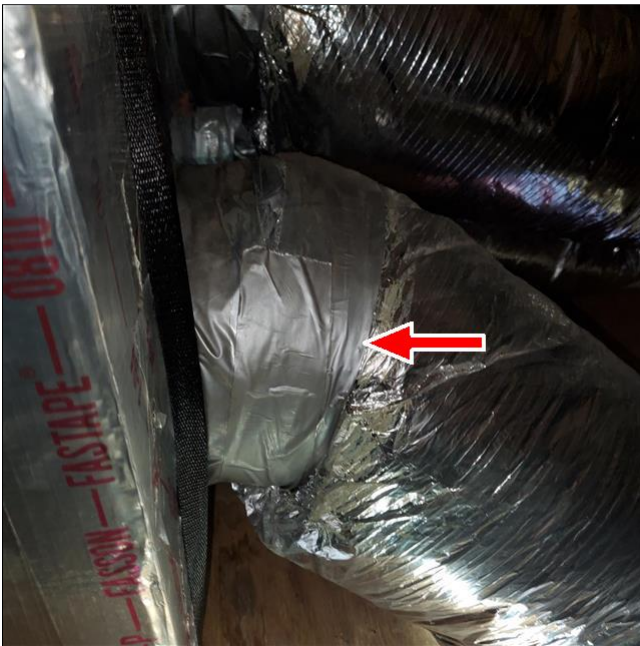
C. Item 4(Picture) Duct tape should not be used to seal ducts to plenums.

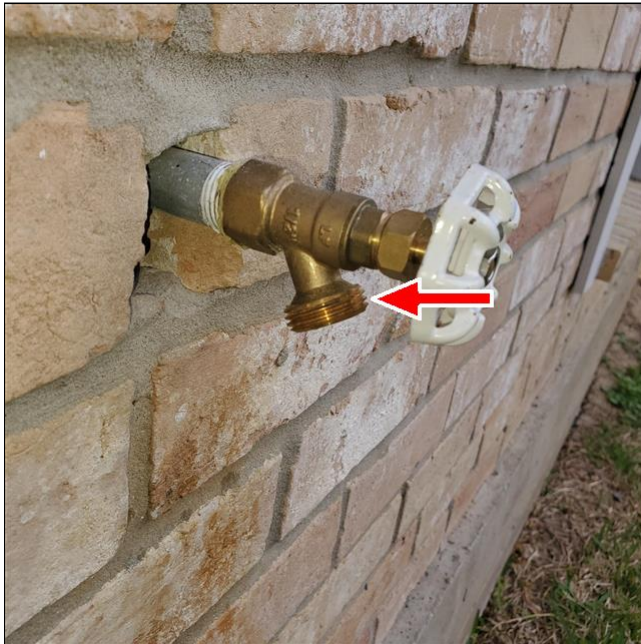
(1) Vacuum breakers were not installed at the exterior hose bibs. It is recommended that vacuum breakers be installed at all hose bibs to prevent the back flow of potentially contaminated water to the drinking supply.

A. Item 1(Picture) Need vacuum breakers at hose bibs.

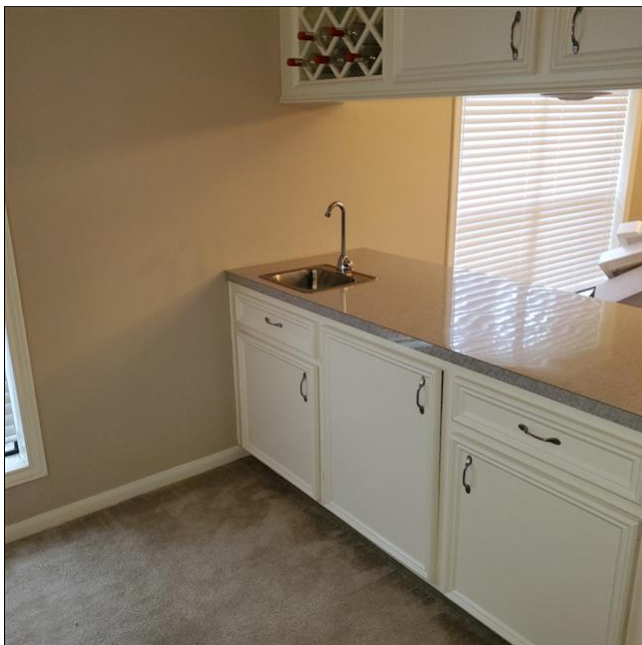
A. Item 2(Picture) Water was shut off to the wet bar sink.
