Web Presentation

Property Address: 12511 Wickwild Circle, Montgomery, TX 77356

JASE Home Inspections

**Jason Autrey T.R.E.C. #20981
15529 Queen Elizabeth Ct.
Montgomery, Tx. 77316
281-906-7168**

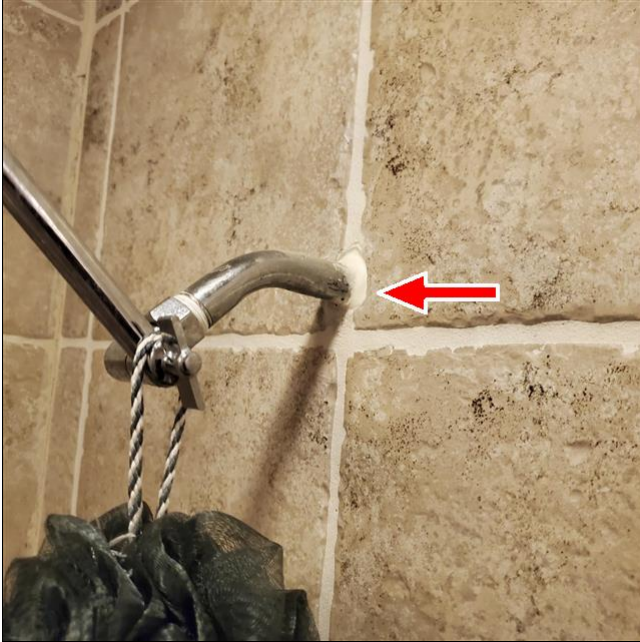
A. Item 3(Picture) Missing an escutcheon.

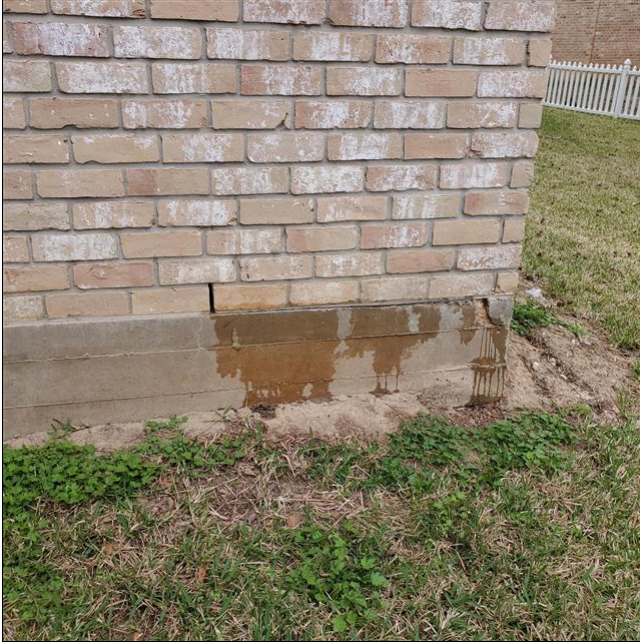
A. Item 5(Picture) Photo of water running down foundation after master shower was tested.

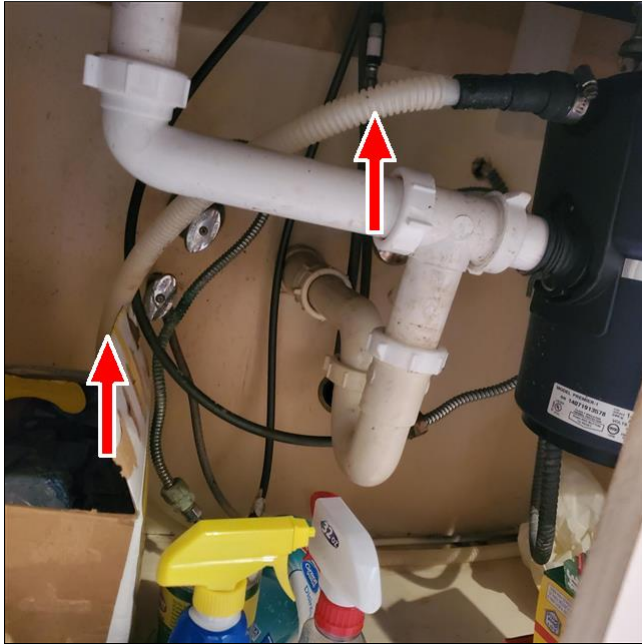
B. Item 1(Picture) No high loop at the drain line.

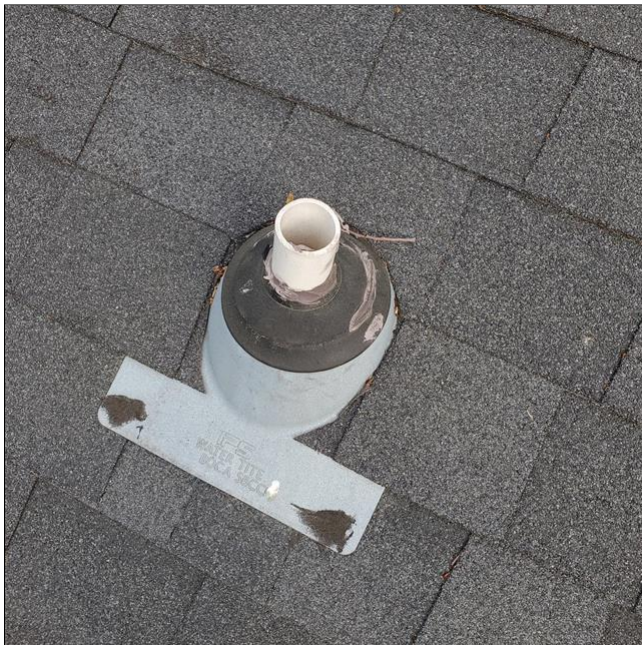
(3) The PVC drain, waste, vent pipes on the roof are not painted. These pipes need to be painted to protect from potential damages by UV rays.

B. Item 2(Picture) PVC should be painted.

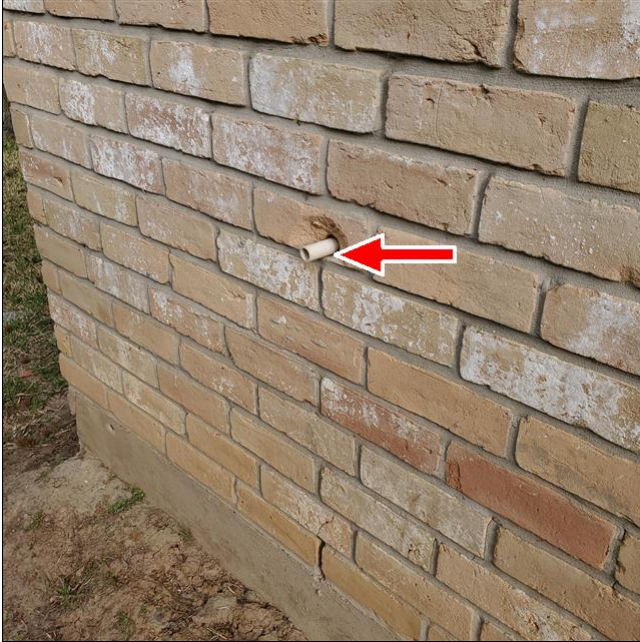
C. Item 2(Picture) Pipe does not have a turndown elbow and is too high from the ground.

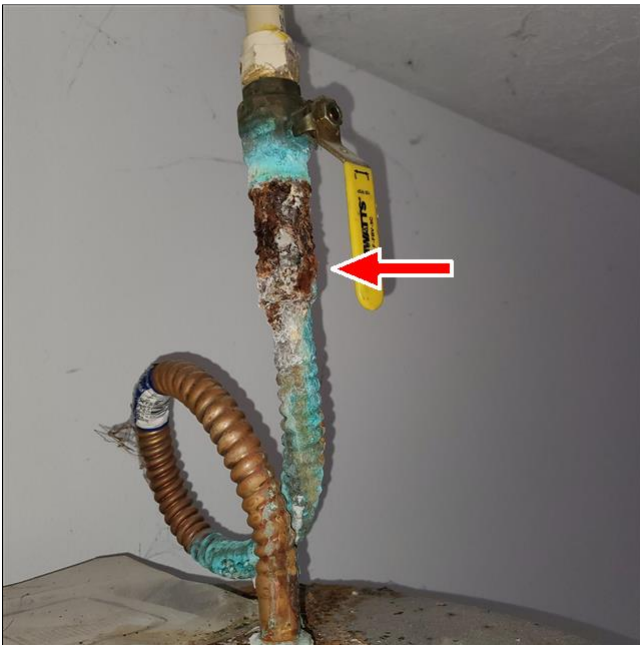
(3) A heavy amount of corrosion was noted at the cold water connections above the water heater. It is strongly recommended that a licenced plumber make repairs.

C. Item 3(Picture) Photo of corrosion at connections.

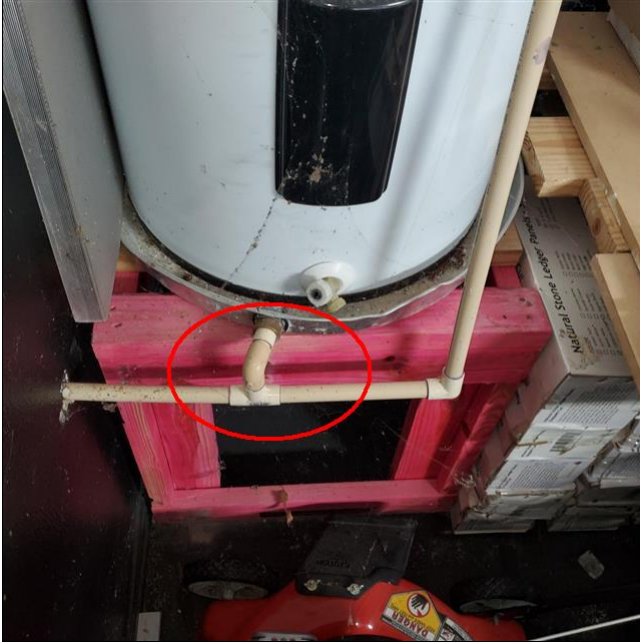
C. Item 4(Picture) Pipes should not be tied together.

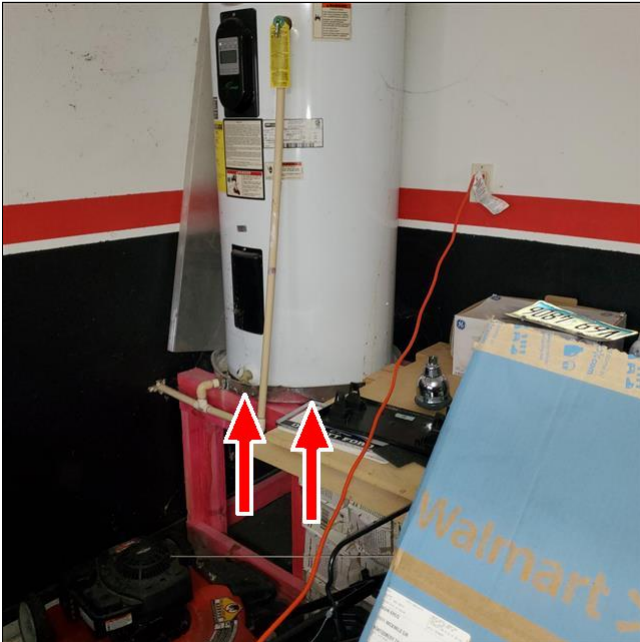
(5) The emergency drain pan under the water heater in the garage does not appear to be properly sloped towards the drain line. The pan needs to be sloped toward the drain line to ensure water exits the home in case of a leak.

C. Item 5(Picture) Pan should slope toward drain line.

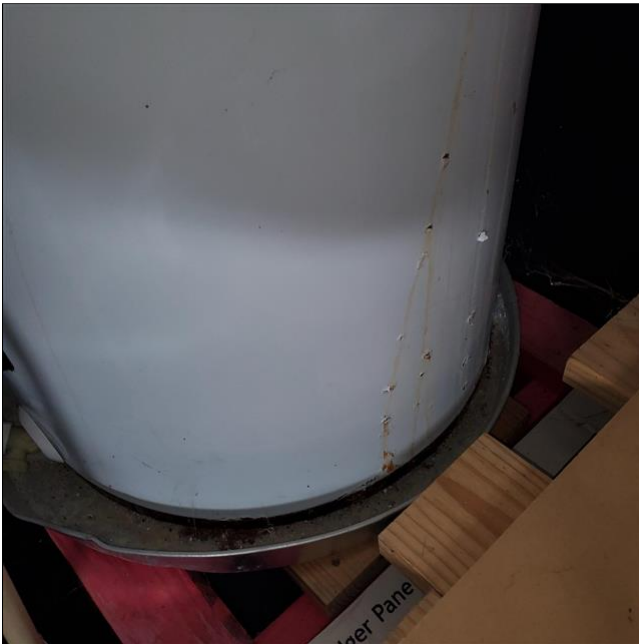
C. Item 7(Picture) Rust near bottom.

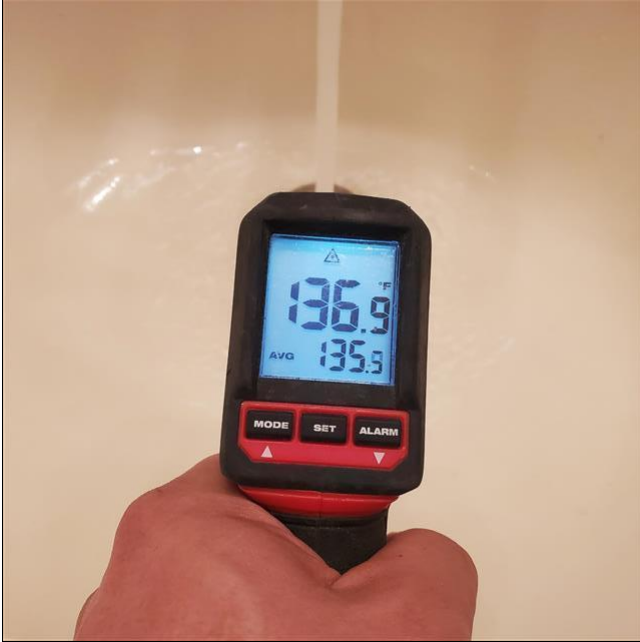
C. Item 8(Picture) Water was too hot.

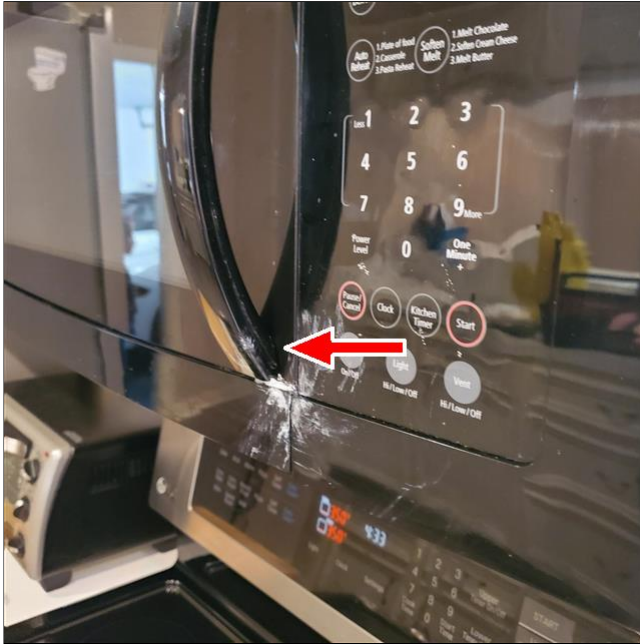
E. Item 1(Picture) Handle was damaged.

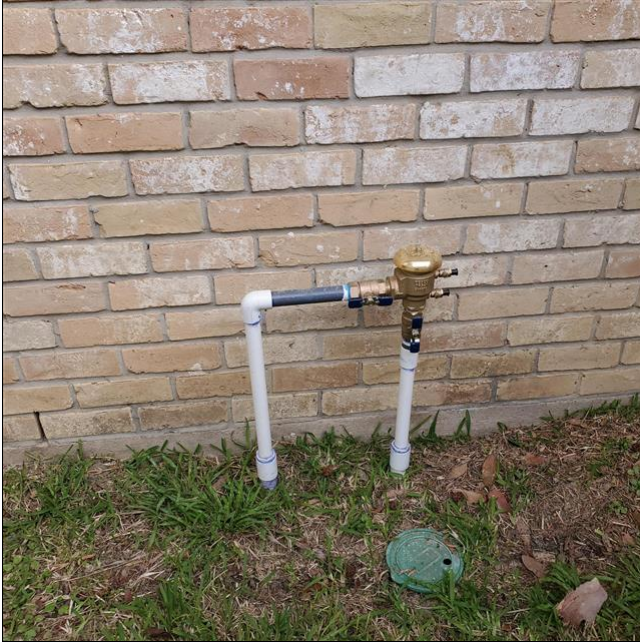
A. Item 2(Picture) Pipes should be strapped to the wall for security.
