RESIDENTIAL INSPECTION REPORT

917 Willow Creek Dr
Deer Park TX 77571

Patricia Fines
FEBRUARY 21, 2019

PROPERTY INSPECTION REPORT

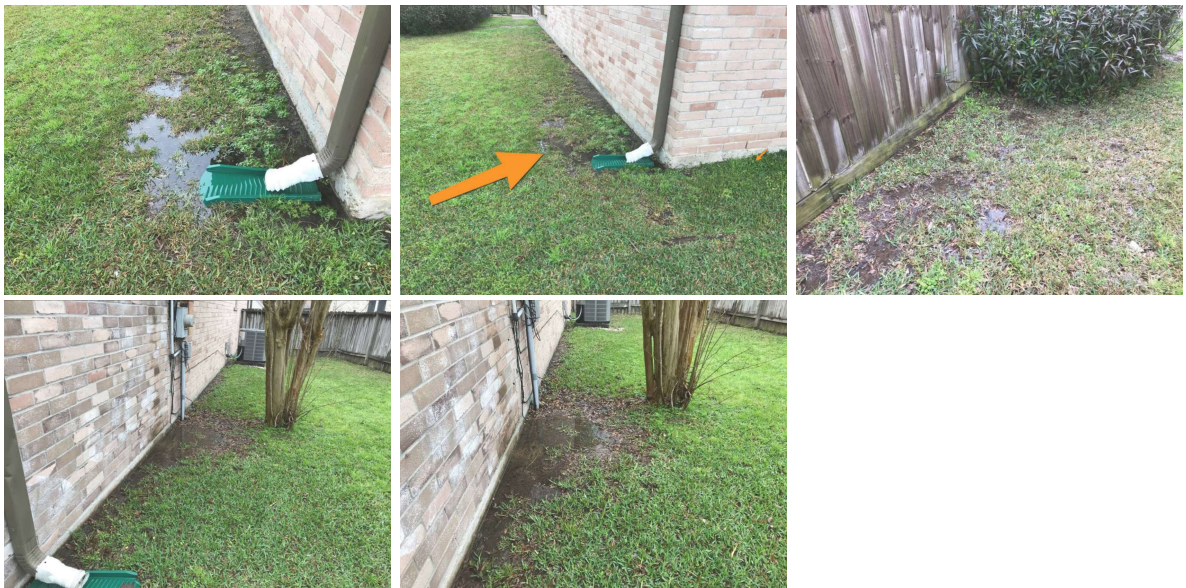
1: Grading & Drainage: Standing Water

Standing water was observed which could indicate poor drainage and/or grading. Monitoring and/or having landscaping contractor remedy drainage/grading is recommended. Grading & Drainage:

Recommendation: Contact a qualified landscaping contractor

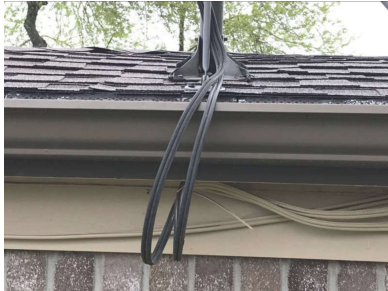
1: Satellite Dish(es) on Roof

Satellite dish(es) mounted to the roof. The inspector was unable to determine the condition of the roofing materials underneath. Remedy as needed.

Recommendation: Contact a qualified roofing professional.

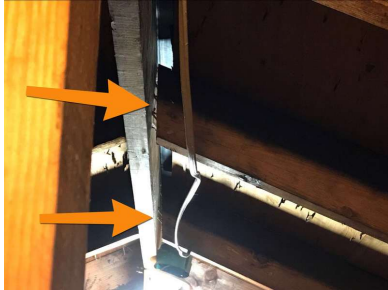
1: Framing: Separation of rafters from ridge

Multiple locations

Rafters were not bearing fully on the ridge board. Further evaluation is recommended.

Recommendation: Contact a qualified professional.

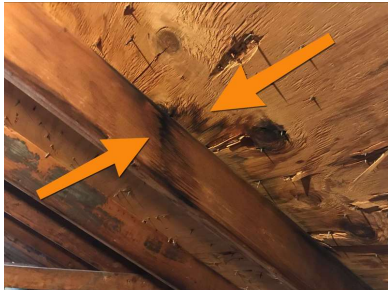
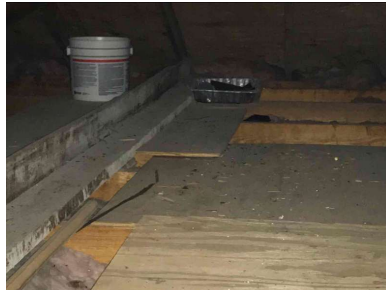
2: Previous Leak

Kitchen area

Observed previous leak on ceiling joists and rafters. No moisture was detected at the time of the inspection. A bucket and a pan were observed in the master bedroom area attic. Monitor and remedy as needed.

Recommendation: Contact a qualified professional.

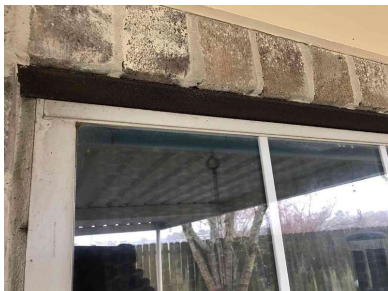
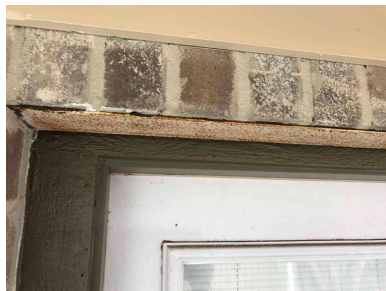
1: Exterior Masonry: Rusted Lintels

Multiple locations like back door and back windows

Rusted lintels were present at the time of inspection. Remedy as needed.

Recommendation: Contact a qualified painter.

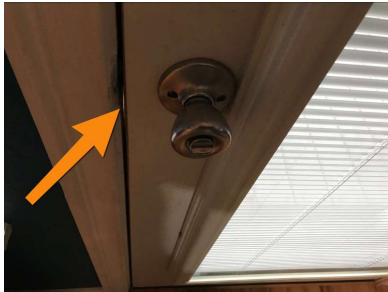
1: Door: Weatherstripping Missing or Damaged

Back door to patio.

Door is missing standard weatherstripping. This can result in significant energy loss and moisture intrusion. Recommend installation of standard weatherstripping.

Recommendation: Contact a qualified door repair/installation contractor.

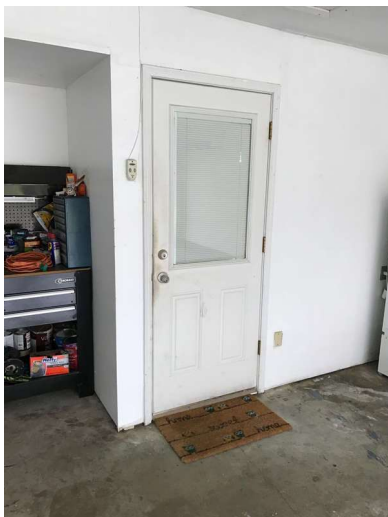
3: Garage Door into Living Space: Not Solid Wood or Metal

For fire safety, the entry door from the garage into the living space should be made of solid wood or steel and be at least 1-3/8 inches thick. Evaluate and remedy as needed.

Recommendation: Contact a qualified door repair/installation contractor.

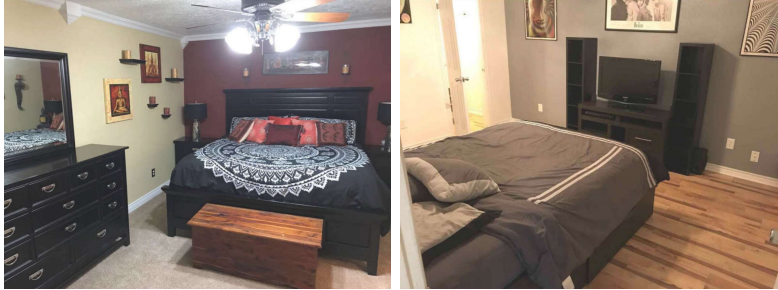
1: Window: Missing

Master bedroom and rear middle right bedroom, rear right bedroom Window missing. Remedy as needed.

Recommendation: Contact a qualified professional.

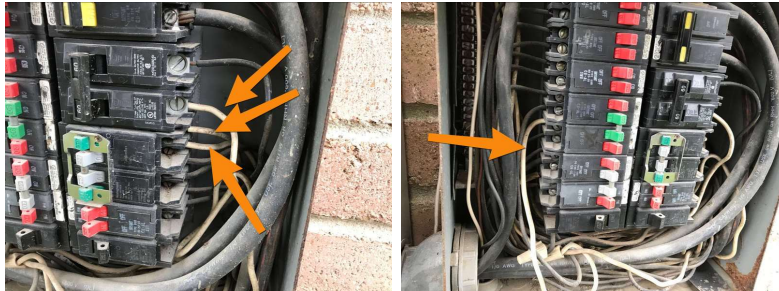
2: White Wires Not Marked

White wires connected to breakers are not marked with black or red electrical tape to indicate that they are "hot". Remedy as needed.

Recommendation: Contact a qualified electrical contractor.

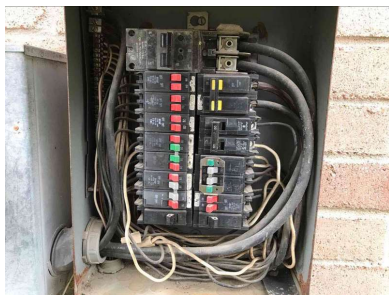
3: Missing Service Cover

The distribution panel cover (dead front cover) was missing. Evaluation and/or remediation by a licensed electrician is recommended.

Recommendation: Contact a qualified electrical contractor.

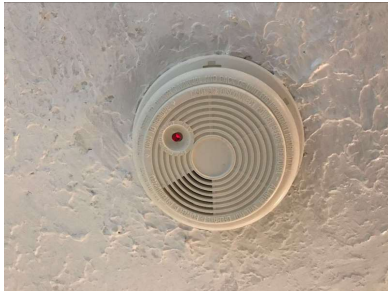
2: Smoke Detector Defective

Not present in required location, Not functioning as intended, Intermittent chirping/beeping - Smoke detectors are required in all bedrooms, hallways to bedrooms, and living areas on every level of the home. These devices should be changed every 10 years for safety. Evaluate the units in the home and remedy as needed.

Recommendation: Contact a qualified professional.

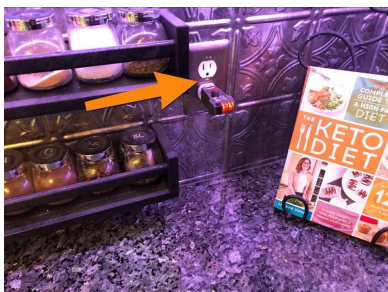
4: Receptacles: No GFCI Protection

Kitchen, garage, hall bathroom,

There was no GFCI protection. Current building standards recommend the installation of ground fault protection:

GFCI protection was not present in all locations. Evaluate and remedy as needed.

Recommendation: Contact a qualified electrical contractor.

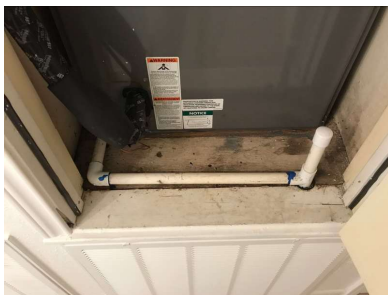
1: Condensate system: Missing emergency pan

By design, this system does not have an emergency overflow pan underneath the evaporating unit. Buyer should consider a pan inside the return air chase with a battery operated sensor to alert of any leaks.

Recommendation: Contact a qualified HVAC professional.

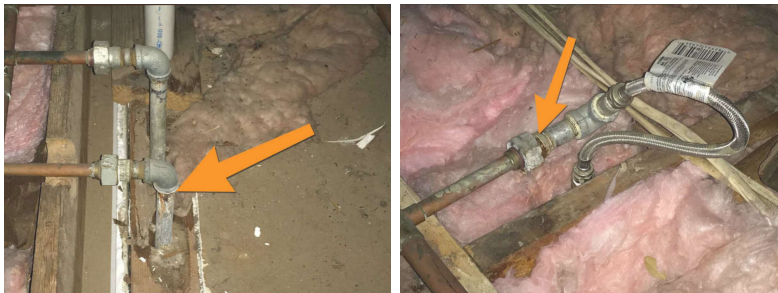
1: Supply piping: Corrosion on Galvanized Pipes

Galvanized water supply piping was corroded. The extent of rusting on the piping is not determined. Evaluation and/or remediation by a licensed plumber is recommended. Multiple plumbing lines have been replaced with copper core CPBC. Various drops were observed to still be galvanized. Inspector cannot determine the extent of replacement.

Recommendation: Contact a qualified plumbing contractor.

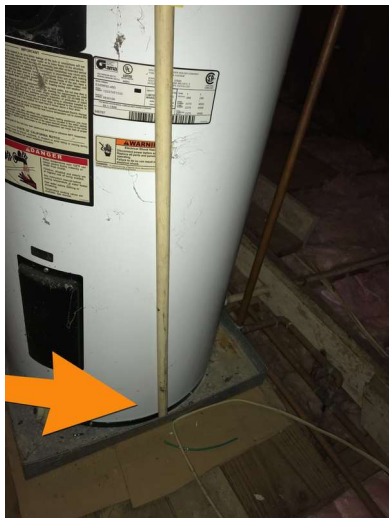
2: TPR Valve: Discharge tube poor termination

Water heater TPR discharge tube did not point towards the ground. The discharge tube should point towards the ground to prevent scalding injuries or damage to property. Remedy as needed.

Recommendation: Contact a qualified professional.

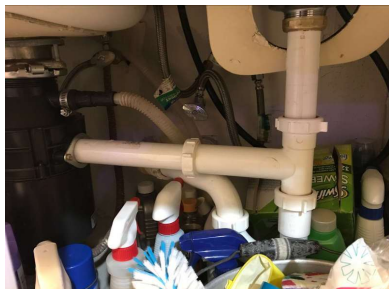
1: No Anti-Siphon Loop

An anti-siphon loop was not installed at the drain hose under the sink. Most manufacturers specifications suggest that in the absence of an air gap, the drain be looped to prevent back washing from the sink.

Recommendation: Contact a qualified professional.

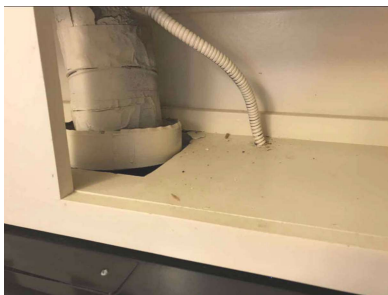
1: Vents Into Cabinet

Kitchen cabinet

Range hood improperly vents into cabinet.

Recommendation: Contact a qualified professional.

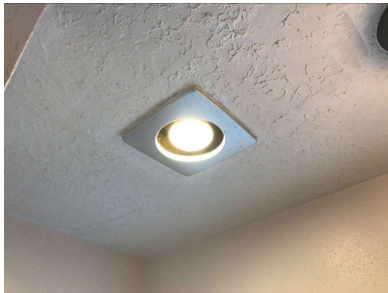
1: Noisy Vent Fan

Hall bathroom

Vent fan was noisy during operation. Evaluate and remedy as needed.

Recommendation: Contact a qualified professional.

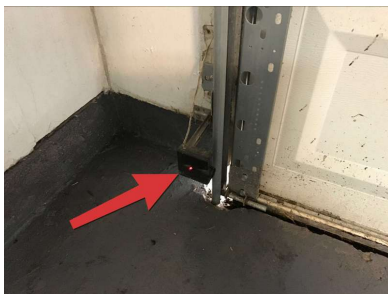
1: Auto Reverse Sensor Not Working

The auto reverse sensor was not responding at time of inspection. This is a safety hazard to children and pets. Evaluation and remediation by a qualified garage door contractor is recommended.

Recommendation: Contact a qualified garage door contractor.
