PROPERTY INSPECTION REPORT

Prepared For: -	Susan Stromatt	
	(Name of Client)	
Concerning:	3028 Teague Road , Houston, TX 77080 (Address or Other Identification of Inspected Property)	
By:	Bob Avery Lic.#: TREC #20559 MAT #1059 (Name and License Number of Inspector)	10/19/2020 (Date)
(Name, License Number of Sponsoring Inspector)

Report Identification: 52965-831

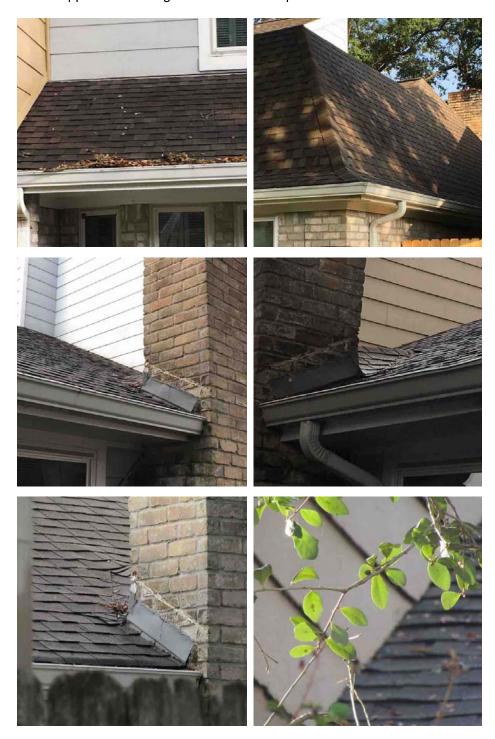
• Roof appears to be in good condition except were noted

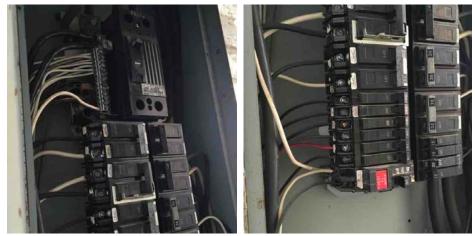
• Double lugging of neutral wiring observed at bus bar (multiple wires per screw down port). This condition does not meet current electrical standards. No more than one wire per port is considered proper. Recommend further evaluation by a qualified electrical contractor to make repairs as needed
