BPG Inspection, LLC

**3146 Castlewood Street
Houston TX 77025**

Client(s): Martin
Inspection Date: 3/28/2021
Inspector: Steve Fusselman , TREC 10405

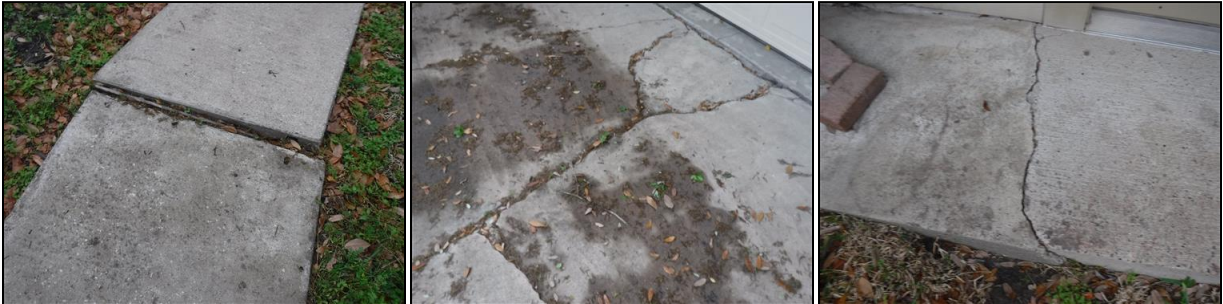
Noted cracks and slab shifting at driveway, patio slabs and sidewalks. Recommend having all concrete slab cracks filled with exterior grade sidewalk repair flexible caulking. This will allow sealant of cracks preventing water infiltration into area that causes further damage until full concrete seal can be applied or total replacement of slabs. Sidewalk repair caulking is the typical product used for this repair. Some trip hazards present.

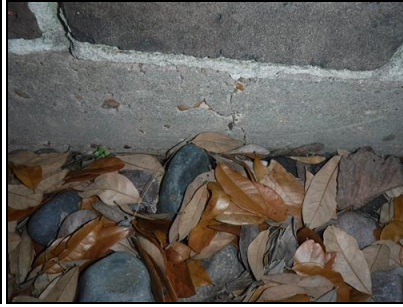
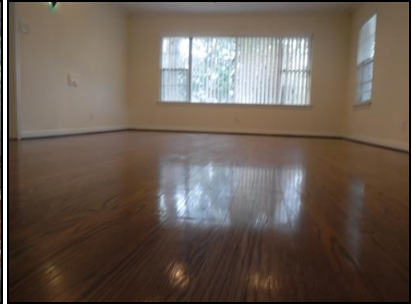
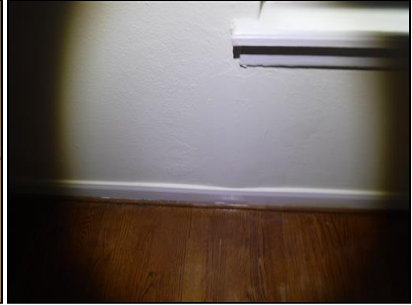
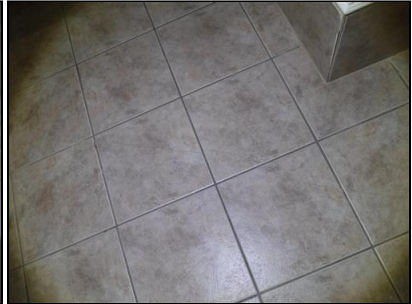
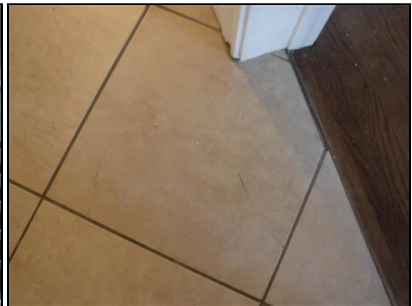
properly, stick or bind in jamb and washout of foundation area at rear exterior. A professional engineer should be consulted to evaluate the current integrity of the foundation and propose necessary repairs (if any).

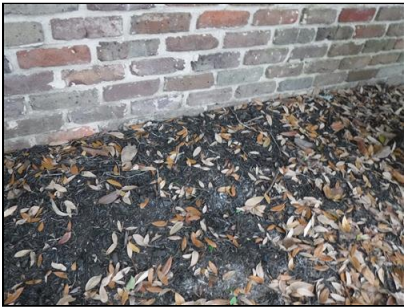
Often times a property owner will add dirt or landscaping materials against the siding and cover the exposed foundation. Maybe the owner was doing some landscape work, or the original grading was simply poorly done. Whatever the reason current building standards require at least four inches of foundation visible below masonry veneer and six inches of foundation below wood siding. Present condition is considered conducive to possible moisture and insect related issues.

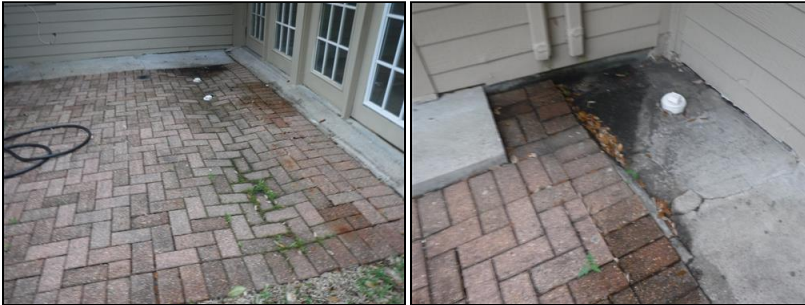
There is a negative slope at the rear of home and can cause or contribute to water intrusion or deterioration. I recommend correcting landscape to drain water away from home. Further review and consultation with engineer needed.

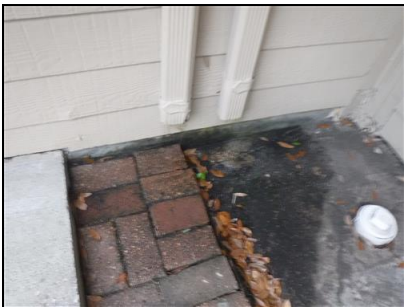
Gutter downspouts should discharge water at least 36 inches away from the foundation. Storm water should flow freely away from structure at points of discharge. (Discharging roof water next to the structure has the potential of causing foundation movement)

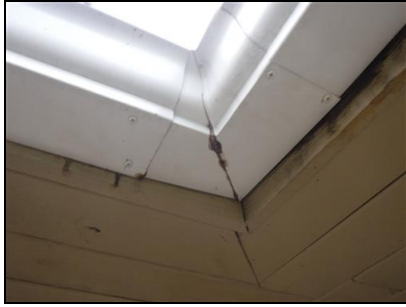
The gutters are rusted and deteriorated in various areas. they may require replacing. Consult with a qualified contractor for repairs.

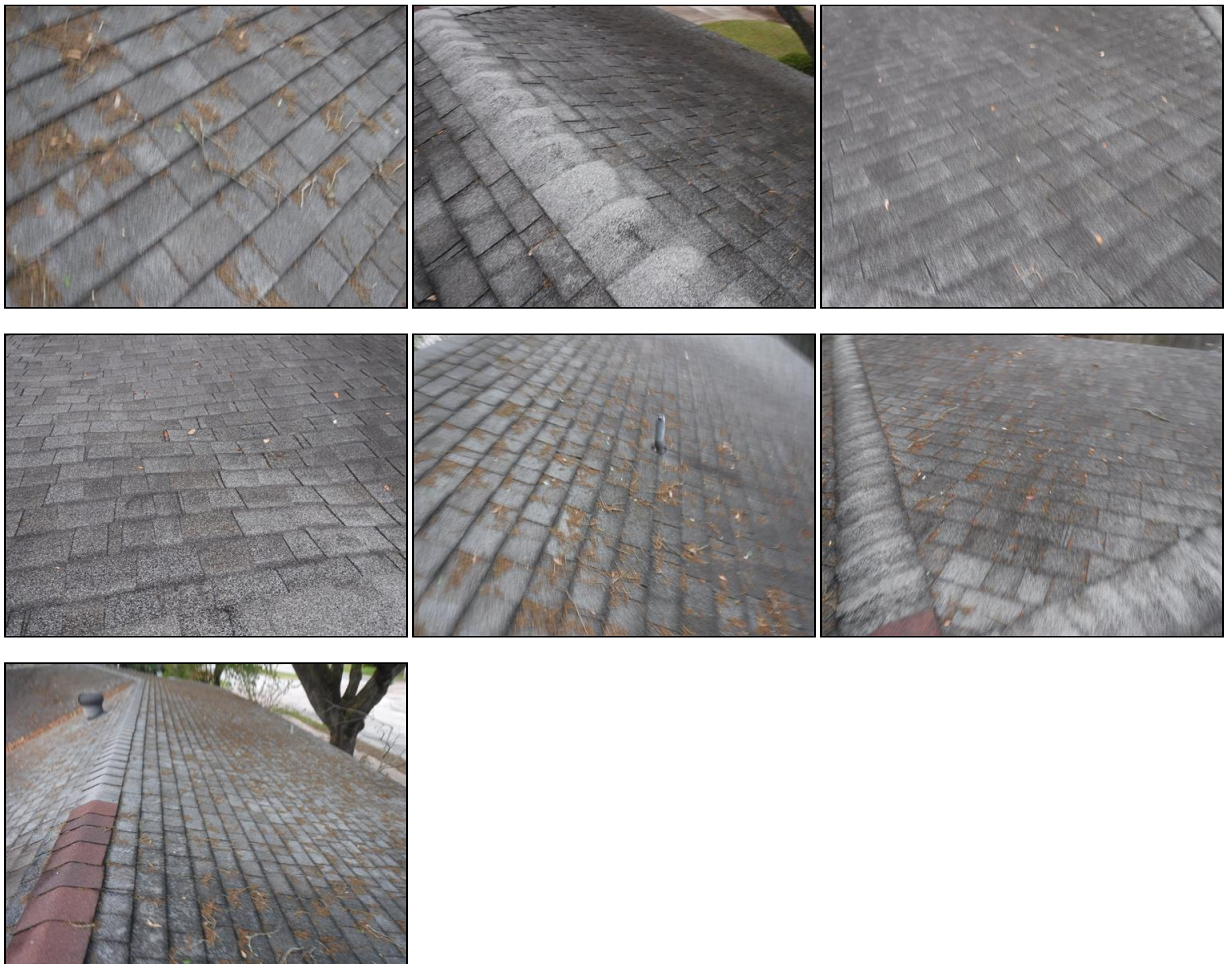
The roof covering appeared in good fair condition. No leaks were active at time of inspection. Shingles appeared to be properly fastened.

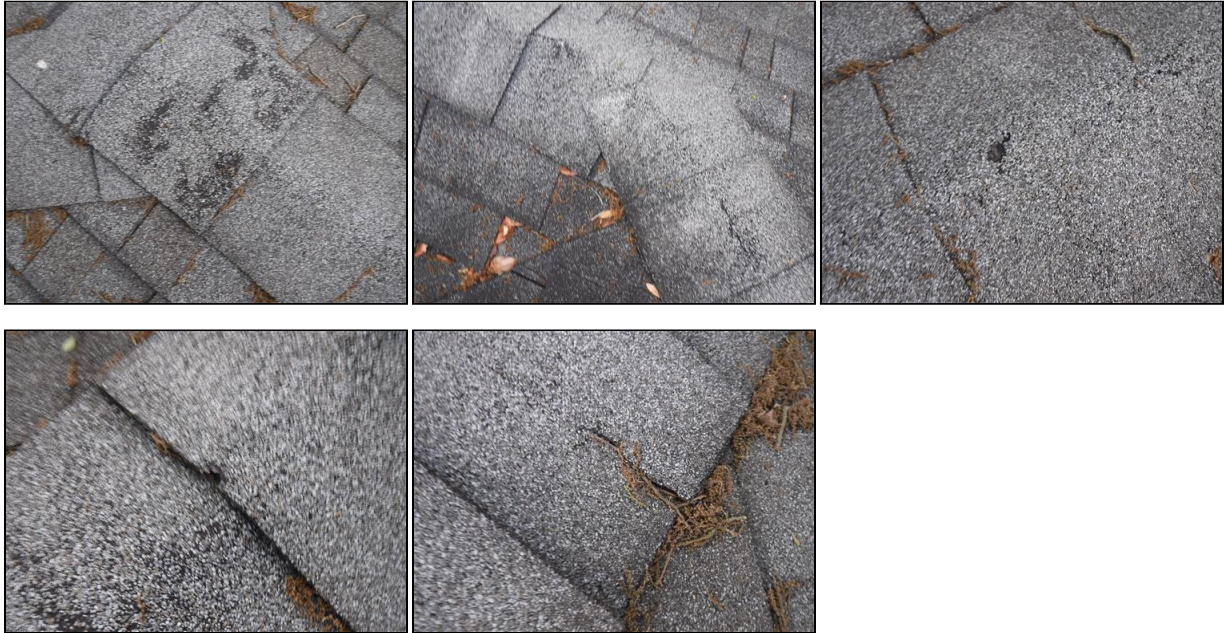
The shingles are worn with some granular loss/damage in various areas. A roofer should perform a maintenance check on the covering for needed repairs, patching or replacement of worn shingles.

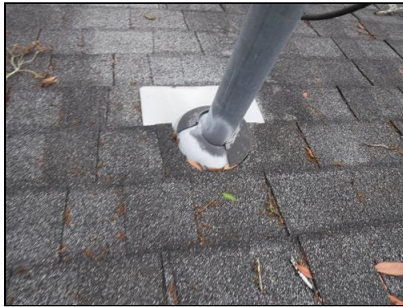
Rubber gasket for main electrical mast is deteriorated and aged and will allow rain water into area. Recommend having area fully repaired as needed.

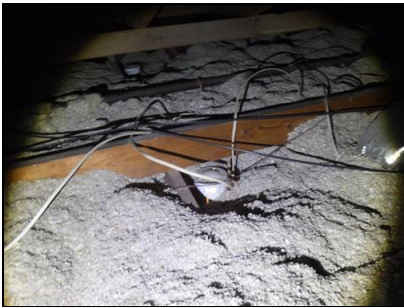
Insulation in contact with can lighting with no I.C. (in contact) rating observed. 3 inch clearance needed. Insulation dams may be installed to create required gap while reducing energy loss.

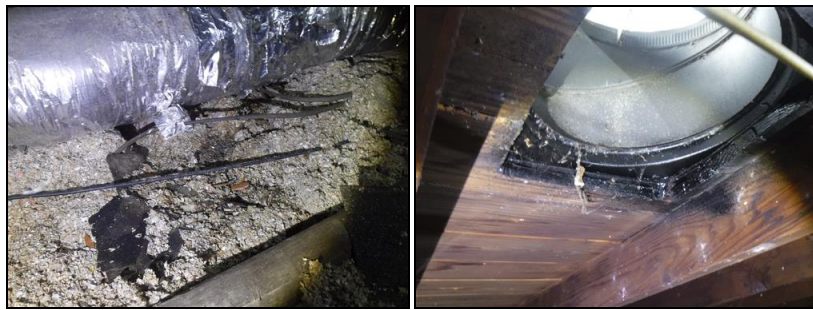
Noted area at left rear side of attic with possible point of water infiltration due to wet insulation, compressed insulation and water staining around turbine vent. Recommend repairing fully.

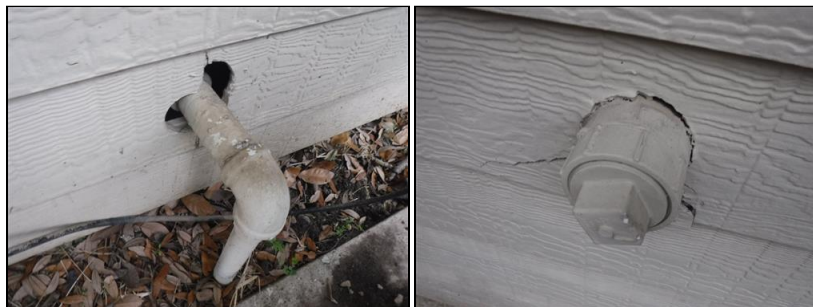
It is recommended that all protrusions through the exterior siding and fixtures mounted on the exterior be sealed in order to prevent moisture incursion. Using a quality exterior caulk type sealant around pipes, wires, light fixtures etc. can prevent moisture related failure of electrical components and siding materials.

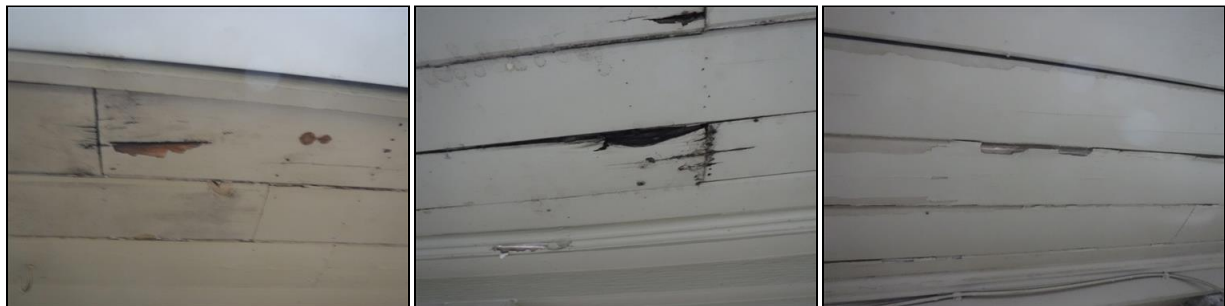
Noted areas of wood fascia/soffits that show signs of age, rot, peeling paint. Recommend all affected areas are fully repaired and sealed as needed.

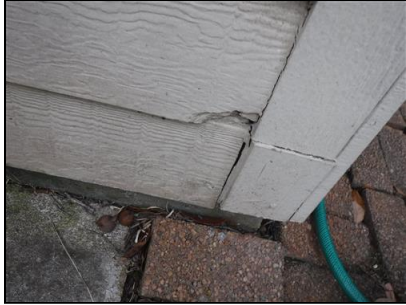
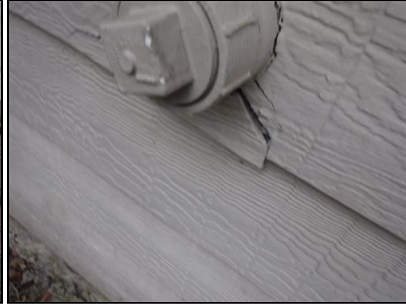
Noted multiple areas of siding board damage. Recommend having areas repaired as needed.

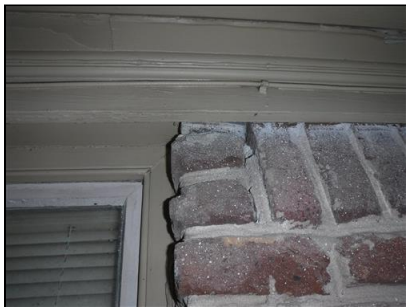
There are joint cracks on the walls in various locations. These cracks appear to be typical settlement/shifting joint cracks with no other visible displacement. Recommend sealing (mortar) crack to prevent moisture incursion and monitor for further settlement/separation

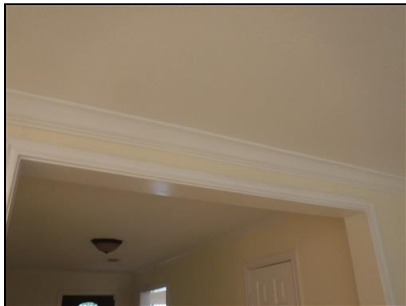
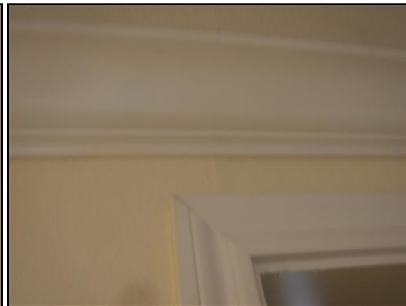
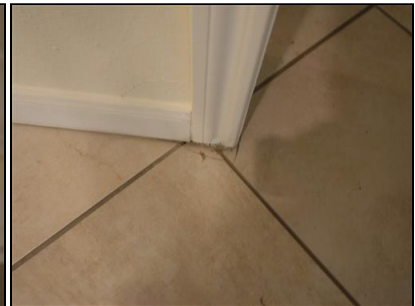
Interior area between living room and foyer appears to have possible header deficiencies due to patched wall cracking, difference in measurements between ceiling and opening and tiles cracked at flooring. Recommend having structural engineer further evaluate and repair as needed by qualified contractor.

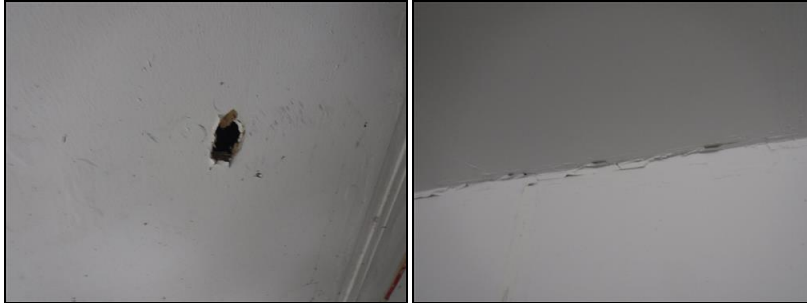
Cracks/voids/damage observed at the ceiling of the garage. Recommend properly repair/refinish the walls/ceiling using proper fire-rated material. Materials should be rated for minimum of 1 hour fire protection.

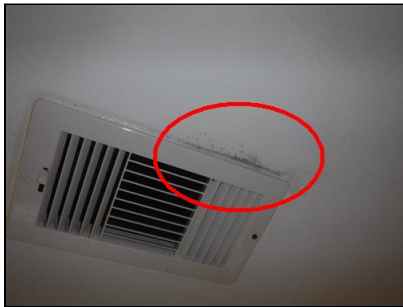
Signs of fungi growth are present on ceiling in several areas in the living room. We did not inspect, test or determine if this growth is or is not a health hazard. The underlying cause is moisture or dampness. Recommend you contact a mold inspector or expert for investigation or correction if needed.

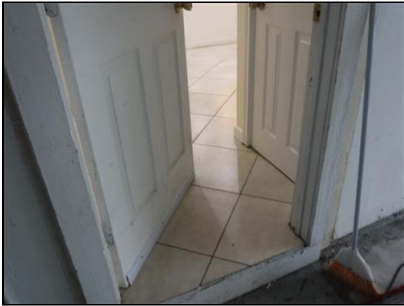
The occupant door leading from the attached garage into the house is not self closing. I recommend installing/adjusting self closing hinges on the door leading from the garage to the living space as a safety feature to prevent exhaust gases (car, appliance) from entering the house.

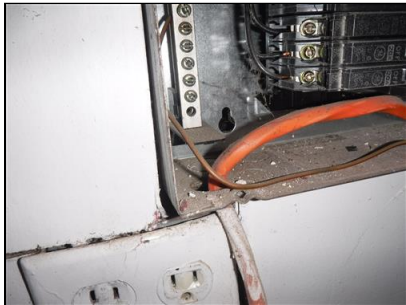
Knockout covers are missing in main panel. These should be replaced to prevent access to live electrical components, preventing injury.

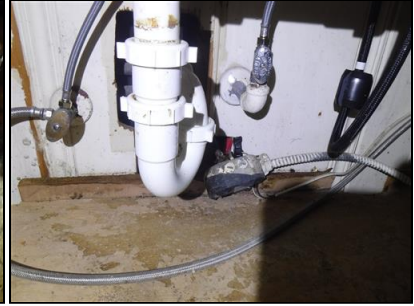
☒ There were exposed connections, open boxes observed in the attic/garage/interior. Secure, enclose in rated enclosures to prevent hazards.

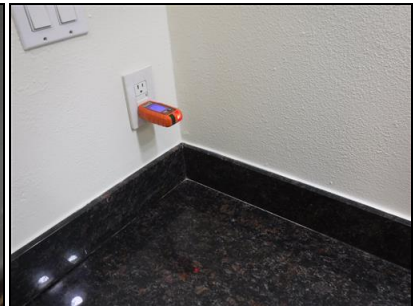
☒ There are no GFCI (Ground Fault Circuit Interrupt) protected outlets in locations called for by today's standards: kitchen, bathrooms, non dedicated garage below 6', exterior outlets,. I recommend updating to current standards.

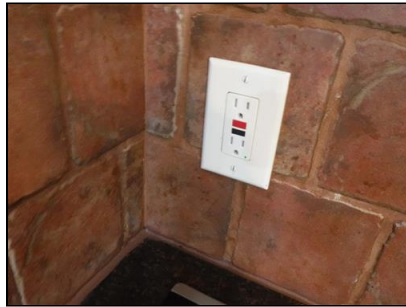
A GFCI is not functioning in the kitchen/exterior. I recommend an electrician to evaluate and repair or replace as needed.

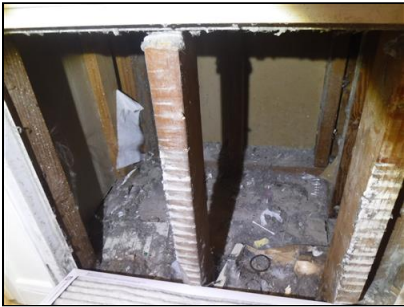
Debris collection in return area. Recommend cleaning return.

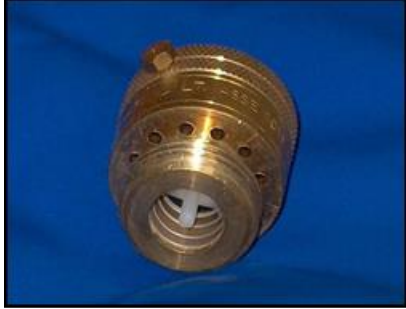
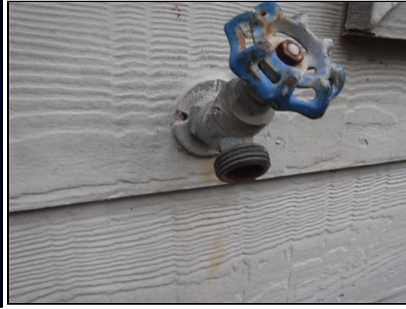
Some exterior hose bibs (faucets) are missing back-flow check valves as called for by today's standards

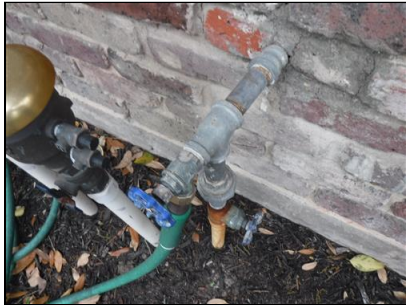
Supply pipes in Exterior must be properly insulated. Current condition will not protect piping during hard freeze periods

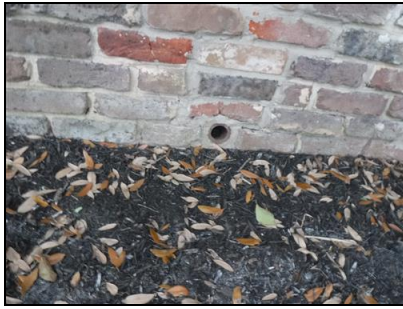
Clean out located at left exterior for kitchen is missing cap. Recommend installing cap as required for today's standards.

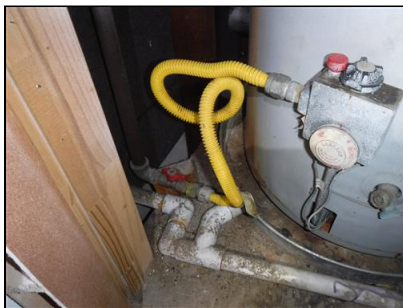
Gas supply to unit is missing a sediment trap, or drip leg as called for by current standards.

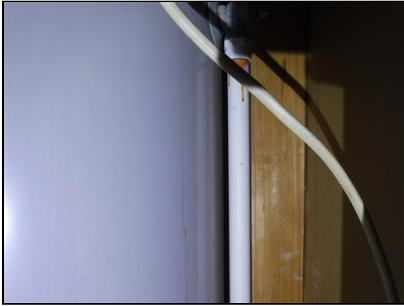
Noted the discharge piping for the water heater T&P valve is plumbed in with PVC. Sch. 40 PVC is only rated for a maximum temperature of 140F and the T&P discharge will be approx. 200F+. Recommend having licensed plumber further evaluate and replace as needed.

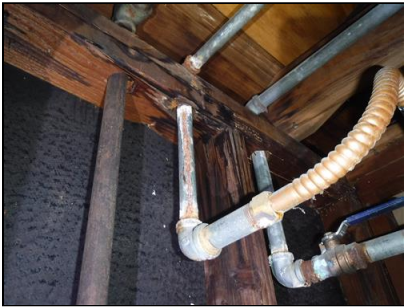
Noted significant rust at water heater inlet/outlet lines at top of tank. No active leaking at time of inspection. Recommend having licensed plumber evaluate and repair, maintenance or replace as needed.

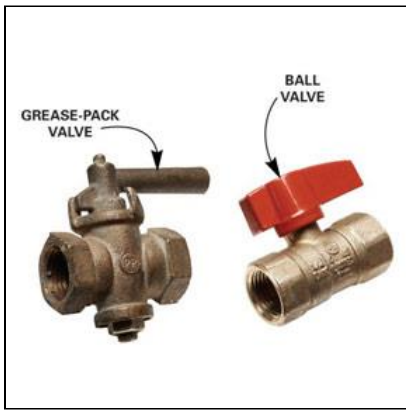
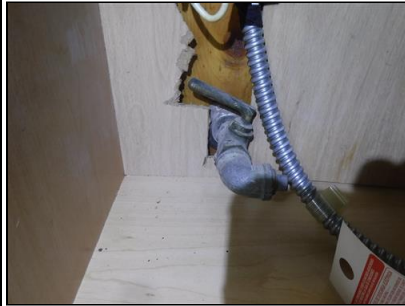
Older "grease pack" gas valves are out of code, and are known to leak over time. These should be replaced.

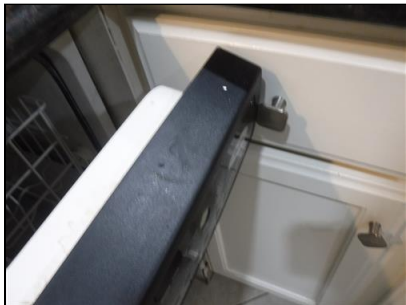
Dishwasher door when opened hits drawer knob. Recommend repairing as needed.
