PROPERTY INSPECTION REPORT

Concerning: 14112 Timber Bluff Drive , Pearland, TX 77584
(Address or Other Identification of Inspected Property)

By: Tommy Amonette Lic.#: TREC 22620 03/03/2021
(Name and License Number of Inspector) (Date)

Home Inspection Report

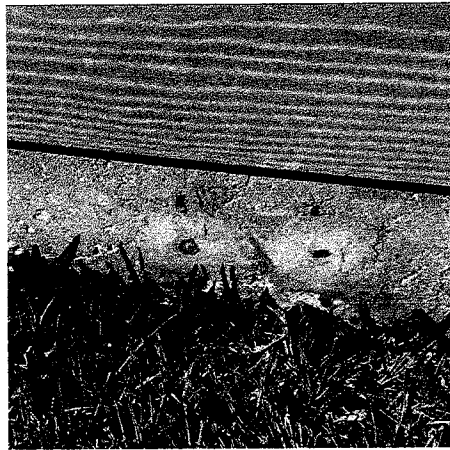
- **Post tension cables are starting to show exposure in areas at the foundation. Recommend sealing these areas to prevent rusting / deterioration on the cables.**

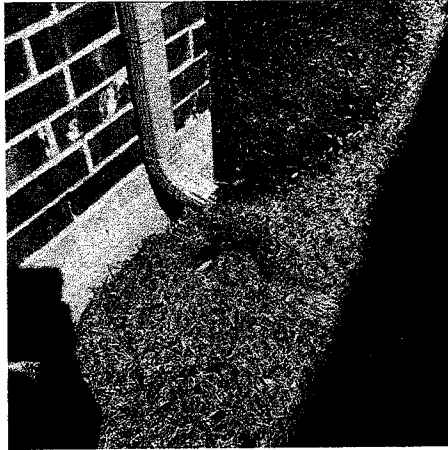
- **Missing splash blocks noted in multiple areas around the home. Recommend installing splash blocks to help with soil erosion and prevent water from discharging at the foundation.**

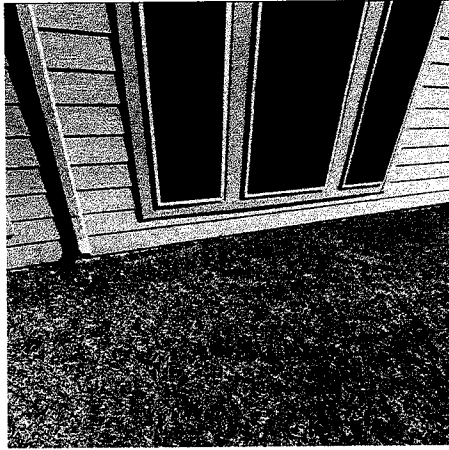
- **Please note, it is recommended to keep clearance of landscaping and grading 4-6 " below exterior siding. Areas of grading around the home appears to be above under 4-6" below the siding.**

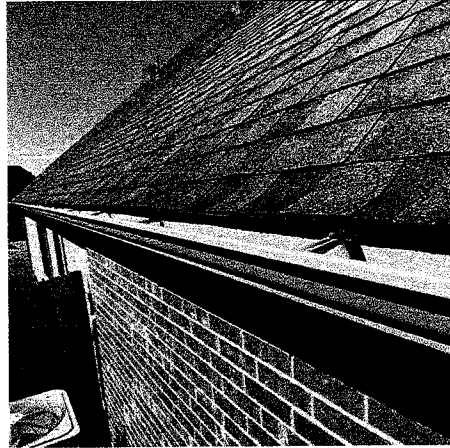
- Gutter troughs are installed on top of the drip edge flashing. This could allow water to drain between the gutter trough and fascia board. Gutter troughs should be installed under the drip edge flashing.

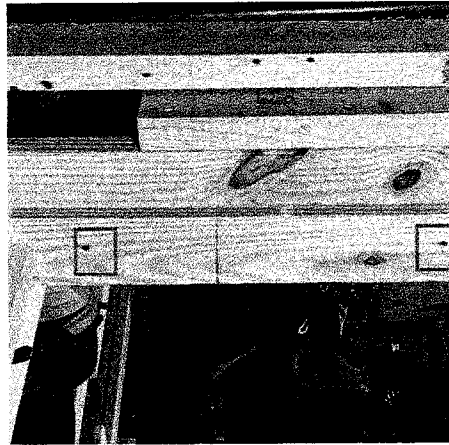
- Attic access has improper fasteners holding the stairs in the ceiling. Approved hardware such as lag bolts or 16D nails are required, not screws.

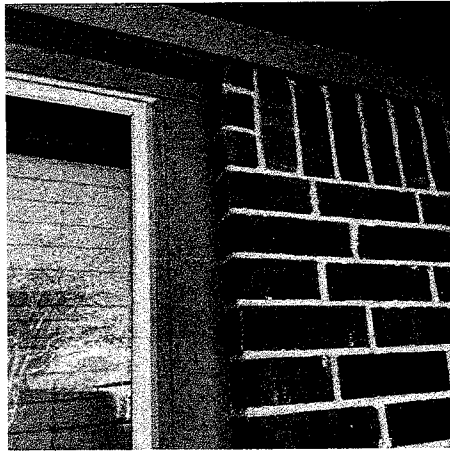
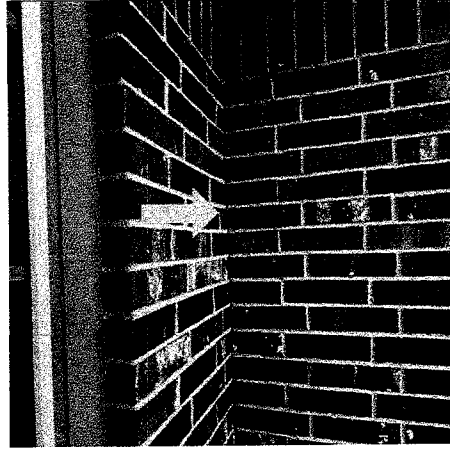
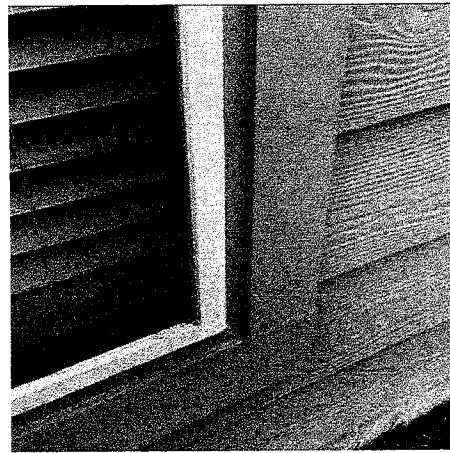
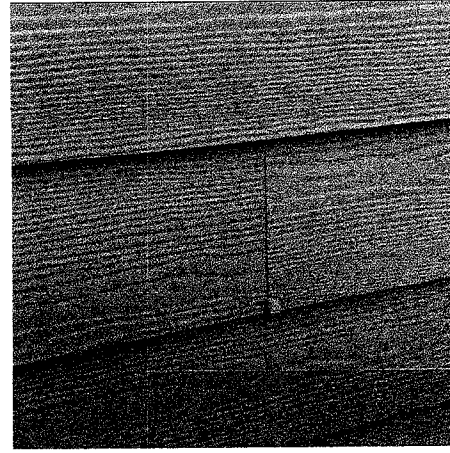
- Sealant was noted deteriorated and/or missing in multiple areas on the exterior siding and trim. Recommend removing old sealant and resealing to prevent water penetration and possible deterioration.

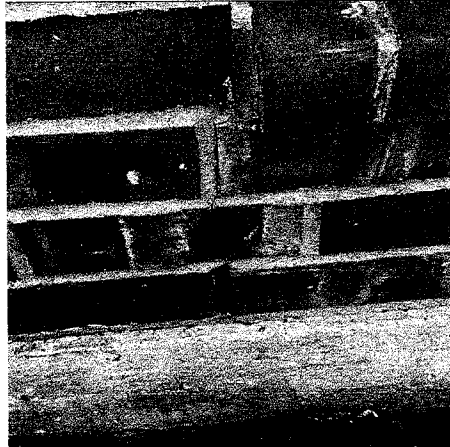
- **Minor cracking was observed in the brick mortar in locations around the home. These do not appear to be structural and are common of most homes. Recommend sealing these cracks to prevent water and/or pest penetration, and monitoring for any future movement.**

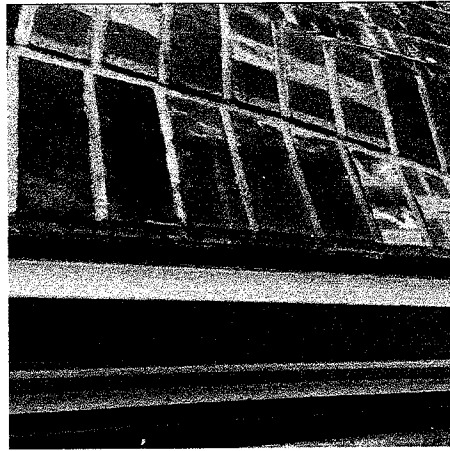
- **Lintel supports above doors and windows are starting to show signs of rusting. Rusting lintels can cause cracks in the brick due to the rust expanding over time. Recommend resealing lintels to avoid further damage.**

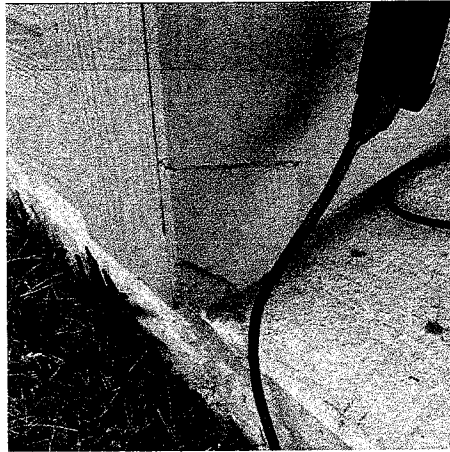
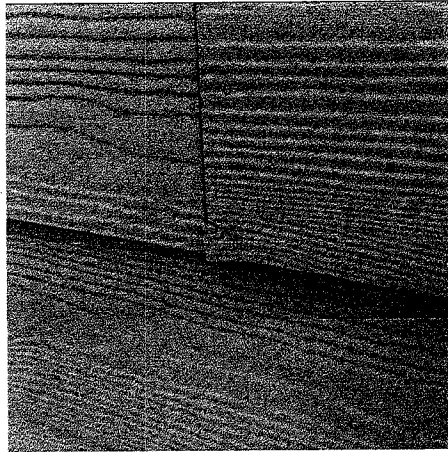
- Minor cracking/damage noted in areas of the exterior siding and trim.

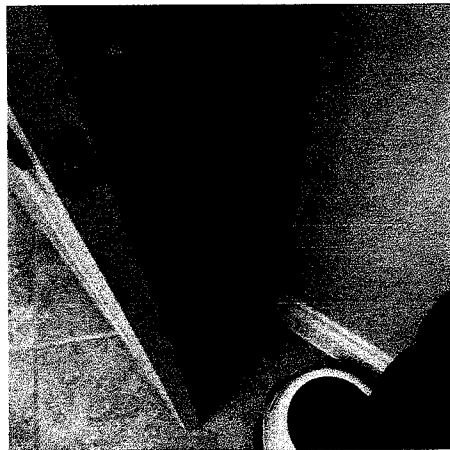
- Door stops are missing in multiple locations throughout the home.

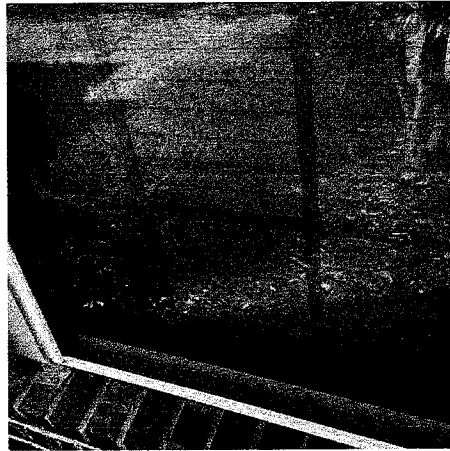
- Front guest bedroom window pane was noted broken. **FIXED**

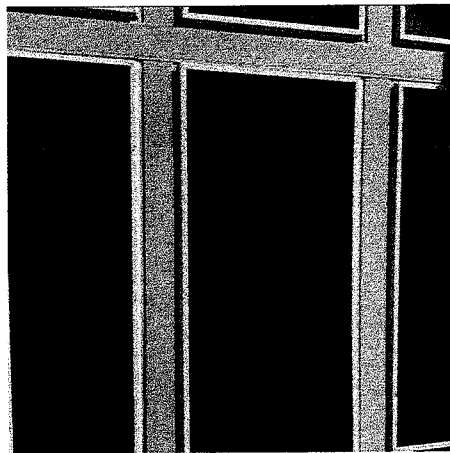
- Exterior screens were noted screwed to the bedroom windows. This impedes the egress through the window. Bedrooms are required to have one egress window that does not require special tools to use, for a emergency exit.

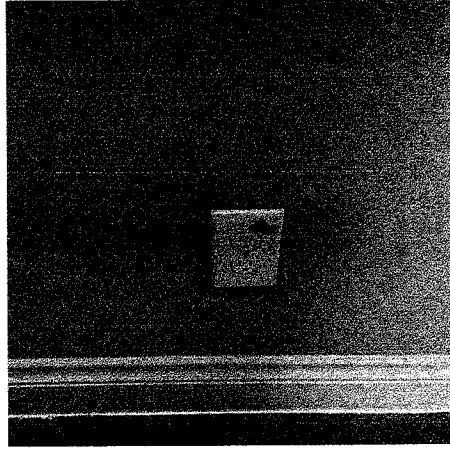
- One interior receptacle was noted loose at the entryway of the home. Overtime this can cause the electrical connection to become loose on the receptacle. Receptacle was marked with blue tape **FIXED**

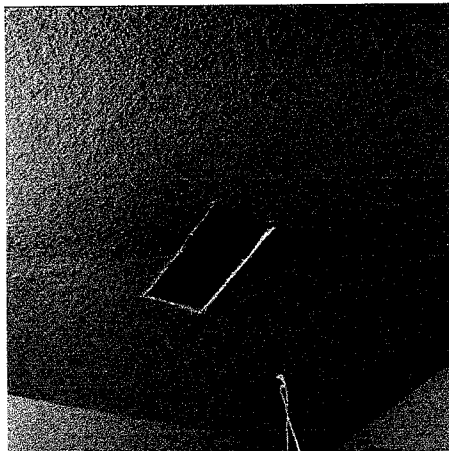
- Vent cover was noted missing in the master bedroom **FIXED**

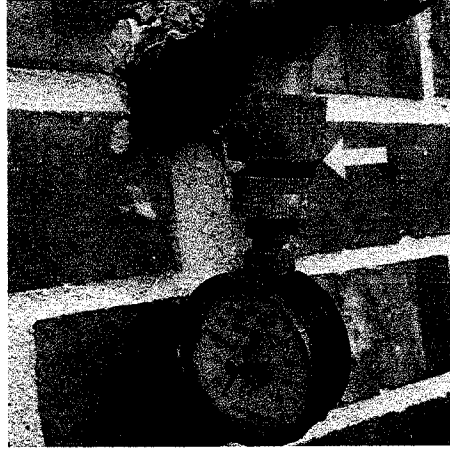
- Hose bib on the West wall appears to be leaking at the anti-siphon device when operated.

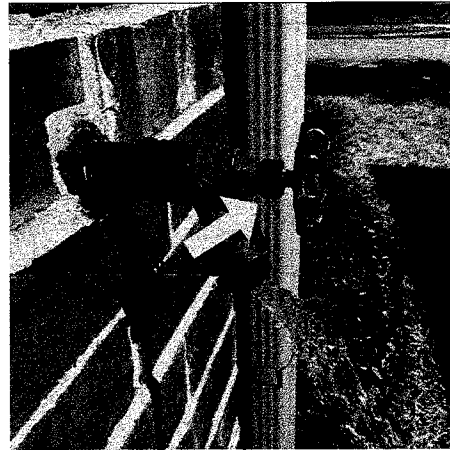
- Hose bib on East wall leaks at the stem seal when operated.

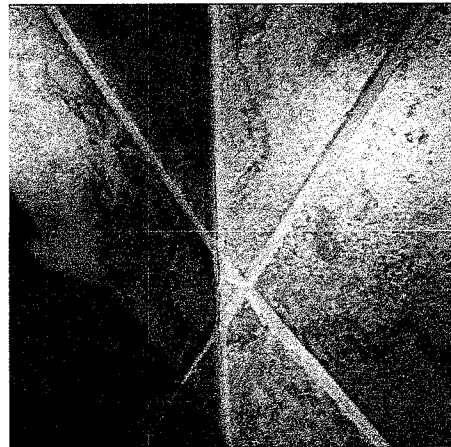
- Tile grout was noted damaged in the bath / shower areas. Recommend repairing these areas to prevent water penetrating into the walls. **FIXED**

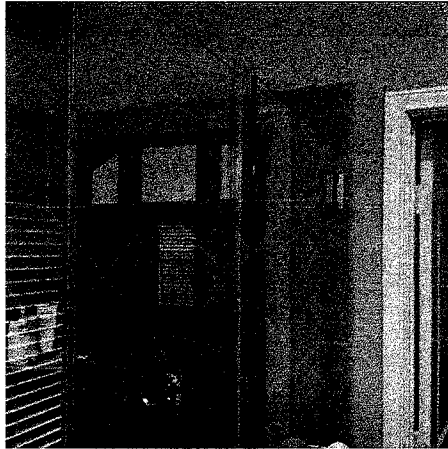
- Master shower door does not appear to close completely. Recommend adjusting the door to operate and seal properly. **FIXED**

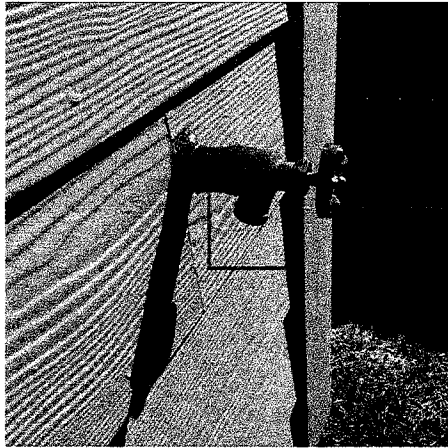
- Hose bib at the back of the home is missing the anti-siphon device. Recommend adding these to prevent backsiphonage into the house water supply

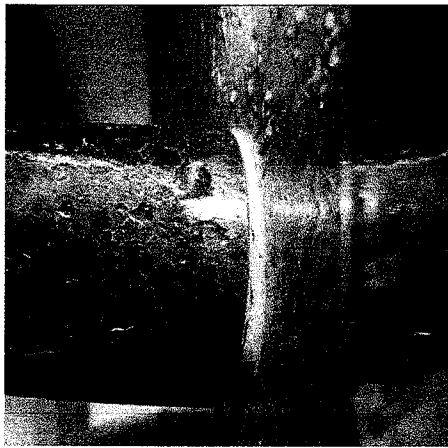
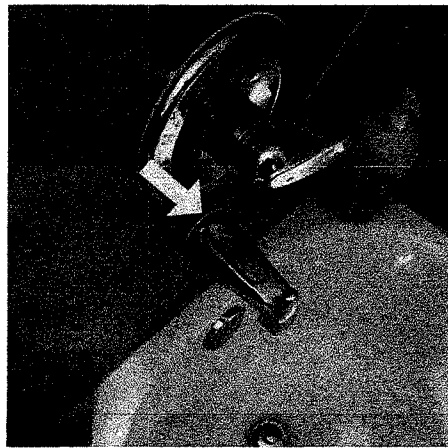
- Tub spouts in the showers/bathtubs should be resealed to prevent water penetration into the walls. **FIXED**

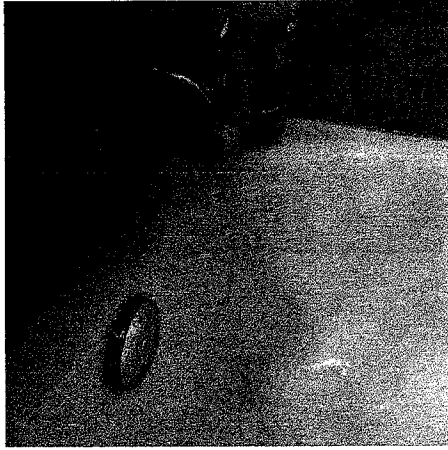
- Water pressure in the hallway bathtub, does not completely change over to the shower head when adjusted, water continues to come out of the spout while the shower is running. **FIXED**

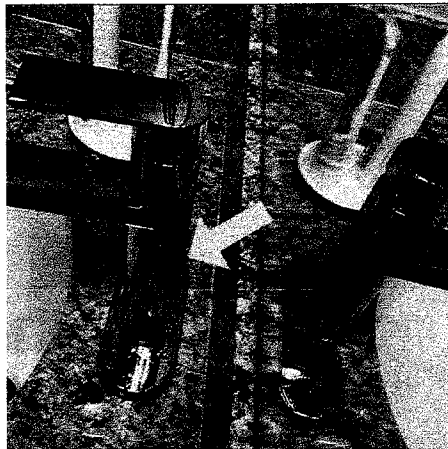
- Pull rod at the master bathroom sink is missing to operate the drain stopper.

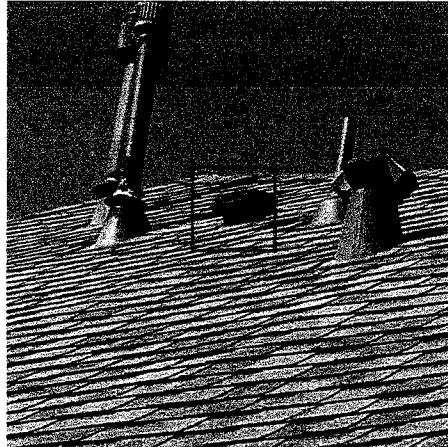
- **Lint appears to be stuck in the vent cover on the roof top. Recommend having the dryer vent cleaned before use. This could be a potential fire hazard.**
