# *Pro House Inspections*

## Property Inspection Report

3210 La Quinta Dr., Missouri City, TX 77459  
Inspection prepared for: Tony Earl and Bridgett Dowdy  
Real Estate Agent: Tywuan Watkins - Diverse City Realty

Date of Inspection: 1/15/2021 Time: 2:00 PM  
Age of Home: 1973 Size: 2900  
Weather: Clear, 60 degrees  
Order ID: 409  
Vacant Home

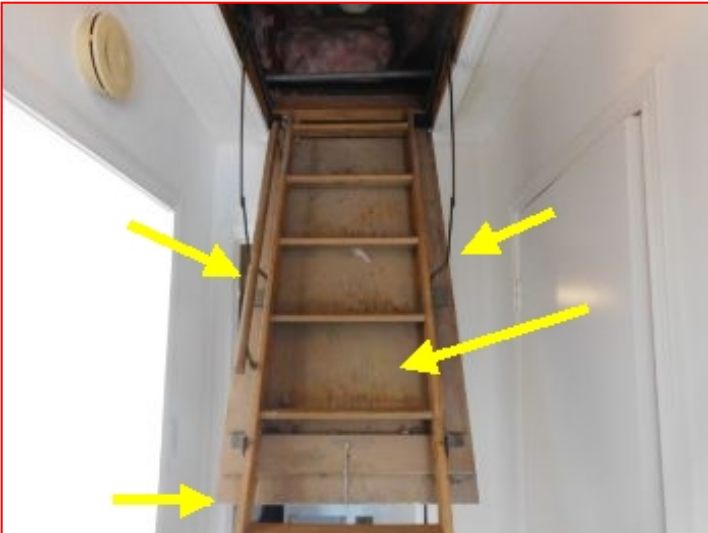
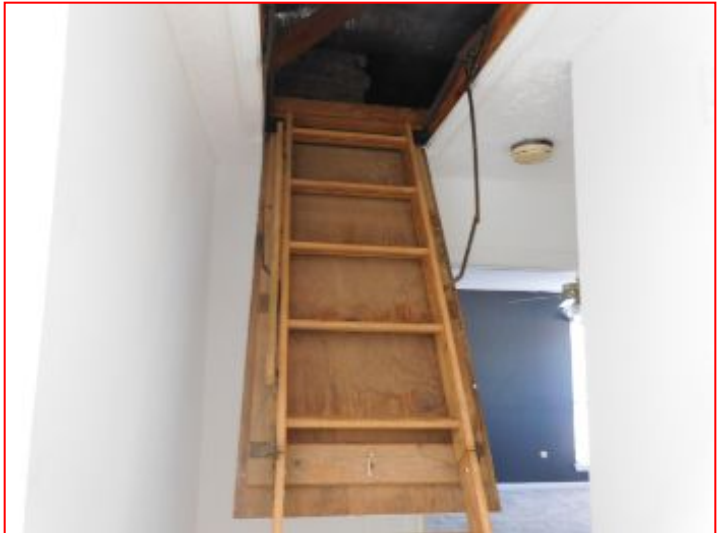
- **Insulate and weather-strip the pull down stairway door to promote insulation barrier to reduce moisture / condensation, Hot / Cold temperatures into the home from this area.**

Insulate and weather-strip the pull down stairway door to promote insulation barrier to reduce moisture / condensation, Hot / Cold temperatures into the home from this area.

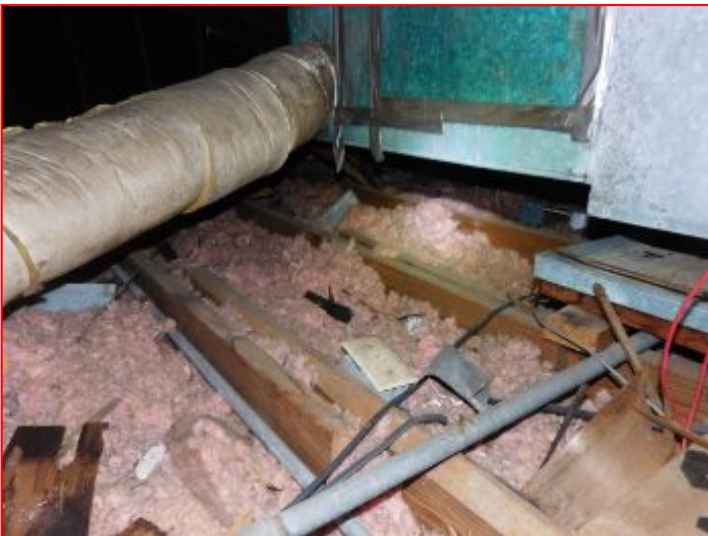
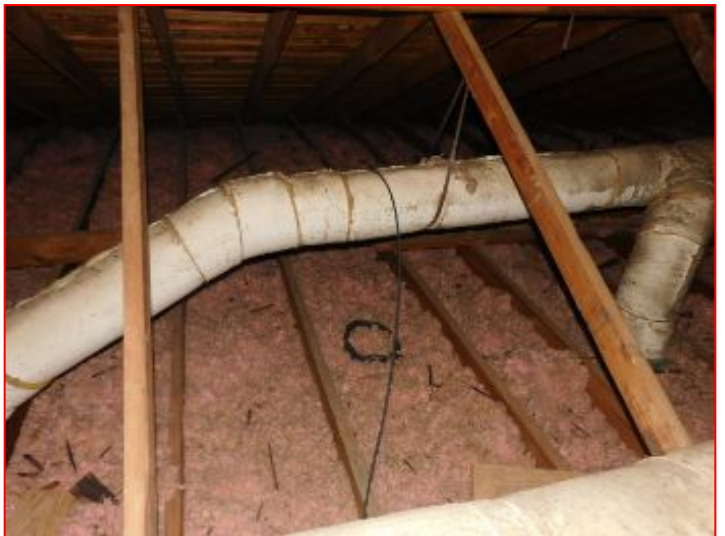
- **Insulation: The insulation provided in the attic has poor coverage in multiple areas compared to today's standards. Recommend upgrading this area of the home to improve energy efficiency. Review by a qualified contractor. Recommendation - Installing insulation to a R38 value. This is equivalent to 12" inches of fiberglass bat type or loose blown in type throughout the attic.**

Low insulation

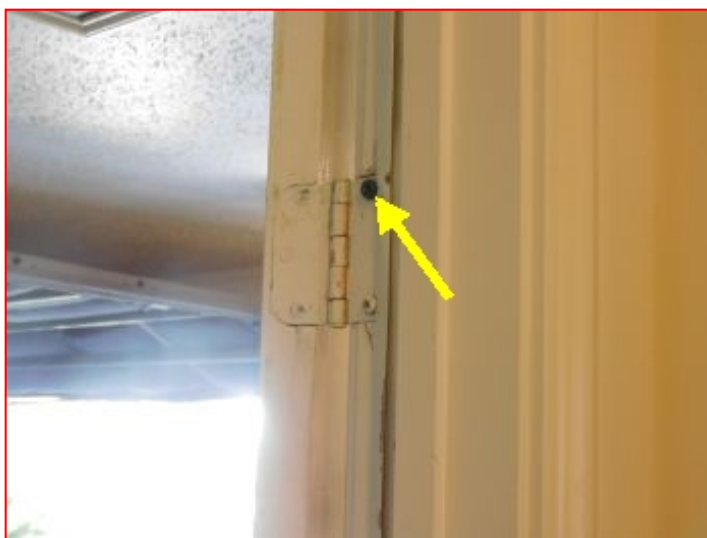
**• Door to house and garage has stripped hinges and does not close properly. Repair needed.**

Door to garage has stripped hinges and does not close properly.

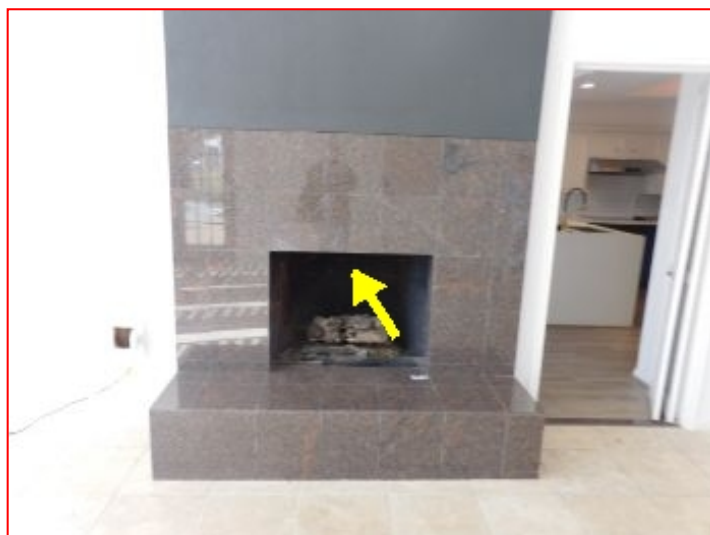
- **This fireplace is not equipped with a damper stop. Any fireplace that is equipped with gas must have the damper set in a permanently open position to prevent accidental carbon monoxide poisoning. This can be easily accomplished with a damper stop that can be purchased at most hardware stores.**

This fireplace is not equipped with a damper stop. Any fireplace that is equipped with gas must have the damper set in a permanently open position to prevent accidental carbon monoxide poisoning.

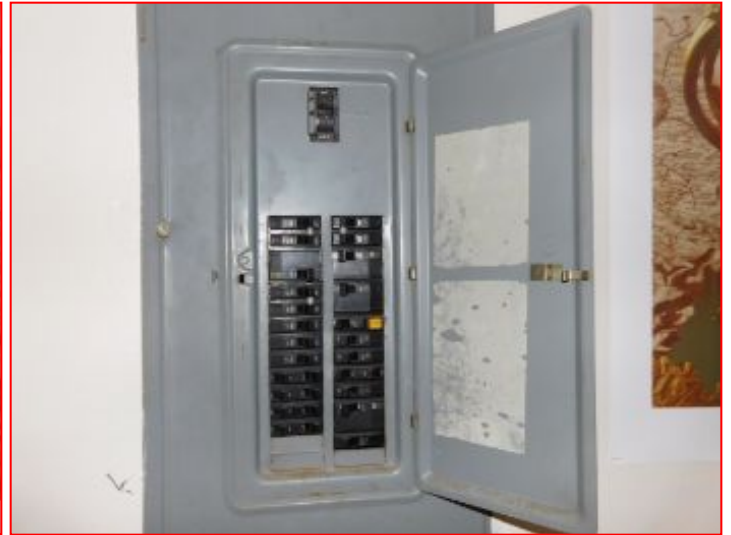
Panel is not labeled properly.

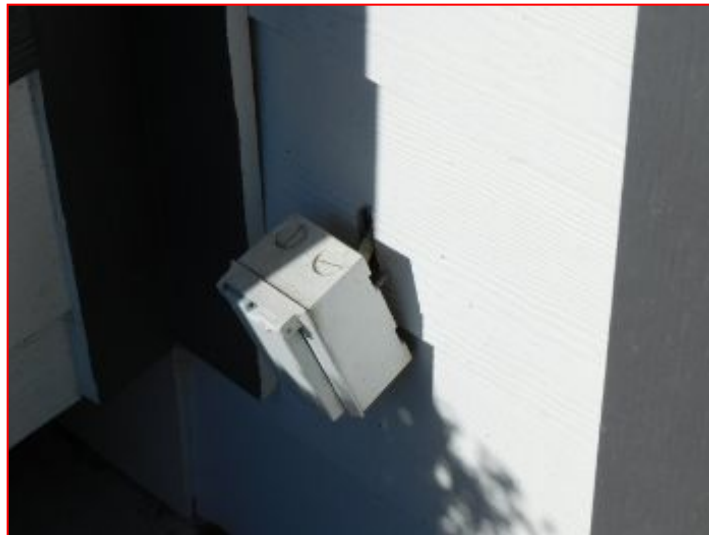
A plug is loose on the outside back wall and should be secured / repaired or replaced for safety reasons.

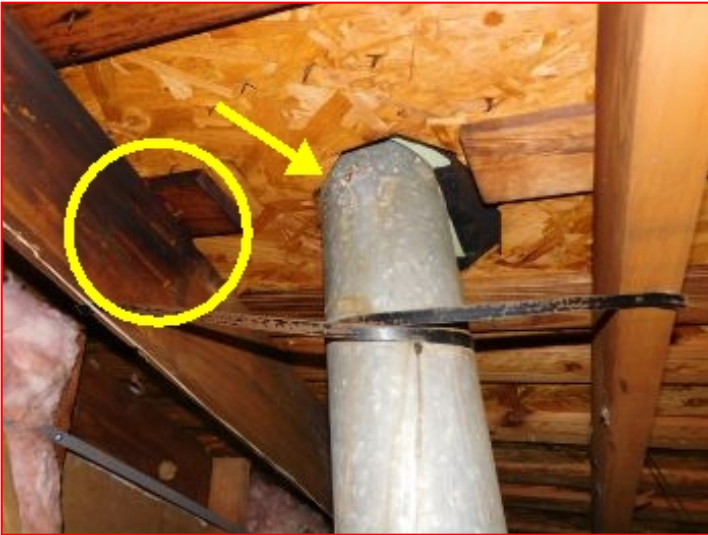
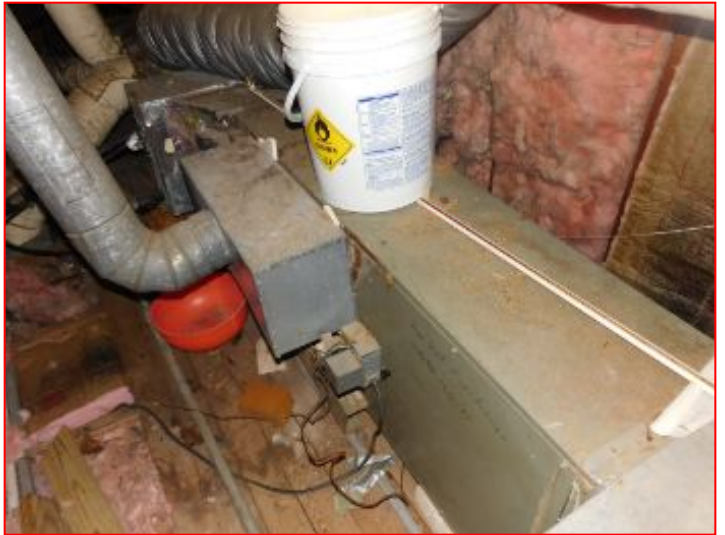
**There is evidence of roof deck overheating, nearly catching fire. Connections to venting system are very poor at the top of the roof penetration. Should be improved and securely attached and strapped to the rafters to reduce movement in high winds for safety reasons. Recommend consulting a licensed contractor.**

Furnace chimney is in contact or too close with the roof deck in the lower attic area. This area should have a minimum 1" clearance from combustibles and pass above the roof 2 ft" for safety reasons. There is evidence of roof deck overheating,

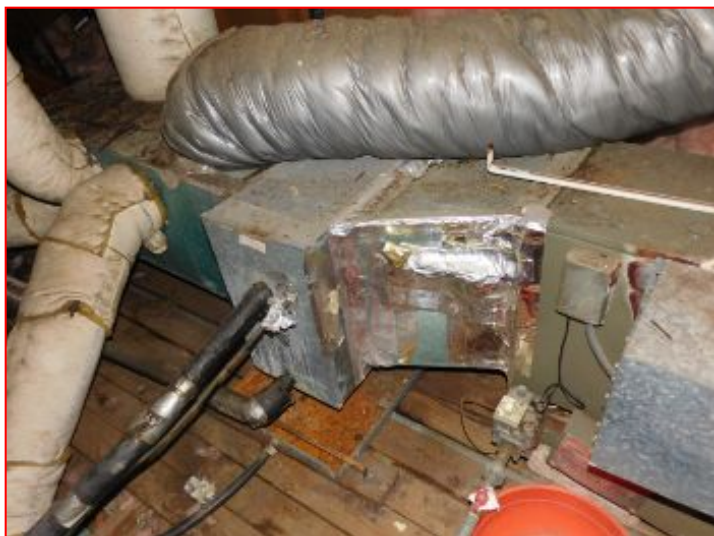
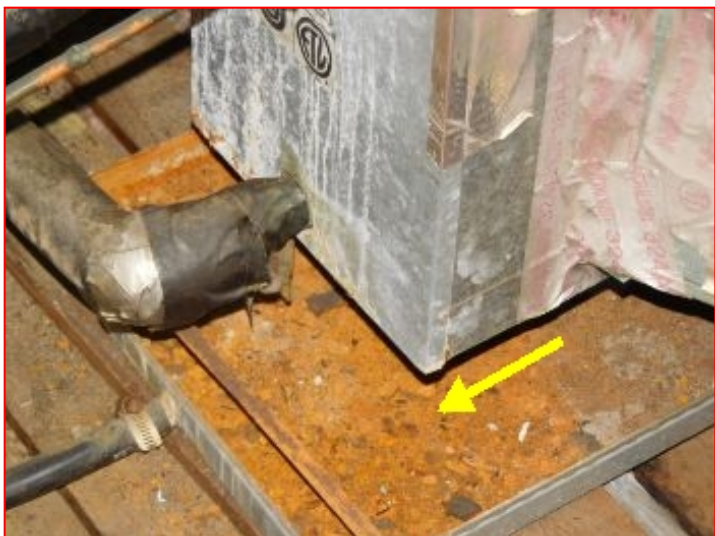
Condensate tray for the system in the attic shows evidence of leakage having occurred in the past. Pan is badly rusted and corroded and may leak when needed. Recommend replacement. Recommend consulting a licensed HVAC contractor to perform corrective action.

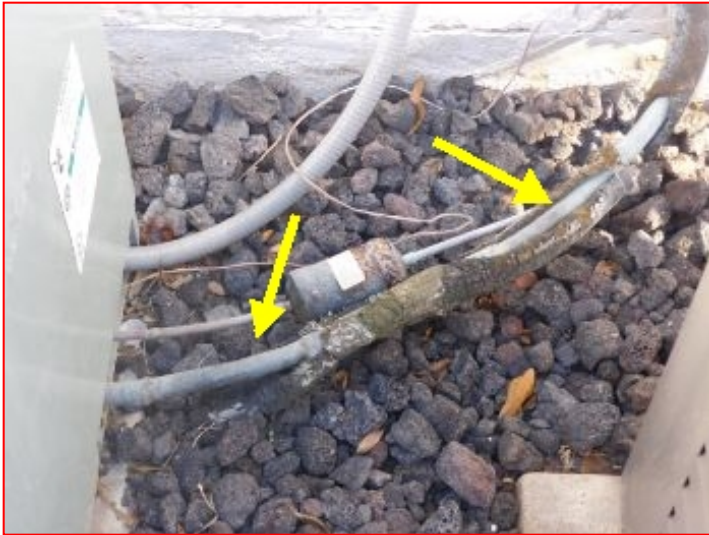
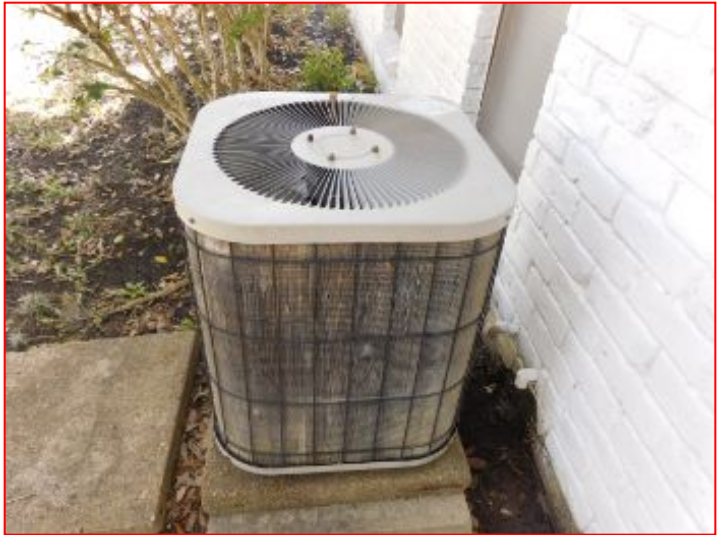
- **The suction lines on the outside a/c compressor has damaged or missing insulation. Should be replaced to prevent sweating and extracting additional heat.**
- **Condensate tray for the system in the attic shows evidence of leakage having occurred in the past. Pan is badly rusted and corroded and may leak when needed. Recommend replacement. Recommend consulting a licensed HVAC contractor to perform corrective action.**

The suction lines on the outside a/c compressor has damaged or missing insulation.

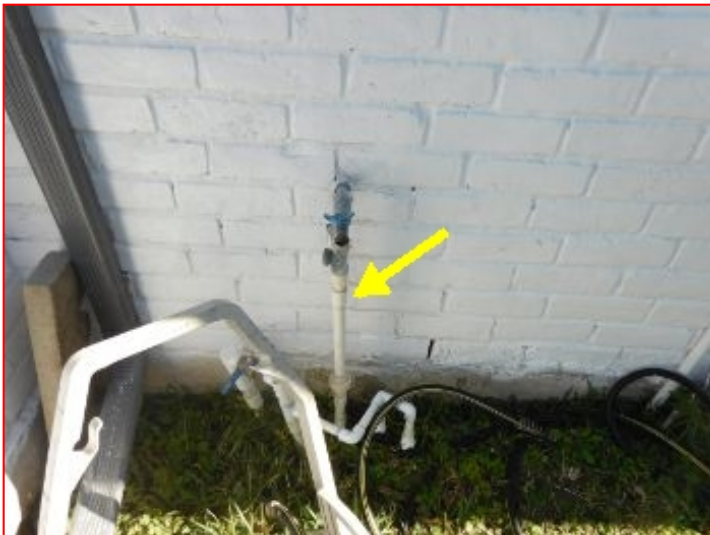
Supply pipe at the shut off valve is located such that it is susceptible to damage / freezing. Insulation is recommended.

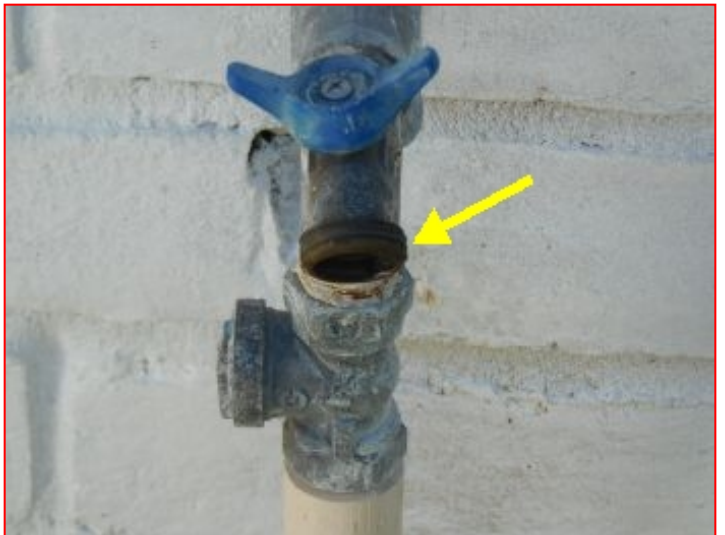
Back flow check valves are not installed on the outside hose bibs.

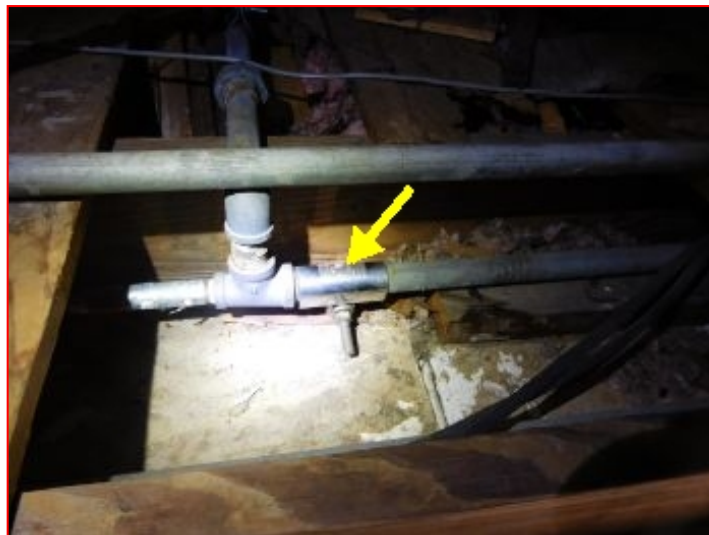
Sign of past patching of galvanized pipe

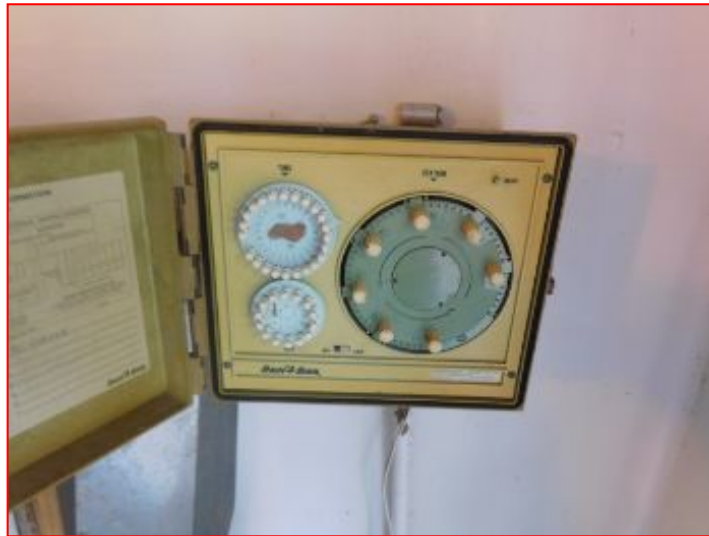
- **System is not operating. Needs evaluation.**

System is not operating. Needs evaluation.

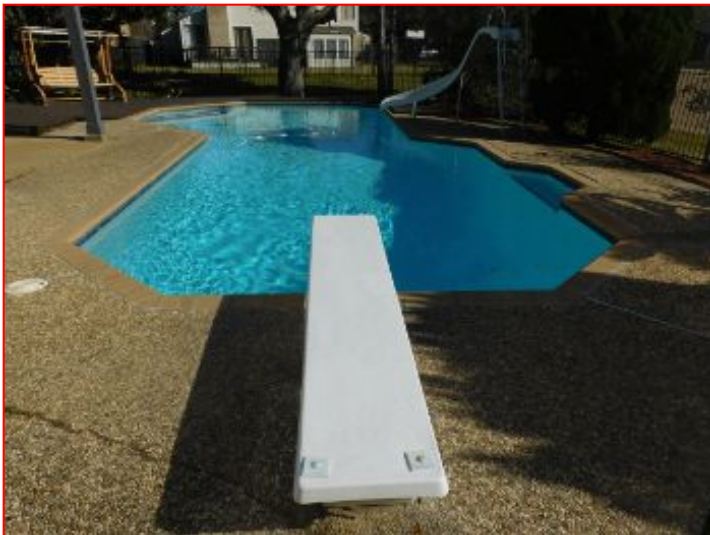
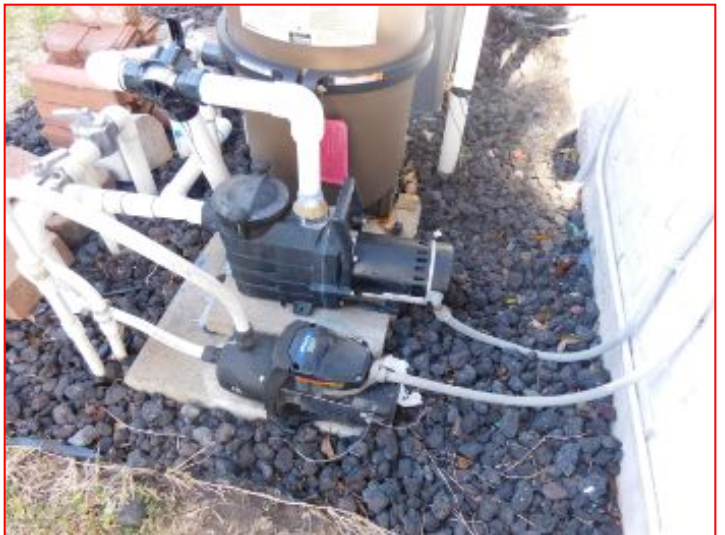
Motors are not grounded as required. Corrective action required for safety reasons. Consult a qualified repair provider.

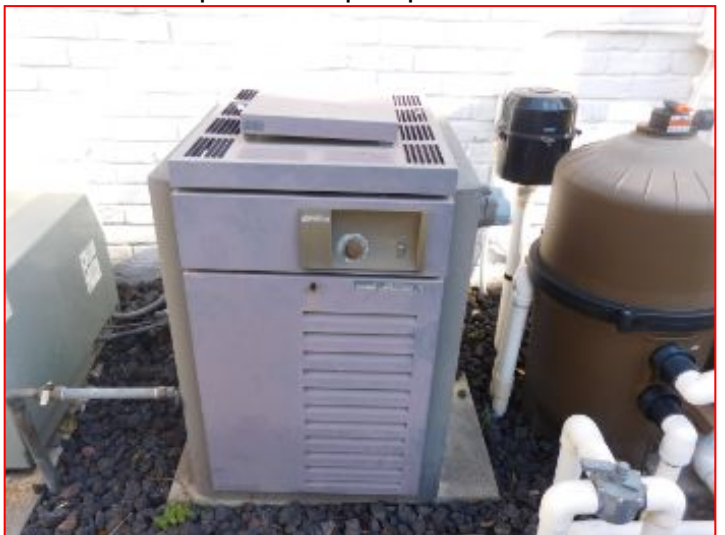
Pool / Spa Heater: Gas operated pool / spa heater is in poor condition and not connected. Needs to be replaced. Consult a qualified provider.

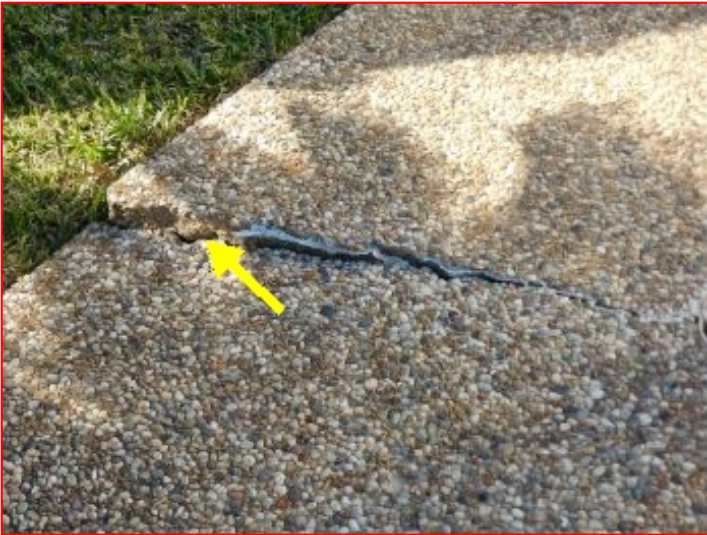
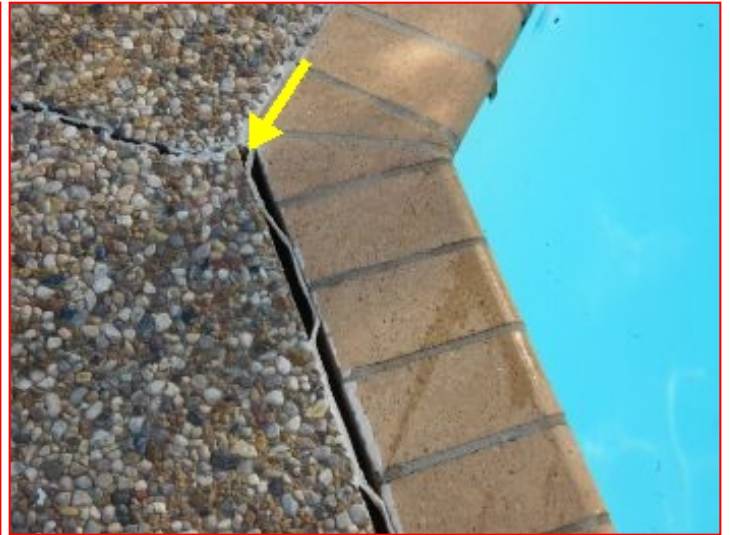
Deck / coping: Decking around the pool area is in poor condition, lifting on the right side of diving board. This may be an indication of a slow underground leak from the pool jet's. Recommend a full underground leak detection and evaluation as to the actual cause and effect proper repairs.

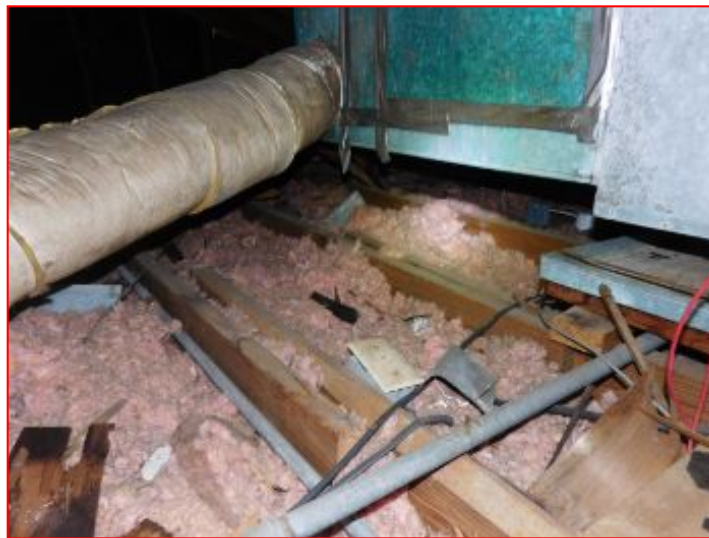
Low insulation
