KLB Home Inspections

Property Inspection Report

12811 Winding Manor Drive, Houston, TX 77044
Inspection prepared for: Jen Houston
Real Estate Agent: Michael Russell - Century 21 Realty Partners

Date of Inspection: 2/5/2018 Time: 10:00 am
Age of Home: 2003 Size: 3,225 Built Sqft
Weather: Overcast

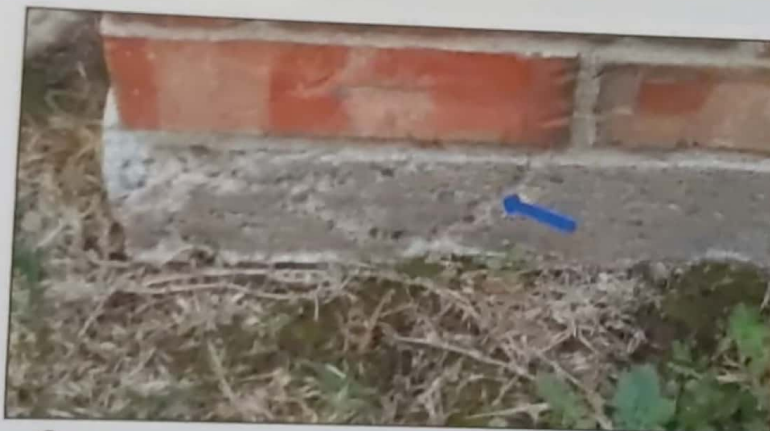
A.2. Corner pops were noted on the corner(s) of the foundation, these are usually considered cosmetic nature unless other movement is noted. Recommend sealing all cracks to help prevent further deterioration. Mainly at - Right side

Corner pops were noted on the corner(s) of the foundation, these are usually considered cosmetic nature unless other movement is noted. Recommend sealing all cracks to help prevent further deterioration. Mainly at - Right side

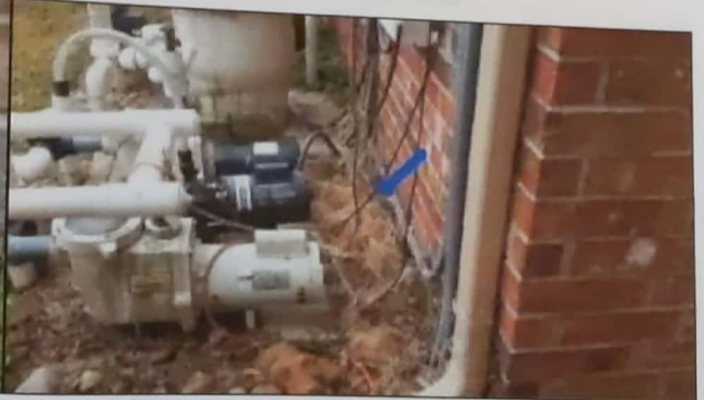
A.3. The foundation wall structure and supports were not fully visible to the inspector due to high soil or foliage located at one or more areas around the buildings perimeter. Mainly at - Front side, right side, rear side

The foundation wall structure and supports were not fully visible to the inspector due to high soil or foliage located at one or more areas around the buildings perimeter. Mainly at - Front side, right side, rear side

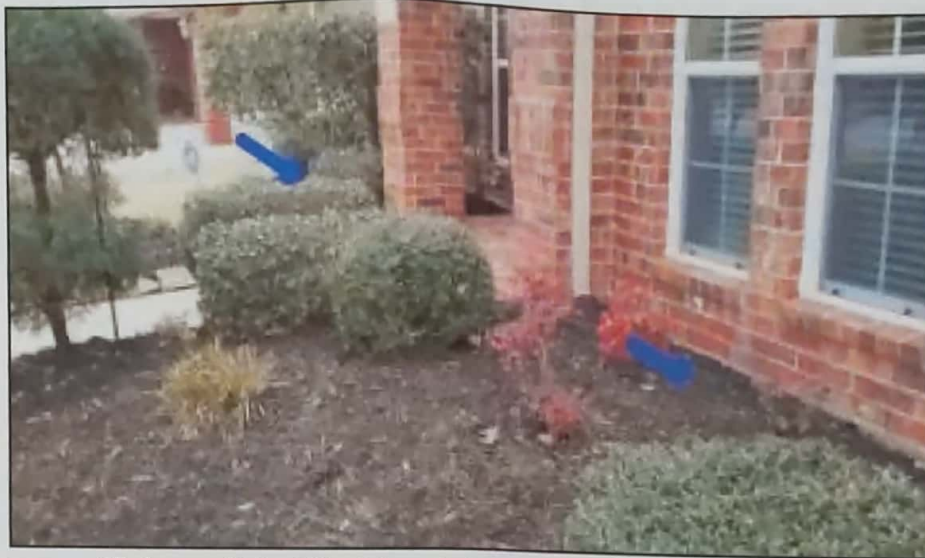
B.1. There is not the proper 6" drop within 10' of the slab around the structure. This may cause water to sit against the slab and can cause foundation issues if not corrected. Recommend resloping or adding drainage to help remove water from slab. Mainly at - Front bedding materials

There is not the proper 6" drop within 10' of the slab around the structure. This may cause water to sit against the slab and can cause foundation issues if not corrected. Recommend resloping or adding drainage to help remove water from slab. Mainly at - Front bedding materials

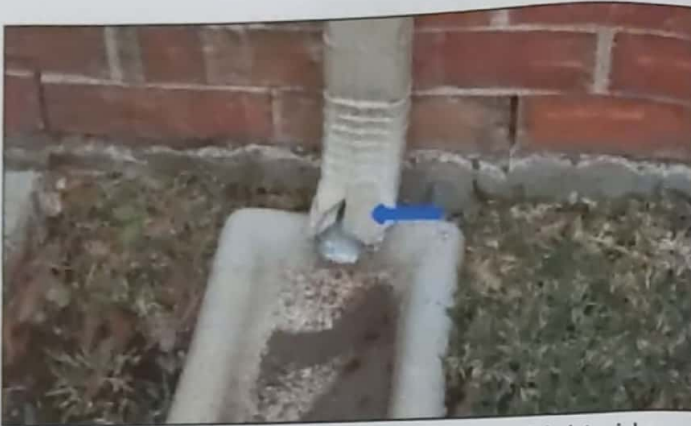
C.2. The gutter is damaged. Mainly at - Right side

The gutter is damaged. Mainly at - Right side

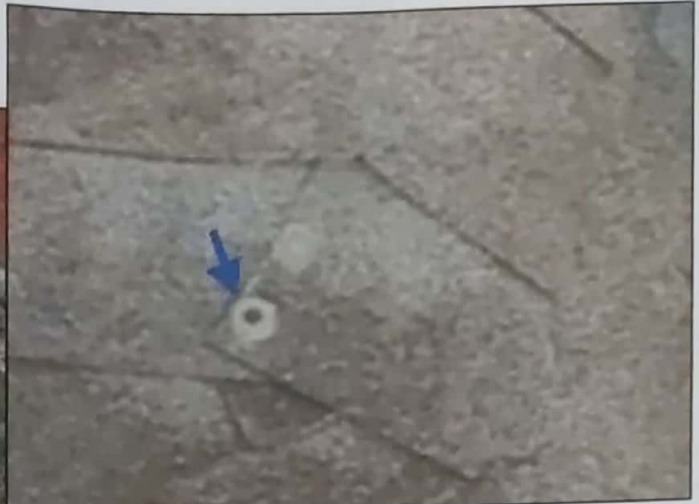
All exposed nails and fasteners on roof should be sealed at all penetrations, ridges and roof to wall connections.

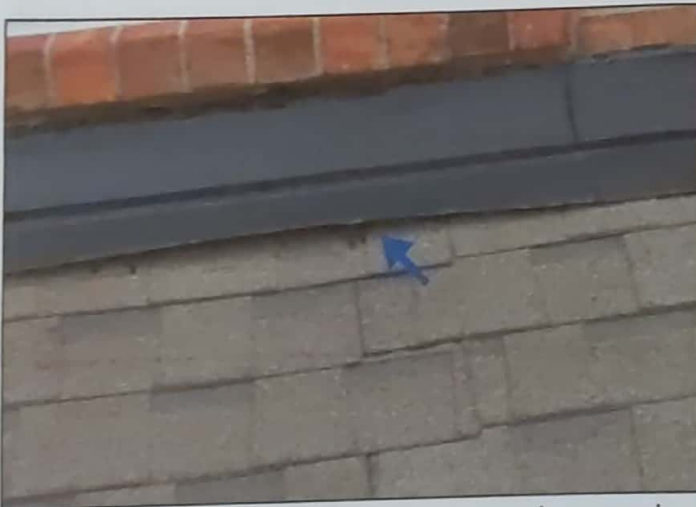
C.5. The roof flashing is lifted. Recommend resealing flashing and sealing nails to help prevent water penetration. Mainly at - Front side above garage

The roof flashing is lifted. Recommend resealing flashing and sealing nails to help prevent water penetration. Mainly at - Front side above garage

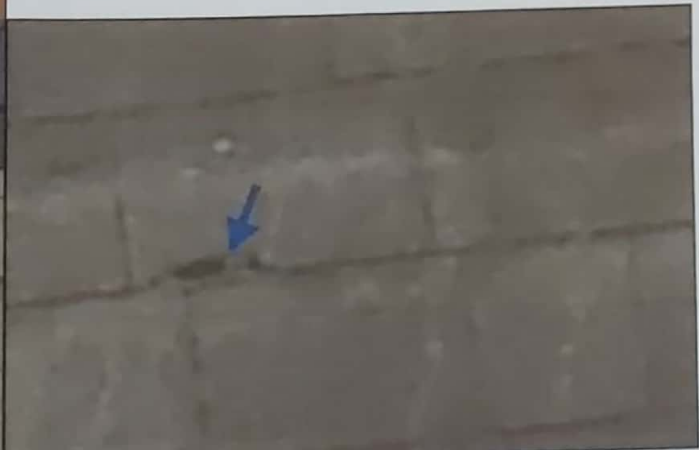
C.6. There are damaged shingles on the roof, recommend repairs or replacement of damaged shingles. Mainly at - Rear side above porch

There are damaged shingles on the roof, recommend repairs or replacement of damaged shingles. Mainly at - Rear side above porch

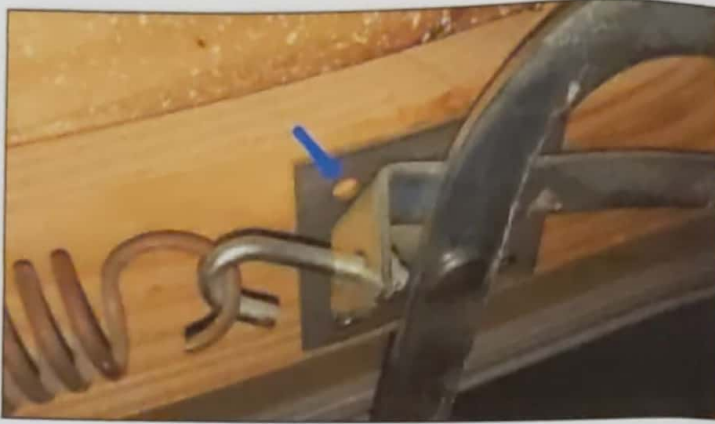
The attic pull-down stairs are not supported properly. It should be hung with 16 penny nails or lag screws in the empty hole at the bracket on the hinge side of the stairway and on the side hinge.

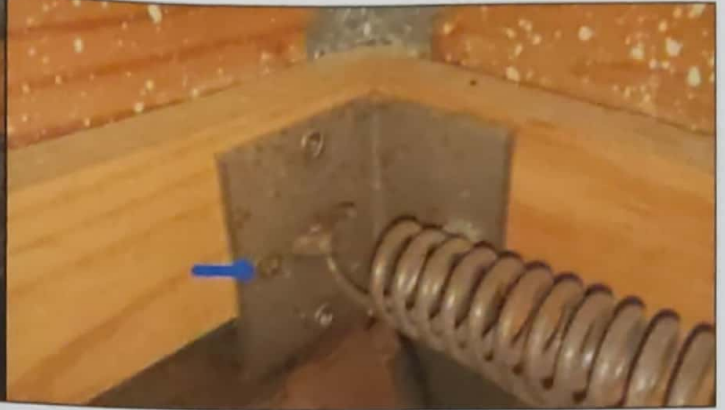
The attic pull-down stairs are not supported properly. It should be installed with 16 penny nails or lag screws not decking or construction screws.

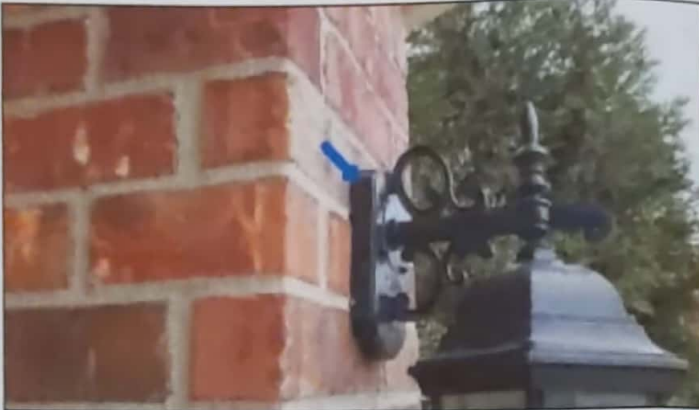
Seal all electrical lighting fixtures at wall connection to help prevent water penetration. It is a good idea to leave a small opening at the bottom to allow any water penetrating to escape.

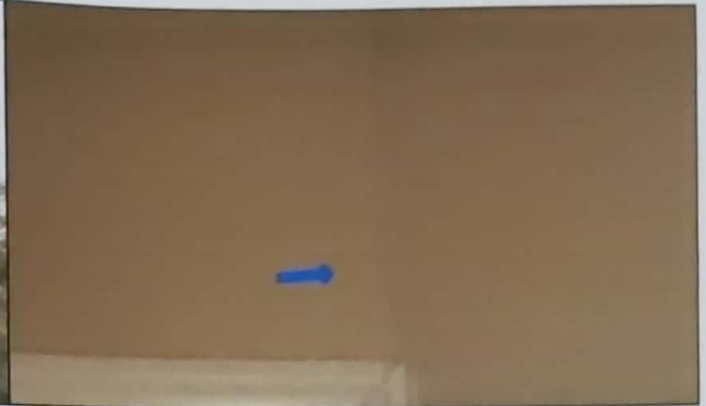
E.3. Minor settlement cracks is noted in the drywall.
Mainly at - Upstairs front right bedroom

Minor settlement cracks is noted in the drywall. Mainly at - Upstairs front right bedroom

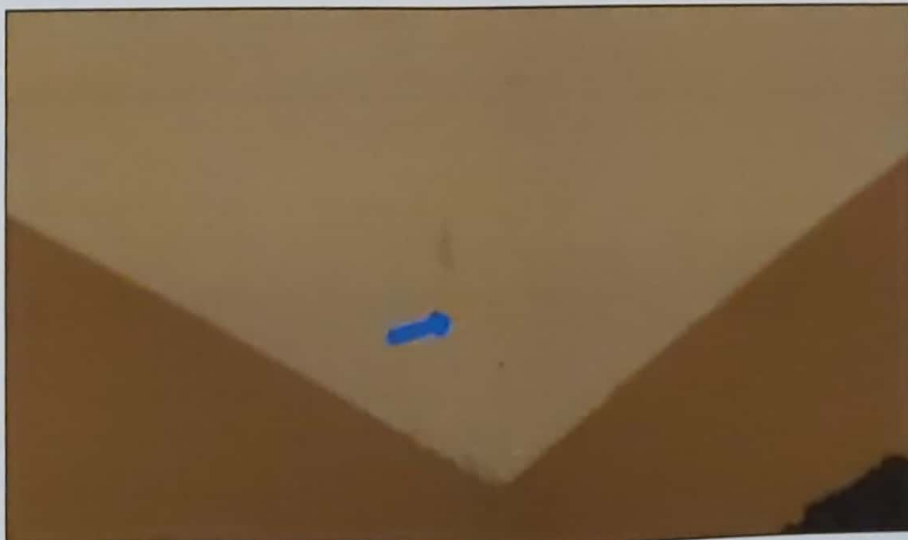
F.1. Minor settlement cracks were noted in the drywall. These are generally considered cosmetic only, unless otherwise noted. Mainly at - Master bedroom, upstairs right rear bedroom

Minor settlement cracks were noted in the drywall. These are generally considered cosmetic only, unless otherwise noted. Mainly at - Master bedroom, upstairs right rear bedroom

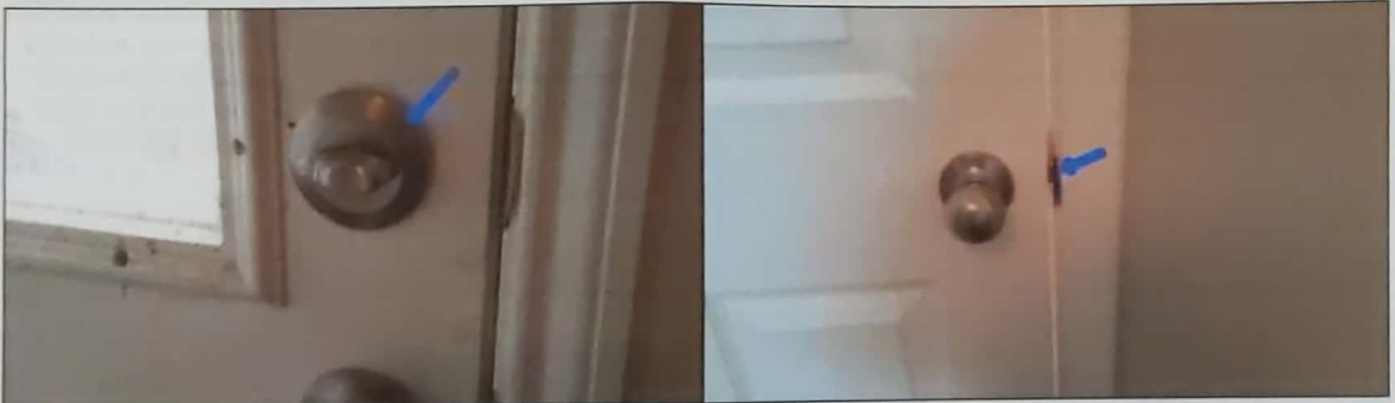
G.2. The door is not latching properly. Mainly at - Upstairs front bedroom entry

G.3. The door lock is not locking. Mainly at - Rear garage door deadbolt

The door lock is not locking. Mainly at - Rear garage door dead bolt

The door is not latching properly. Mainly at - Upstairs front bedroom entry

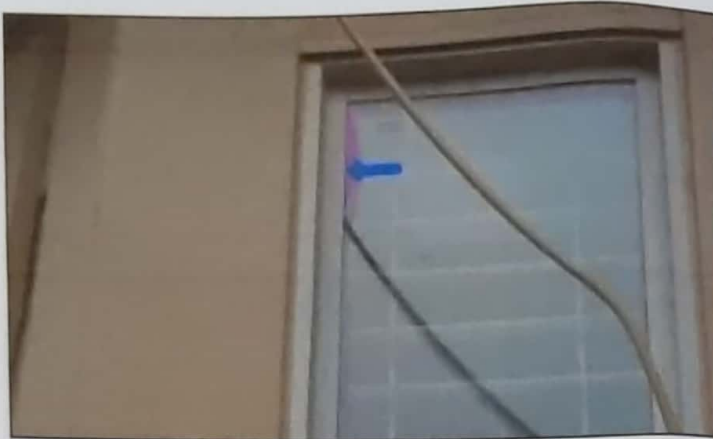
H.3. Window pane(s) that have lost their thermal seal. Signs of lost seals in the thermal pane windows may appear and disappear as temperature and humidity changes. Mainly at - Left side bay window

Window pane(s) that have lost their thermal seal. Signs of lost seals in the thermal pane windows may appear and disappear as temperature and humidity changes. Mainly at - Left side bay window

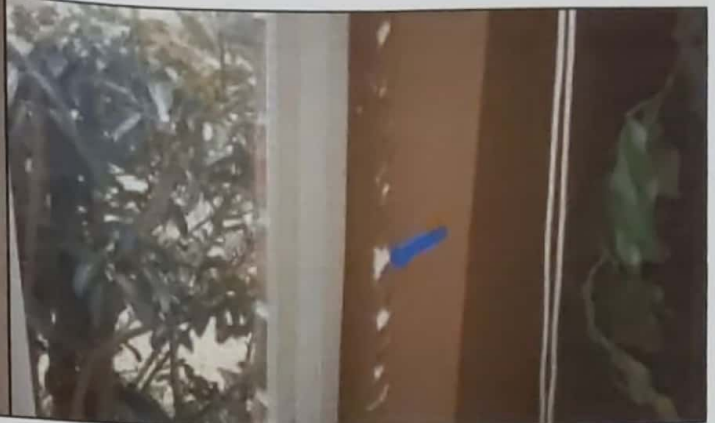
Sealant is needed around the interior of the windows between the window framing and the drywall to help prevent water penetration. Mainly at - Front left dining room

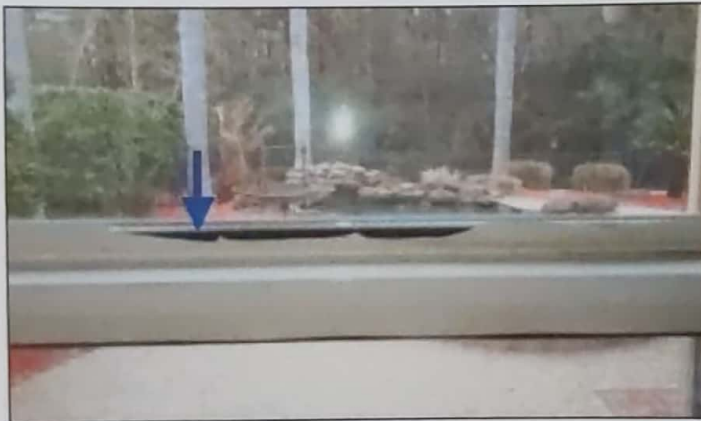
H.1. Glazing bead is damaged or deteriorated, recommend replaced or sealing to prevent moisture penetration. Mainly at - Breakfast nook

Glazing bead is damaged or deteriorated, recommend replaced or sealing to prevent moisture penetration. Mainly at - Breakfast nook

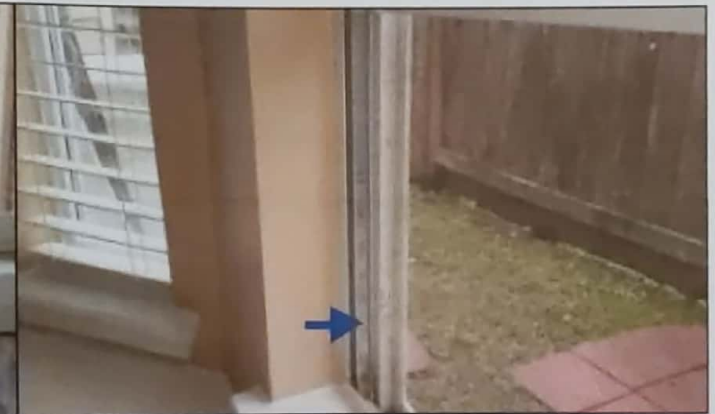
H.2. Springs were not attached or broken on window(s). Mainly at - Breakfast nook left window

Springs were not attached or broken on window(s). Mainly at - Breakfast nook left window

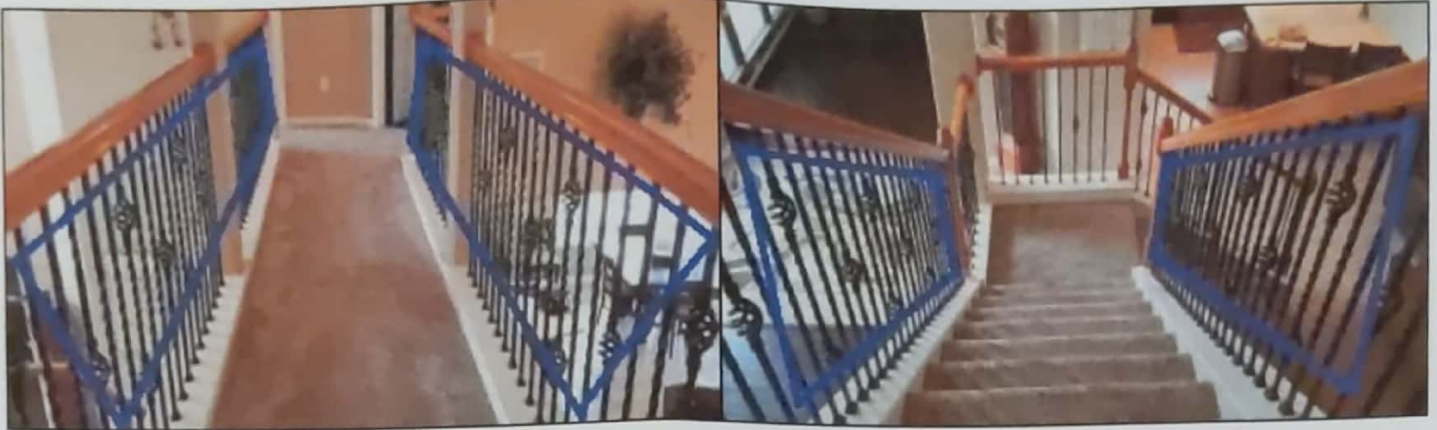
I.1. Loose balusters is noted. Mainly at - Staircase and balcony

Loose balusters is noted. Mainly at - Balcony

Loose balusters is noted. Mainly at - Staircase

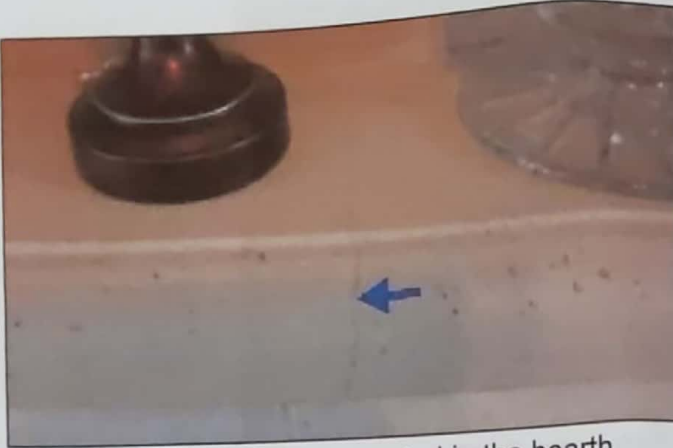
J.2. Settlement cracks are noted in the hearth, recommend sealing.

Settlement cracks are noted in the hearth, recommend sealing.

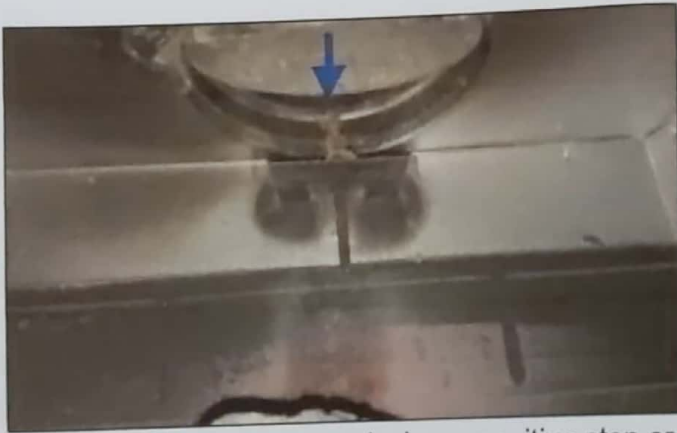
J.1. The fireplace damper is missing a positive stop or damper clamp to ensure proper ventilation for the gas logs, recommend adding damper clamp.

The fireplace damper is missing a positive stop or damper clamp to ensure proper ventilation for the gas logs, recommend adding damper clamp.

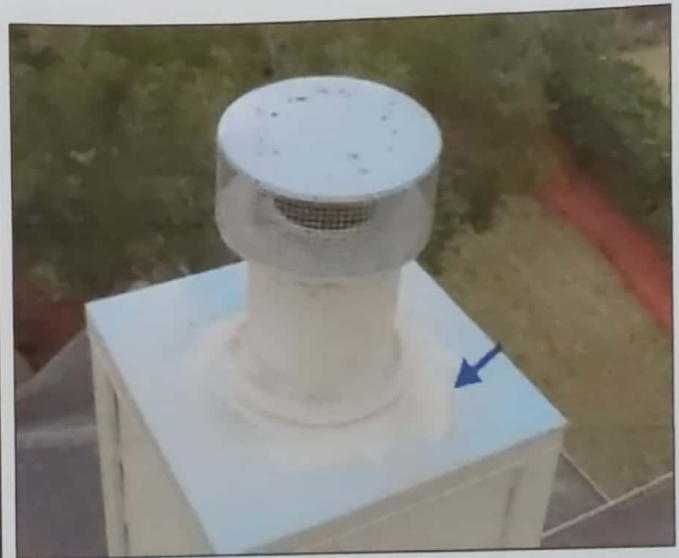
J.3. Fireplace cap was rusting paint cap to chimney to help prevent further deterioration.

Fireplace cap was rusting paint cap to chimney to help prevent further deterioration.

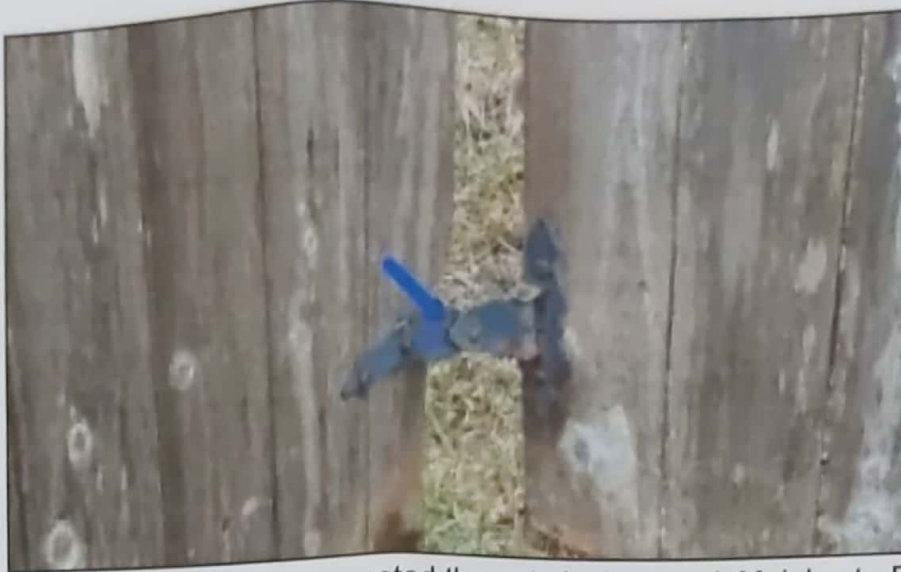
L.1. Although fences are not inspected it was noted the gate is damaged. Mainly at - Right side gates

Although fences are not inspected it was noted the gate is damaged. Mainly at - Right side gates

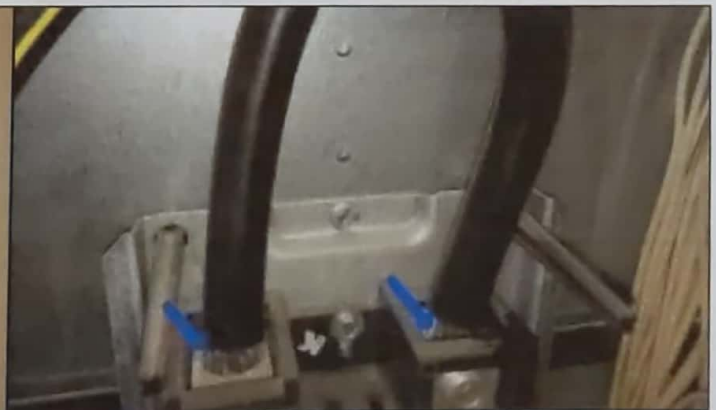
There is no antioxidant on main aluminum feeds to the panel box. This should be used to help prevent overheating.

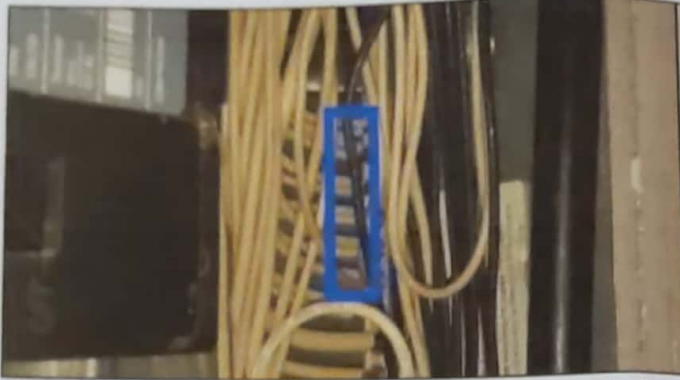
There are more than one neutral wire located under the same screw. Neutral wires should be separated to individual screws.

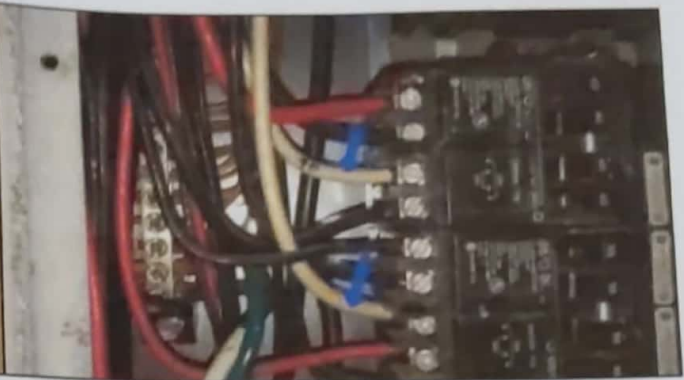
A.4. White wires being used as hot conductors should be marked as hot.

White wires being used as hot conductors should be marked as hot.

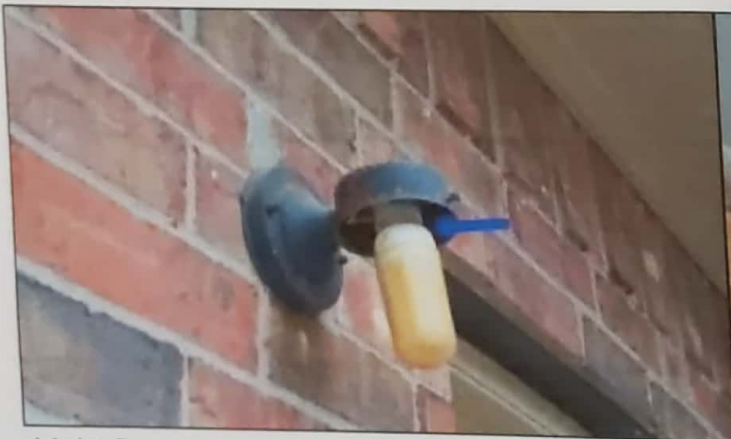
B.4. Light fixture(s) were missing their globe. Mainly at - Right side

Light fixture(s) were missing their globe. Mainly at - Right side

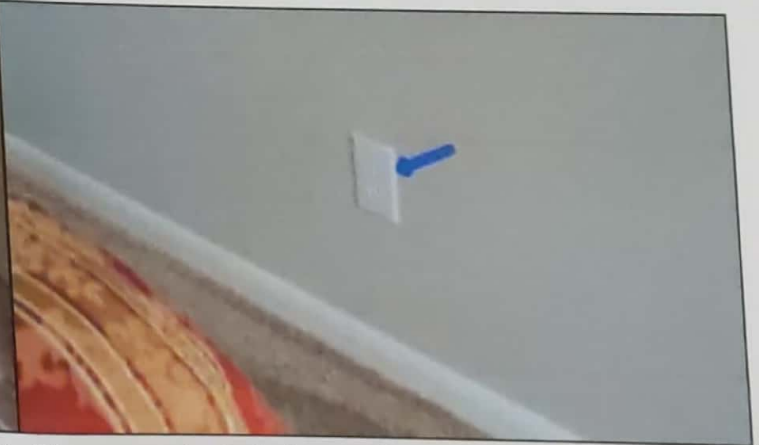
B.5. The receptacle is loose. Mainly at - Upstairs front bedroom

The receptacle is loose. Mainly at - Upstairs front bedroom

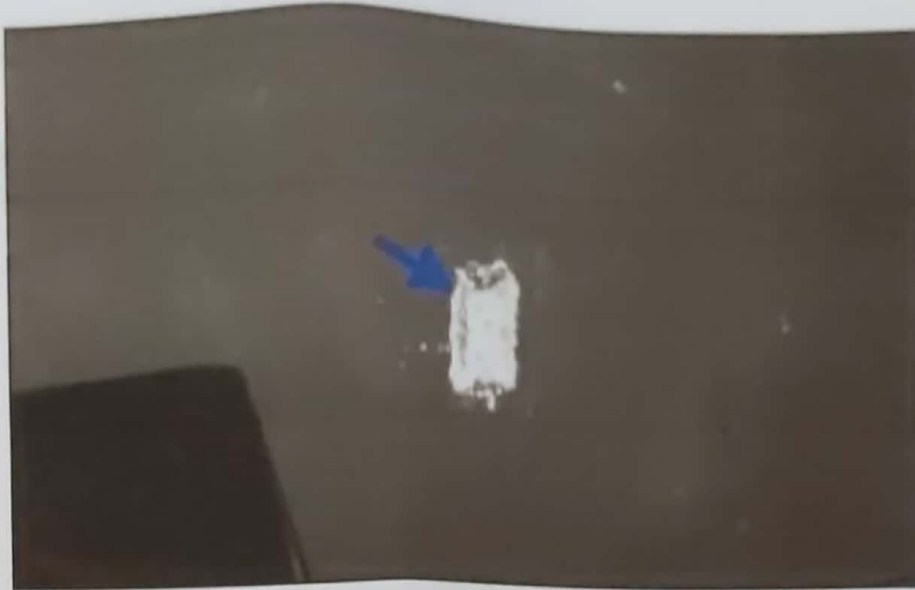
B.2. Receptacle plate(s) are broken or missing, recommend replacing covers to help prevent electrical shock. Mainly at - Upstairs media room

Receptacle plate(s) are broken or missing, recommend replacing covers to help prevent electrical shock. Mainly at - Upstairs media room

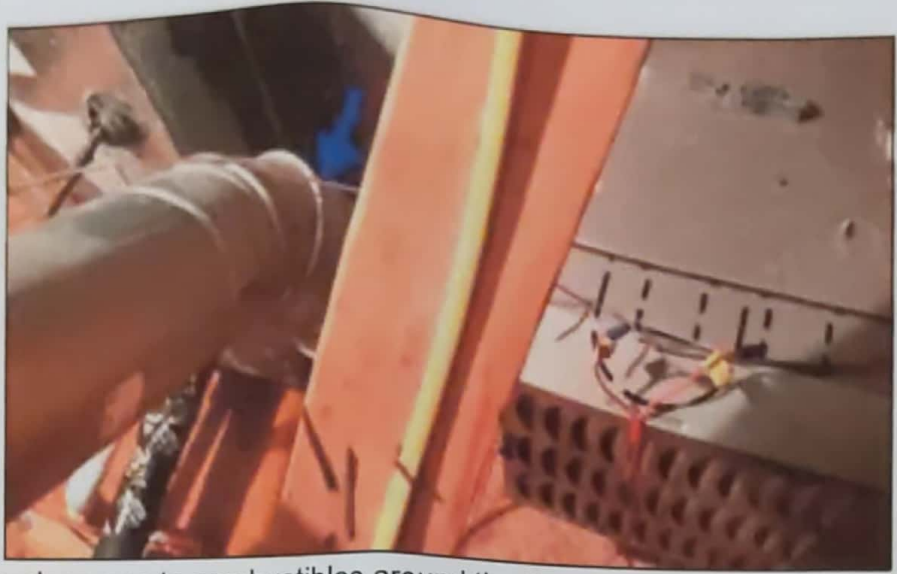
A.1. There is improper clearance to combustibles around the flue pipe. Upstairs flue pipe is in contact with unit wiring.

There is improper clearance to combustibles around the flue pipe. Upstairs flue pipe is in contact with unit wiring.

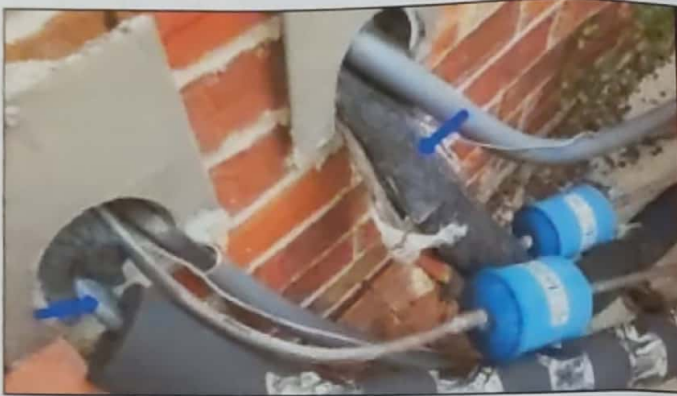
B.1. The insulation is missing or damaged on the A/C suction line at the condensing unit. Recommend repair or replacement to prevent cooling loss from exterior temperatures.

The insulation is missing or damaged on the A/C suction line at the condensing unit. Recommend repair or replacement to prevent cooling loss from exterior temperatures.

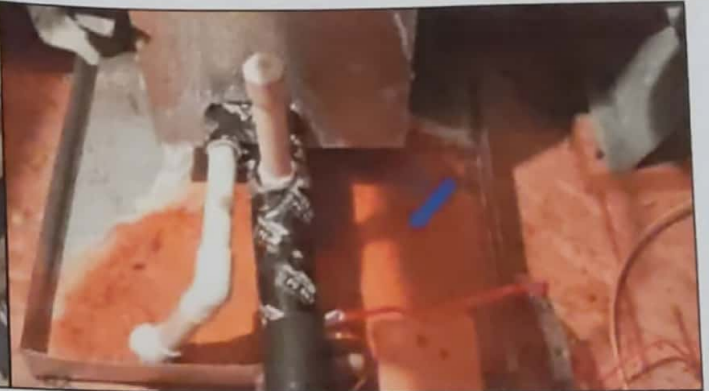
B.2. There is rust noted in the drain pan. Indications are that the pan is operating as intended at time of inspection. Upstairs unit

There is rust noted in the drain pan. Indications are that the pan is operating as intended at time of inspection. Upstairs unit

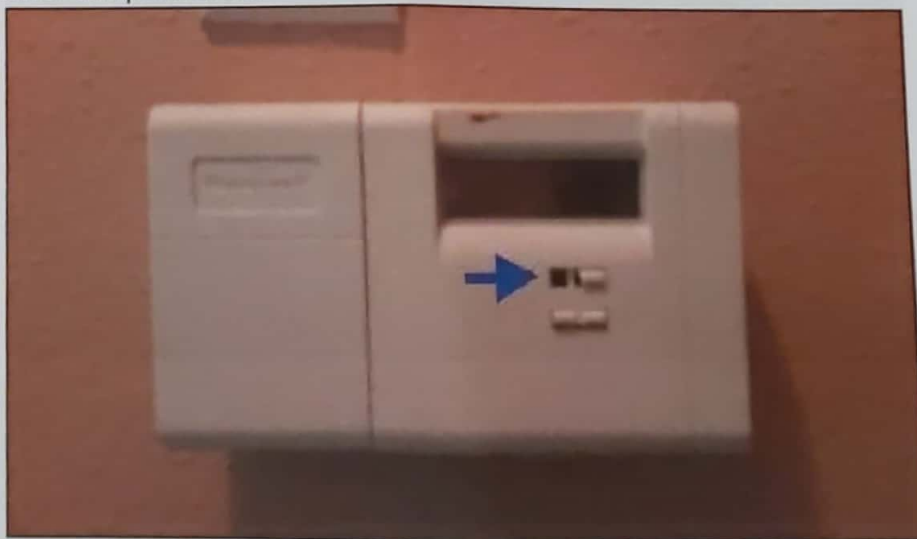
B.3. The thermostat cover is damaged. Recommend repairs or replacement as needed for proper operation

The thermostat cover is damaged. Recommend repairs or replacement as needed for proper operation

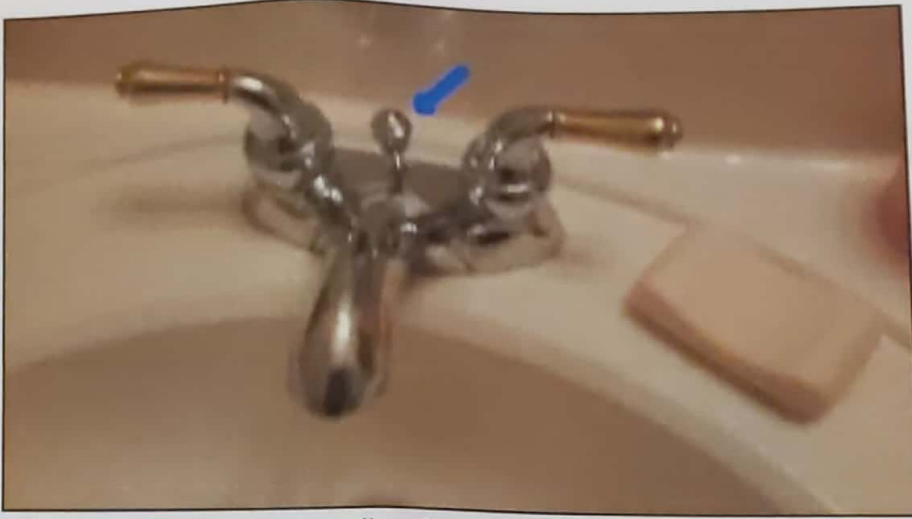
The sink drain stopper is not sealing/functioning. Mainly at - Upstairs bathroom

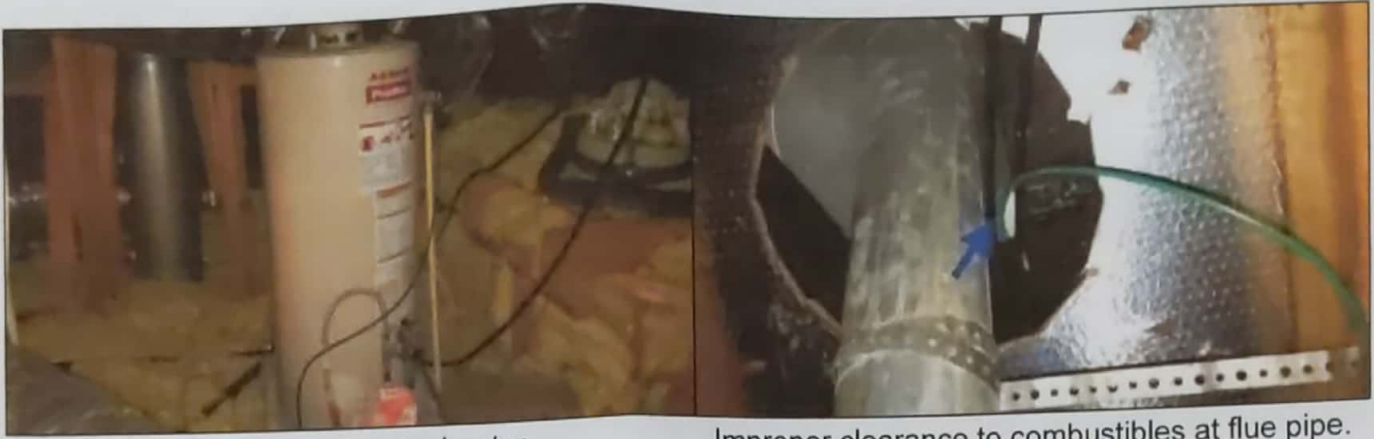
C.1. Improper clearance to combustibles at flue pipe. Recommend cutting wood or other combustible material back at least 1" away from the flue pipe.

Improper clearance to combustibles at flue pipe. Recommend cutting wood or other combustible material back at least 1" away from the flue pipe.

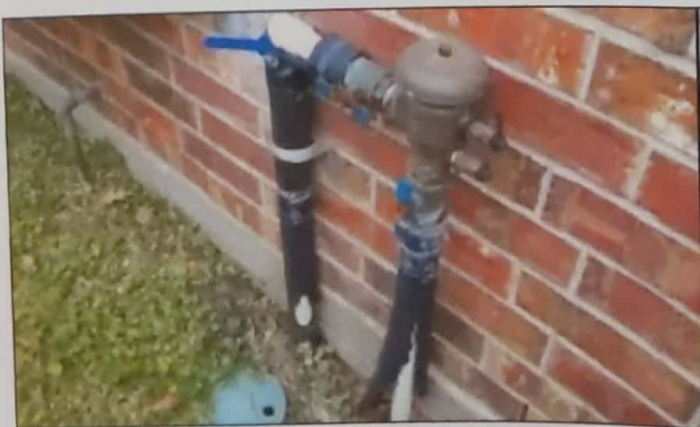
Sprinkler vacuum breaker lines insulation is damaged or missing.

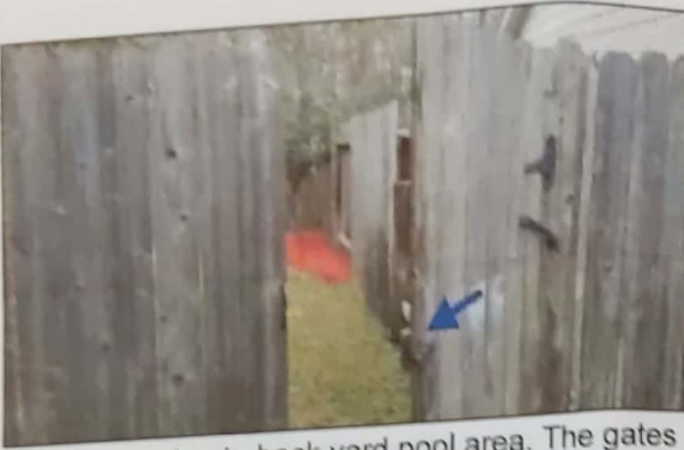
B.1. Improper gates to back yard pool area. The gates around the pool should be at least 48" tall, self closing, self latching, open outward, latch inside at least 3" below top of gate and can be locked with no opening over a 1/2" within 18" of the latch.

Improper gates to back yard pool area. The gates around the pool should be at least 48" tall, self closing, self latching, open outward, latch inside at least 3" below top of gate and can be locked with no opening over a 1/2" within 18" of the latch.

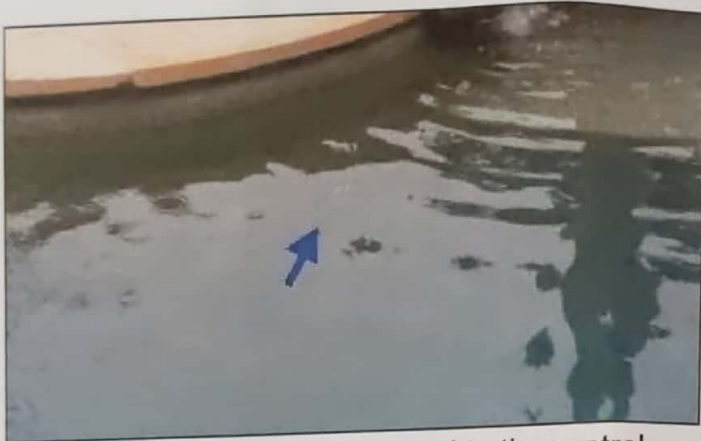
The pool light did not respond to the control.

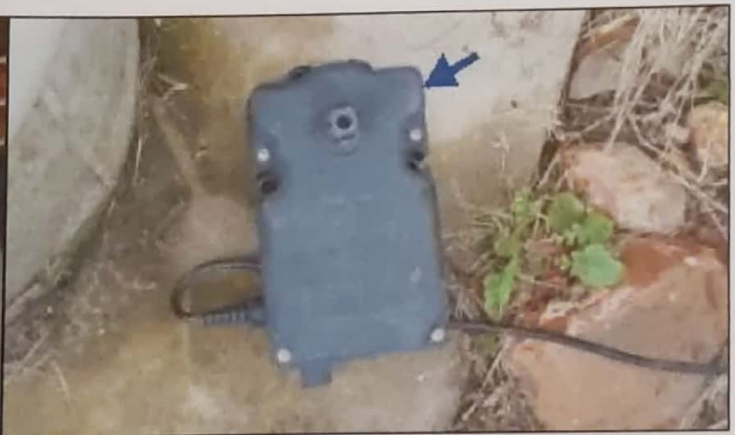
B.3. Control valve has been removed and was not operating at the time of inspection. Recommend pool specialist be consulted for further evaluation and/or repairs.

Control valve has been removed and was not operating at the time of inspection. Recommend pool specialist be consulted for further evaluation and/or repairs.

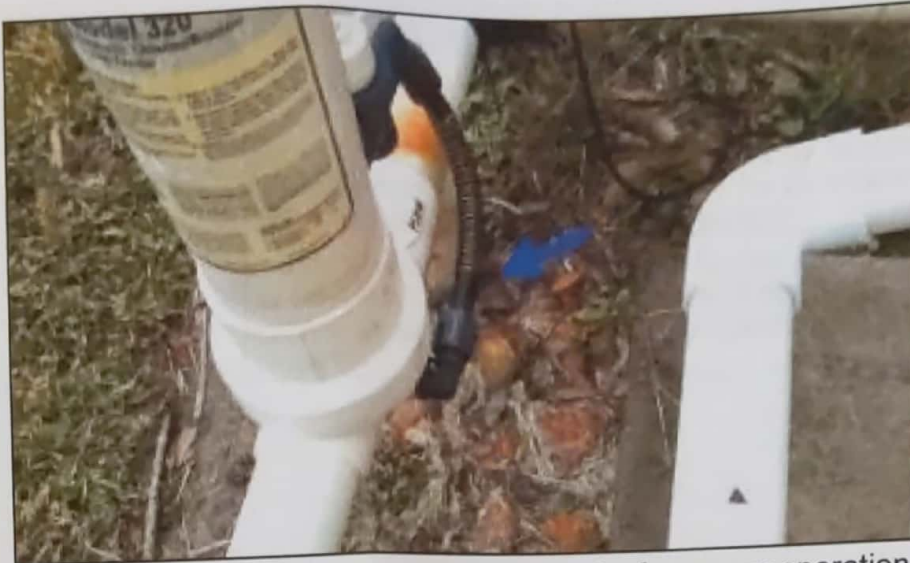
B.4. Chlorine feeder is leaking, recommend repairs for proper operation.

Chlorine feeder is leaking, recommend repairs for proper operation.
