PROPERTY INSPECTION REPORT

Concerning: 20327 Clydesdale Ridge Drive , Humble, TX 77338
(Address or Other Identification of Inspected Property)

By: Dan Romero Lic.#: 5674 04/17/2021
(Name and License Number of Inspector) (Date)

Home Inspection Report

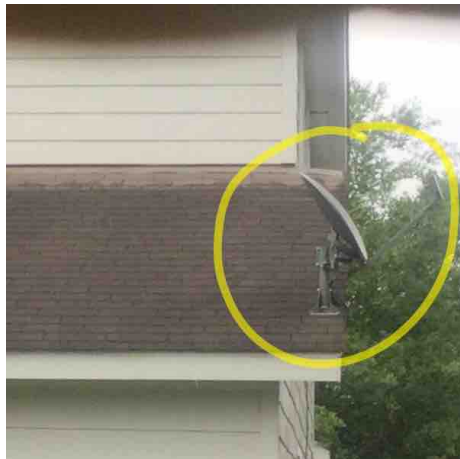
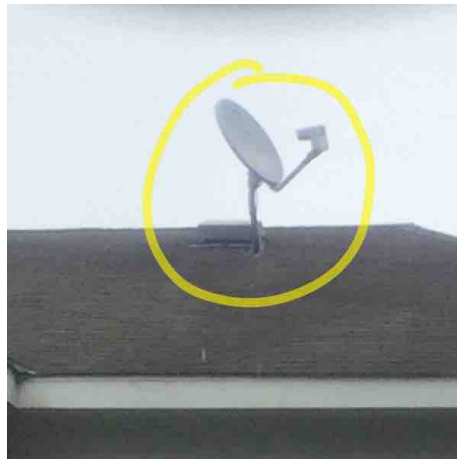
Observed 2 satellite dishes located at the back side slope of the home. Satellite dishes are not recommended to be installed on roofs as they are prone to leakage.

It is recommended and advised to have the dish removed and the roof repaired by a qualified roofing contractor to prevent future leaks.

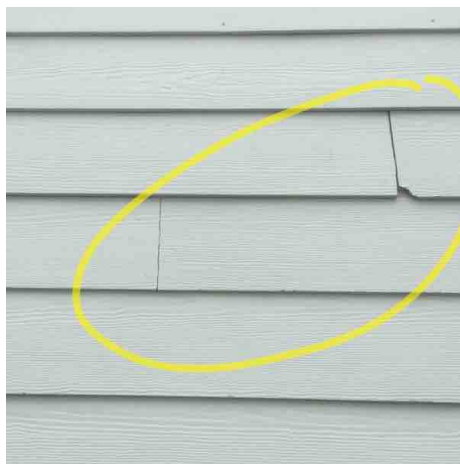
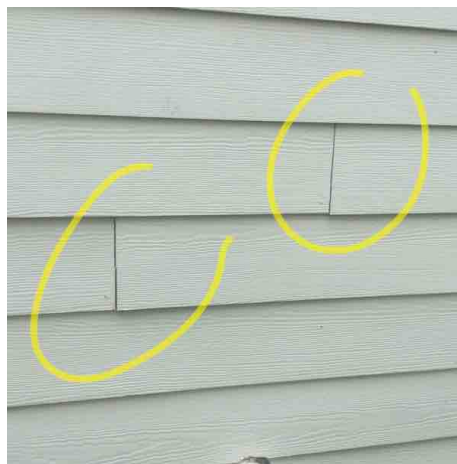
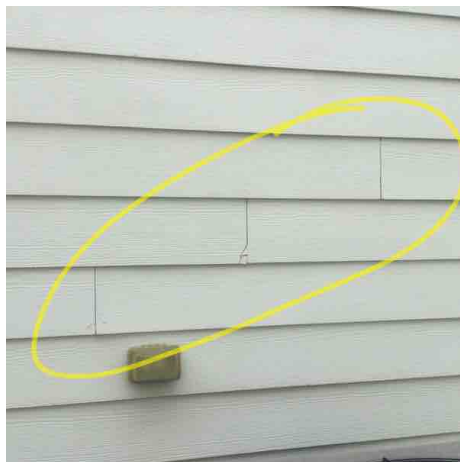
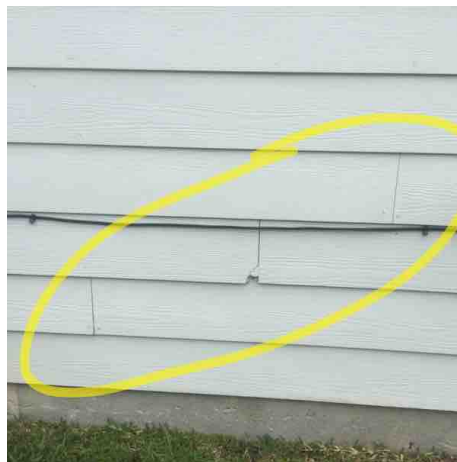
Observed separation and open gaps along the siding joints at various areas.

Repairs and corrections are recommended and advised to improve conditions.

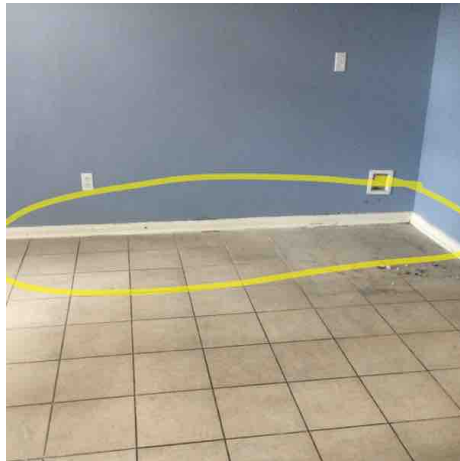
Observed damaged and rotted base board at the kitchen wall where refrigerator was located.

Repairs and corrections are recommended and advised by a qualified specialist.

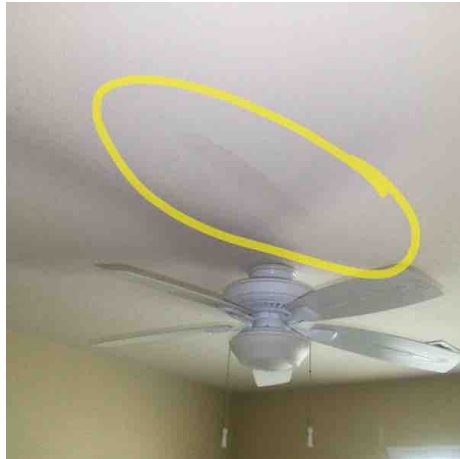
Observed stain at the back upstairs bedroom.

At the time of the inspection the stain did not appear to be active, but consulting with the seller or seller agent is recommended and advised.

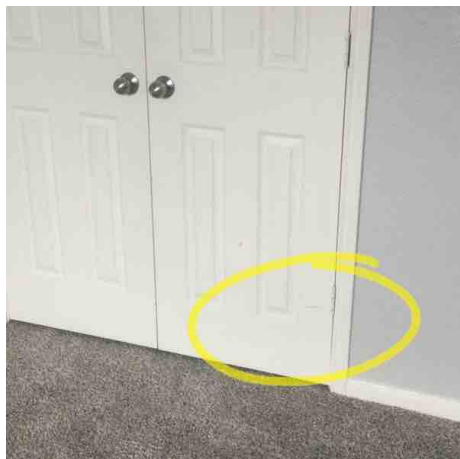
Observed damaged door at the back bedroom closet.

Repairs and corrections are recommended and advised.

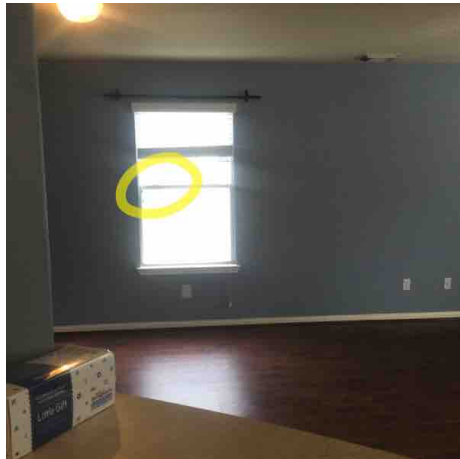
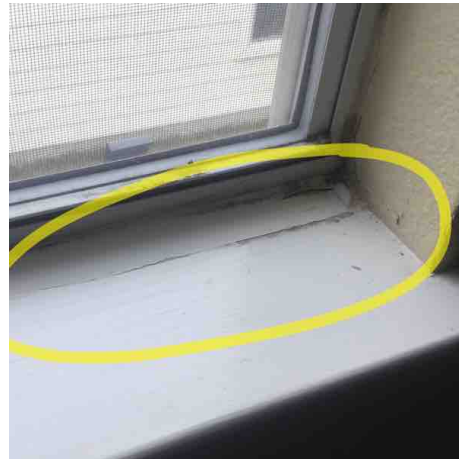
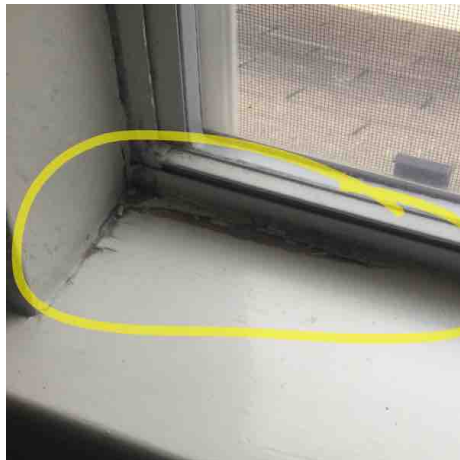
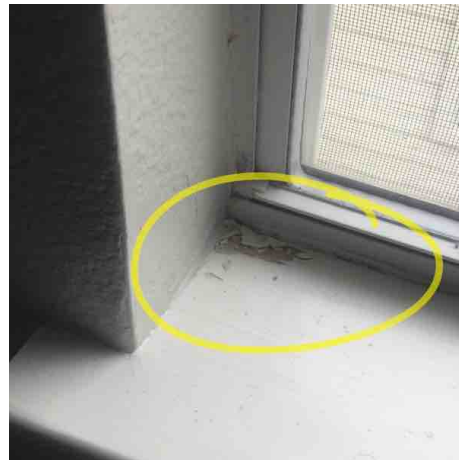
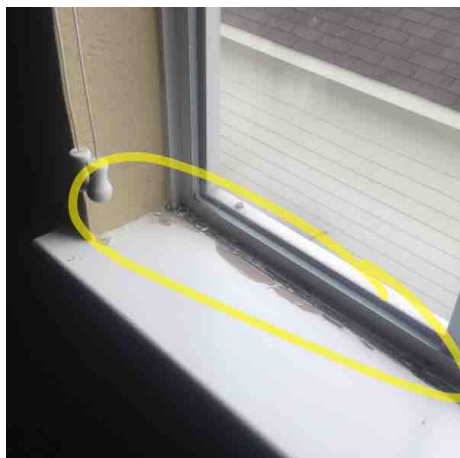
• The windows were double pane insulated glass units.
All windows operated as designed at the time of the inspection , but there was at least one that had a broken latch at living room.
Observed peeling paint at several window seats upstairs due to moisture intrusion.

Repainting, repairs, and corrections are recommended and advised.

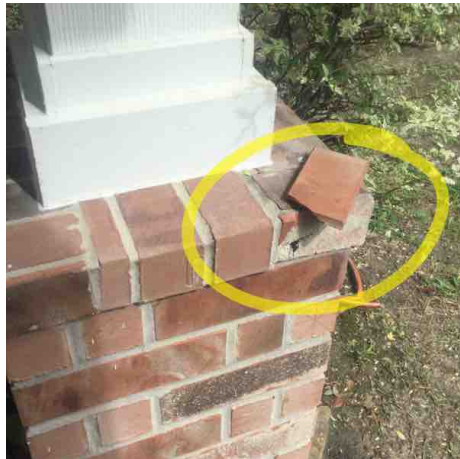
Observed broken and damaged brick veneer at the porch column.

Repairs and corrections are recommended and advised.

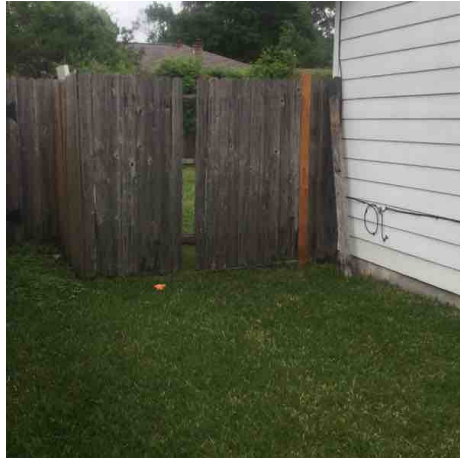
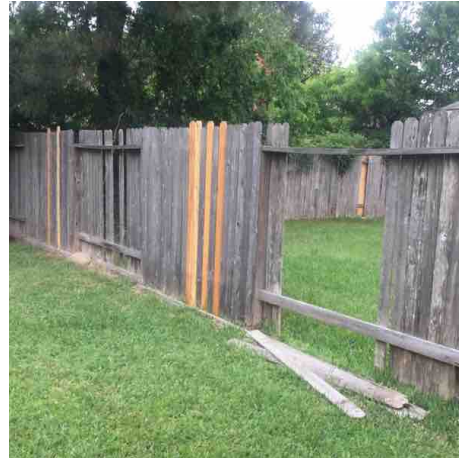
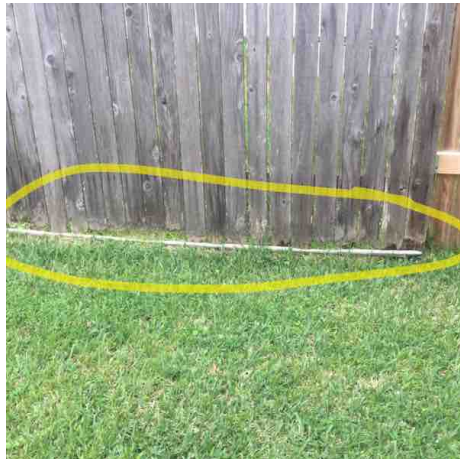
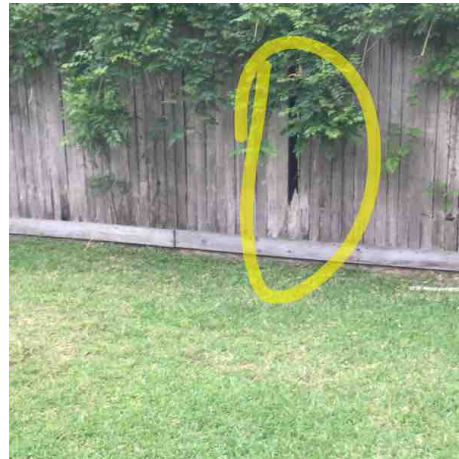
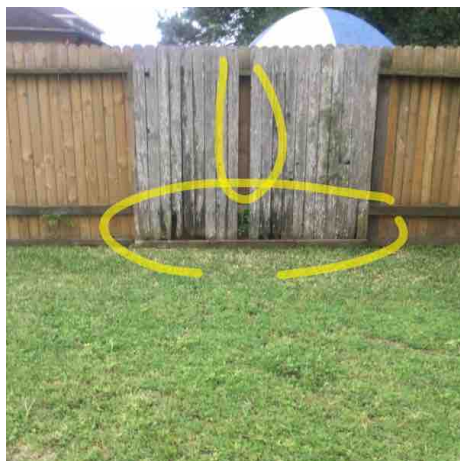
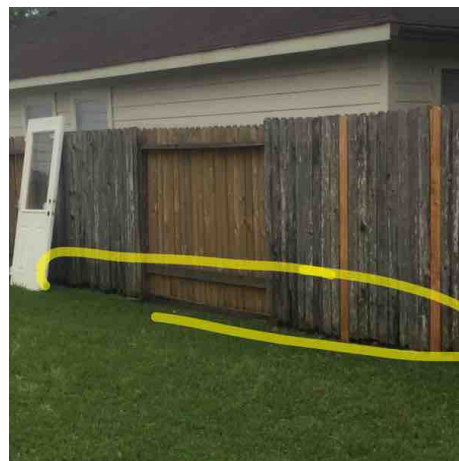
Observed damaged and missing fence boards at various areas.

Repairs and corrections are recommended and advised.

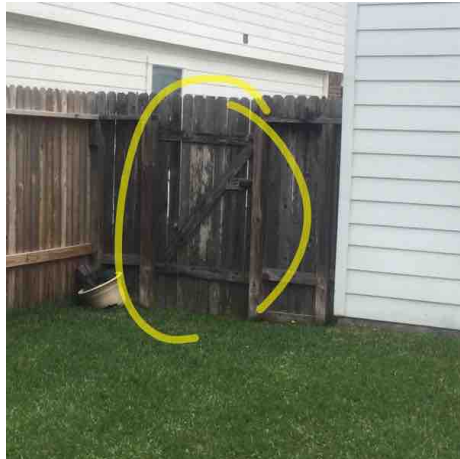
The gate was not opening correctly as it was hard to operate.

Repairs and corrections are recommended and advised.

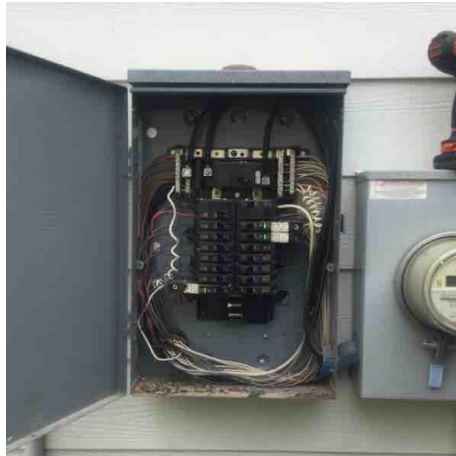
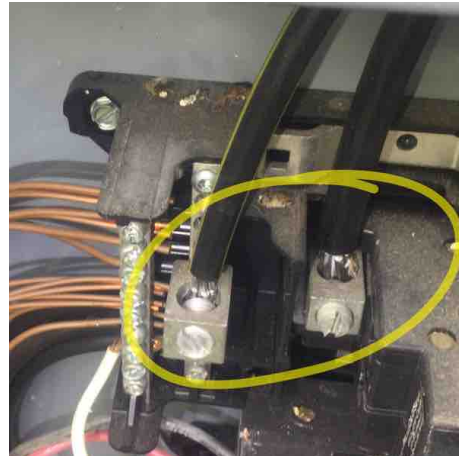
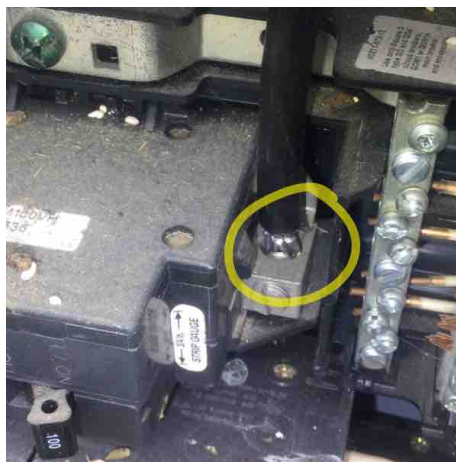
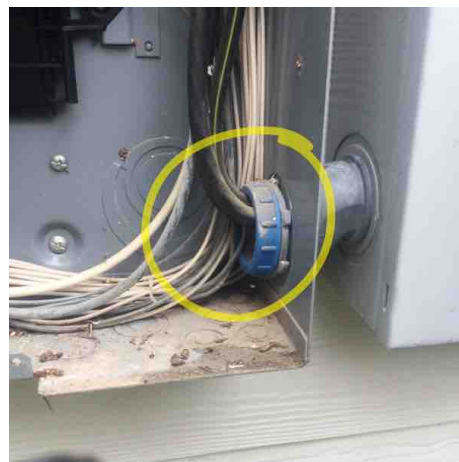
Observed missing bonding jumper clamp at the connector between the meter can and panel.

Observed missing anti oxidant material at the main lug terminals.

Repairs and corrections are recommended and advised by a licensed electrician.

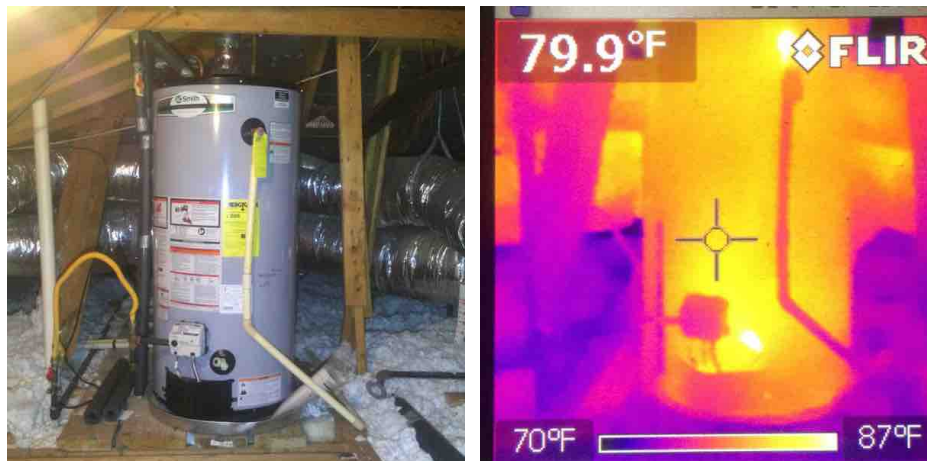
On the day of the inspection the water utility was not connected and so the water heater could not be inspected or tested.

Further evaluation by a licensed specialist is recommended and advised.

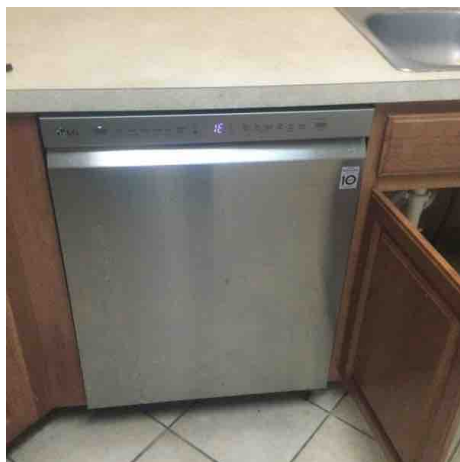
At the time of the inspection the water utility was not connected and so the dishwasher could not be tested or properly inspected.

Further evaluation by a qualified appliance specialist is recommended and advised.

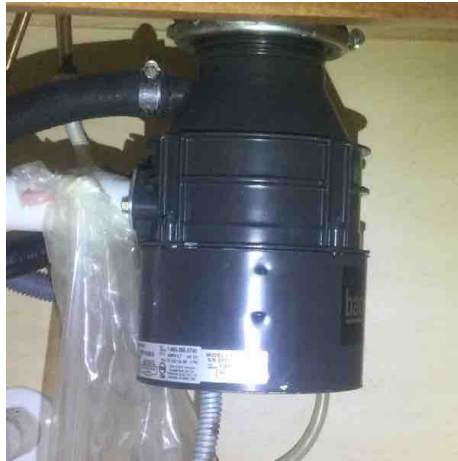
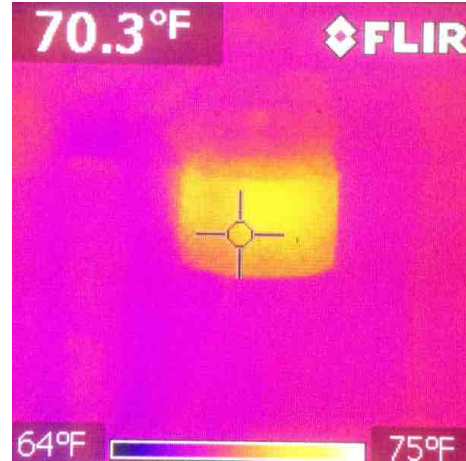
At the time of the inspection the unit was functioning but was making loud excessive noise.

Further evaluation and corrections by a qualified appliance specialist is recommended and advised.
