## Web Presentation

**Property Address:** 2025 Avenue M, Galveston, TX

**Spot On Inspection, PLLC**

# Safety Deficiencies

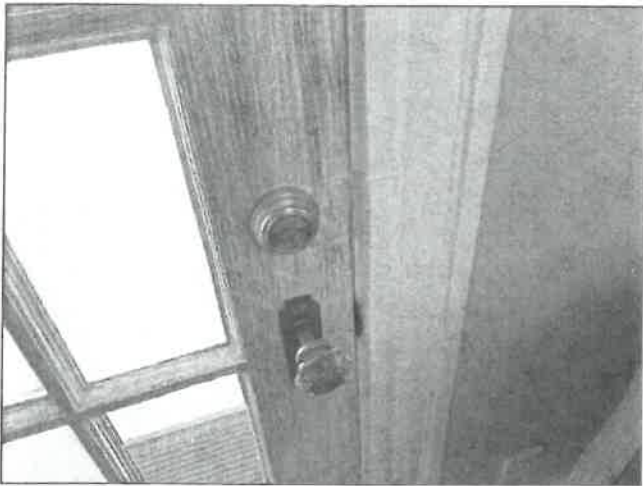
G. Item 1(Picture)

The Front entry door has a double cylinder deadbolt lock (Requires a key on the inside to open). This is an emergency egress issue. A qualified contractor should be consulted for replacement with an interior thumb turn.

*owner did not want interior thumb turn hook because glass door*

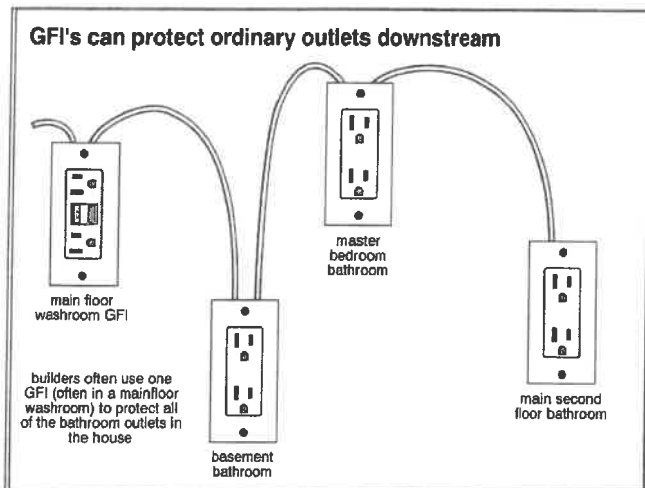
B. Item 1(Picture)

(1) Two plug receptacle(s) in the north apartment kitchen (plug receptacles serving counter space only) are not Ground Fault Circuit Interrupter (GFCI) protected. This is a safety concern. The purpose of GFCI is as a safety device designed to protect humans from electrocution hazards at any place where they are likely to be in prolonged direct contact with electrical devices, especially those devices with motors. They also protect from electrocution hazards near open water receptacles such as sinks, tubs and pools. A licensed electrician should be consulted for installation of appropriate GFCI protection in all kitchen, bathroom, garage, pool area and exterior plug receptacle locations.

*seller installing*

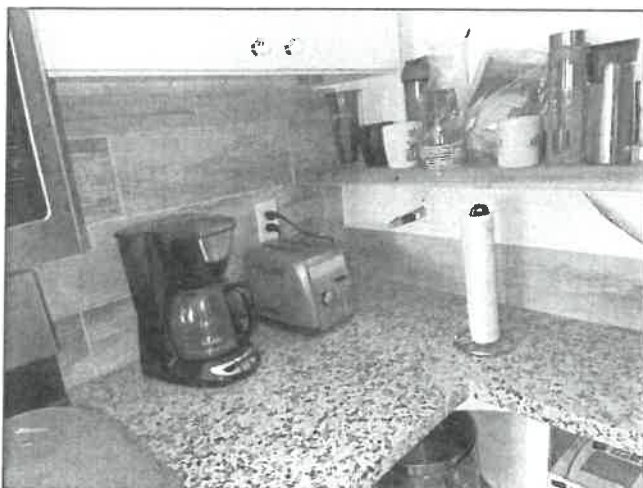
B. Item 3(Picture)

*GFCI replaced by owner*

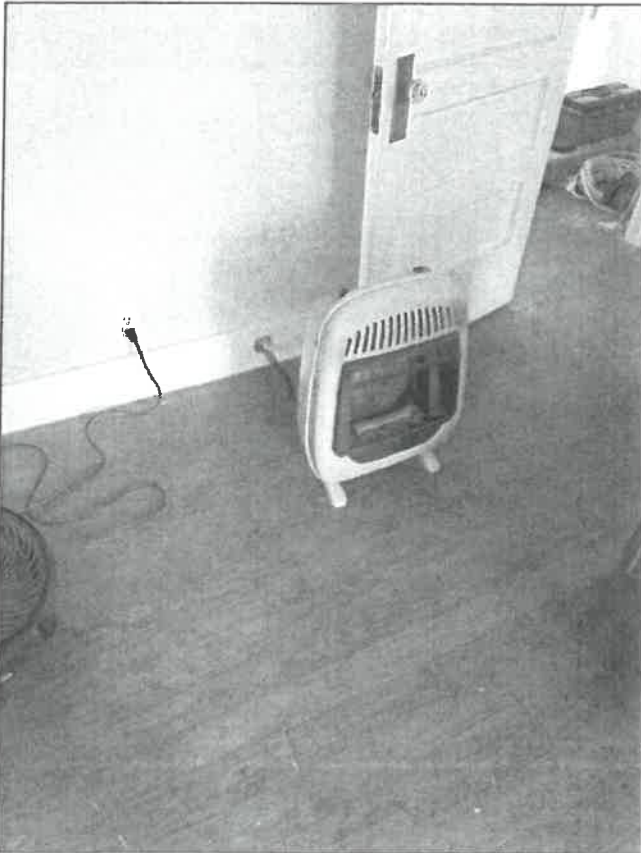
A. Item 2(Picture)

(2) South apartment heating sources were not inspected. These are unventilated natural gas devices not meeting current safety requirements. I recommend removal.

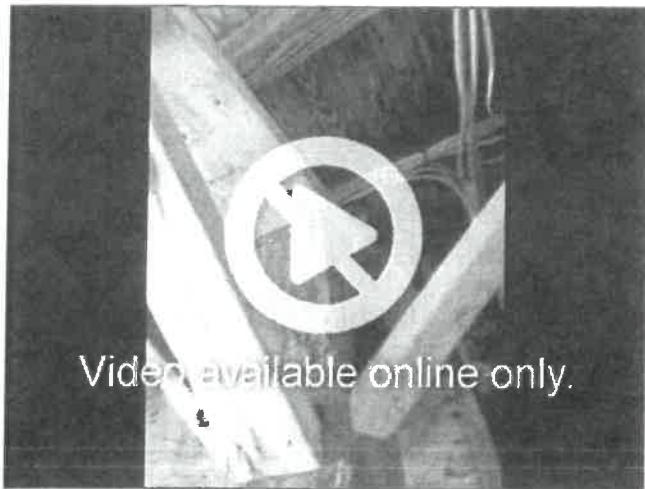
A. Item 1(Video)

(1) It is the opinion of this inspector that the adequate performance of garage apartments foundation cannot be determined via one time inspection. There are multiple indications of prior structural movement present. The lower half of the north wall is leaning approximately 16 degrees at the Northwest corner. This lean extends across the entire length of this wall. There are extensive structural repairs. These repairs are not in accordance with industry standard practices and may not be sufficient to prevent further structural movement.

see engineer reports  
2012  
2014  
2021

The foundation should be evaluated by a qualified structural engineer with experience with this type of foundation system.

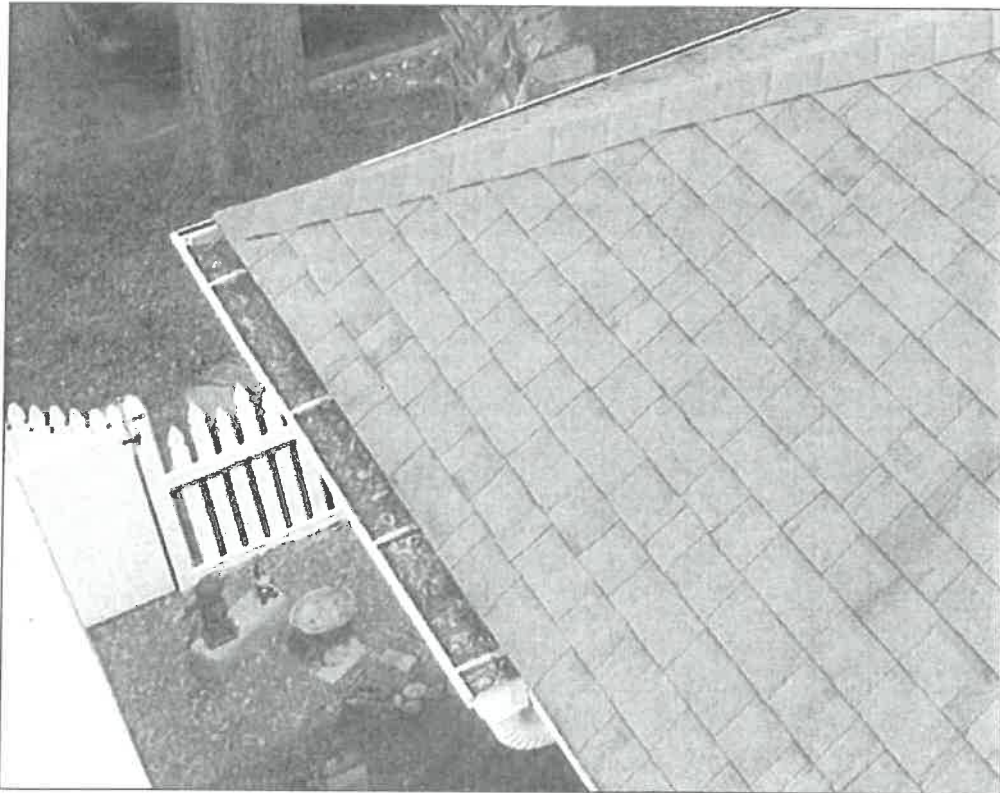
B. Item 4(Picture)

(3) The gutters are full of debris in areas. The debris in gutters can also conceal rust, deterioration or leaks. Debris in gutters prevents proper water flow and may allow moisture intrusion into the structure. A qualified contractor should be consulted for correction.

*gutters will be cleaned by owner*

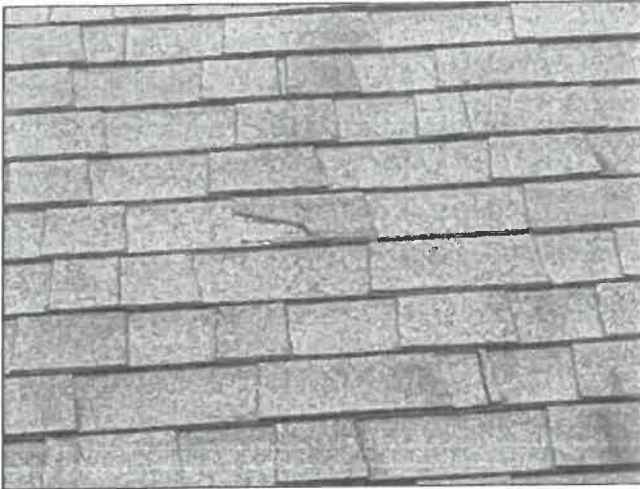
C. Item 1(Picture)

(1) The roof covering has damaged and missing shingles on the west and south roof slope(s). A qualified contractor should be consulted for correction.

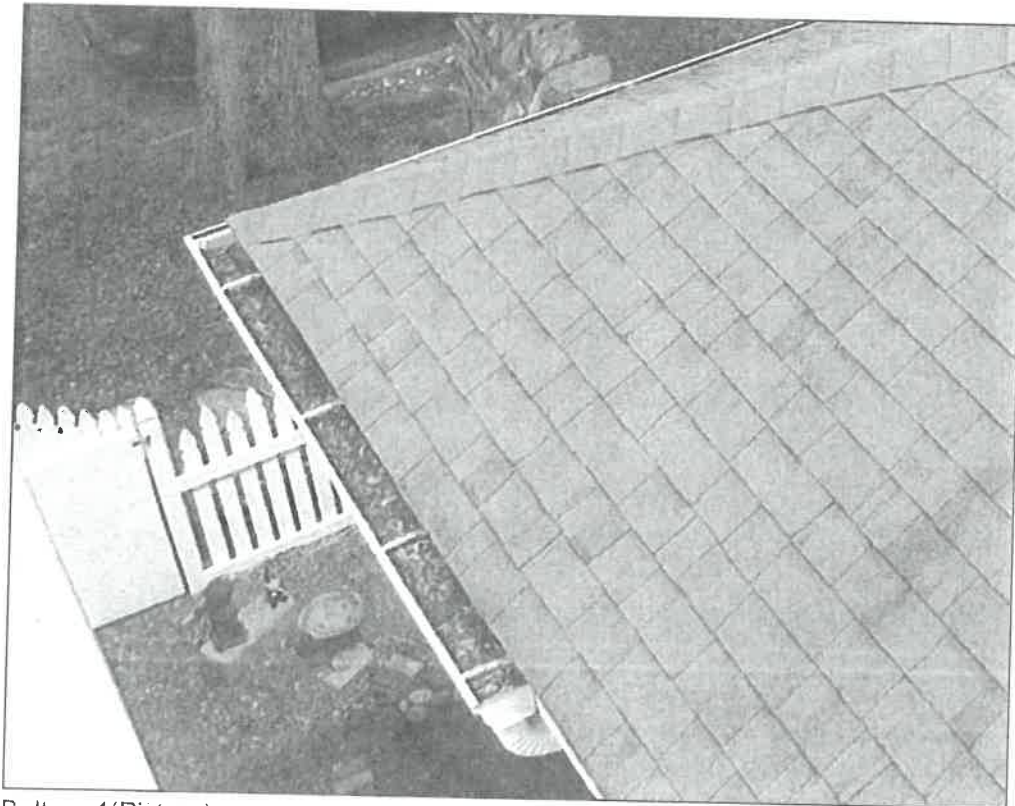
B. Item 4(Picture)

✘ (3) The gutters are full of debris in areas. The debris in gutters can also conceal rust, deterioration or leaks. Debris in gutters prevents proper water flow and may allow moisture intrusion into the structure. A qualified contractor should be consulted for correction.

gutters will be cleaned by owner

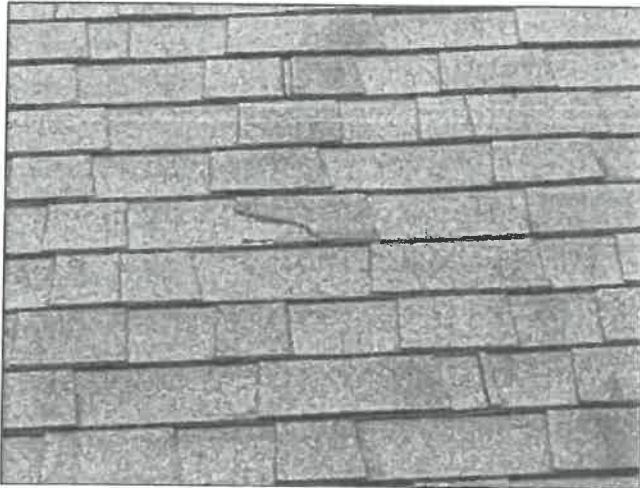
C. Item 1(Picture)

**X** (1) The roof covering has damaged and missing shingles on the west and south roof slope(s). A qualified contractor should be consulted for correction..

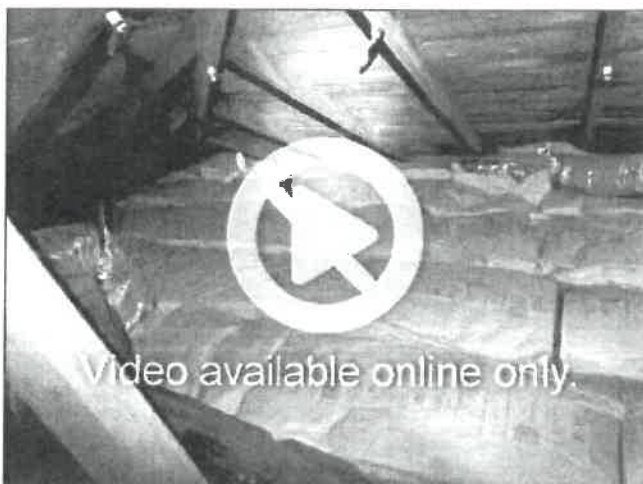
D. Item 1(Video)

**X** (1) The attic does not have adequate insulation. The attic should be insulated to R-30 or better. Insulation should cover all attic joists and wall studs adjacent to interior spaces to prevent thermal bridging. A qualified contractor should be consulted for correction.

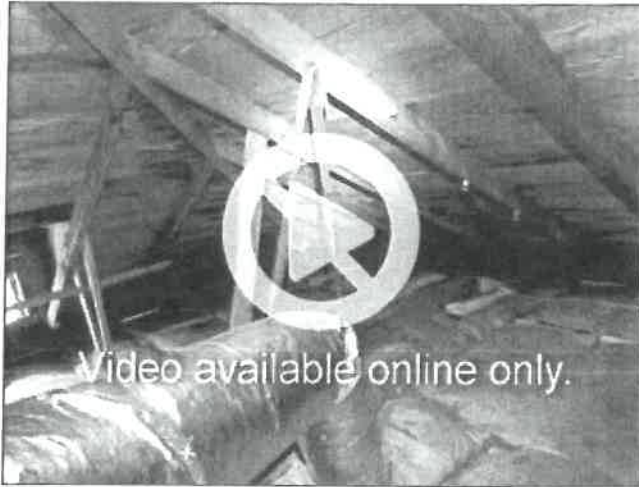
D. Item 2 (Video)

**X** (2) Rafter bracing may not be adequate. I recommend the installation of a purlin brace at the mid span of the rafter on each side of the attic.

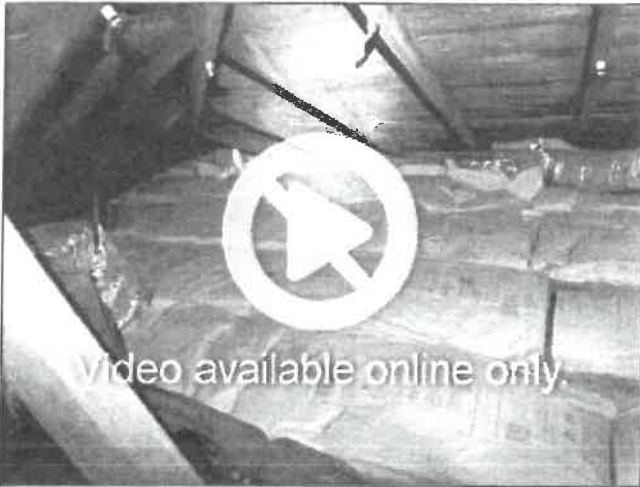
*bracing is to code*

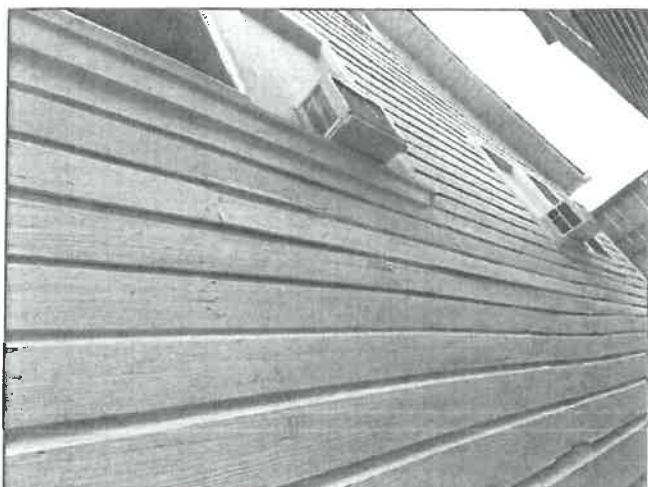
E. Item 4(Picture)

(2) There are multiple examples of wood exterior siding and trim products in poor condition on all sides of both structures. Deteriorated finish is causing moisture intrusion damage in multiple areas. A qualified contractor should

be consulted for correction.

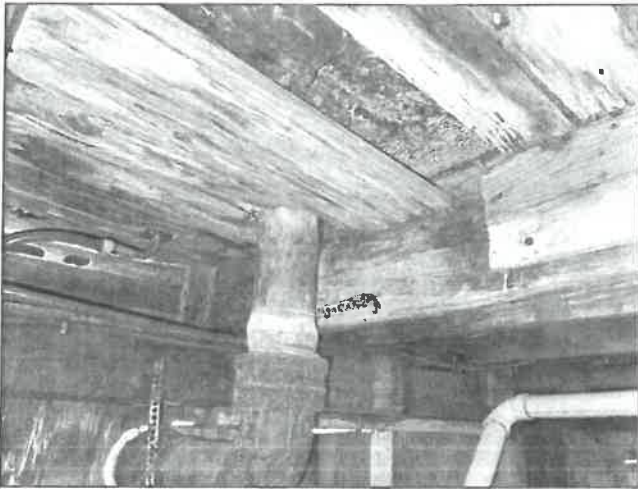
F. Item 1(Picture)

(2) There are areas of moisture intrusion damage in the subfloor and crawlspace skirting of the primary structure. A qualified contractor should be consulted for correction of all damaged areas. I recommend removal of all wood siding and trim products within 8 inches of the grade level and repair of all damaged structural components

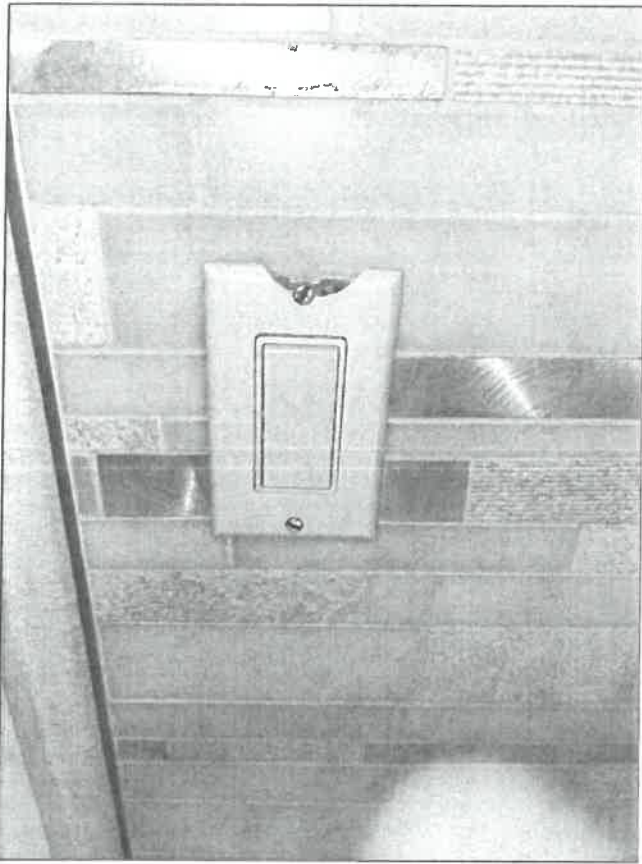
(5) The switch outlet has a damaged wall cover plate in the primary kitchen. A qualified contractor should be consulted for correction.

*seller to replace*

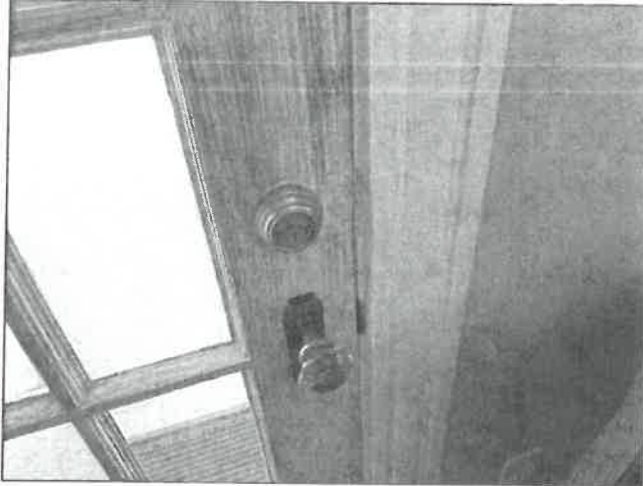
G. Item 1(Picture)

The Front entry door has a double cylinder deadbolt lock (Requires a key on the inside to open). This is an emergency egress issue. A qualified contractor should be consulted for replacement with an interior thumb turn.

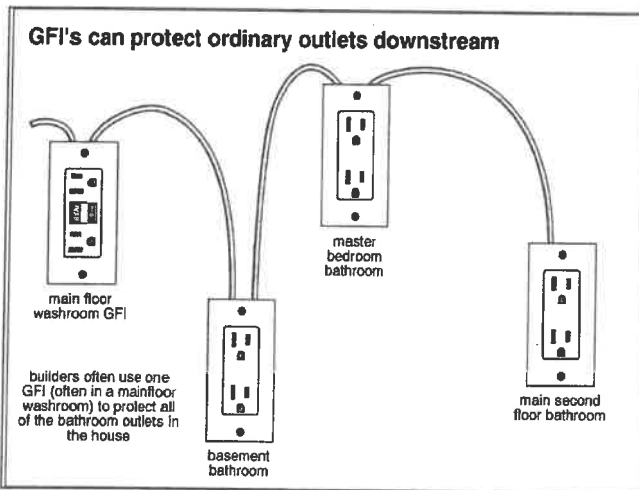
B. Item 1(Picture)

**+** (1) Two plug receptacle(s) in the north apartment kitchen (plug receptacles serving counter space only) are not Ground Fault Circuit Interrupter (GFCI) protected. This is a safety concern. The purpose of GFCI is as a safety device designed to protect humans from electrocution hazards at any place where they are likely to be in prolonged direct contact with electrical devices, especially those devices with motors. They also protect from electrocution hazards near open water receptacles such as sinks, tubs and pools. A licensed electrician should be consulted for installation of appropriate GFCI protection in all kitchen, bathroom, garage, pool area and exterior plug receptacle locations.

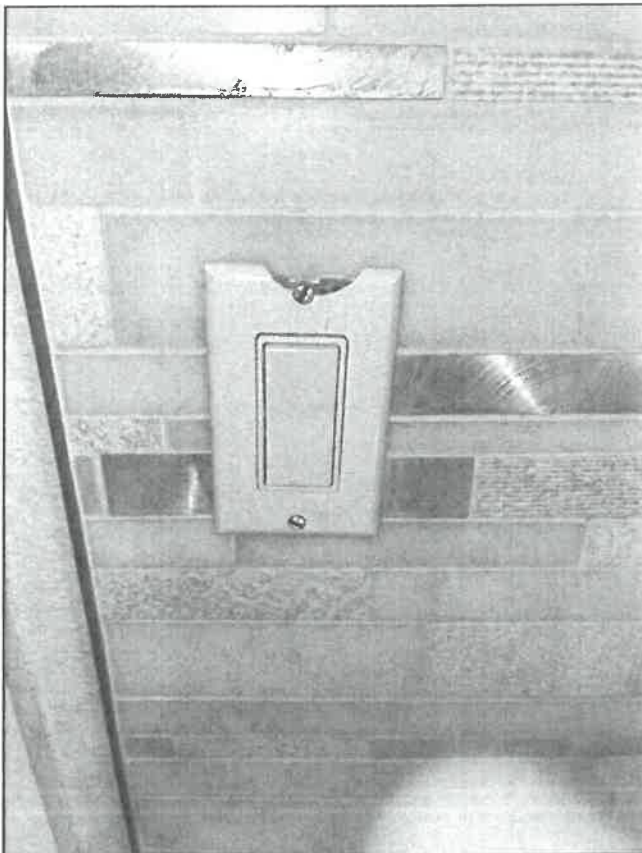
B. Item 14(Picture)

**X** (5) The switch outlet has a damaged wall cover plate in the primary kitchen. A qualified contractor should be consulted for correction.

5/2/12 to replace

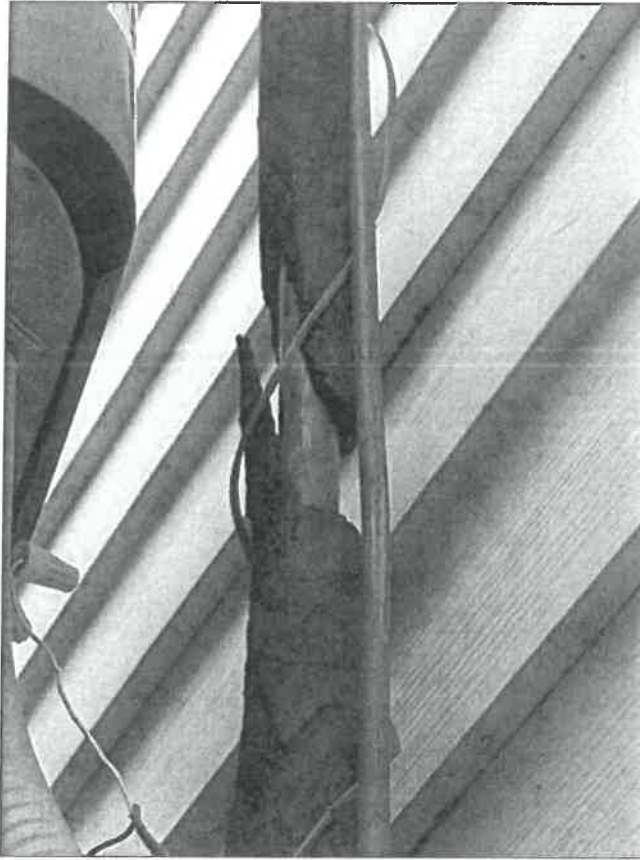
B. Item 1(Picture)

~~X~~ (1) Air-conditioner refrigerant line insulation is deteriorated for the primary structure. A qualified contractor should be consulted for correction.

*Seller to replace 98*

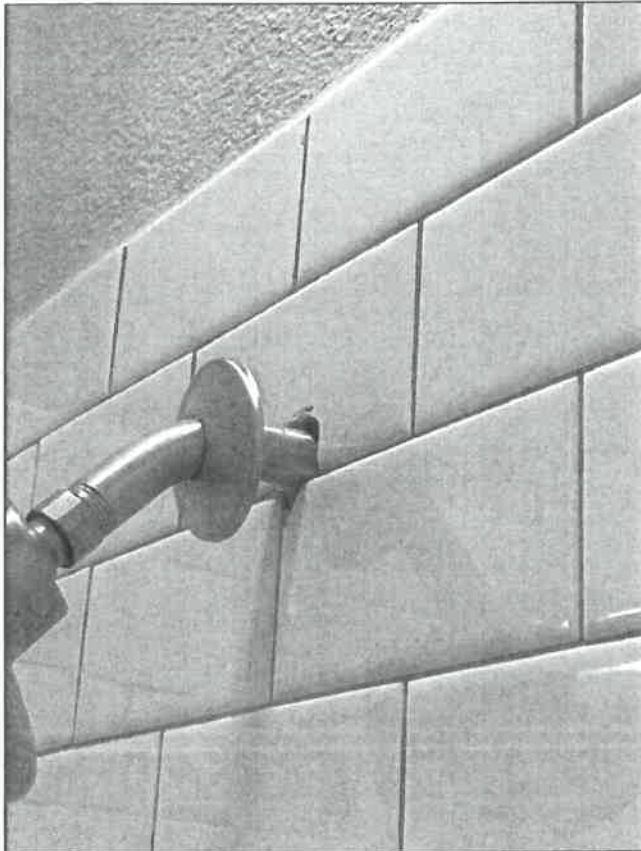
A. Item 1(Picture)

**X** (1) Master shower escutcheon is not properly secured. This may result in moisture intrusion into the structure.

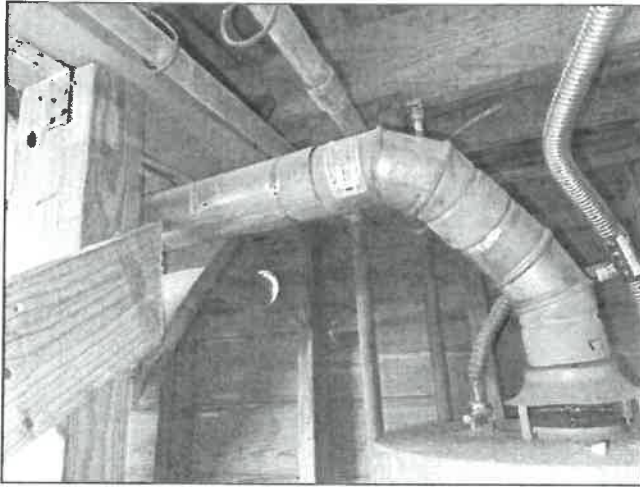
C. Item 1(Picture)

(1) Water heater exhaust flue is not properly installed. This may result in carbon monoxide infiltration into the structure and is a serious health hazard. A qualified plumber should be consulted for correction.
