PREMIUM INSPECTIONS

14 N Hutcheson St, Houston, TX 77003

Date of Inspection: 6/8/2018 Time: 9:00 AM

Property Inspection Report

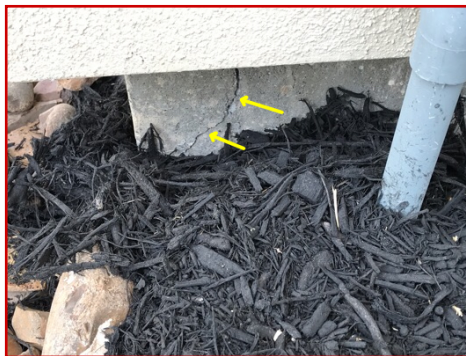
—A corner crack / spalling was observed. This is quite typical in all houses due to the fact it is difficult to reinforce that area. There is no reason for concern and there is no foundation issue causing it. This should be patched or repaired.

Corner crack

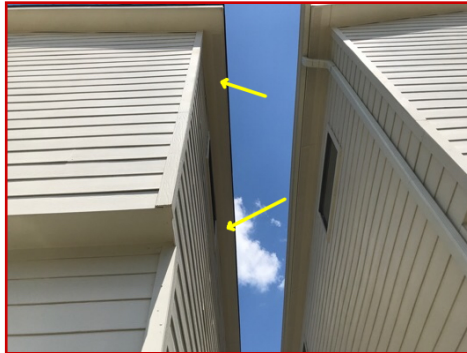
- The home had no roof drainage system to channel roof drainage away from the foundation. The Inspector recommends installation of a roof drainage system to help protect the home structure and occupants.

No gutters

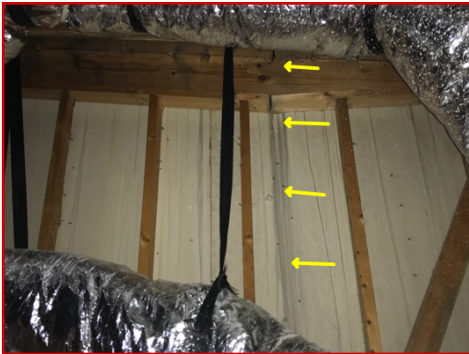
Apparent moisture intrusion

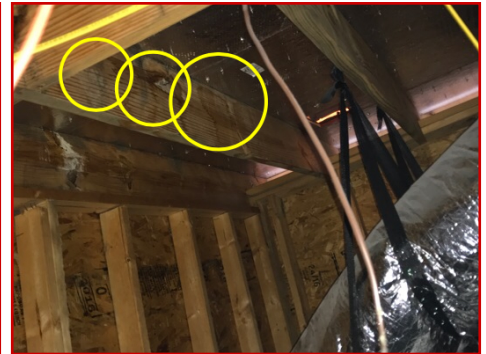
Signs of moisture intrusion

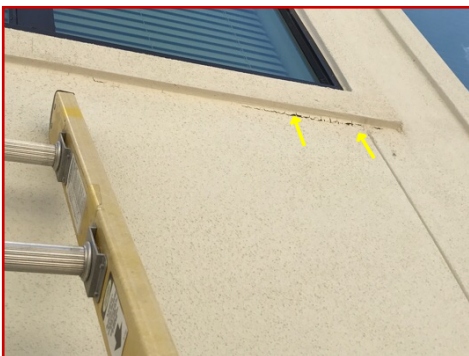
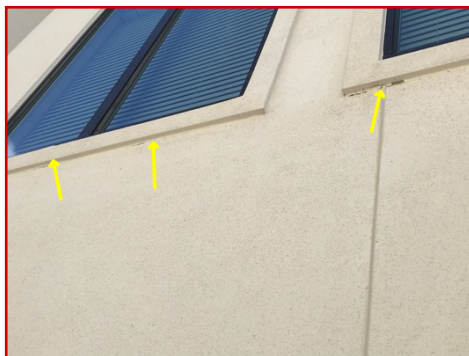
• The home had areas of cracked broken sealant below one of more windows in the stucco area. The Inspector recommends application of an appropriate sealant at these areas to help prevent damage from moisture intrusion to the home materials, the exterior wall structure. All work should be performed by a qualified contractor.

Cracked sealant

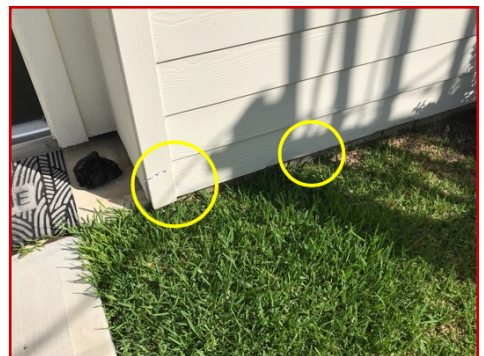
• The Hardy Board siding covering exterior walls had damage visible. This damage should be repaired to help prevent damage from moisture intrusion to the home materials, the exterior wall structure and to prevent development of microbial growth such as mold. All work should be performed by a qualified contractor. Because of the age of the siding, finding matching siding material may be difficult. The Inspector recommends that before the expiration of your Inspection Objection Deadline you consult with a qualified contractor to gain an idea of options and costs for repair or replacement.

Damaged siding

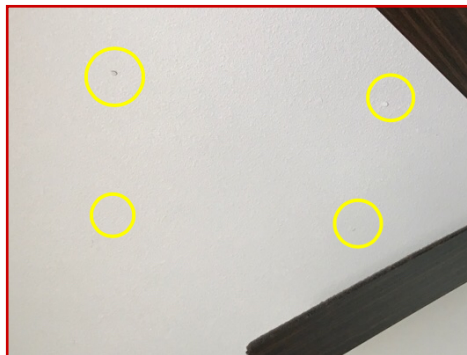
- **Protruding nail heads visible in ceilings appeared to be the result of framing members shrinking after original construction was complete. Framing lumber is often installed with a relatively high moisture content and typically shrinks as it dries. Once framing has reached moisture equilibrium with the homesite environment, framing will become stable and nail pops can be repaired without concern that they will reappear. The time required to reach stability depends on the moisture content of framing materials at the time of original construction and humidity levels at the homesite. The time frame may vary between one and two years in many environments. The Inspector recommends repair by a qualified drywall or painting contractor once the condition appears stable.**

Nail pops in downstairs office

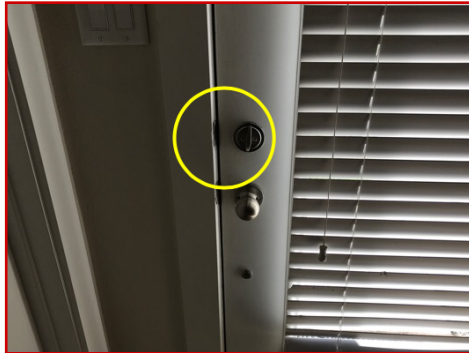
- At the time of the inspection, the Inspector observed few deficiencies in the condition of exterior doors. Notable exceptions will be listed in this report.
- At the time of the inspection, the Inspector observed no deficiencies in the condition of the interior doors.
- **Entry door rattled while closed and would benefit from having the strike plate trim tabs adjusted. The Inspector recommends adjustment by a qualified contractor.**

Main entry door rattles when closed

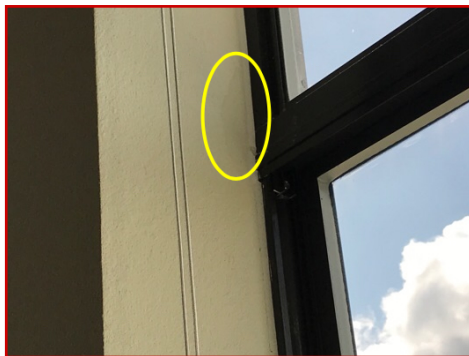
• A Window frame in the down stairs bedroom exhibited minor damage that appeared to be from moisture intrusion. Sealant around the window exteriors should be maintained to avoid continuing damage.

Signs of past moisture intrusion in down stairs bedroom window

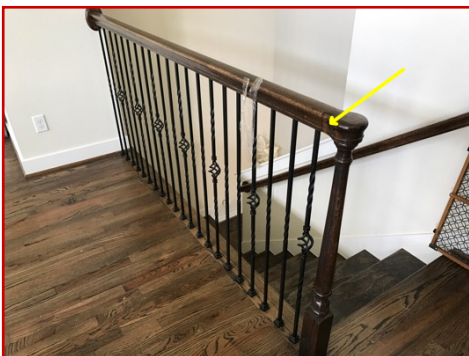
• The horizontal guardrail assembly at an interior walkway had loose balusters that for safety reasons should be securely fastened by a qualified contractor.

Banister is loose

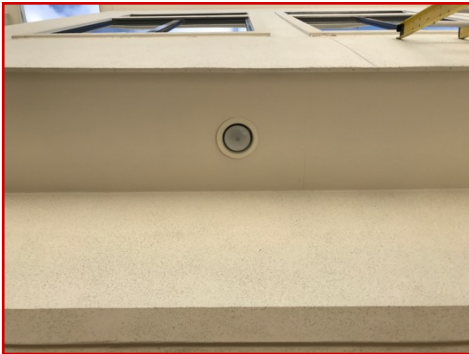
- One or more lights are inoperative. If the bulbs are not blown, then the circuit should be investigated.

Exterior garage light did not respond

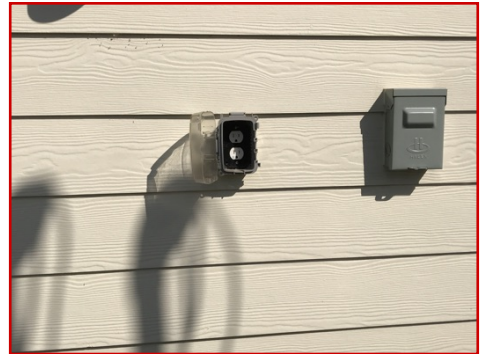
AC outlet, weather protected, no GFCI

The Inspector recommends updating the existing exterior electrical circuits to include GFCI protection.

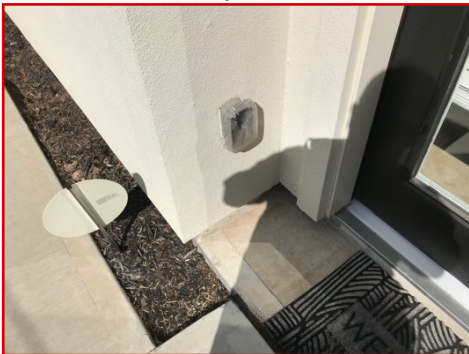
No GFCI

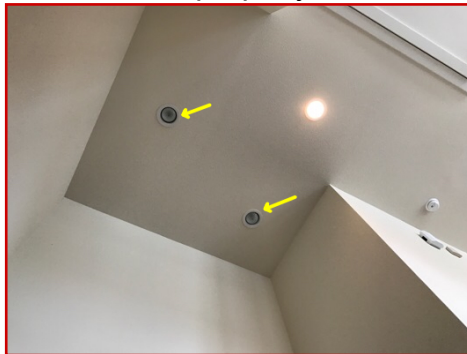
Unresponsive light fixtures

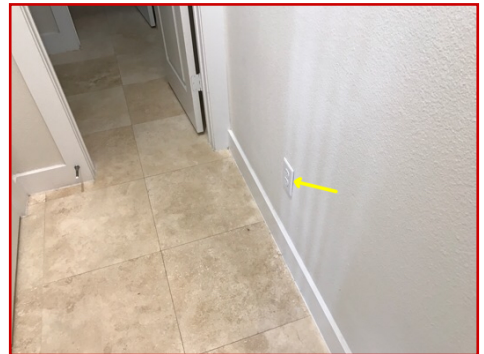
- Electrical receptacles at various areas in the home were improperly secured and moved when plugs were inserted. Receptacles should be securely installed to prevent fire, shock and/or electrocution hazard. Loose outlets should be corrected by a qualified electrical contractor.

Loose outlet by downstairs bathroom

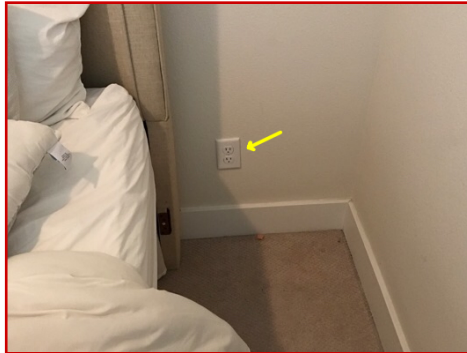
Loose outlet in downstairs bedroom

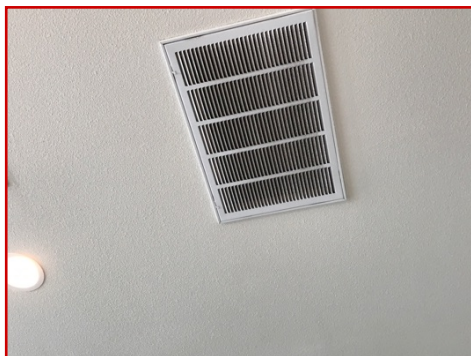
- Reduced indoor air quality.
 - Increased resistance resulting in the filter being sucked into the blower. This condition can be a potential fire hazard.

- Frost build-up on air-conditioner evaporator coils, resulting in reduced cooling efficiency and possible damage.
 - Reduced air flow through the home.

Upstairs return, dirty filter

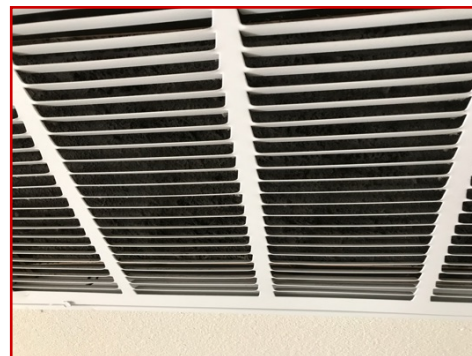
Downstairs return, very dirty filter

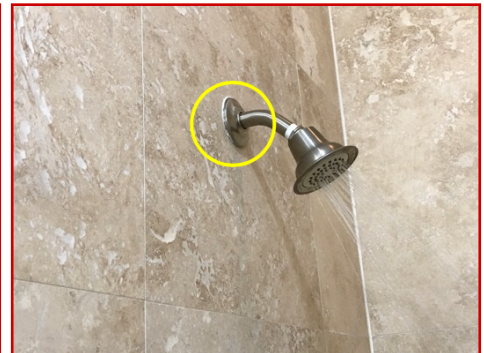
Shower head in master is loose at wall connection

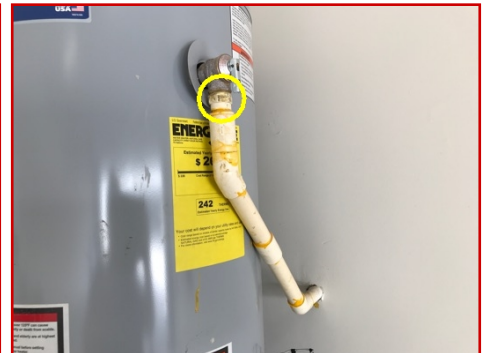
TPR valve coupler is wrong material

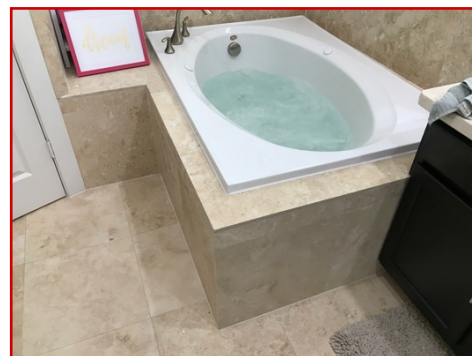
- The whirlpool bathtub and all its components are mostly in satisfactory condition. This item is performing its intended function at the time of the inspection.
- No hatch was provided for access to the pump for the whirlpool tub. A hatch should be provided to allow for inspection, service and repair of tub, pump and electrical equipment.

No access to motor

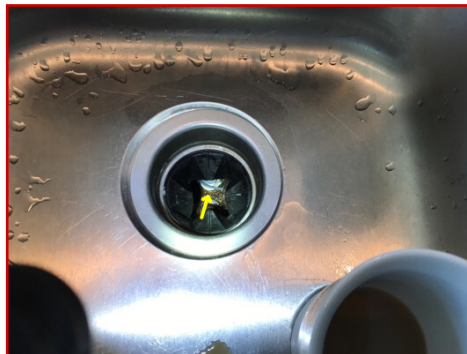
- At the time of the inspection, the Inspector observed few deficiencies in the condition and operation of the garbage disposal. Notable exceptions will be listed in this report.
- There is foreign material present in the garbage disposer and should be cleaned out before use to avoid damage or injury.

Foreign material in disposal

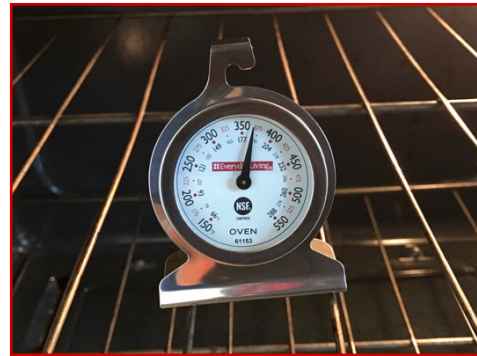
Oven set to 350 degrees, after 20 min oven is within specs, it would still benefit from adjustment

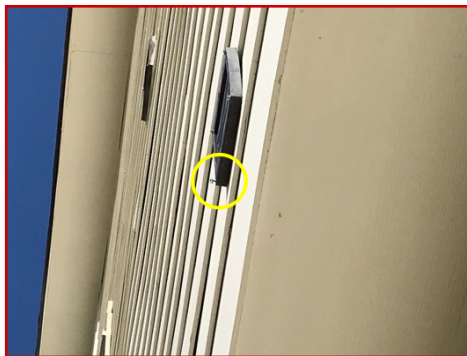
- All bathroom exhaust fans, heaters, and vent piping appeared functional and in mostly satisfactory condition, at time of inspection. This item is performing its intended function. Buyer is advised that no warranty is offered on this or any other appliance, as outlined in Inspection Agreement.
- One of more exterior bath vent covers has screws pulling out. Recommend these be properly secured to ensure a correct seal. Any corrections should be made by a qualified professional.

Loose fastener on bath fan cover
