Inspection Report

Property Address:
1504 Veranda Mist Dr.
League City TX 77573

PROPERTY INSPECTION REPORT

By: Adam Wells TREC License # 21140 / Bryan & Bryan Inspections 10/18/2017
(Name and License Number of Inspector) (Date)

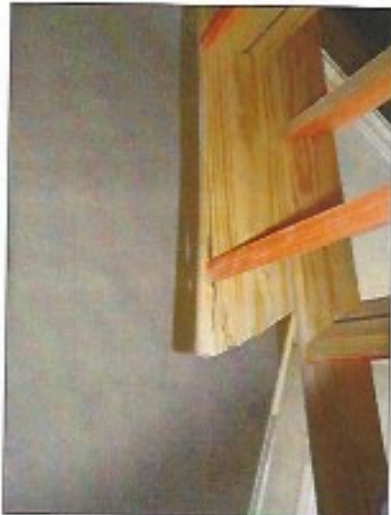
(2) The bottom of the attic ladder is damaged on both sides. Remedy as needed.

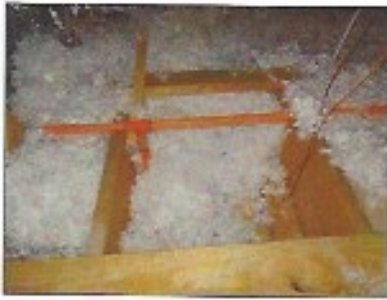
(3) Noted gaps in the insulation at the top of the attic stairs to the right. This may reduce the R value of the insulation system.

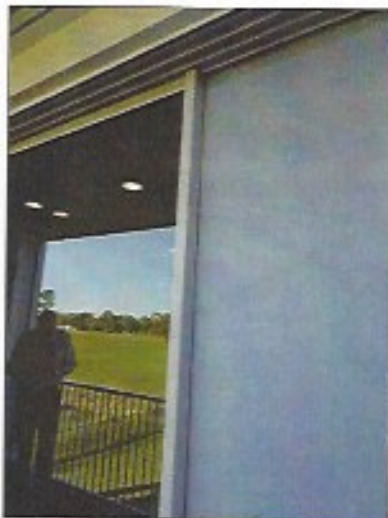
(3) The sliding glass door on the second floor balcony binds on the siding as it opens. Evaluate and remedy as needed.

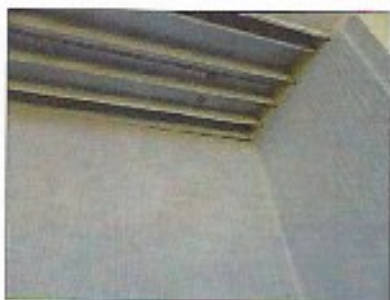
(4) Caulk/seal gaps at siding panels on the back side of the home at the second floor balcony.

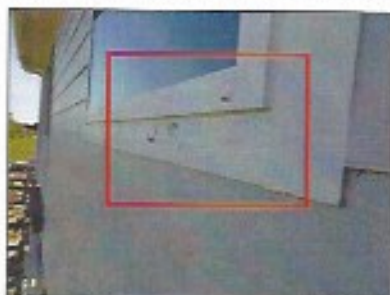
(5) Missing paint was observed at window trim on the back side of the home. Remedy as needed.

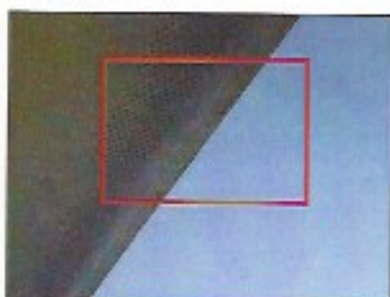
(6) Damaged fascia board was observed on the back side of the home above the third story balcony. Remedy as needed.

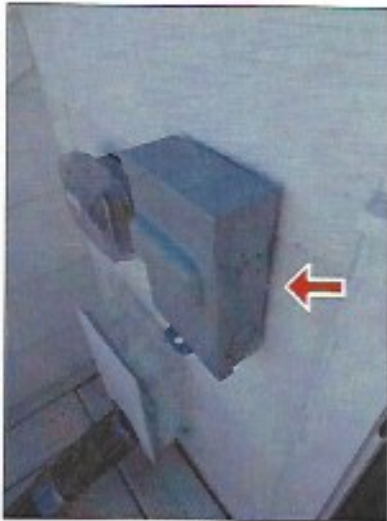
(7) Ensure A/C disconnect box(s) is (are) properly secured and sealed (caulked) to the wall to prevent water/air infiltration.

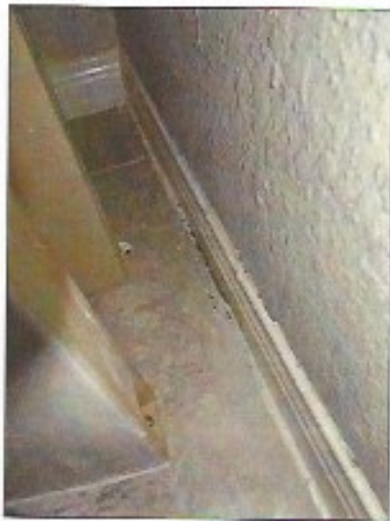
Grout is missing behind the pedestal sink in the 1/2 bathroom.

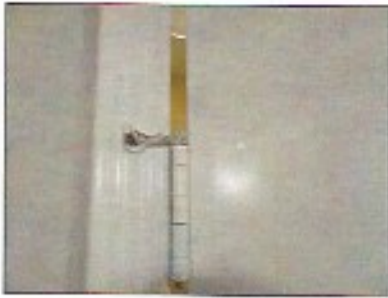
(1) Door stop for the upstairs front left bedroom is not installed properly and has damaged the door.

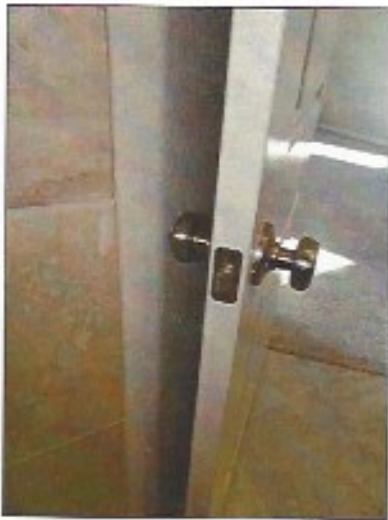
(2) Door stops are missing/need adjustment to prevent doors from hitting other interior components.
Location(s): Multiple locations.

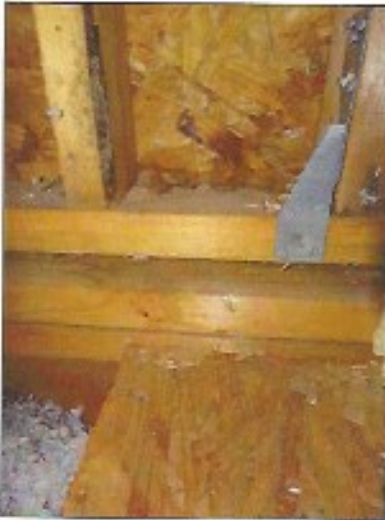
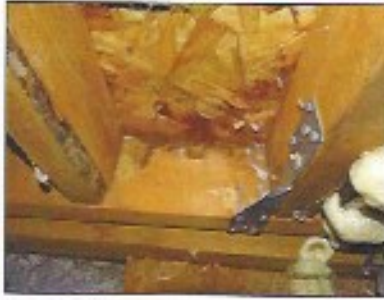
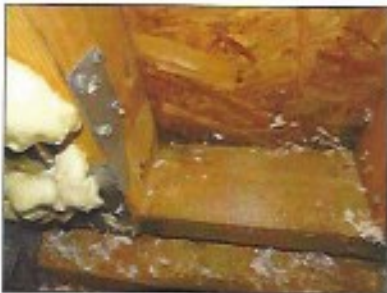
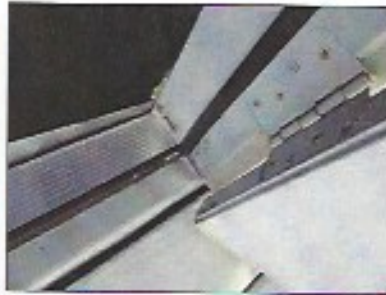
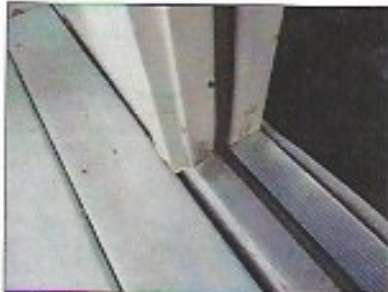
(3) Moisture intrusion was noted at the roof access door in the attic. Evaluation by a qualified contractor is recommended to determine the best method of remedy.

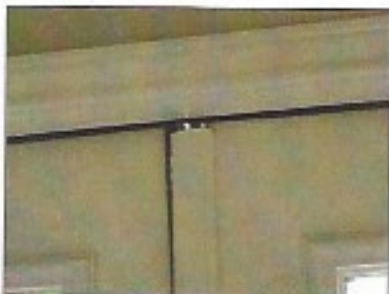
(4) A large gap was noted at the French doors at the front of the second floor patio. Evaluate and remedy as needed.

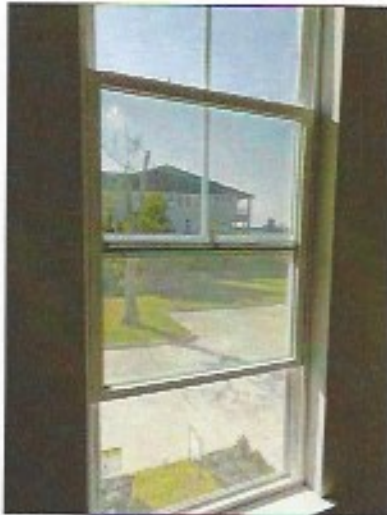
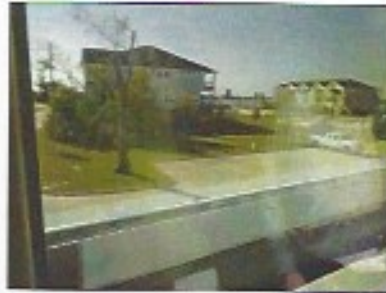
Location(s): Areas include, but are not limited to; Den/Study on 2nd Floor

There is evidence of thermal seal failure. Failed thermal window seals may not all be visible at the time of the inspection due to several factors which include; recent seal failure (which may not reveal signs of failure), the time of day of the inspection as well as the low humidity levels which reduces the chance of condensation build-up inside the window (which reveals a failed thermal seal). Evaluate all windows and remedy as needed.

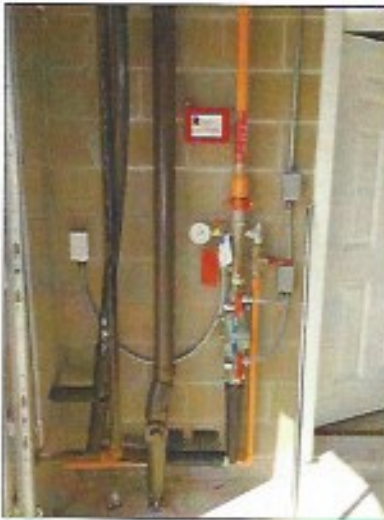
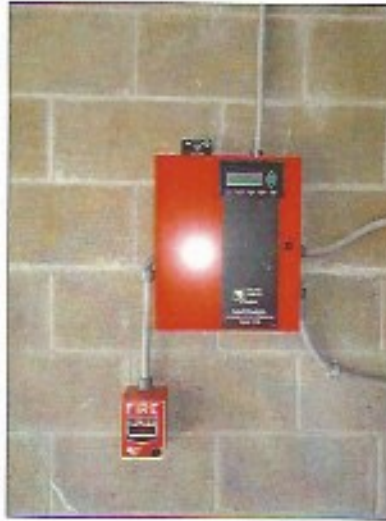
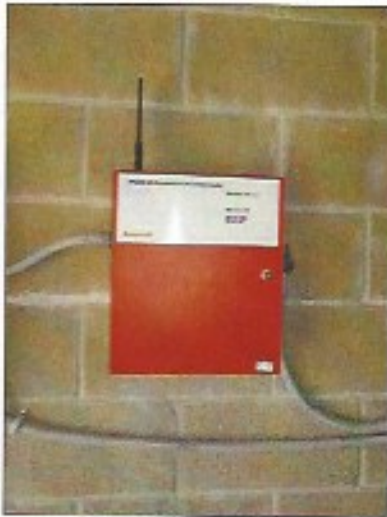
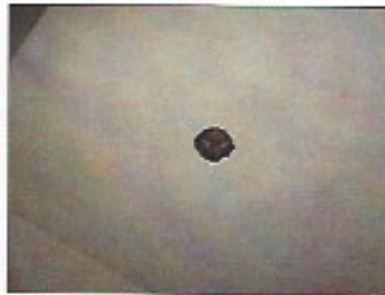
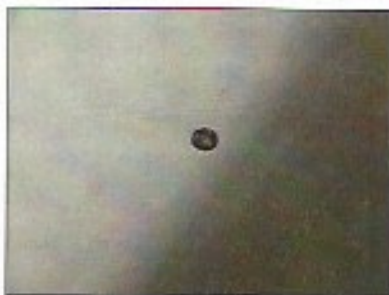
(1) **Note:** Fire suppression systems are not inspected. Missing suppression head covers were observed on the first floor/garage area. If further evaluation is desired, consult with a qualified contractor.

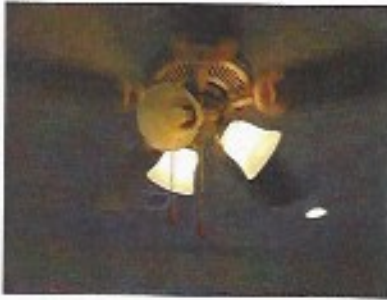
(2) Lights are not functioning. This may be a result of a bad bulb: test with new bulb and remedy if needed.
Location(s): Front Entry, Living Room Fan

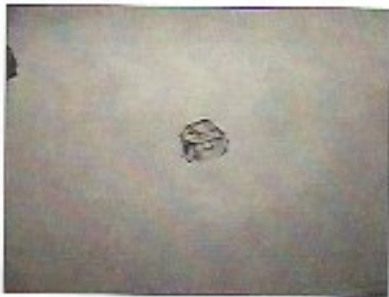
(3) Missing light fixture was observed. Recommend installation of a light and/or removal of wires.
Location(s): Under stairs closet on the first floor/garage.

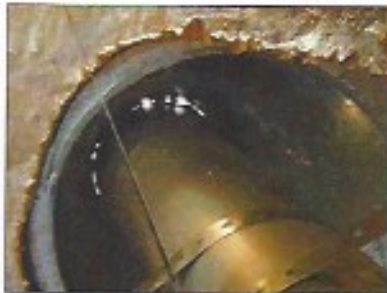
(3) Daylight was observed around the furnace vent pipe in the attic. Sealing around the vent pipe and flashing is recommended to prevent moisture intrusion.

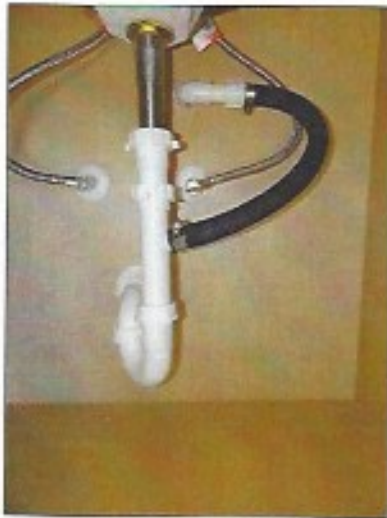
Location(s): Upstairs Hall Bathroom Lavatory

(3) **Note:** Periodic maintenance of the discharge point for the condensate drain line is recommended. Condensate can cause build-ups in traps that are not utilized often causing slow drainage.

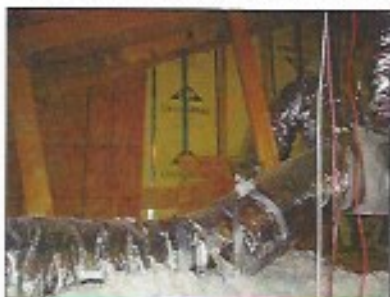
(2) Disconnected ducting strap(s) was observed. Secure as needed.
Location(s): Return duct at the front of the unit.

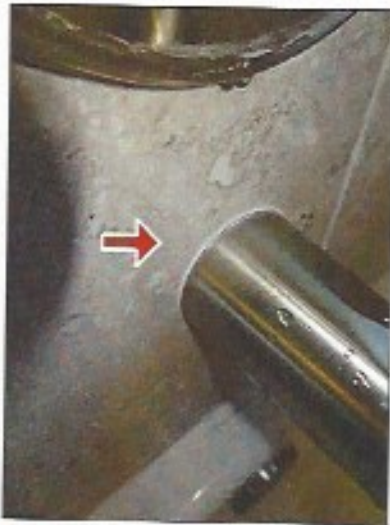
Location(s): Master Bath

(2) Seal (caulk) the gap between the bathtub spigot and bathtub stall wall to prevent water penetration.

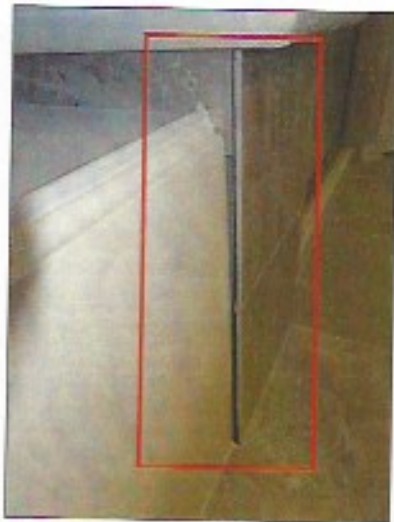
(3) Tile at the master bathtub is not properly finished. Remedy as needed.

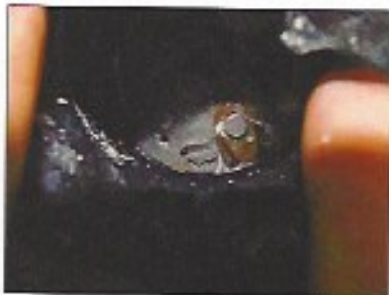
The garbage disposal appears to be jammed and full of debris. The emergency reset tripped during operation and does not appear to be functional.

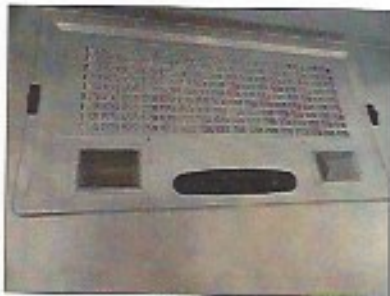
(1) The light does not function at the kitchen exhaust. This may be the result of a bad bulb. Replace and test or remedy as needed.

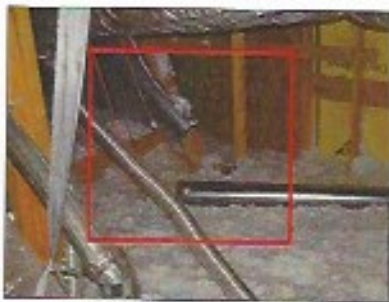
(2) The kitchen exhaust vent pipe is disconnected in the attic. Evaluate and remedy as needed.

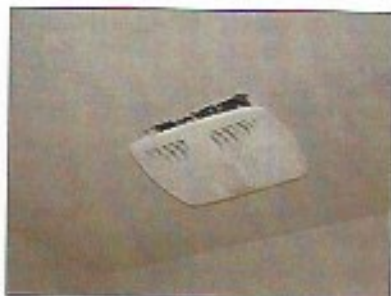
The exhaust fan in the utility room is loose from the ceiling. Secure as needed.
