LONE STAR HOME INSPECTIONS

PROPERTY INSPECTION REPORT

Concerning: 62 N Swanwick Pl, Tomball, Texas 77375
(Address or Other Identification of Inspected Property)

By: Steve Carter, TREC# 4279 1/4/18
(Name and License Number of Inspector) (Date)

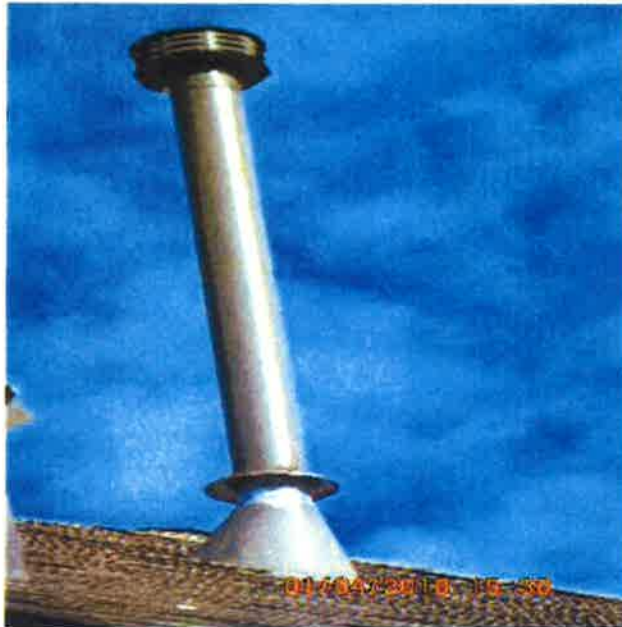
Reposition water heater storm collar and recaulk.

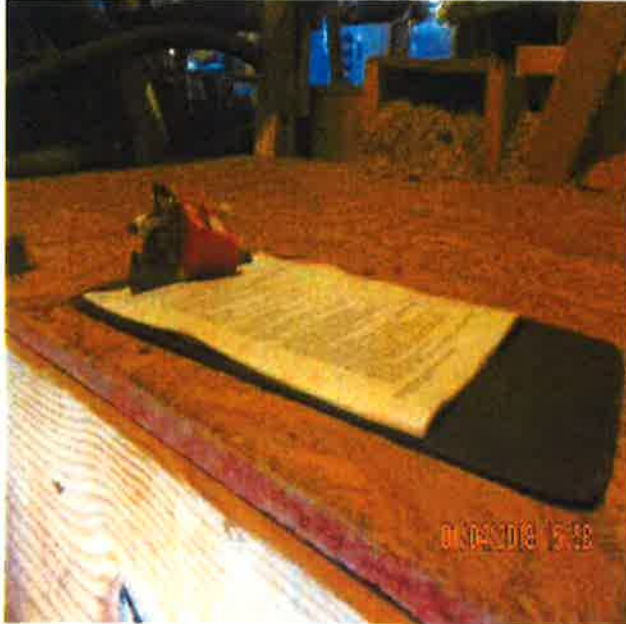
Existing attic flooring did not comply with accepted industry specifications for floor sheathing. The attic should have an unobstructed passageway from the

attic access to the service side of all equipment. The flooring should be solid and continuous (not 7/16" OSB) and not less than 24 inches wide. On the control side of the equipment and on other sides where access is necessary for servicing, a level working platform extending a minimum 30 inches from the edge of the equipment with a 36 inch high clear working space should be provided.

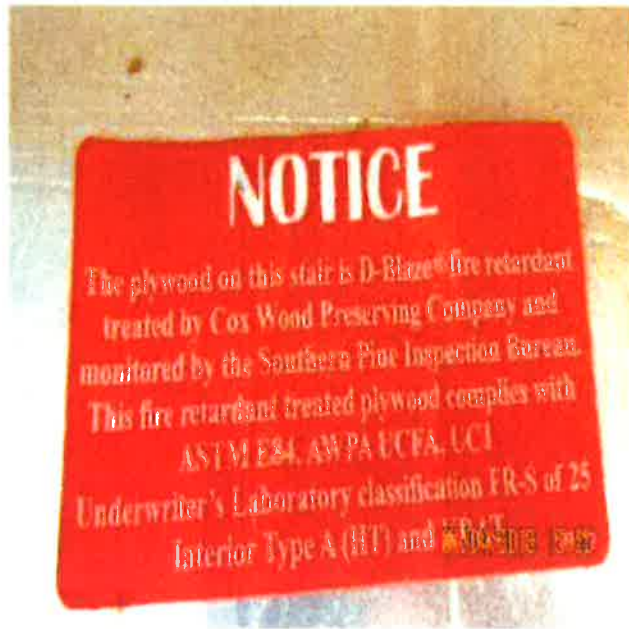
Disappearing stairway has been installed at the ceiling of attached garage disrupting the firewall between house and garage. The garage shall be separated from the residence and its attic area by not less than ½ inch gypsum board applied to the garage side. ½ inch gypsum has a 30 minute fire rating. The plywood of the attic stairway has been pressure treated and labeled as fire retardant however there is no industry rating on folding attic stairways such as "15 minute", "20 minute", or "30 minute".

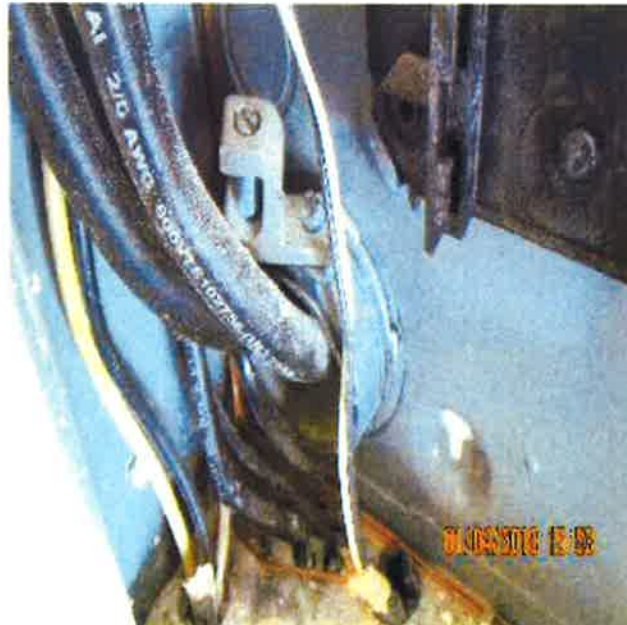
Concrete encase grounding electrode should only be used with foundations that are in direct contact with the earth. Construction in the Greater Houston area requires foundations to be placed over a vapor barrier (6 mm plastic) which insulates the foundation from direct contact with the earth. Supplemental grounding rod should be installed a minimum of six feet from main grounding rod. The meter panel box feeder conduit is not properly bonded to ground. Standard locknuts or bushings shall not be the sole means for the bonding at the service entrance.

The main distribution panel and neutral bus bar do not appear to be properly bonded to ground.

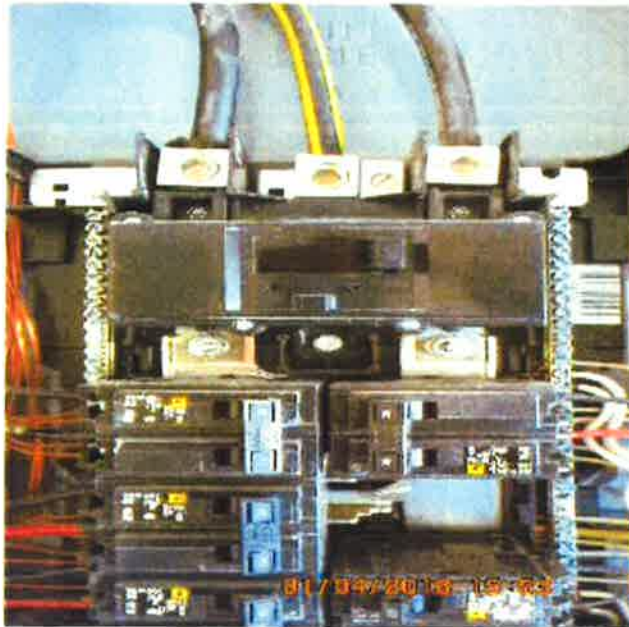
Oversized 40 amp. oven breaker(s) within the main distribution panel should be replaced. The purpose of the breaker is to provide protection to the conductors first and to the (6.8kW) appliance second. Over sizing is not allowed as the wires could overheat and or the appliance could burn without the breakers tripping.

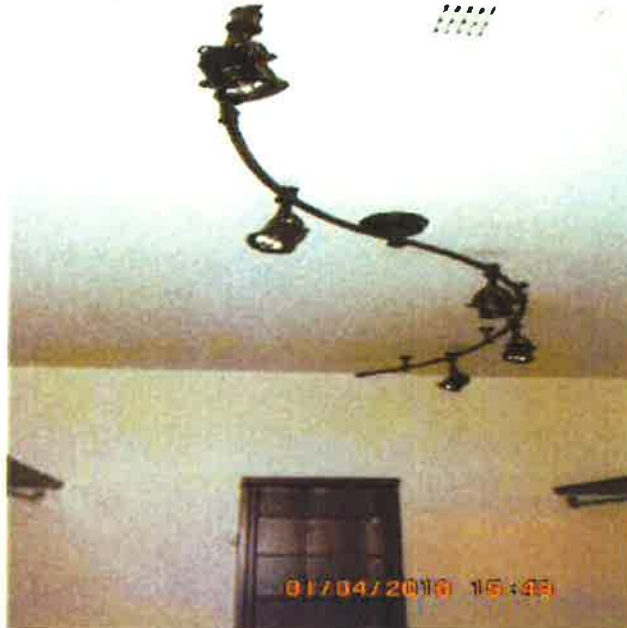
High Intensity pendant lighting present in the master closet. The types of luminaires installed in clothes closets shall be limited to surface-mounted or

recessed incandescent luminaires with completely enclosed lamps, and surface-mounted or recessed fluorescent luminaires. Incandescent luminaires with open or partially enclosed lamps and pendant luminaires or lamp holders shall be prohibited.

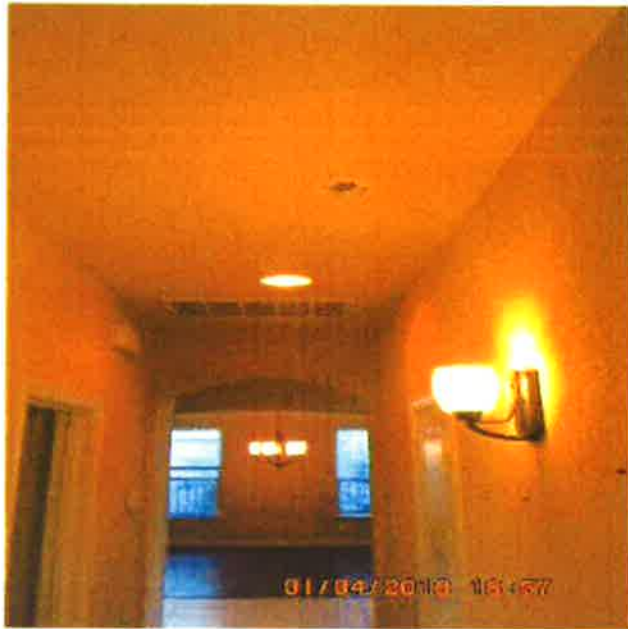
Smoke detector is missing.

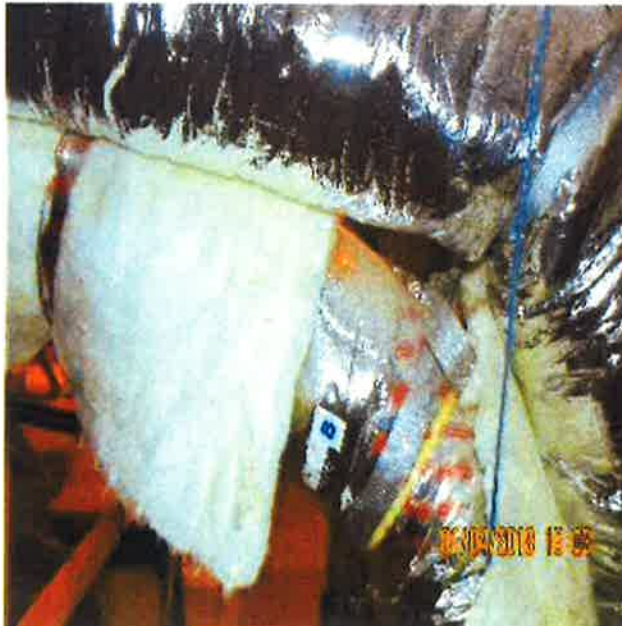
Flexible air ducts were observed in contact with each other. Air ducts in contact with each other or other insulation material generate sweating to ceilings at the point of contact with each other or other building materials. Clearance or separation from contact with each other by strapping with HVAC nylon strapping material minimum 1.5 inch wide prevents sweating.

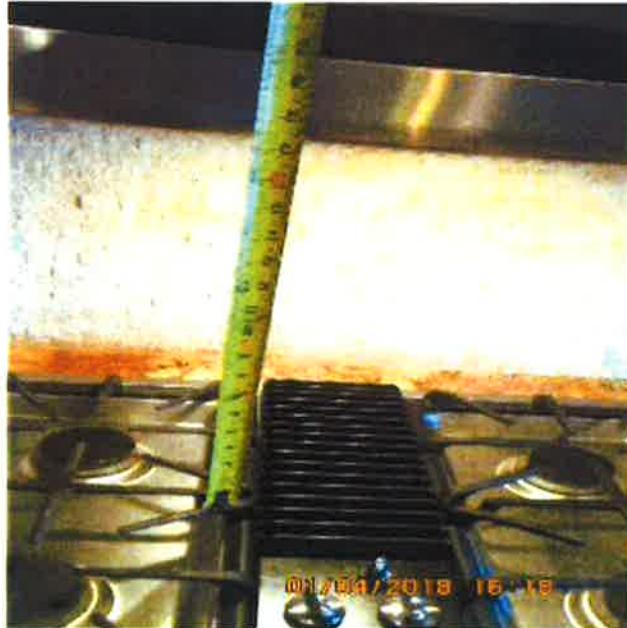
Household cooking appliances shall have a vertical clearance above the cooking top of not less than 30 inches to combustible material and metal cabinets. A minimum clearance of 24 inches is permitted when a listed cooking appliance or microwave oven is installed over a listed cooking appliance and in compliance with the terms of the manufacturers installation instructions for the upper appliance.
