11603 Cedar Creek Dr.  
Houston, TX 77077

## PROPERTY INSPECTION REPORT

**Prepared For:** Megan Larch Dominick  
(Name of Client)

**By:** Christian Martinez, Lic#21090 05/10/2018  
(Name and License Number of Inspector) (Date)

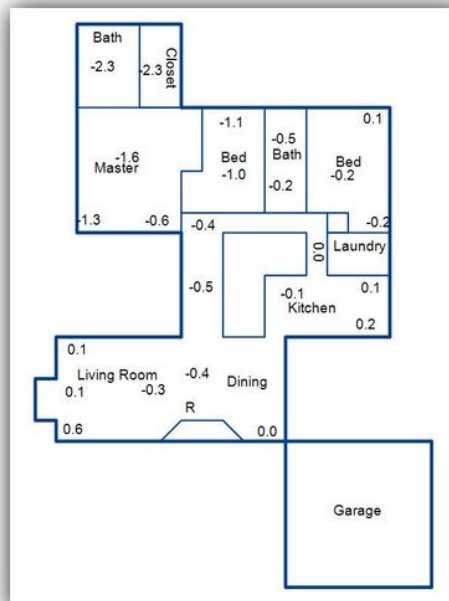
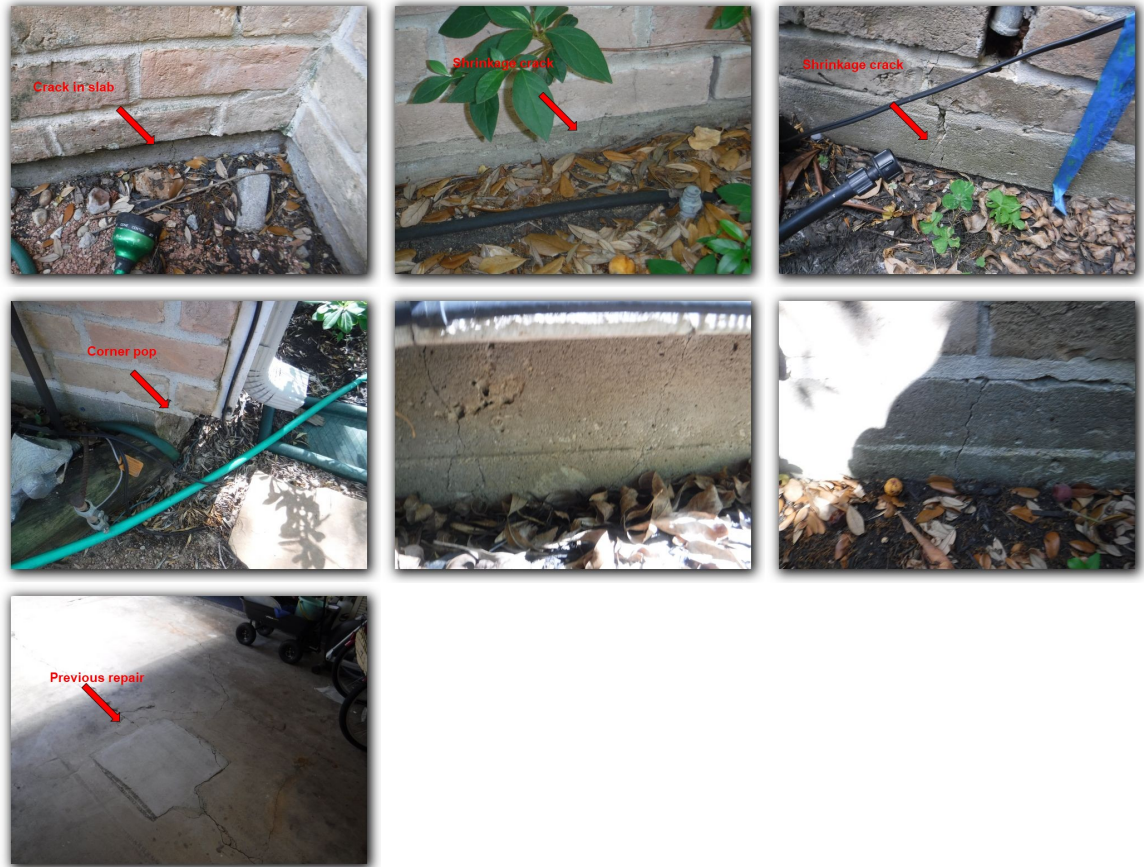
Structural movement and/or settling noted. Visible differential movement was noted at the interior and exterior of the structure in the form of:

- Cracks in the foundation wall at multiple locations
- Mortar and brick cracks
- Cracks in the drywall finish
- The zip level reading a greater than 2 inch difference from the highest point to the lowest point

Suggest that an expert in this field be consulted for further evaluation of the structure and to provide suggestions as to what, if any, corrective actions should be taken.

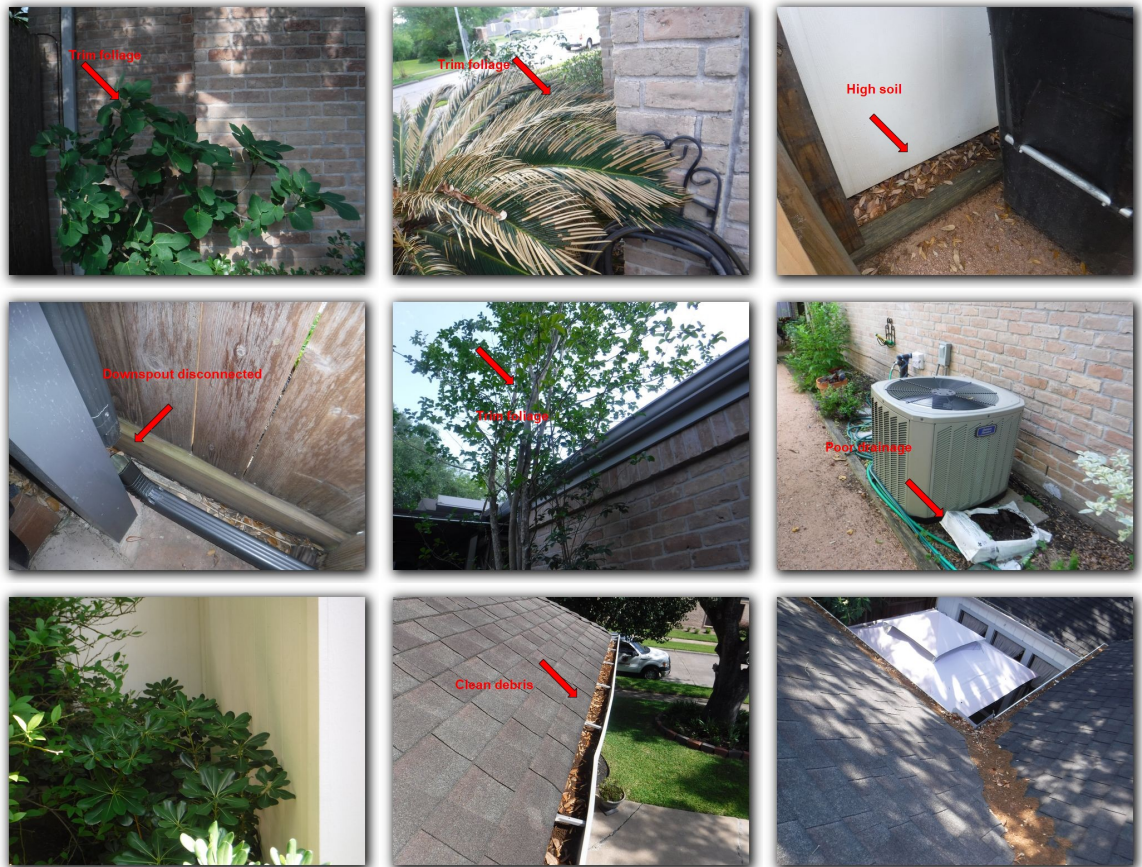
- Recommend trimming foliage in contact with the siding to prevent premature wear or damage to the veneer.
- Recommend cleaning debris in the gutters to allow them to operate properly.
- Poor drainage was observed along the sides and rear of the home, recommend correction to prevent standing water near the foundation wall.
- High soil conditions were observed along the right and rear sides of the home. Recommend the soil be pulled back to prevent moisture and pest intrusion.
- Downspout along the right side of the patio was detached. Repair as needed.

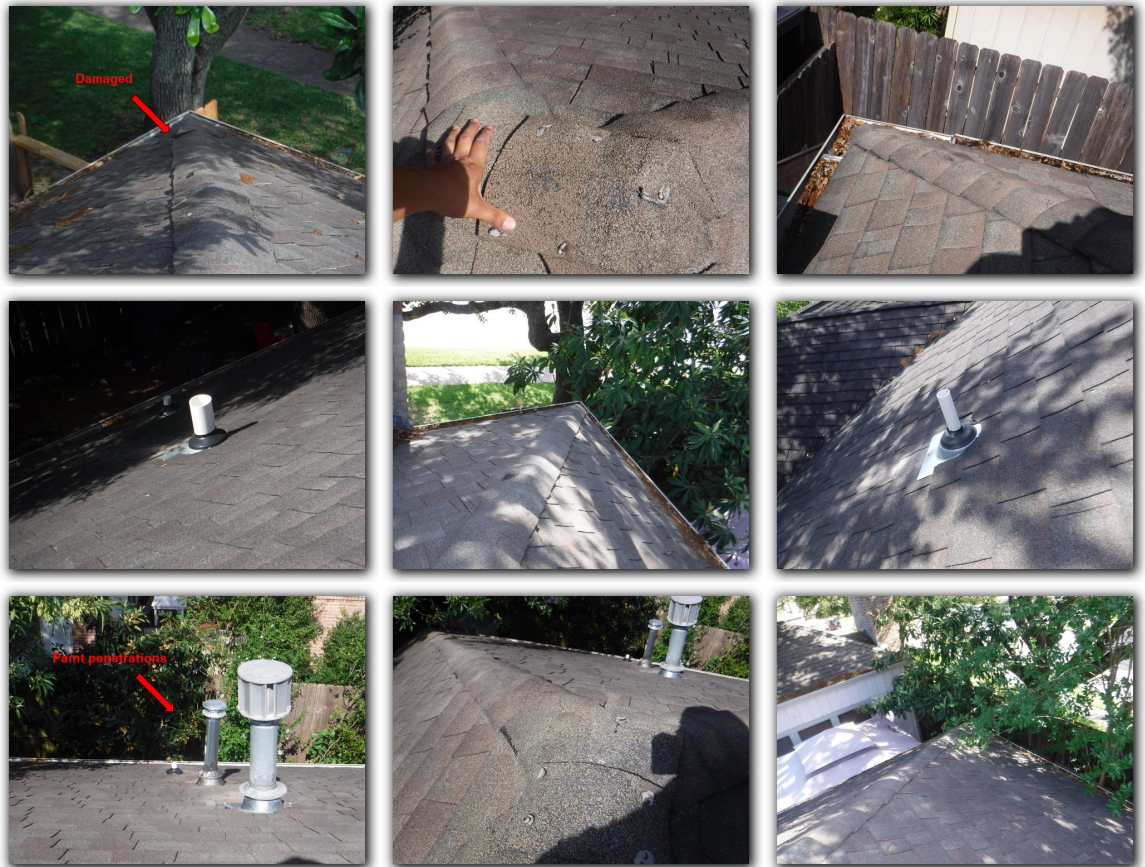
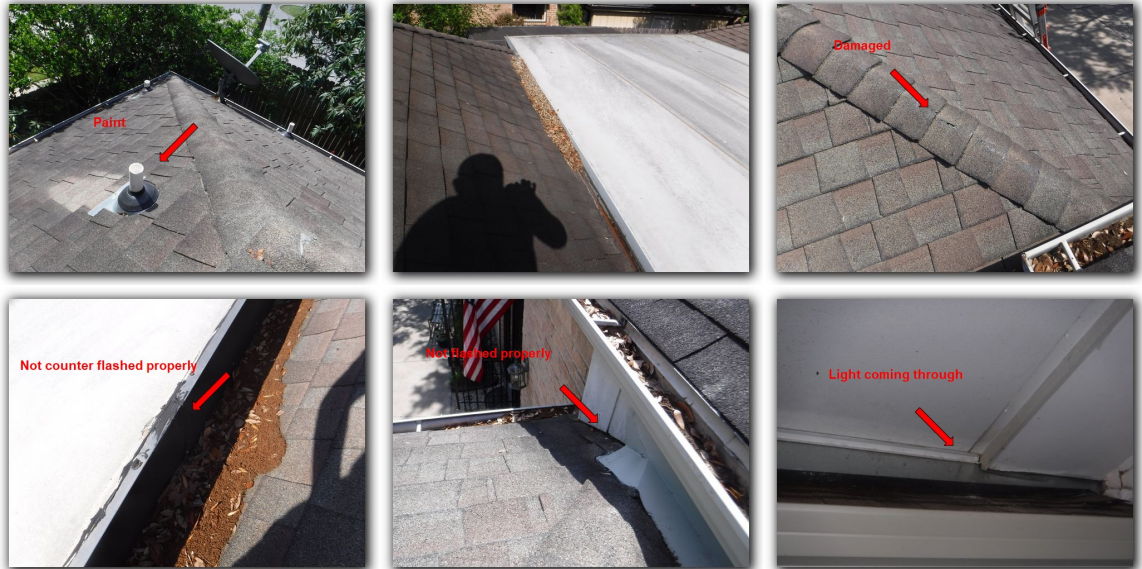
The roof covering is in need of repairs due to:

- Damaged shingles at multiple locations
- Flues and plumbing vents that need to be painted
- Exposed nail heads that need to be sealed
- Portions of the flashing not installed properly for the right porch covering and near the detached garage

a Certified Roofing Company should be consulted for further evaluation.

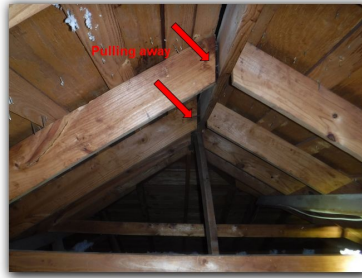
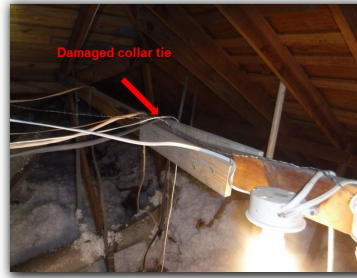
- Collar tie at the center of the attic space was observed to be damaged and not repaired properly. Repair as needed to prevent the roof structure from sagging over time.

- Rafters were observed to be beginning to pull away from the ridge board at the rear left portion of the attic space. Recommend monitoring and repairing as needed.

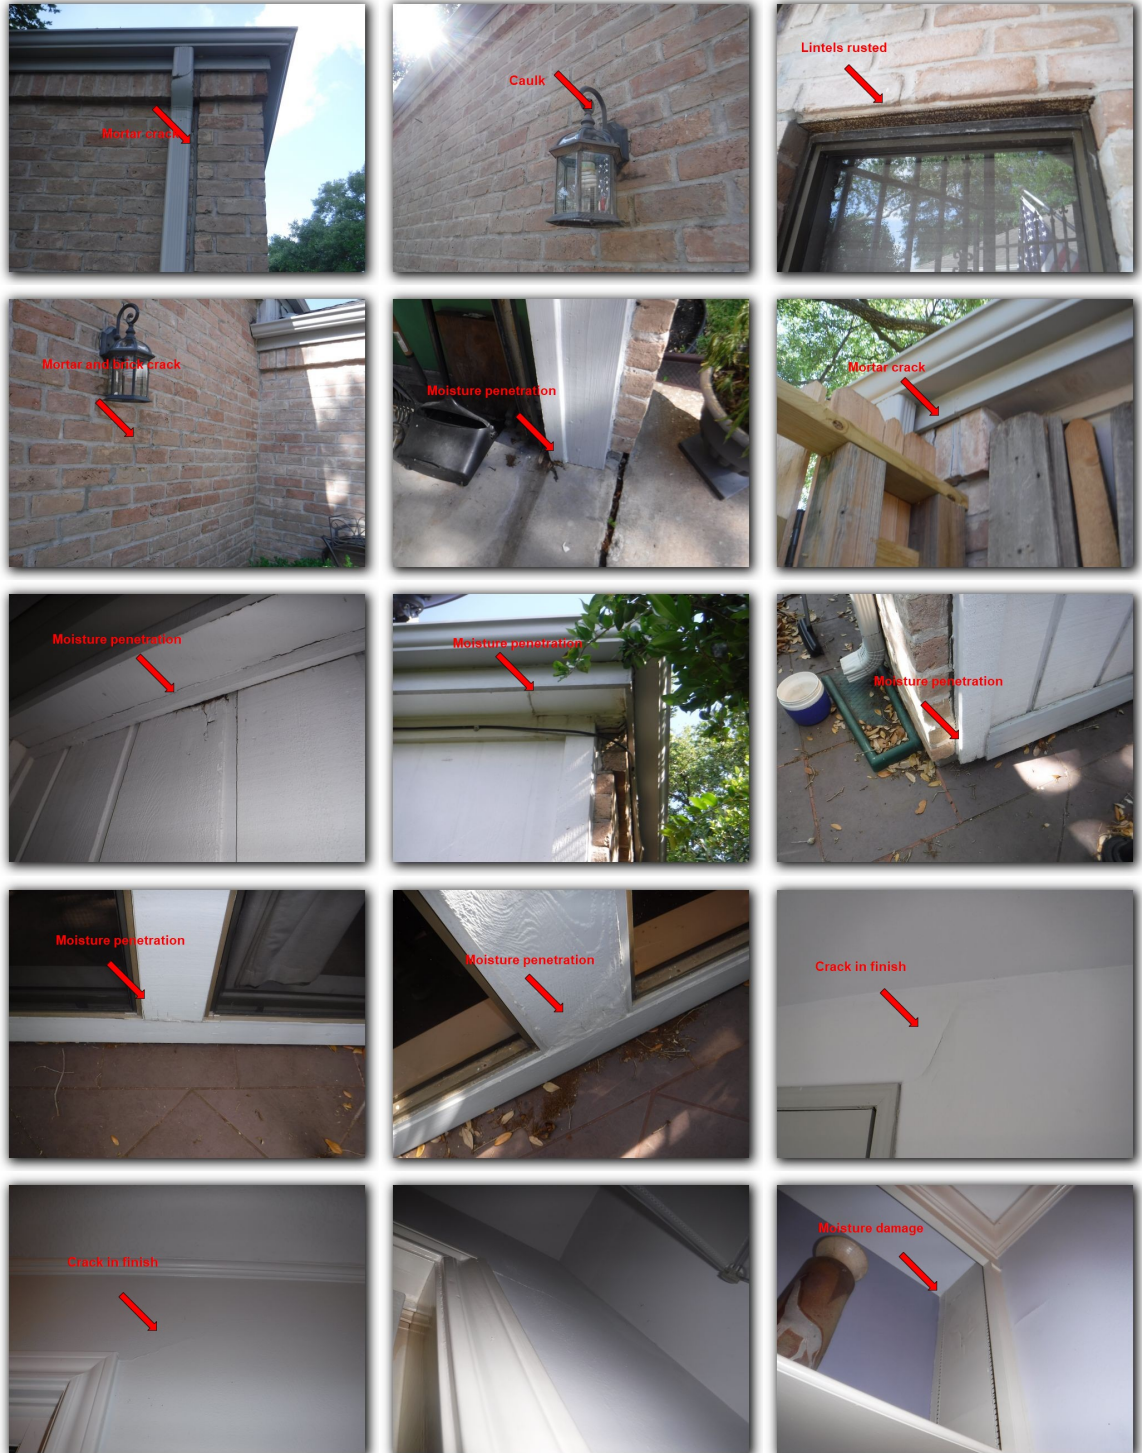
- Caulking and sealing is needed on the exterior veneer at one or more locations to prevent any possible moisture penetration into the building. These locations include around wall vent covers, electrical outlets/fixtures, transitions between siding, plumbing penetration and A/C lines.

- Mortar and brick cracks were observed at multiple locations around the home. Repair as needed to prevent further deterioration.
- Moisture penetration was observed to the wooden trim, fascia boards and siding at multiple locations around the home. Repair as needed to prevent further deterioration.

- Steel lintels above the windows and doors were observed to be rusted. Recommend properly painting/sealing to prevent further deterioration.
- Weep holes were missing in the brick veneer above the windows and doors. These allow any moisture that accumulates behind the veneer to wick out. Weep holes are required at all brick veneer and should be spaced no more than 33 inches.

- Cracks were observed to the drywall finish around the windows and doors at multiple locations. Repair as needed to prevent further deterioration.
- Moisture penetration was observed to the built-in cabinet finish to the right side of the fireplace. The thermal imaging camera showed no indication of an active leak at the time of inspection. Recommend monitoring.

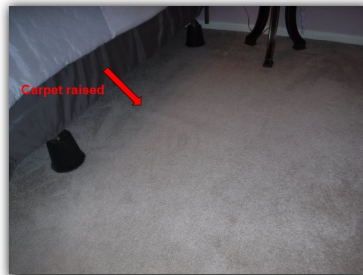
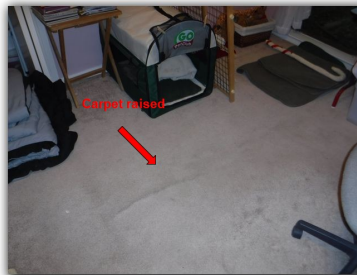
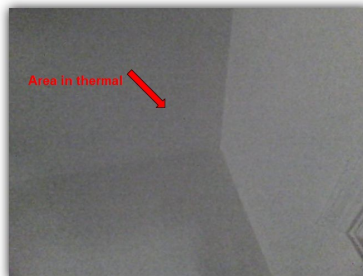
- The thermal imaging camera showed an indication of an active leak at the master bathroom ceiling. Recommend further evaluation and repair to prevent further deterioration.

Note: In the thermal image, the orange portions indicate dry areas while the blue portions indicate moist areas.

- Cracked tape joints and nail pops were observed at multiple locations around the ceiling finish. Recommend repair to prevent further deterioration.

- Carpet was observed to be raised in the bedrooms. Recommend the carpet be re-stretched to prevent a tripping hazard.

- Cracks were observed in the tile grout at multiple locations. Repair as needed.

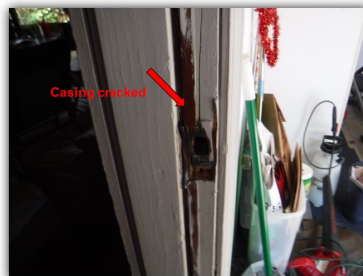
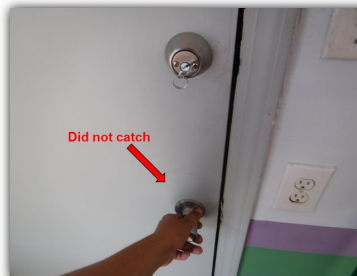
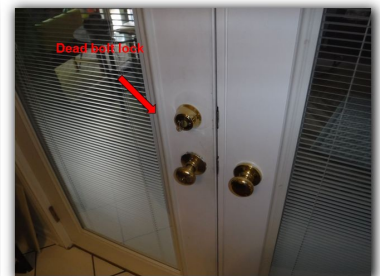
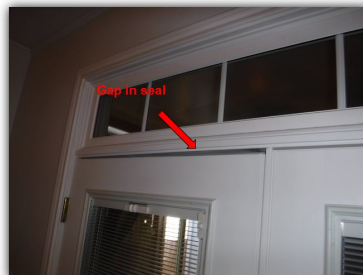
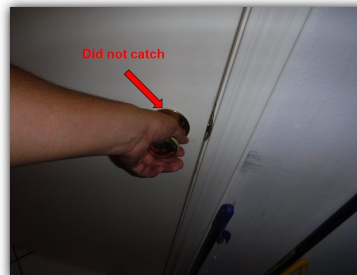
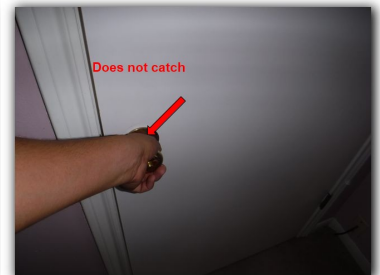
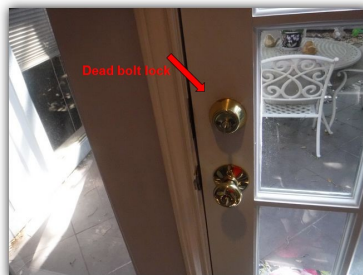
- Gaps were observed in the weather seal around the exterior doors. Repair as needed to prevent moisture, pest, and air intrusion.
- The casing for the garage door was damaged. Repair as needed for safety purposes.
- Deadbolt locks were in use at multiple exterior doors. Recommend these be updated to a thumb latch type as this is a hazard in the event of an emergency.
- The garage door did not catch properly at the hardware. Recommend adjustment.

- Multiple doors around the home did not catch properly at the hardware. Recommend adjustment to allow for easier operation.

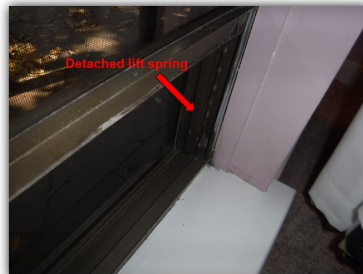
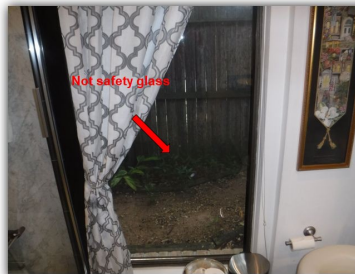
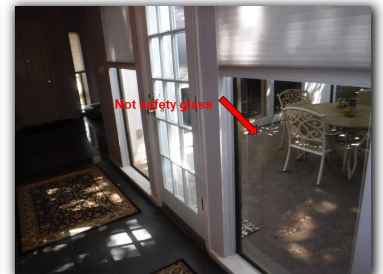
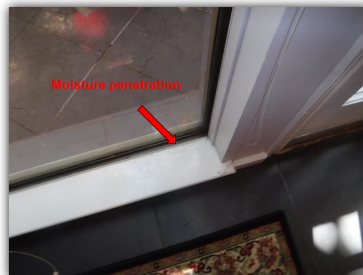
- Lift spring for the right master bedroom window was detached. Repair as needed to allow for easier operation.
- Windows near the left side exterior door do not appear to be safety glass. While this may have not been an issue when the home was originally built, recommend correction as windows within 24 inches of the arc of the door are required to be safety glass.
- Due to their size and location, the large picture windows at multiple locations were observed to not be safety glass. While this may have not been an issue when the home was originally built, recommend repair for safety purposes.
- Moisture penetration was observed to the window sills in the left hallway and living room windows. Recommend monitoring and repairing as needed.
- All other portions of the windows appear to be performing as intended at the time of the inspection.

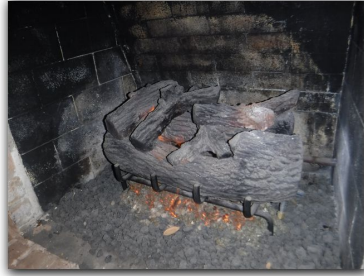
- No anti-closing device was installed at the damper for the gas log system. This safety device prevents the damper from completely closing and ensures that proper ventilation is provided at all times
- The fireplace and chimney appear to be performing as intended at the time of the inspection.

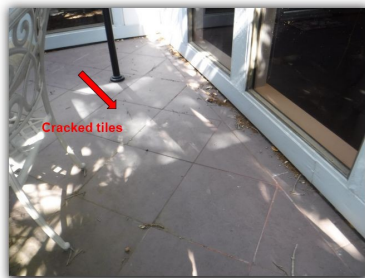
- The tiles at the left patio were observed to be cracked. Repair as needed to prevent further deterioration.
- All other portions of the porches appear to be performing as intended at the time of inspection.

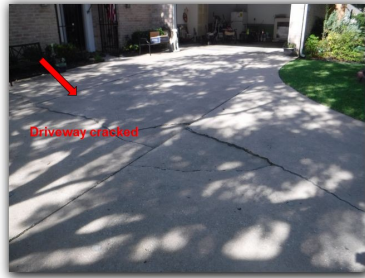
- The driveway was observed to be cracked. Recommend sealing to prevent further deterioration.

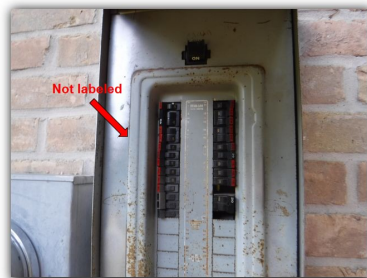
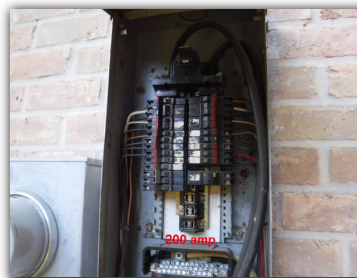
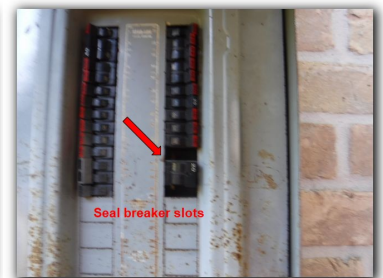
- Branch circuit breakers within the panel were not labeled properly. Recommend correction for safety purposes when servicing equipment or making repairs.
- Recommend sealing open breaker slots for safety purposes.
- A discontinued Federal Pacific (FPE) panel was noted to be in use. In some investigations per Federal Pacific Electric (FPE) hazards web site (<http://www.inspect-ny.com>), Federal Pacific Electric "Stab-lock" service panels and their breakers could be a latent hazard because they could fail to trip in response to an over current, possibly leading to electrical fires. The breakers may also fail to shut off internally, even if the toggle is switched to "off". Recommend updating / replacing panel for safety concerns.

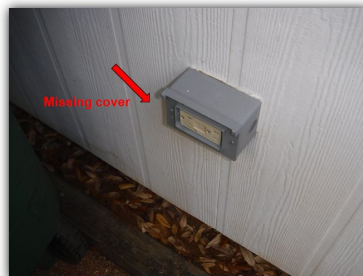
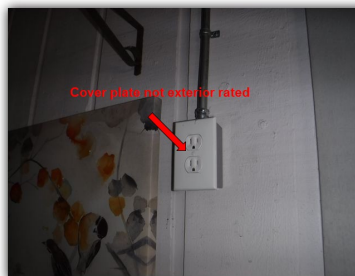
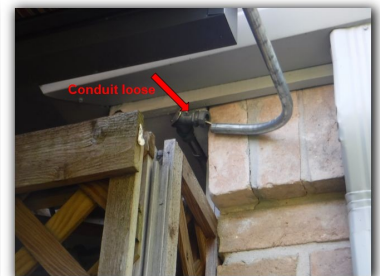
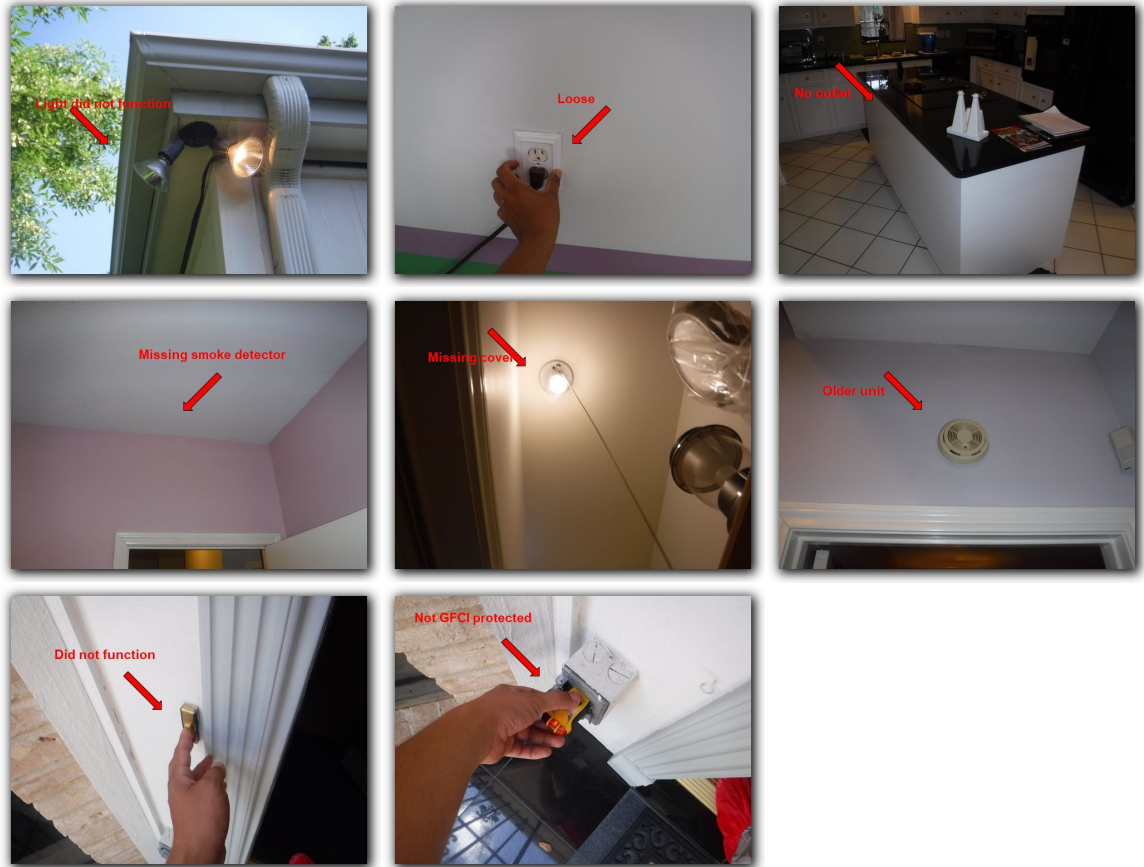
- Multiple light fixtures in the closets were missing their bulb cover. Recommend correction to prevent damage.
- Smoke alarms were observed to be missing from their required locations and the ones present appear to be older than 10 years. Recommend correction and the addition of a carbon monoxide detector for safety purposes.
- Multiple light fixtures around the home did not function, possibly bulb related. Correct as needed.
- The doorbell unit did not function. Repair as needed.

- Cover plate for the exterior outlet along the right side of the detached garage was missing. Repair as needed.
- Recommend the proper exterior rated cover be placed over the outlet at the right porch to prevent moisture and pest intrusion.
- Conduit for the wire near the right porch was loose. Repair as needed.
- Cover plates for the outlet in the garage was loose. Repair as needed.
- No electrical outlet was observed to be placed on the kitchen island. While this may have not been an issue when the home was originally constructed, recommend repair for safety purposes.
- No GFCI protection was observed at the exterior front porch outlet. Repair as needed for safety purposes as all electrical outlets within 6 feet of water source should be GFCI protected.

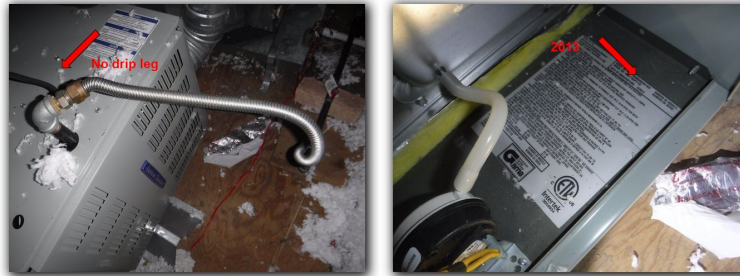
- A drip leg for the gas line was not installed for the furnace. A drip leg serves as a collection area for sediment to reduce the chance of clogged gas valves or burners.
- The heating equipment appears to be performing as intended at the time of inspection.

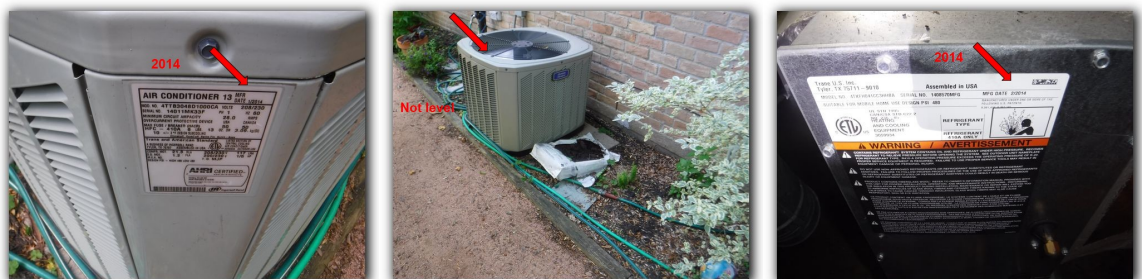
- Condenser unit is not level, recommend having unit leveled to promote best overall operation and function.
- The A/C equipment appears to be performing as intended at the time of the inspection.

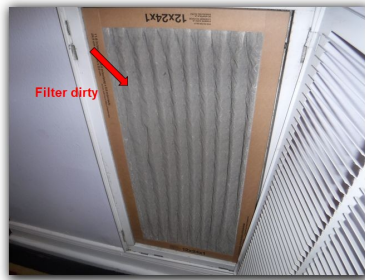
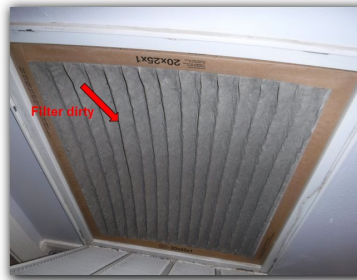
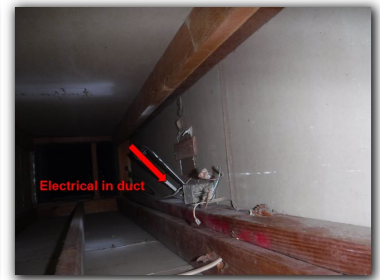
- The return air filters were observed to be dirty. Recommend replacement to allow the system to operate efficiently.
- Electrical wiring and junction box was placed inside the return air register, this is not a recommended installation as it can pose a hazard in the event of a fire. Recommend correction.
- All other ducts and vents visually appear to be intact and in overall sound condition at the time of the inspection. Some areas of the ductwork were visually obscured from view.

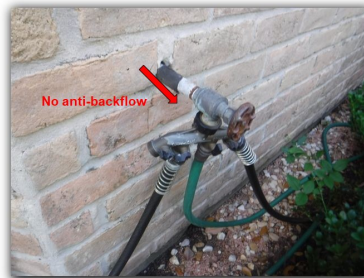
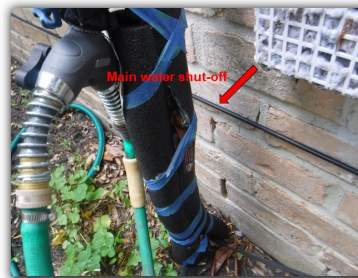
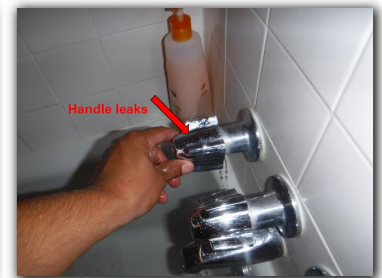
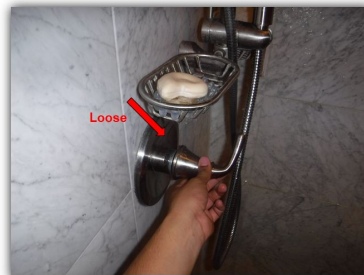
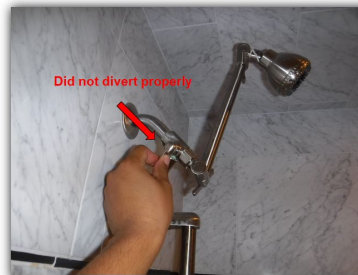
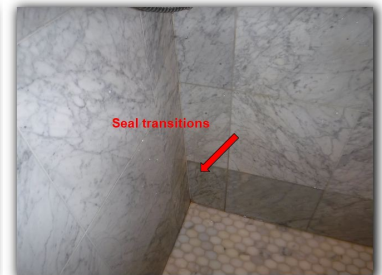
- Recommend caulking and sealing around all transitions and penetrations within shower enclosures to prevent moisture penetration.
- The shower handles for the hallway bathroom tub would leak when operated. Repair as needed.
- The shower head in the master bathroom would not divert the water properly between fixtures. Repair as needed.
- The control handle for the master bathroom shower was loose. Repair as needed.

- No anti-siphon devices were observed on the exterior hose bibs. Recommend correction to prevent dirty water from entering the potable water supply.

Note: Galvanized plumbing was observed to be in use at the home, this type of plumbing is known to develop issues over time such as low water pressure and pin hole leaks. It would be wise to budget for replacement in the future. Typical life expectancy for Galvanized piping is between 40-50 years.

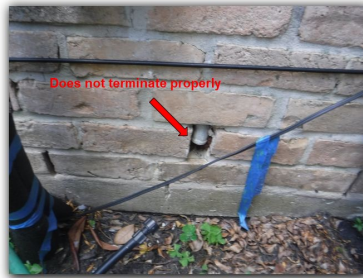
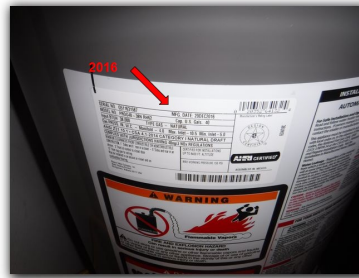
- The temperature and pressure relief valve did not terminate fully to the exterior on the right side. Repair as needed to prevent moisture damage in the event it were to become active.

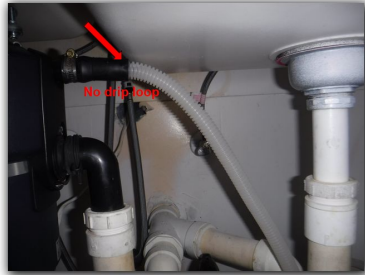
- No drip loop or air gap installed for the dishwasher. This prevents dirty water in the sink from backing into the clean water used for the dishes. Recommend correction.

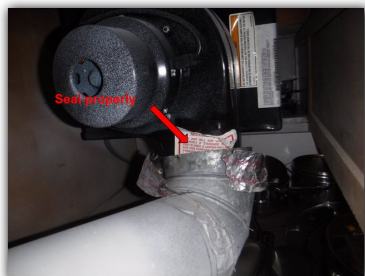
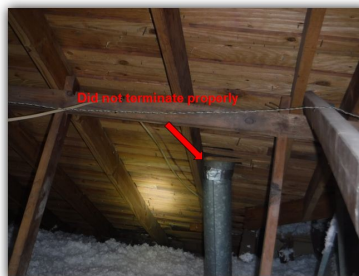
- Recommend properly sealing around the vent pipe for the range hood to prevent cooking fumes from escaping into the cabinet.

- Vent pipe for the kitchen fan did not fully terminate to the exterior. Correct as needed.

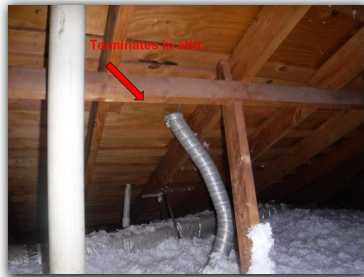
- The exhaust fans terminate into attic area. All exhaust fans should terminate to the exterior of the dwelling to prevent moisture issues
- All other portions of the exhaust fans appear to be performing as intended at the time of the inspection.

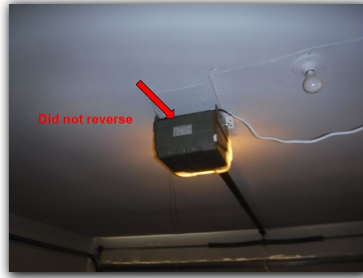
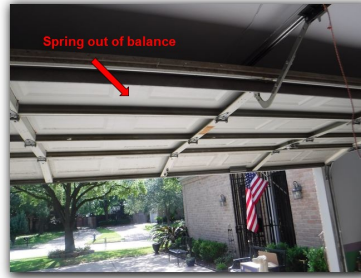
- The operator did not reverse when tested for an obstruction. Recommend adjusting the sensitivity of the garage door operator to prevent damage to the unit or property.
- Spring for the overhead garage door was observed to be out of balance when manually operated. Recommend adjustment to prevent stress on the operator.
- All other portions of the garage door operator appear to be performing as intended at the time of the inspection. Internal reversing mechanism was operating properly at the time of the inspection.

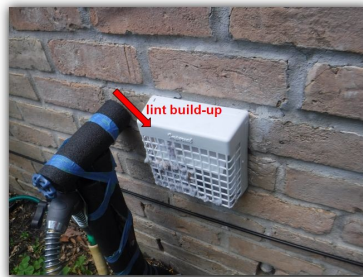
.- The dryer vent is blocked open from lint buildup. Recommend cleaning out vent.
