Property Inspection Report

18511 Purdy Court, Houston, TX 77084
Inspection prepared for: Raed
Date of Inspection: 4/4/2021 Time: 8:30am
Weather: Cloudy
The outside temperature is 57°.

Inspector: Zachary Hernandez
License #24019
Houston, TX
Phone: 832-557-5624
Email: hernzachary@gmail.com

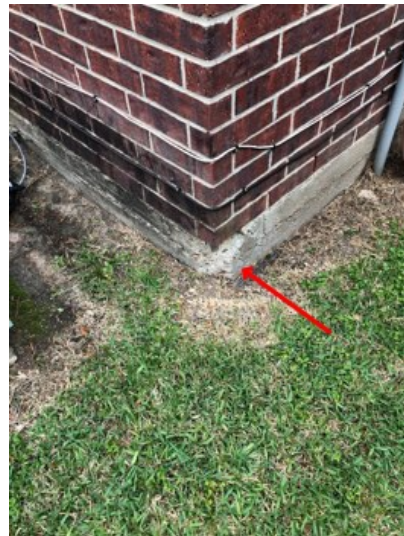
There was a shear crack in the foundation. These are cosmetic and are not associated with structural movement. Location: front, rear

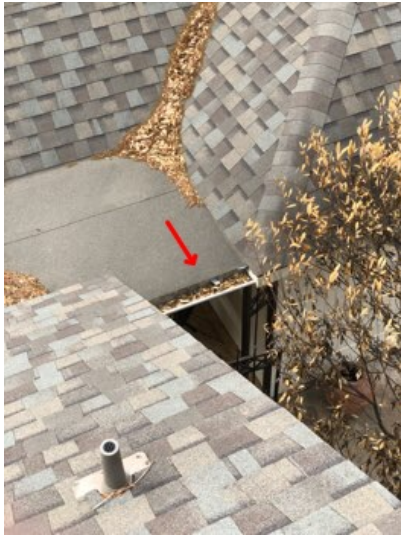
The gutters have debris in them.

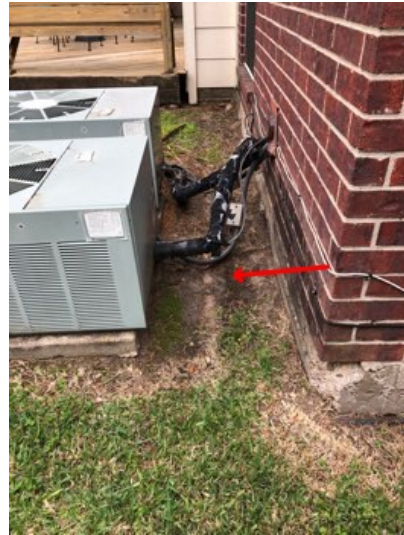
Soil erosion was observed during the inspection. Location: rear, garage

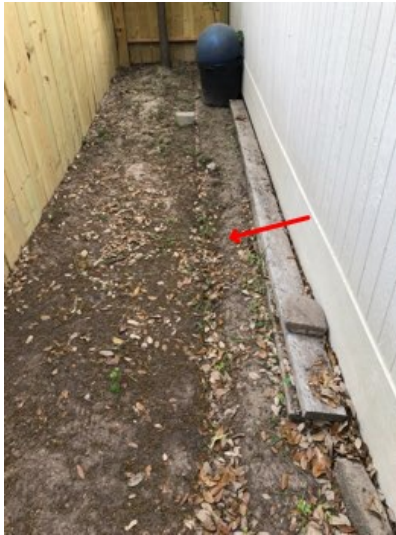
Soil erosion was observed during the inspection. Location: rear, garage

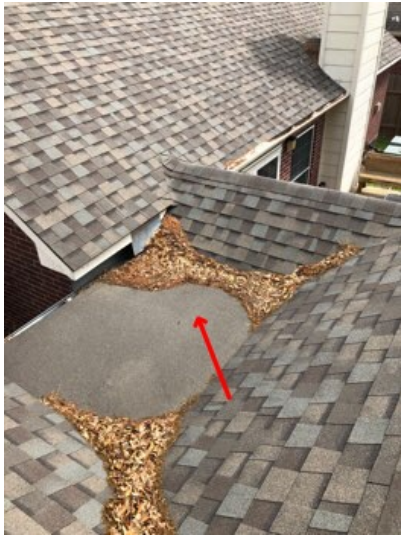
Recommend removing debris from the roof covering. Unable to determine the condition of the roof covering underneath.

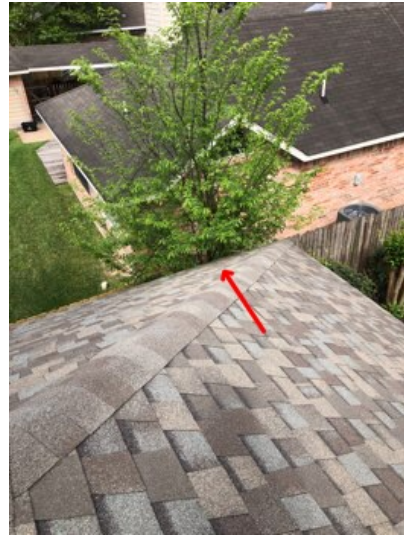
Trees in contact with/hanging near the roof.

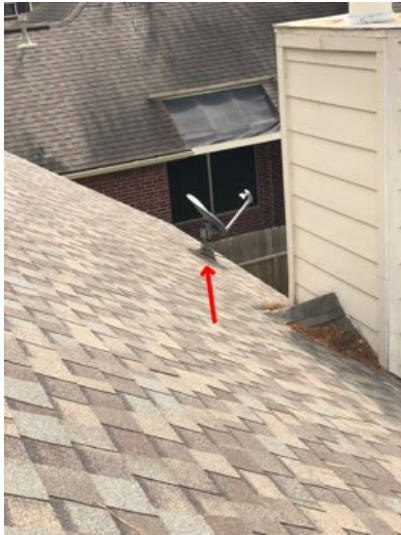
The condition of the roofing materials under the satellite dish could not be determined.

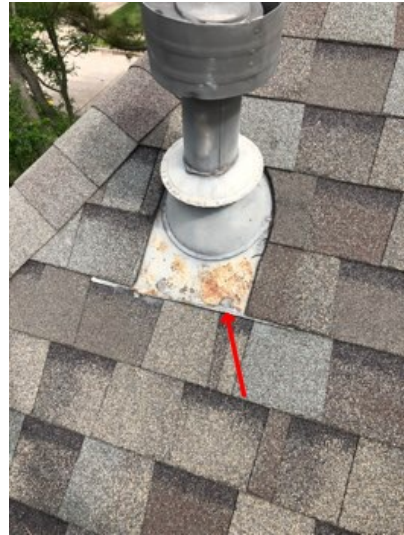
Attic vent is rusted.

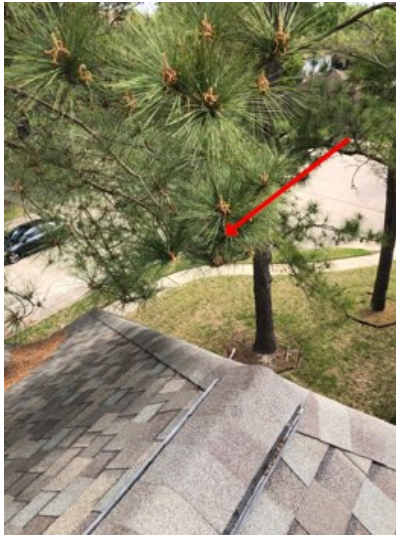
Trees in contact with/hanging near the roof.

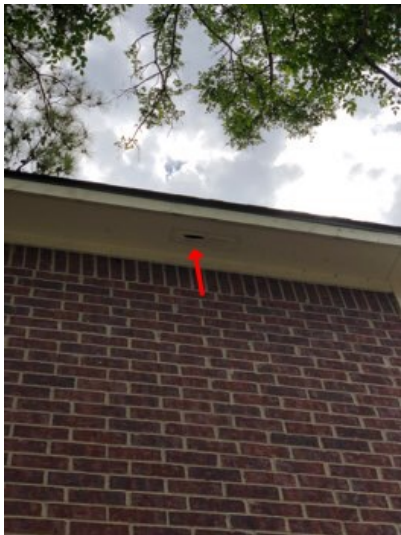
There were damaged soffit vent screen(s).

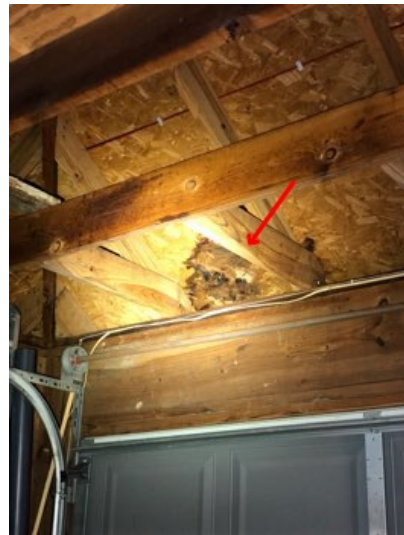
Prior moisture intrusion was observed on the roof sheathing. Area tested dry at time of inspection.

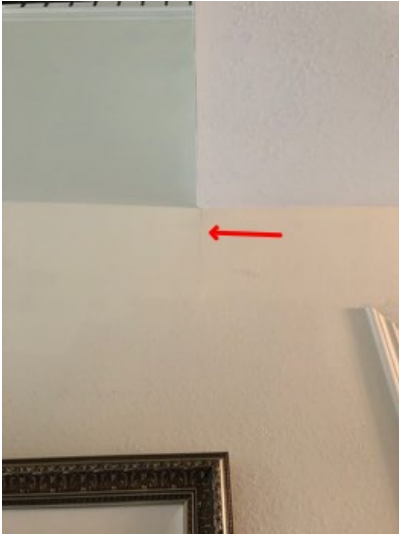
Multiple locations where there were hairline cracks observed on the drywall.

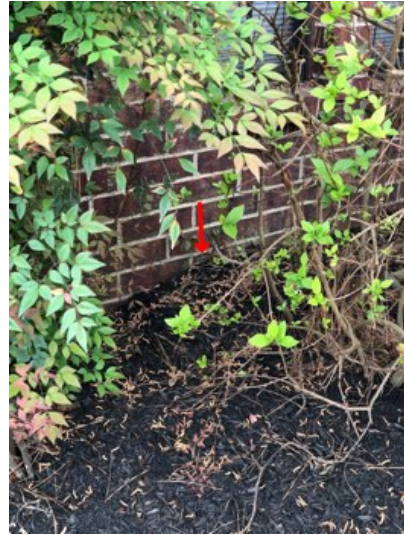
High soil was observed at the front and the garage. There should be 4 inches of slab showing for brick and 6 inches for siding.

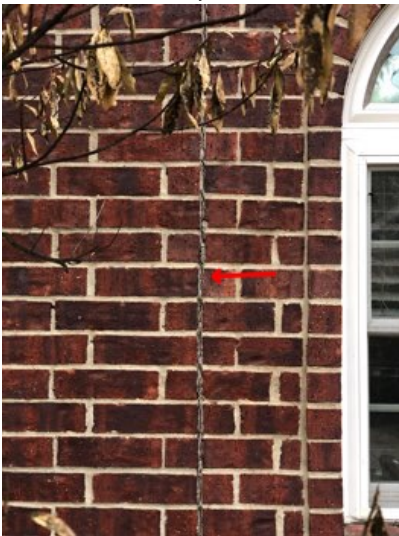
Multiple locations where the expansion joint sealant was deteriorated.

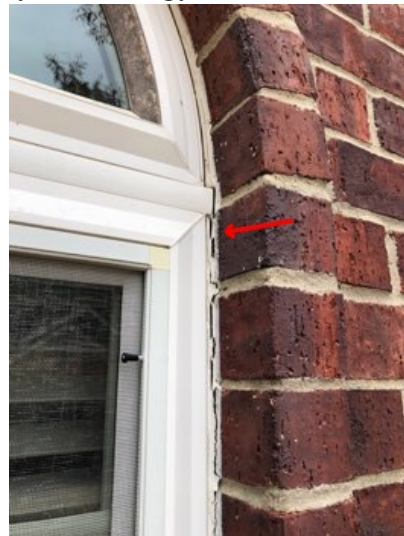
The sealant around the window on the right side was deteriorated.

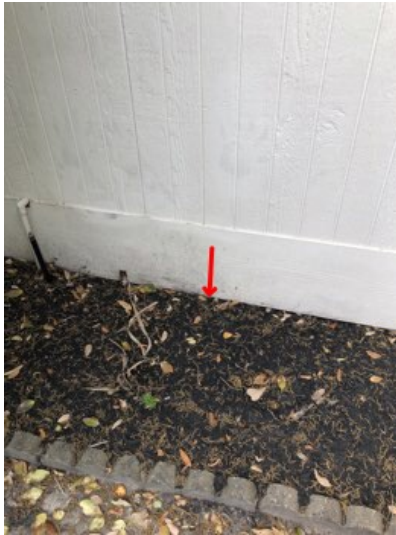
High soil was observed at the front and the garage. There should be 4 inches of slab showing for brick and 6 inches for siding.

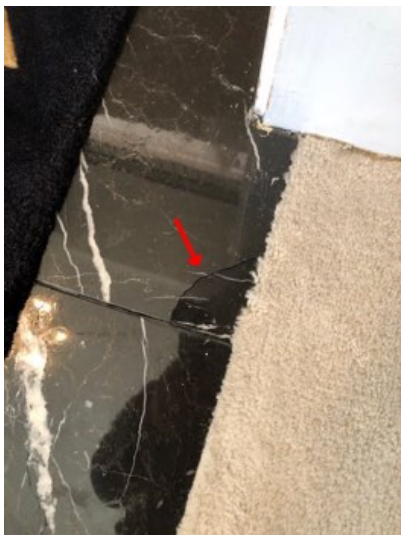
Cracked tiles were noted at the front entry and laundry area.

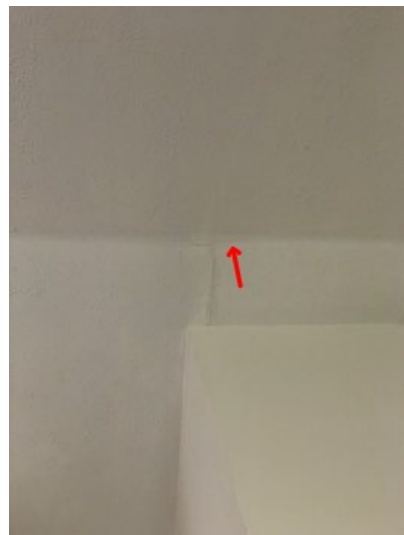
Cosmetic cracks were noted at the first floor living room and second floor left rear bedroom.

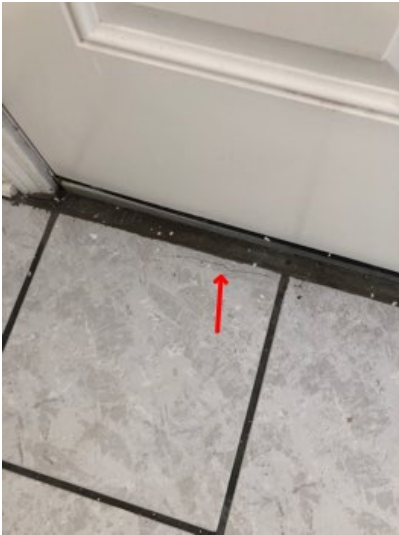
Cracked tiles were noted at the front entry and laundry area.

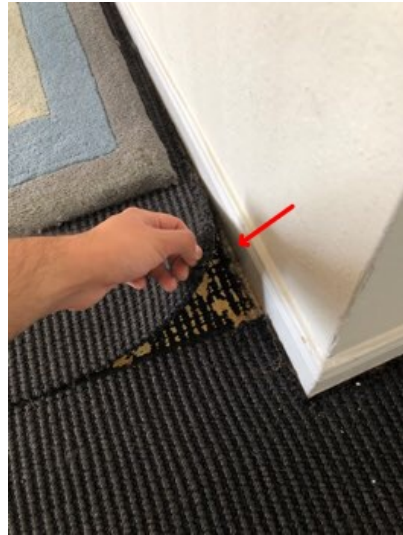
Loose carpet was noted at the second floor hall.

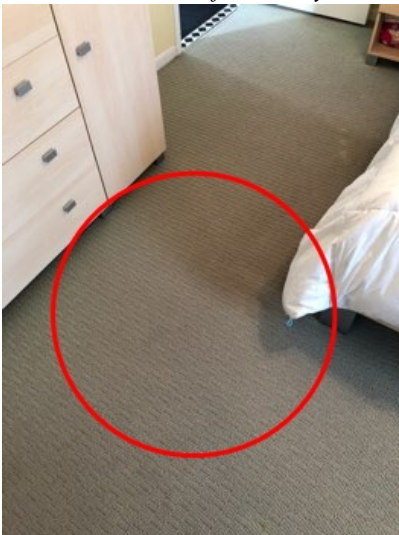
Areas on the second floor where the subfloor was squeaky when stepped on. This is due to the subflooring Not properly fastened to the joist.

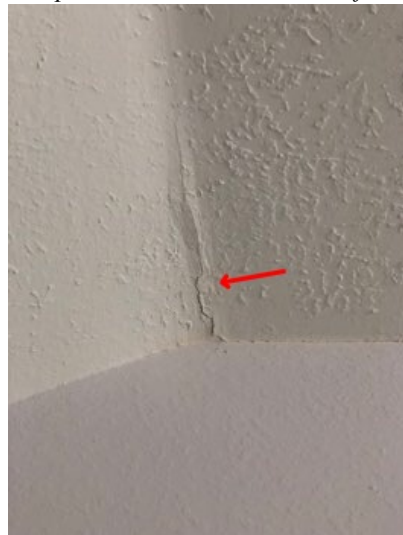
Cosmetic cracks were noted at the first floor living room and second floor left rear bedroom.

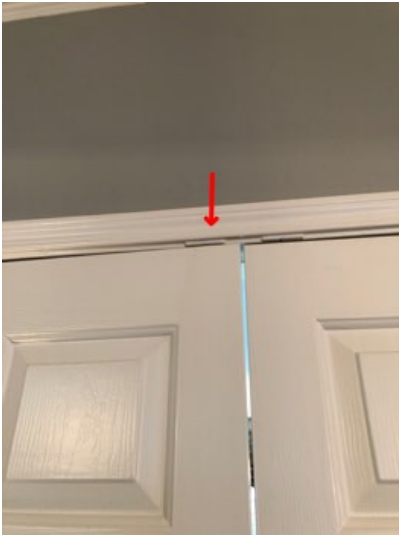
The door does not latch at the kitchen, second-floor bathroom, second-floor front left bedroom closet.

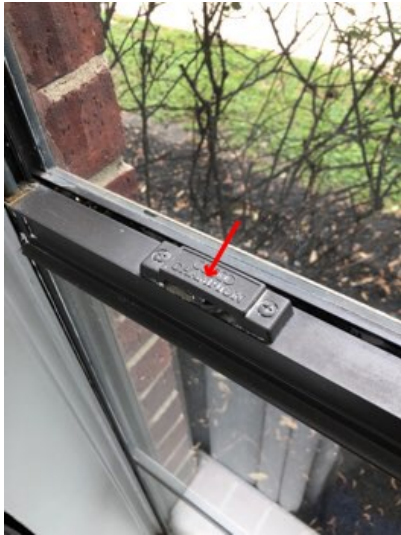
Multiple locations where the window hardware was damaged.

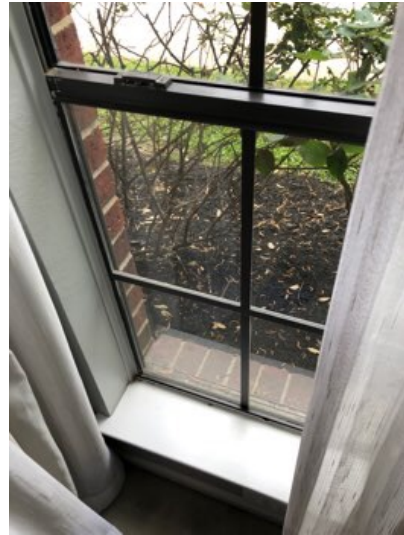
Missing window screens for the windows at the front and right of the house.

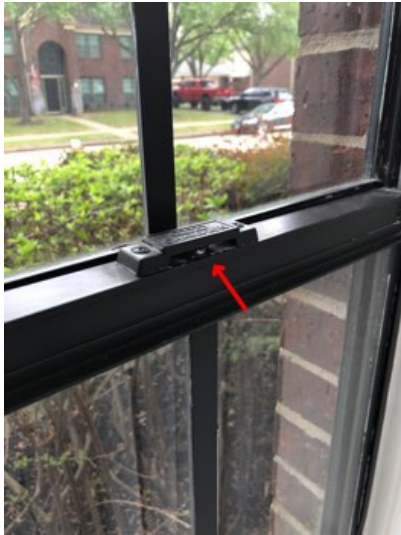
Multiple locations where the window hardware was damaged.

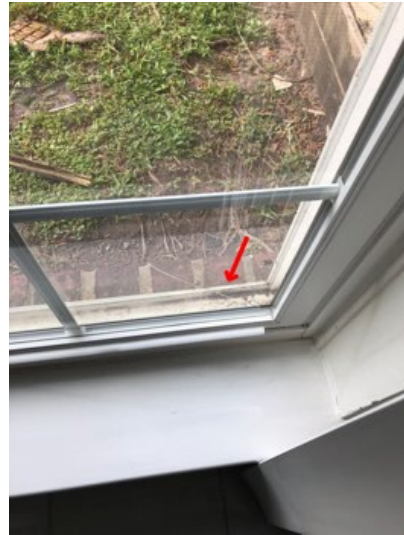
Cracked window panes were observed at the first floor living room.

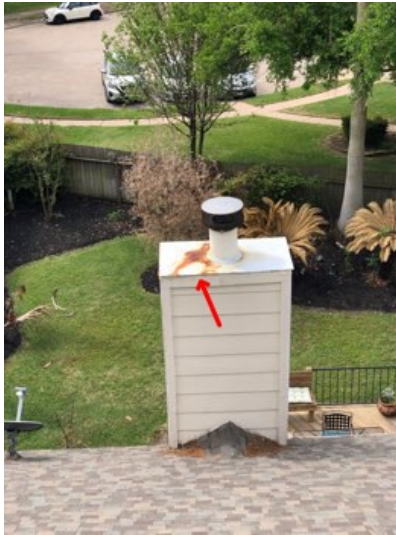
The chimney cap was rusted.

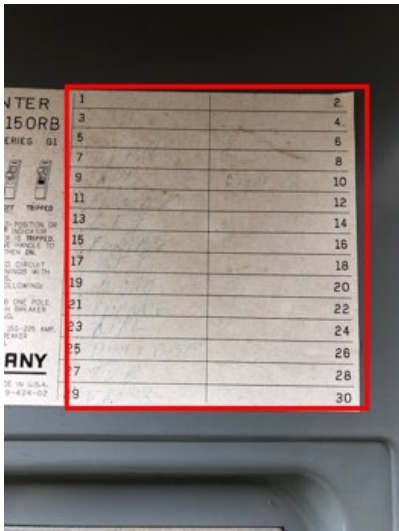
The circuit labels are worn and difficult to read.

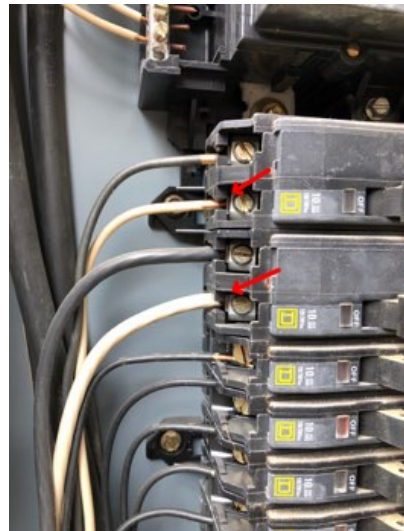
There are white wires in the panel that should be labeled as hot wires.

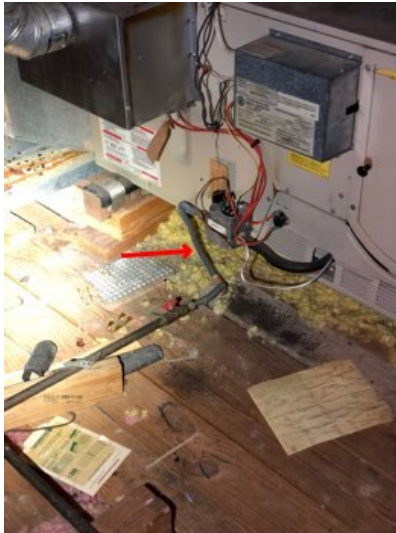
Missing drip legs on the gas lines for both units. These help prevent sediment in the gas line from entering the units.

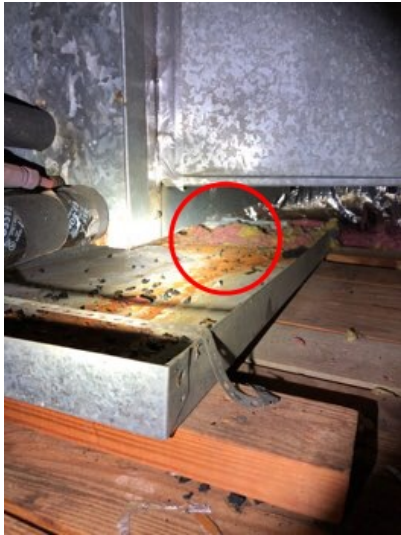
There was rust and insulation inside one of the drain pans.

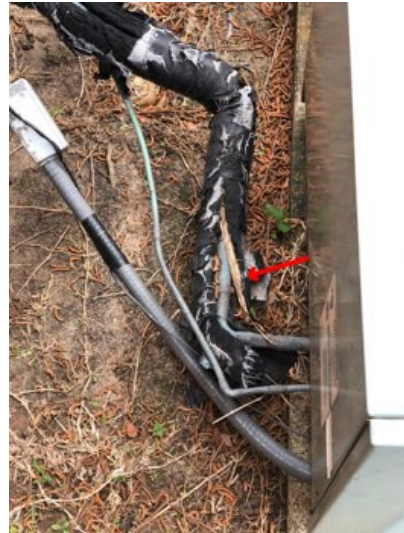
The insulation on the refrigerant lines was deteriorated.

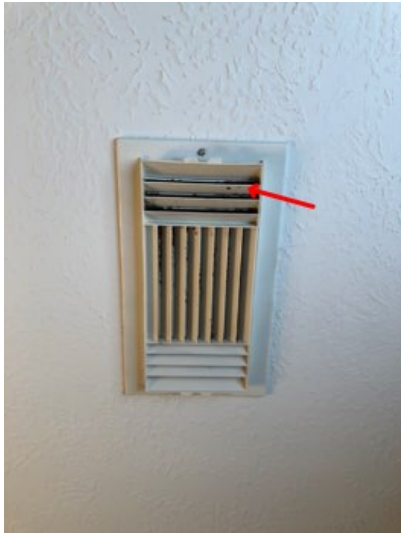
There was a dark substance on the registers on the second floor. This can be due to an excessive amount of humidity in the system at times.

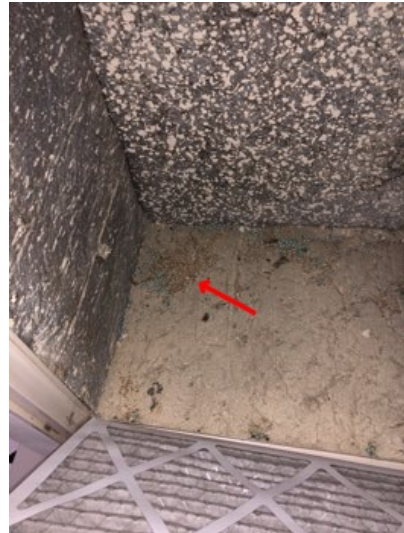
There was dust inside the return chase on the first floor.

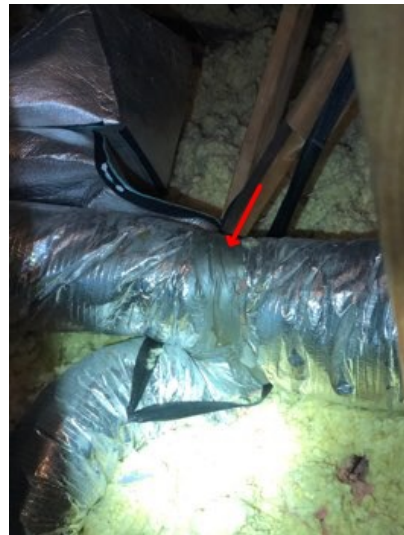
Improper tape was used on the ducts.

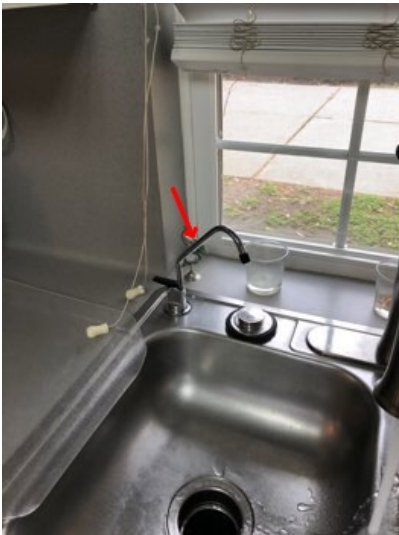
The pot filler in the kitchen did not work.

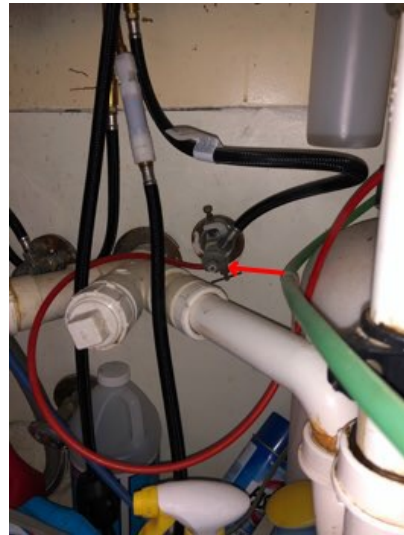
Missing shut off handle underneath the kitchen sink.

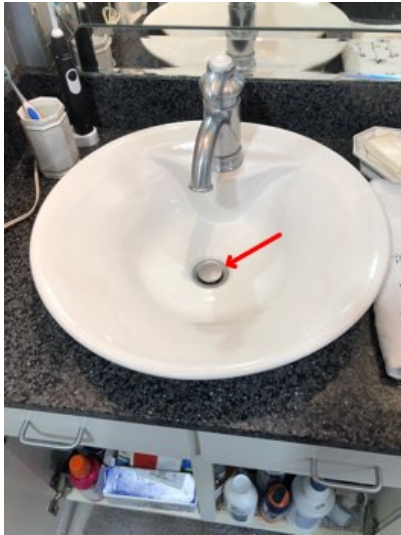
The drain stop did not properly hold water in the primary bathroom left sink.

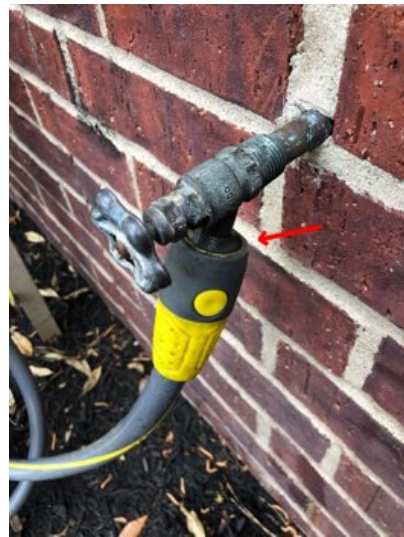
Missing backflow protectors on the exterior water faucets.

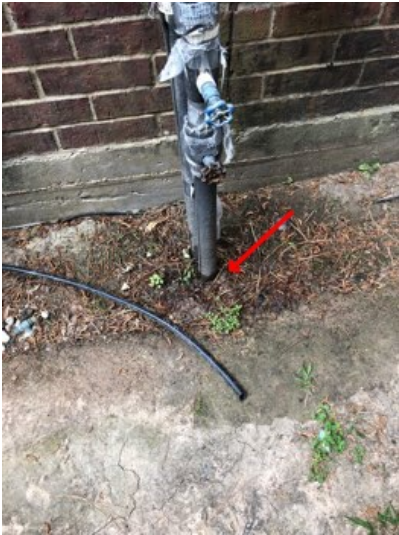
There was a leak from the piping on the left side of the house.

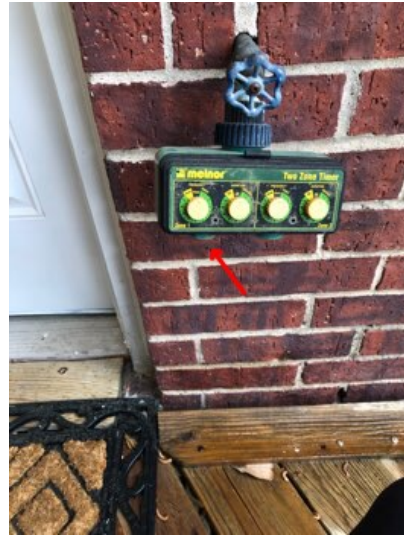
An exterior water faucet was dripping at the rear of the house.

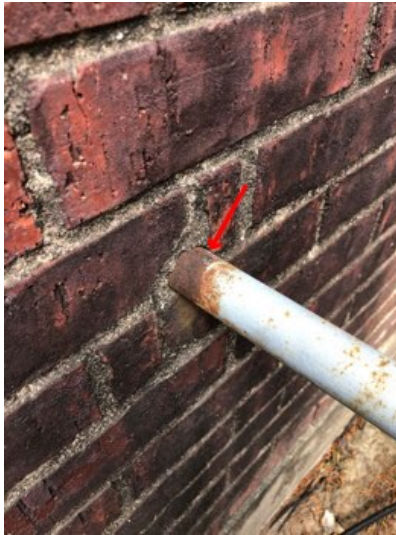
The gas service line entering the house was rusted.

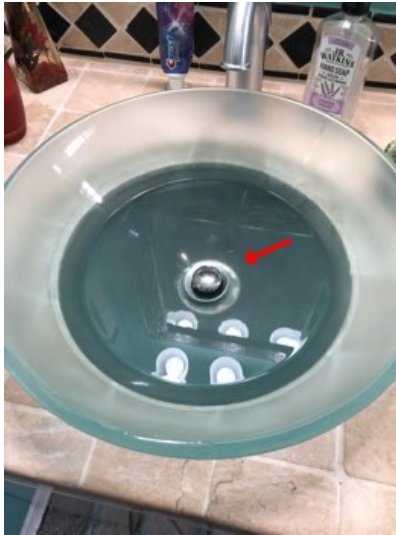
The second-floor bathroom left sink drained slowly.

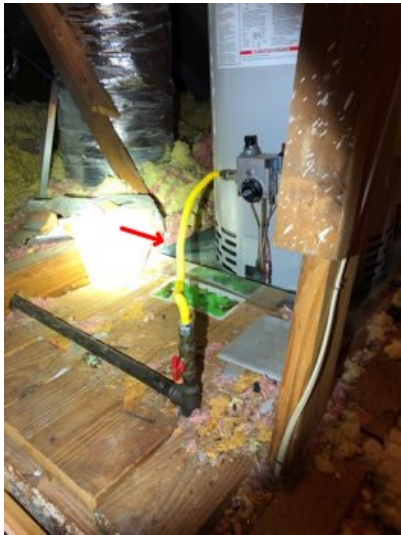
Missing drip leg on the gas line for the water heater. This helps prevent sediment in the gas line from entering the unit.

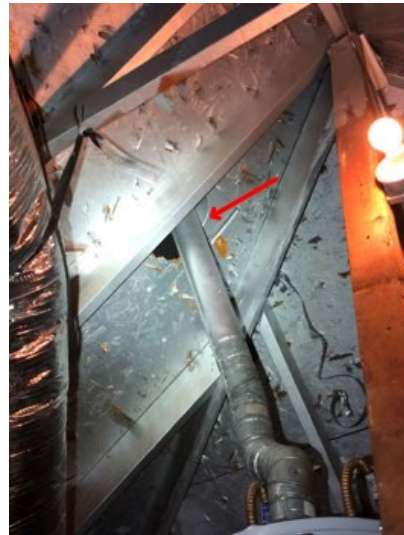
Missing vent pipe strap for the water heater vent.

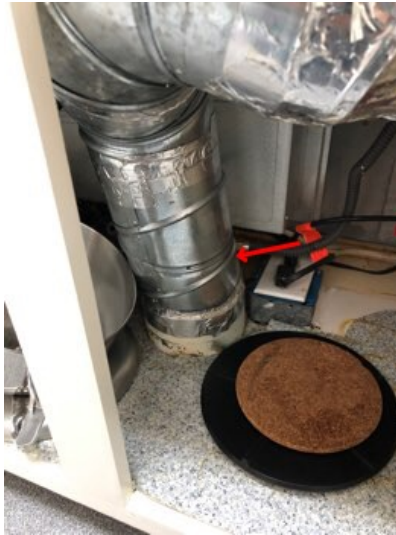
There was an air leak from the range hood vent.

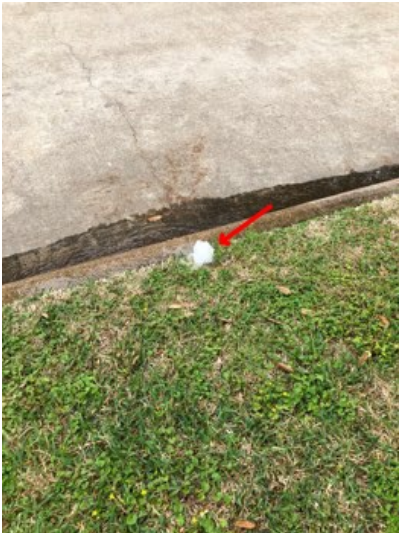
Multiple locations where the sprinkler heads were broken.

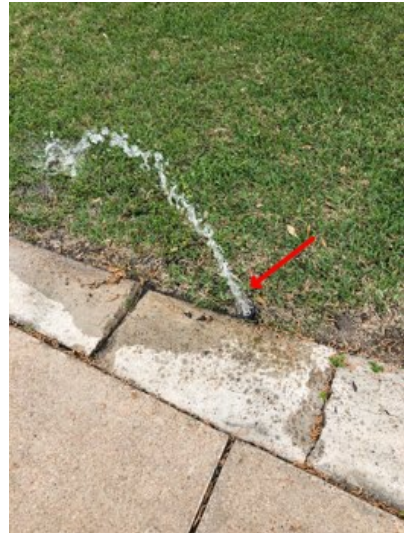
Multiple locations where the sprinkler heads were broken.

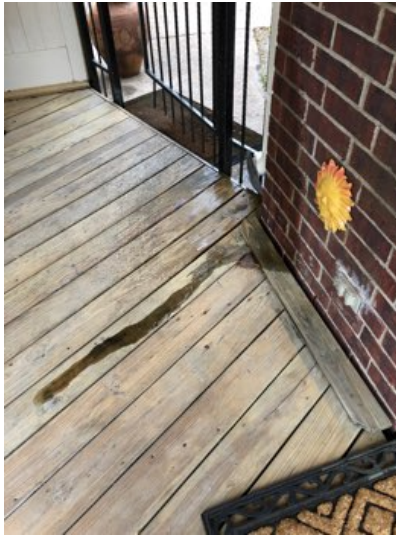
There were sprinkler heads underneath the deck.
