RedFish Inspections

Property Inspection Report

10 Bishops Ct, Sugar Land, TX 77479
Inspection prepared for: Lenre Ikpeekha
Real Estate Agent: Jane Lam - RE/MAX Southwest

Date of Inspection: 5/24/2021 Time: 1:00 PM - 5:00 PM
Age of Home: 30 years old Size: 3890 sqft
Weather: Cloudy

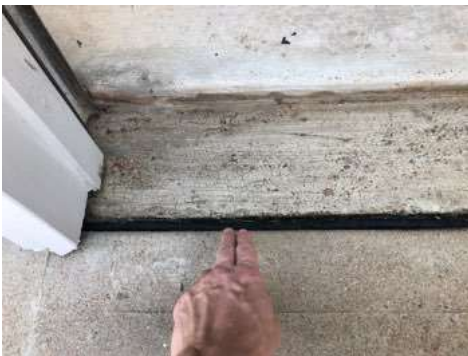
Driveway/walk to foundation:
Monitor area for insect activity

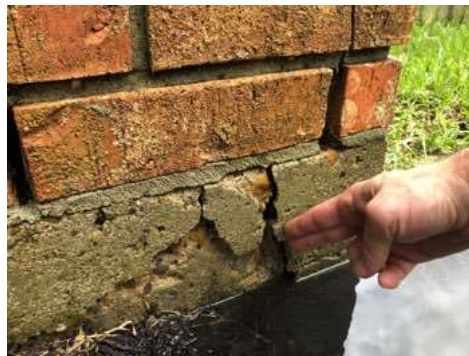
Corner cracks were noted on one or more corners of the foundation. Corner cracks are generally caused by the early removal of form boards and/or improper flashing installation between the slab and the brick veneer/stone veneer. No structural defect was noted with this condition. We recommend having these

cracks patched/sealed to minimize the opportunity of insect infestation. This was observed on the front, rear

Right front: corner crack

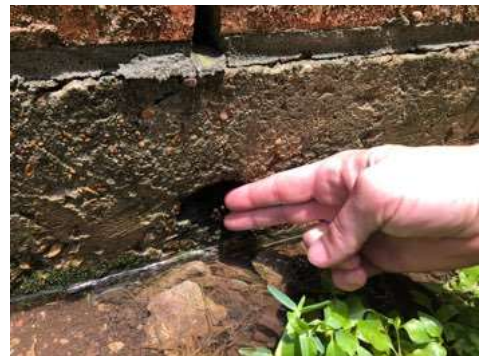
Post tension cable ends were observed on the exterior of the foundation. These should be repaired by a professional, competent and qualified foundation specialist to prevent corrosion/deterioration of the foundation's reinforcement. All exposed tendons should be patched with an approved material and method by the Post Tensioning Institute (PTI).

This was observed on the right.

Right: exposed tendon head

1. The pocket former recesses should be filled with concrete patch material immediately after the tendon tails have been cut.
2. The patch material used should be non-shrink grout that will attain the same minimum compressive strength as the concrete foundation.

3. Prior to installing the concrete patch material, the pocket former recesses should be cleaned of any dirt, grit, oil or other substances so that a good bond is attained between the concrete and the patch material. A bonding agent can be used to enhance bond of the patch material to the concrete; however, it is important that the recommended application instructions from the bonding agent manufacturer are followed.

4. If an encapsulated system is used, the posttensioning material supplier's recommendations for cutting, capping and patching should be followed.
5. Under no circumstances should the concrete patch material used for filling the pocket former recesses contain chlorides or other chemicals known to be deleterious to the prestressing steel.

6. The pocket former recesses should be completely filled eliminating all voids and finished to match as closely as possible the surrounding edge of the foundation.

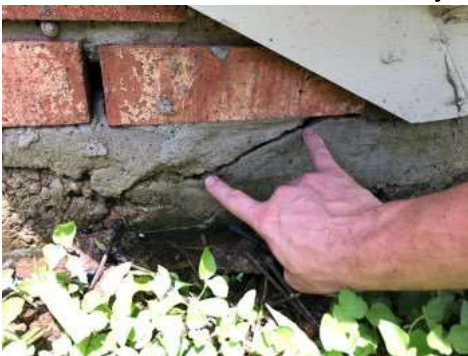
Larger than usual cracks with some displacement were noted in the foundation slab. This could be indicative of foundation movement. We recommend monitoring. This was observed on the right.

Right: crack with displacement

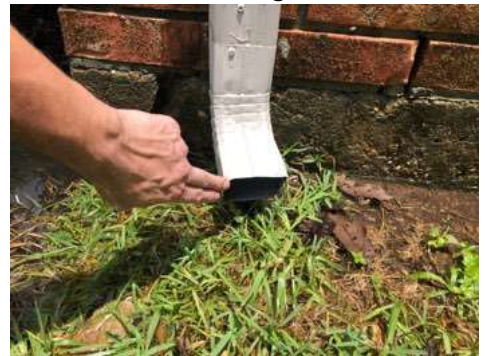
Downspout extension missing, discharge near structure

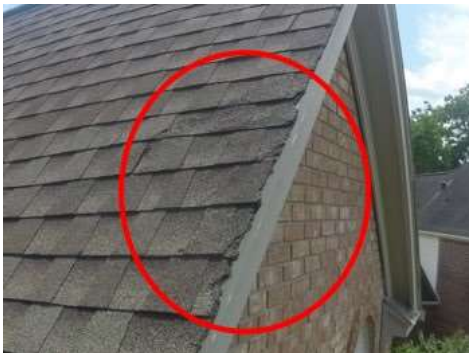
Front: damaged shingles

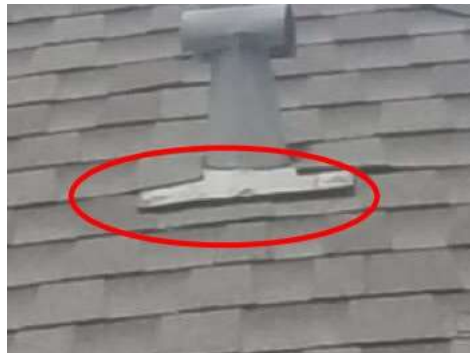
Loose or uplifted flashing was noted on the roof. We recommend having this secured to avoid water intrusion. This was observed on the right, and rear.

Right: uplifted flashing

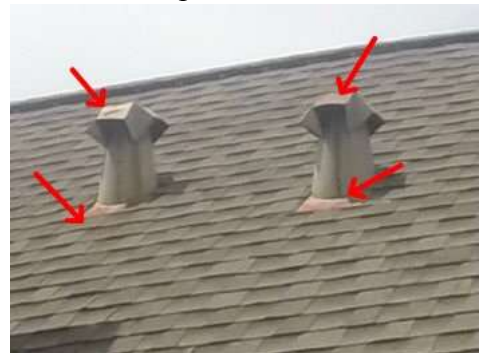
Corrosion was noted on the flashing in multiple areas of the roof. We recommend having these areas cleaned, treated and painted to prevent them from further deteriorating.

Rust on flashings

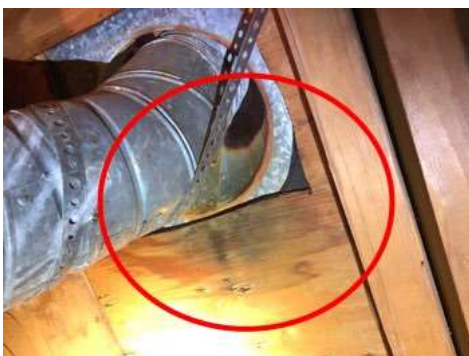
Moisture stains

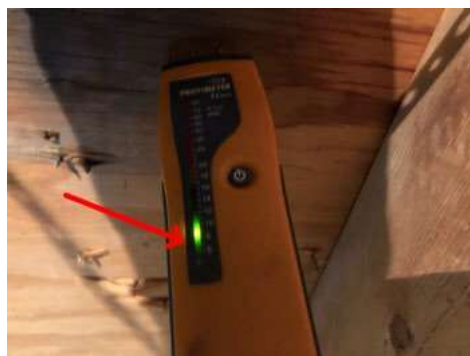
Moisture stains confirmed dry

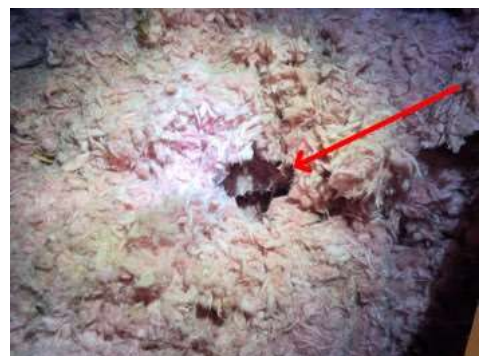
Vermin and other pests are part of the natural habitat, but they often invade homes. Rats and mice have collapsible rib cages and can squeeze through even the tiniest crevices. And it is not uncommon for them to establish colonies within crawlspaces, attics, closets, and even the space inside walls, where they can breed and become a health-hazard. Therefore, it would be prudent to have an exterminator evaluate the residence to ensure that it is rodent-proof, and to periodically monitor those areas that are not readily accessible.

Tunneling: evidence of vermin activity

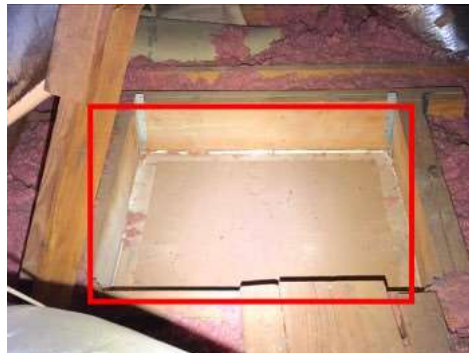
Scuttle panel lacked insulation

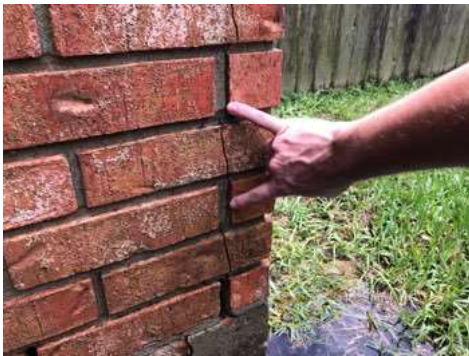
Right front: step crack

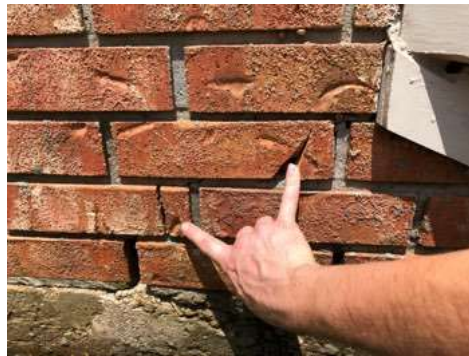
Right: step crack

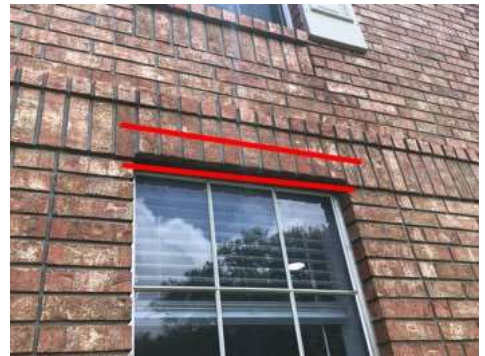
Front: missing weep holes

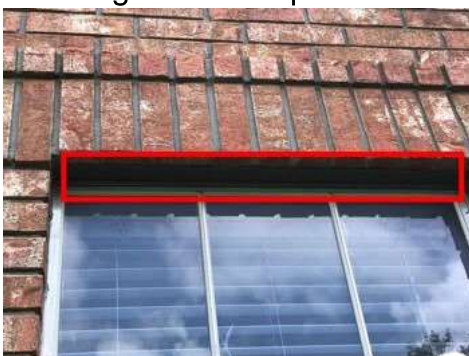
Front: rust on lintels

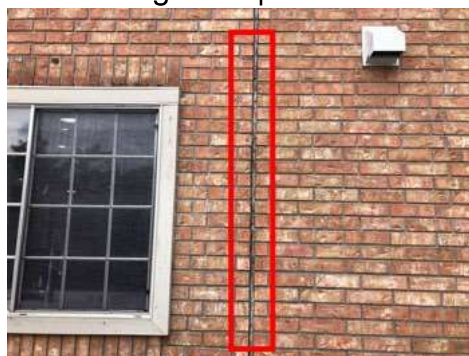
Left: missing caulk at expansion joint

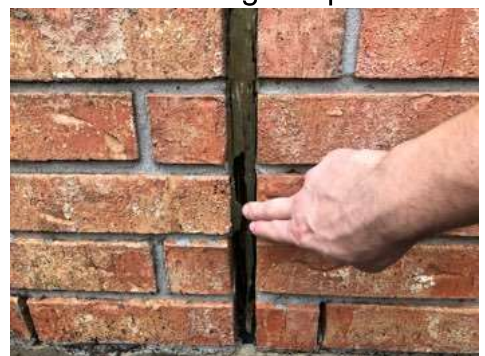
Left: wood decay at expansion joint spacer

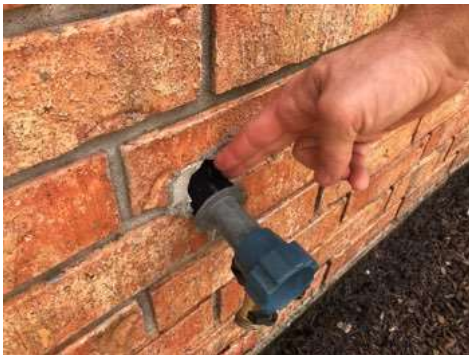
Around house: caulk needed at wall protrusions

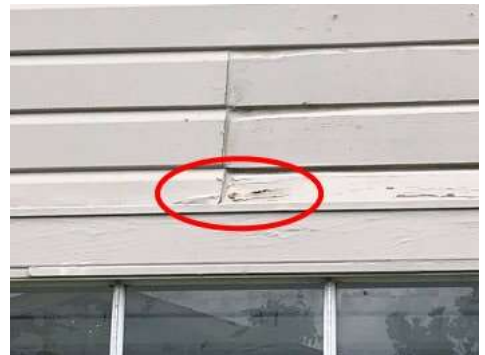
Rear: wood decay at siding

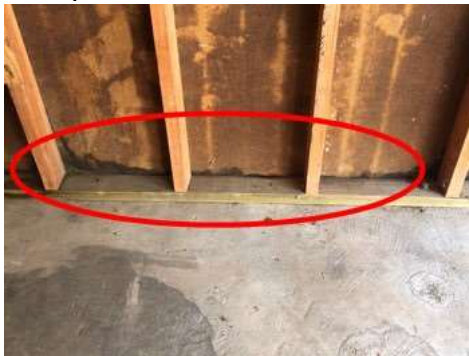
Moisture staining was noted and the area was confirmed with a moisture meter and infrared thermal Imager to have elevated moisture. We recommend repairs to the problem water source prior to repairs to the interior finish. This was observed in the garage.

Garage: moisture stains

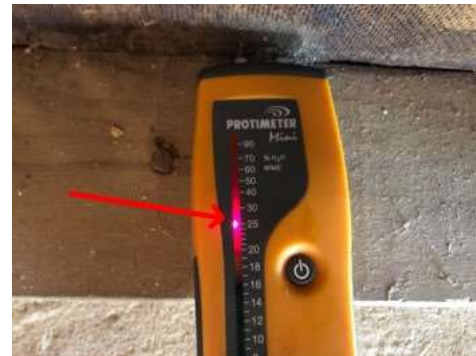
Garage: moisture stains confirmed wet

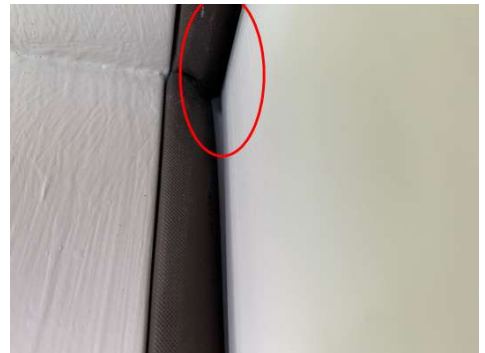
Back door: did not close flush.

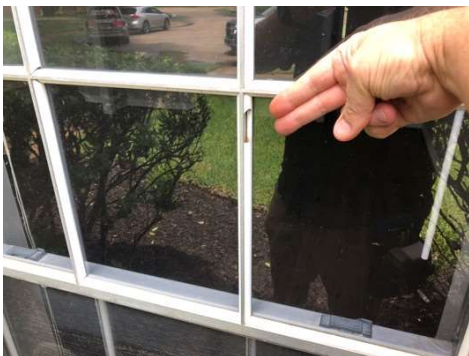
Around house: Damaged weather stripping

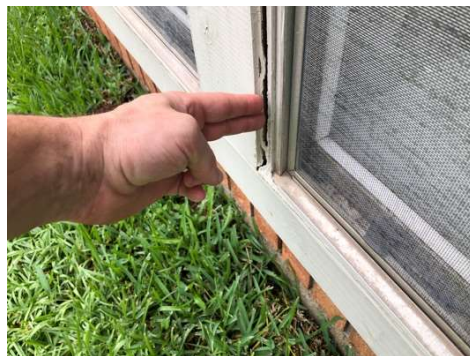
Around house: deteriorated caulk

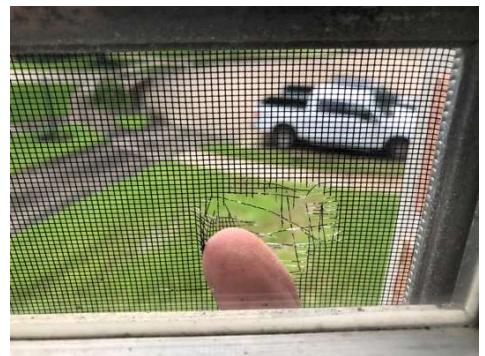
Throughout house: Damaged screen

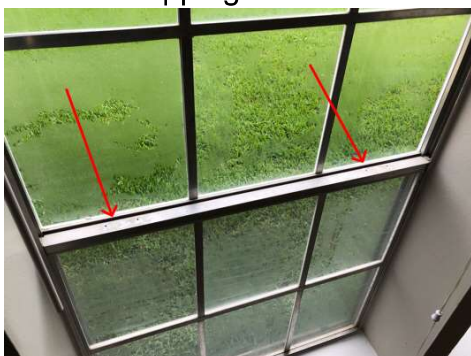
Window hardware was missing. We recommend having them replaced. This was observed throughout the house .

Windows Throughout house: missing hardware

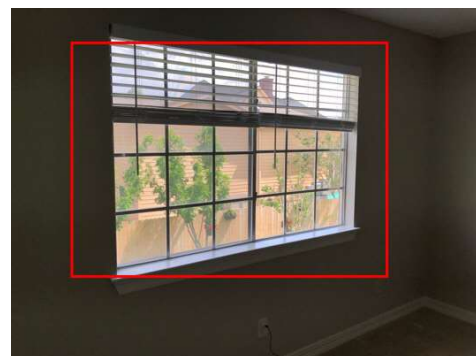
A window was inoperative. We recommend having this repaired/improved to allow proper use as intended and an egress. Observed in Bedroom 3 and Bedroom 4.

Bedroom 3 and Bedroom 4: windows inoperative

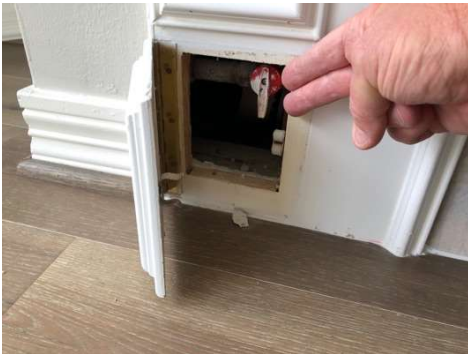
No locking mechanism on valve hatch

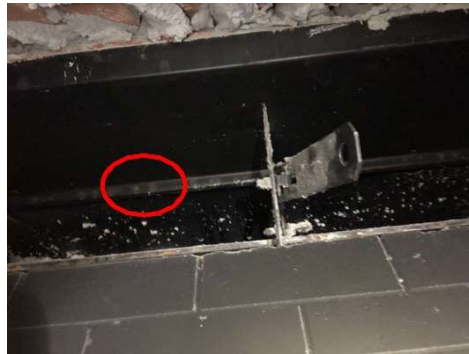
The fireplace damper was missing a clamp to prevent the damper from completely closing. Gas fireplaces should have a clamp installed on the damper to allow gases to escape up the flue in the event of a gas leak.

Flue open, missing clamp

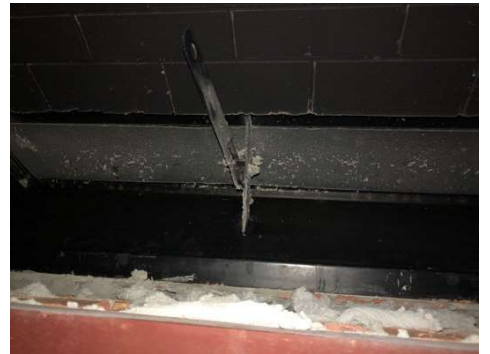
Flue closed: Clamp missing on damper

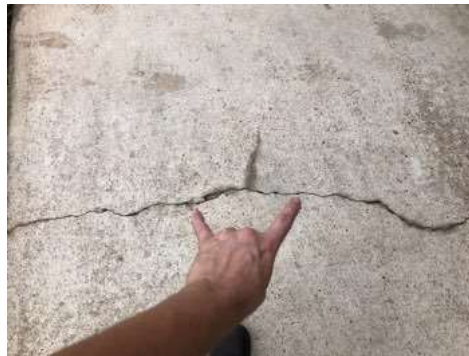
Hairline cracks were observed in the porch slab. These are not uncommon, where under 1/4 inch wide and should be monitored.

Back porch: hairline crack

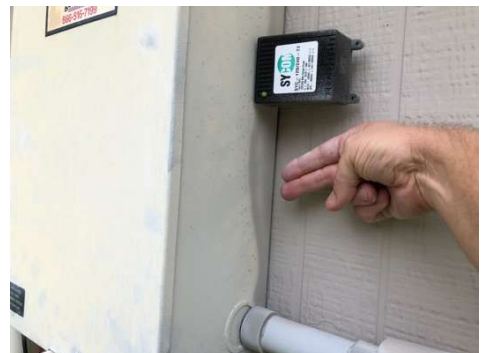
Service panel : Caulk missing at wall connection

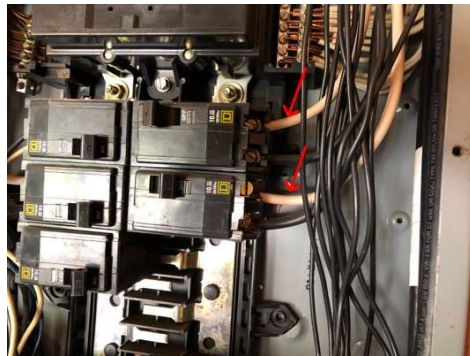
Sub panel : improperly color coded conductors

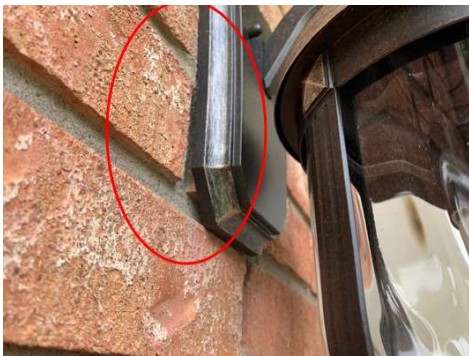
Around House: Caulk missing at fixture to wall connection

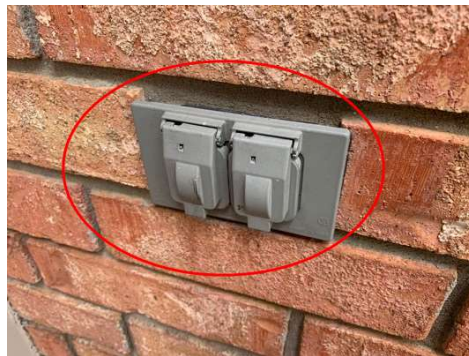
Today's standards require having a bubble cover on all exterior receptacle outlets exposed to the elements. We recommend making the upgrade.

Exterior: Bubble cover recommended

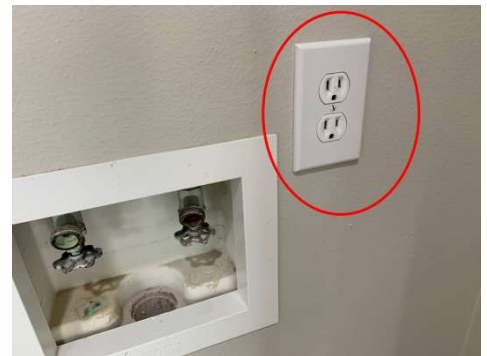
A receptacle outlet was found to not be protected by a Ground Fault Circuit Interrupter (**GFCI**) receptacle. Today's standards require GFCI protected outlets be installed at all 120 and 240 volt circuits at the kitchen counters/islands, laundry rooms, in basements, crawlspaces, garages, the home exterior as well as any interior receptacles located within 6 feet of a plumbing fixture as measured by flexible cord, to avoid potential electric shock or electrocution hazards. We recommend having this repaired per today's standards. This condition was observed in the Laundry Room.

Laundry Room: outlet not GFCI

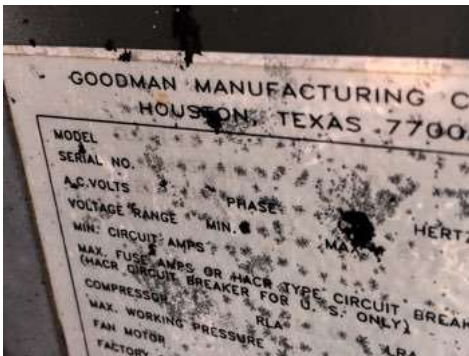
Condenser unit 1 model and serial numbers faded

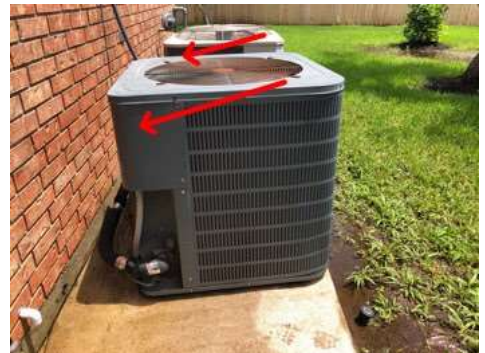
Both units: out of level

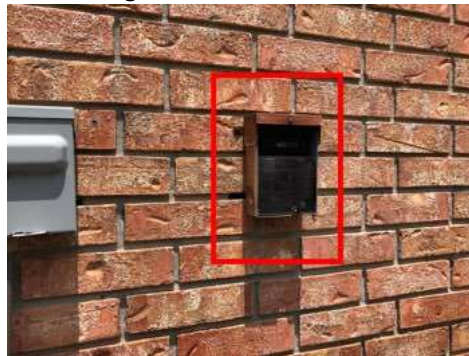
Unit 2: missing deadfront at disconnect

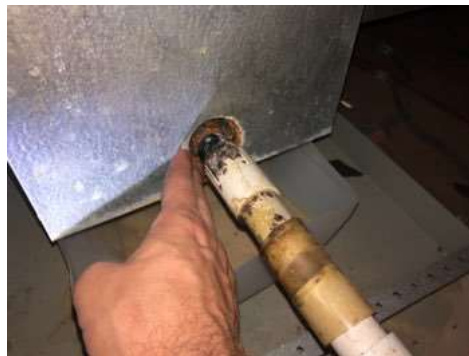
An air leak was noted at the evaporating coils cabinet. We recommend having this sealed for improved efficiency. This was observed at both units.

Unit 1: air leak at cabinet

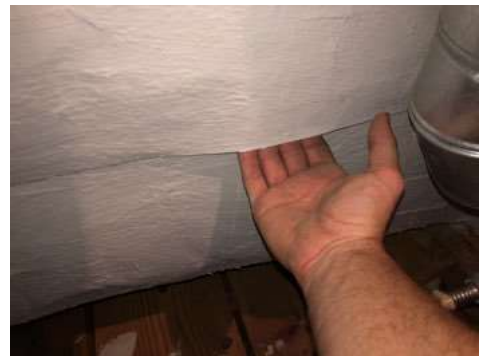
Unit 2: air leak at cabinet

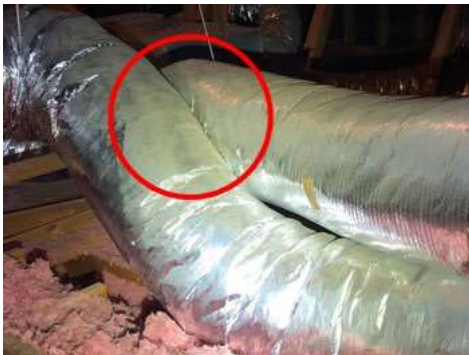
Ducts in contact

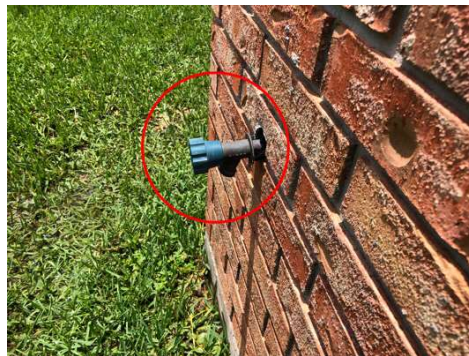
Around house: Missing back flow preventer

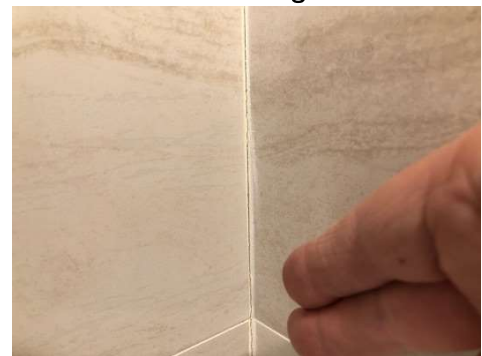
Deteriorated caulking/grout was noted, which may allow damage from moisture intrusion of the wall assembly at a bathroom. We recommend having this recaulked. We observed this in bathroom 2 and bathroom 3.

Bathrooms: cracked grout

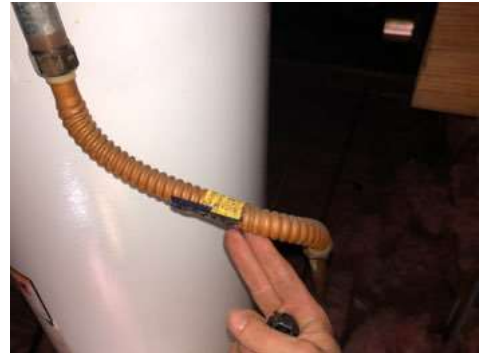
Both units: Improper material for TPR extension pipe

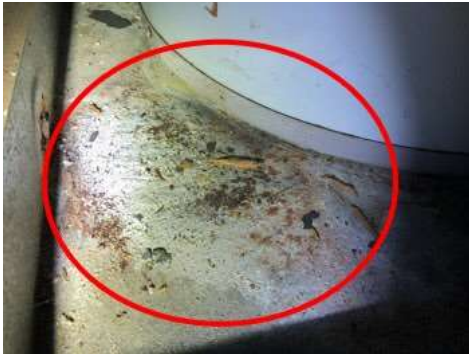
Both units: debris in safety pan

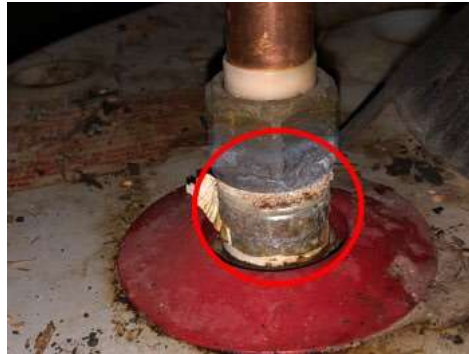
Both units: corroded fittings

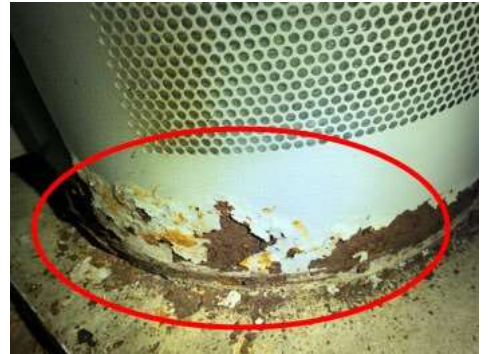
Unit 1: corroded tank

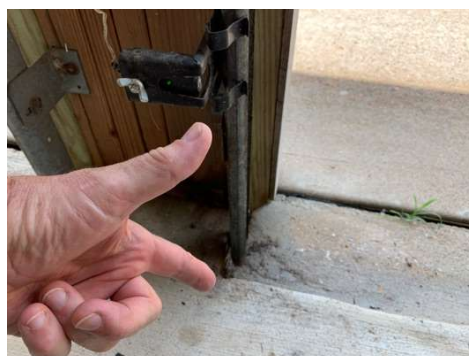
Photo eye sensor more than 6" off ground

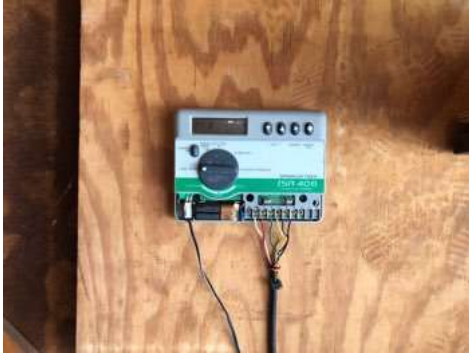
multiple attempts to get the system to operate in the manual mode, we were unable to successfully test the sprinkler system. We recommend having this further evaluated and repaired as needed.

Garage: controls to sprinkler system
