## PROPERTY INSPECTION REPORT

**Prepared For:** WEI LIU SHEN  
(Name of Client)

**Concerning:** 10 BISHOP COURT, SUGARLAND, TX 77479  
(Address or Other Identification of Inspected Property)

**By:** Jayant Patel, Lic #Texas Real Estate Commission # 8050 05/31/2021  
(Name and License Number of Inspector) (Date)

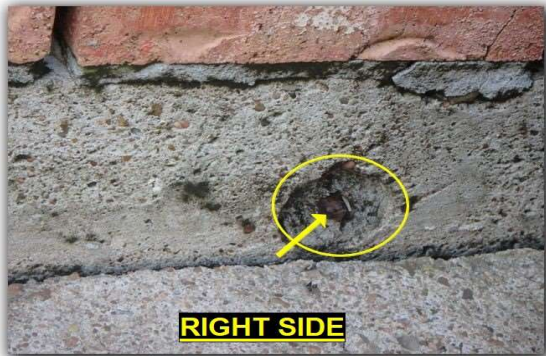
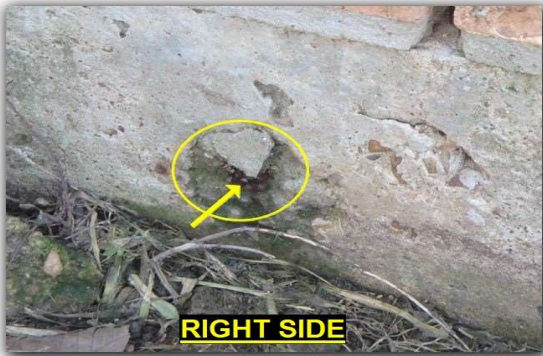
Post tension cable ends: Right side foundation perimeters: Most cable ends were exposed, that need to be covered with cement to prevent further corrosion of cables.

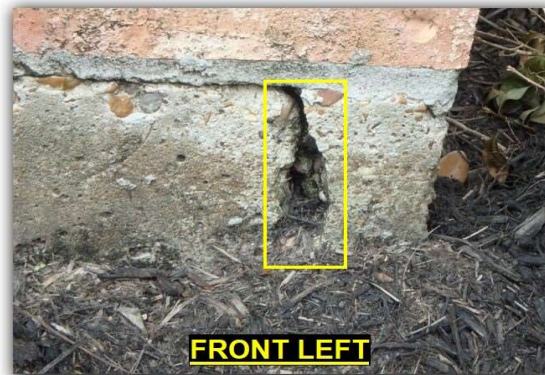
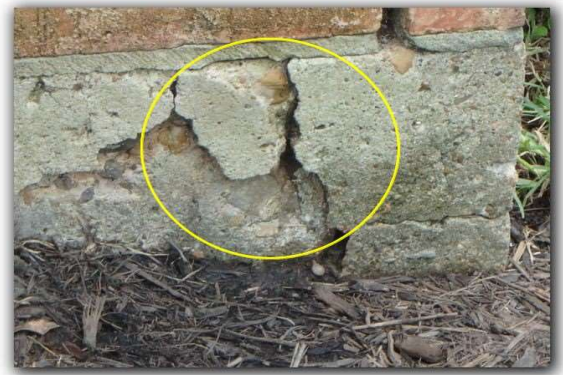
Spallings were observed on some foundation perimeter corners, such as on front left and right corners. Spallings are more of cosmetic in nature and are structurally insignificant.

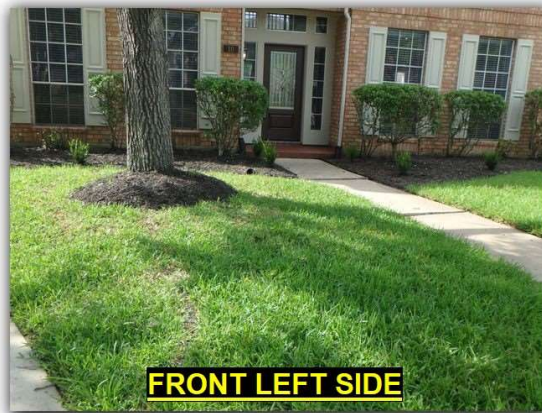
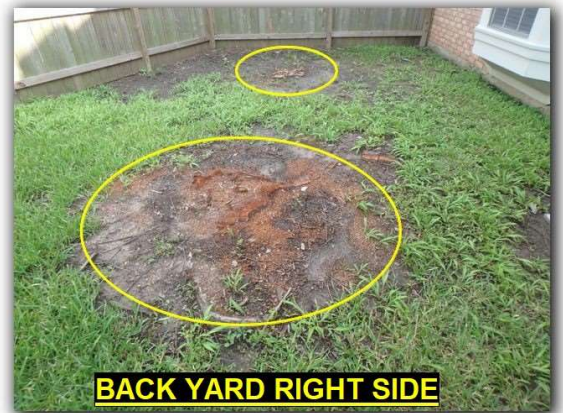
Right side: Some trees appeared to be cut on right side of the home. The soil appeared to be moist. Please note that in the long run, the tree roots are known to affect the foundation integrity and tree branches would deteriorate the roof tops.

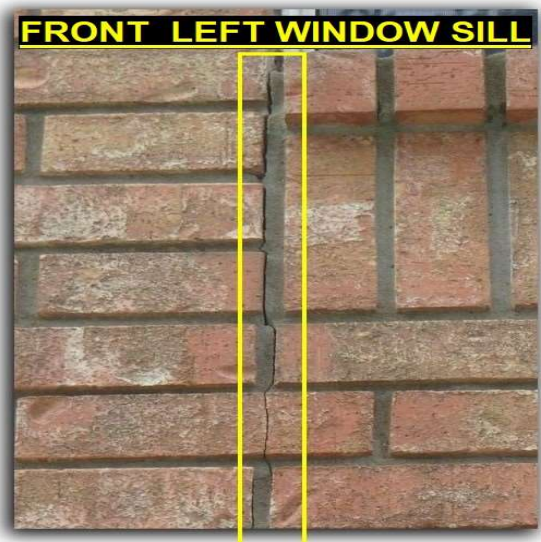
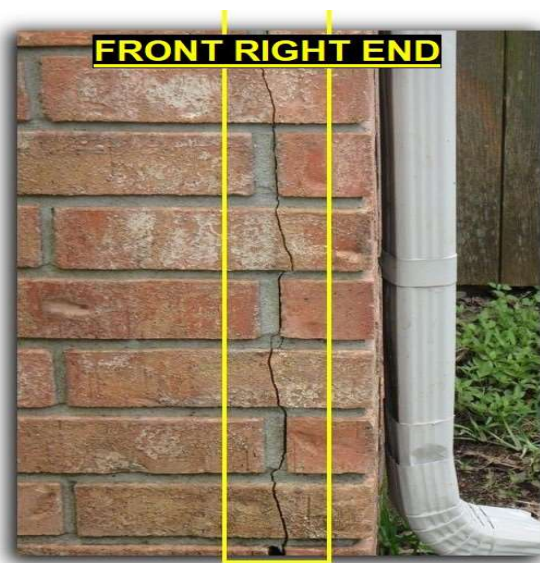
Brick veneer cracks: Front left window sill and front right corners: Minor vertical cracks were observed.

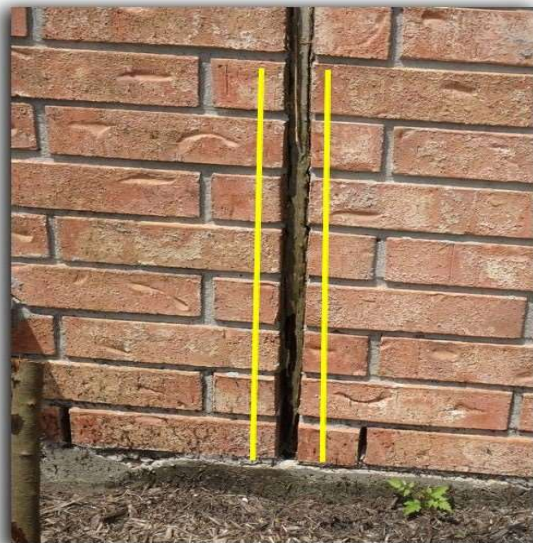
Expansion joints: The expansion joints to be caulked in bottom section on both the sides.

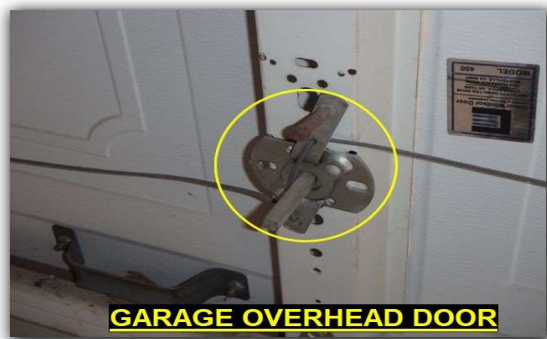
Garage Overhead Door: Right - Manually operated door: The door latch handle was missing. It could be hard to manually operate this door. There was no garage door opener for this overhead door.

Garage Overhead Door: Manually operated door: The door latch handle was missing. It could be hard to manually operate this door. There was no garage door opener for this overhead door.

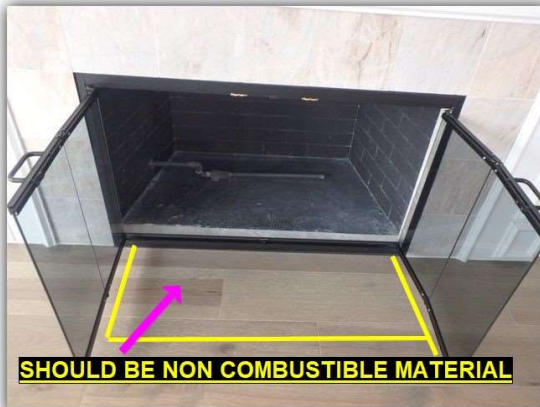
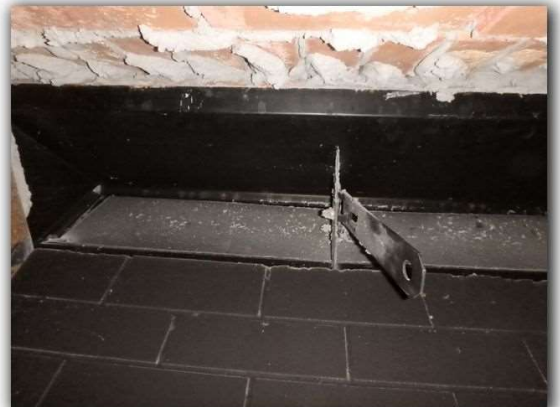
Hearth: Hearth is a non combustible material required around the fireplace to prevent fire hazard. The fireplace is required to have hearth on top, bottom, and on both the sides of the fireplace. Hearth is also required on front of the fireplace. This fireplace lack the hearth on front of the fireplace (should be non combustible material). Please note that this is a fire hazard.

fireplace is required to have hearth on top, bottom, and on both the sides of the fireplace. Hearth is also required on front of the fireplace. This fireplace lack the hearth on front of the fireplace (should be non combustible material). Please note that this is a fire hazard.

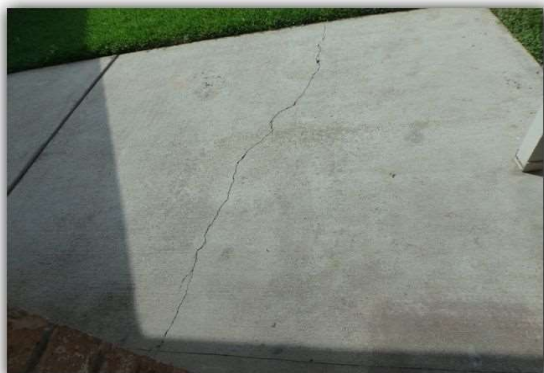
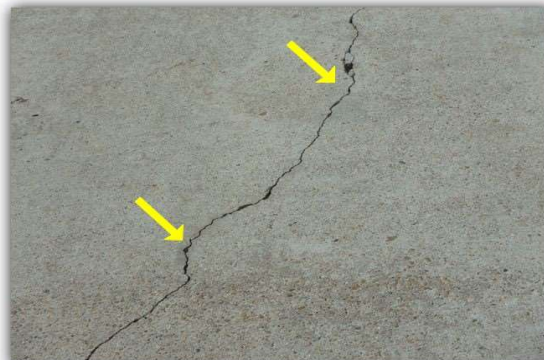
Patio: Some cracks were observed in concrete blocks.

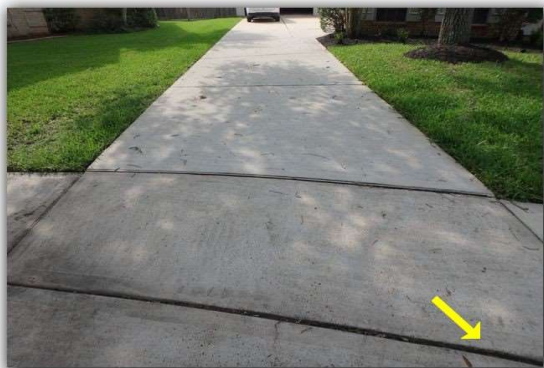
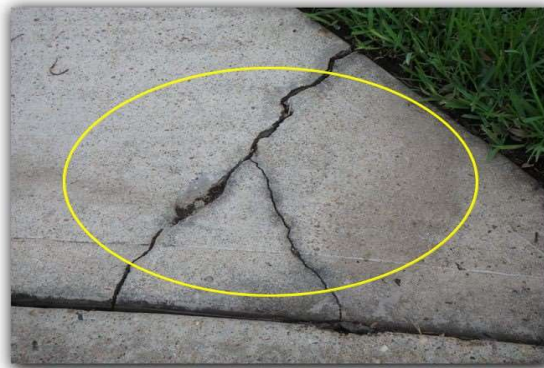
Drive Way: One concrete block at front, by curb side was cracked.

One concrete block at front, by curb side was cracked.

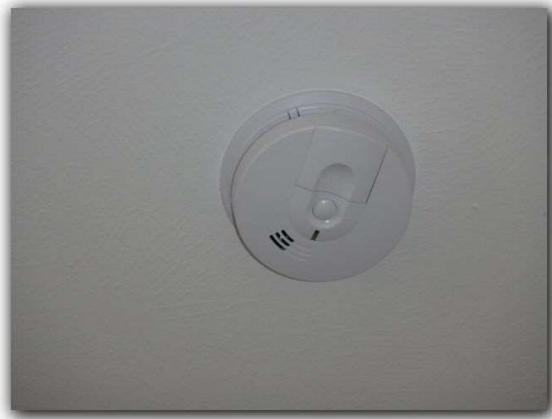
Smoke Alarms: Installed only in hallways,  
Install smoke alarms. Smoke alarms are required in each sleeping room.

Install Carbon Monoxide alarms: Carbon monoxide alarms are required on each floor, and in the hallway / vicinity of the sleeping room areas.

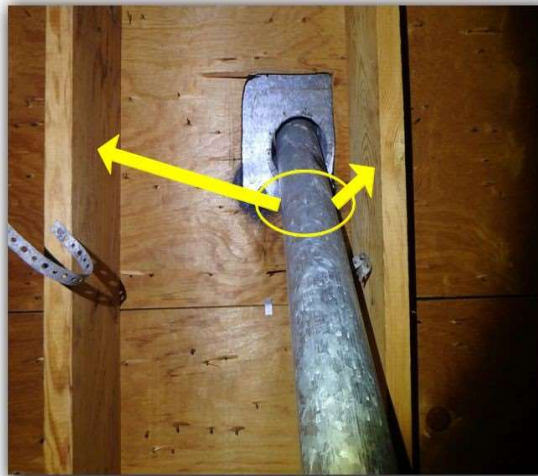
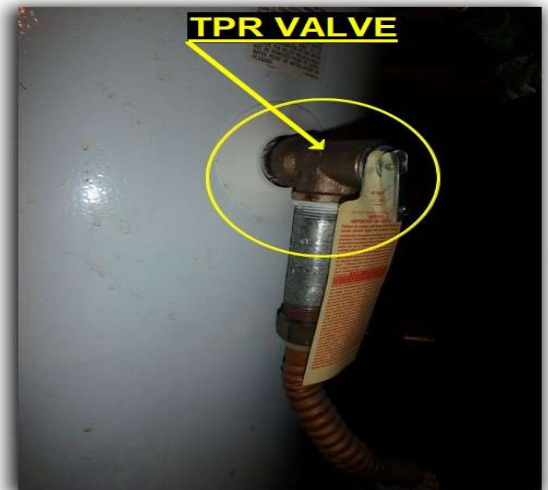
Temperature and Pressure Release valve: The TPR valve was jammed and was not operational. Please also note that a leaking TPR valve could significantly damage the property especially if the Water Heater units are located in the attic.

Exhaust duct: To be strapped / fastened to the roof structure. (the strap was broken)  
Please note that this is a safety requirement.

Exhaust duct: To be strapped / fastened to the roof structure. (the strap was broken). Please note that this is a safety requirement.

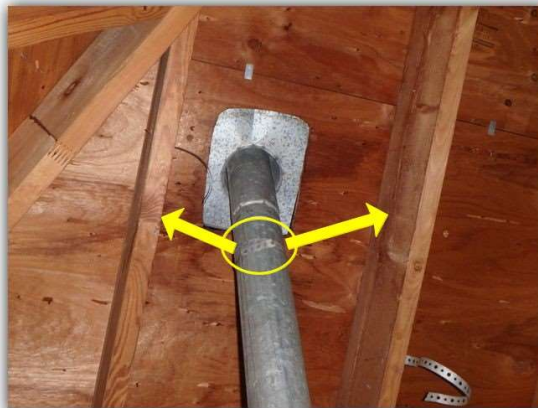
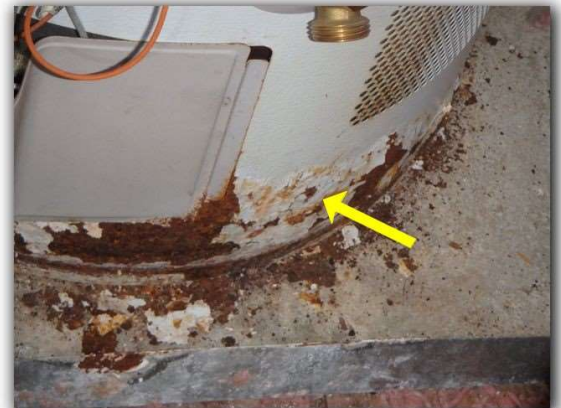
Temperature and Pressure Release valve: The TPR valve was jammed and was not operational. Please also note that a leaking TPR valve could significantly damage the property especially if the Water Heater units are located in the attic.

Exhaust duct: To be strapped / fastened to the roof structure. (the strap was broken)  
Please note that this is a safety requirement.

Bottom of the unit was corroded.

Exhaust duct: To be strapped / fastened to the roof structure. (the strap was broken). Please note that this is a safety requirement.
