PROPERTY INSPECTION REPORT

Concerning: 1921 Woodbury Street, Houston, Texas 77030

By: Alan C. Chang TREC #6270 / Texas HomeSpection Inc. 5/14/2021

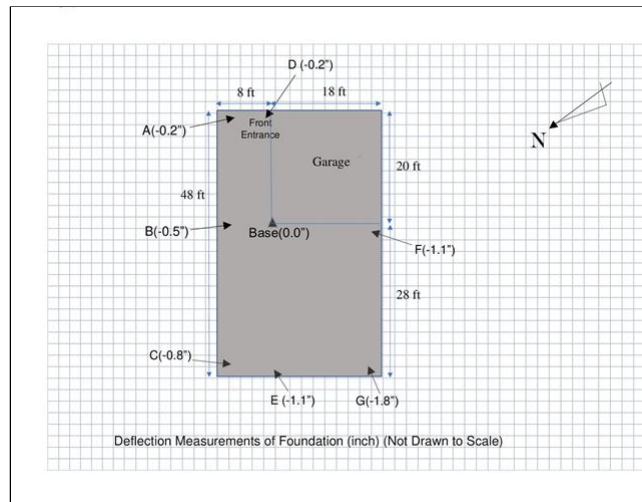
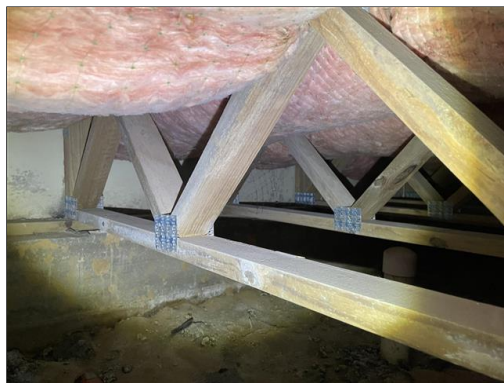
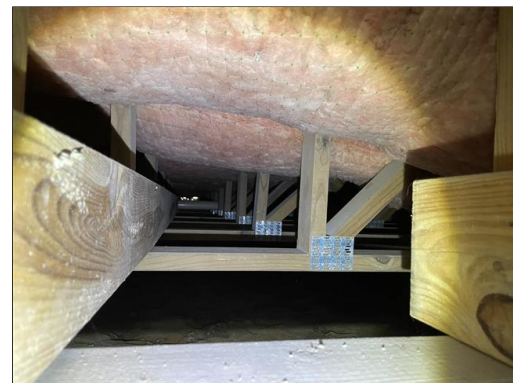
The raised engineered floor-truss foundation is performing its intended function. No visible portion of cracks found at perimeter of concrete/brick skirts. All gusset plates are present at connected truss members. There is no visible foundation-induced conditions on the exterior brick veneer walls indicating excessive structural movements. Crawl space is inaccessible due to the truss members block the space. Based on IBC 2012, Section 1604.3, 20-foot span (L), deflection of up to 1.0 inches in a single floor member would be permissible per the IBC. The maximum deflection reading, 35 feet from referenced base, in the house using Smart Leveler is 1.8 inches within acceptable range (see picture).

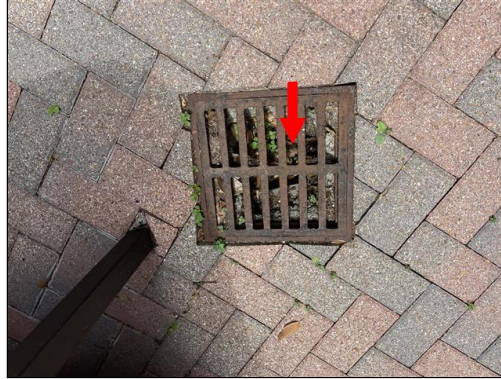
B. Item 1(Picture)

Debris and tree leaves in the catch basin of backyard need cleaning to prevent blockage of the drain to storm sewer.

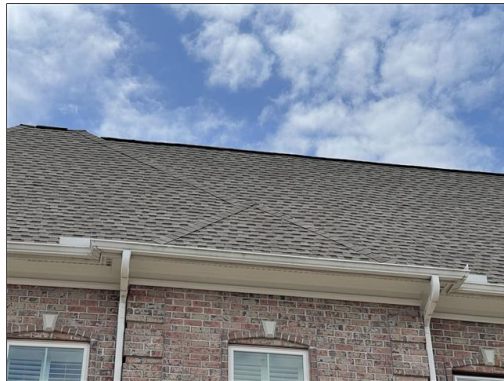
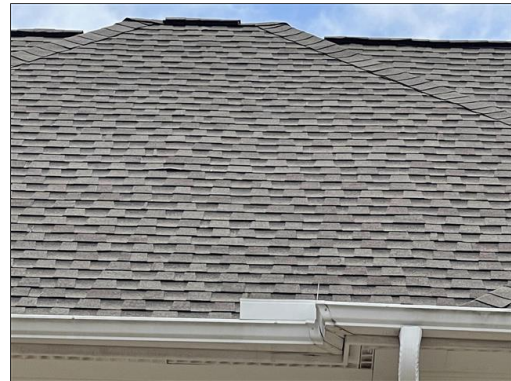
Architectural roof shingles appear normal and perform as intended. The life expectancy of a composition roof can be ranged from 15 - 30 years, depending on the quality of the material, roof ventilation, solar and wind exposure and installation. The low-end shingle is normally around 15 years. Shingles labeled as 30 year life expectancy used to last approximately 20-25 years in the Houston area.

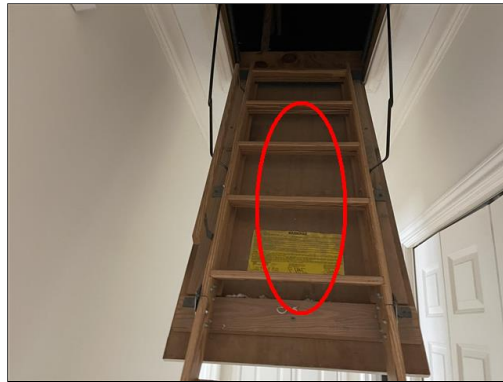
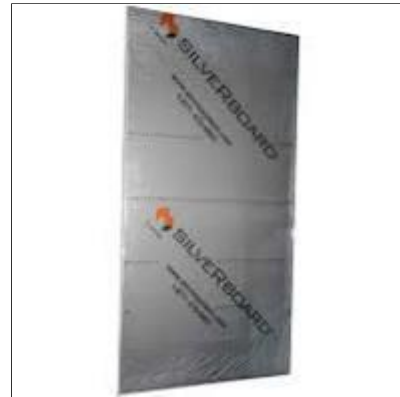
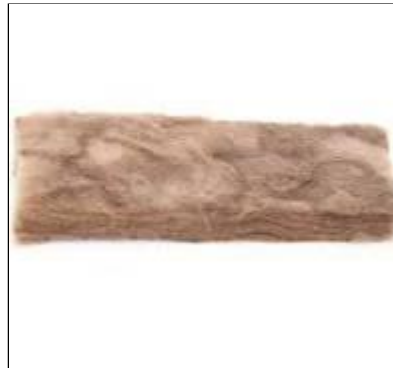
(1) The purlin and brace structural systems in the attics appear normal. Ventilation is

created by ambient outside air entering into the attic space via soffit or eave vents and exiting the attic via roof vents. Based on the IRC 2012, the minimum vent area is 1 sq.ft. net free ventilation area for every 150 sq.ft. of attic floor space. The current attic floor area is approximately 1,200 sq.ft. and the required minimum vent area is 8 sq.ft. The current attic ventilation area present with soffit vents, ridge vents, and power vent appear to be adequate.

(2) Missing insulation noted on attic access door. Recommend install form board insulation or batt insulation to prevent energy loss.

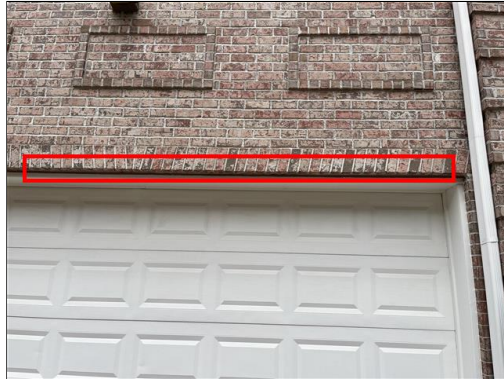
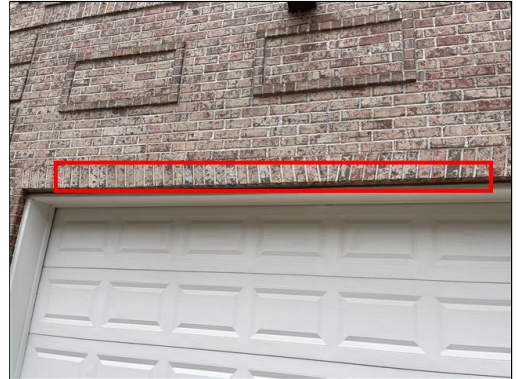
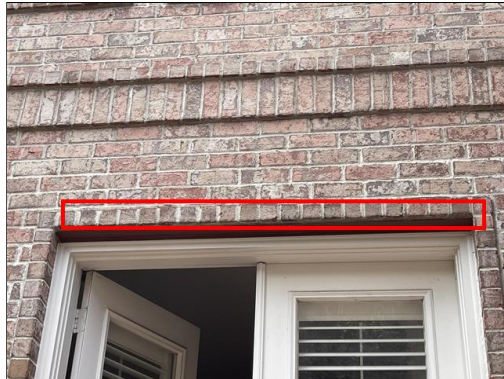
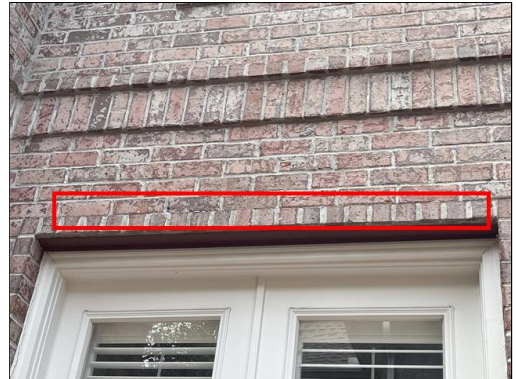
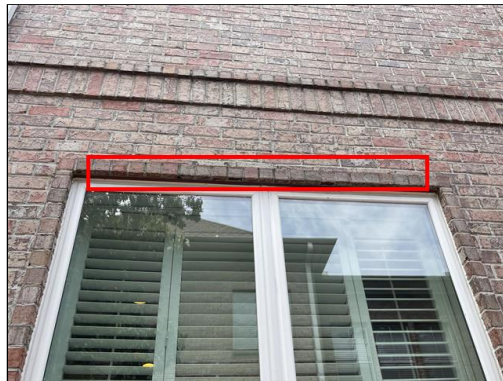
No weep holes are provided in the brick veneer wall above overhead garage door and exterior door and windows. Weep holes are the gaps left at mortar joints in external masonry walls for moisture to escape from internal wall cavity which could prevent wood rot, metal fasteners turning to rust and wood-destroying insects entering wall spaces.

Weep hole (not less than 3/16" in diameter) is required to install every 33 inches according to today's standards IRC 2012 R703.7.6 .

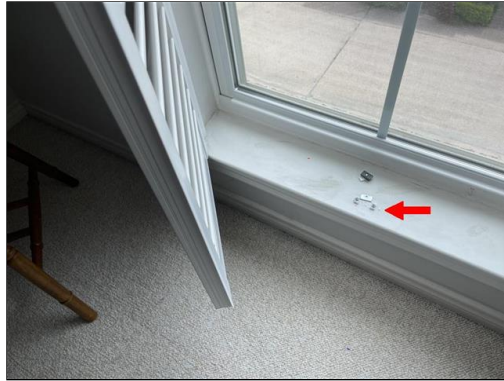
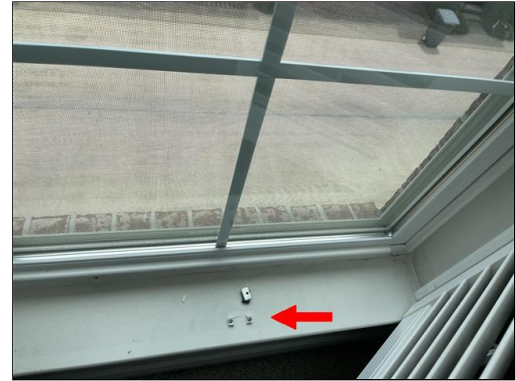
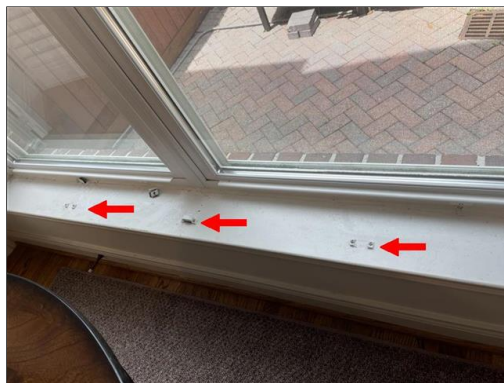
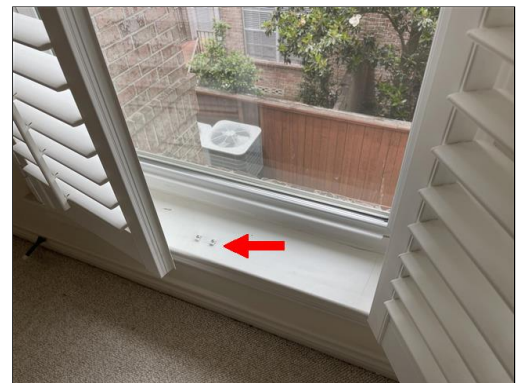
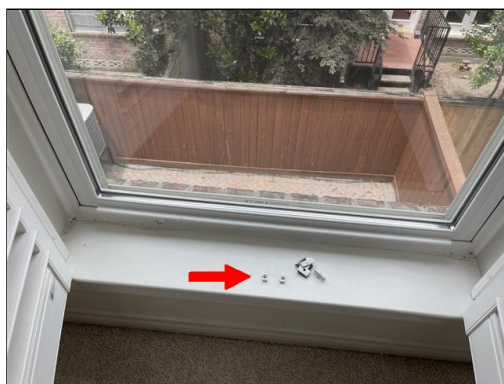
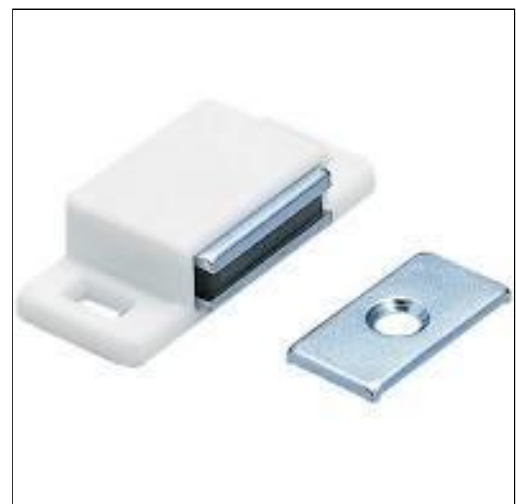
Most magnetic catch of window shutter are either broken or missing and need to screw to the window ledge to keep the shutter closed.

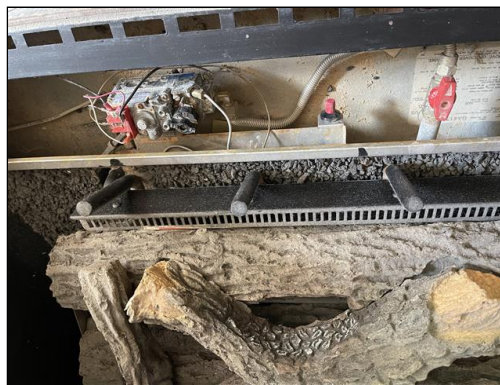
J. Item 1(Picture)

(1) Pilot light is not present when gas valve is on, turning control to Pilot and button click with igniter. The igniter may not function properly. Recommend service by a fireplace technician to ensure it's in working condition.

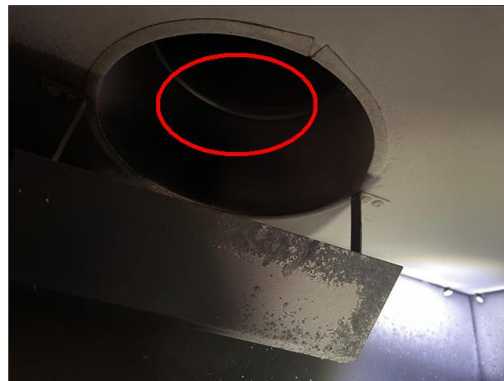
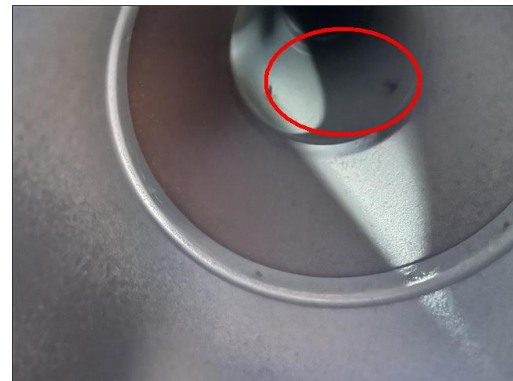
(2) Fireplace damper and damper handle are not present. The damper is a vent that controls airflow in and out of the chimney and make your fireplace run as efficiently as possible. Recommend install a damper to prevent energy loss.

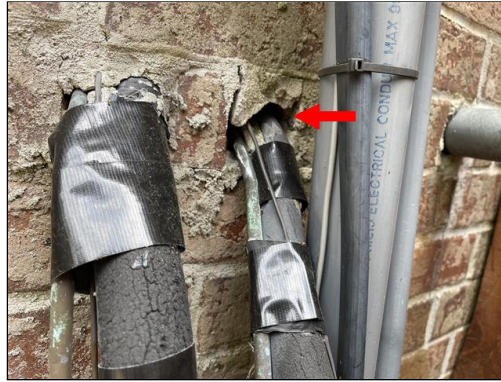
L. Item 1(Picture)

Holes found at A/C suction line entering the brick wall near outdoor unit. Rodents can get into the wall space and attic through this hole. Seal the hole with expanding form sealant is recommended.

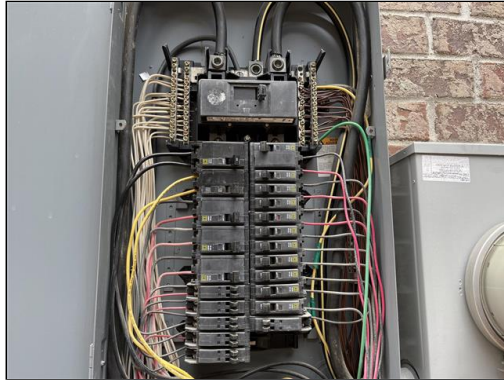
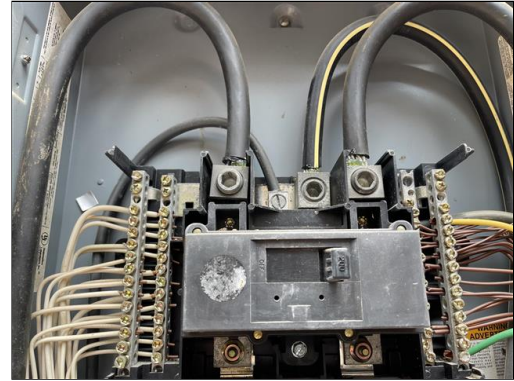
Main disconnect: 200 amps; breaker size match each wire size; bonding bar present between neutral and ground bar appear normal.

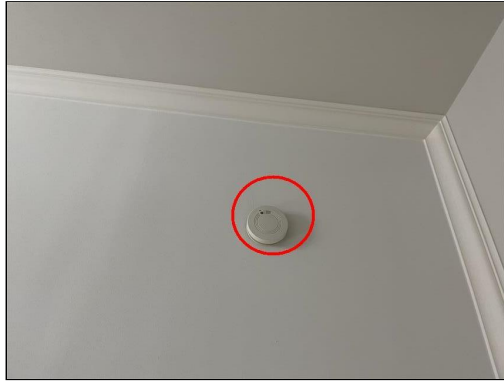
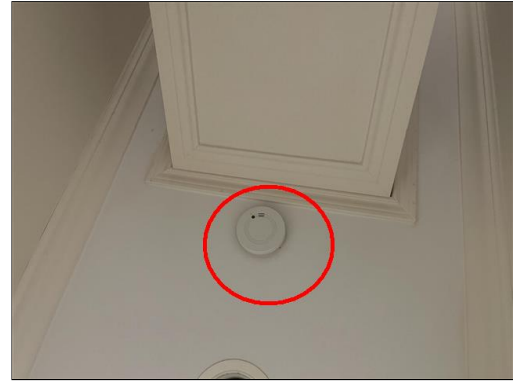
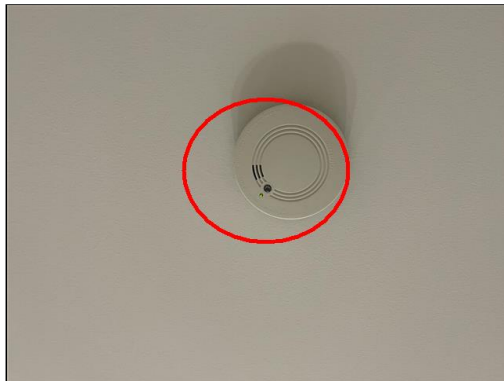
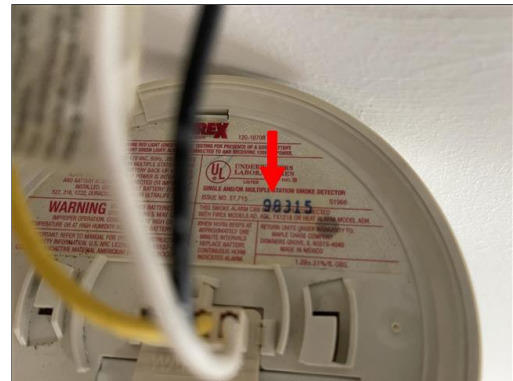
Most smoke detectors are not functioning in the bedrooms and in the vicinity of bedrooms upstairs. Several smoke detectors tested but not responded properly. All the smoke detectors (manufactured date: 1998) are over 20 years. In accordance with US National Fire Protection Association (NFPA) Standard 72, National Fire Alarm and Signalling Code, the smoke detector for over 10 years old and don't respond properly need to replace.

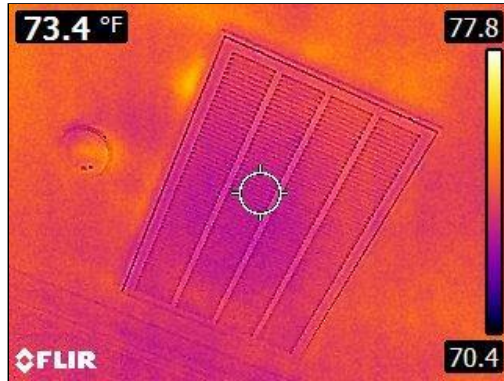
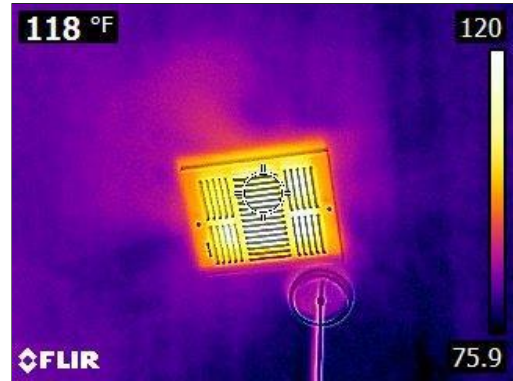
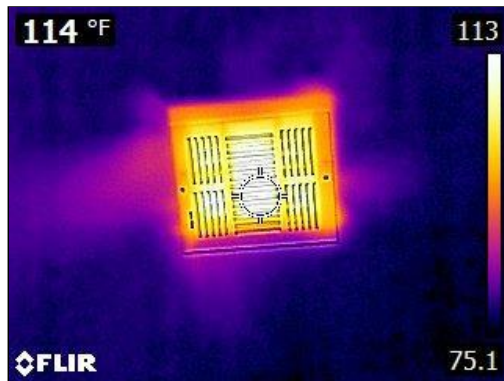
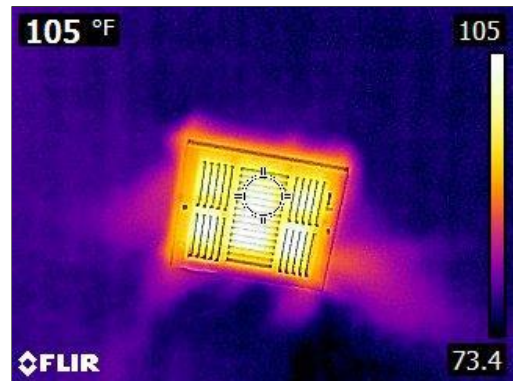
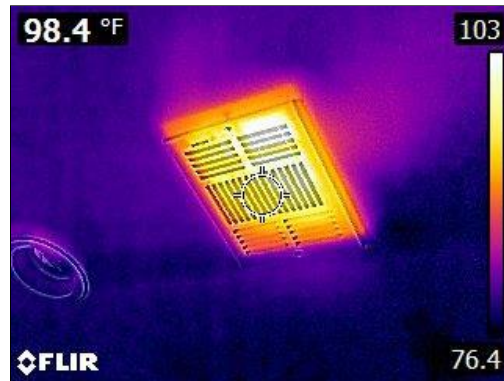
(1) The operation and functionality of the first-floor gas furnace appear normal and perform as intended. The typical supply temperature of this type of furnace is 110 - 135 (F). The temperature rise between 30(F) to 60(F) is within acceptable range of furnace rating. The average life expectancy of most components of gas furnaces is between 16 and 20 years.

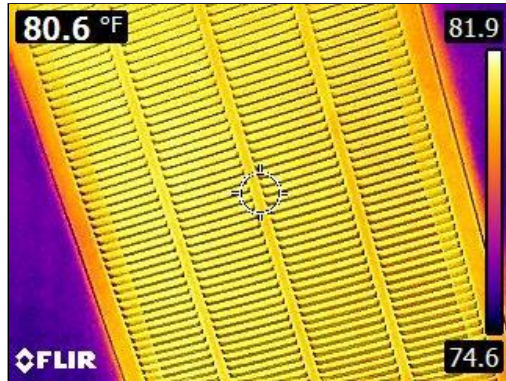
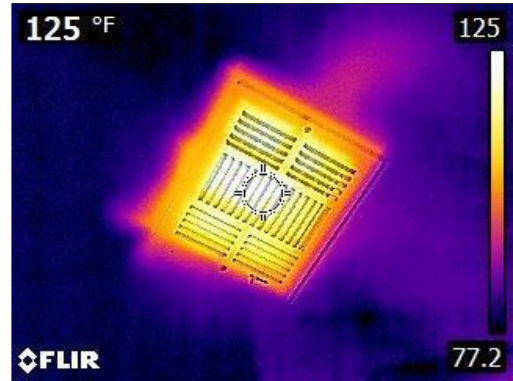
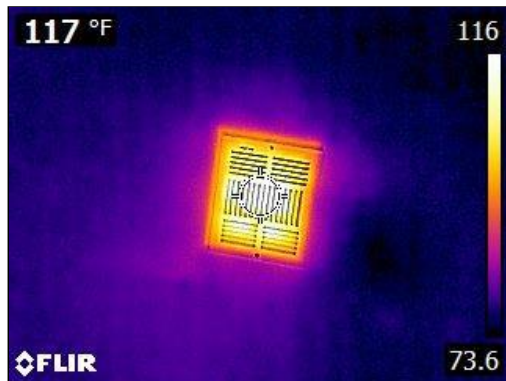
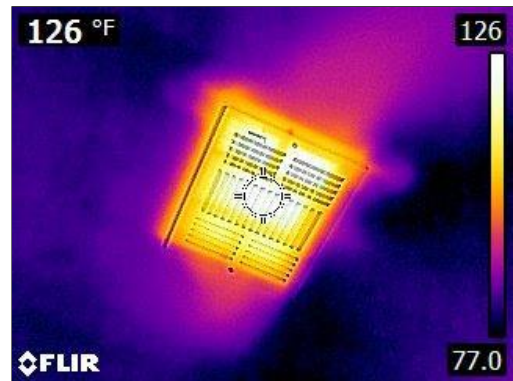
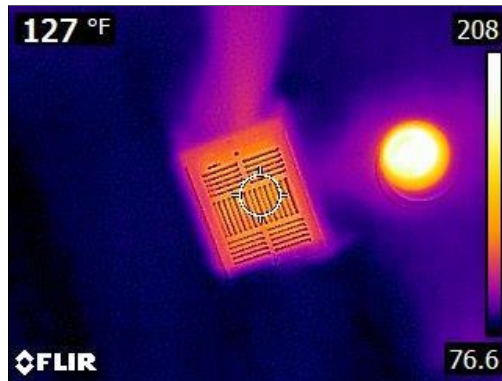
(2) The operation and functionality of the second-floor gas furnace appear normal and perform as intended. The typical supply temperature of this type of furnace is 110 - 135 (F). The temperature rise between 30(F) to 60(F) is within acceptable range of furnace rating

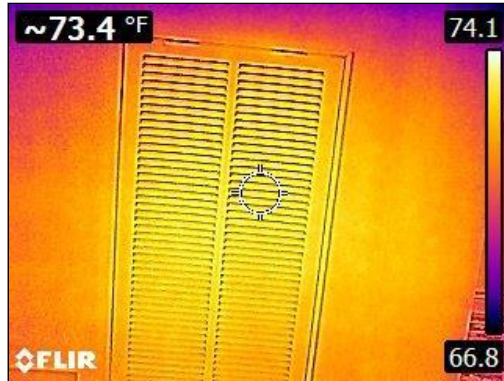
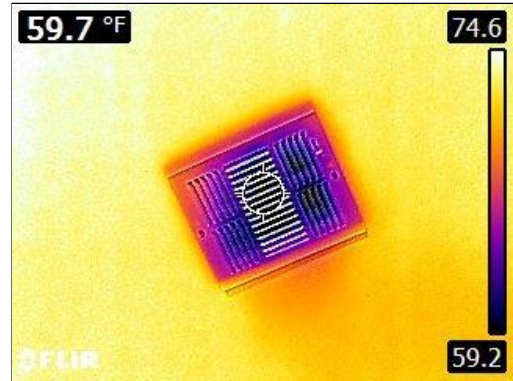
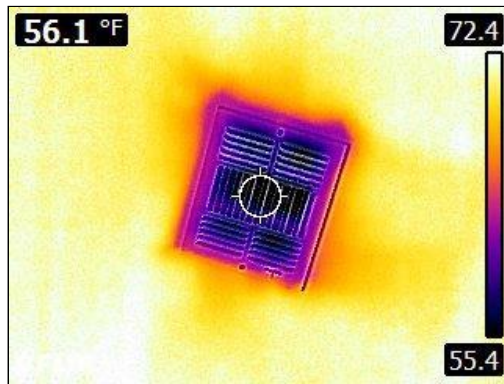
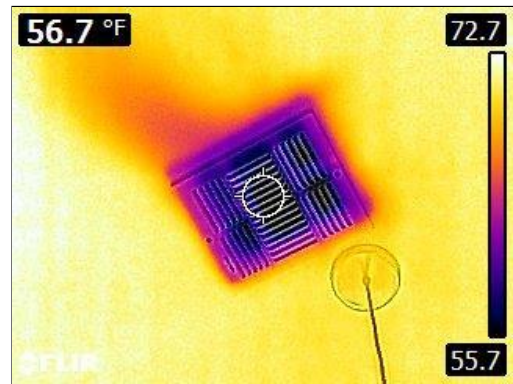
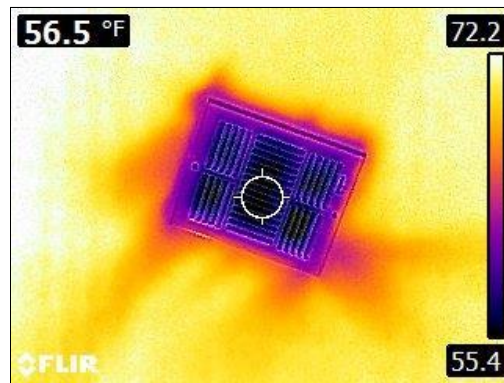
(1) The supply air temperature on the first-floor system read 56.1(F) to 59.7 (F), and the return air temperature was 73.4 (F), the ambient temperature differential ranges between 14(F) to 22(F) indicates that the unit is cooling as intended. The average life expectancy of a centralized air conditioner is said to be 10-15 years.

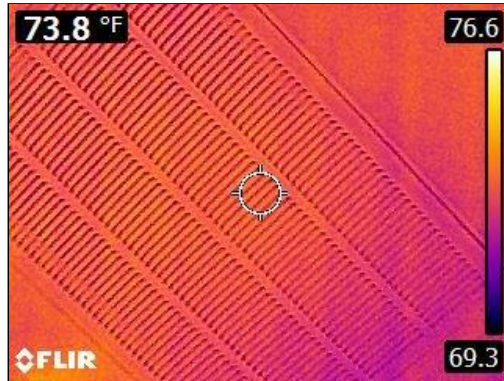
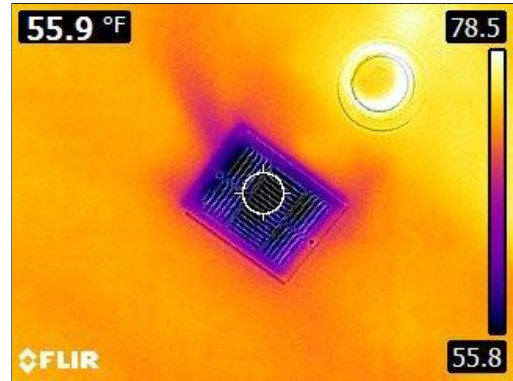
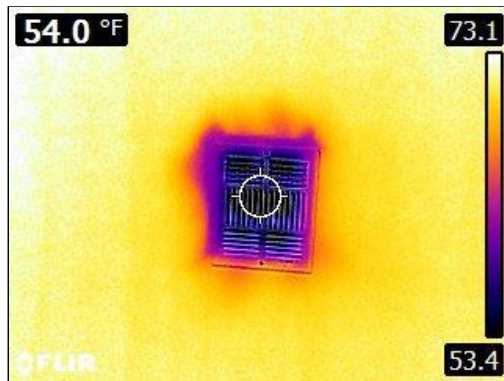
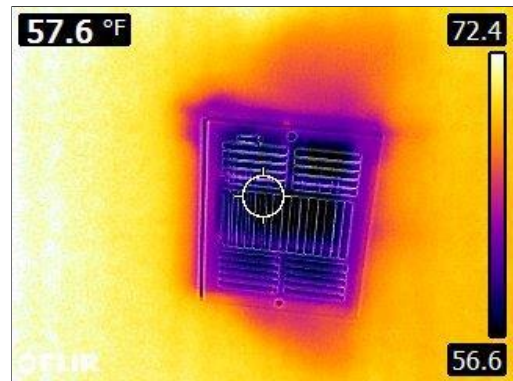
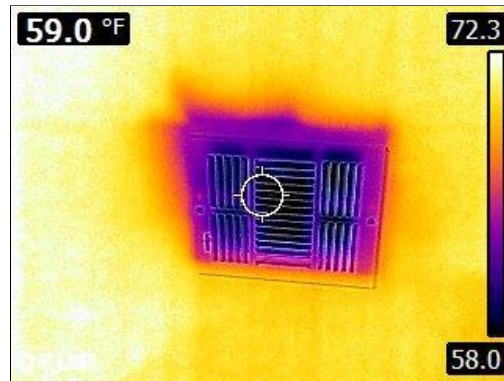
(2) The supply air temperature on the second-floor system read 54.0(F) to 59.0 (F), and the return air temperature was 73.8 (F), the ambient temperature differential ranges between 14(F) to 22(F) indicates that the unit is cooling as intended. The average life expectancy of a centralized air conditioner is said to be 10-15 years.

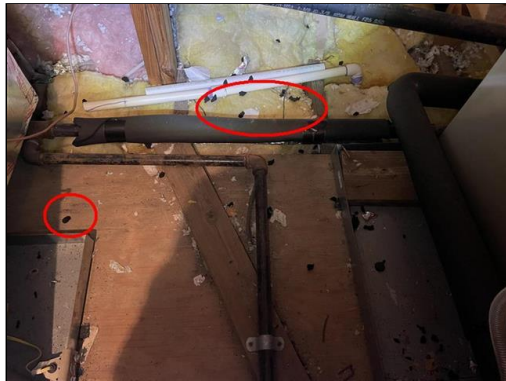
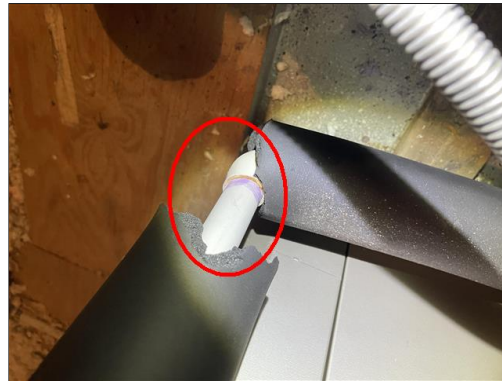
(3) The form insulation of suction line in attic appears chewed and worn by rodents. Recommend contact a qualified pest control service to inspect and remove the rodents from attics. Broken/missing section of suction line can lead to condensation dripping on the attic floor and need to insulate with form insulation.

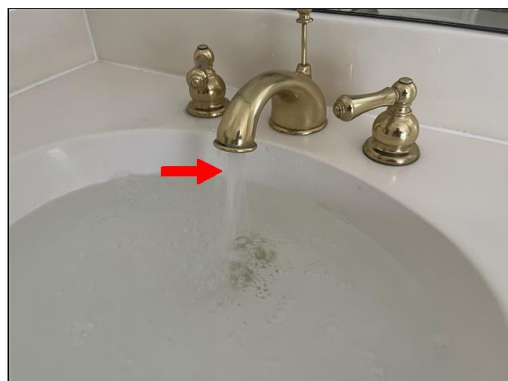
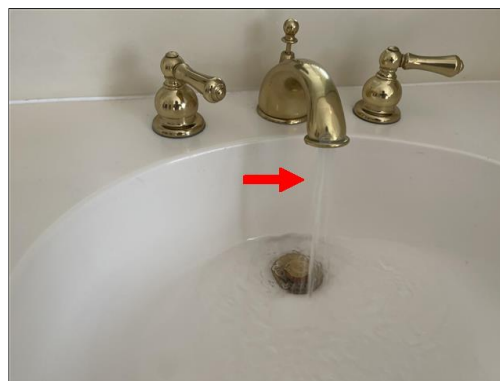
The water pressure in the master bath lavatory faucets are too low. The aerator appears to be clogged with water scales and debris and need to replace.

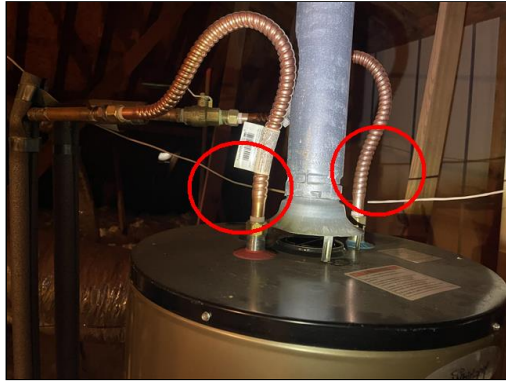
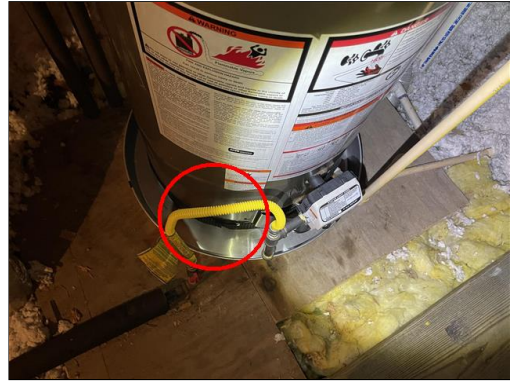
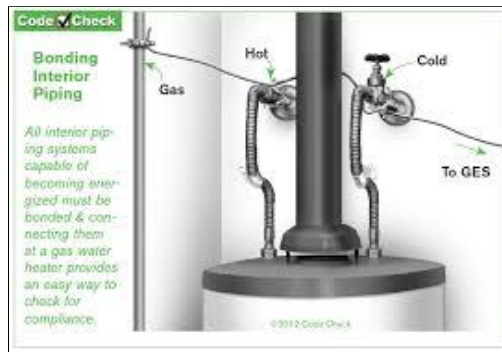
Missing bonding cables at hot,cold water, CSST lines and black-iron gas pipe at water heater in attic. Bond hot and cold water lines to gas line with AWG#6 as required based on Standard of Practice (SOP) , IRC 2015 G2411.1.1 (International Residential Code) to prevent lightning shock(s) to energizing the pipes during severe weather. Bonding refers to the process of connecting different systems together so they have the same electrical potential as the electrical service

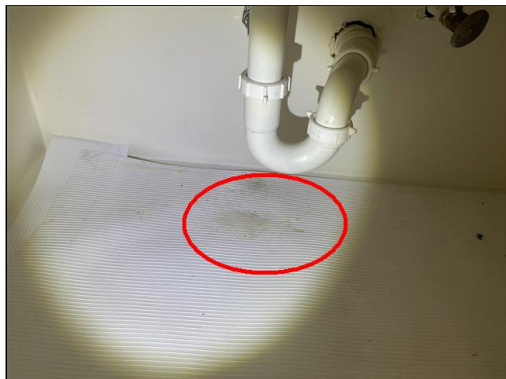
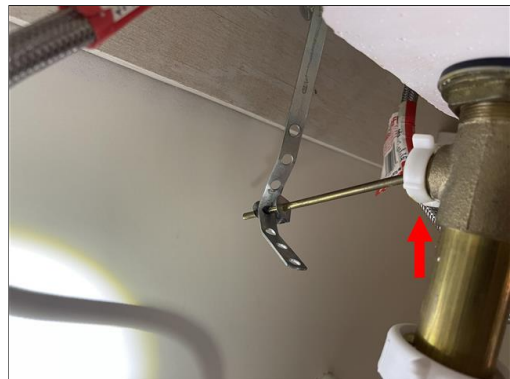
Left cabinet floor of master bath noted with water leaks on floor. The pivot rod joint of water stop appear to be the leaking source and need repairs.

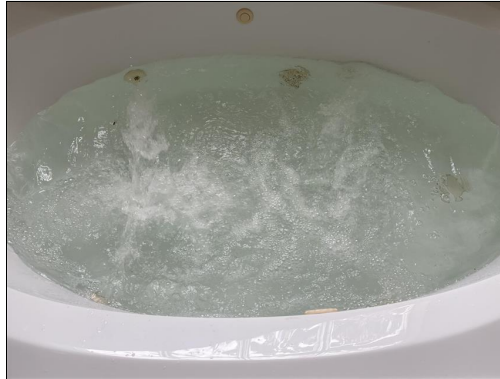
D. Item 1(Picture)

Operation and functionality of jacuzzi appear normal and are performing as intended; GFCI present.

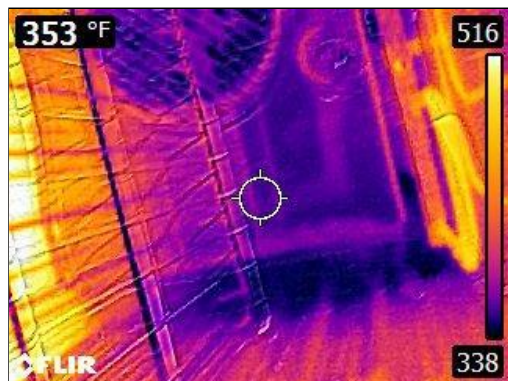
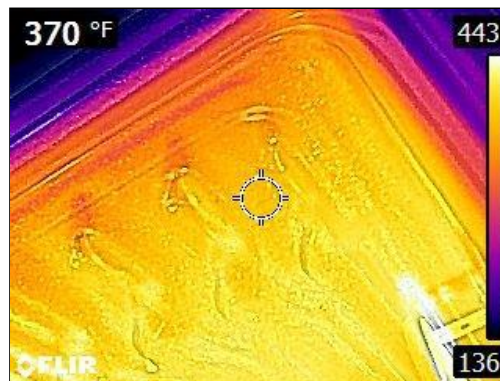
Upper and lower oven units appears normal. Each oven set to 350(F) and temperature accuracy is within 25(F).

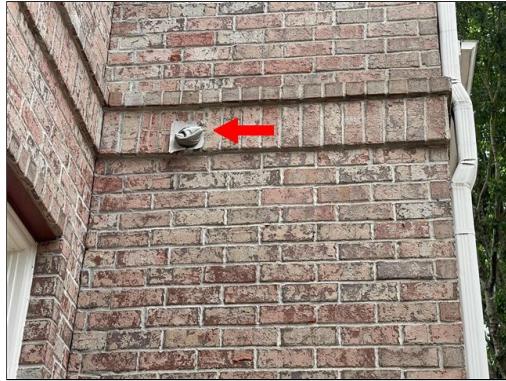
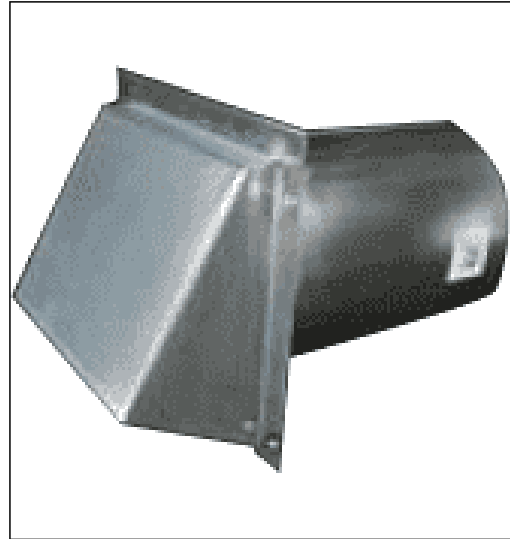
Vent hood for an exhaust pipe on the back wall is missing. The pipe outlet is crushed/closed should be opened and installed with vent hood with damper.

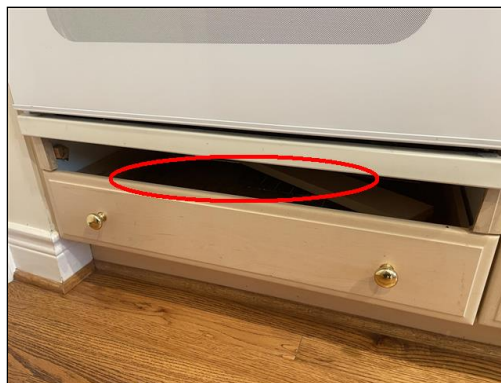
I. Item 1(Picture)

The fascia board under oven is not present and should be installed back to the cabinet.
