# PROPERTY INSPECTION REPORT

Concerning: 1520 Market Street , Galveston, TX 77550  
(Address or Other Identification of Inspected Property)

By: Danny Marlow Lic.#: 23187 02/09/2021  
(Name and License Number of Inspector) (Date)

**DATE OF INSPECTION: 02/09/2021**  
Inspection No. 521350-610

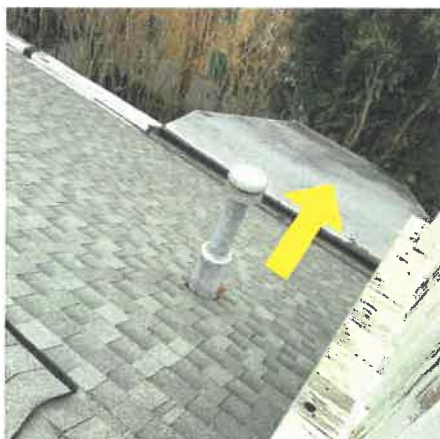
- Asphalt shingles and roll roofing.
- Roof was accessed for inspection.
- Roll roofing over porch area on left side of home was showing moderate wear.

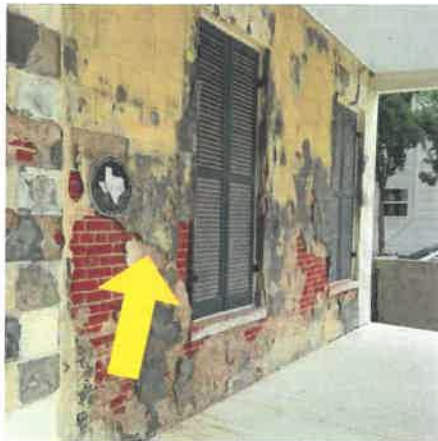
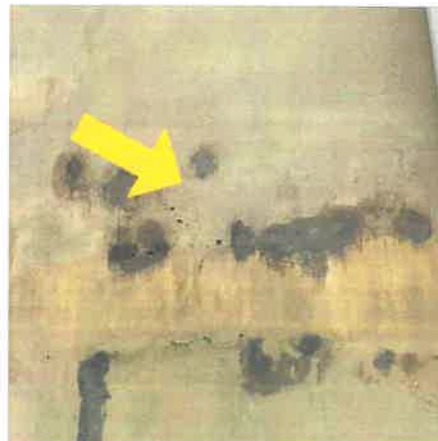
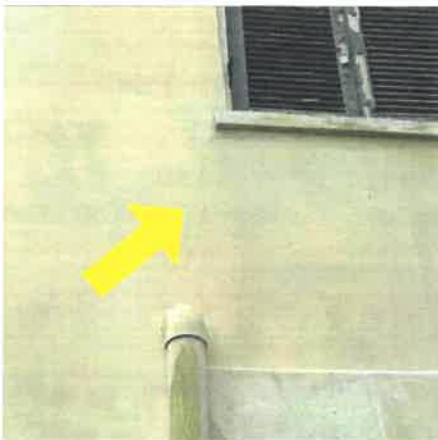
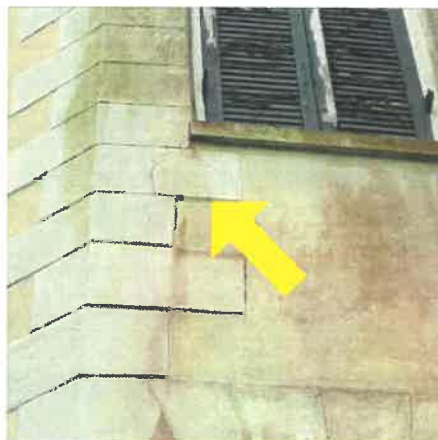
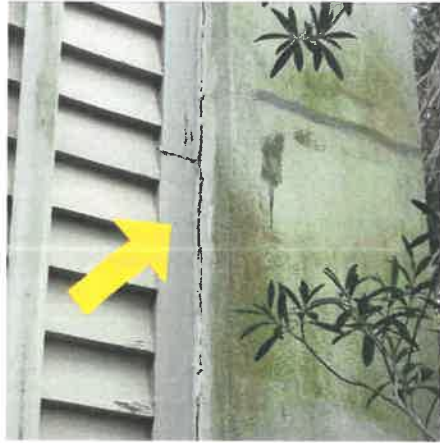
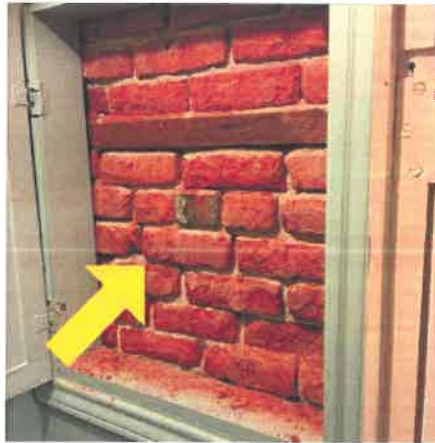
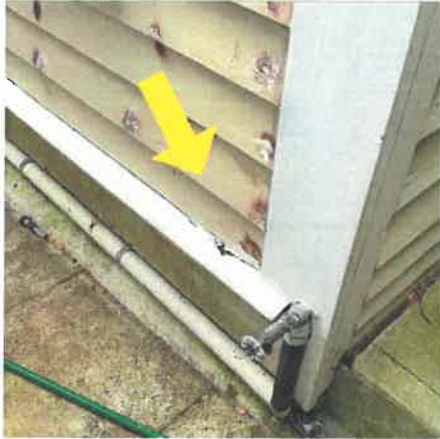
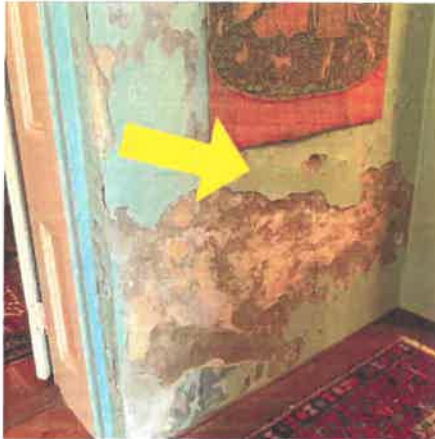
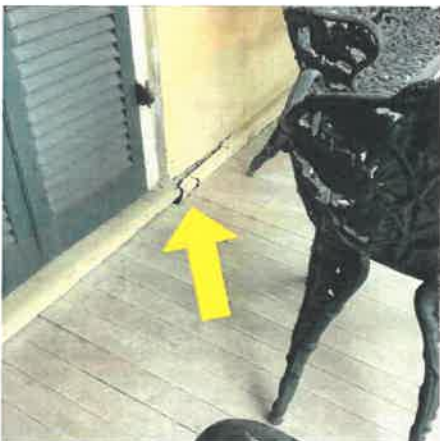
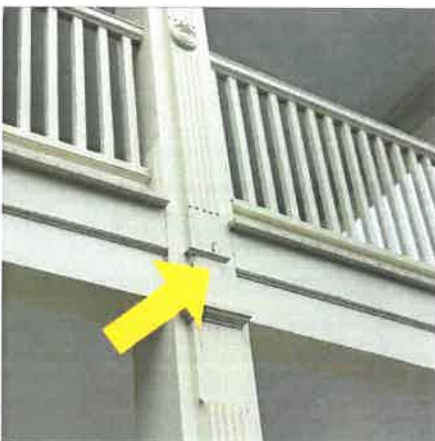
- Concrete /parchment/ brick and wood siding with wood trim.(exterior).
- There were various areas where parchement was noted as deteriorating and coming off brick (exterior and on interior wall in addition). Recommend having qualified contractor evaluate and repair as needed to prevent further damages and deterioration.
- There was cracking in parchement noted in multiple areas on exterior walls.
- Mortar in bricks was showing deterioration. Recommend having qualified contractor evaluate and make repairs as needed to prevent further deterioration and damages.
- There minor wood rot noted at various areas of trim. Recommend repairs to prevent further deterioration and damage.
- There were multiple areas where caulking has failed. Recommend re-caulking as needed to prevent possible water penetration and further damages.

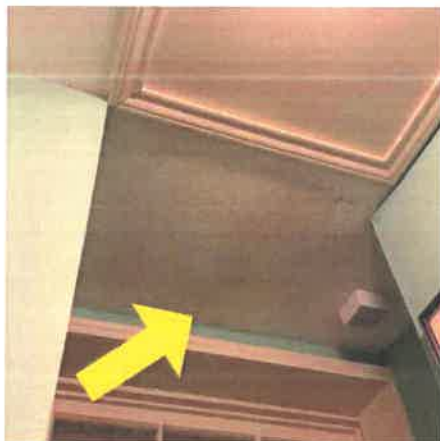
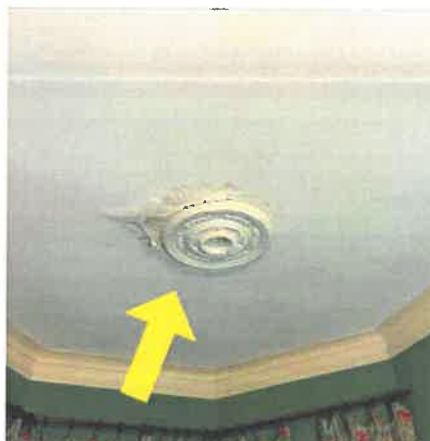
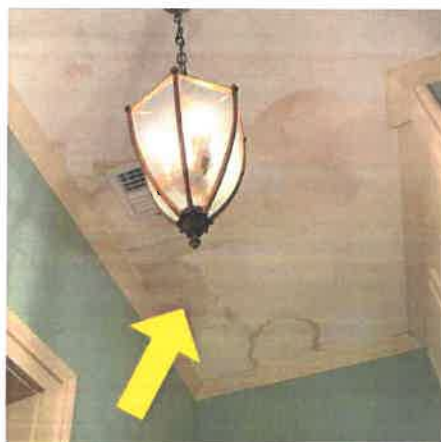
- There were miscellaneous areas where ceiling damage was noted( from possible previous leaks). No moisture was detected with infrared camera at time of inspection.

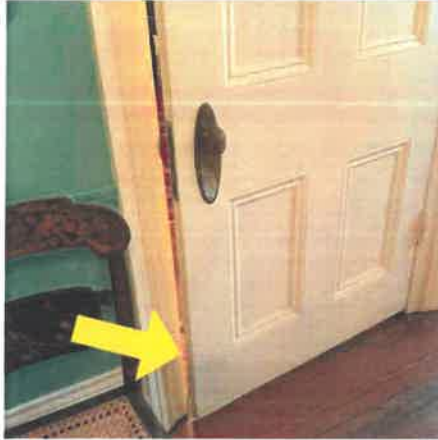
- Door in dining area was noted to be dragging on door frame when closed. Recommend repairs/adjustments for proper operation.

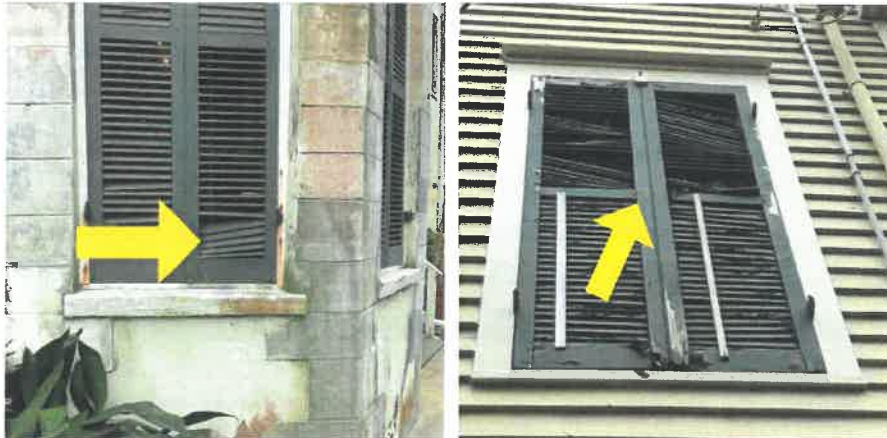
- Windows were noted as being original to the era, most were operating as designed. There were various windows that were not opening (damaged/painted shut). Recommend having qualified contractor evaluate and repair as needed for proper operation.
- Miscellaneous exterior shutters were showing wood rot/damages.

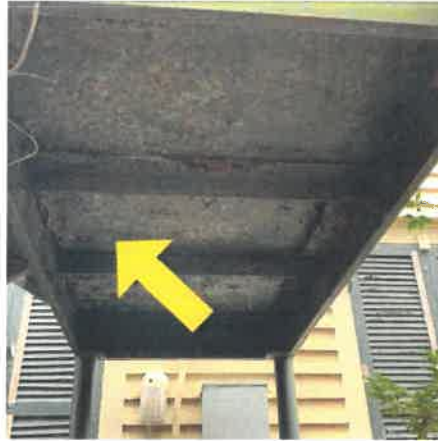
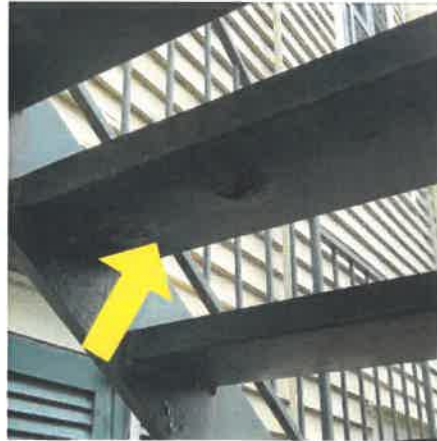
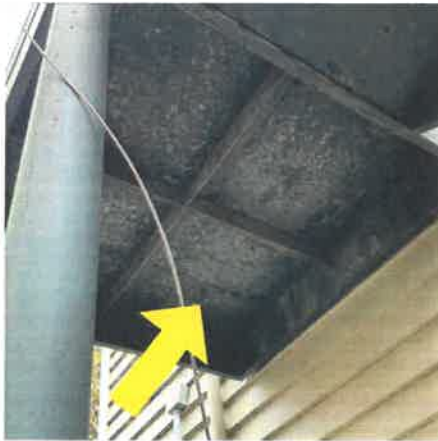
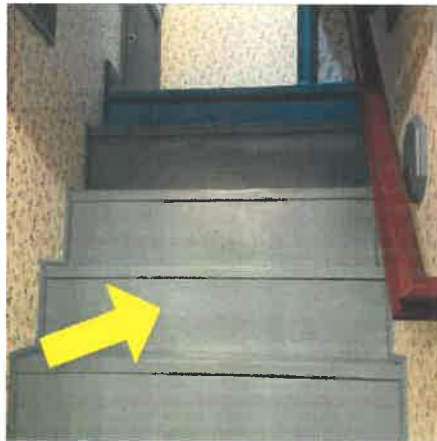
- Stair steps are too high/narrow at upstairs staircase. This is a trip hazard. Consult with a professional general contractor for evaluation.
- Metal staircase on back exterior of home was showing moderate to heavy rusting. Recommend having qualified contractor evaluate and repair as needed for safety.

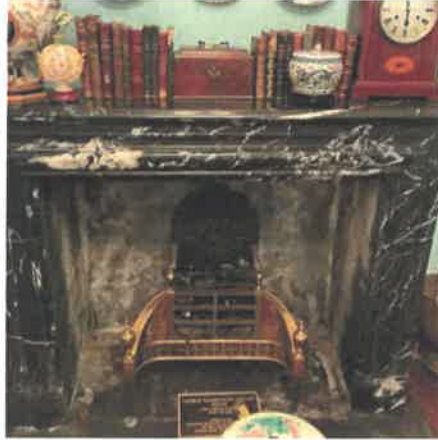
- Fireplace has been closed off and not in use.

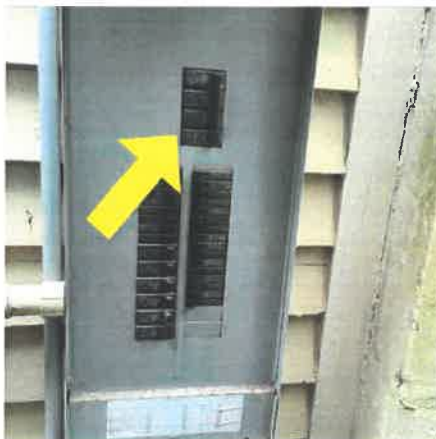
- 120/240 volt, 200 amp service.
- Main disconnect is located in service panel on back exterior of home.
- Consult electrician to locate/verify/provide access to ground connection. Unable to locate at time of inspection.

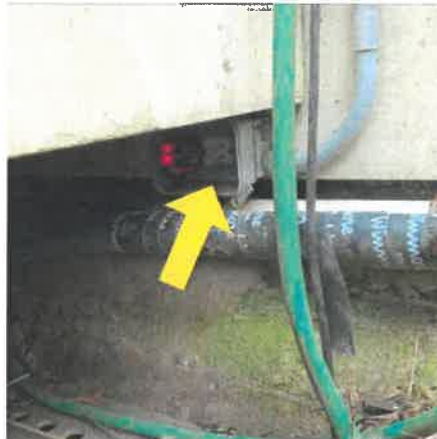
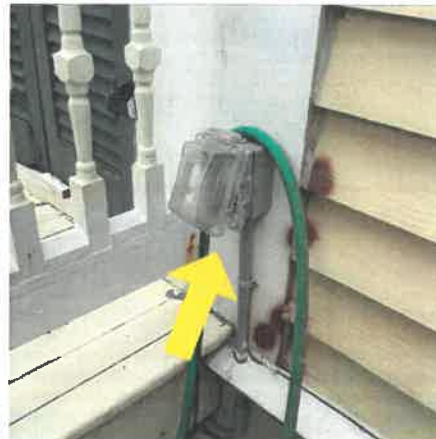
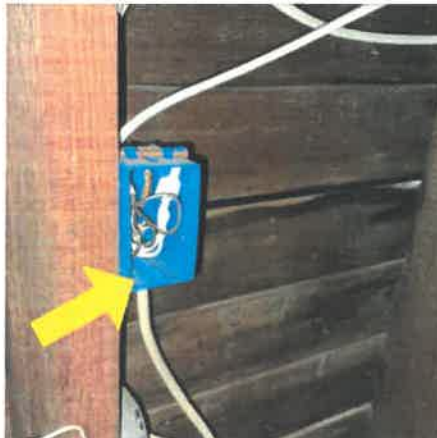
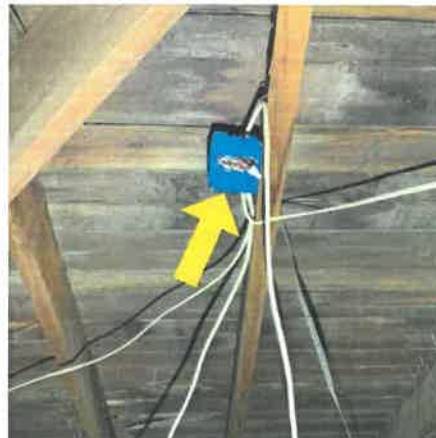
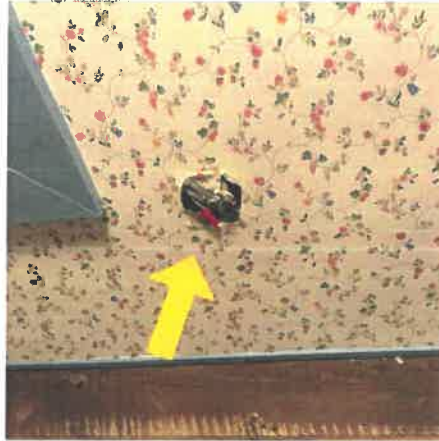
- All wiring appears to be copper and in good condition.
- Smoke detectors were not found in all required areas. Smoke detectors are required in all sleeping rooms, just outside of sleeping rooms and in living area of each floor. Recommend installing smoke detectors in all required areas for safety.
- Multiple receptacles are not GFCI protected in required areas. Receptacles in wet areas, outside and in garage are required to be GFCI protected to reduce the risk of electrical shock( left exterior at deck & garage). Recommend installing GFCI receptacles for safety.
- There were open junction boxes noted in attic. Recommend installing cover plates for intended protection and safety.
- There was an open junction box noted in ceiling of 3rd floor. Recommend installing cover plate for intended protection and safety.

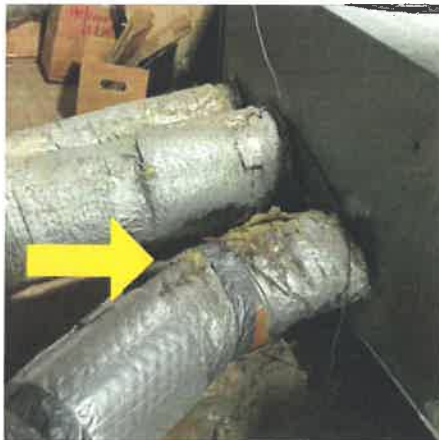
- There was minor damage noted on duct work. Recommend repairs for intended protection.

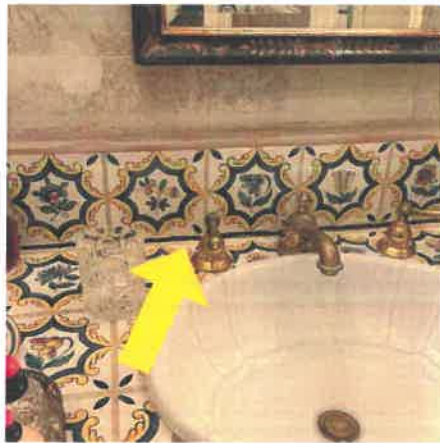
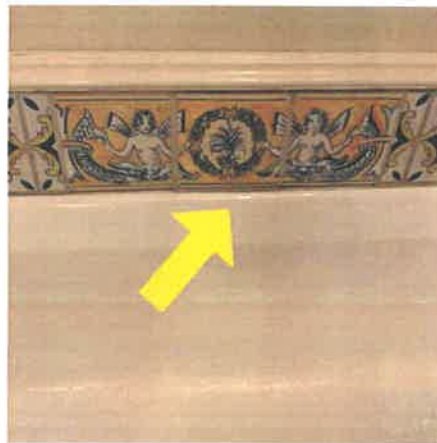
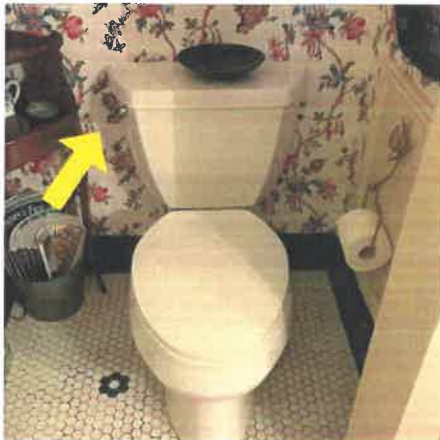
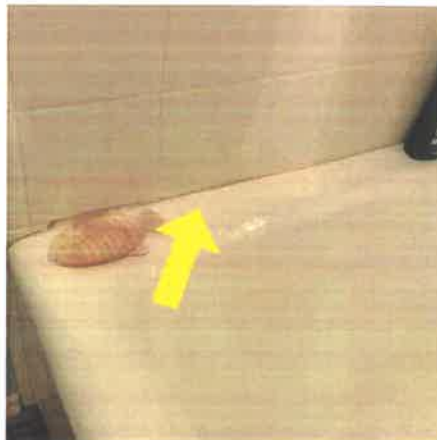
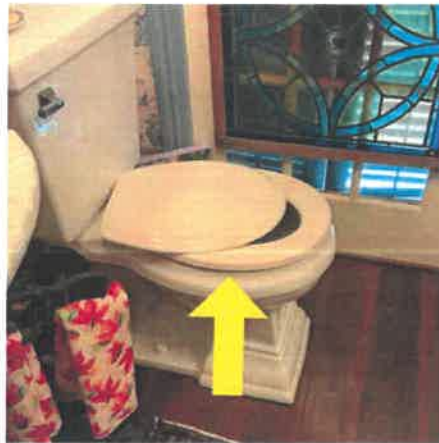
- Water meter is located in back yard at alley.
- Main water cut off was not located at time of inspection.
- Static water pressure was 59 psi. at time of inspection. Normal water pressures should be between 40 and 80 psi.
- There was damaged grout noted at upstairs bathtubs and bathroom sink. Recommend grout/caulking repairs as needed.
- There was a damaged toilet seat noted at downstairs toilet. Recommend replacement.

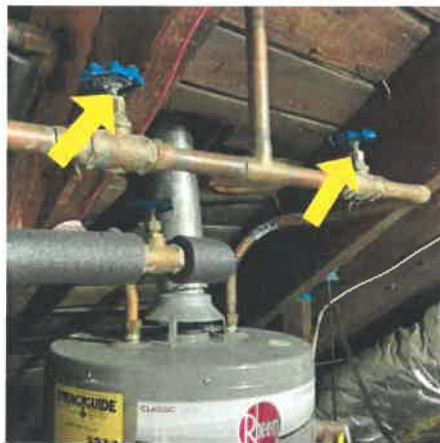
- (2) 40 gallon water heaters ( manufactured in 2012 & 2014)
- Natural gas energy sources.
- All systems were operating as designed at time of inspection.
- There were water leaks noted at both water heater water shut off valves. Recommend having licensed plumber evaluate and repair as needed.
