LC Home Inspections, PLLC Property Inspection Report

Property Address 12407 Pepper Creek Lane Pearland, TX 77584

Inspection prepared for: Jenna L. Hazzard Date of Inspection: 01/11/2018

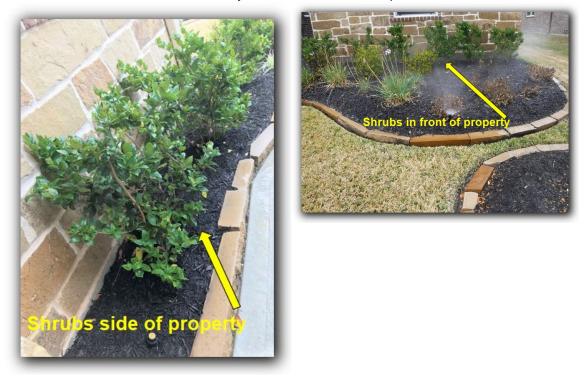
\checkmark 1. Gutter splash block under gutter downspout not placed correctly- water should be allowed to flow freely away from the foundation. In current position, water will not run away from the house where it can pool and cause damaged to the foundation

\blacksquare 2. Shrubs around foundation may cause future foundation problems.

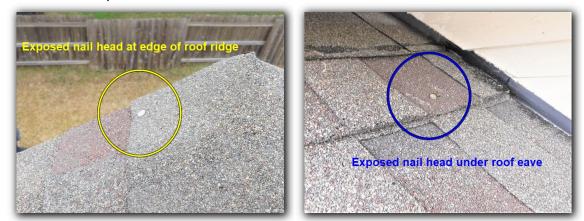
☑ 1. Torn, damaged, perforated or missing ridge cap shingles - shiingle should be repaired to prevent further damage and potential area for water intrusion.

\square 2. Exposed or lifting nail heads - Nail heads should sealed. Unsealed head will rust and lead to possible moisture intrusion.

<u>Minor repairs to the roofing are recommended</u>. Damaged roofing material should be repaired. All roof penetrations and flashing should be examined and sealed or painted as necessary

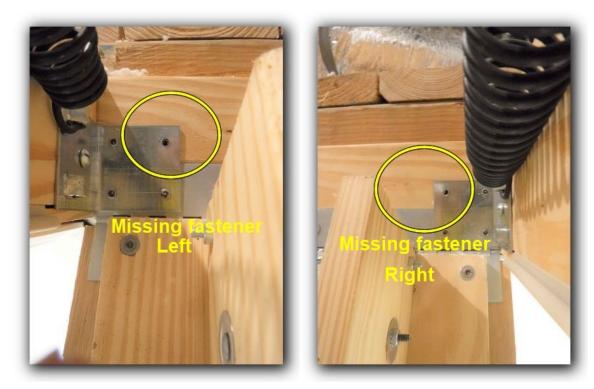
\square 1. The attic ladder was missing fasteners.- Attic ladder brackets are designed for specifict location of fasteners. Manufacturers typically require the use of 16d nails or 1/4" x 3" lag bolts be installed through the corner brackets for personal safety. This condition should be further evaluated and corrected as necessary

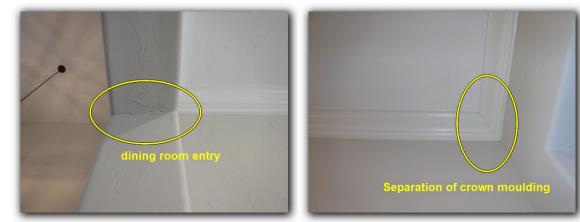
☑ 1. Minor cracks in wall joints or trim

| =Inspected | NI=Not Inspected | NP=Not Present | D=Deficient |
|---|---|---|---|
| | Floor/wall trim wall | in corner of living room | Hole in corner in storage area under stairs Master Bath Closet |

moulding above bathroom doorway to Master Bath

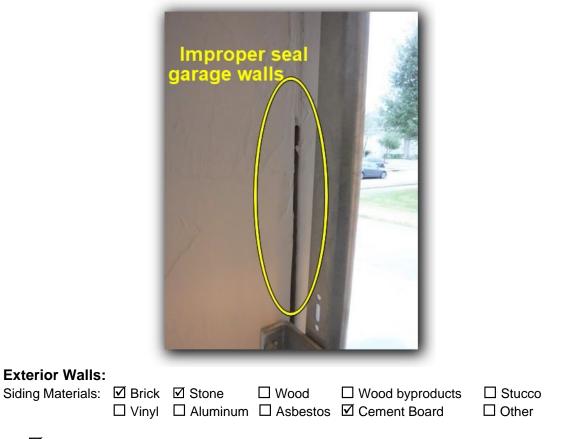
\blacksquare 2. Incomplete seal to wall in garage

Separation of trim from ceiling

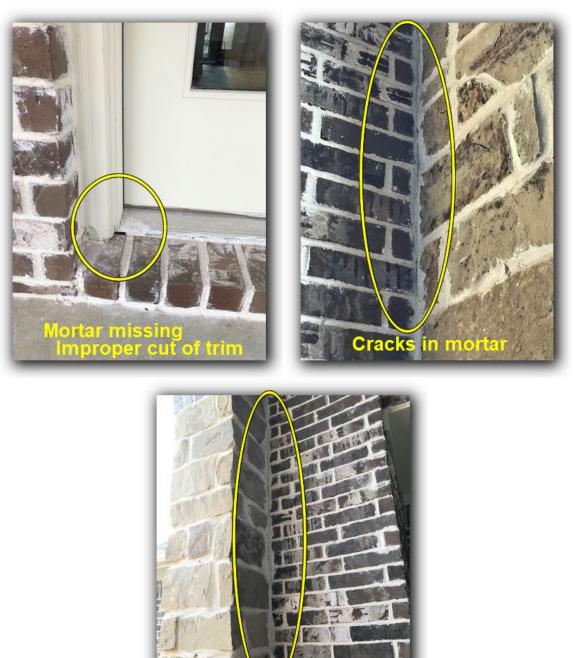
\blacksquare 3. Mortar is separated or missing in some areas

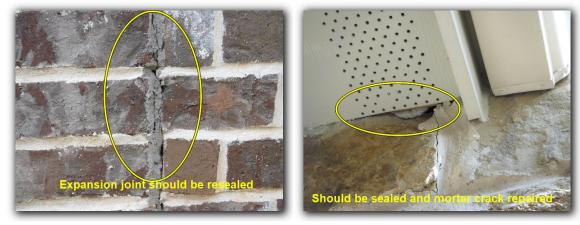
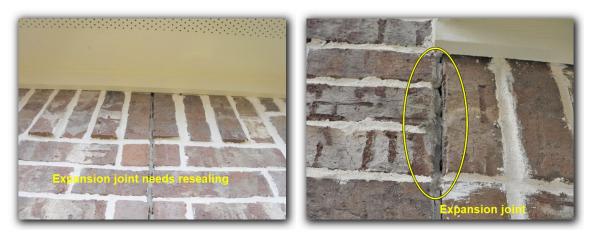
\blacksquare 4. Caulking / sealant is separated or missing in some areas all expansion joints

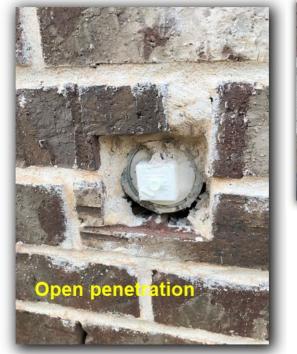
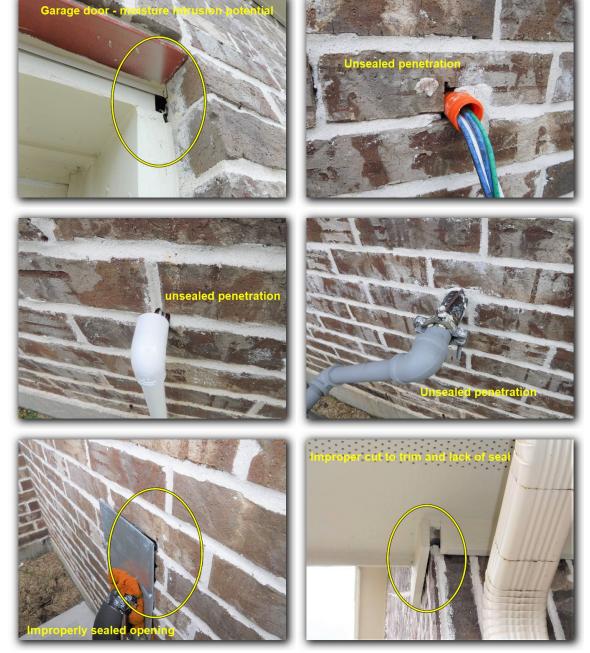
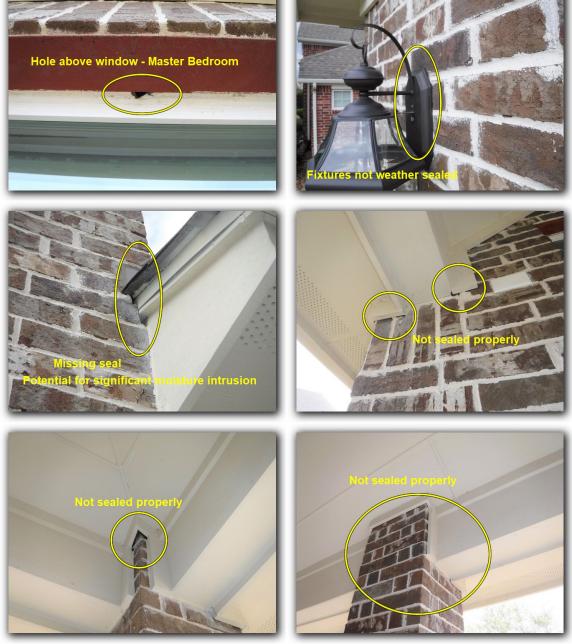
\blacksquare 5. Possible water/insect penetration areas at exterior walls - all exterior wall penetrations should be sealed to prevent water or insect intrusion

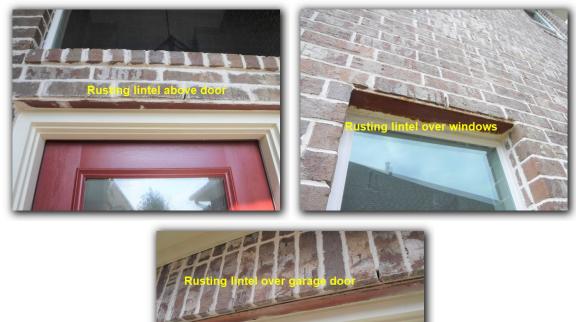
\boxdot 6. Rust forming on steel lintles over doors and windows - The steel lintels should be treated and repainted to prevent further rusting. Over time, additional rusting lintels will expand and form cracks in the mortar.

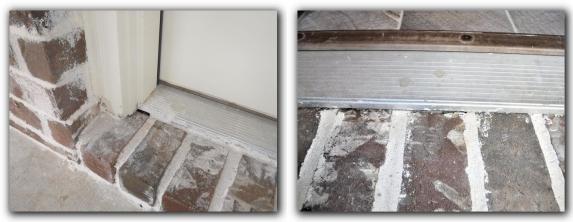
✓ 1. Exterior door thresholds not sealed properly

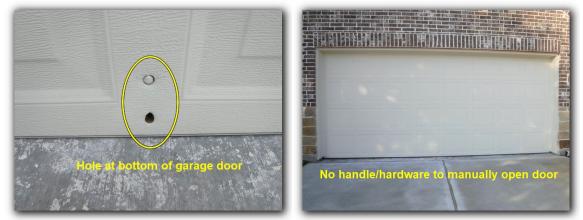
\blacksquare 3. Missing garage door hardware

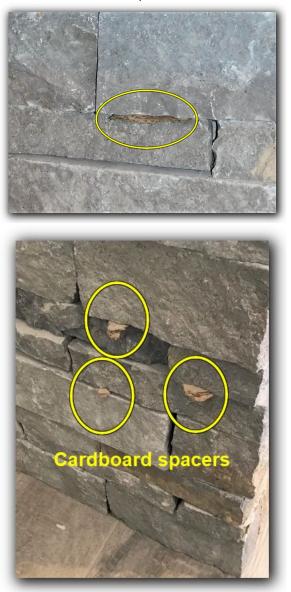
- ☑ 1. No gas valve shut-off key available
- ☑ 2. Cardboard spacers found between fireplace stone veneer

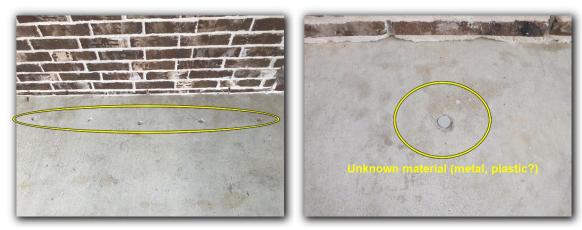
Unknown objects embedded into patio floor - possible termite barrier. It appears home may have been treated for termites. recommend discussion with seller to determine reason and need for future potential maintenance.

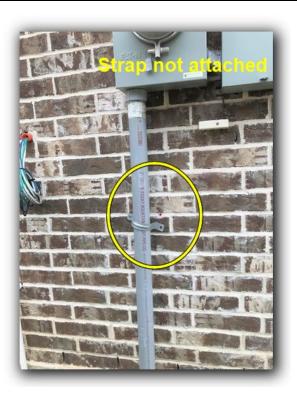
☑ 1. Service lateral conduit not secured properly

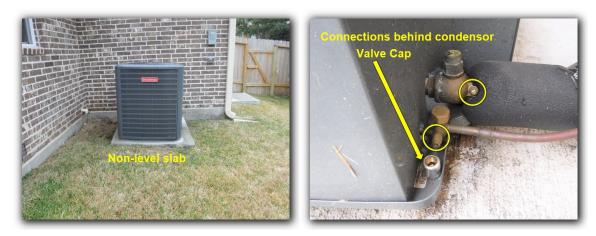
☑ 1. Condenser unit not level or 3" above grade

Refrigerant travels with the lubricating oil through an a/c system. When the condenser is out-of-level, the oil can separate and the compressor may operate without adequate lubrication. Most manufacturer installation manuals specify that the unit be mounted on a level surface. Additionally, refrigerant lines can be stressed

- ☑ 2. Condenser refrigerant and suction lines not capped
- ☑ 3. Recommend cleaning, servicing and / or further evaluation of condenser by a licensed professional

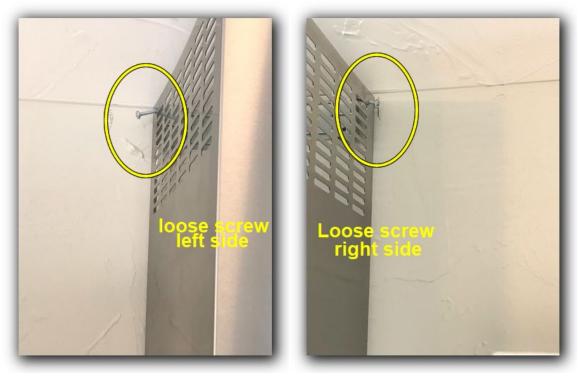
☑ 1. Fan / Motor assembly not secured properly

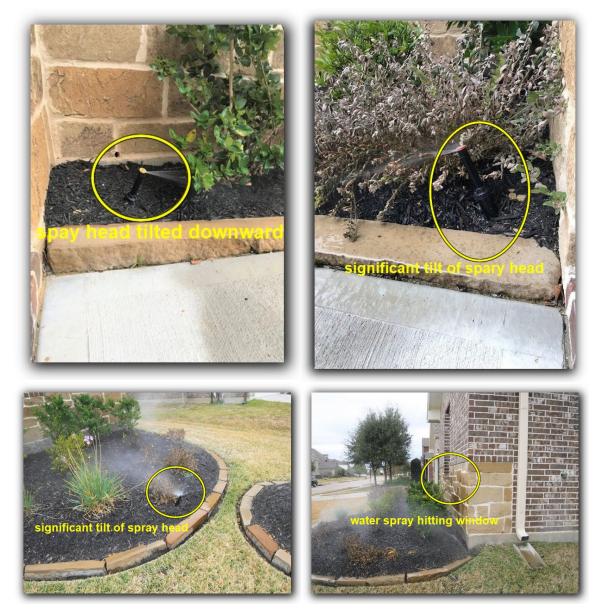
☑ 1. Unable to access zone control valves- access required to check for leaks or drip of control valve. However, rainy weather condition at day of inspection would have prevented accurate assessment

☑ 2. Pop-up sprayers not perpendicular (tilted) to grade and may require adjustment - improper spray head alignment may affect performance
