HouseCheck

Property Inspection Report

5331 Dumfries Dr, Houston, TX 77096
Inspection prepared for: Jim Sherry
Real Estate Agent: -

Date of Inspection: 12/4/2019 Time: 2:00 PM
Age of Home: 1960 Size: 2315
Order ID: 1572

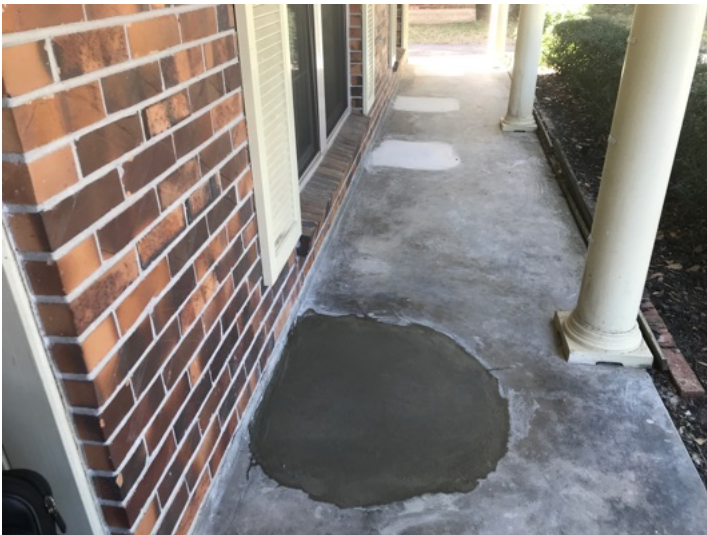
- There appears to have been repairs performed on the foundation throughout home. It is unclear as to the effectiveness of the repairs and this determination is beyond the scope of this inspection. Recommend consulting with seller regarding extent of repairs and obtain any documentation pertaining to warranty, engineer comments, contractor comments, etc. If this is unavailable, then it is recommended that a structural engineer fully evaluate the foundation slab and subsequent repairs.

Signs of previous foundation work on house

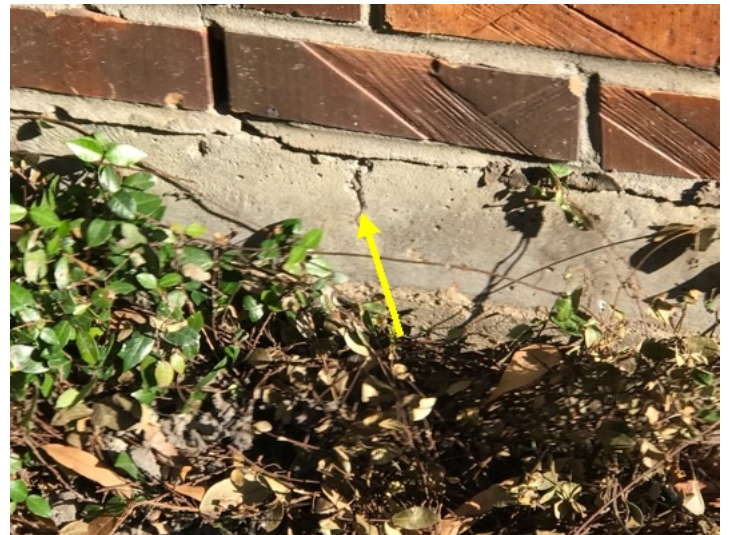
Cracks in grade beam right side

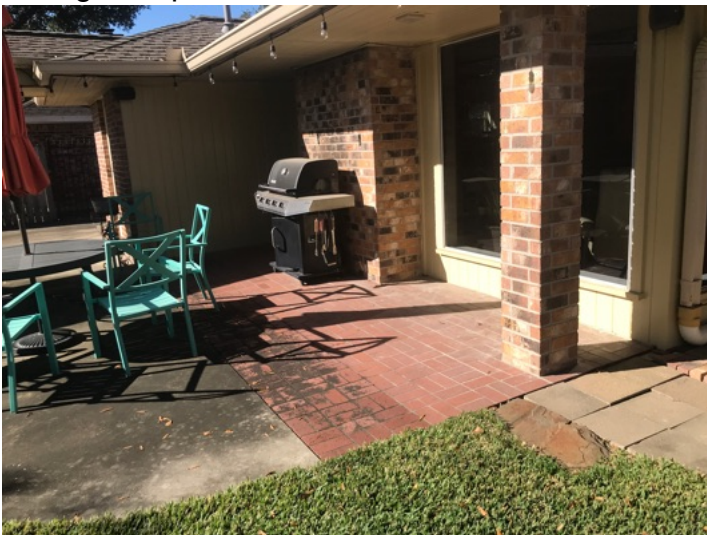
- The rear patio deck is butted against the slab of house restricting view of slab.
- Concrete slab at right side of garage restricted view of slab.
- **Observed excessive cracks at garage floor. Recommendation: Further evaluation of slab in garage by a licensed engineer.**

Rear patio deck obstructed view of slab

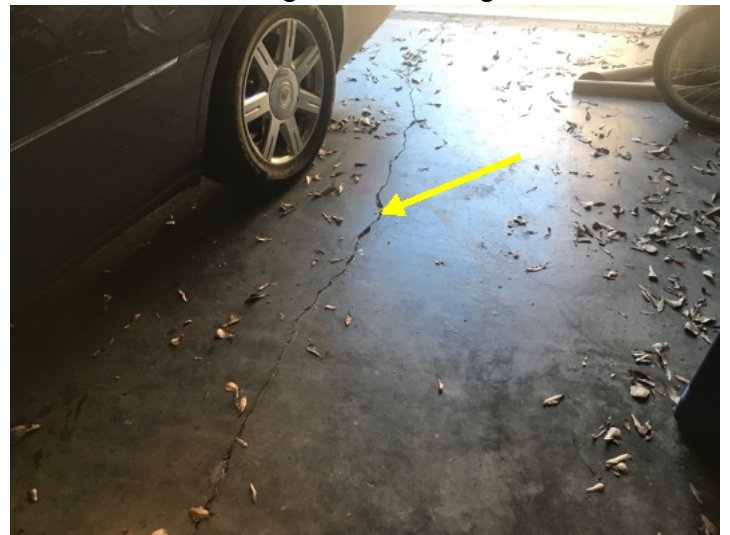
Cracks in the garage floor

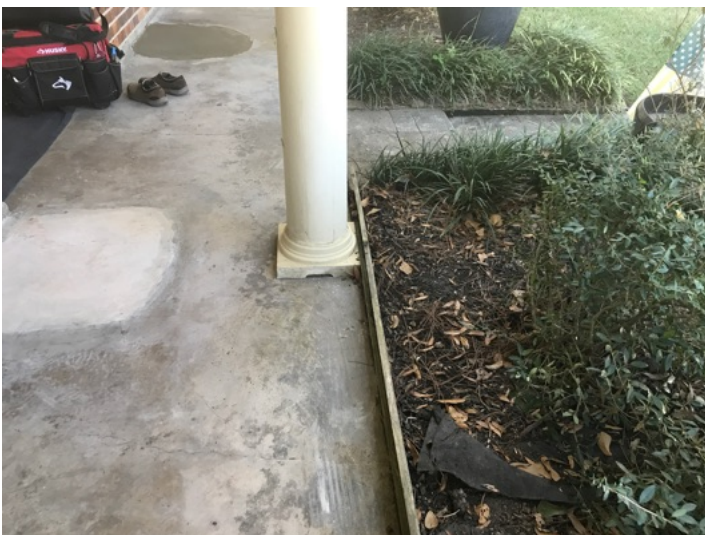
Signs of previous foundation work on house

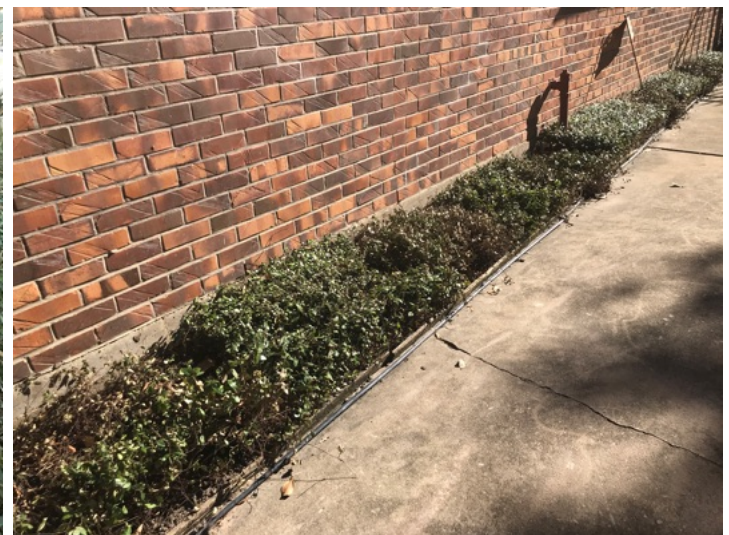
- Recommend trimming or removal of vegetation growing in contact with the siding at perimeter of dwelling. This restricts view of siding/slab, as well as, allows vegetation to grow on the dwelling preventing proper visual monitoring of the dwelling for insect infestation. Vegetation also promotes moisture levels that will cause siding to rot and create conducive conditions for wood destroying insects.

Heavy vegetation against slab

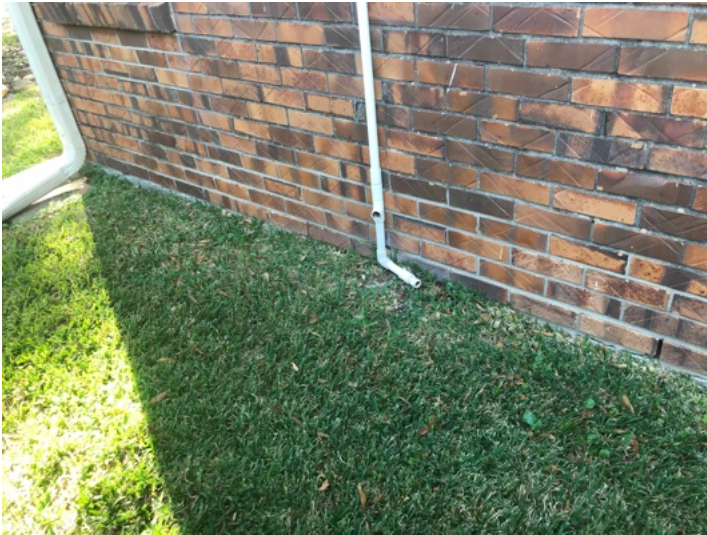
- The soil line is too high on the left side of the house. Under current building standards there should be at least 4-inches of foundation visible below masonry veneer and 6-inches of foundation visible below wood type veneer. High soil levels may allow water penetration and or insect infestation at perimeter of dwelling. Grading of soil should be maintained so that proper drainage and monitoring of the foundation can be performed.

High soil at slab

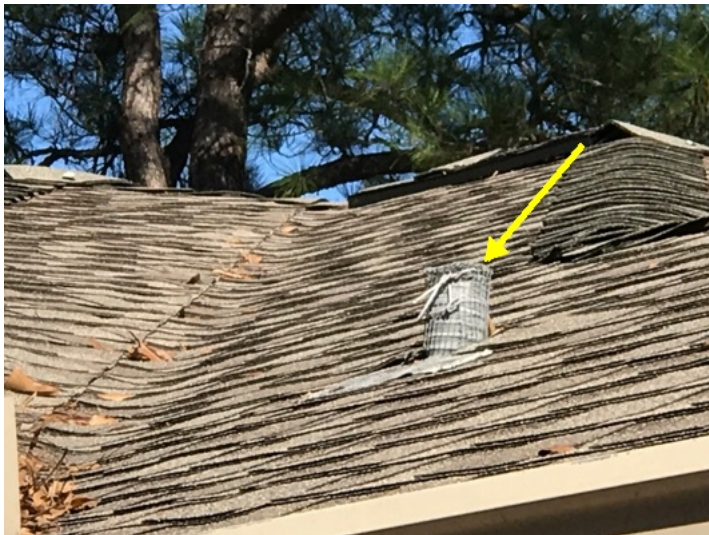
Inadequate height for vent stack at right rear corner of roof

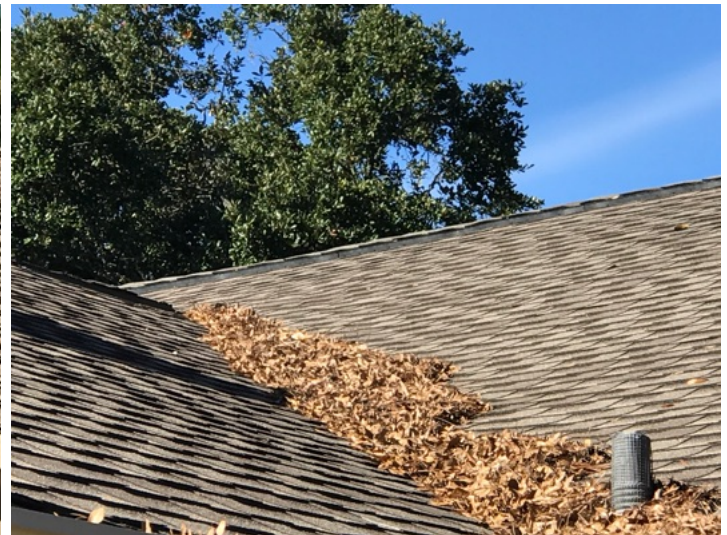
- There is debris from nearby tree on roof covering. This debris can impede the roof coverings ability to shed water causing cause leaks and premature aging of the roof cover. Roof coverings should remain free from debris.
- Current standards mandate all plumbing vent stacks extend a minimum of 6 inches above the roof slope. One or more were observed to not meet this standard.
- All deficiencies noted in red should be further evaluated by a roof professional.

Debris on the roof

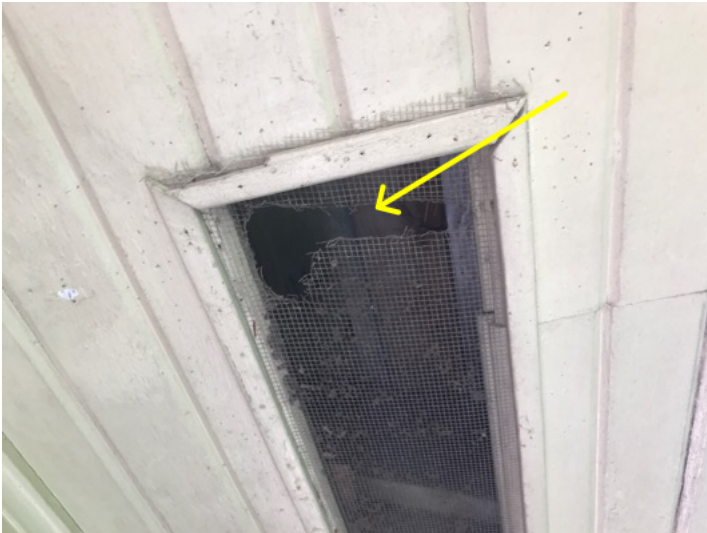
Damaged soffit vent at rear of house

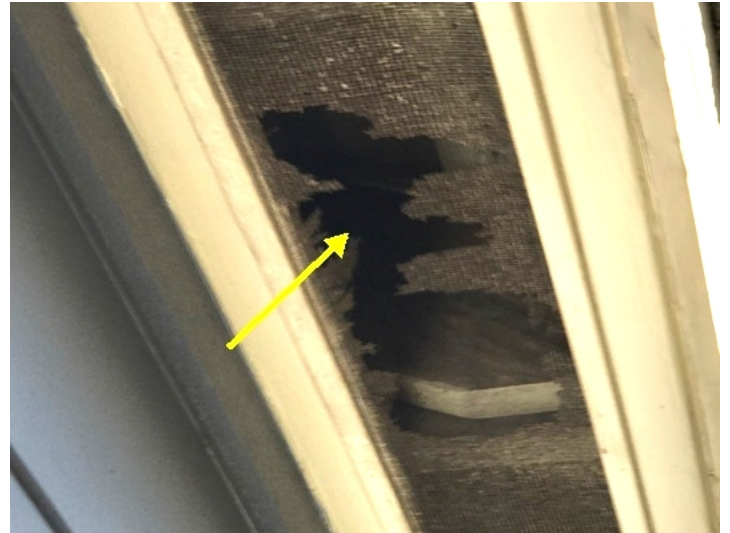
Damaged soffit vent at rear of garage

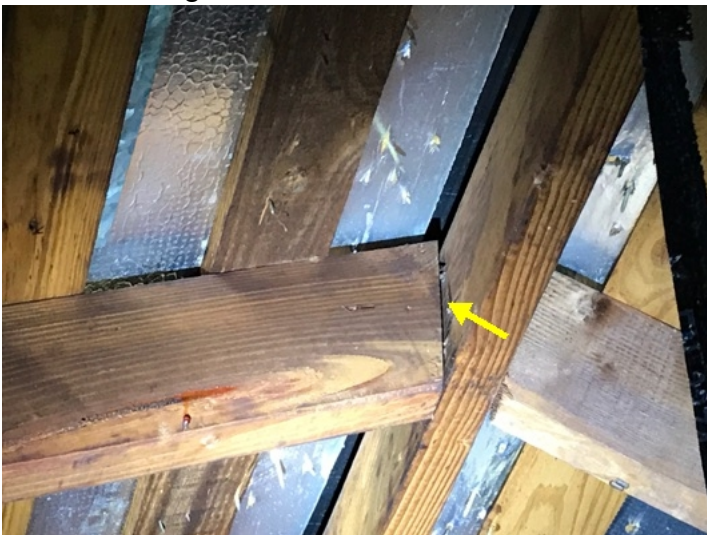
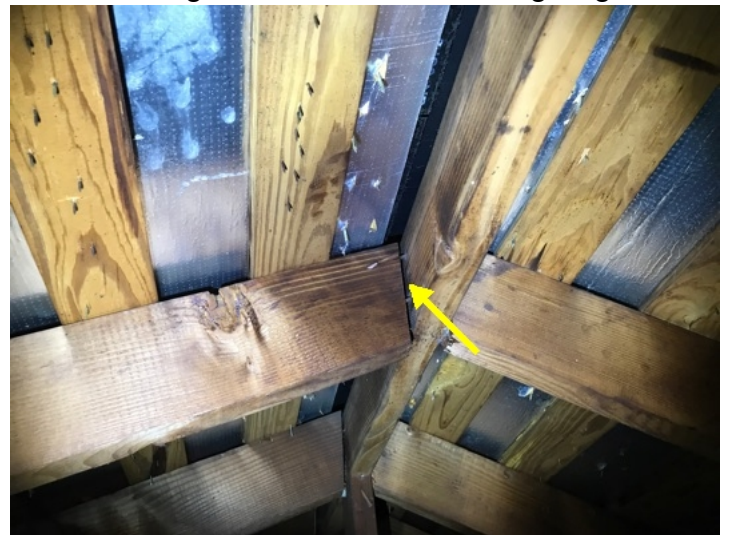
- Limitation: The inspector could not access or view all areas of the attic due to a limited/absent walkway.
- Insufficient insulation was noted in the attic space per today's current standards. Improvements to the insulation may increase energy efficiency.
- Observed damaged soffit vent (mesh) at rear of house and rear of garage.
- Found various rafters separating from ridge board at roofing structure. Rafters should be secured to ridge board by scabbing from common rafters to ridge board.

Rafters not adequately secured to ridge board

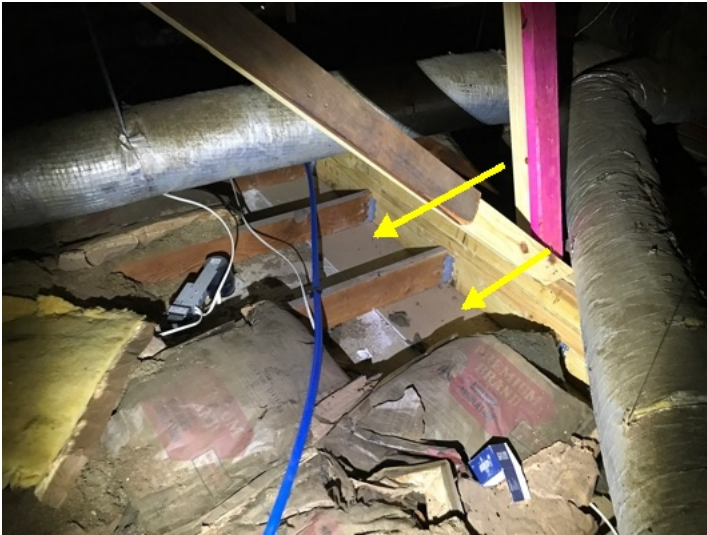
Missing insulation in attic

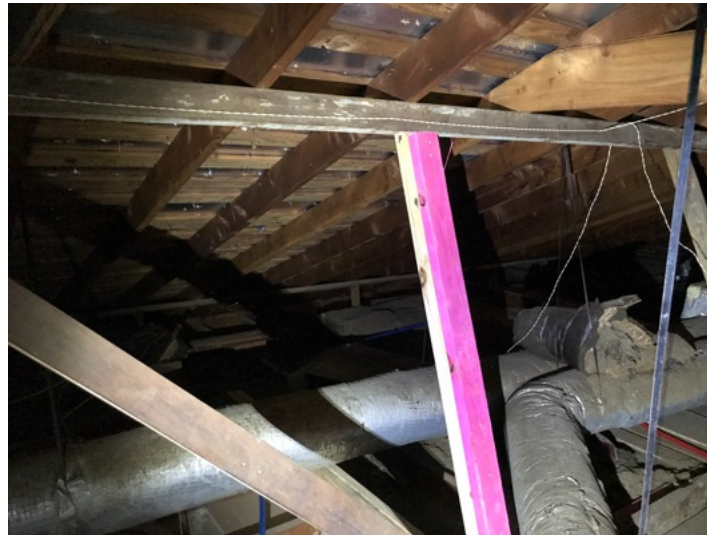
Observed previous repairs to structural members

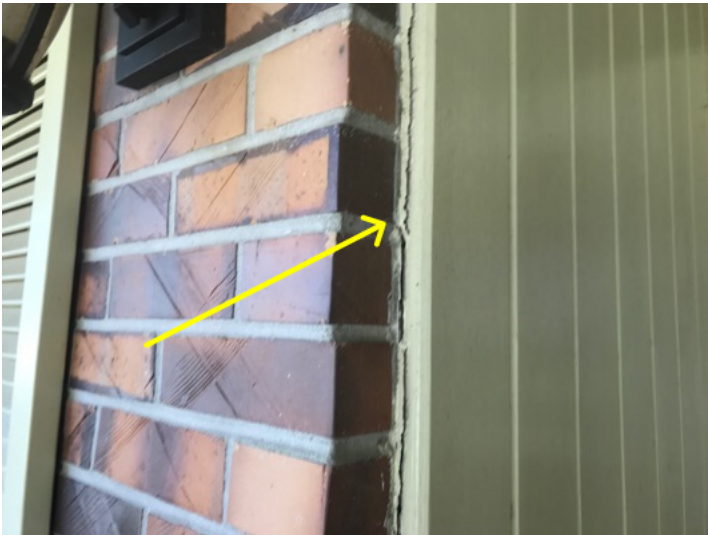
Deteriorated sealant at siding transition

- Seam cracks (cosmetic damage) observed in the following locations: living room, right front bedroom and left front bedroom.
- I recommend that you seal all transitions between differing types of exterior sheathing around the perimeter of dwelling. This will help prevent moisture penetration of the structure.

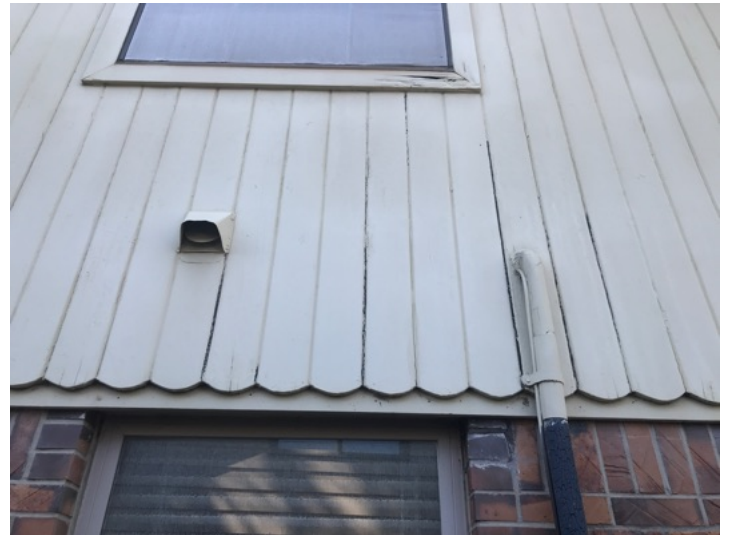
- Missing sealant at gaps (butt joints) in the wood siding at various places at sides of the house. Any void in the siding prevents the siding from performing its intended function and allows an avenue for moisture to enter.

Siding butt joints need sealant

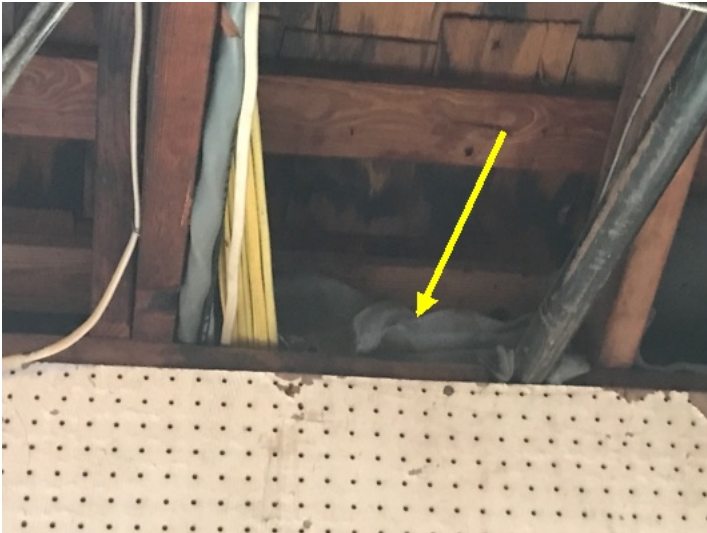
- Observed inadequate/missing firewall at entrance to breezeway from within the garage.

Inadequate firewall for conductors at the breezeway

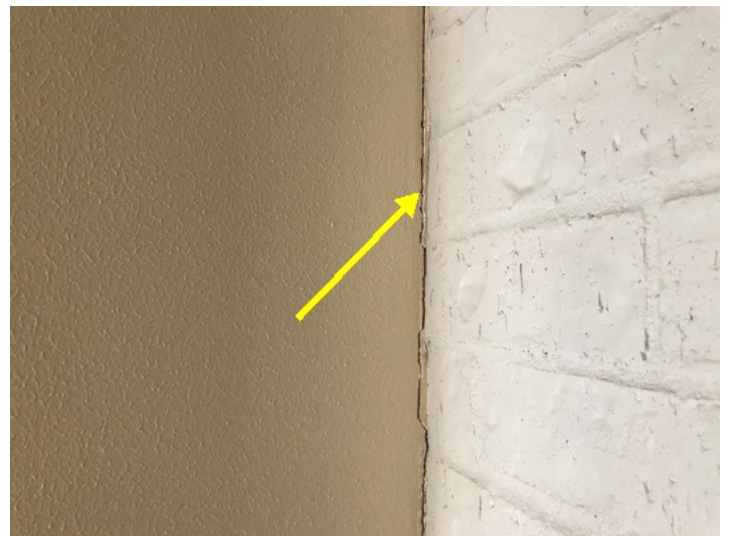
Gaps/voids at living room wall

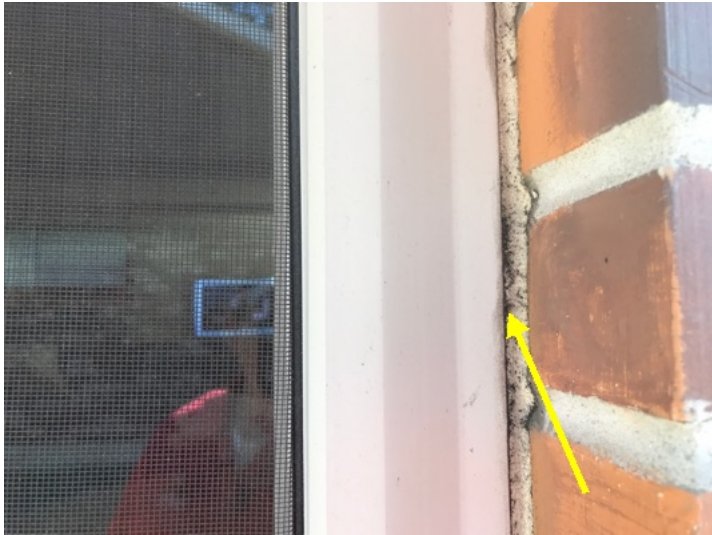
- Found various windows around the house are not adequately sealed due to failure in caulking/glazing. Any gaps between window frame and siding allow an avenue for moisture to enter.

Deteriorating window sealant

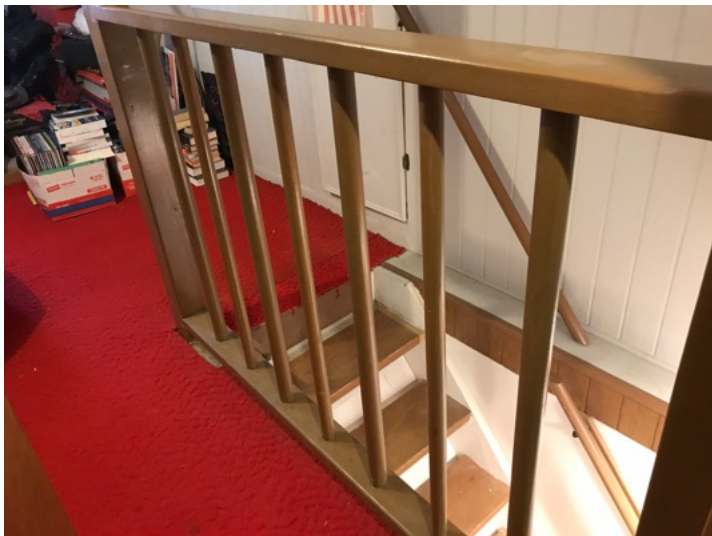
- Inadequate baluster spacing is present to the upstairs railing. (4" maximum spacing allowed.)
- Modern hand rails are supposed to have closed ends to prevent cloths snagging and tripping.

Hand railing balusters spaced too far apart

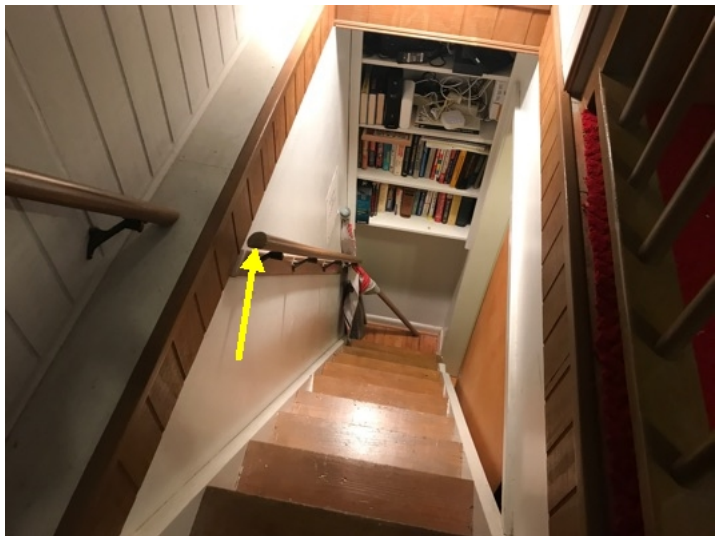
Open ended handrails

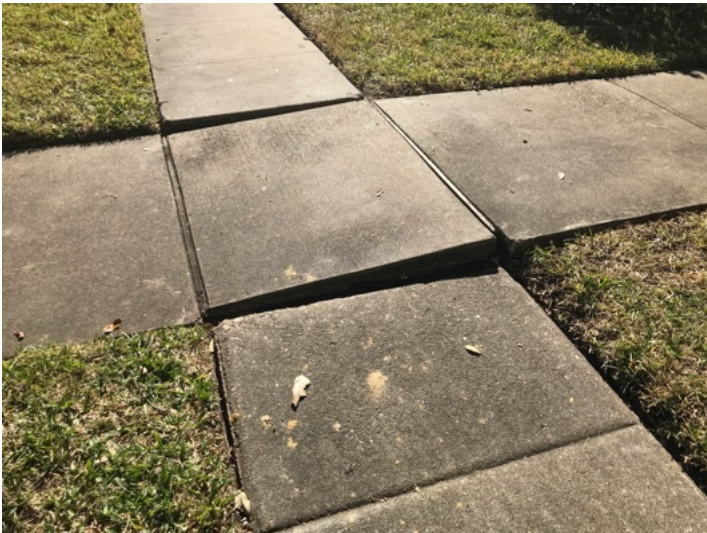
• One or more walkways have lifted/uneven sections in the following locations: . This condition can create a tripping hazard (resulting in personal injury) or may continue to separate over time.

Sidewalk heaving

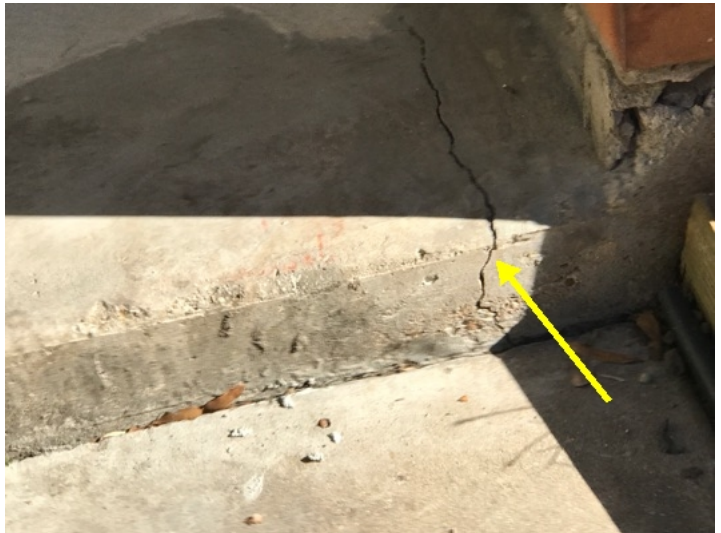
Cracks found at various places at front porch

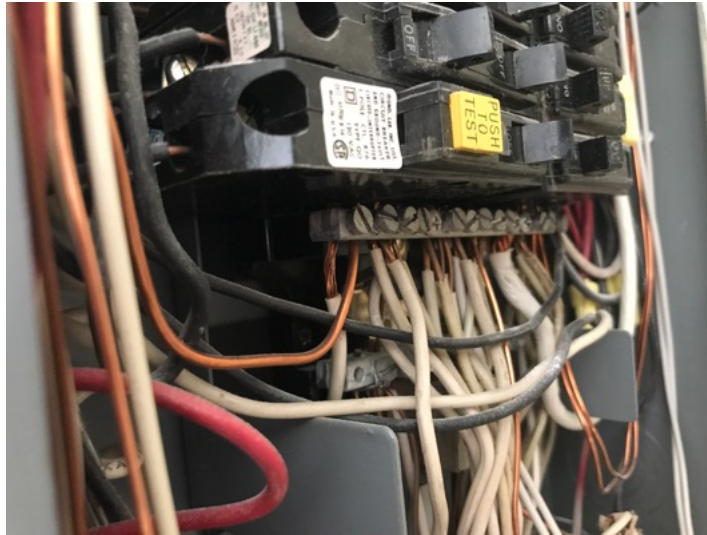
- **Double taps** observed to the neutral bus at the subpanel. This configuration is improper, as it can cause electrical arcing or overheating. Recommend further evaluation by a licensed electrician.
- The breakers at the exterior service panel are not fully/properly labeled.
- All deficiencies noted should be evaluated and repaired by a licensed electrician.

Double lugged neutral wires at sub panel

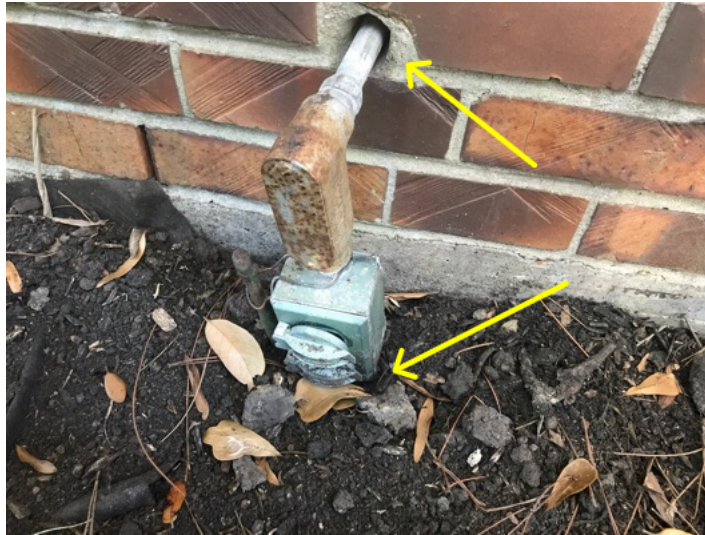
Outlet in contact with soil (front of house)

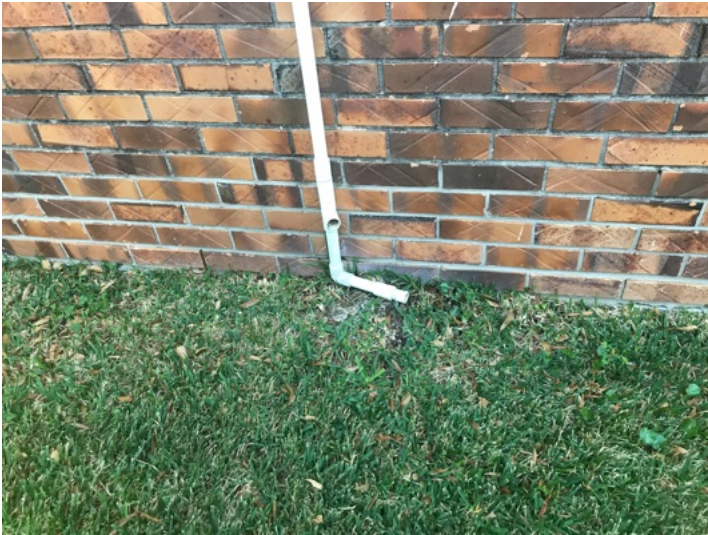
A/C discharge line terminates at slab

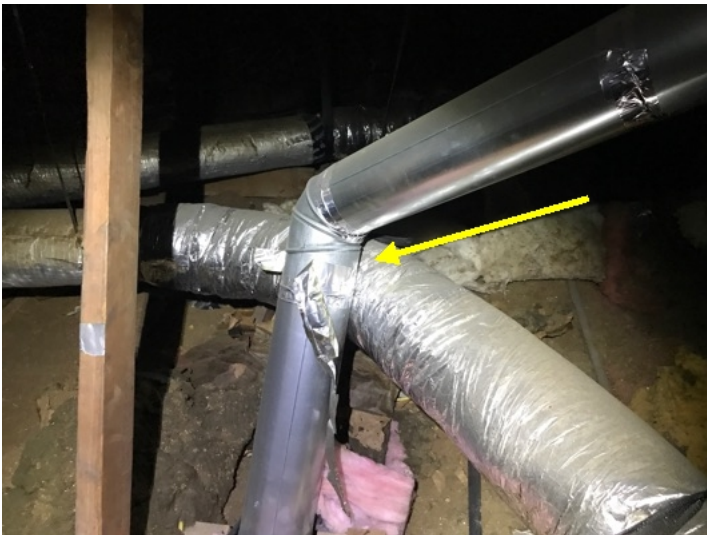
- Ductwork is torn/disconnected at the observable air handler closet or attic space in the following locations: .
- Observed duct in contact with range hood vent pipe.
- All deficiencies noted should be evaluated and repaired by a licensed HVAC professional.

Air ducts in contact with vent pipe

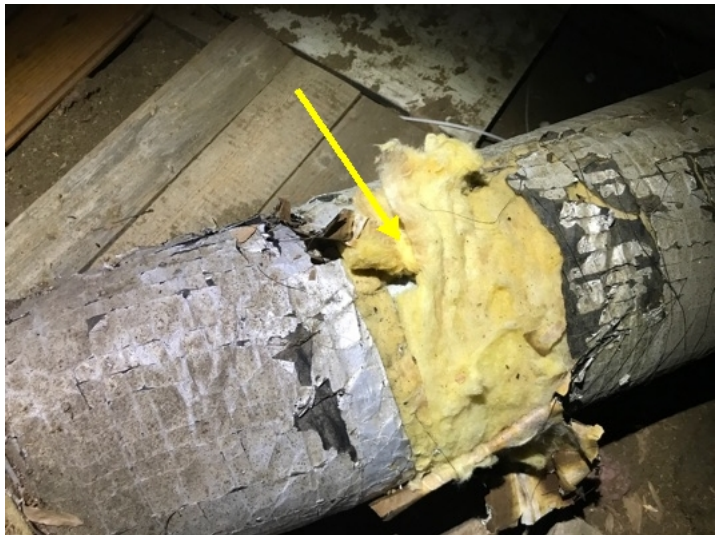
Damaged/missing insulation on air ducts

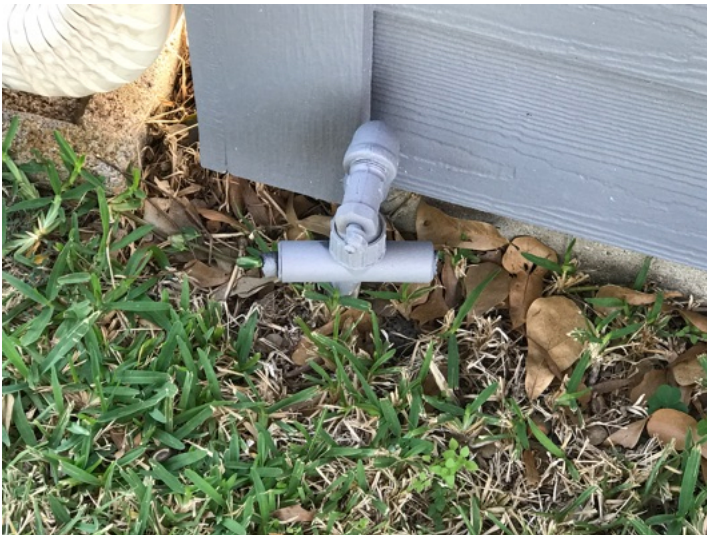
Damaged exterior faucet (left rear corner of garage)

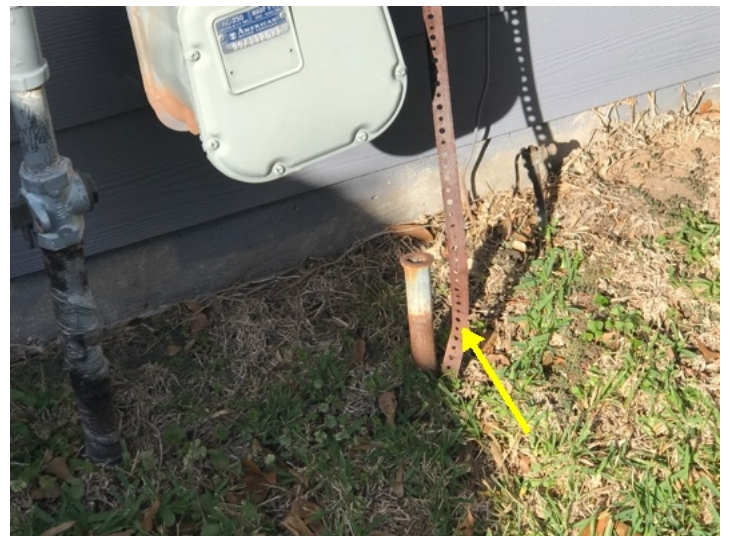
- Static Water Pressure Reading: 64 PSI
- Plumbing Supply Material(s): PEX
- The exterior gas meter does not appear to be bonded. Recommend further evaluation by a licensed electrician.
- Observed faucet at right side of house inoperative.
- Damaged faucet found at left rear corner of garage.
- Hall Bathroom - The toilet short-cycles and does not flush properly. In some cases, this requires holding down of the flush lever for a full flush cycle. Recommend properly repair toilet by a qualified tradesman.
- All deficiencies noted should be evaluated and repaired by a licensed plumber.

Gas meter not grounded

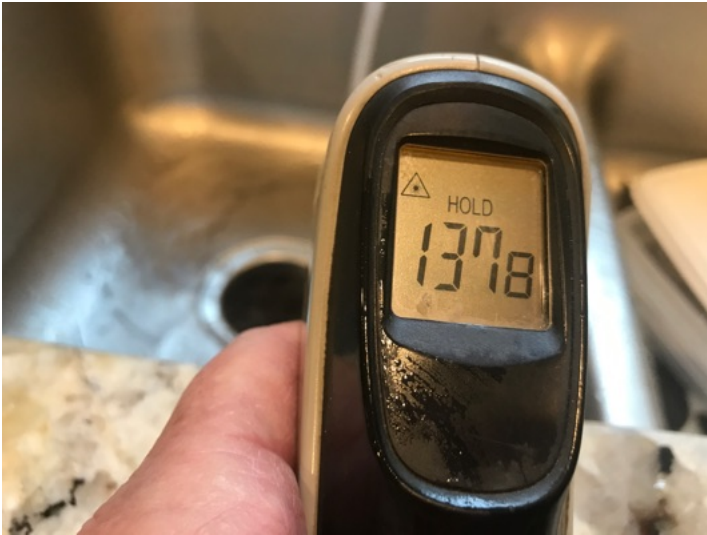
- Brand: Whirlpool // Year Manufactured: 2014
- Excessive hot water was measured at plumbing fixtures in the following bathrooms/locations: kitchen. Standard hot water temperature should be measured between 90-120 degrees throughout the residence.
- The water heater is missing an emergency drain pan as required.
- All deficiencies noted should be evaluated and repaired by a licensed plumber.

Water temperature at sink

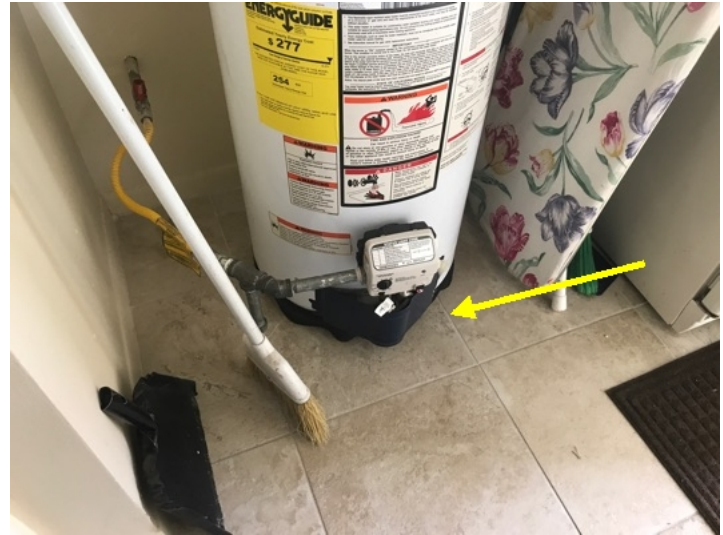
Missing Emergency drain pan

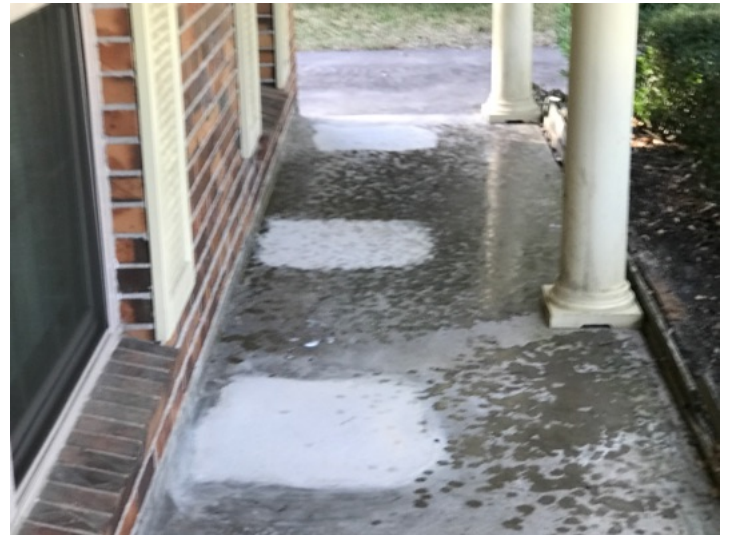
- Excessive over-spray present to the following Zones: 2, 4, 5
- Observed sprinkler head on zone #2 would not oscillate.
- All deficiencies noted should be evaluated and repaired by a licensed irrigation professional.

Overspray zone two

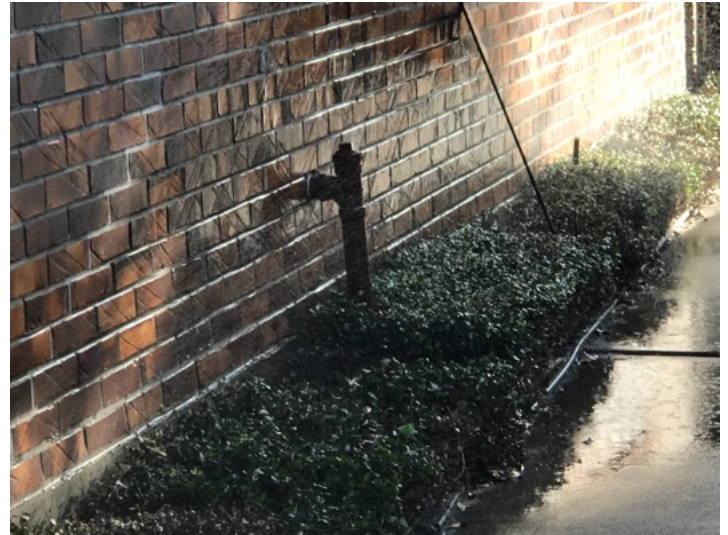
Overspray zone three
